**North Carolina Department of Transportation  
Phase II Investigation  
State Project: R-5709  
WBS Element: 50205.1.1  
Moore County**

**Parcel 79  
Robert L. Schloegl Property  
9820 NC 211 Hwy  
Aberdeen, North Carolina  
October 21, 2021**

**Wood Environment & Infrastructure Solutions, Inc.  
Project: 20478R5709**

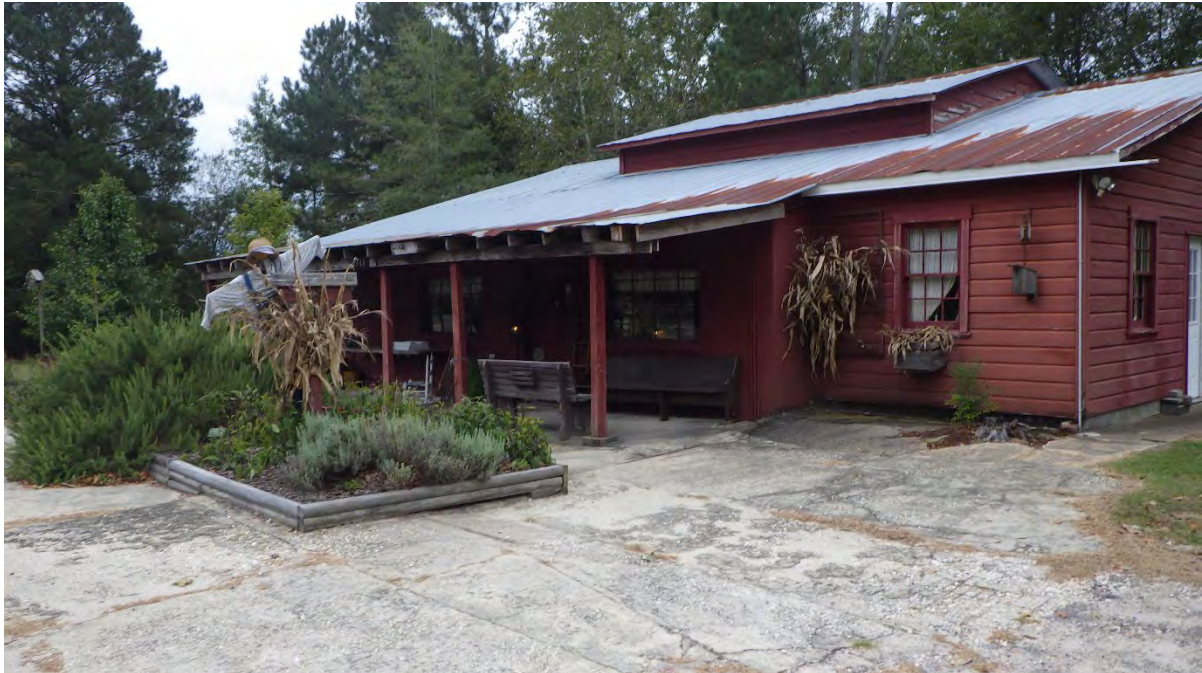
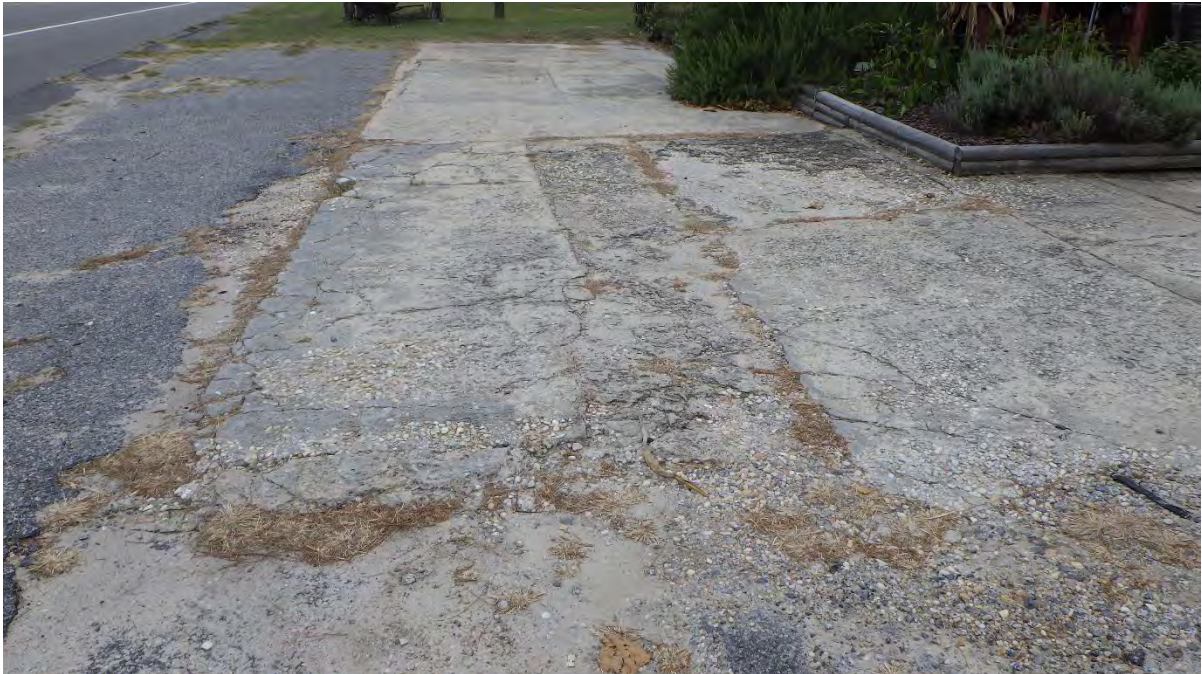
This is a vacant Bed and Breakfast and possible former gas station with UST features remaining on site. No monitoring wells or USTs were observed on site. No incident record can be located in NCDEQ's database.

*Possible former disperser island location*
