STRUCTURE
SUBSURFACE INVESTIGATION

COUNTY ALAMANCEPROJECT DESCRIPTION REPLACE BRIDGE NO. 14
ON NC 87 OVER CANE CREEK

STATE	STATE PROJECT REFERENCE NO.	sheet no.	total sheets
N.C.	BR-0060	1

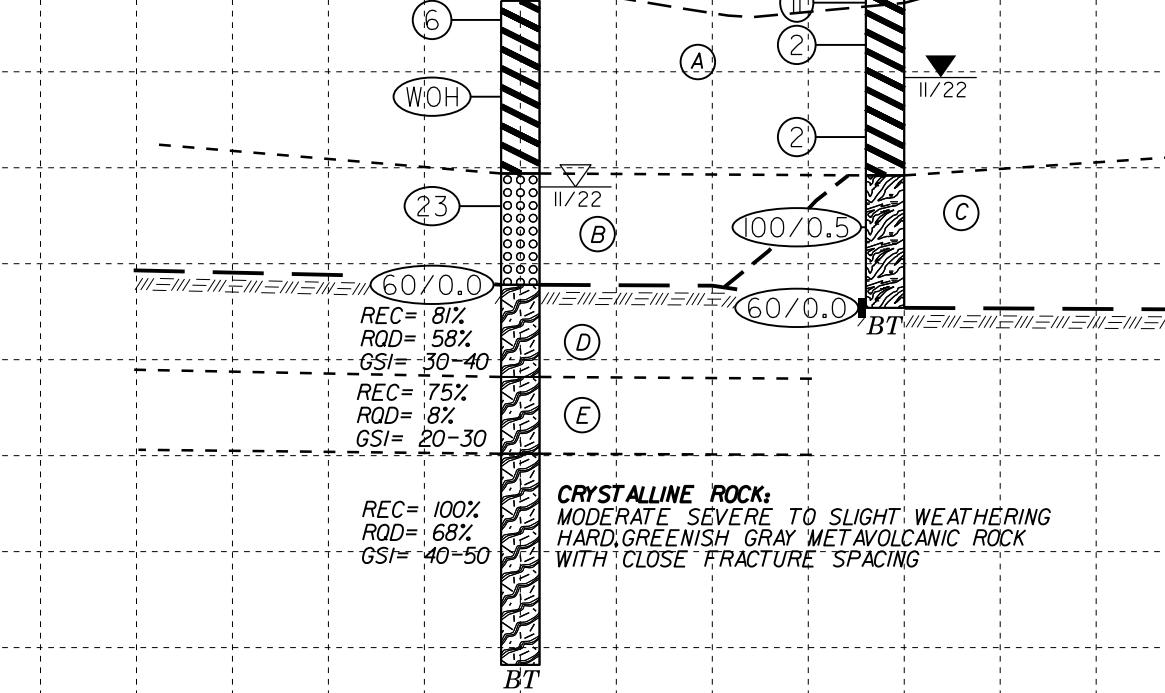
CROSS SECTION ALONG BENT
NO. 2 AT -L- STA. 21+49

445 (A) **ALLUVIAL:**
446 MOIST, VERY SOFT TO
447 STIFF, BROWN TO GRAY,
448 SILTY CLAY (A-7) WITH
449 TRACE GRAVEL

435 (B) **ALLUVIAL:**
436 WET, MEDIUM DENSE,
437 BROWN AND GRAY,
438 COARSE SAND (A-1)
439 WITH TRACE GRAVEL

445 (C) **WEATHERED ROCK:**
446 GRAY METAVOLCANIC ROCK

435 (D) **CRYSTALLINE ROCK**
436 MODERATE WEATHERING, HARD,
437 GREENISH GRAY, METAVOLCANIC ROCK
438 WITH CLOSE FRACTURE SPACING

445 (E) **CRYSTALLINE ROCK**
446 MODERATE TO MODERATE SEVERE
447 WEATHERING, HARD, GREENISH GRAY,
448 METAVOLCANIC ROCK, WITH CLOSE
449 FRACTURE SPACING

425 B2-A
426 21+45
427 10' LT

425 B2-B
426 21+47
427 9' RT

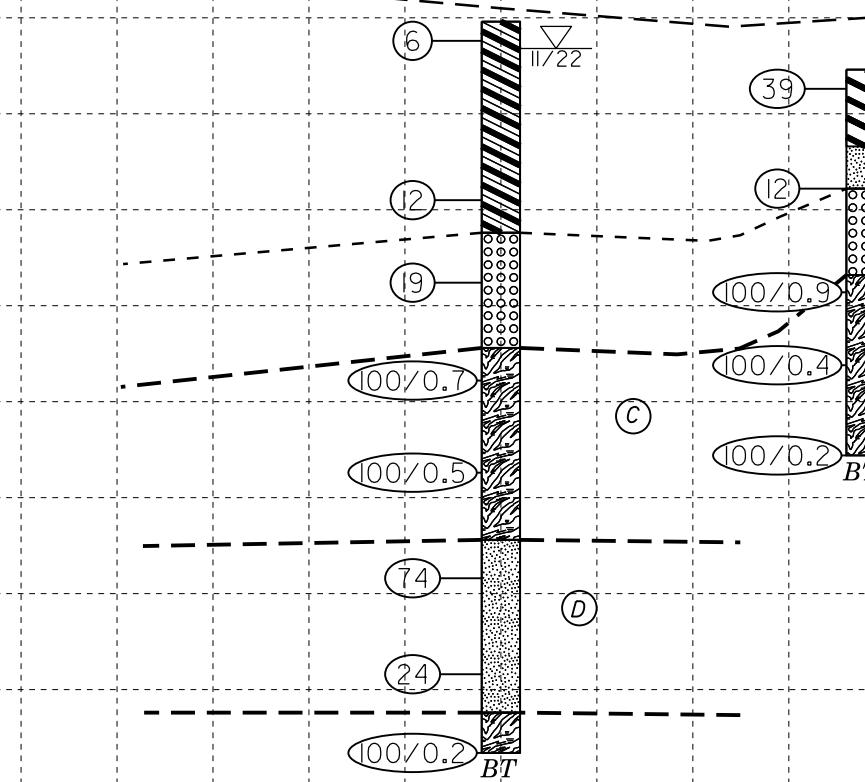
CROSS SECTION ALONG END
BENT NO. 2 AT -L- STA. 22+34

440 (A) **ALLUVIAL:**
441 MOIST, MEDIUM STIFF TO
442 HARD, YELLOWISH BROWN
443 TO GRAY, SILTY CLAY (A-7-6)
444 TO COARSE TO FINE SAND SILT
445 (A-4) WITH TRACE GRAVEL

440 (B) **ALLUVIAL:**
441 MOIST, MEDIUM DENSE,
442 GRAY, COARSE SAND (A-1)
443 WITH TRACE GRAVEL

440 (C) **WEATHERED ROCK:**
441 BROWN TO GRAY
442 METAVOLCANIC ROCK

440 (D) **RESIDUAL:**
441 MOIST, VERY STIFF TO
442 HARD, BROWN, FINE TO
443 COARSE SANDY SILT (A-4)

430 SS-2
431 EB2-A
432 22+36
433 10' LT

430 SS-3
431 EB2-B
432 22+36
433 9' RT

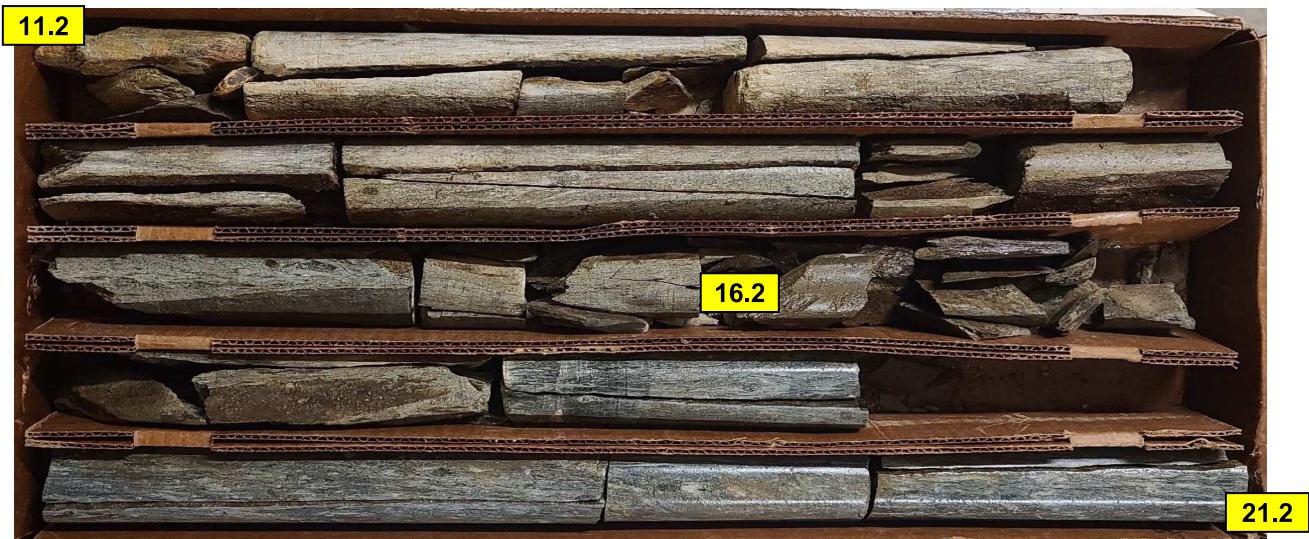
BOX 1: 11.2 - 21.2 FEET

WBS 67060.1.1		TIP BR-0060		COUNTY ALAMANCE			GEOLOGIST J. Kardon			
SITE DESCRIPTION Replace Bridge No. 14 on NC 87 over Cane Creek					GROUND WTR (ft)					
BORING NO. EB1-A		STATION 20+04		OFFSET 9 ft LT		ALIGNMENT -L-		0 HR.	19.2	
COLLAR ELEV. 435.7 ft		TOTAL DEPTH 21.2 ft		NORTHING 777,141		EASTING 1,912,285		24 HR.	FIAD	
DRILL RIG/HAMMER EFF./DATE TRI9435 CME-55 87% 05/09/2022					DRILL METHOD Mud Rotary/ NQ Core		HAMMER TYPE Automatic			
DRILLER R. Toothman		START DATE 11/22/22		COMP. DATE 11/23/22		SURFACE WATER DEPTH N/A				
ELEV (ft)	DRIVE ELEV (ft)	DEPTH (ft)	BLOWS PER FOOT			SAMP. NO.	▼ MOI	L O G	SOIL AND ROCK DESCRIPTION	
			0.5ft	0.5ft	0.5ft				ELEV. (ft)	DEPTH (ft)
440										
435	434.7	1.0	4	2	2				435.7	0.0
430	432.3	3.4	1	1	0				434.7	1.0
425	427.2	8.5	1	3	1				428.2	7.5
420	424.5	11.2	60/0.0						424.5	11.2
415									414.5	21.2

424.5	424.5	11.2	5.0	N=60/0.0 13:45/1.0 10:25/1.0 4:07/1.0 3:45/1.0 6:30/1.0	(5.0) 100%	(4.5) 90%		(9.5) 95%	(9.0) 90%		424.5	11.2
420	419.5	16.2	5.0	6:00/1.0 4:30/1.0 5:52/1.0 5:00/1.0 5:30/1.0	(4.5) 90%	(4.5) 90%					414.5	21.2
415	414.5	21.2

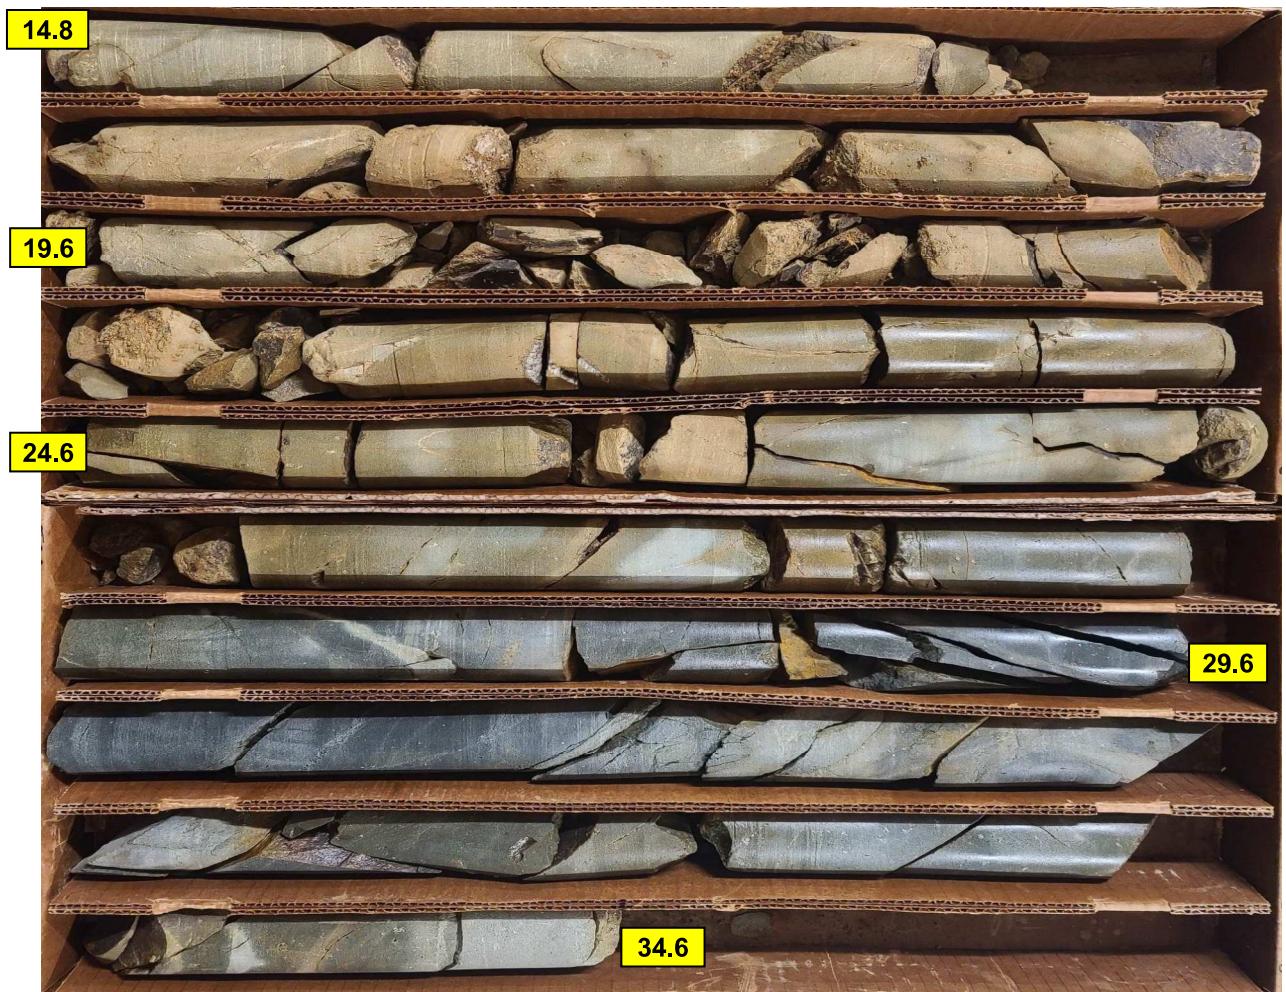
B2-A

BOXES 1 & 2: 14.8 - 34.6 FEET

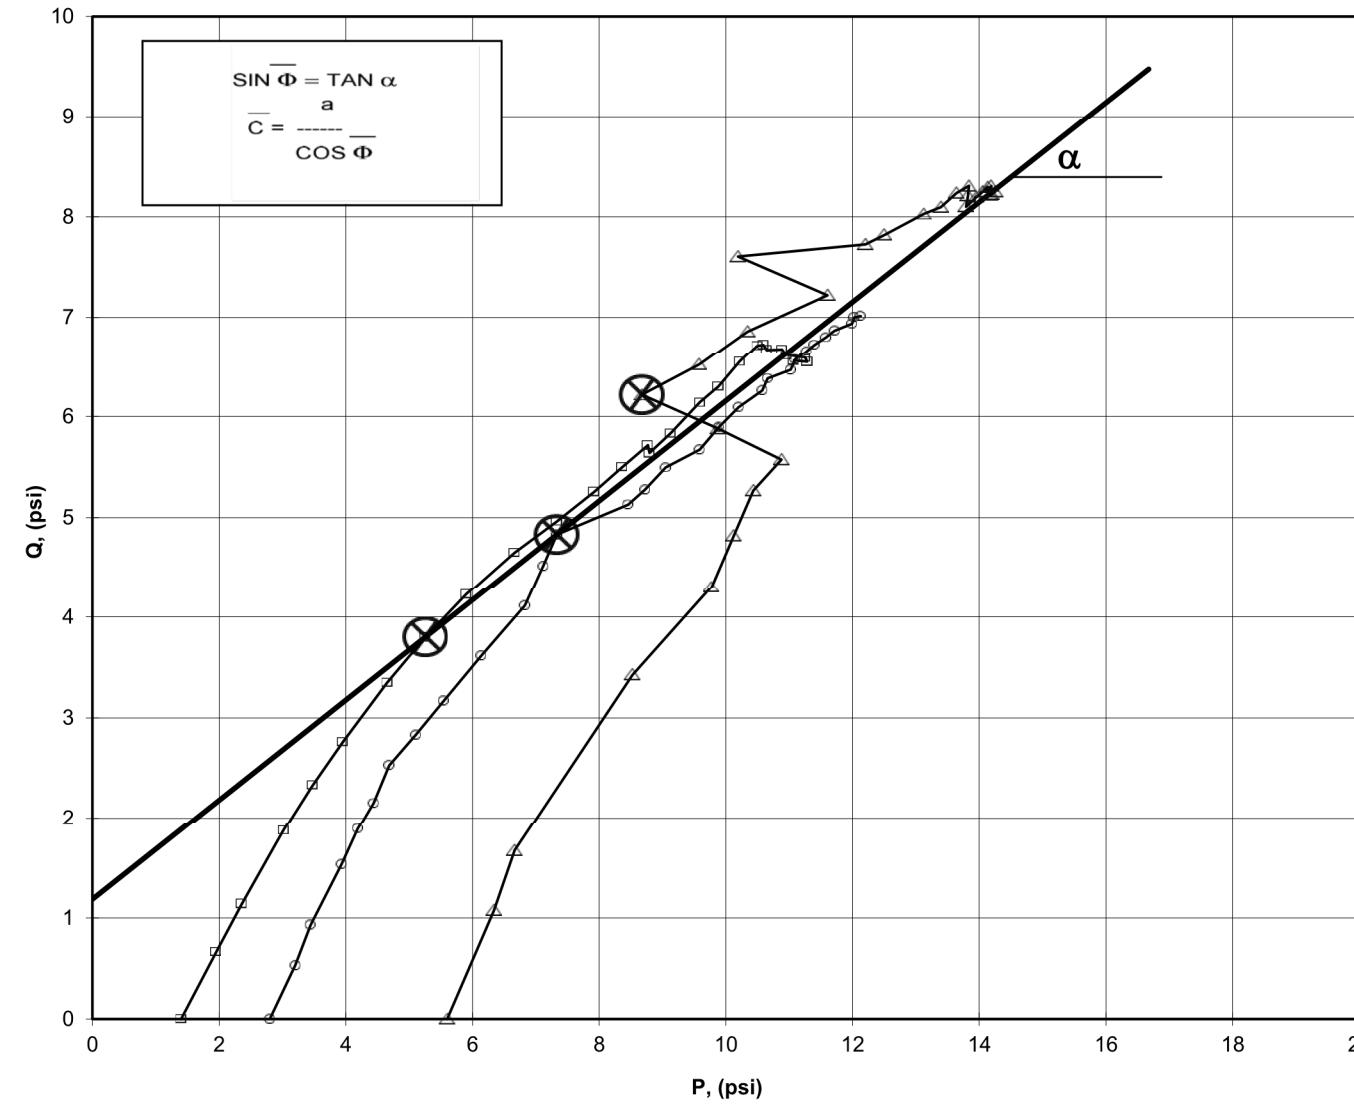
Consolidated Undrained Triaxial Test with Pore Pressure

Boring No.: EB1-A
Depth (ft): 2.9-4.9
Sample No.: ST-1

$a = 1.19$	$C = 1.37$
$\alpha = 26.4$	$\Phi = 29.81$

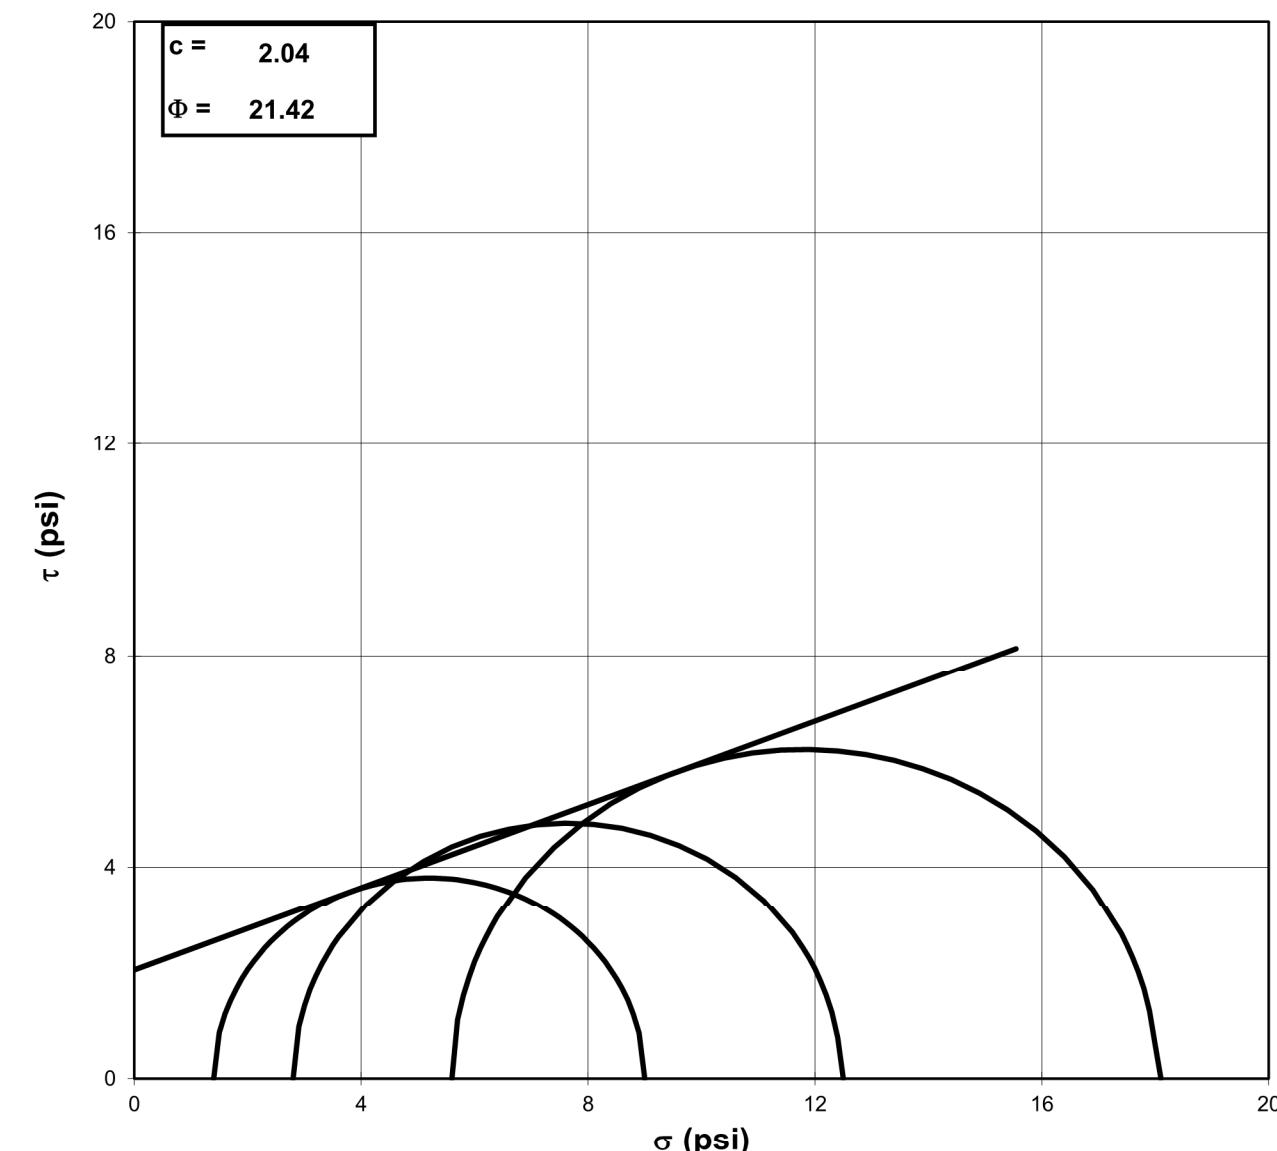
MOHR TOTAL STRENGTH ENVELOPE
AASHTO T-297

Boring No.: EB1-A
Depth (ft): 2.9-4.9
Sample No.: ST-1

Failure Based on Maximum Effective Principal Stress Ratio

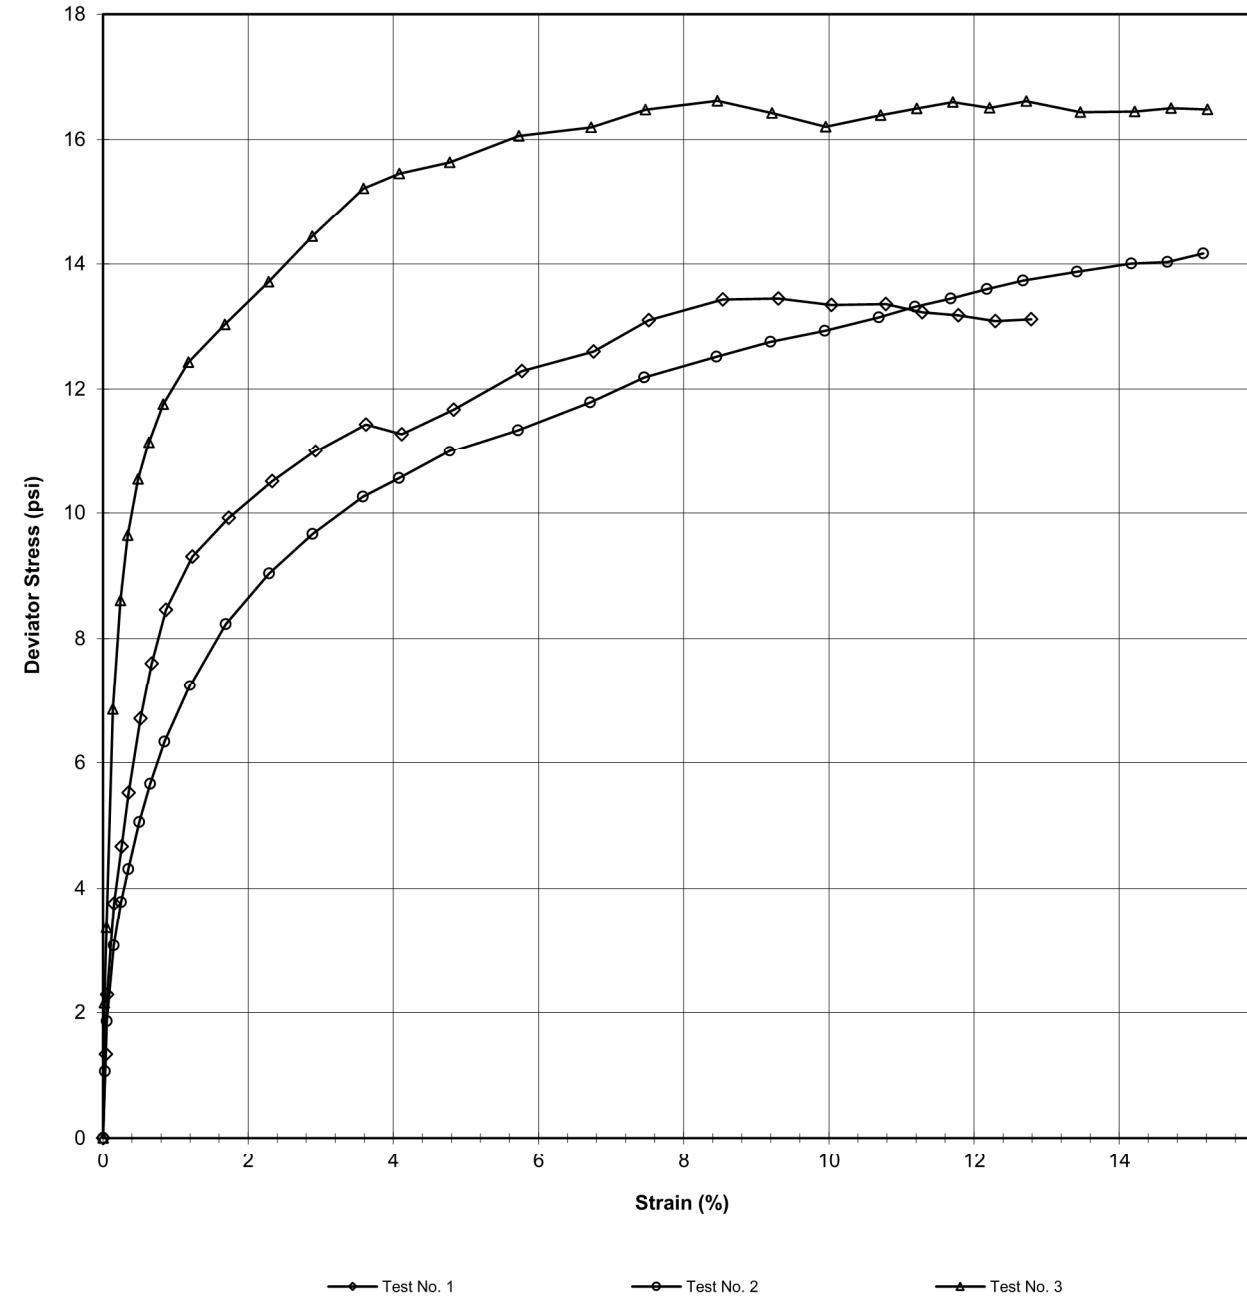
**CONSOLIDATED UNDRAINED TRIAXIAL TEST
WITH PORE PRESSURE READINGS**
 AASHTO T-297

Boring No.: EB1-A
 Depth (ft): 2.9-4.9
 Sample No.: ST-1

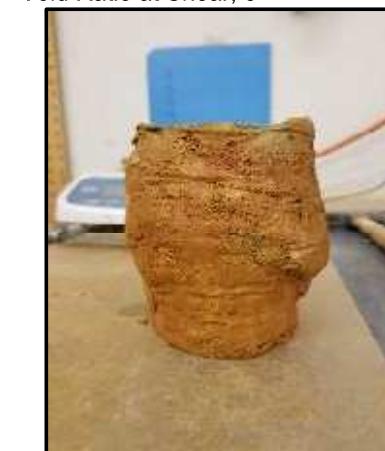
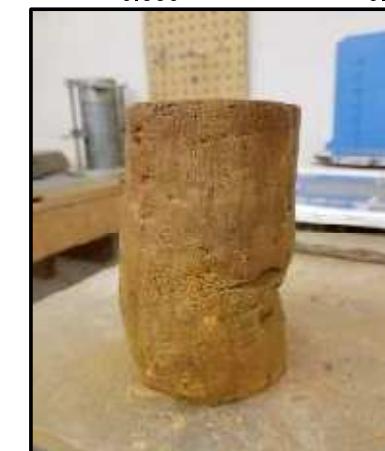
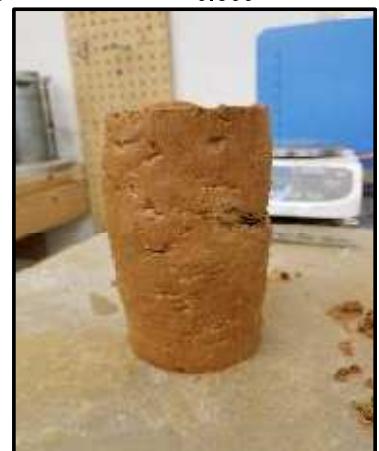
Boring No.:	EB1-A	EB1-A	EB1-A
Depth (ft):	2.9-4.9	2.9-4.9	2.9-4.9
Sample No.:	ST-1	ST-1	ST-1
Test No.	T1	T2	T3
Deformation Rate (in/min)	0.002	0.002	0.002
Back Pressure (psi)	60.0	60.0	60.0
Consolidation Time (days)	1	1	1
Moisture Content (%) (INITIAL)	25.7	25.7	25.7
Total Unit Weight (pcf)	111.4	112.2	112.5
Dry Unit Weight (pcf)	88.6	89.3	89.5
Moisture Content (%) (FINAL)	46.7	36.7	35.3
Initial State Void Ratio, e	0.888	0.874	0.870
Void Ratio at Shear, e	0.885	0.887	0.869

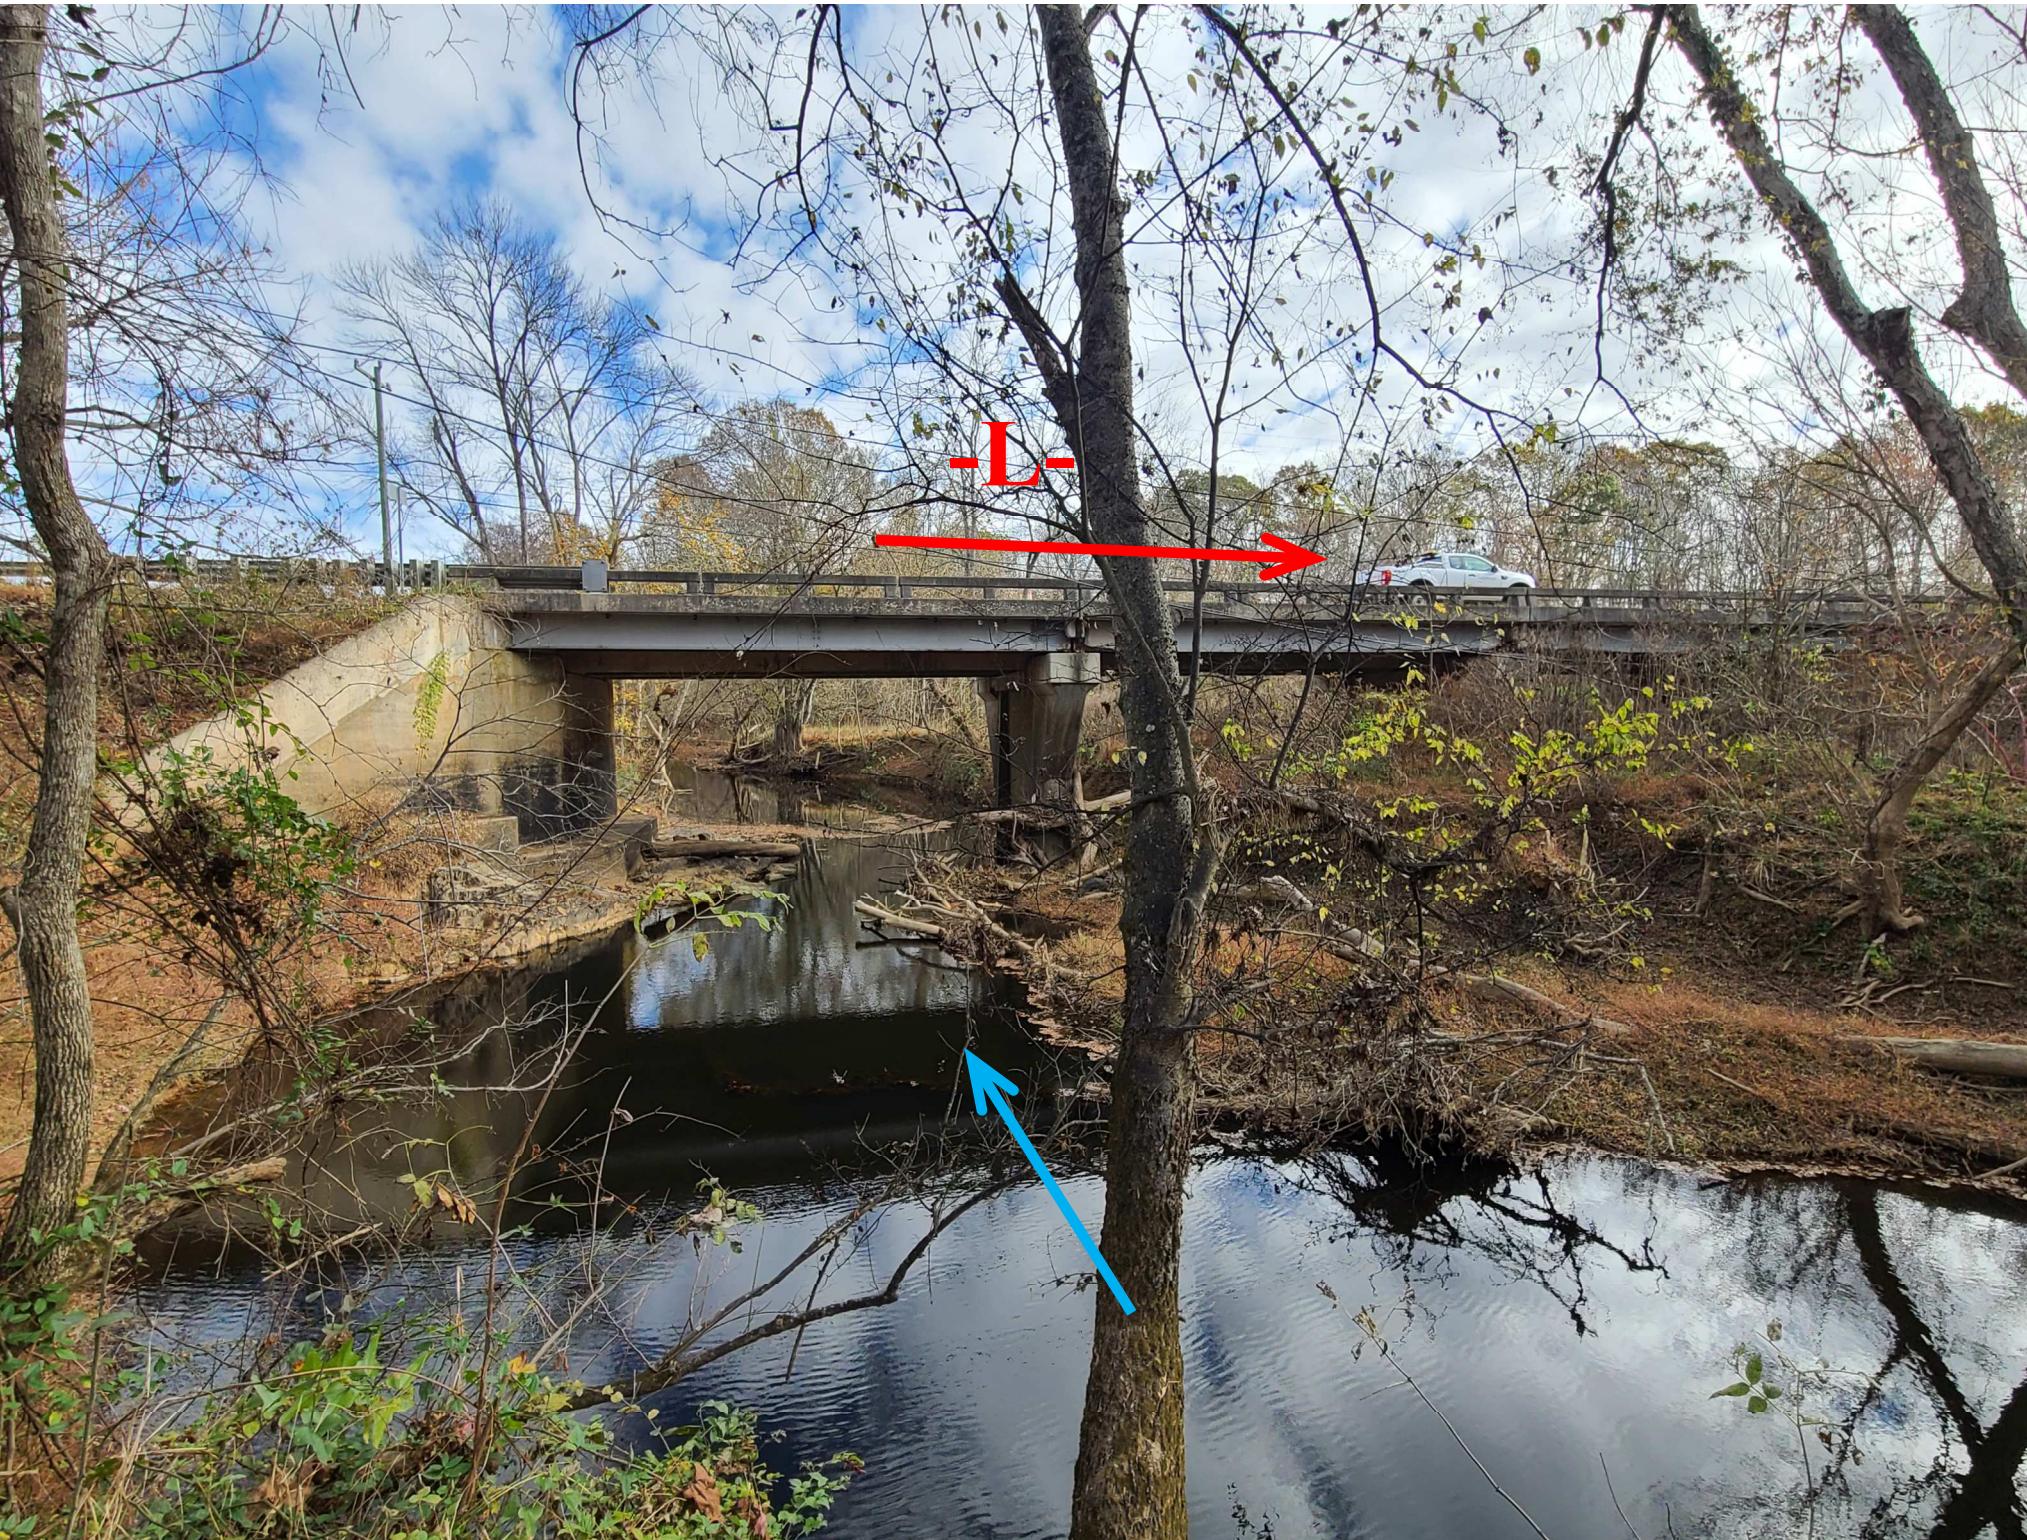
SITE PHOTOGRAPH

View of Existing Bridge No. 14 from West of Bridge Looking East
