STATE OF NORTH CAROLINA DEPARTMENT OF TRANSPORTATION DIVISION OF HIGHWAYS GEOTECHNICAL ENGINEERING UNIT

ROADWAY SUBSURFACE INVESTIGATION

COUNTY BEAUFORT & HYDE PROJECT DESCRIPTION BRIDGE NO. 66 ON US 264 OVER PUNGO RIVER

WBS Number: 67004.1.1  
 TIP Number: BR-0004  
 PROJECT ID: 44305  
 COUNTIES: Beaufort and Hyde  
 DESCRIPTION: Bridge No. 66 on US 264 over Pungo River  
 SUBJECT: Geotechnical Inventory Report

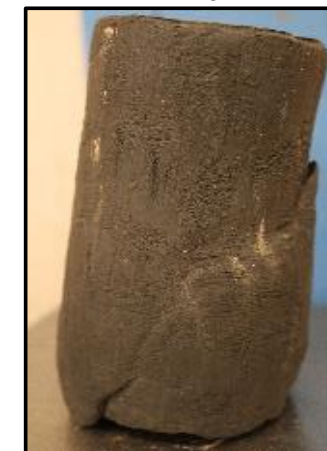
**SAMPLE CONDITION SUMMARY**

Boring No.:	EB1-B
Depth (ft):	33-35
Sample No.:	ST-3
Test No.:	T1
Deformation Rate (in/min)	0.001
Back Pressure (psi)	60.0
Consolidation Time (days)	2
Moisture Content (%) (INITIAL)	47.7
Total Unit Weight (pcf)	106.6
Dry Unit Weight (pcf)	72.2
Moisture Content (%) (FINAL)	45.0
Initial State Void Ratio, e	1.318
Void Ratio at Shear, e	1.225
