**Phase II Site Assessment Report  
December 1, 2021  
WBS Element: 45786.1.1  
State Project: B-5833  
Yadkin County**

**Parcel #: 011  
Add-On Venture Properties, LLC Property  
5652 and 5704 US Hwy 21; Jonesville, NC, 28642  
PIN #: 4869563147, 4869562417, 4869563091  
Facility ID No.: 00-0-0000023364  
Groundwater Incident #: 37795**

Seramur & Associates, PC was contracted to complete a Phase II Environmental Site Assessment at:

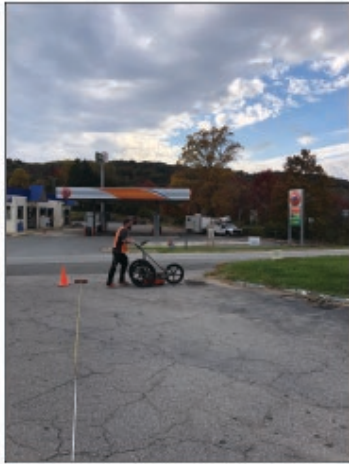
Photo 1. Collecting GPR grid data at Parcel #015.

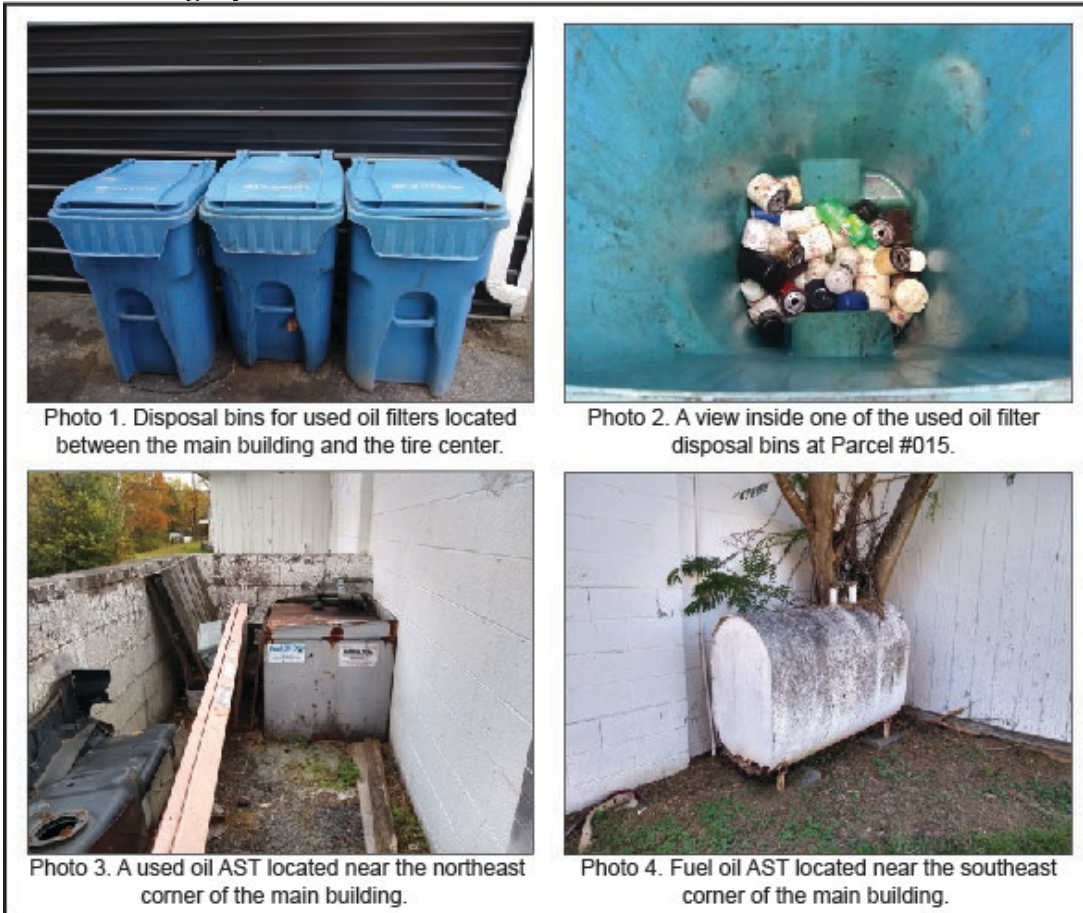
### 3.1 Plate 2 – Photographs of Parcel #015

The magnetometer hillshade map shows numerous magnetic anomalies in the eastern portion of the grid. These anomalies were produced by the metal canopy above the dispenser island and the western edge of the active UST system (Figure 5). The western portion of the grid shows a few isolated anomalies produced by metal traffic control poles and signs. Larger magnetic anomalies that could represent abandoned USTs were not recorded in Grid 1.
