**Revised Mid-Currituck Bridge  
Submerged Aquatic  
Vegetation Mitigation Plan,  
December 1, 2023 (Final)**

# Revised Mid-Currituck Bridge Submerged Aquatic Vegetation Monitoring and Mitigation Plan

December 1, 2023

DOCUMENT NO. CSA-RKANDK-FL-20-81045-3418-05-REP-01-FIN

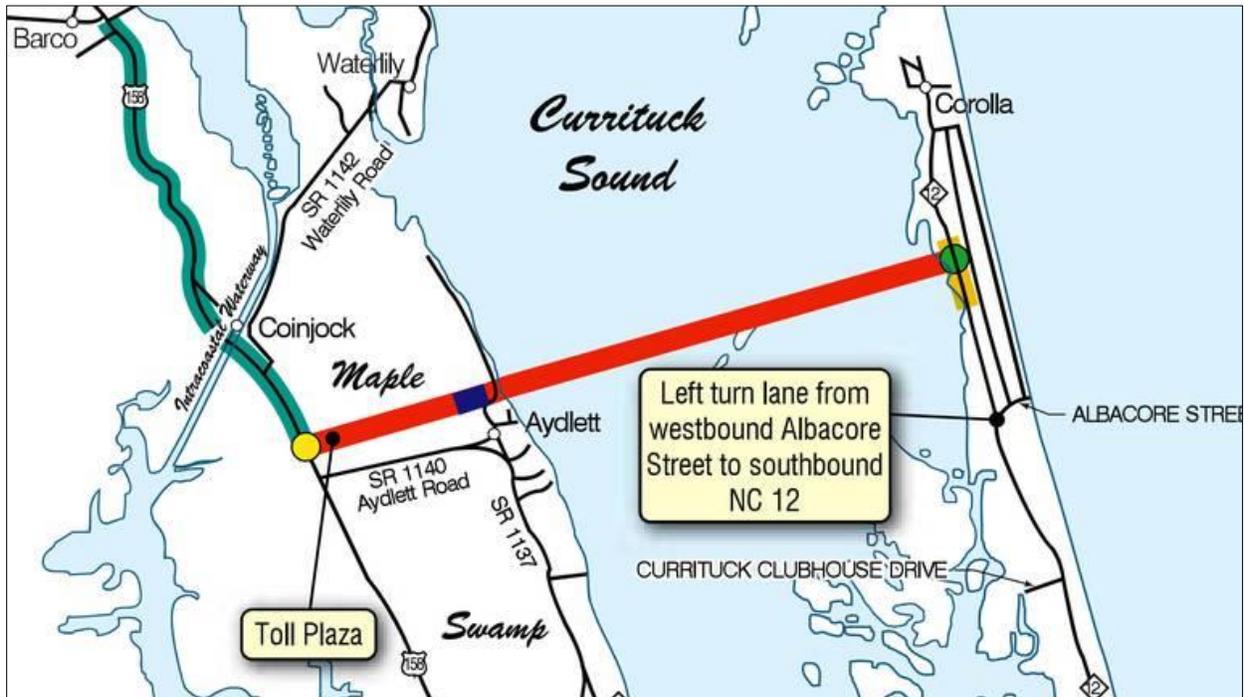
Figure 1. NCDOT Selected Alternative; alignment for the Mid-Currituck Bridge.

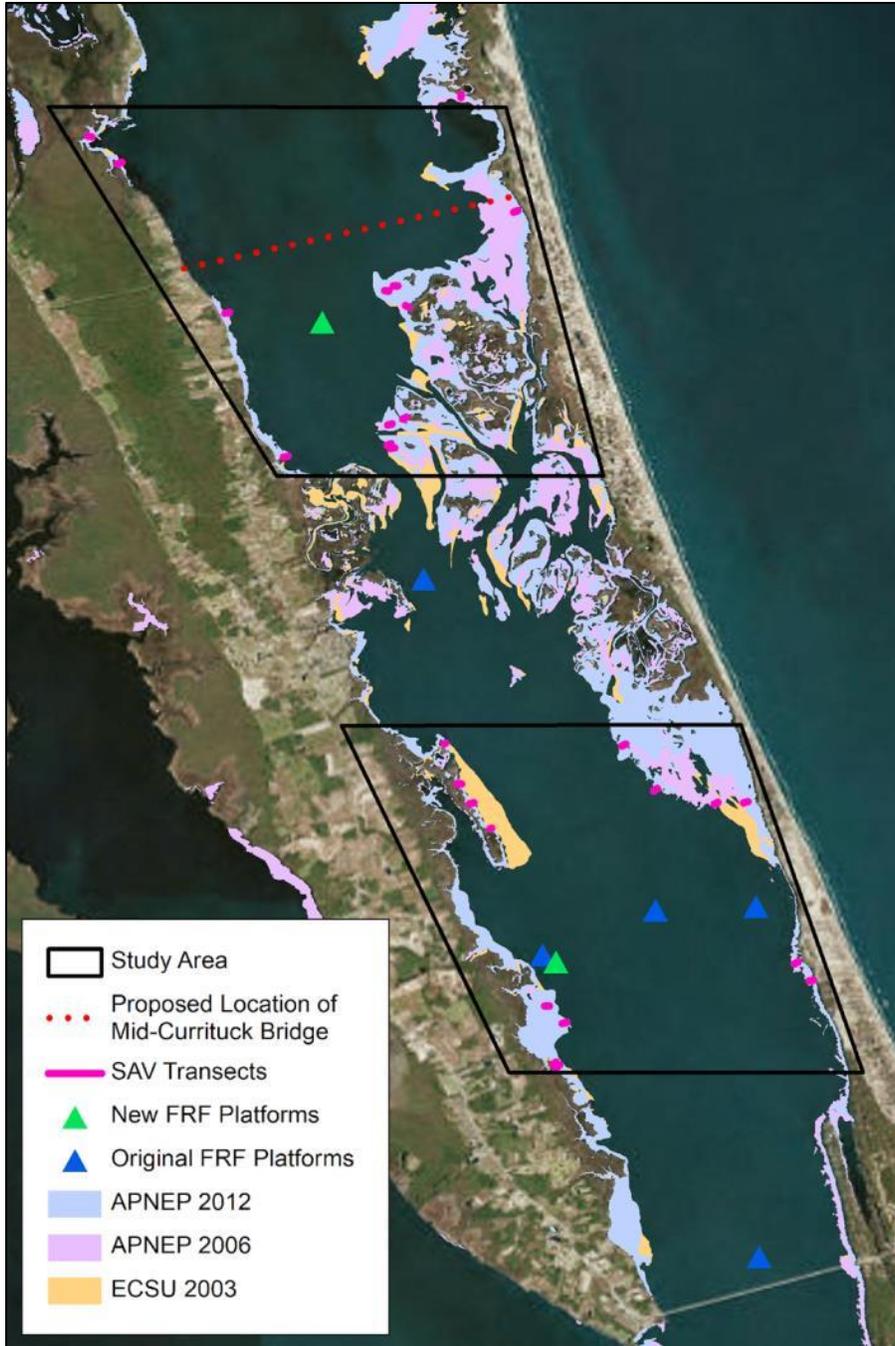
Figure 2. Previous SAV distribution data in Currituck Sound in 2003 from Elizabeth City State University (ECSU) and in 2006 and 2012 from the Albemarle-Pamlico National Estuary Program (APNEP) for the NCDOT-funded SAVE Currituck Study. Water quality data is also being collected for the SAVE Currituck Study by the USACE Field Research Facility (FRF). Map provided by D.R. Corbett, ECU.

**Description:** The eastern side of Currituck Sound supports extensive SAV beds (**Figure 2**). However, the distribution and density of SAV has been spatially and temporally dynamic, likely due to the life history

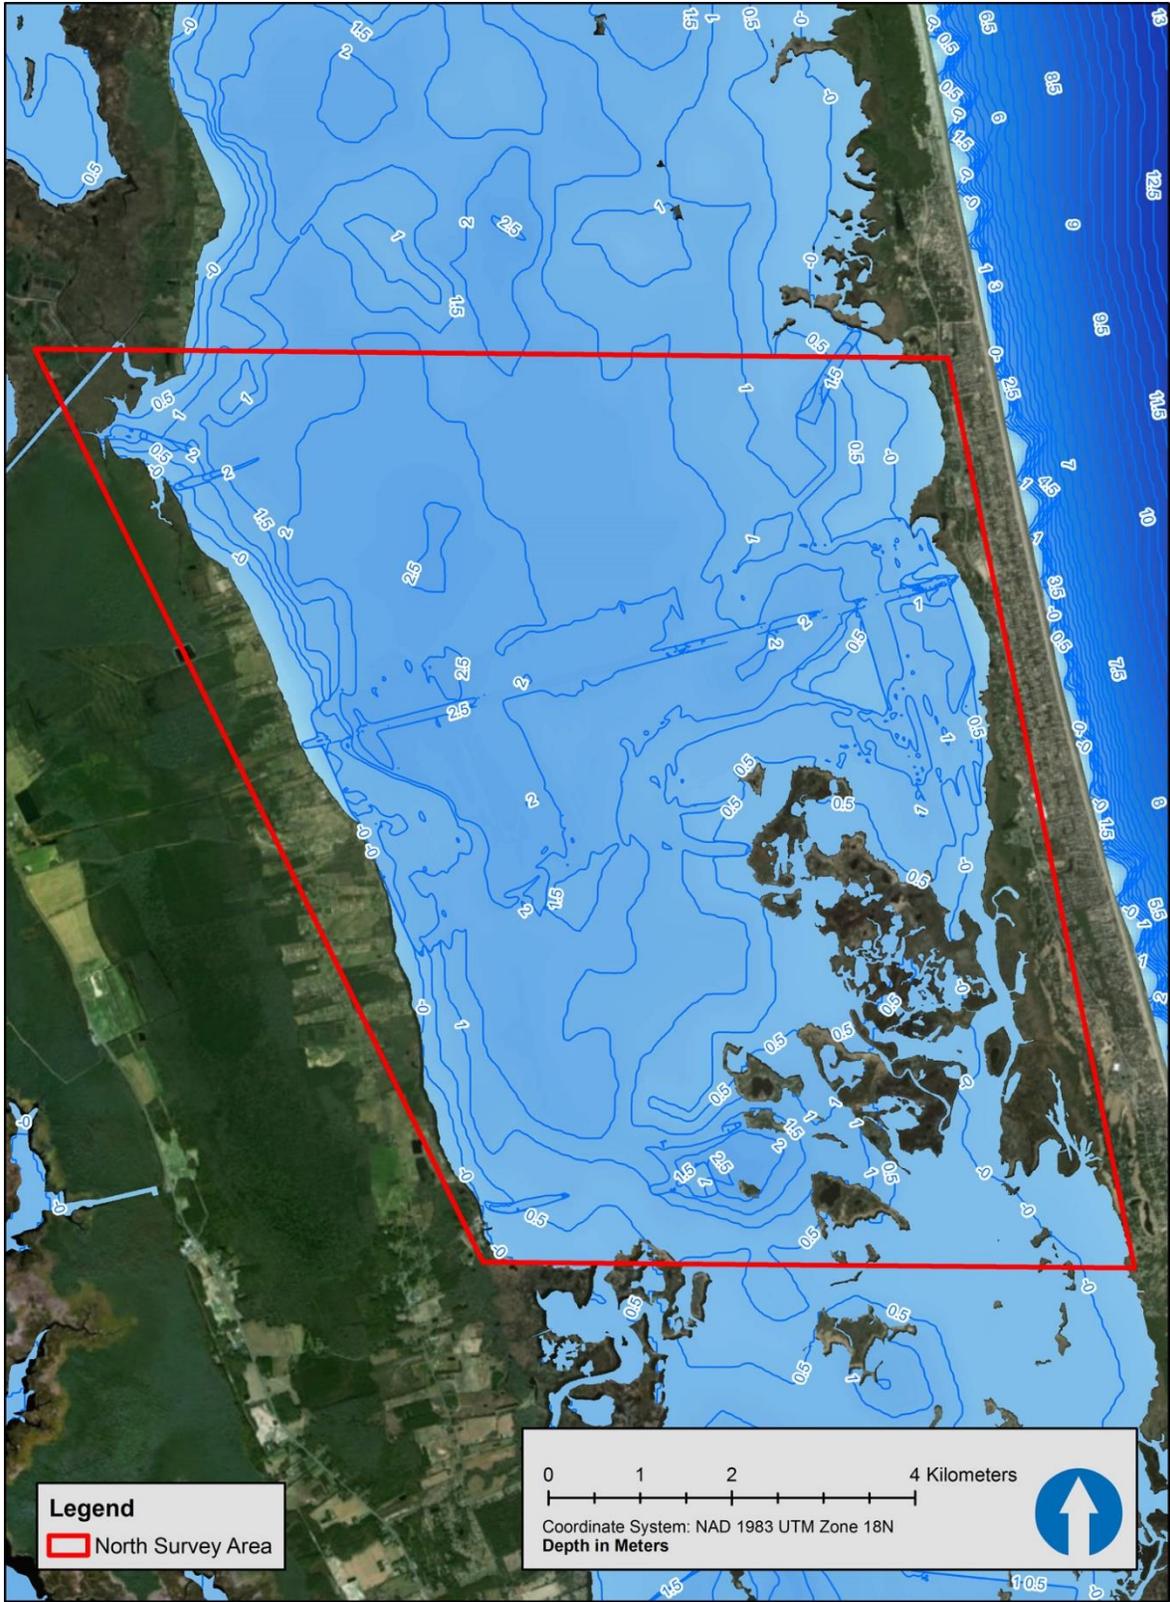
Figure 3. Comprehensive bathymetry data for Currituck Sound compiled for the NCDOT-funded SAVE Currituck Study. Map provided by CSA Ocean Sciences Inc., 2018.

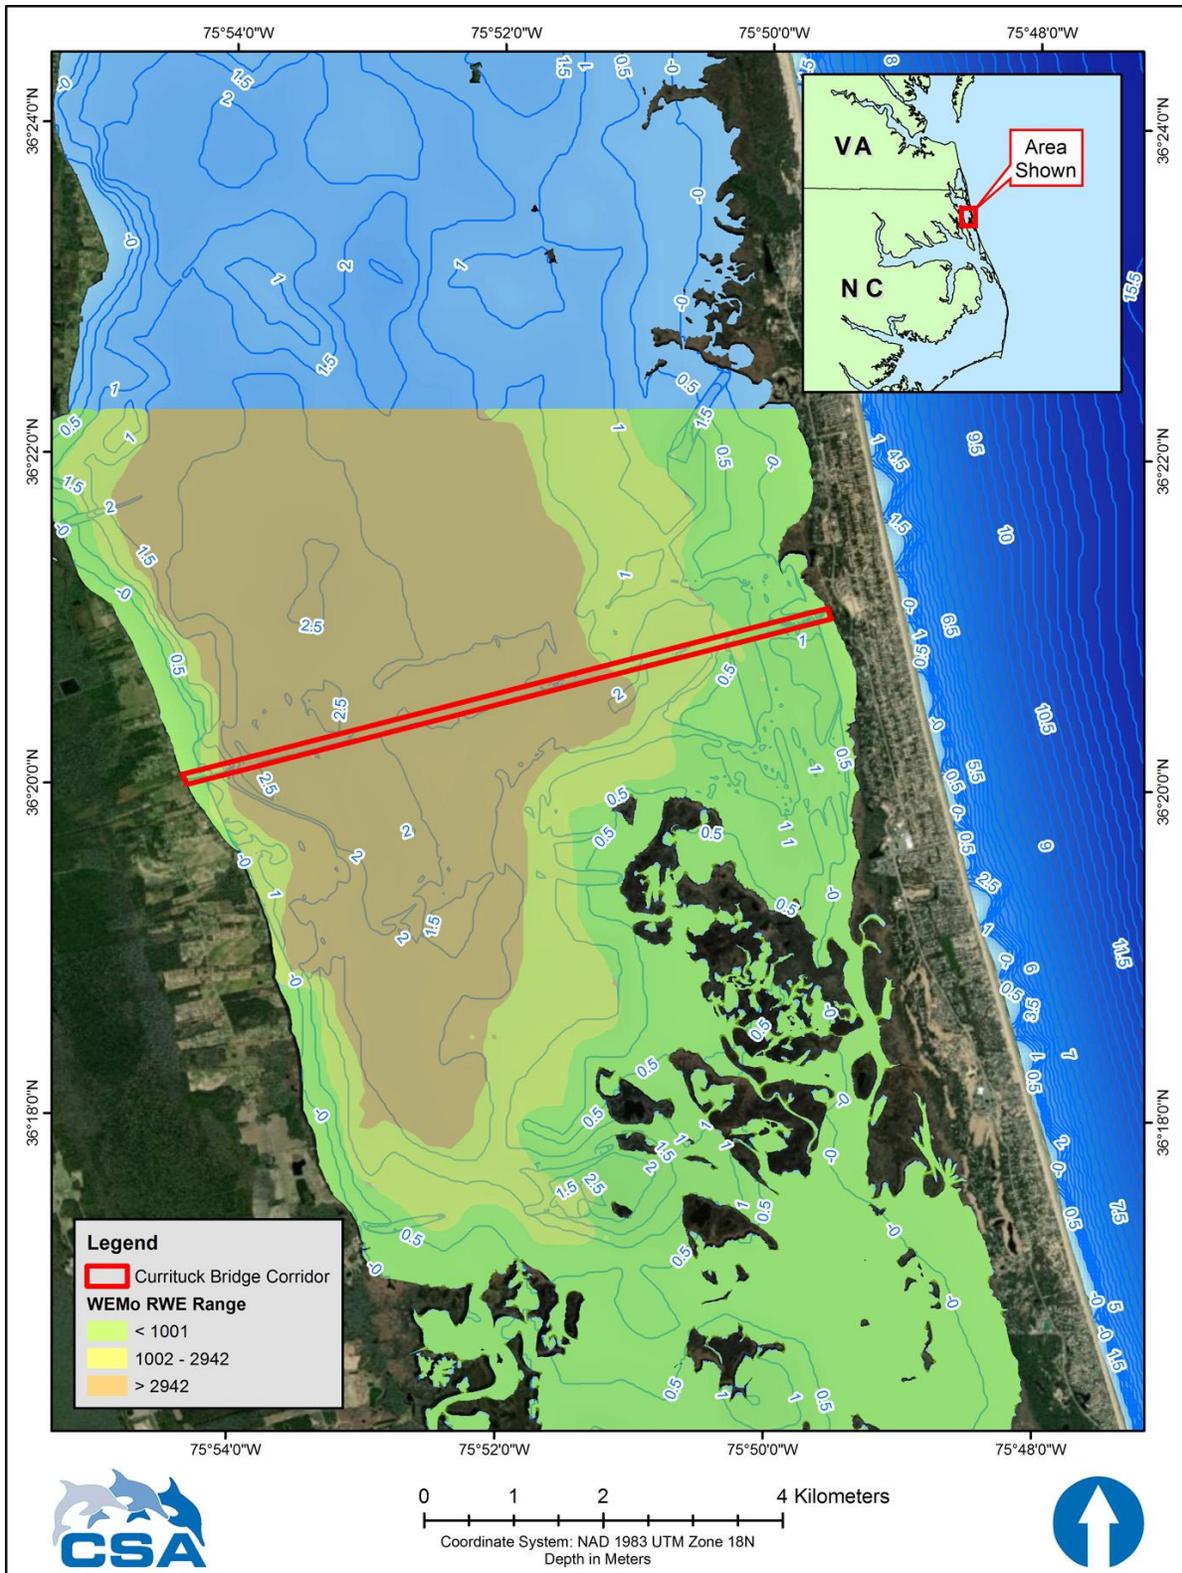
Figure 4. Results from the Wave Exposure Model (WEMo) analysis in Currituck Sound for the NCDOT-funded SAVE Currituck Study showing representative wave energy (RWE) zones. Map provided by CSA Ocean Sciences Inc., 2018.

However, this option would only be appropriate for non-high wave energy areas. According to the Currituck WEMo data (**Figure 4**), wave energy is in the low category along the shoreline at both landing sites (<1001 joules/meter<sup>2</sup>); however on the western side there is a gradient to high wave energy within approximately 0.5 km from shore (again, recalling that the WEMo model data represent nominal water level conditions; slight elevation of water levels could allow substantially increased wave transmission to

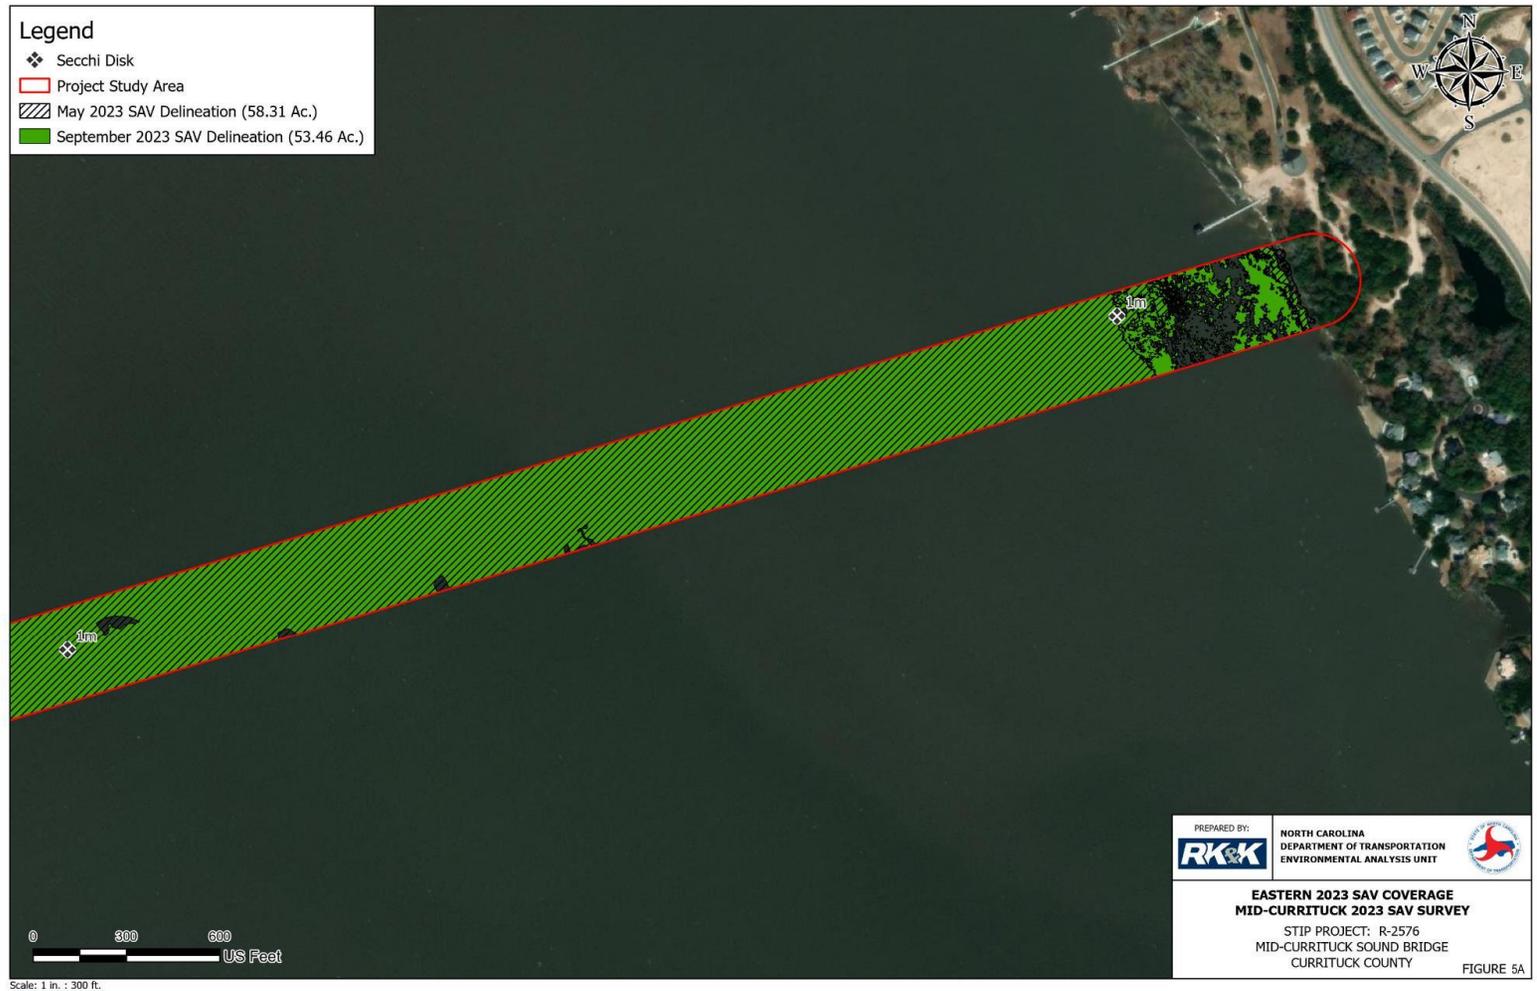
Figure 5a. East end of the proposed Mid-Currituck Bridge alignment showing SAV cover in May and October 2023.

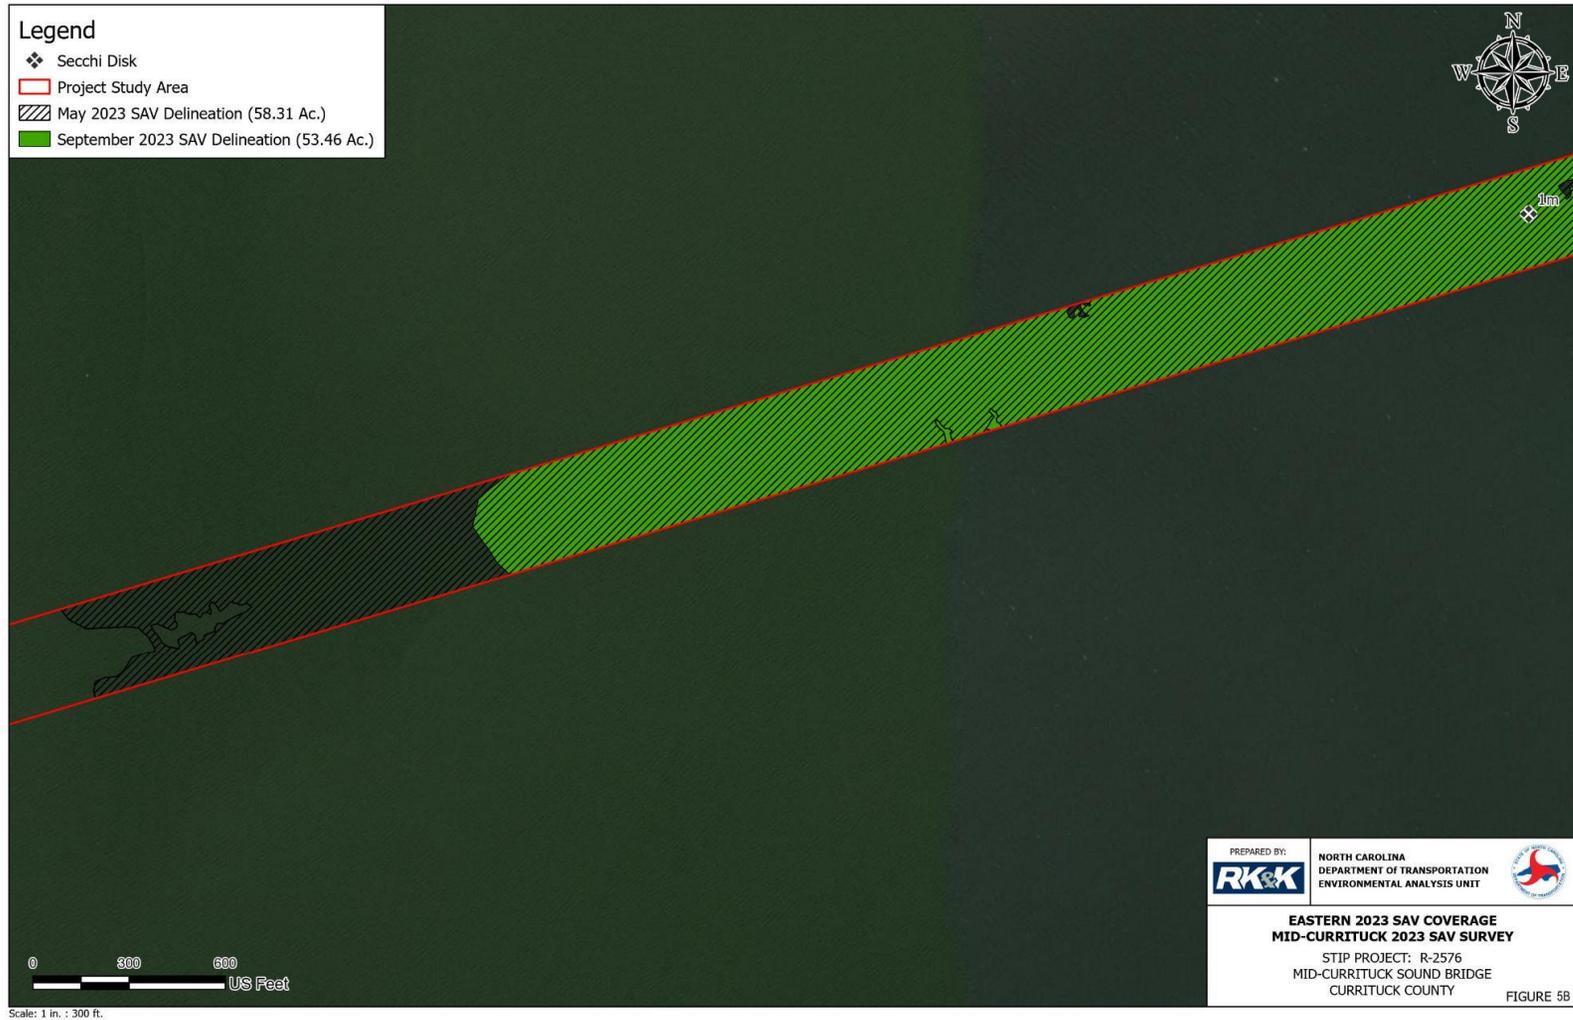
Figure 5b. Middle of the proposed Mid-Currituck Bridge alignment showing SAV cover in May and October 2023.

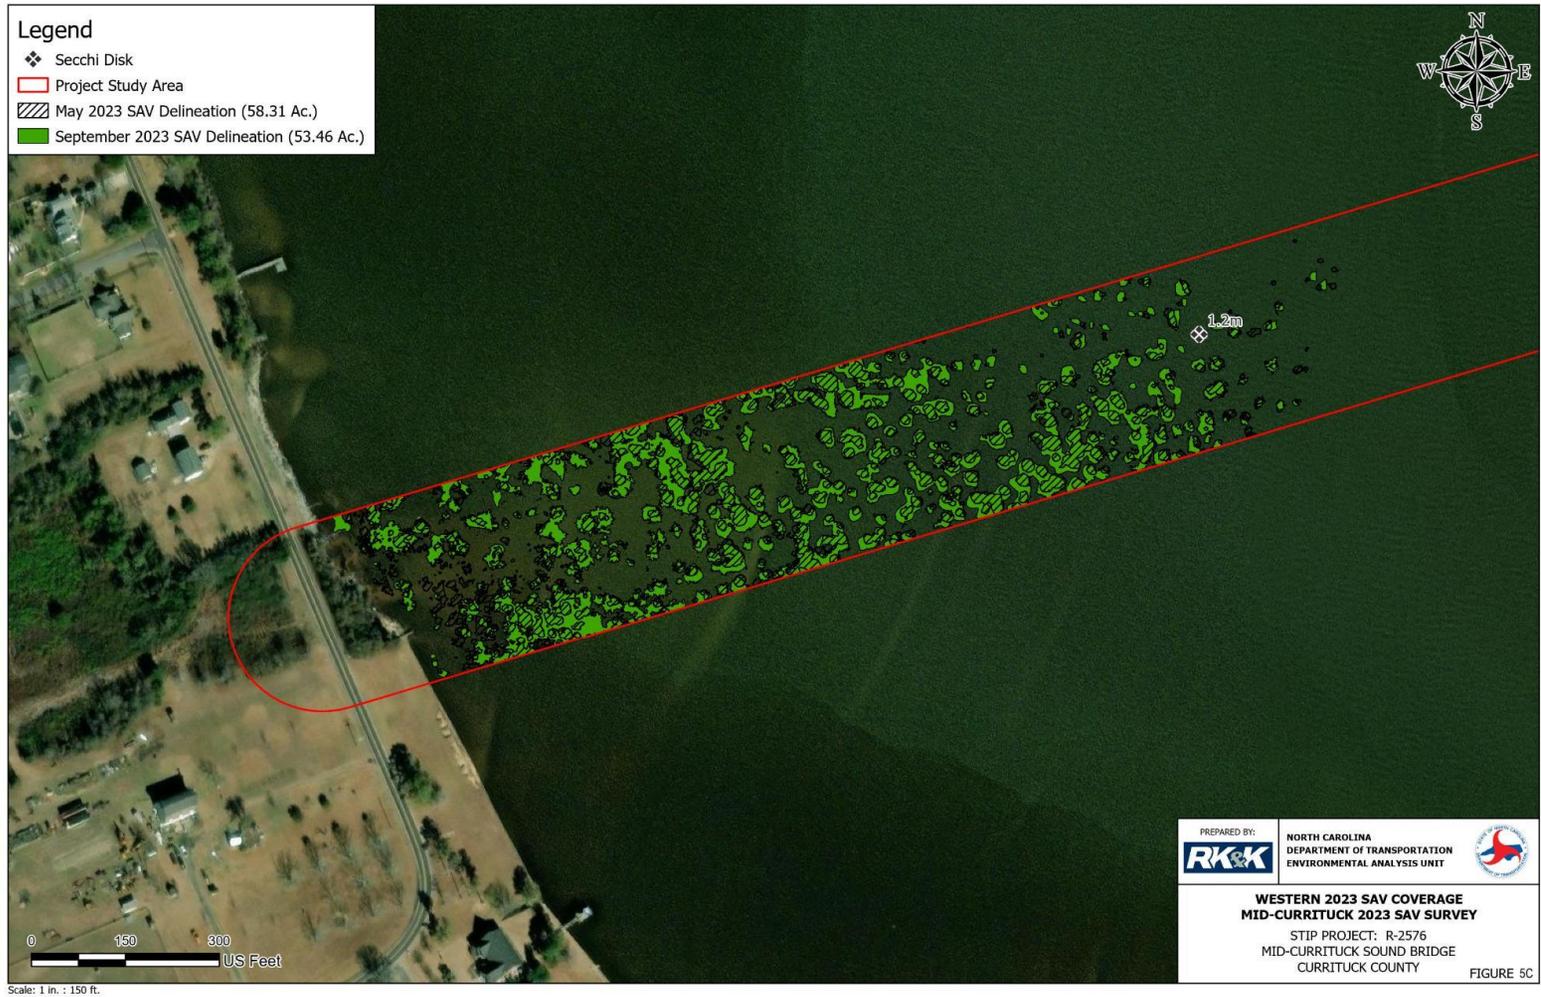
Figure 5c. Mainland (west) end of the proposed Mid-Currituck Bridge alignment showing SAV cover in May and October 2023.

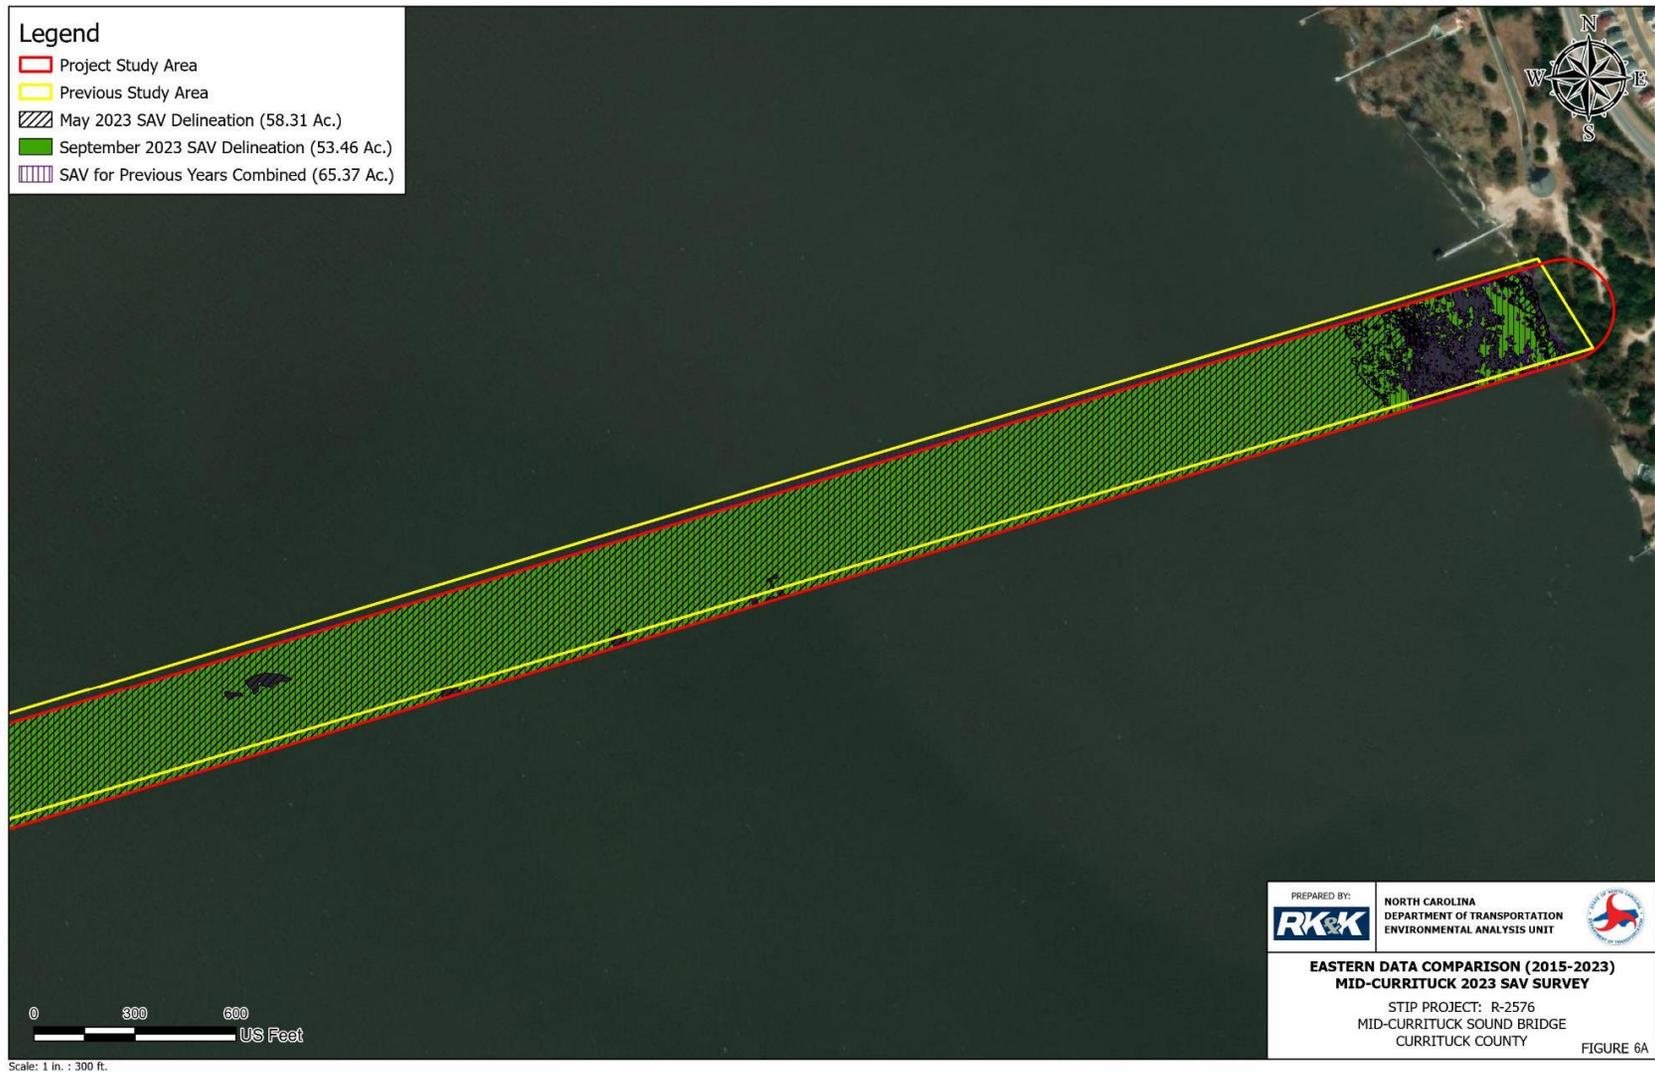
6a. East end of the proposed Mid-Currituck Bridge alignment showing submerged aquatic vegetation (SAV) cover in 2023 and previous years.

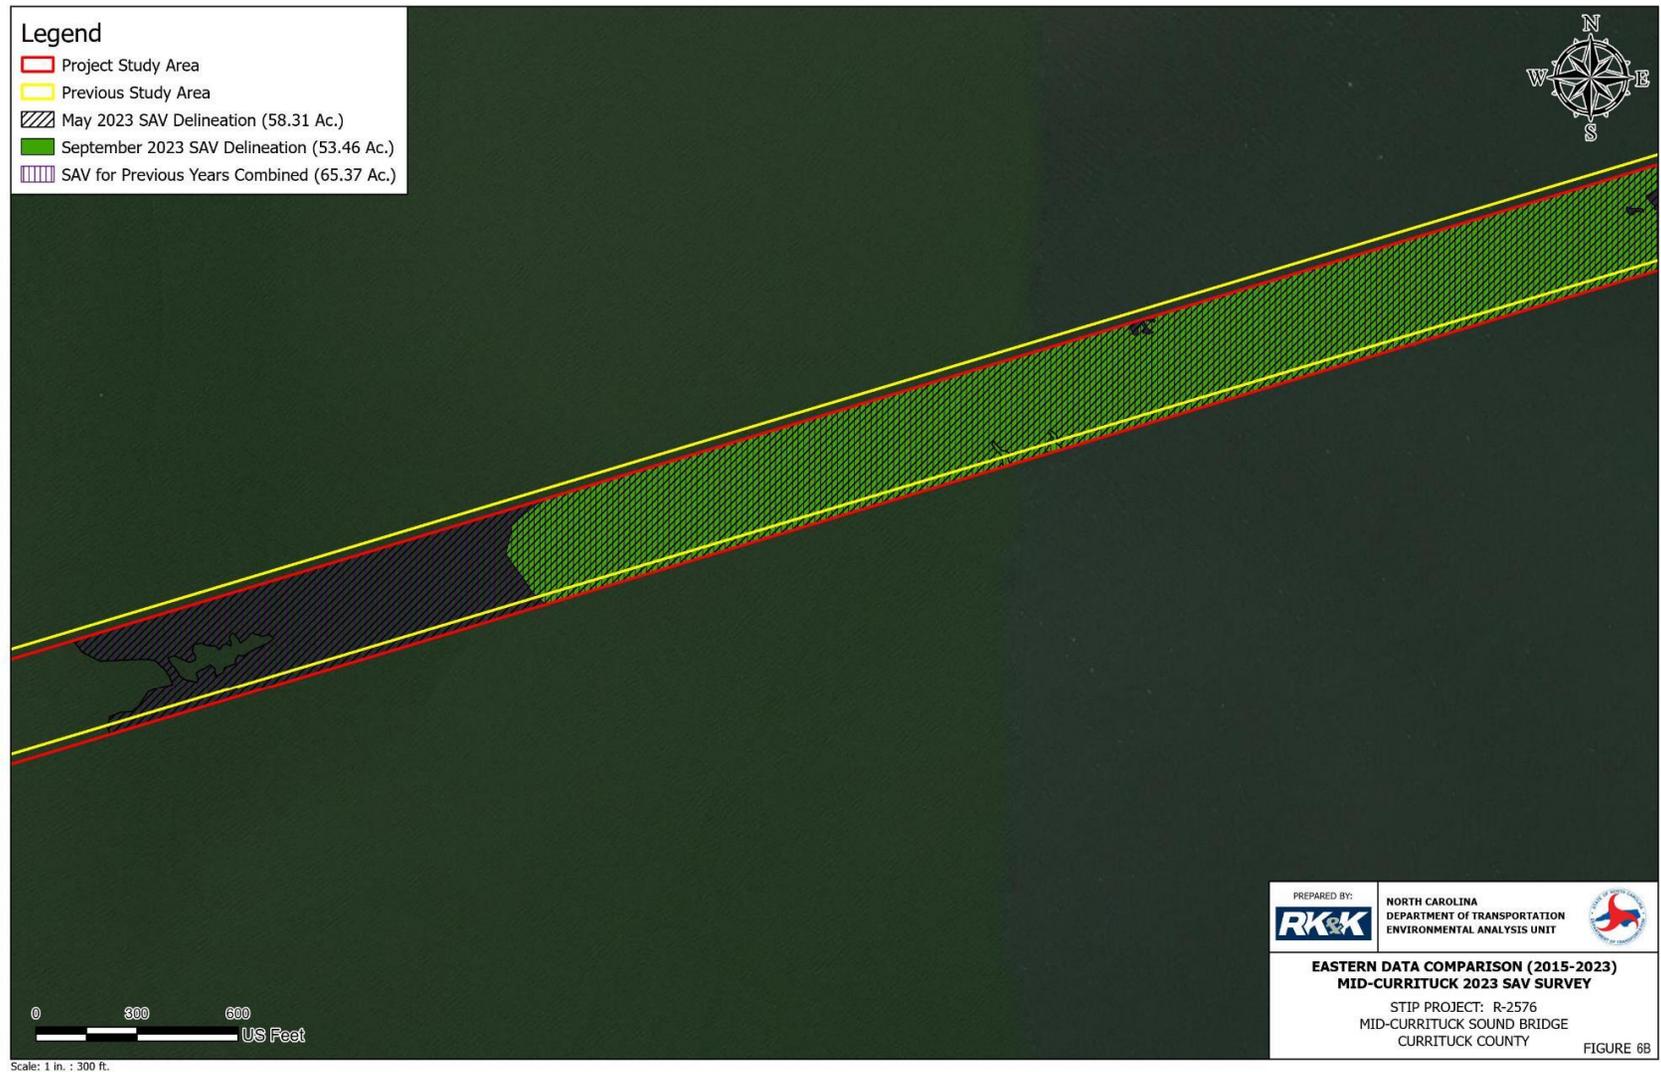
6b. Middle of the proposed Mid-Currituck Bridge alignment showing submerged aquatic vegetation (SAV) cover in 2023 and previous years.

Until the September 2022 survey, water depths ranging from -6 to -11 MLLW feet were not occupied with SAV (**Figure 6b**). During the September 2022, and both 2023 surveys, SAV was observed in water depths of -7.3 feet, not accounting for daily wind or tide variations. Deeper open waters (> -7.4 feet) were assessed and no SAV was located. Water clarity was measured with a Secchi disk and ranged from 1.0m to 1.2m across the study area in May and 0.4m to 1m in September 2023 (RK&K 2023).

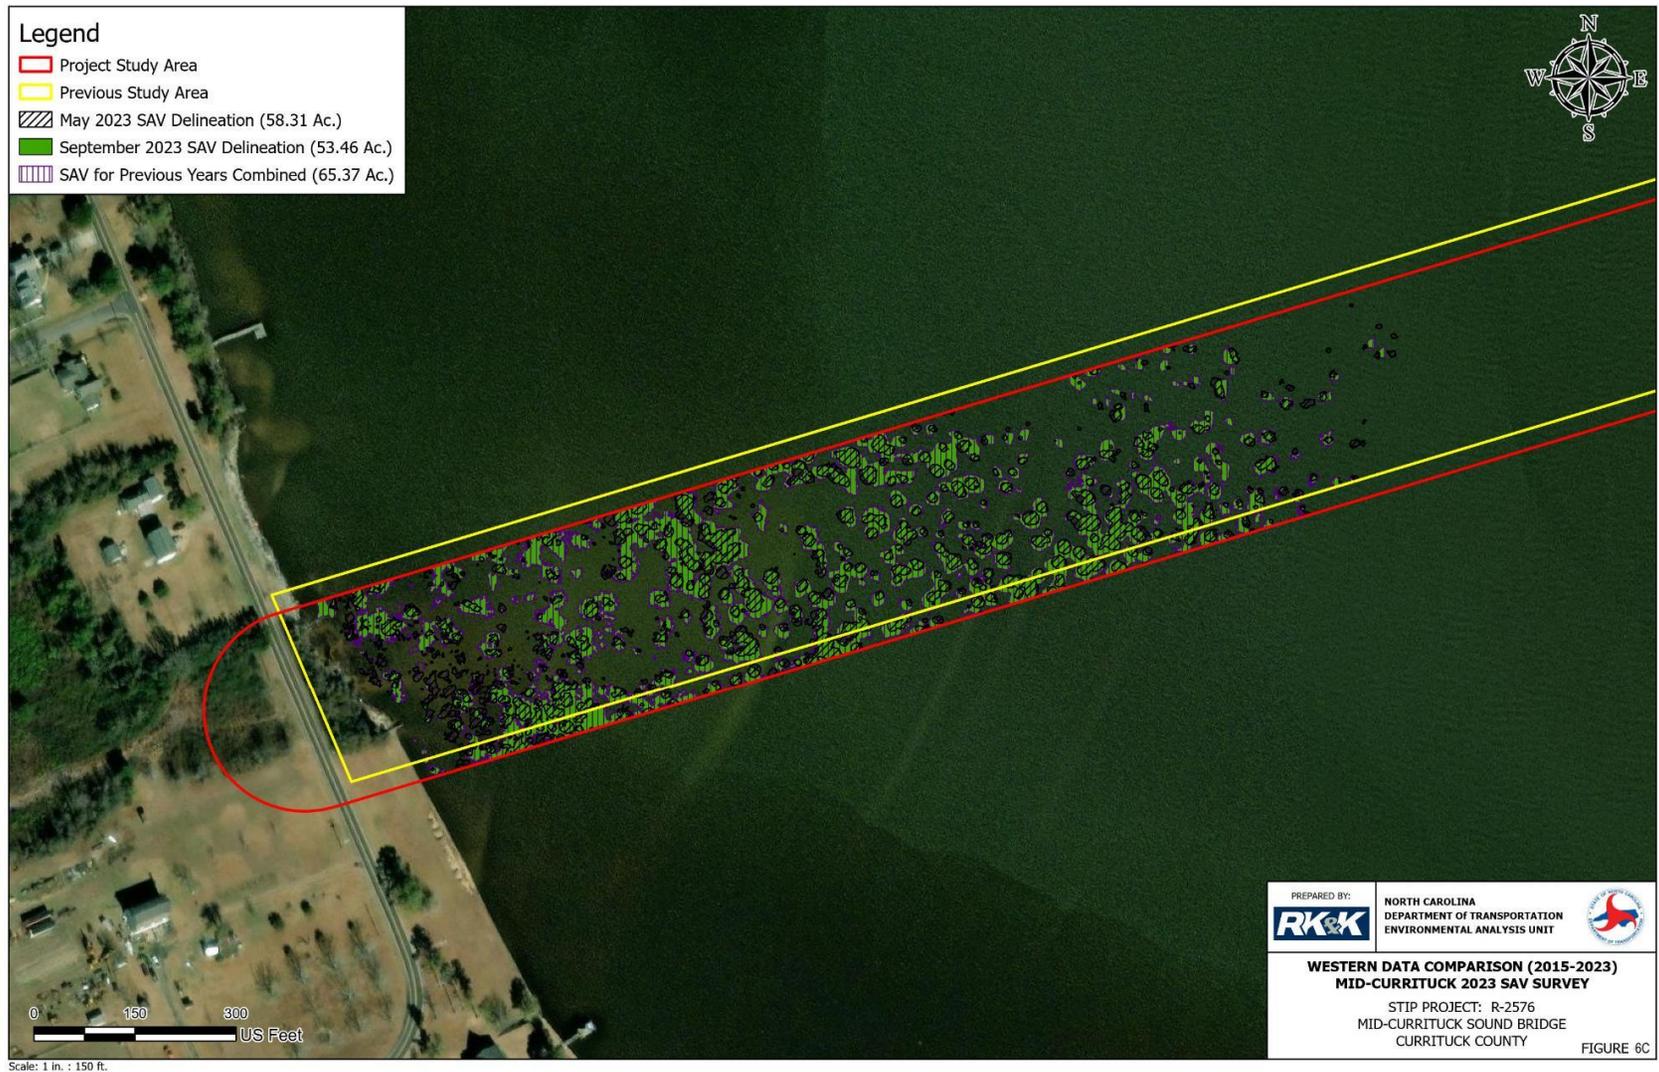
6c. West end of the proposed Mid-Currituck Bridge alignment showing submerged aquatic vegetation (SAV) cover in 2023 and previous years.

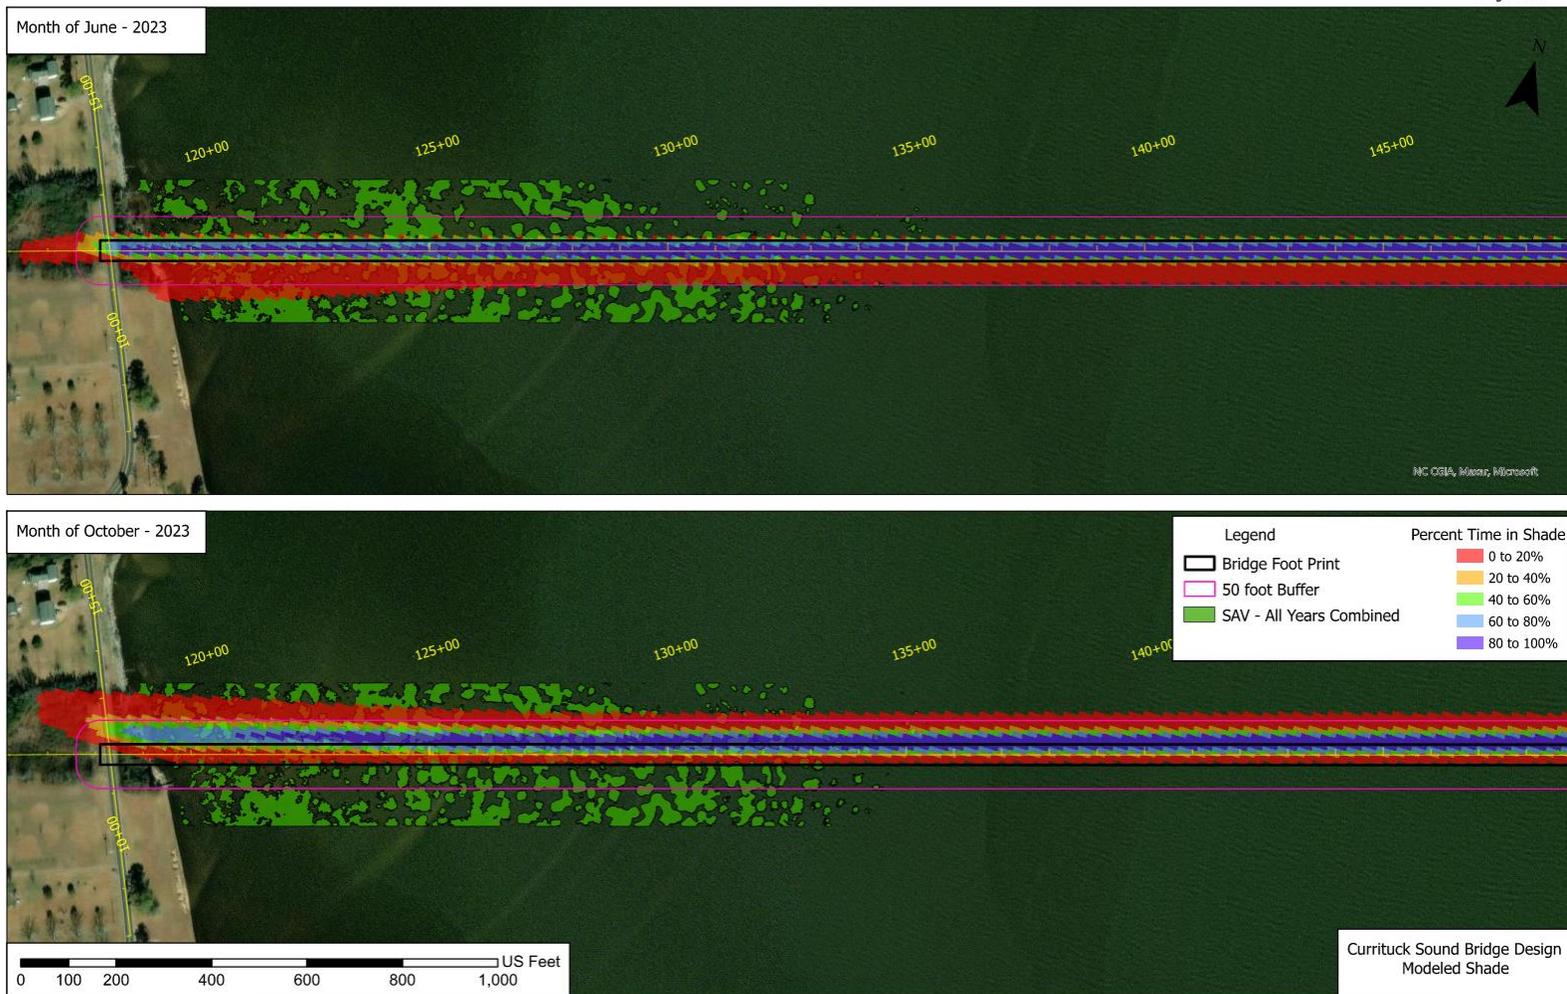
Figure 7a. West end of the proposed Mid-Currituck Bridge alignment showing SAV cover, and various gradations of shading predicted by the shading tool for the months of June and October 2023. *Please zoom in on electronic version to better view legend.*

The tool utilizes the solar angle for a given geographic location, day of the year, and time of day to cast a shadow from a selected structure on the surrounding environment. The shading tool was applied to the Selected Alternative for the proposed Mid-Currituck Bridge structure at two different times of year, June, and October, to account for seasonal differences in solar angle and extent of SAV habitat. Results from the shading tool for the eastern and western shores of the bridge corridor are displayed in **Figures 7a-7d** and show various gradations of shading (percent time in shade) within the corridor footprint. The shading tool bins the percent time in shade into five strata: 0 to 20%, 20 to 40%, 40 to 60%, 60 to 80%, and 80 to 100%.

Estimations of acreage of SAV within the alignment corridor affected by varying percent time in shade was calculated by the shading tool for the alignment in June (**Table 3**) and October 2023 (**Table 4**). Results from the shading tool will be verified with field-based monitoring, which will include photosynthetic active radiation (PAR) measurements at the water’s surface and SAV abundance and density estimations for each of the five shading strata.

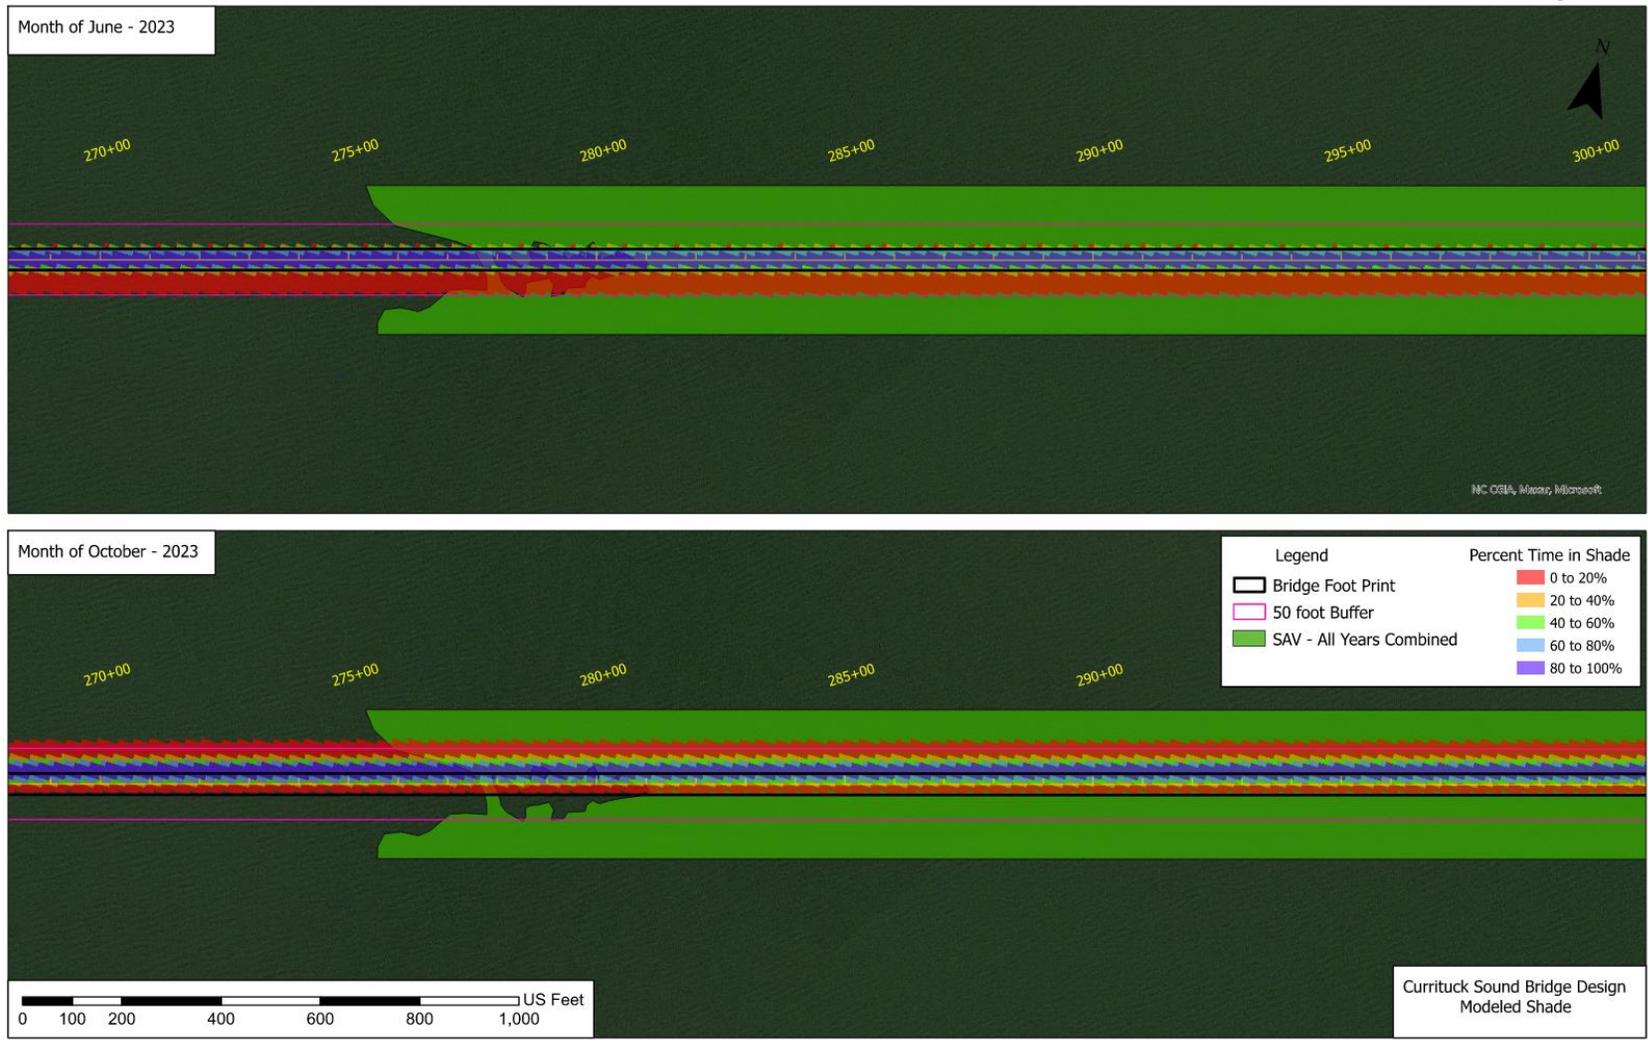
Figure 7b. Toward middle of the proposed Mid-Currituck Bridge alignment showing SAV cover, and various gradations of shading predicted by the shading tool for June and October 2023. *Please zoom in on electronic version to better view legend.*

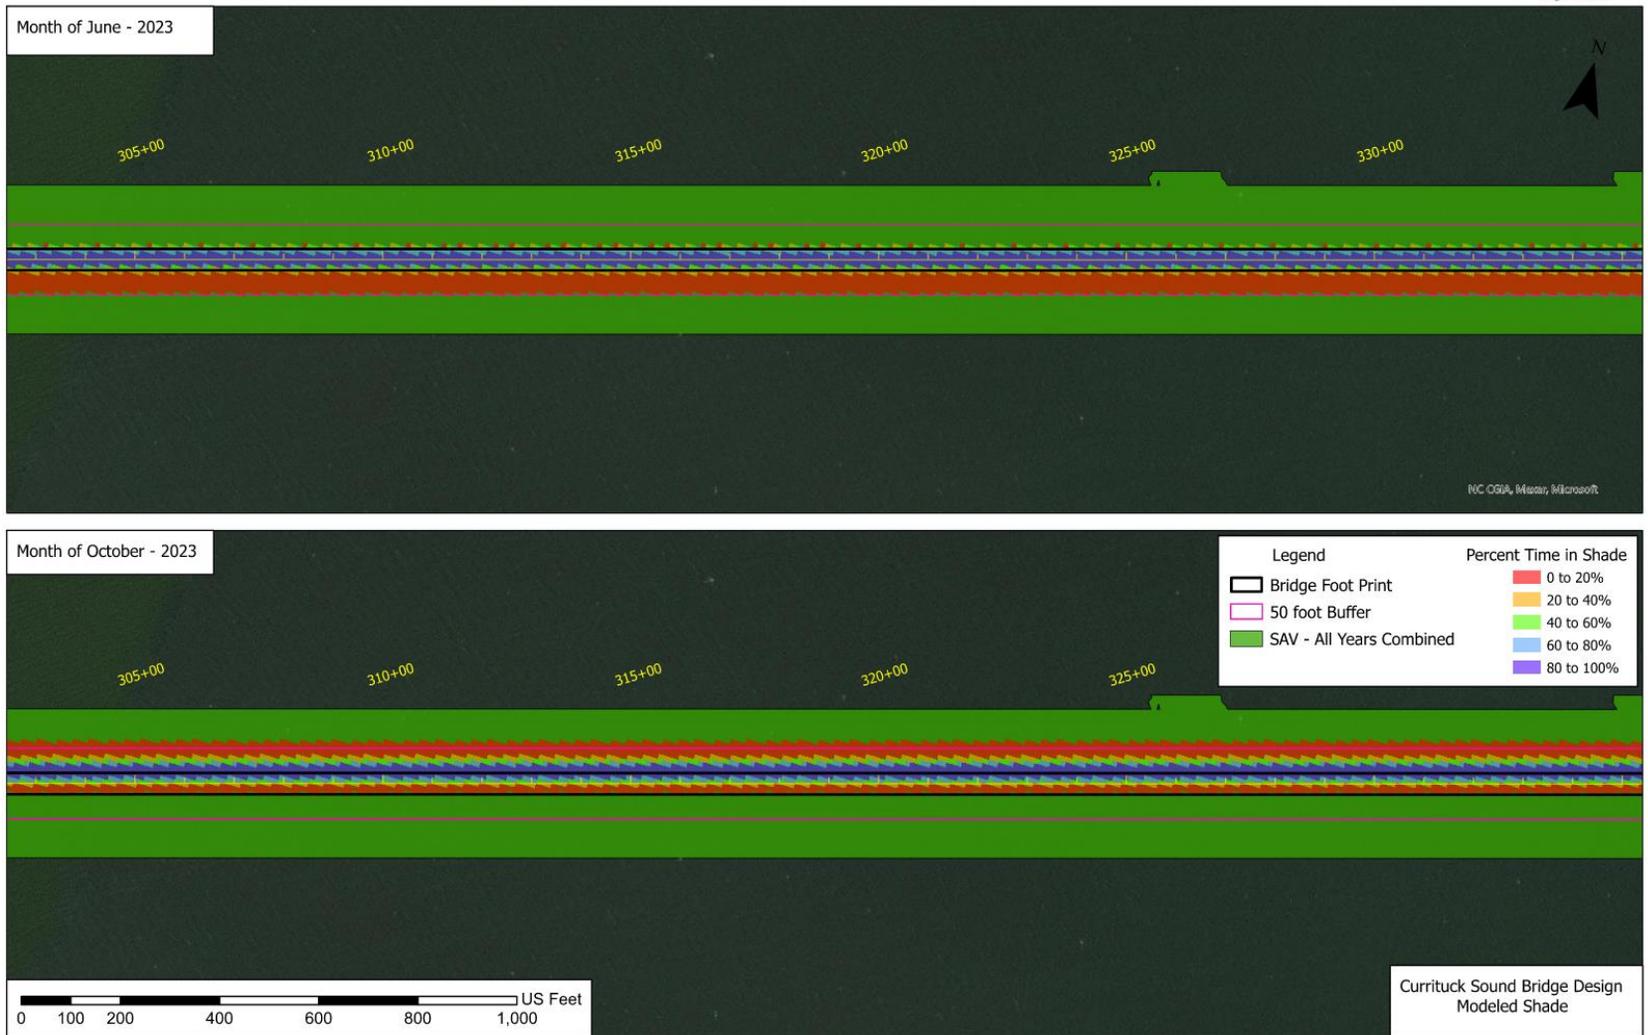
Figure 7c. Middle (east) of the proposed Mid-Currituck Bridge alignment showing SAV cover, and various gradations of shading predicted by the shading tool for June and October 2023. *Please zoom in on electronic version to better view legend.*
