**Revised Mid-Currituck Bridge  
Submerged Aquatic  
Vegetation Mitigation Plan,  
December 1, 2023 (Final)**

# Revised Mid-Currituck Bridge Submerged Aquatic Vegetation Monitoring and Mitigation Plan

December 1, 2023

DOCUMENT NO. CSA-RKANDK-FL-20-81045-3418-05-REP-01-FIN

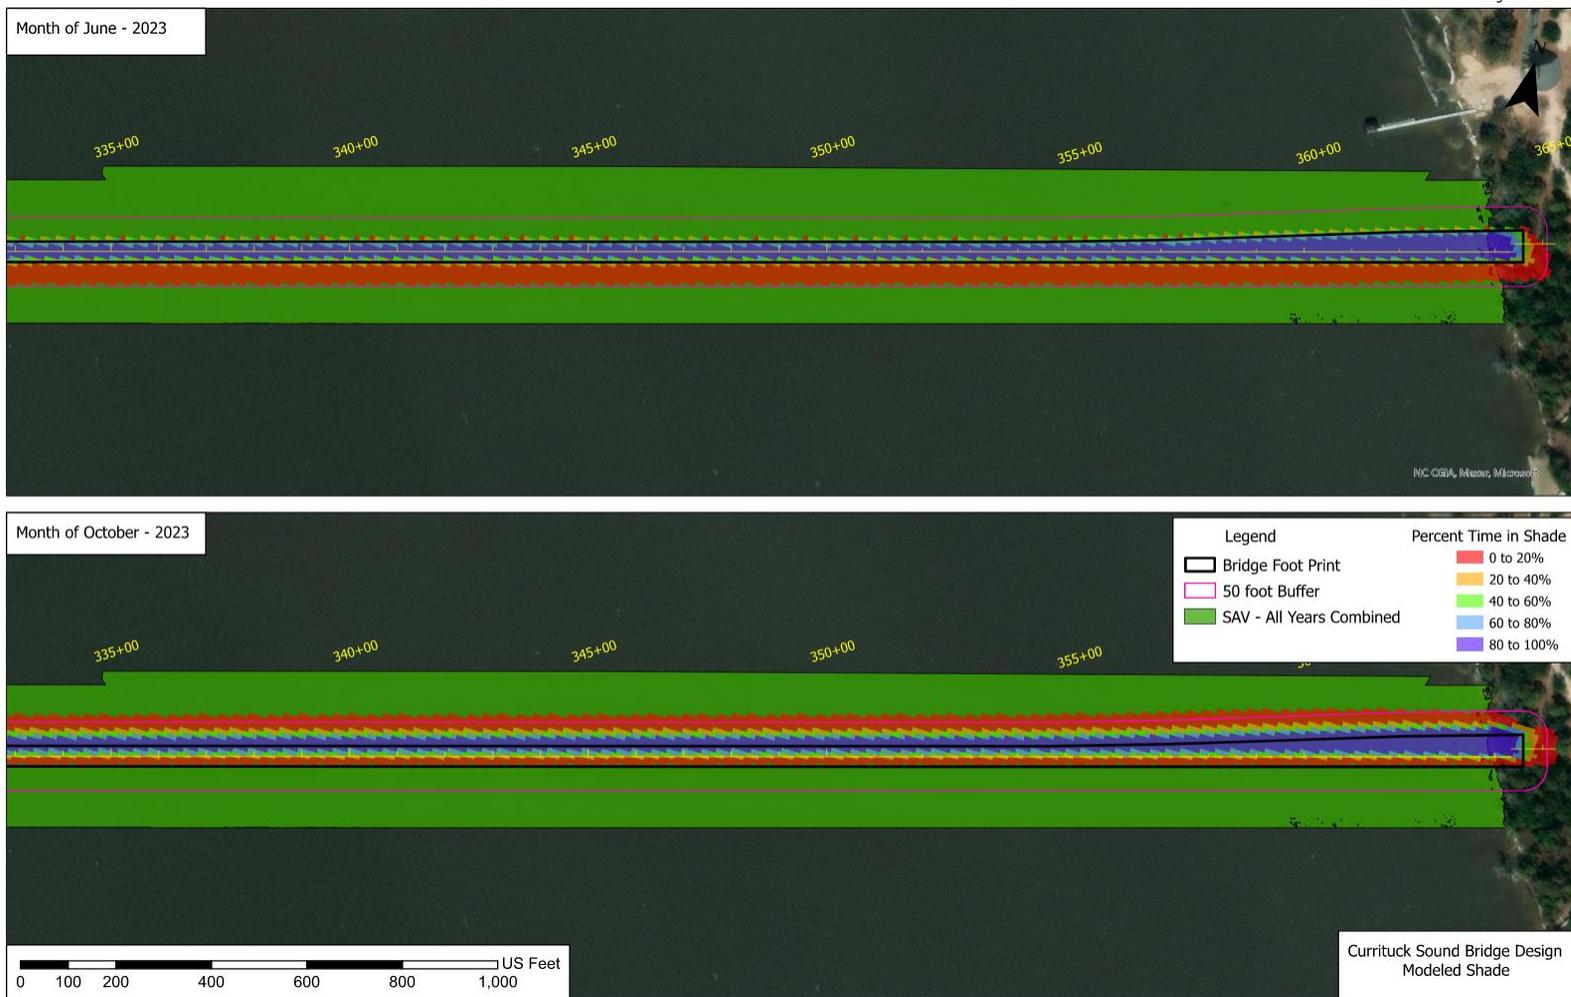
Figure 7d. East end of the proposed Mid-Currituck Bridge alignment showing SAV cover, and various gradations of shading predicted by the shading tool for June and October 2023. *Please zoom in on electronic version to better view legend.*

Estimations of acreage of SAV within the alignment corridor affected by varying percent time in shade was calculated by the shading tool for the alignment in June (**Table 3**) and October 2023 (**Table 4**). Results from the shading tool will be verified with field-based monitoring, which will include photosynthetic active radiation (PAR) measurements at the water’s surface and SAV abundance and density estimations for each of the five shading strata.

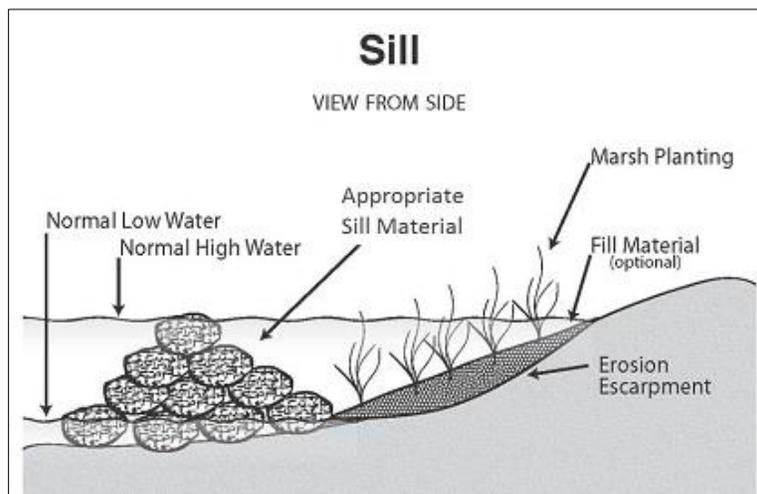
Figure 8. Schematic of a living shoreline that includes a sill feature. Drawing by NCDEQ, no date.

**Methodology:** Living shorelines could be installed at the shoreline along selected portions of the shoreline on either side of the bridge landing sites or at appropriate locations as determined by the NCDOT and the appropriate agencies where erosion of existing riparian vegetation is observed, and wave energy is moderate. Construction of living shorelines could require specialized machinery to effectively place heavier material such as rock, coconut fiber logs, or sandbags along the edge of the shoreline or several meters from the shoreline underwater, to create a sill feature (**Figure 8**). A comprehensive synthesis report evaluating 27 marsh sill projects in eastern North Carolina found them to be effective at combating shoreline erosion (Fear and Bendell, 2011). Native species of marsh grasses (*Spartina* spp.) could be obtained from local plant nurseries and planted along the shoreline or in the intertidal area between the sill and emergent marsh along shore.
