NCDOT MINIMUM CRITERIA DETERMINATION CHECKLIST

TIP Project No.: U-5857

State Project No.: 46384.1.1

SR 1406 (Rockfish Road) and new route (Gillis Hill Road Extension), SR 1406 (Rockfish Road) from SR 1003 (Camden Road) to north of Westfield Drive and Gillis Hill Road extension from north of Westfield Drive to SR 1418 (Lindsay Road) in Hoke County. Widen to multi-lanes, part of on new location.

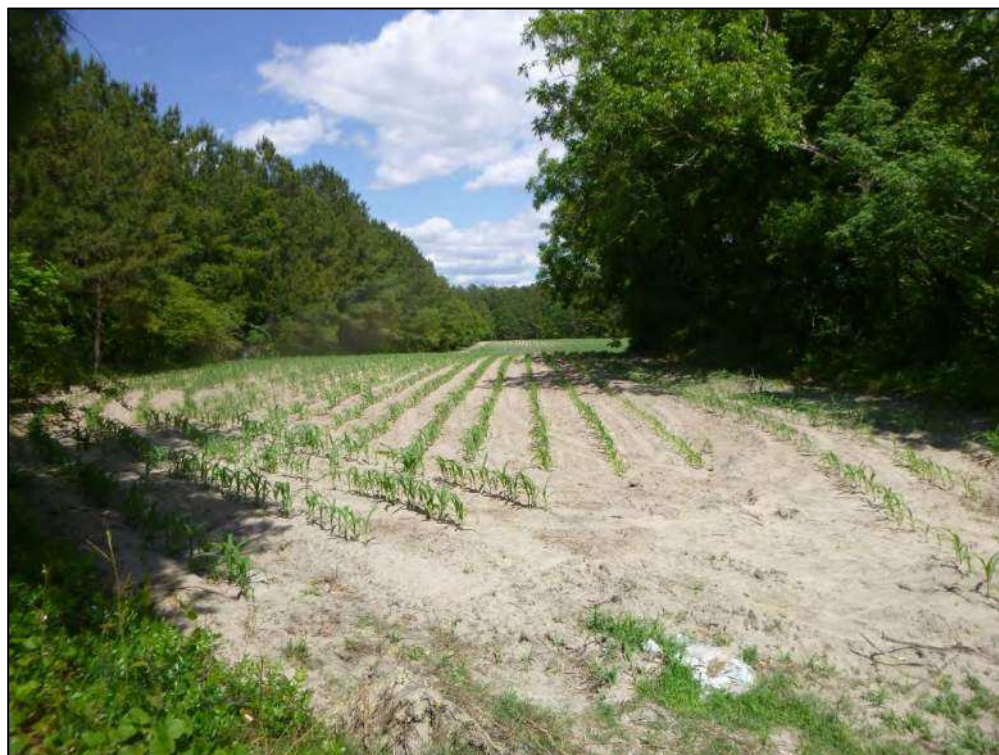
Figure 24. Overview of site 31HK4012, facing east.

Site Number: 31HK4012	NRHP Recommendation: Not Eligible
Site Type: House Site	Elevation: 210 ft AMSL
Components: 20 th Century	Landform: Hilltop
Quad Name: Parkton	Distance to Water: 825 m/2,706 ft to Stewarts Creek
UTM Coordinates: E677391, N3872088 (17N, NAD 83)	Soil Type: Wagram loamy sand
Site Dimensions: 100 m NW/SE x 45 m NE/SW	Vegetation: Agricultural field/Wooded area
Artifact Depth: 0–50 cmbs	No. of STPs/Positive STPs: 22/8

Historic maps show a structure in this location beginning in 1921 and continuing to 1972 (Figures 8, 9, and 12); Google Earth imagery shows the building was gone by 1993 (Figure 30). The historic artifacts recovered from the site are consistent with a twentieth century occupation and, given the poured concrete foundation, cinder block foundation, and historic artifact scatter, the site dates to the twentieth century.

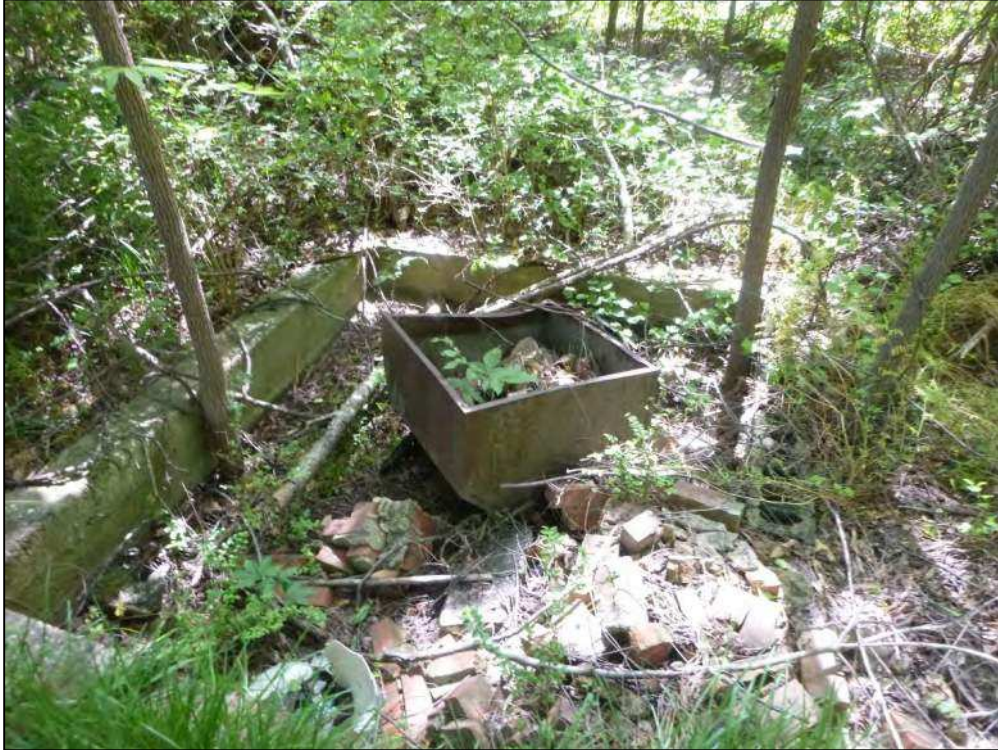
Figure 26. Poured concrete foundation at site 31HK4012, facing west.

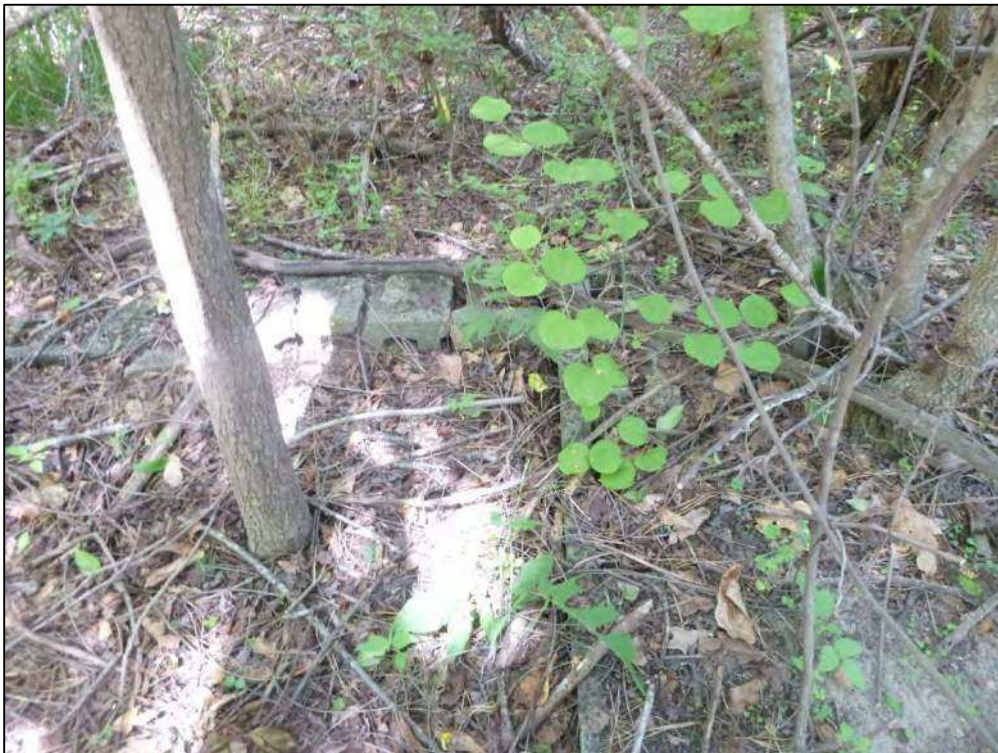
Figure 27. Cinder block foundation at site 31HK4012, facing northwest.

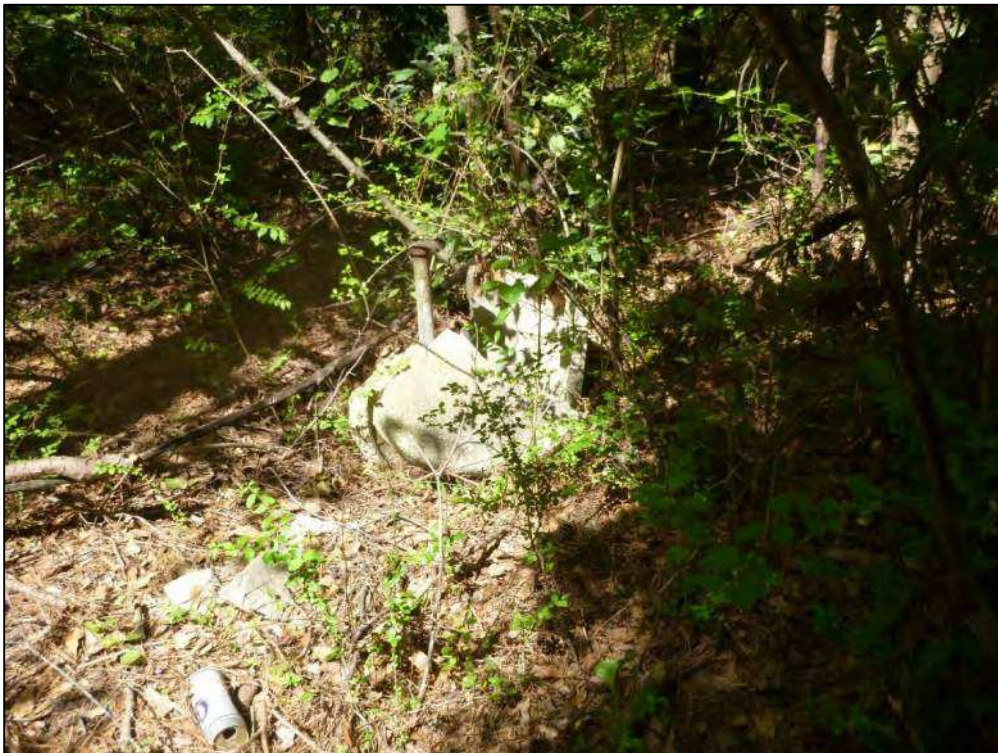
Figure 29. Cement lined well at site 31HK4012, facing northeast.

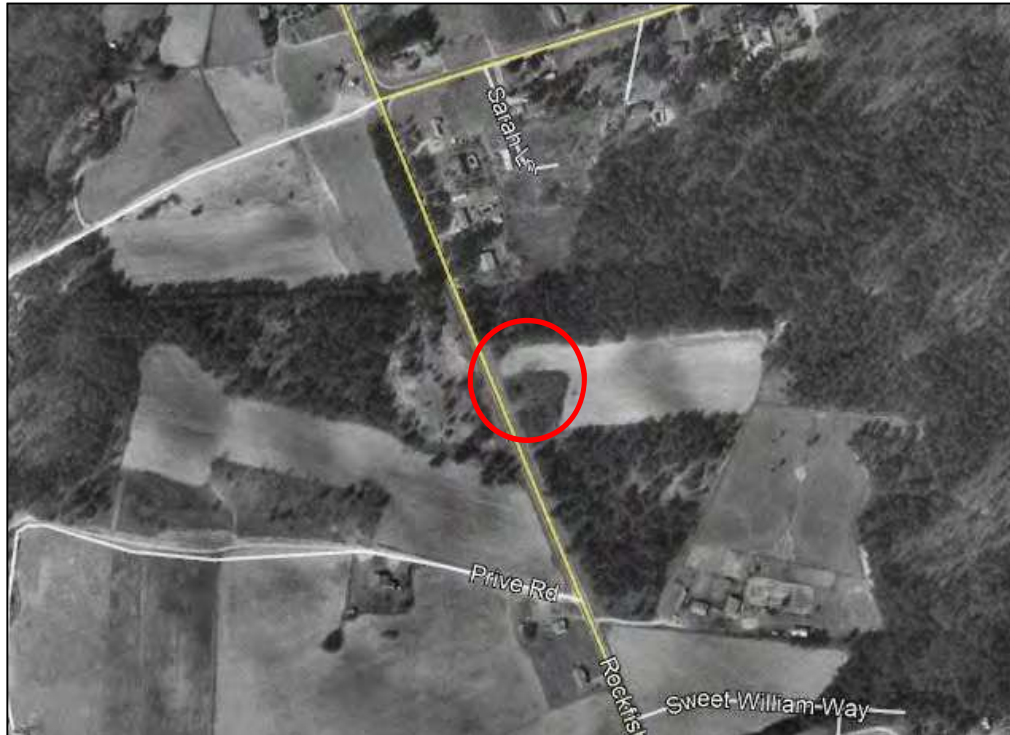
Figure 30. Google Earth imagery from 1993 showing the buildings associated with site 31HK4012 are gone.

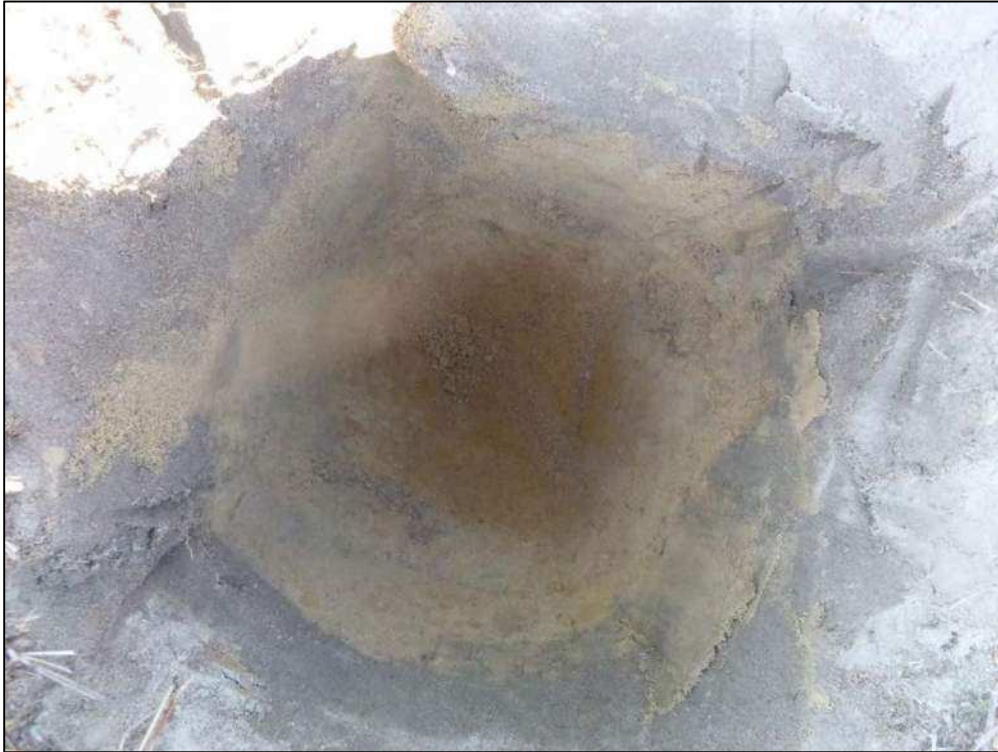
Figure 38. Typical soil profile in Area 2.

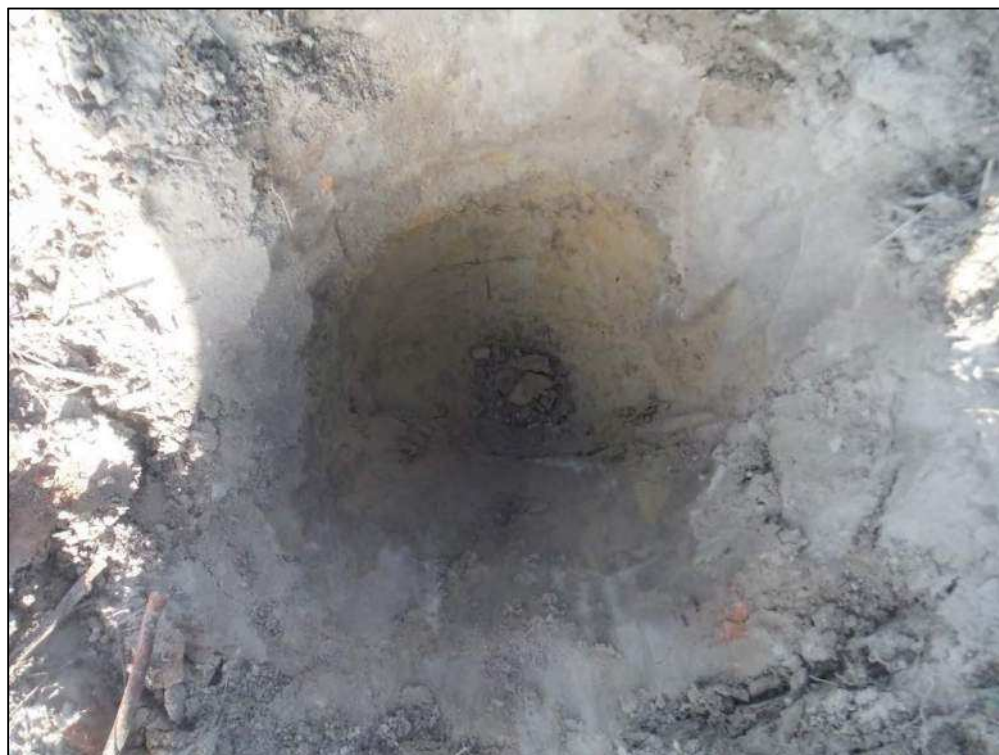
Figure 40. Typical soil profile in Area 3.

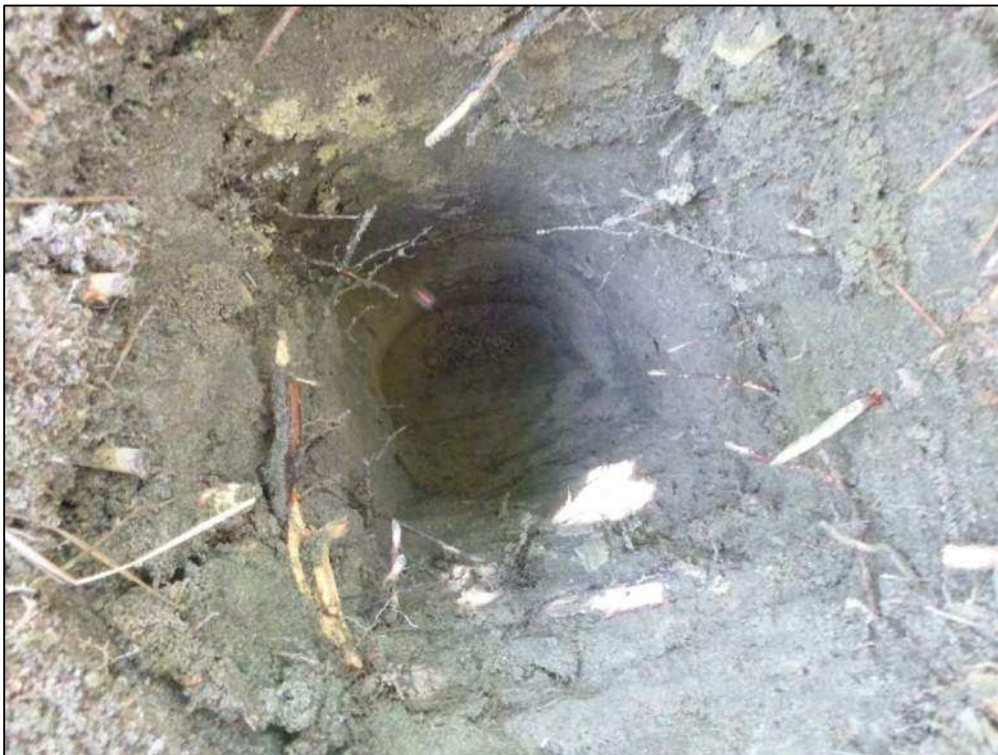
Figure 44. Typical shovel test profile in Area 4.

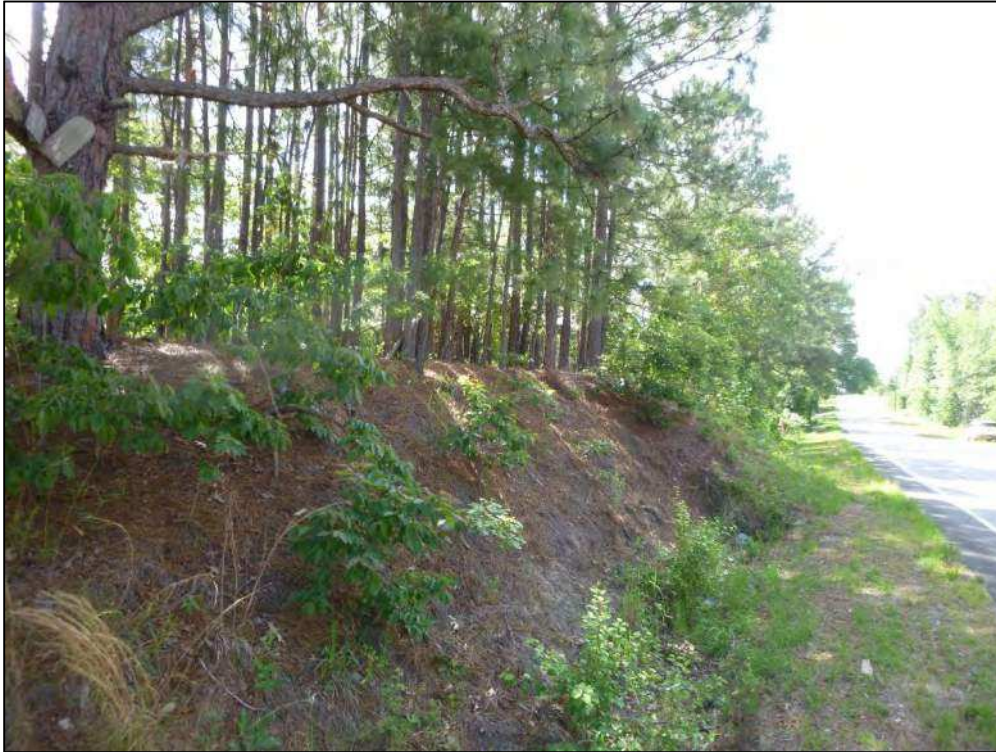
Figure 50. View of steep embankment from Rockfish Road, facing south.

Although the cemetery is not eligible for inclusion in the NRHP, the vast majority of the cemetery, including the 35 marked graves, are within the current APE (Figure 49). The existing cut line of the embankment currently extends into the cemetery boundary and is not a straight line, as the embankment extends to the west to accommodate a grave that is on the edge of the embankment (Figure 51). There is very little space in this location to widen the roadway and not impact graves. It is recommended that the roadway not expand to the east of Rockfish Road in this section of the APE. If there is no way to avoid impacting the grave sites, additional work will need to be completed to identify graves, both marked and unmarked, in the impact area and relocate them to a new location per North Carolina state law (GS 65, GS 70, GS 14-148 and GS 14-149).

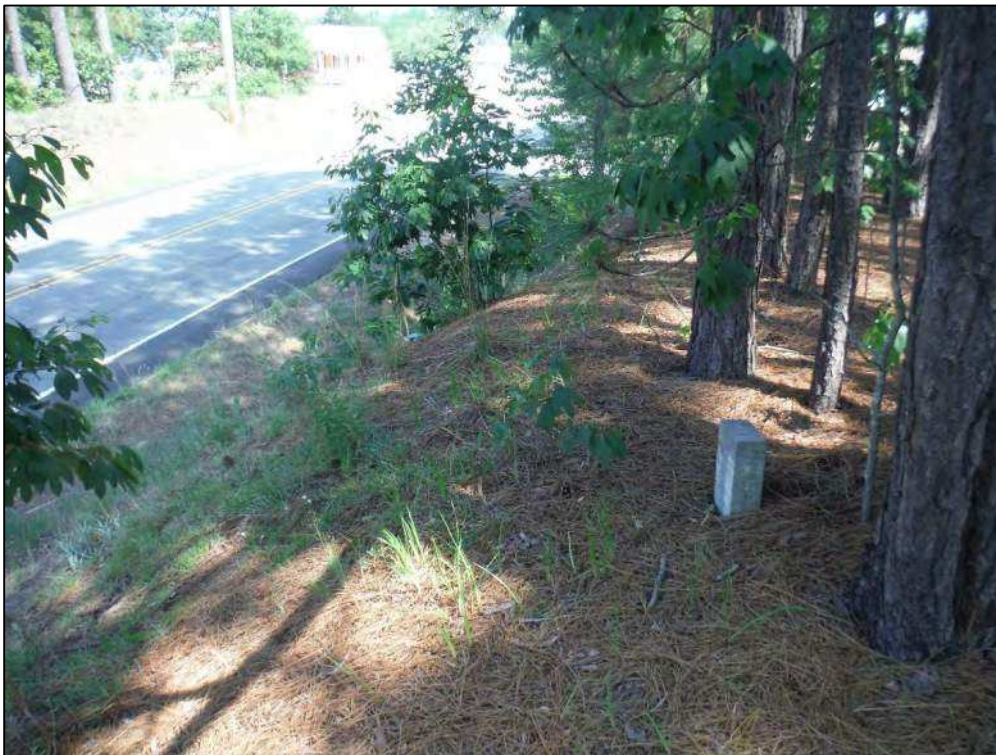
Figure 51. View of steep embankment from cemetery and headstone on edge of embankment, facing north.
