# **NCDOT STIP A-0010A**

**US 19/23 (Future I-26) Improvements**

## **Concurrence Point 2A Bridging and Alignment Review**

**March 2019**

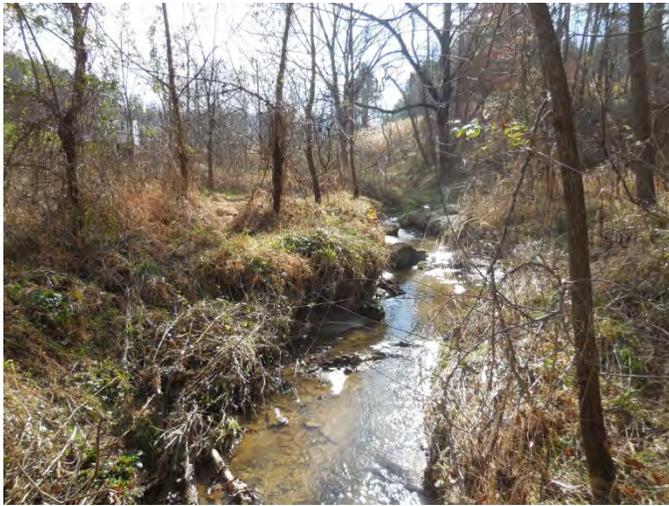
Site 1 is located at Gentry Branch, a tributary to Adkins Branch, classified as WS-II, HQW, and crosses Whitt Road. The surrounding area consists of mainly agricultural land and sparse residential land use. Homes are located within 200 feet of the crossing but are at an elevation at least 20 feet higher than the stream bottom. The stream banks are nearly vertical in places, with erosion evident, and heavy vegetation.

Site I – looking upstream

Because the existing culvert is in good condition and the high height of fill at the location, it is recommended to retain and extend the north end of the existing culvert. There is a stream confluence located at the downstream end of the existing culvert. Approximately 70 feet of the incoming stream will need to be relocated to account for the new outlet location.

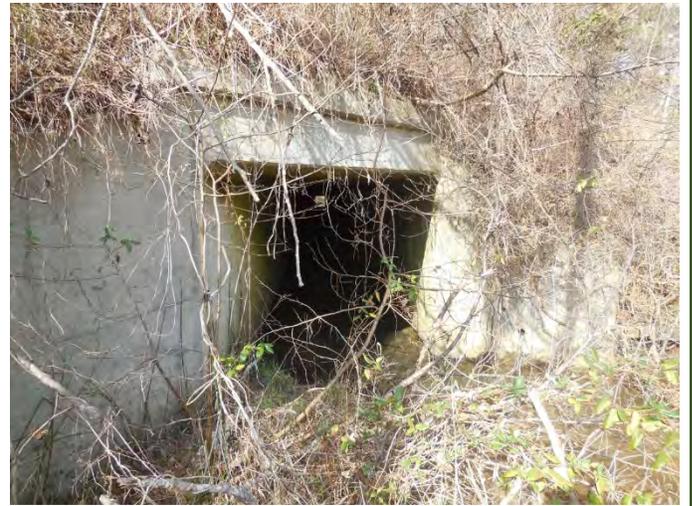
Site I – upstream face

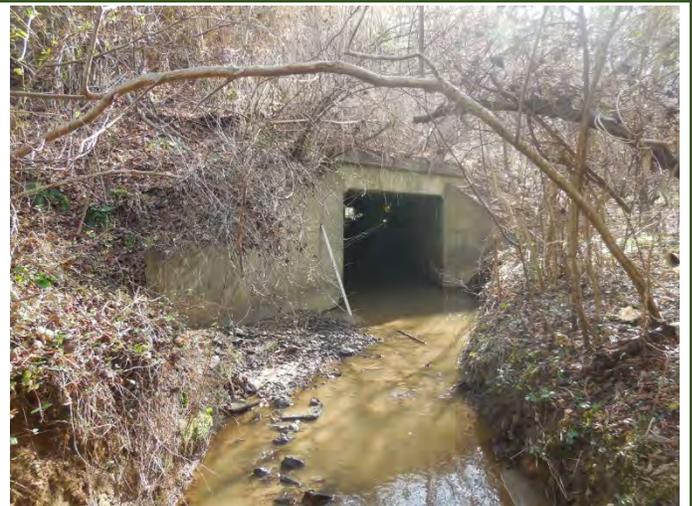
Site I – downstream face

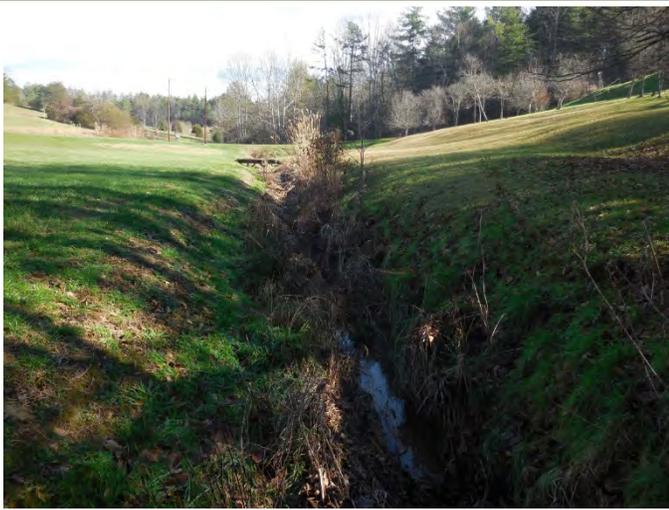
Drainage Area: 0.14 square miles  
Existing Structure: 52" CMP with headwall that has deformed to 56"x50"  
Existing Channel: upstream bottom width 2'; downstream channel width 3'  
Recommended Structure: Replace with 72" CMP

Site 3 – looking upstream

The next downstream structure is a 42" corrugated metal pipe, located approximately 50 feet downstream, which serves as a conveyance under a driveway to a nearby home. It is recommended that the pipe be replaced due to the potential for upstream development and the discrepancy between the existing pipe and calculated minimum size requirement.

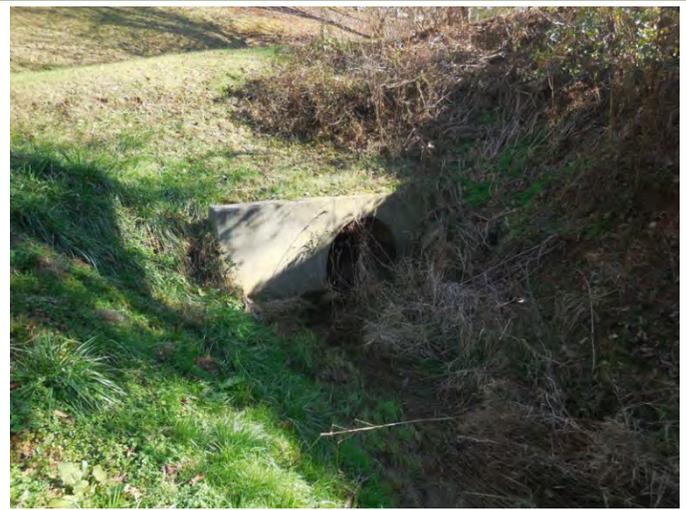
Site 3 – upstream face

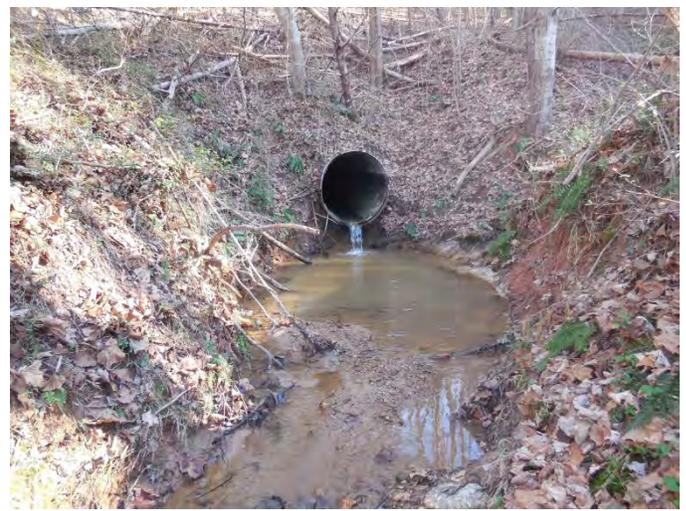
Site 3 – downstream face

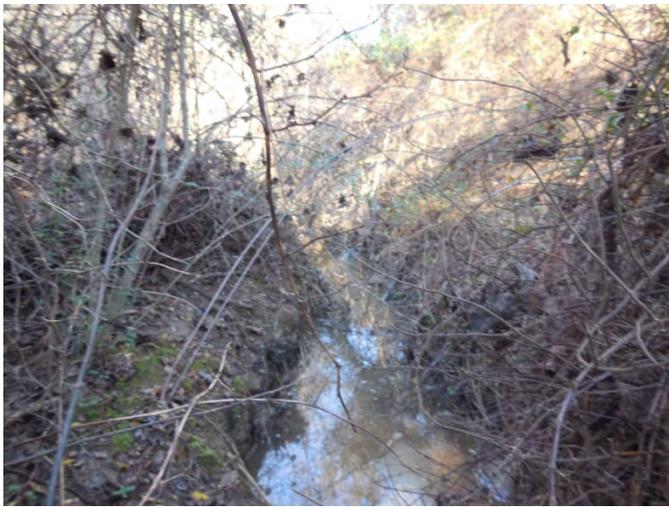
The existing 66" CMP does not show signs of deficiency, however its capacity is insufficient to handle the 50-year storm event. The new 96" CMP should retain the current stream slope and extend to the proposed fill line.

Site 4 – looking upstream

Drainage Area:	0.36 square miles
Existing Structure:	66" CMP with upstream headwall
Existing Channel:	Downstream channel width of 4'
Recommended Structure:	Replace with 96" CMP

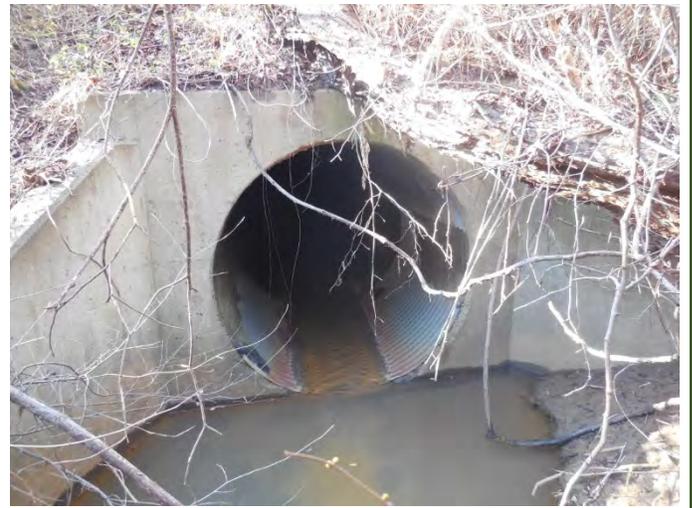
Site 4 – upstream face

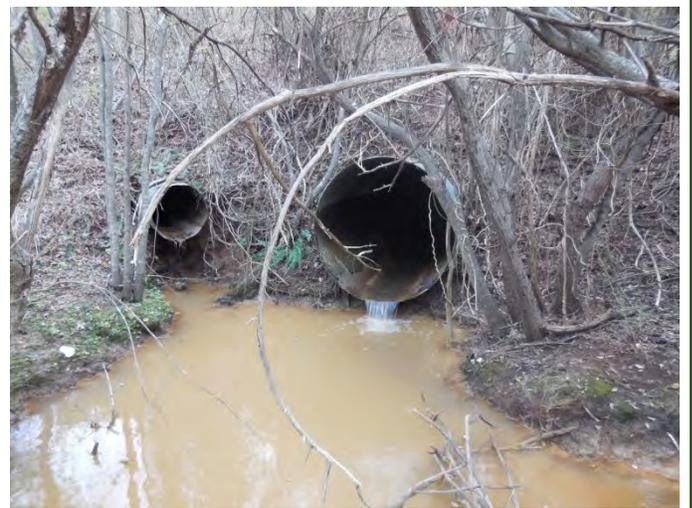
Site 4 – downstream face

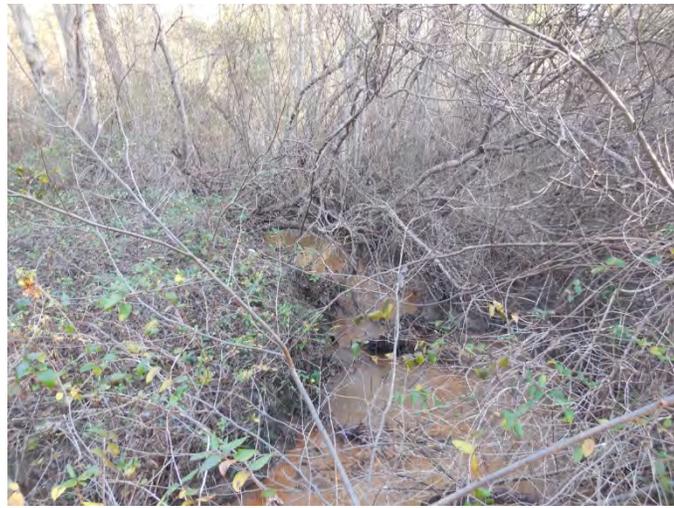
Site 8 also carries Blackstock Branch, and is at the intersection of the on ramp to US 19 and Jupiter Road. The area is characterized by heavy brush and trees and a steep fill slope. The banks of the downstream stream are approximately 8' high. The upstream end has a stream width of 4', with vertical banks. At the time of field investigation, a repair to a slope failure had just been completed. The slope failure was at the upstream side, at the east corner of the headwall.

Site 8 – looking upstream

The existing 60" CMP does not show signs of deficiency; however, its capacity is insufficient to handle the 50-year storm event. The new structure should retain the current stream slope and extend to the proposed fill line.

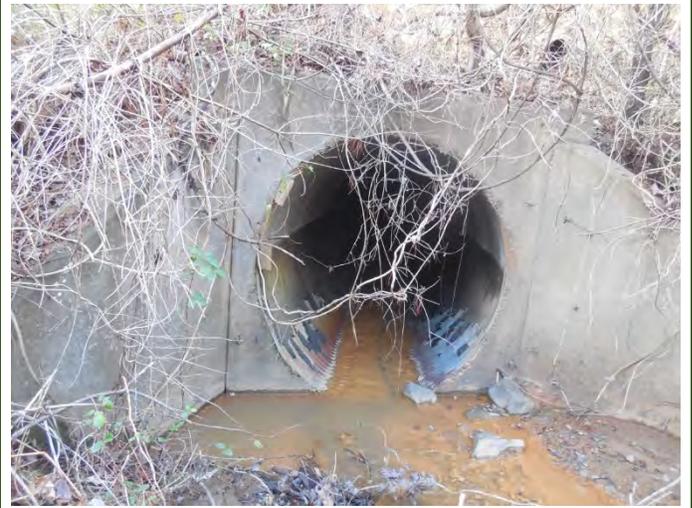
Site 8 – upstream face

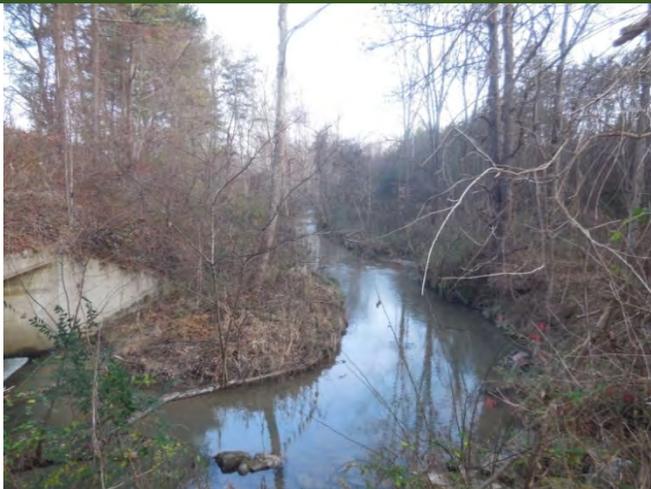
Site 17 – looking upstream

This crossing was calculated to require a 3@10'x10' culvert to meet the size requirements for a 50-year storm event; however, this culvert does not show signs of insufficiency and it is therefore recommended to retain and extend the existing culvert 50 feet. The culvert should retain the normal slope of the stream. An improved inlet should be added to the upstream end of the culvert to mimic the existing conditions.

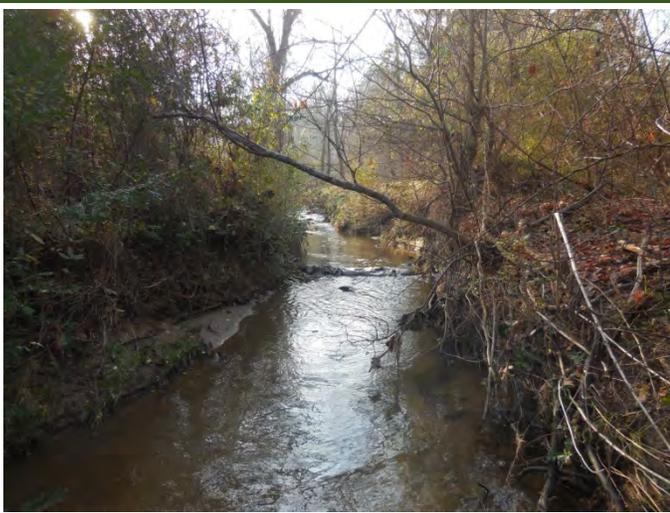
Site 18 is located on Little Flat Creek, about a mile upstream from the confluence with Flat Creek and flows under I-26. The banks are approximately 3 feet high and grassy. The surrounding area is wooded. During the time of field visit, there was evidence of a recent high water of up to 2-3 feet above the normal water surface. There is a home within 300 feet of the structure, but it is located between 5 feet and 10 feet above the normal water surface.

Site 18 – looking upstream

Drainage Area: 3.04 square miles  
Existing Structure: 3@ 8'x8' RCBC  
Existing Channel: Upstream width of 10' and downstream width of 12'-15'  
Recommended Structure: Extend existing 3@8'x8' RCBC (18')

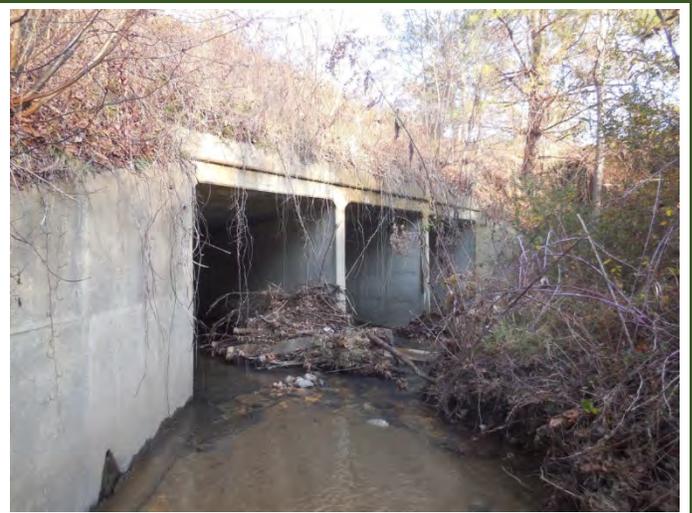
Site 18 – upstream face

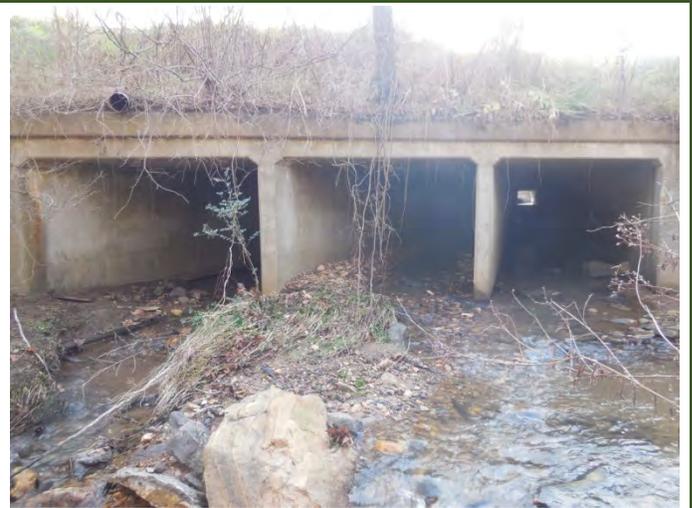
Site 18 – downstream face

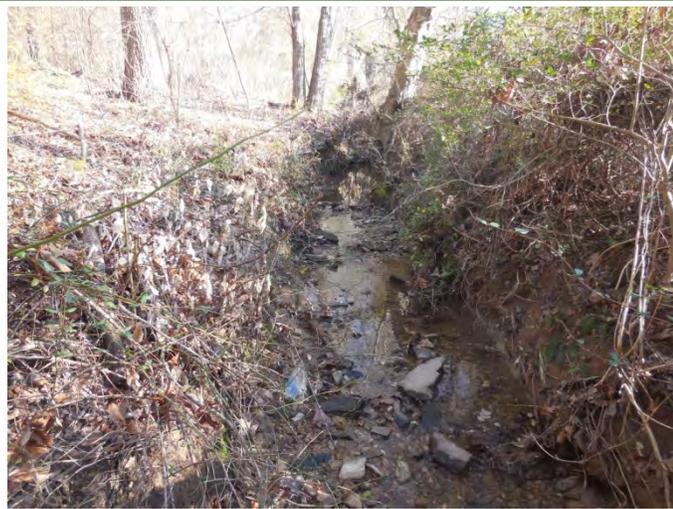
This crossing spans an unnamed tributary of Gill Branch on I-26. The culvert likely has a blind junction. The upstream side has a 4-5 feet base with vertical banks. The stream at the downstream end of the crossing is approximately 8' wide. There is a 2-foot drop from the end of the pipe to the streambed. The banks are eroded and are vertical, reaching 8-10 feet tall.

Site 19 – looking upstream

Drainage Area:	3.0 square miles
Existing Structure:	48" CMP
Existing Channel:	Downstream channel width of 8'
Recommended Structure:	Replace with 84" CMP

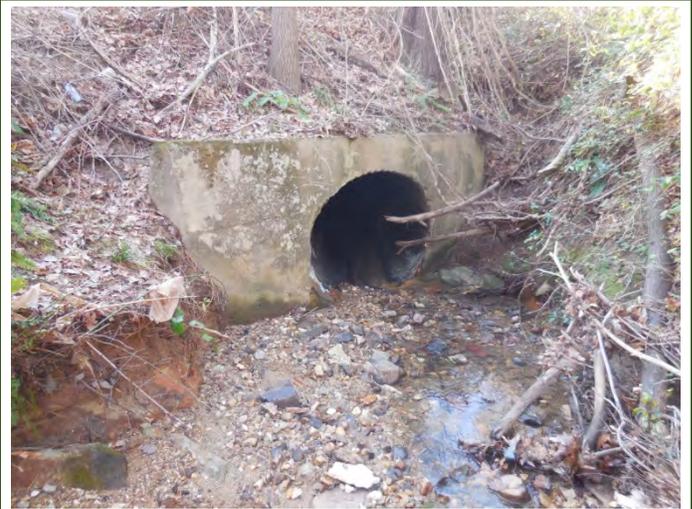
Site 19 – upstream face

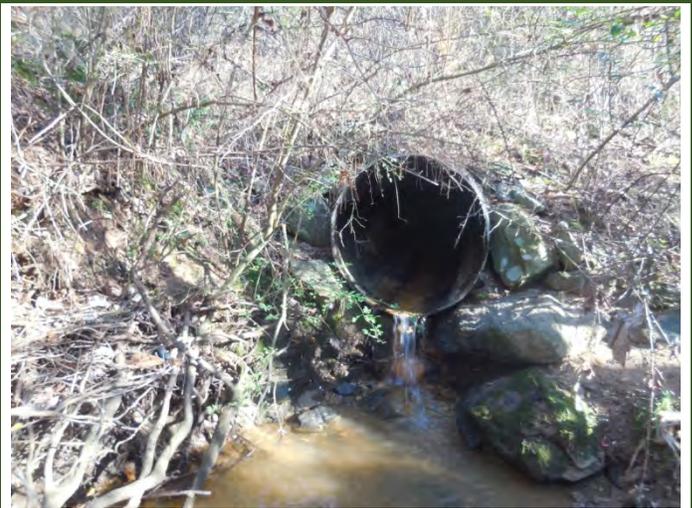
Site 19 – downstream face

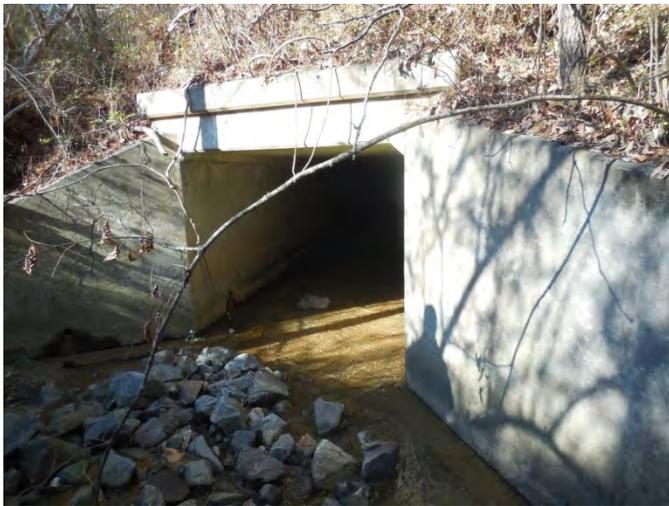
Site 20A – upstream face

It is recommended to retain the RCBC. The flow requirements for a 50 year storm indicated that a single 7'x7' RCBC would be required; however, since the drainage area is small and this recommendation only proposes to increase the existing height by 1 foot, it would likely be most cost effective to retain the length of the existing culvert.

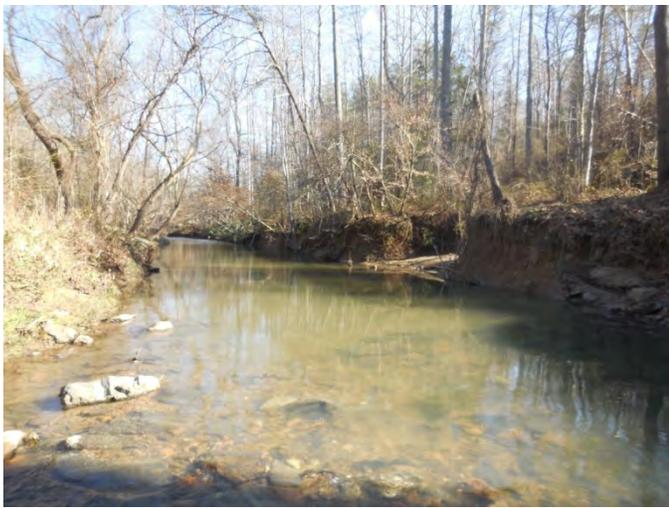
Site 28 crosses Reems Creek with two 4-span bridges with concrete bents and a reinforced concrete floor on steel I-beams. The bridge carrying the northbound lanes of I-26 is structure number 100370, and the I-26 southbound lane structure is 100373. Both span Reems Creek. The existing bridges are approximately 270' long each. This bridge replacement is listed in the NCDOT STIP as B-4442. This crossing is Reems Creek has a Re-delineated floodplain, though the FIRM indicates that the hydraulic effects of the road at this location on the special flood hazard area have not been determined. The bridges will need to be replaced to accommodate the new road alignment.

Site 28 – looking upstream

Drainage Area:	31.4 square miles
Existing Structure:	2@ 4-span bridges; 270 feet long
Existing Channel:	Stream width varies between 20' and 30' with 4'-6' tall vertical banks
Recommended Structure:	Replace with 2@ 4-span bridges 290 feet

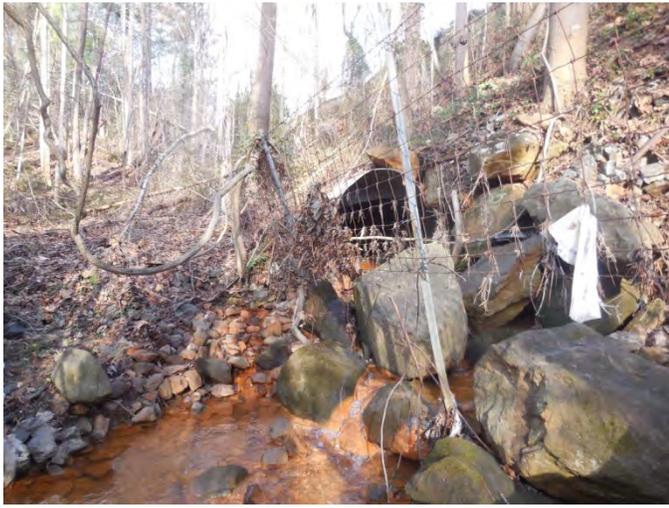
Site 31 – looking upstream

It is recommended to replace the existing structure with an 84" CMP.

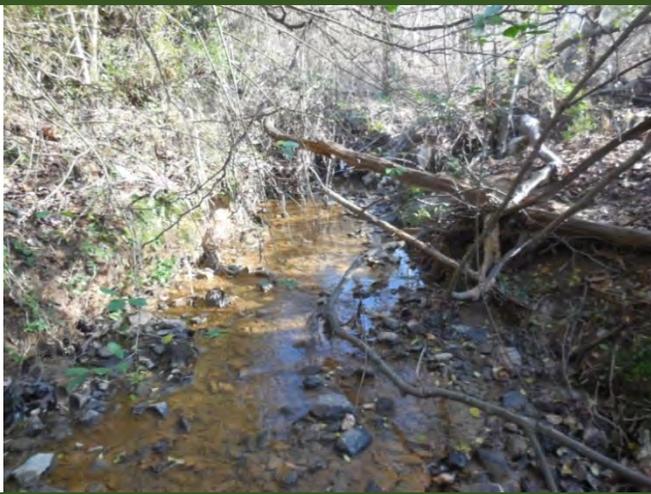
Site 32 carries an unnamed tributary of Wagner branch on I-26. The inlet pipe to the tributary is a 42" corrugated metal pipe with a concrete headwall. The outlet pipe is a 60" CMP. There are visible drop inlet structures located throughout the length of the pipe. There is evidence of erosion along the pipe also. Water is flowing around the upstream headwall and inlet. The upstream and downstream banks are unstable and there are surrounding branches and foliage around the downstream face. Although no significant buildup of debris was noted at the time of the field visit, there is a moderate potential for buildup as the banks are highly vegetated. The incoming upstream flow enters from a sharp angle. There is a high water mark at 7 feet above invert.

Site 32 – looking upstream

The recommended action is to replace the existing 42"/60" CMP system with an 84" CMP and drop inlets. As the existing system carries stream flow and allows for additional water along its length, the replacement system should do the same.

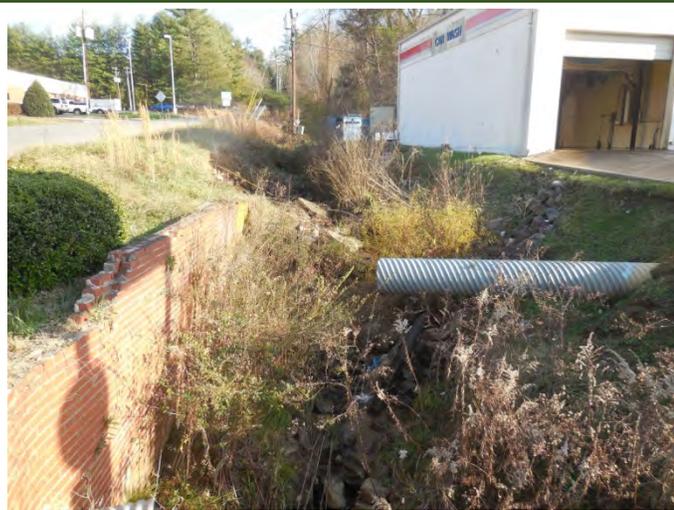
Site 33 conveys an unnamed tributary adjacent to Leisure Mountain Road. The vertical banks have an abundance of vegetation and are also unstable with considerable erosion. There are two pipes which appear to originate from the adjacent car wash, which contributes to the upstream flow. At this inlet, the slopes are failing, as is the brick and concrete retaining wall. At the downstream face, there is an intersecting fence and an approximate 2-foot drop into a 12-foot wide pool. The area is heavily wooded and, the vertical banks are unstable. Riprap is present and there is approximately 100 cubic yards of erosion. There is a berm located roughly 50 to 60 feet.

Site 33 – looking upstream

The recommended action is to replace the existing 48" CMP with a 72" CMP.

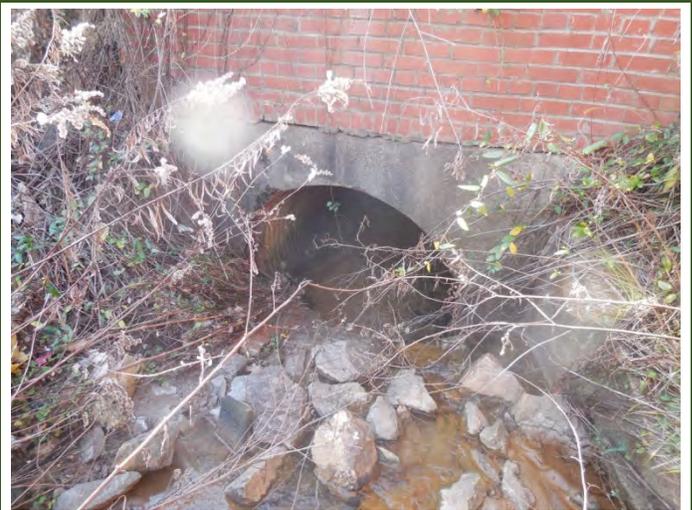
Site 33 – upstream face

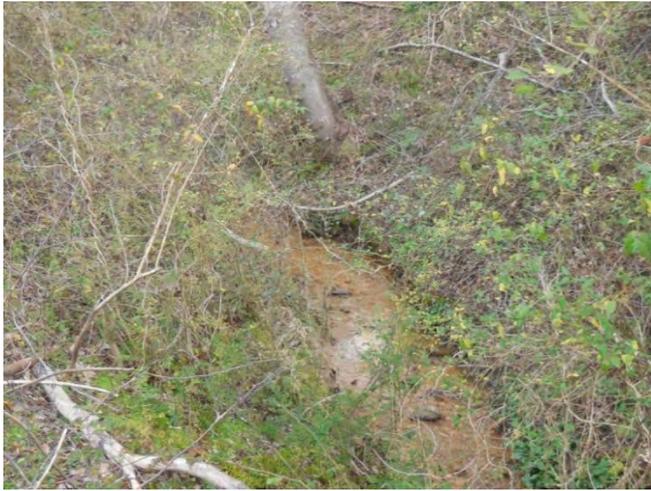
Site 37 conveys an unnamed tributary to Beaverdam Creek Tributary 1. Site 37 is located on I-26 and Old Weaverville Road. Evidence of accumulating sediment buildup is present at the downstream end. Banks at the upstream and downstream ends of the culvert are all in stable condition. The upstream channel flows parallel to I-26 and turns to enter into the upstream end at a headwall. Additionally, there is a residence located within 200 feet of the stream, at an elevation approximately 10 feet above the stream bottom. At the downstream end, there is a residence within 50 feet of the channel at an elevation of roughly 5 feet above the banks.

Site 37 – looking upstream

The recommended action is to extend the existing 66" CMP to the proposed fill limits (130'). However, a 72" pipe was sized to fit the flow at this location for a 50-year storm. Because the existing culvert is in good condition, it is recommended to keep the existing culvert.

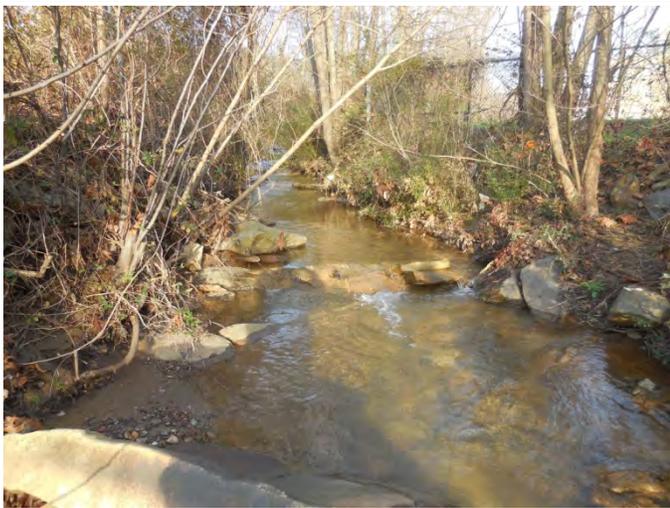
Site 39B carries Beaverdam Creek Tributary 1 at the intersection of Weaverville Road and the ramps to I-26 northbound lanes. The banks are stabilized with riprap. There is a large rock at the culvert entrance, and at the time of field visit, the flow was limited to the east barrel. There is roughly 1 cubic yard of erosion behind the wingwall at the upstream side. Downstream is the confluence with Beaverdam Creek. This site has a re-delineated floodplain and the crossing is in special flood hazard zone AE. It should be noted that there are commercial properties and buildings located both up and downstream of this site within the flood zone.

Site 39B – looking upstream

The new structure is recommended to be a single 9'x 9' box culvert to meet the size requirements for a 50-year storm event.

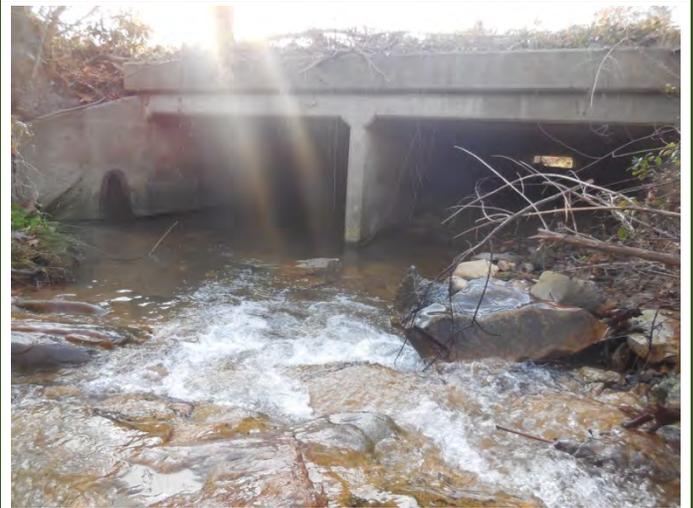
Site 39B – upstream face

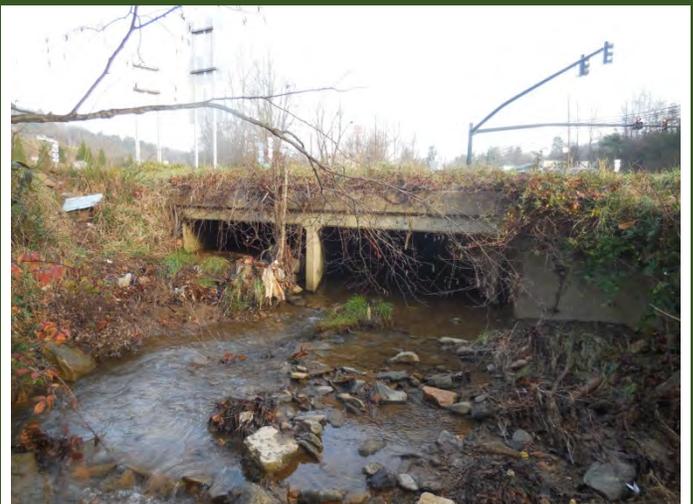
Site 39B – downstream face

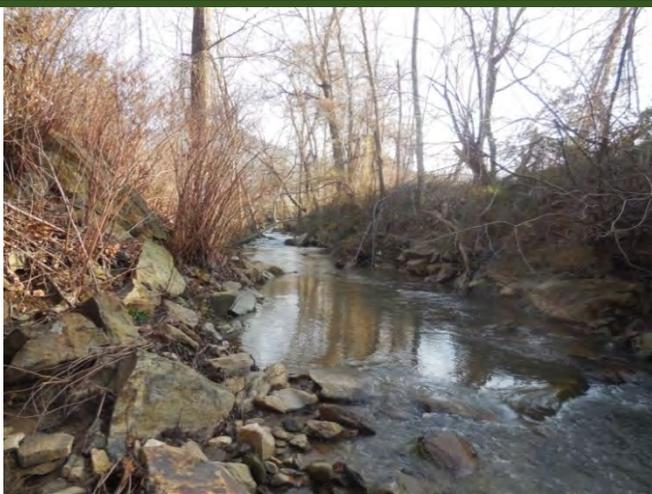
Site 41 is approximately 500 feet downstream of the confluence of Beaverdam Creek Tributary 1 to Beaverdam Creek on I-26. Flow is in a westerly direction. The site consists of two 5-span bridges of I-26. The stream is characterized by 4 to 5 feet tall banks, with vertical sides at the stream location, and 4:1 side slopes beyond that. There is Class A riprap lining the banks beneath the bridge. A railroad track lies in span 2 of the bridges. The stream flows in span 4, and a gravel road with access to a waste facility is located beneath span 5 of the bridges. The bridges are in good condition, but will be replaced as part of the project.

Site 41 – looking upstream

Drainage Area:	11.9 square miles
Existing Structure:	2@5-span bridge 380' long
Existing Channel:	Stream base width of 12'-15' with depth of flow 3'
Recommended Structure:	Replace with 2@ 5-span bridges 380' long

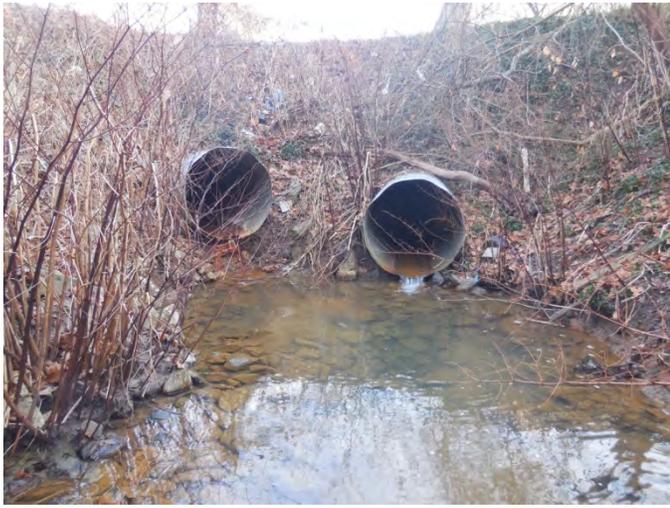
Site 44 is an unnamed tributary to the French Broad River on I-26. The surrounding area consists of woods and businesses with parking lots. At the upstream side, there are two 54-inch pipes carrying the flow. The southern pipe is reinforced concrete with a corrugated metal pipe extension. The north pipe is corrugated metal. It was noted that the pipes seem to flow beneath a business located just upstream. There is a plunge pool at the base of the two pipes, approximately 50 feet across and 50 feet upstream of site 44. The banks surrounding the pool have a slope of approximately 1:1. The upstream end of the pipe has riprap inlet protection. It was noted that there were two sewer manholes located at each the north and south sides of the pool, at the top of the slopes.

Site 44 – looking upstream

There is no recommended action for this crossing. The existing dimensions are calculated to be hydraulically sound for the facilitation of a 50 year storm event. There is insufficient space allotted to expand the length of this culvert so the fill slopes should be adjusted at this location to fit the current inverts.

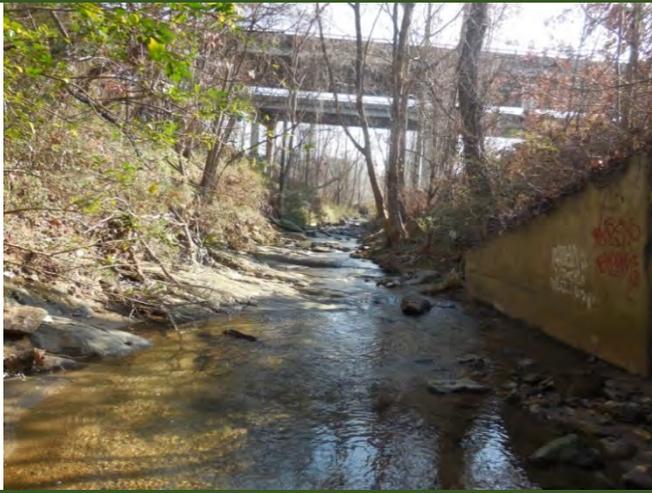
Site 48 – looking upstream

It is recommended to extend the existing RCBC 108 feet. The new structure is recommended to retain the existing dimensions which currently exceed the size requirements for a 50-year storm event.

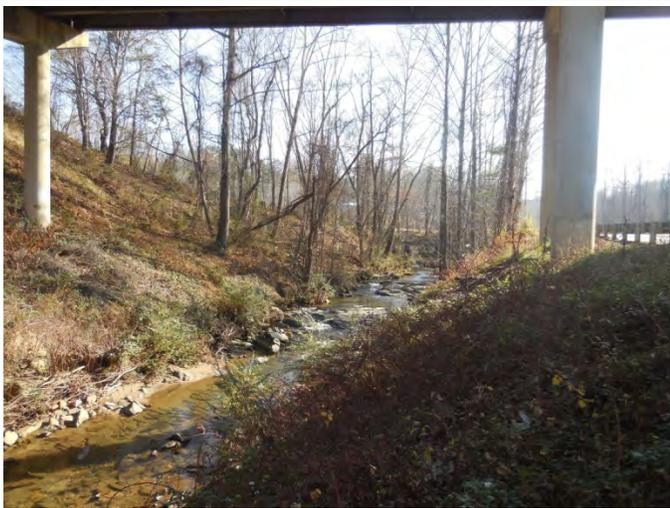
Site 49 – looking upstream

Drainage Area:	3.71 square miles
Existing Structure:	2@ 4-span bridge 310 feet long
Existing Channel:	Sandy/gravel bottom with large submerged rocks
Recommended Structure:	Replace bridges 310 feet long

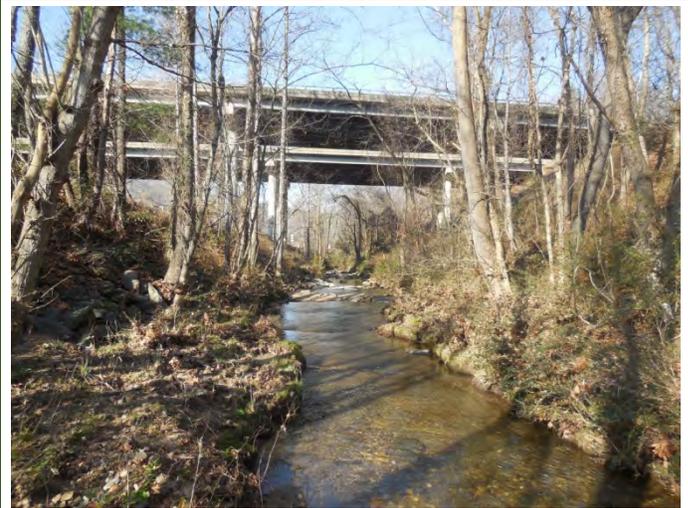
Site 49 – upstream face

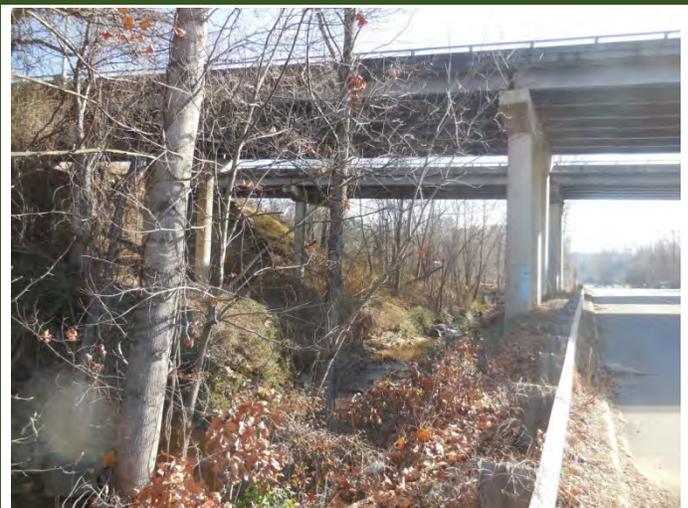
Site 49 – downstream face

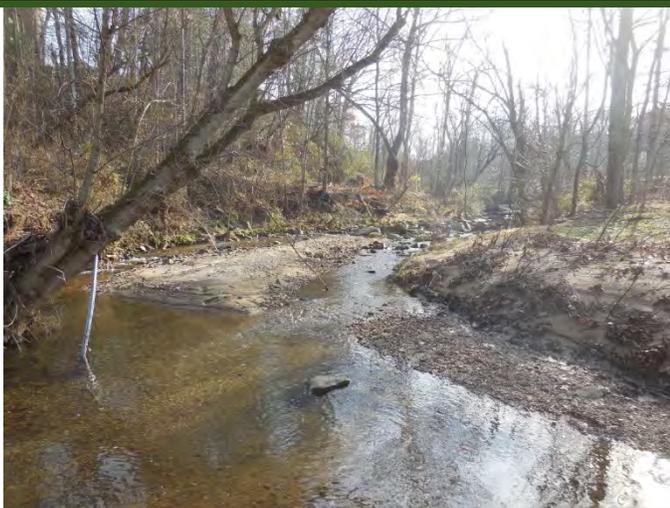
Site 51 – looking upstream

It is recommended to retain the existing RCBC, which exceeds the size requirements for a 50-year storm event.

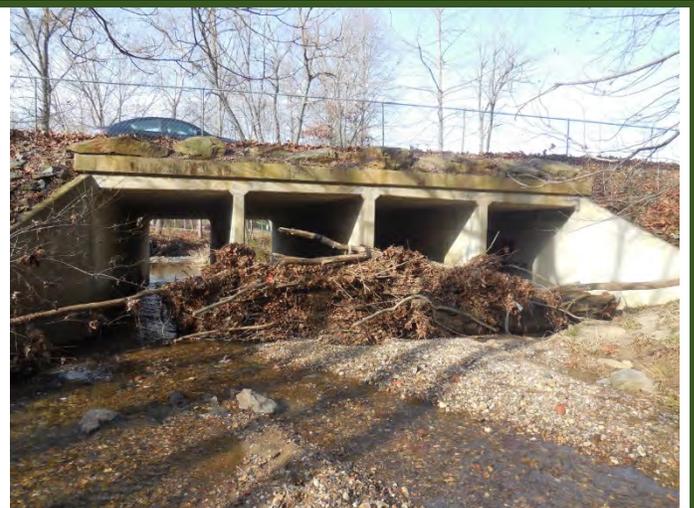
Site 51 – upstream face

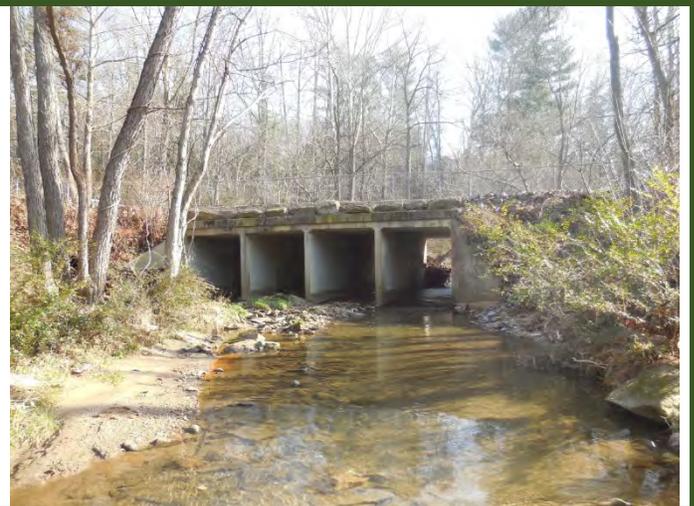
Site 51 – downstream face
