PRELIMINARY HYDRAULICS STUDY
FOR
ENVIRONMENTAL IMPACT

NCDOT TIP NO. R-3410
Widening of NC 42 from US 70 Business to NC 50
Johnston County, NC

2-13-2018

SUNGATE DESIGN GROUP, P.A.

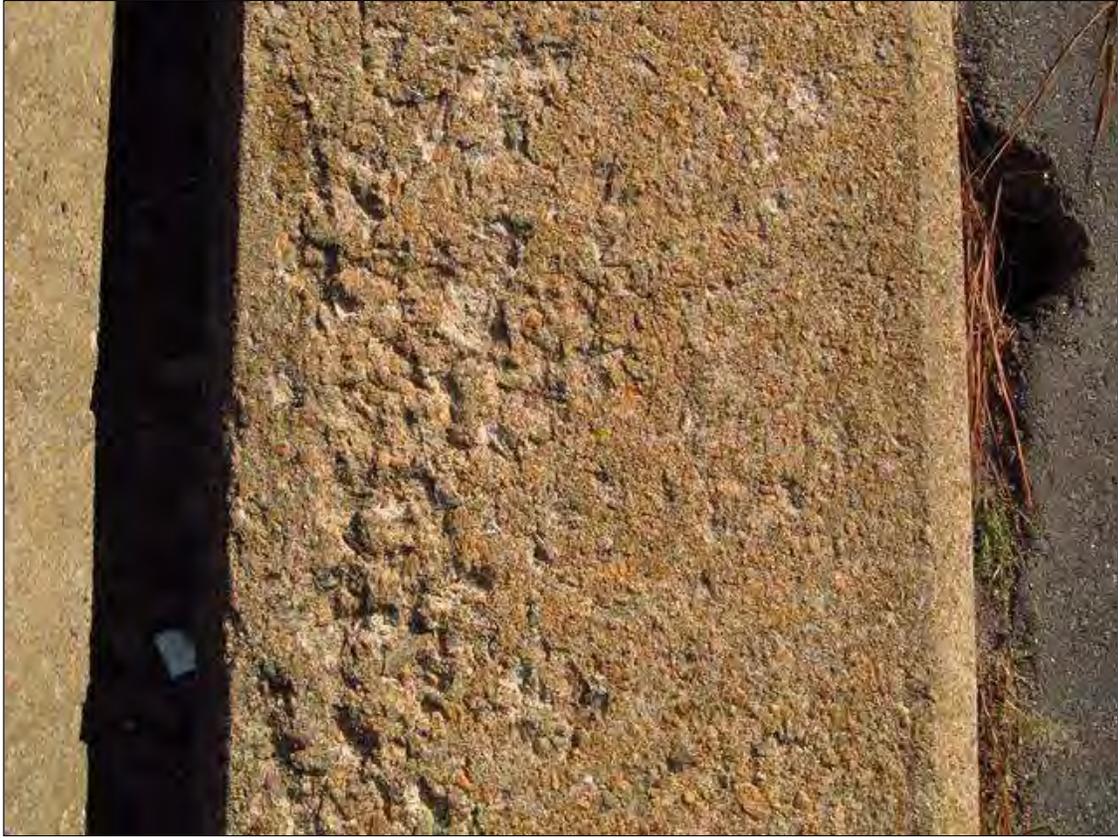
Abrasion along deck curbs

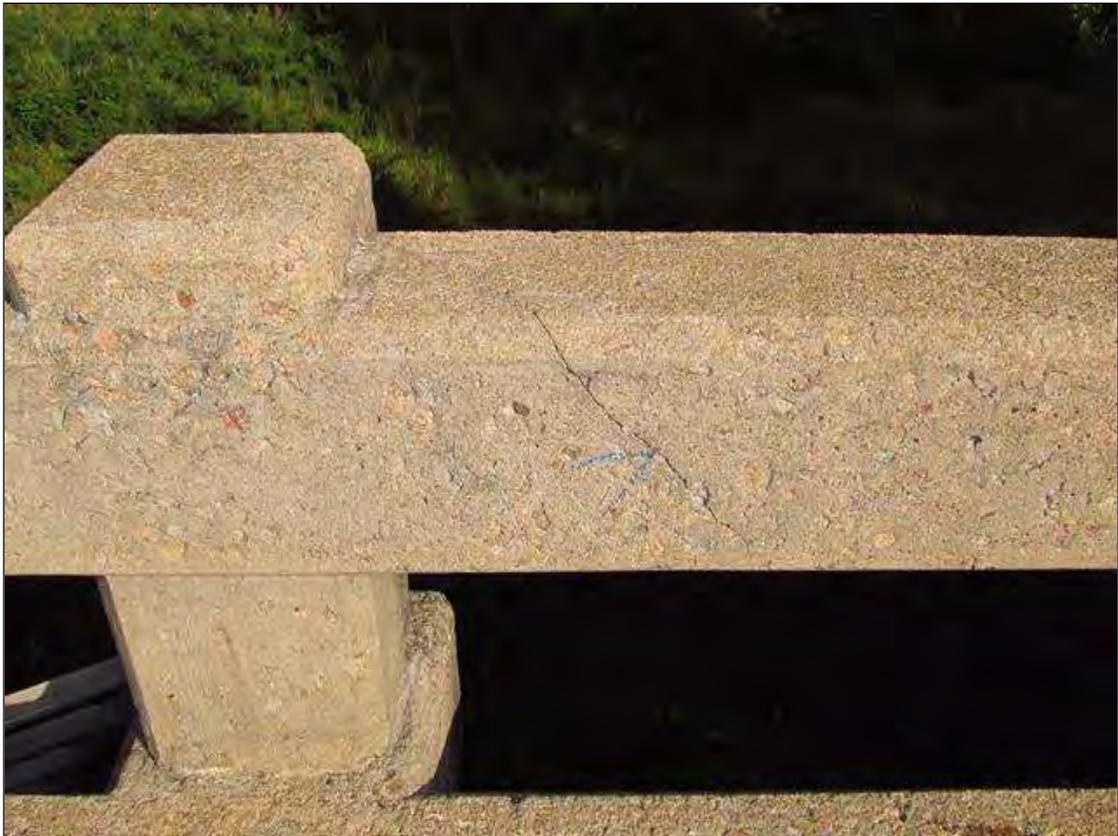
Transverse crack in the Left side guardrail in Span 1

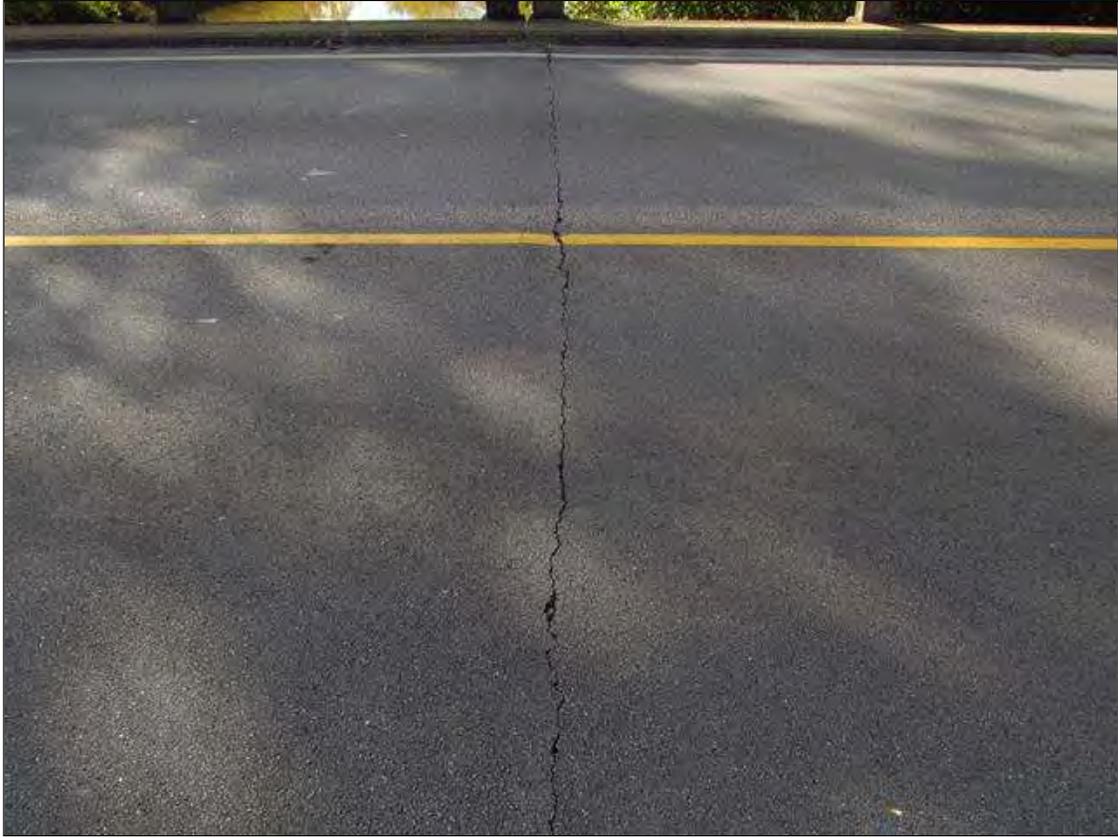
Transverse crack in Wearing surface over Bent 2

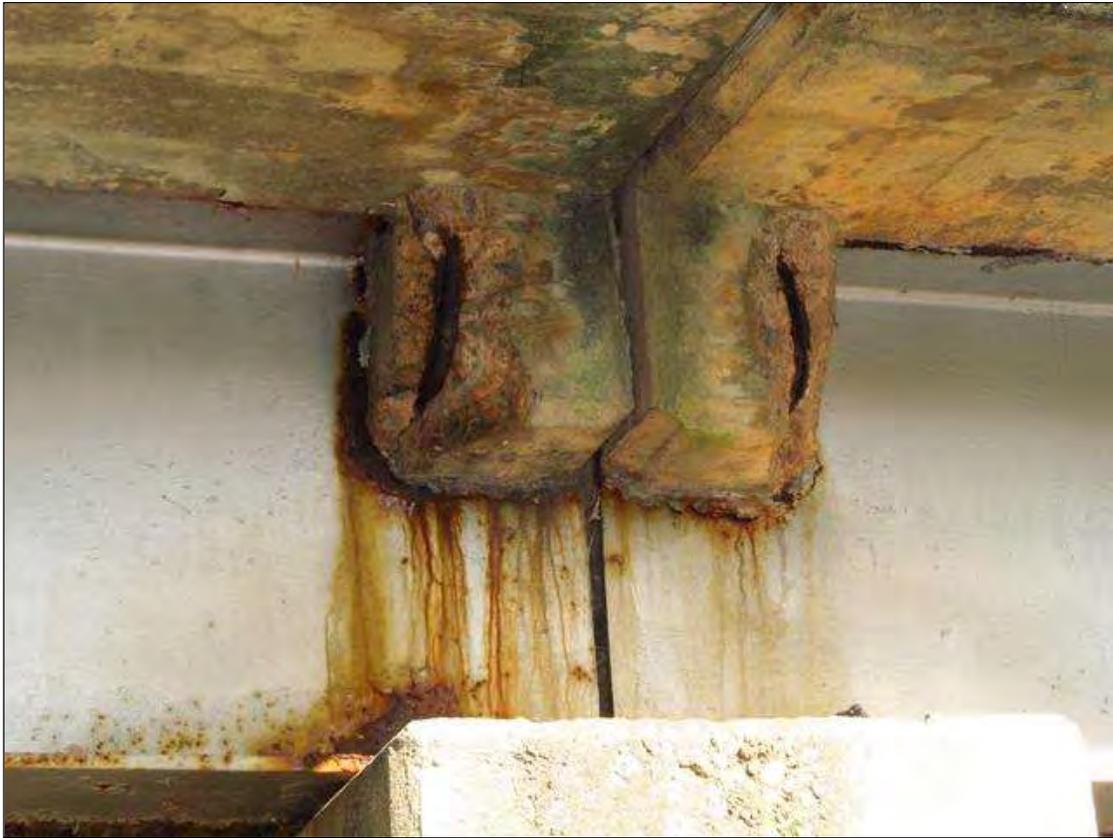
Section loss in the ends of Beam 1 over Bent 2 - other beams similar

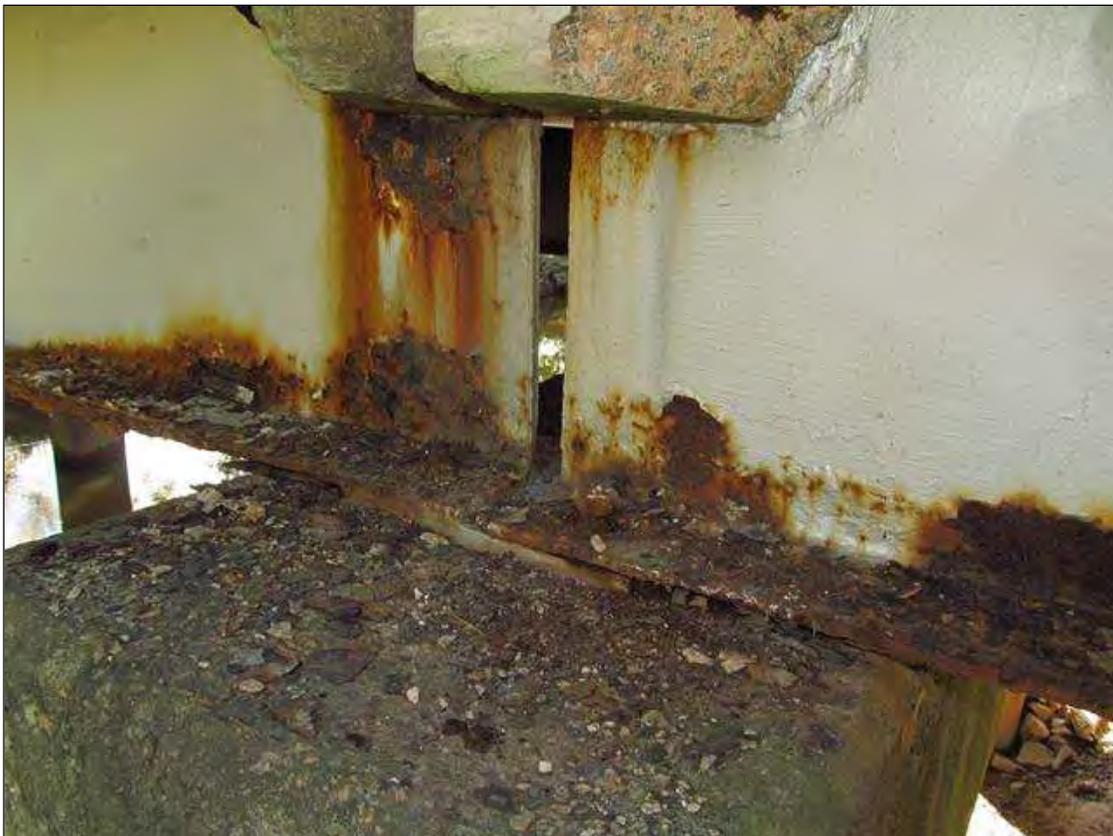
Section loss in Beam 1 Bearing assemblies at Bent 2 - other bearings similar

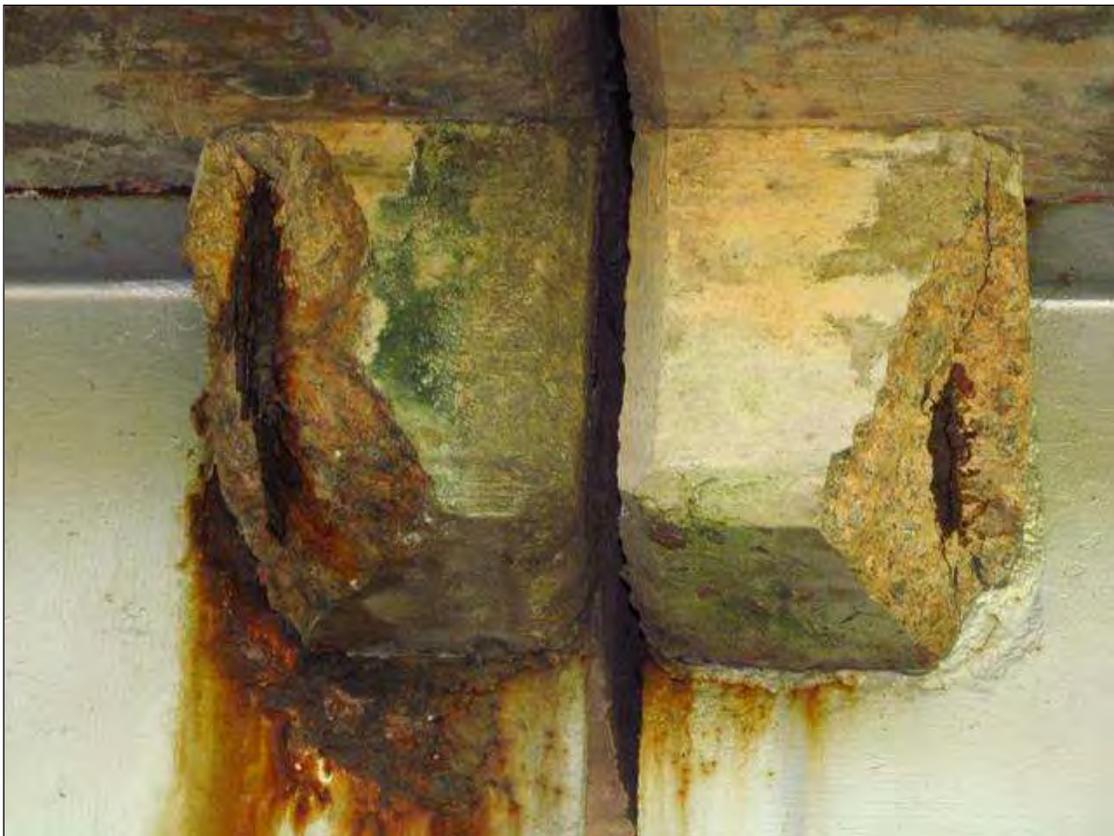
Spalling with Section loss to Exposed rebar in Span 2 end Diaphragm at Bent 2 bay 2 - bay 1 similar

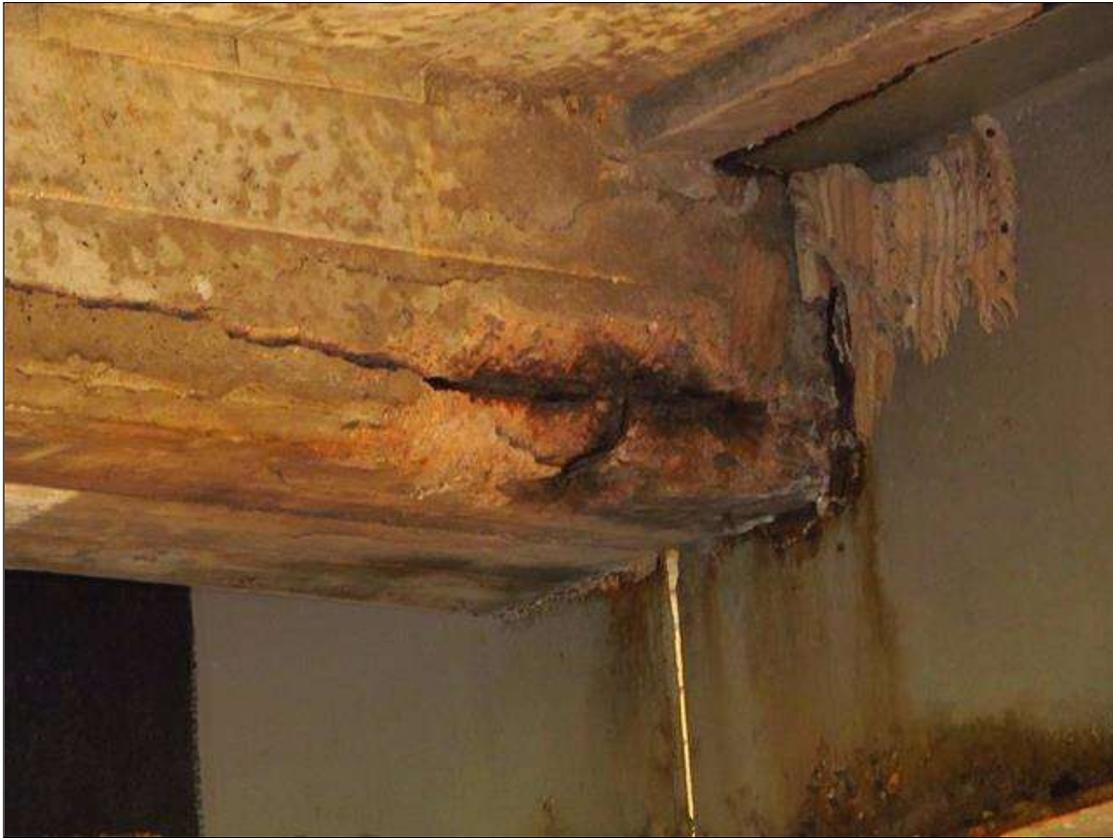
Spall with Section loss to Exposed rebar in Face of cap at Bent 2 Span 2 side at left end

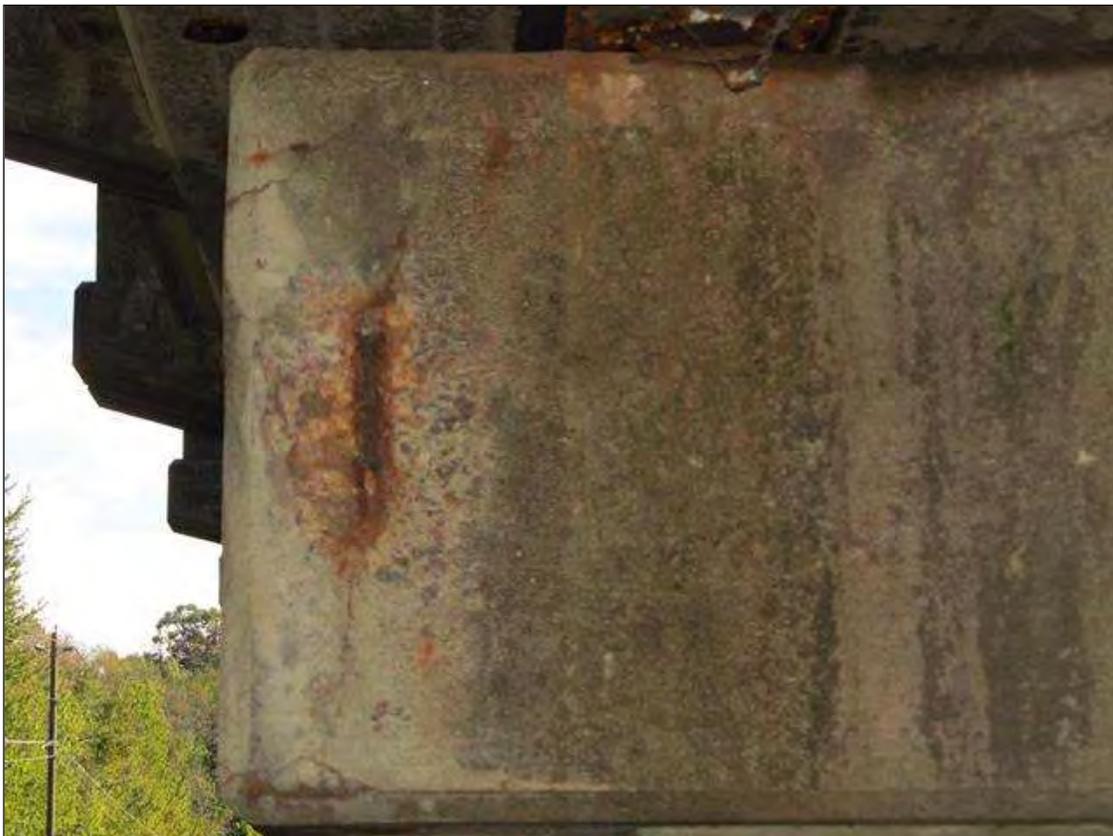
Spalling and Delamination in Backwall at End Bent 1 to the Left side of Beam 1

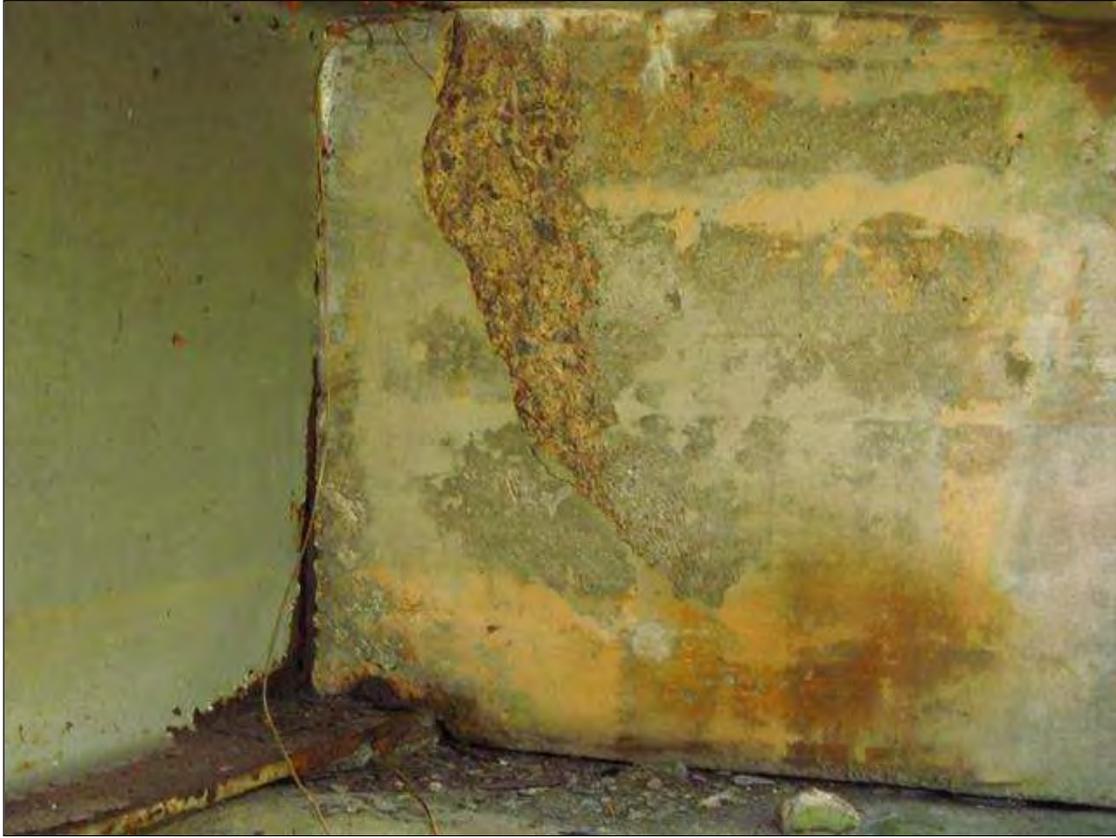
Grout Repair cracked and separated across End Bent 2

Details Erosion under span 5 between bent 4 piles to stream 3 ft wide x 6 ft long.
End bent 2 berm cracked and settled 2 in, has been repaired with grout, repair is cracked.

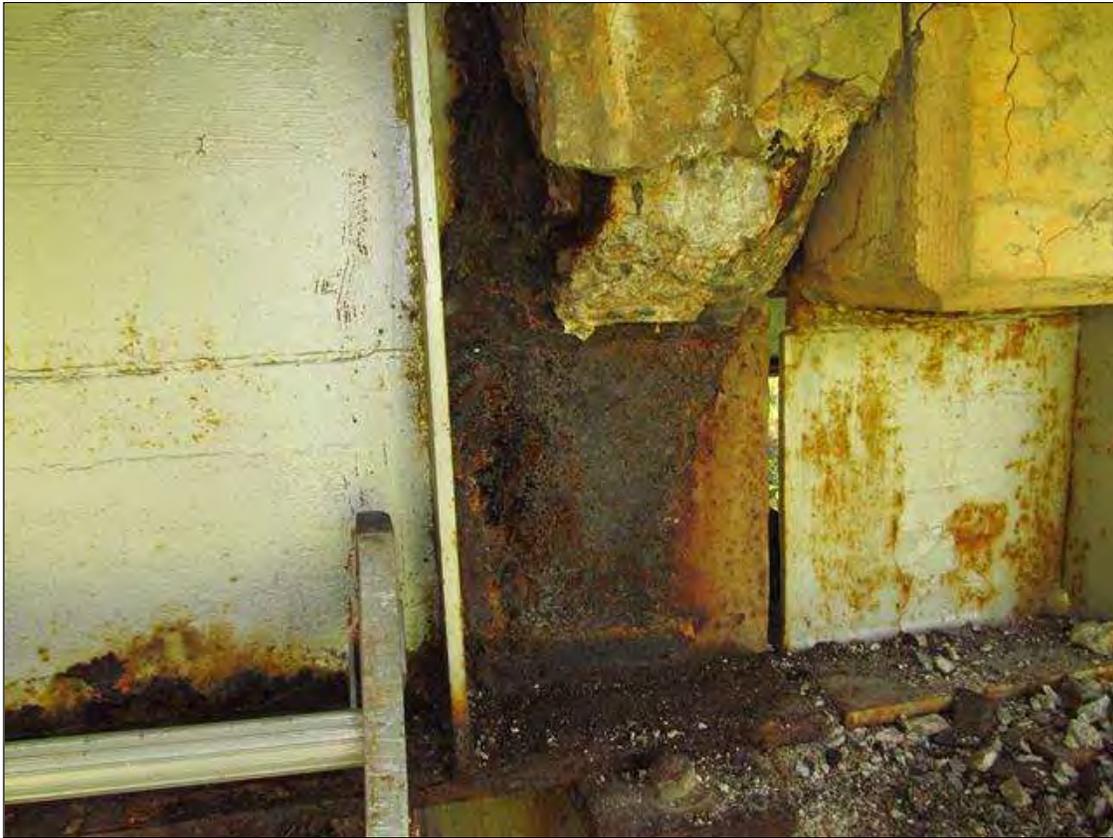
Section loss in the Bottom flange of Beam 1 in Span 5 over Bent 4 extending out 4 ft.

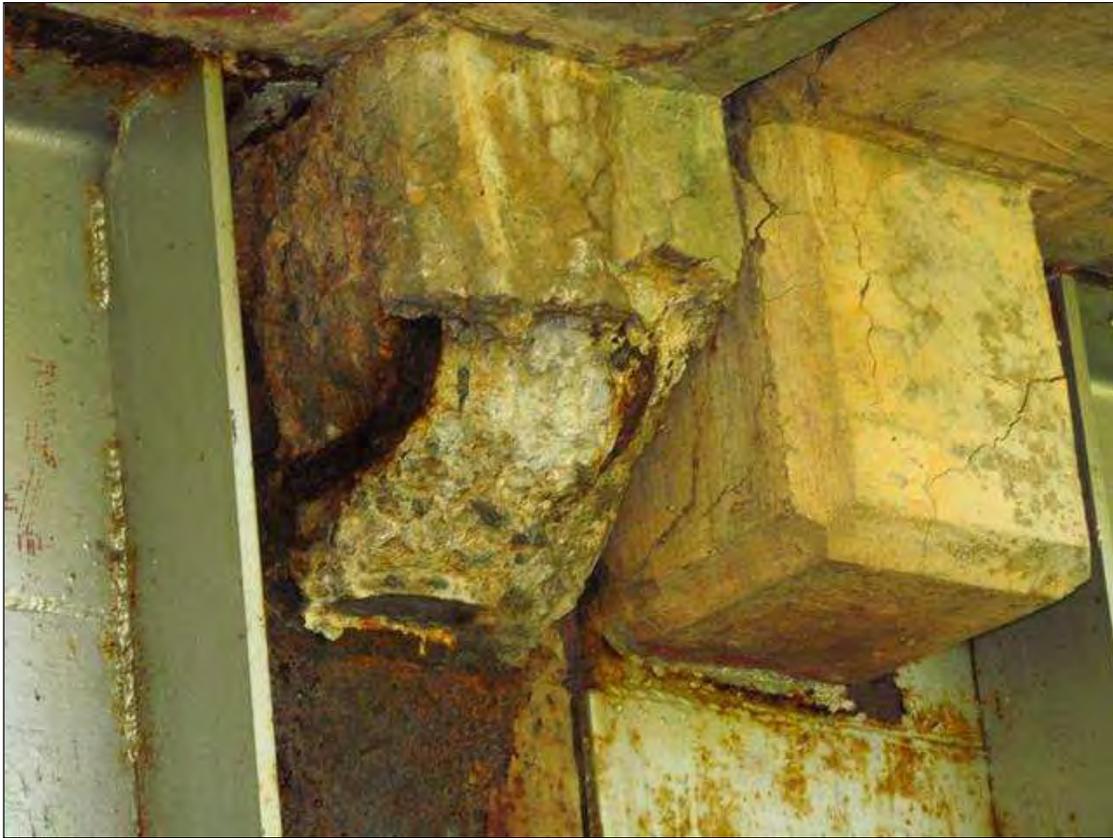
Section loss in existing repair (Bottom flange and web) of Beam 1 in Span 5 over Bent 4 - other repairs similar

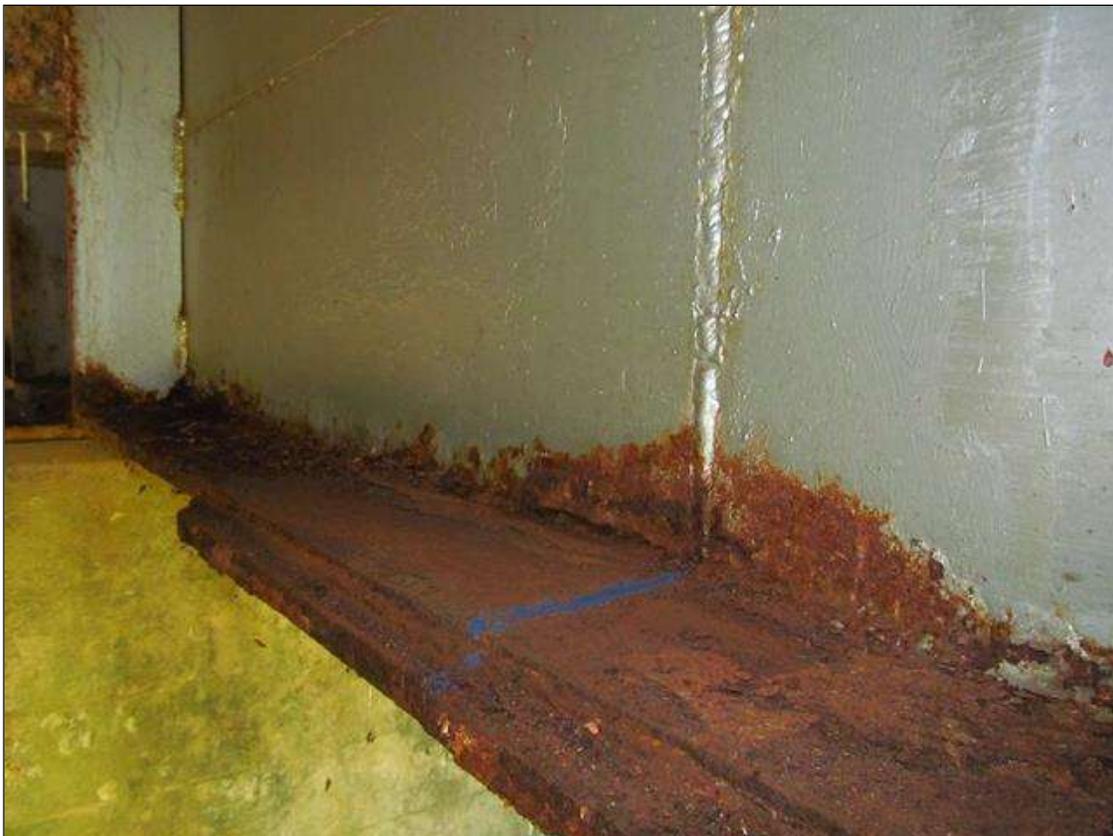
Rust scale along edges of cover plate for Beam 1 in Span 5 near Bent 4

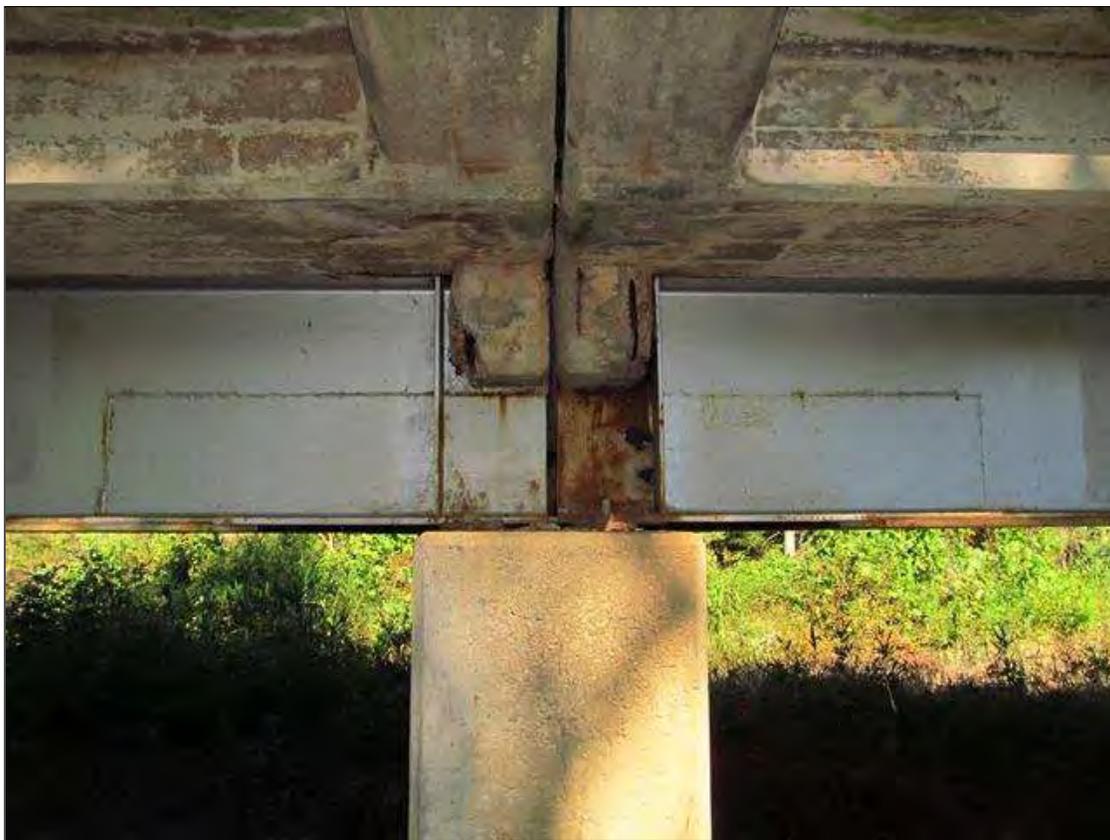
Ends of beams over Bent 4 all have existing repairs

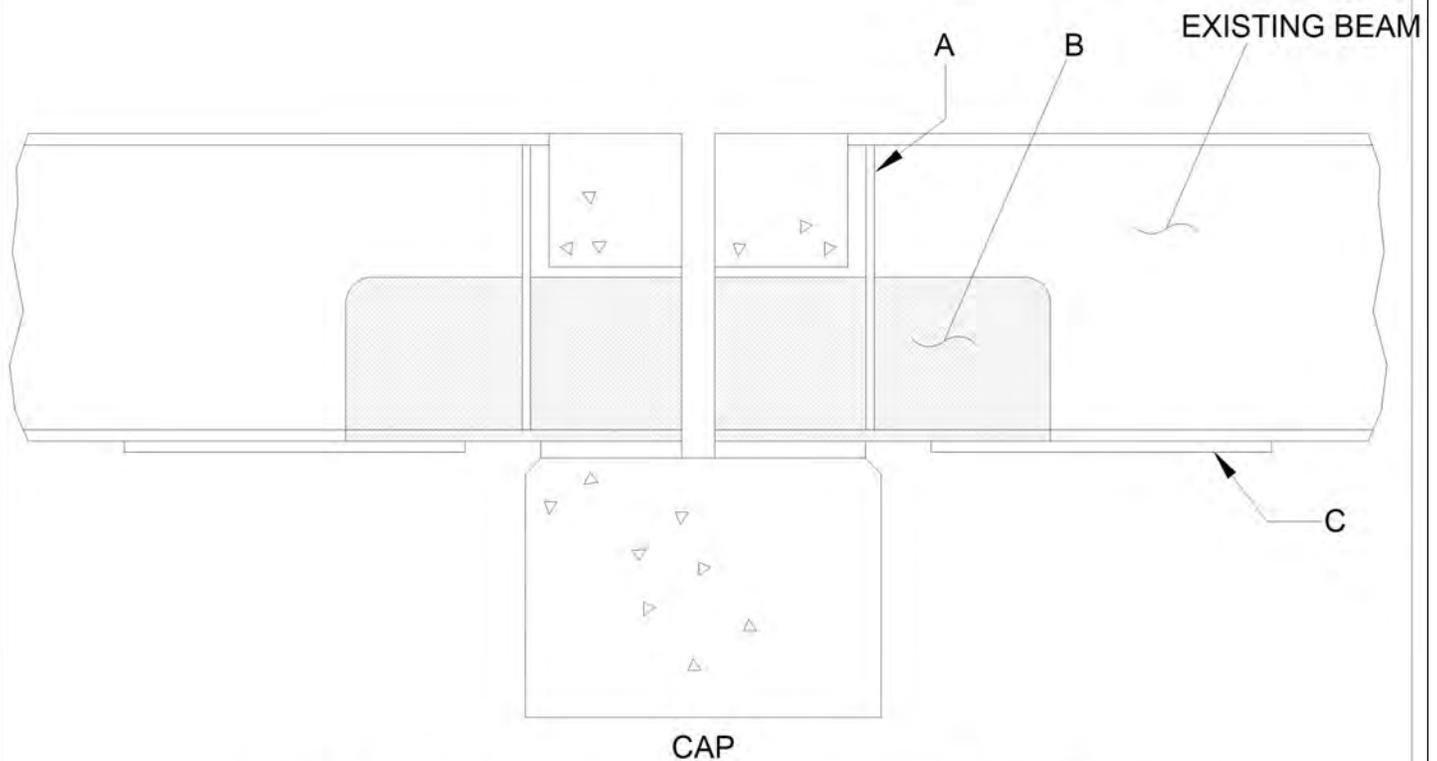
TYPICAL BEAM REPAIRS FOR BEAMS 1-3
BENT 4 SPANS 4 & 5

A	1/2" x 5" VERT. STIFFNER 12" FROM END OF BEAM
B	14" x 3' SECTION OF WEB AND BTM FLANGE REPLACED
C	3/4" x 12" x 3' COVER PLATE ADDED TO BTM FLANGE

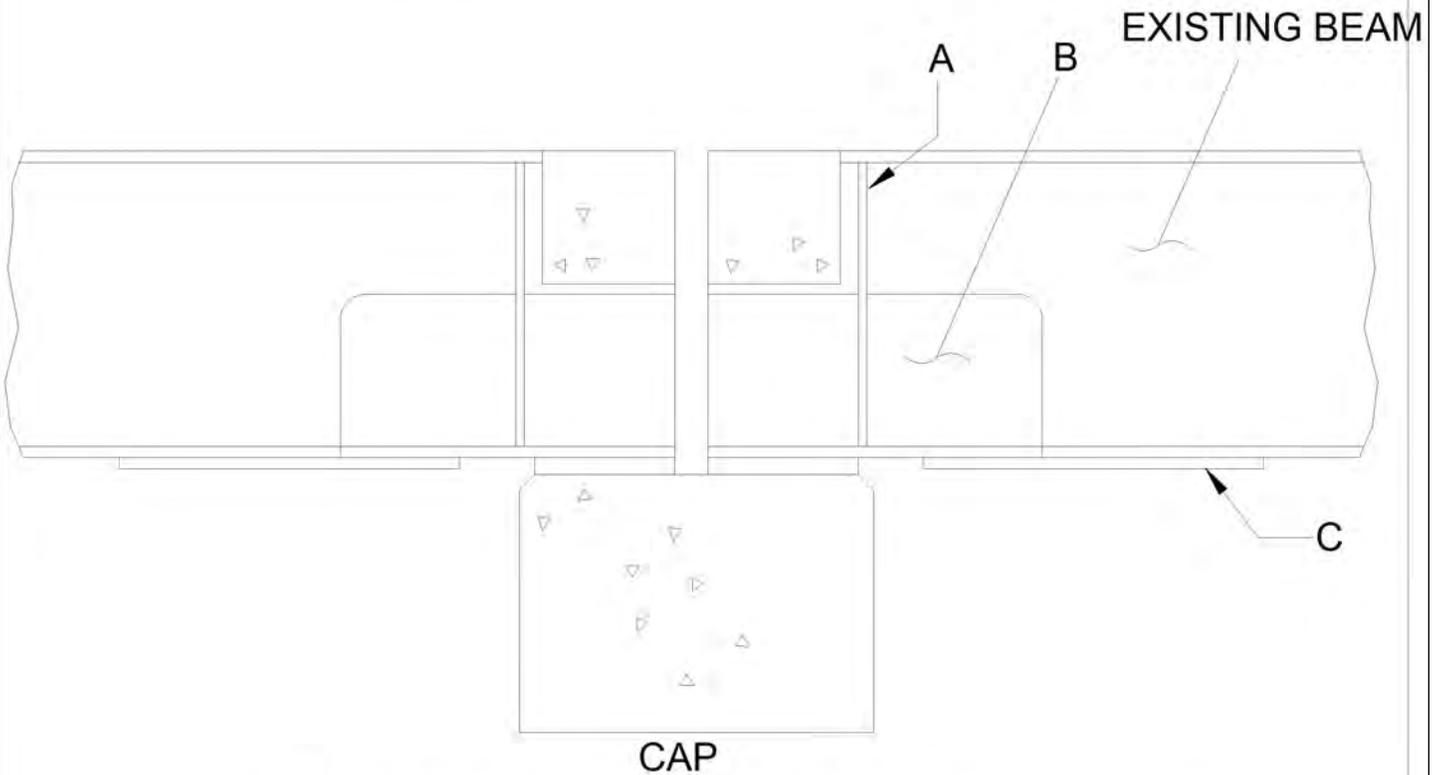
BEAM 4 REPAIR AT BT4 SPANS 4 & 5

A	1/2" x 5" VERT. STIFFNER 12" FROM END OF BEAM
B	14" x 4' SECTION OF WEB AND BTM FLANGE REPLACED
C	3/4" x 12" x 3' COVER PLATE ADDED TO BTM FLANGE

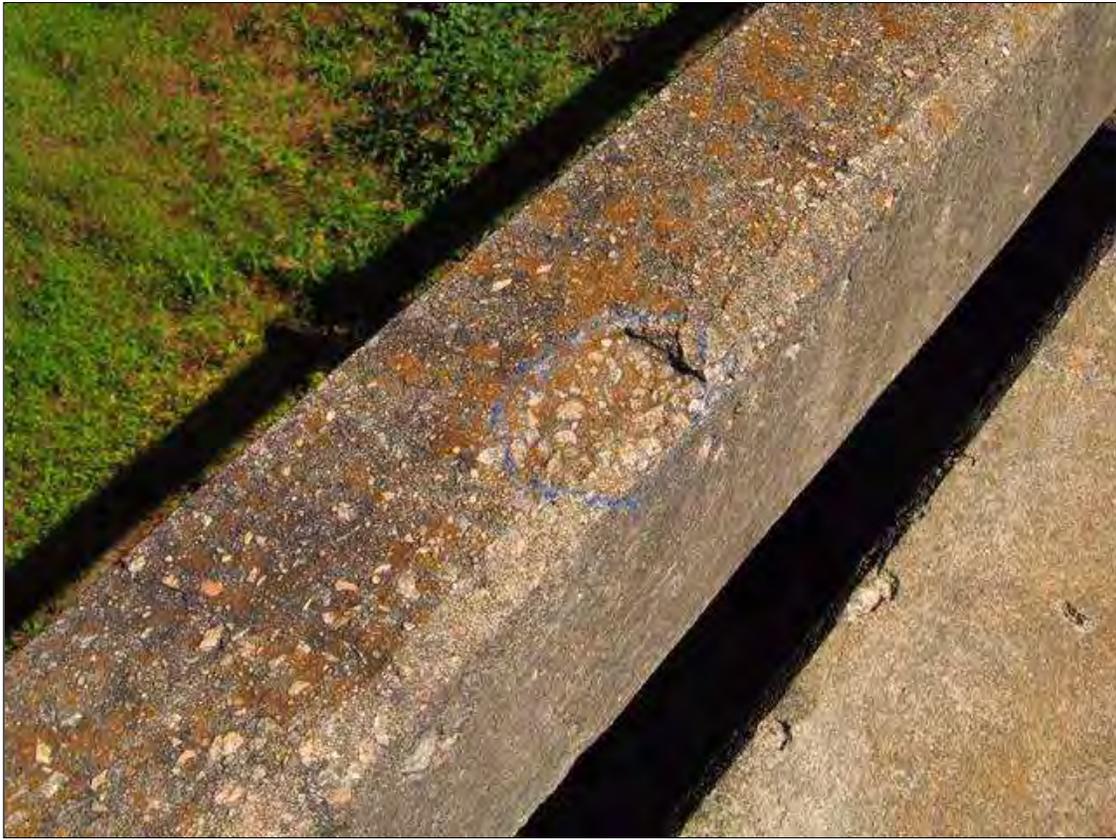
Spall in the left guardrail in Span 2

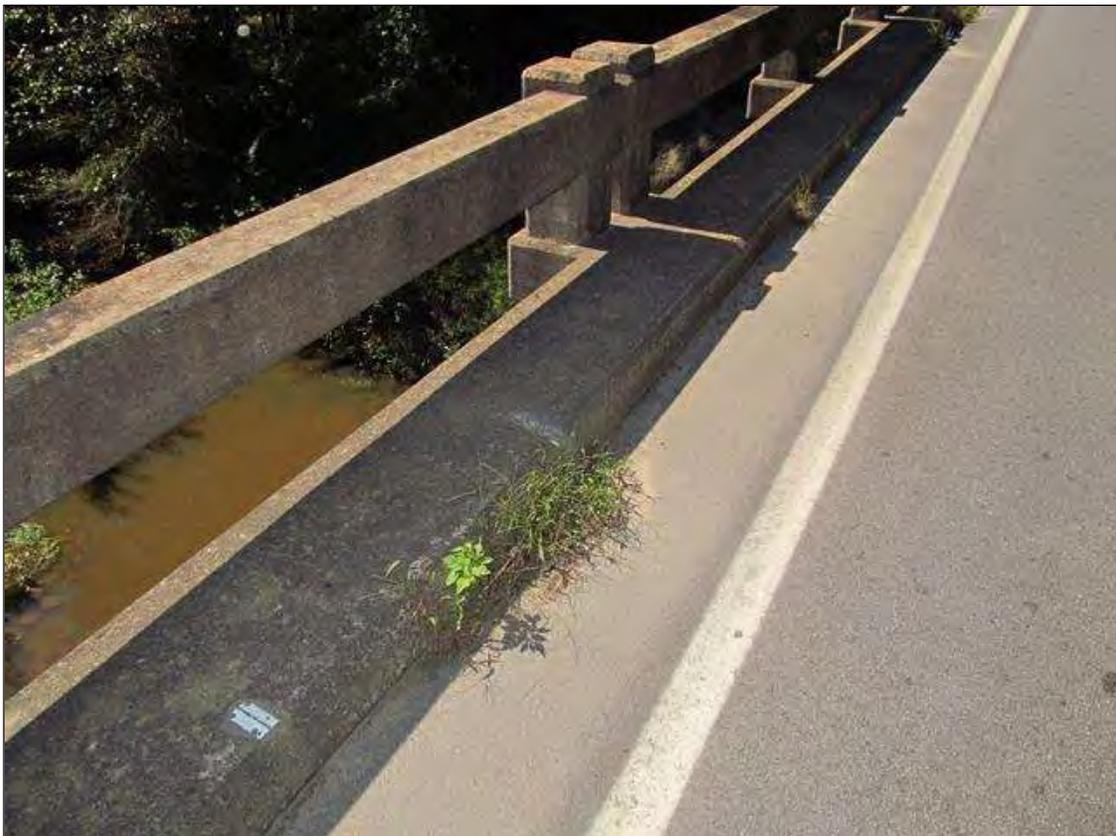
Dirt and Vegetation along deck curblines

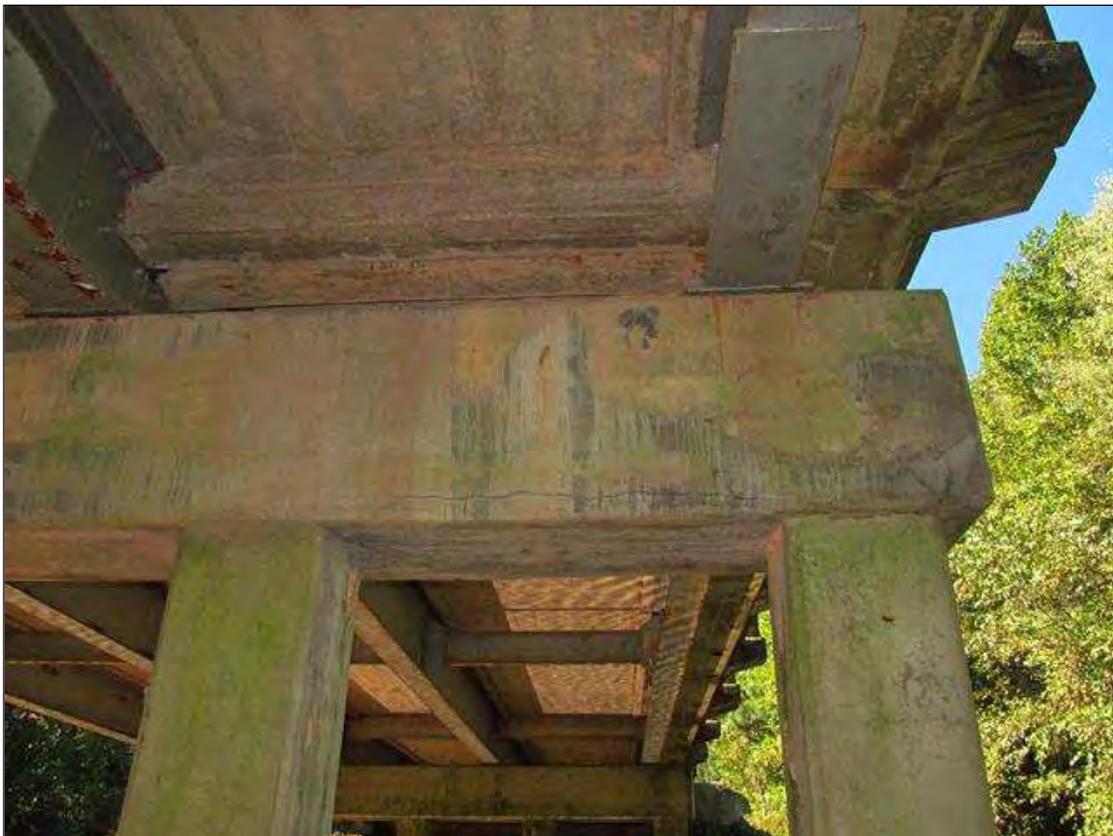
Horizontal crack in Face of cap at Bent 2 Span 3 side between piles 1 & 2

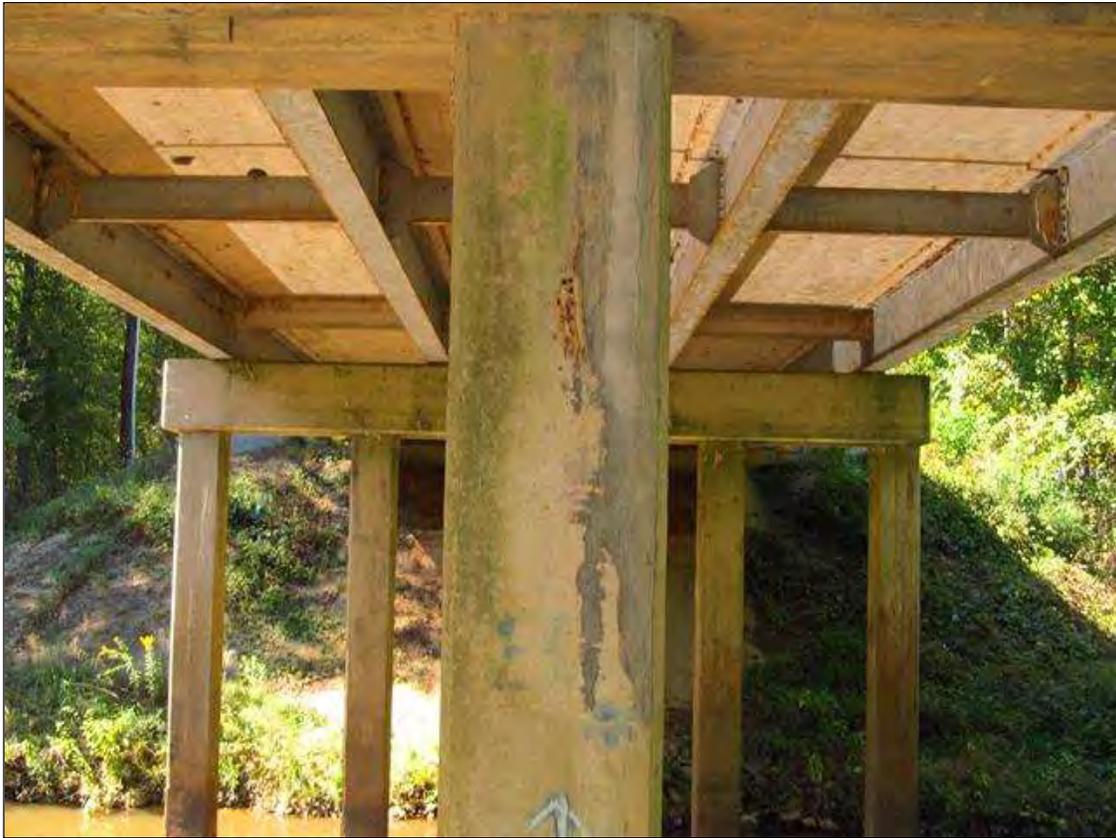
Cracked patch in Span 3 side of Pile 3 at Bent 2

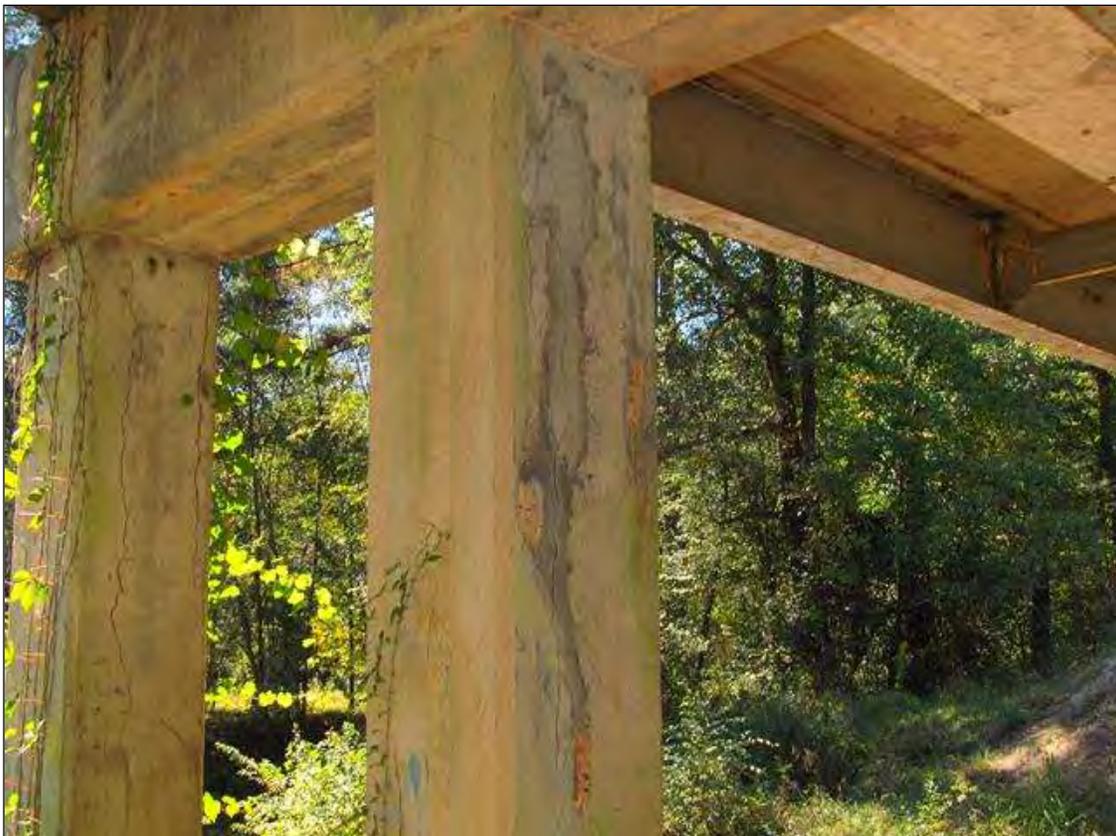
Cracked patch in the Left side of Pile 4 at Bent 2

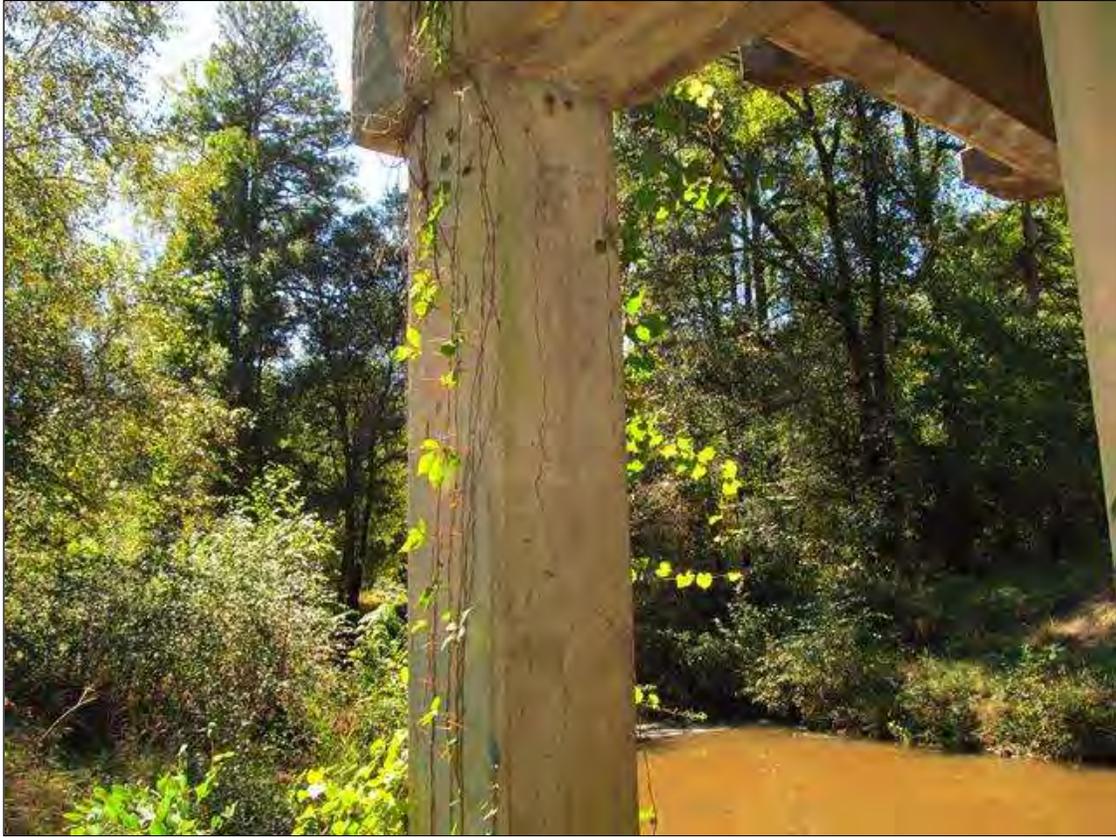
Vertical cracks and Delamination in the Left side of Pile 5 at Bent 2

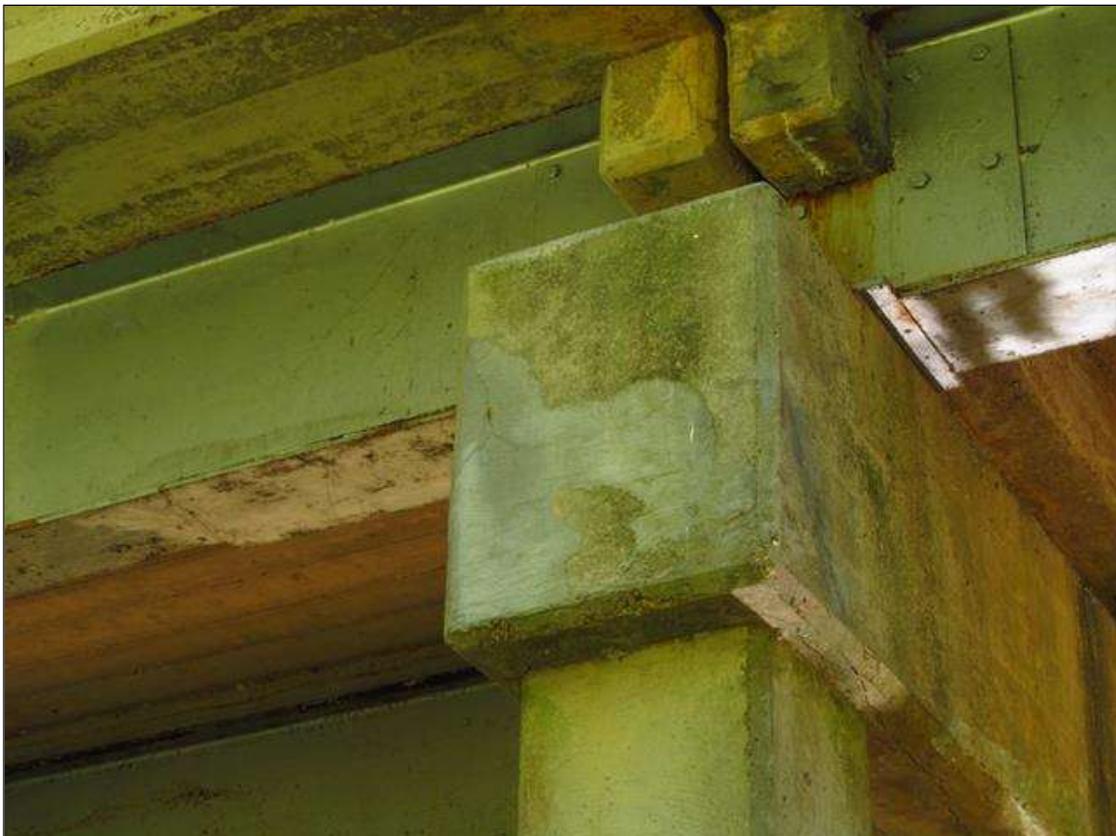
Repair patch in left End of cap at Bent 2

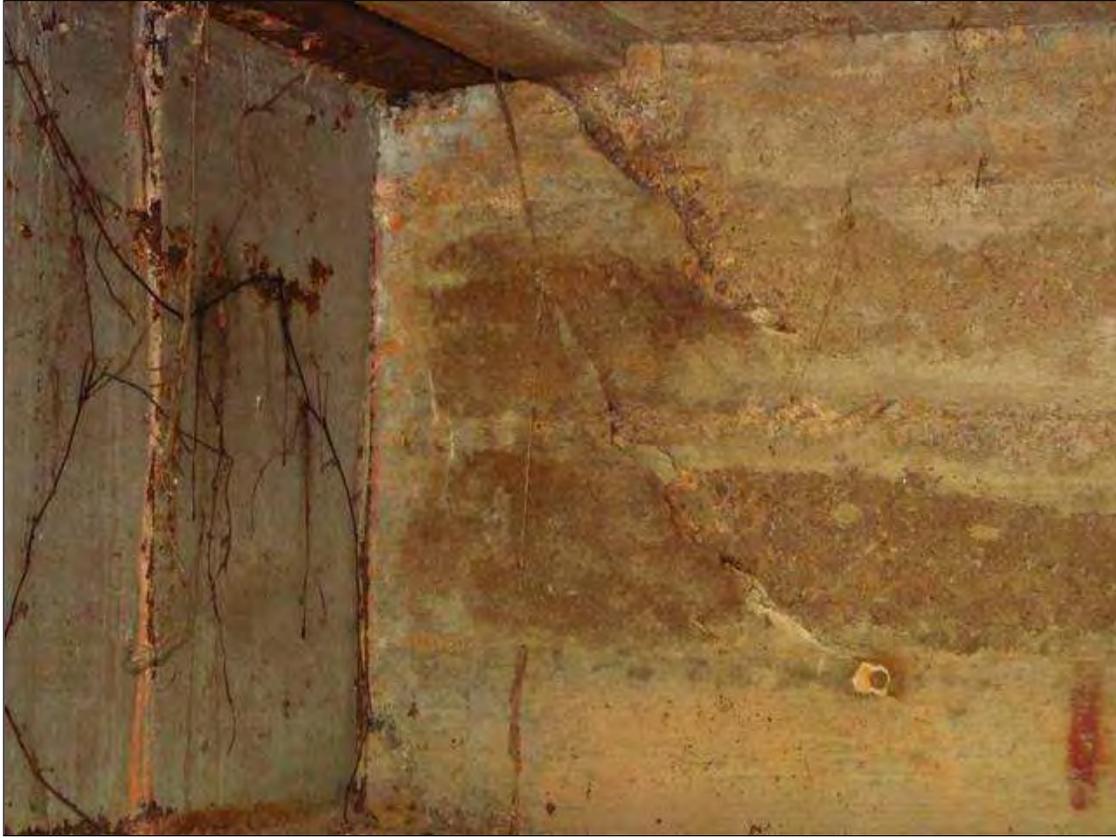
Cracking and Delamination in End Bent 1 Backwall Adjacent to the Left side of Beam 4 - other areas similar

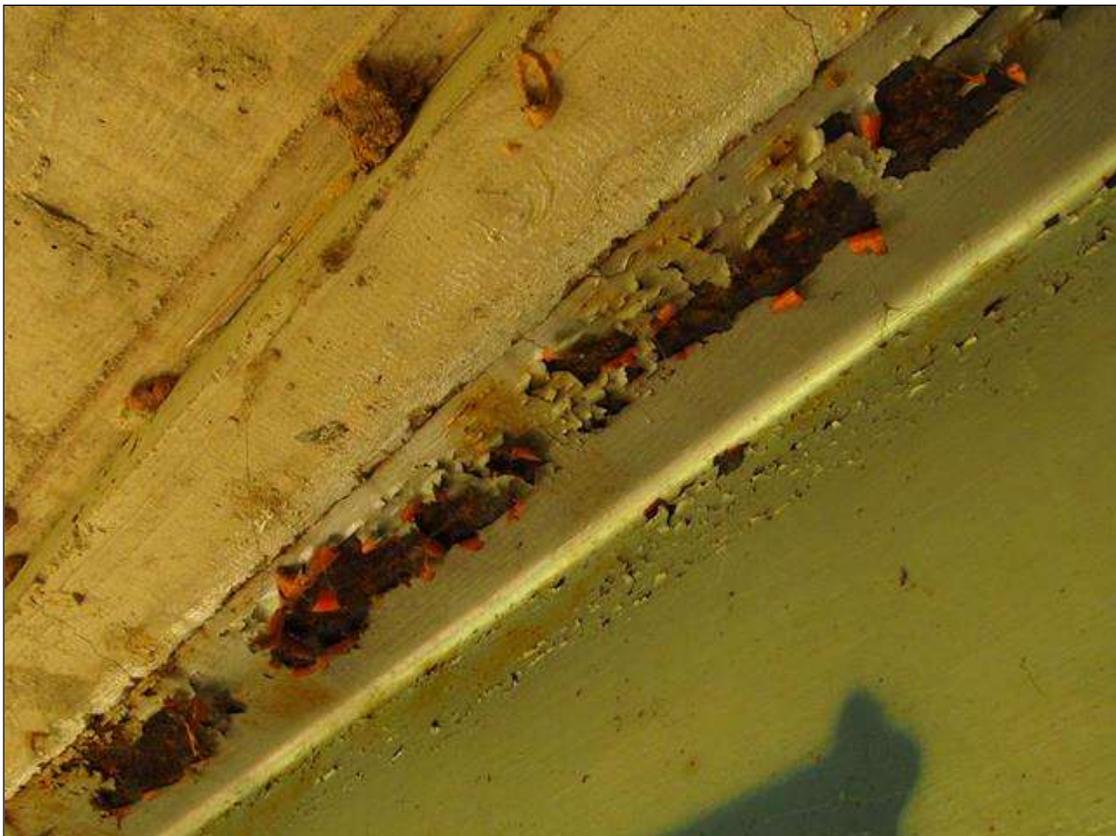
Peeling paint with Surface rust to exposed steel in beam webs and flanges throughout structure
