PRELIMINARY HYDRAULICS STUDY
FOR
ENVIRONMENTAL IMPACT

NCDOT TIP NO. R-3410
Widening of NC 42 from US 70 Business to NC 50
Johnston County, NC

2-13-2018

SUNGATE DESIGN GROUP, P.A.

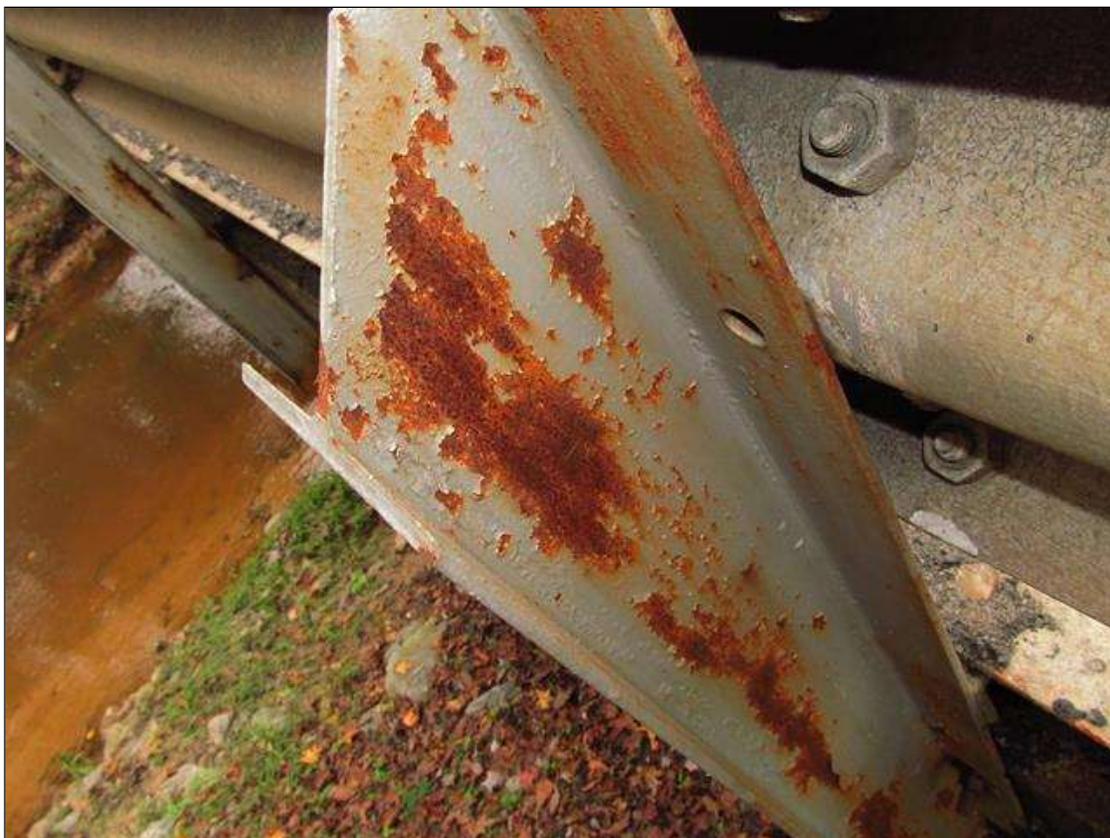
Widespread areas of peeling/missing protective coating with Surface rust to exposed steel in guardrail posts

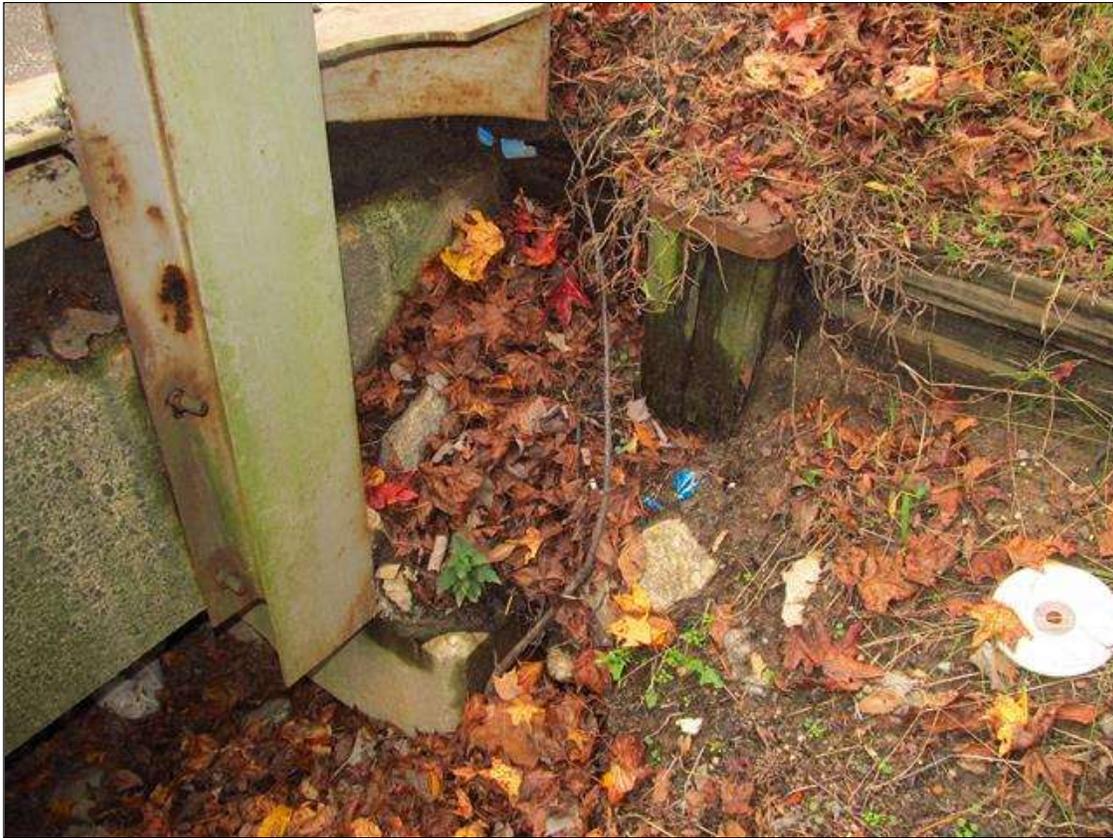
Dirt and debris buildup at the left end of End Bent 1 cap

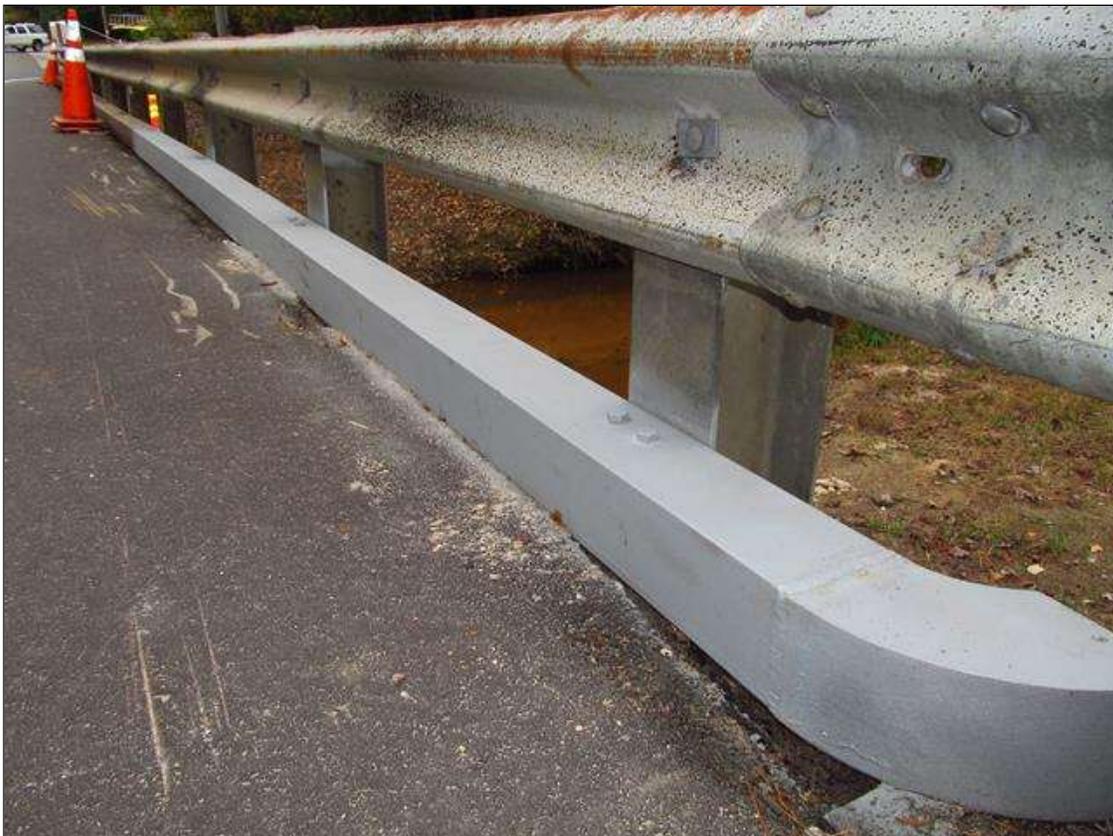
Section of wheelguard has been replaced along the Right side of Span 1

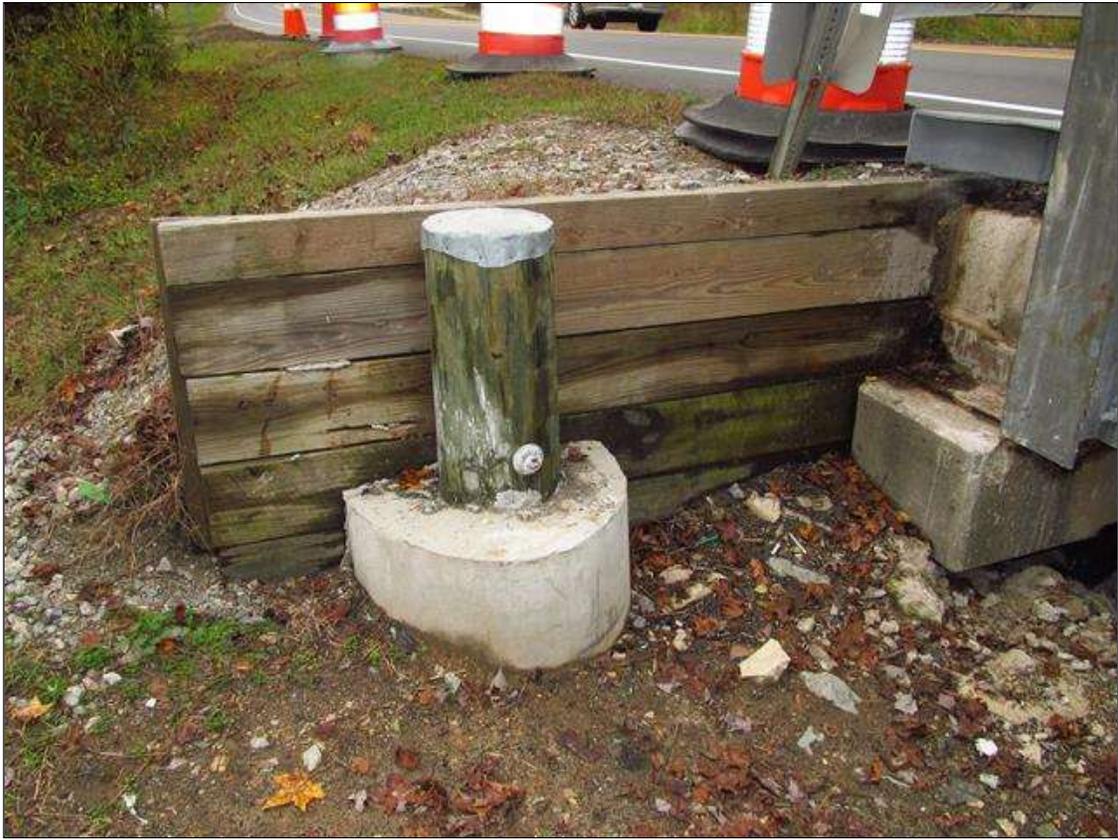
Structure has temporary pile repairs at bulkheads

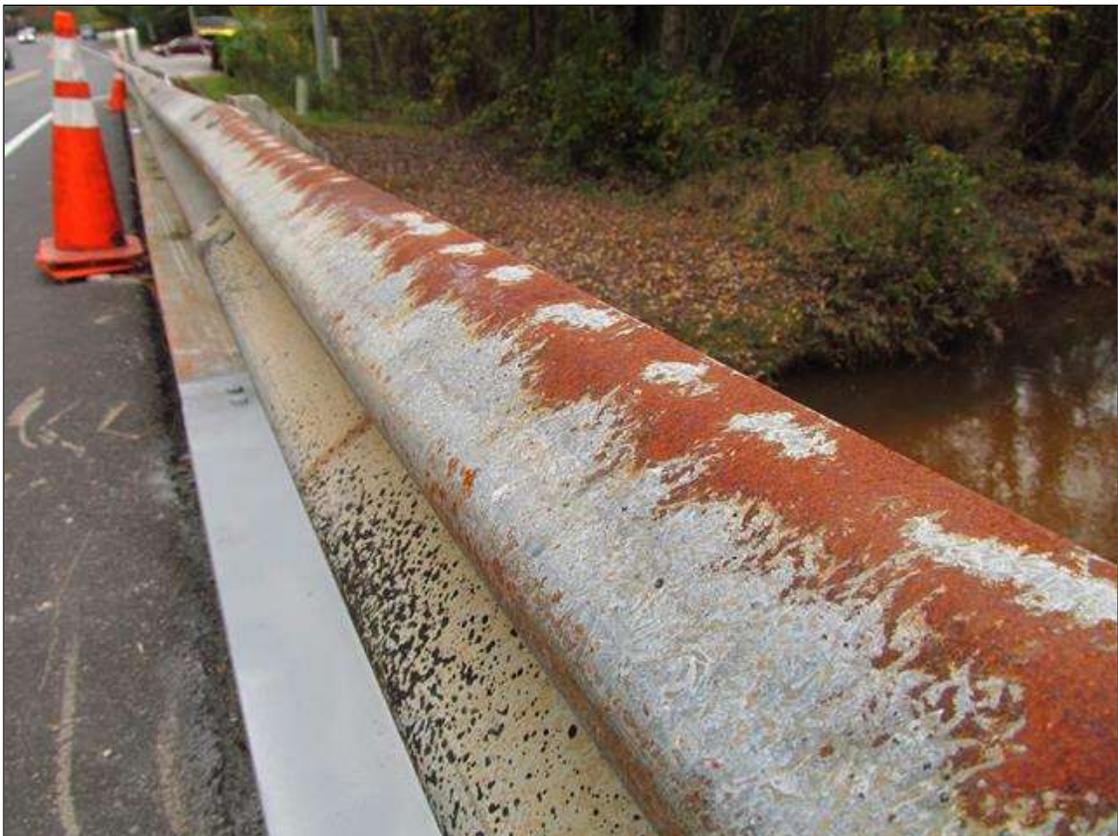
Areas of corrosion along guardrails

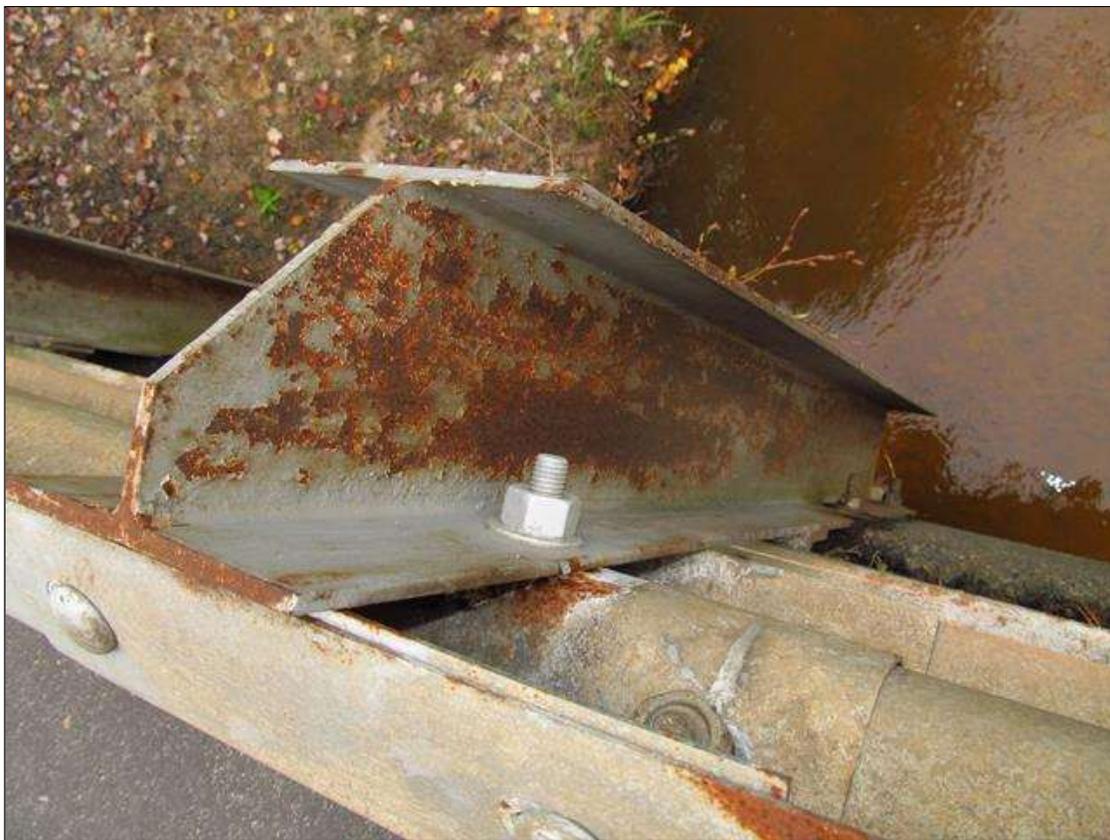
Areas of corrosion in guardrail posts

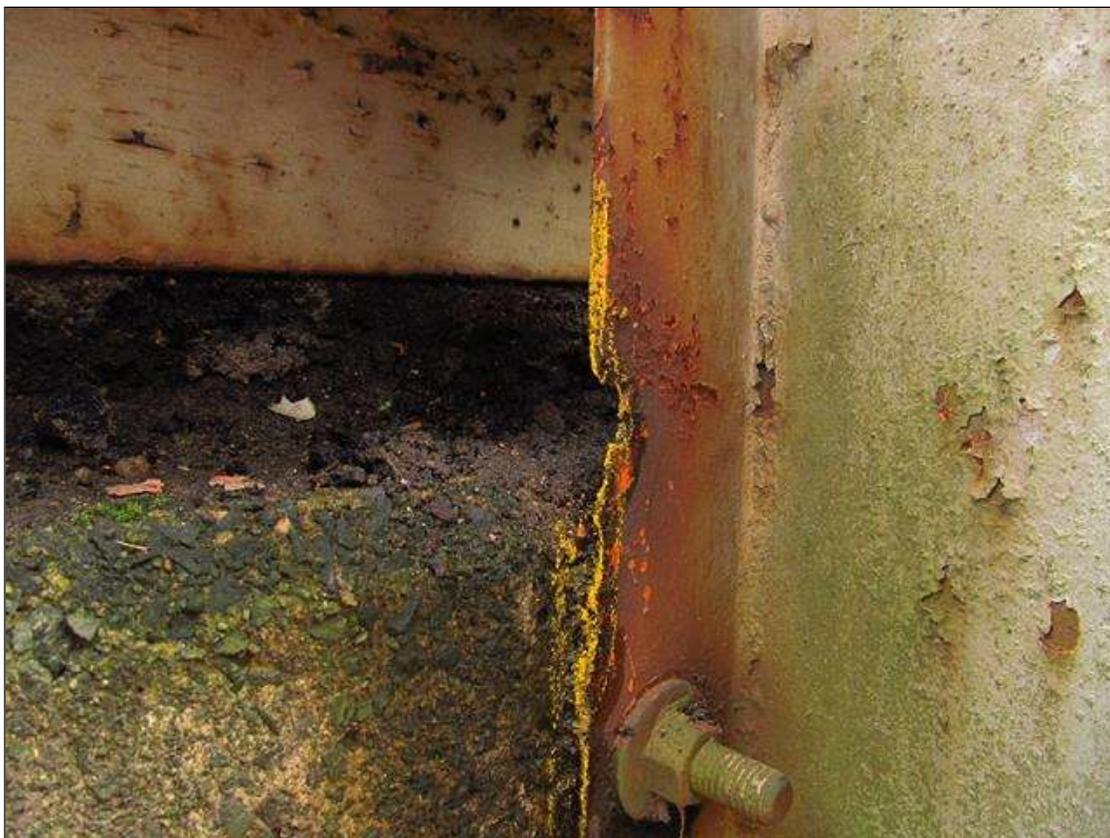
Random spots of Section loss in guardrail post flanges where posts are touching the exterior slabs

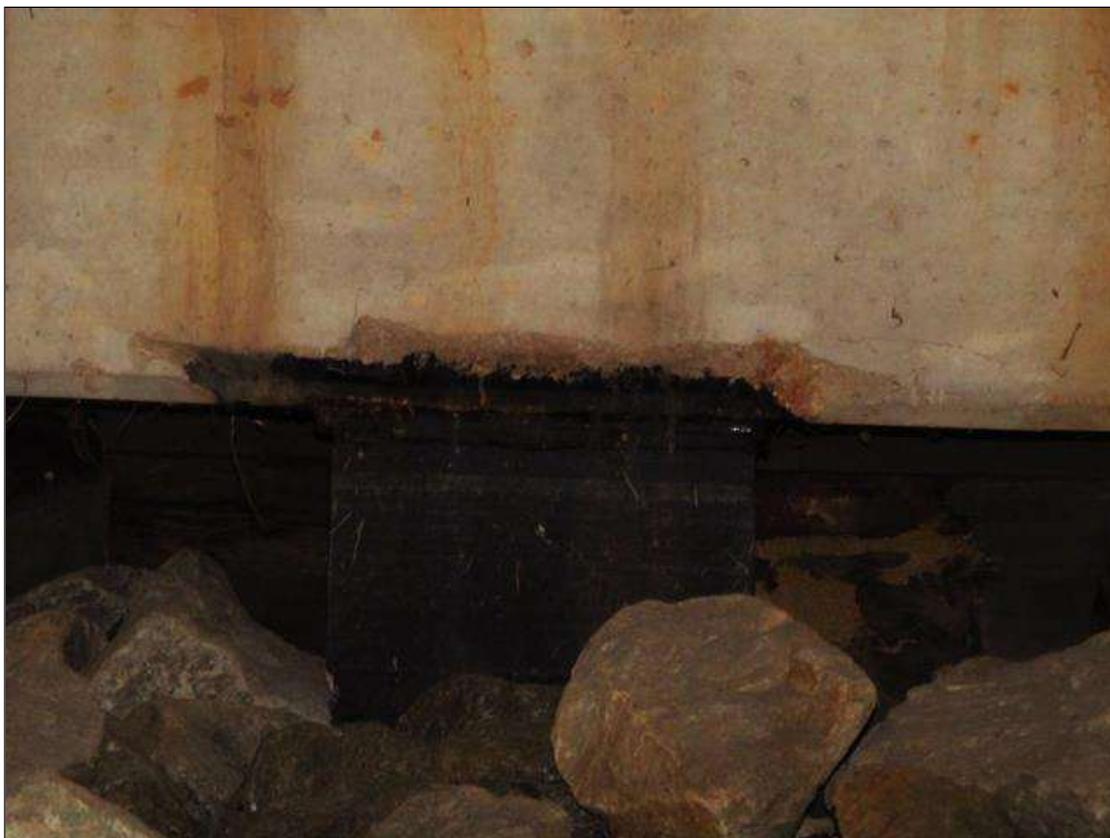
Spalling in bottom edge of End Bent 1 cap at piles bearing plates

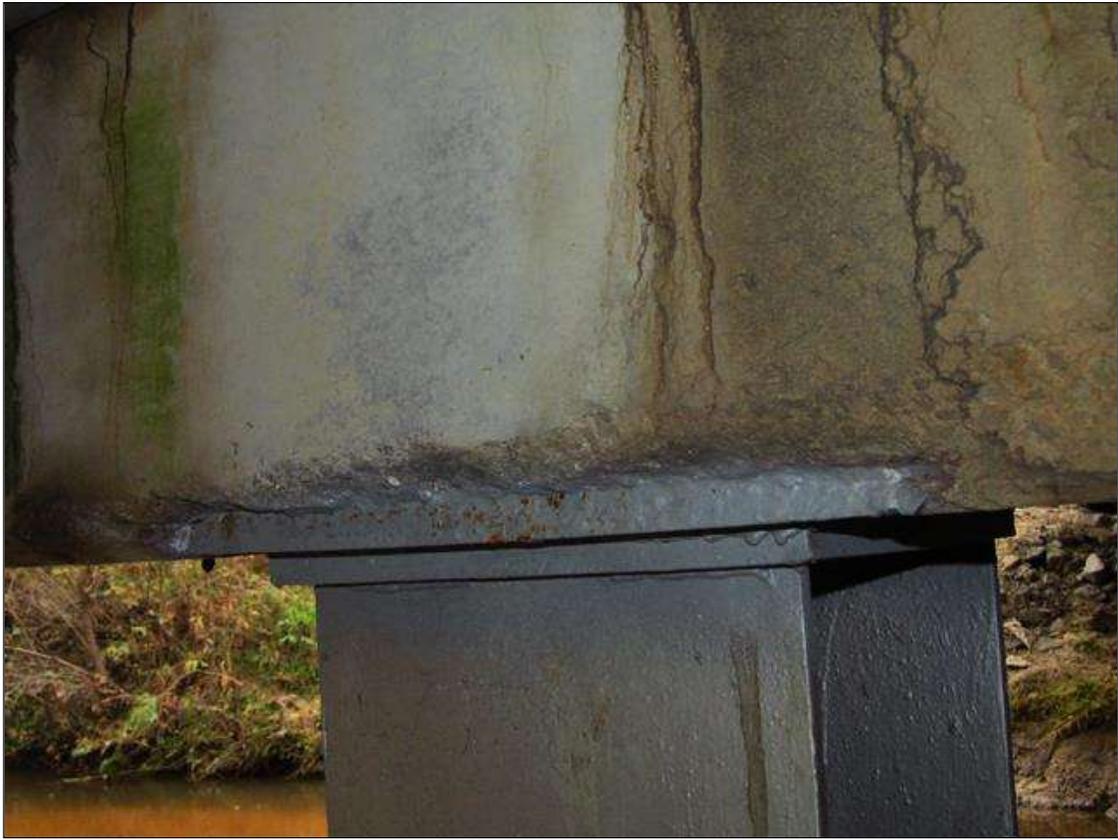
Spalling along bottom edge of Bent 1 cap at pile bearing plates

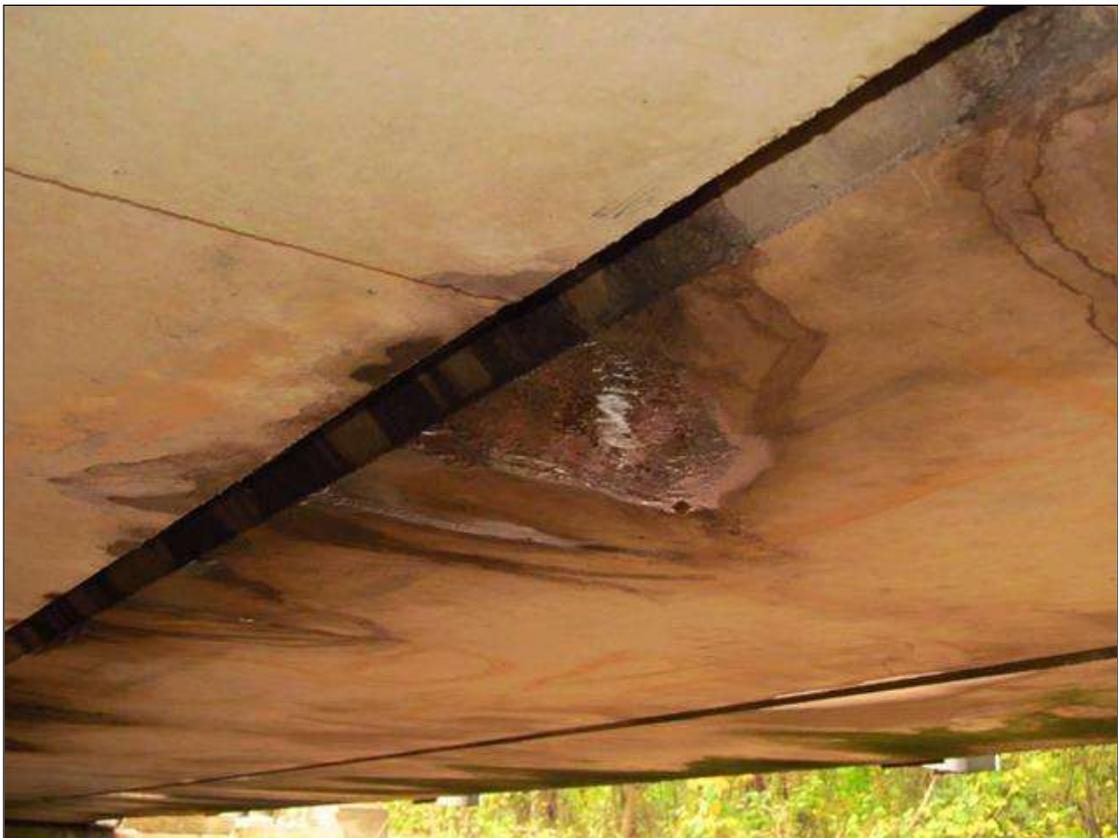
Random leakage between slab units

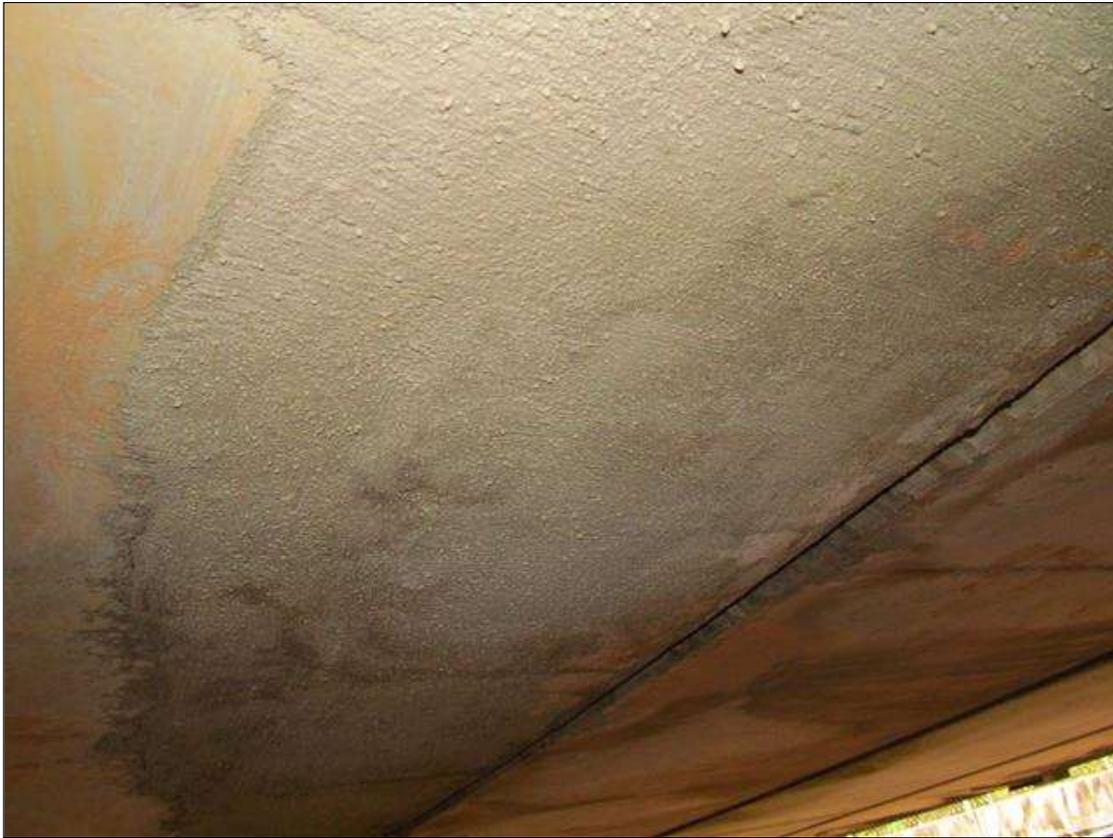
Repair patch in the bottom of slab #4 in Span 2

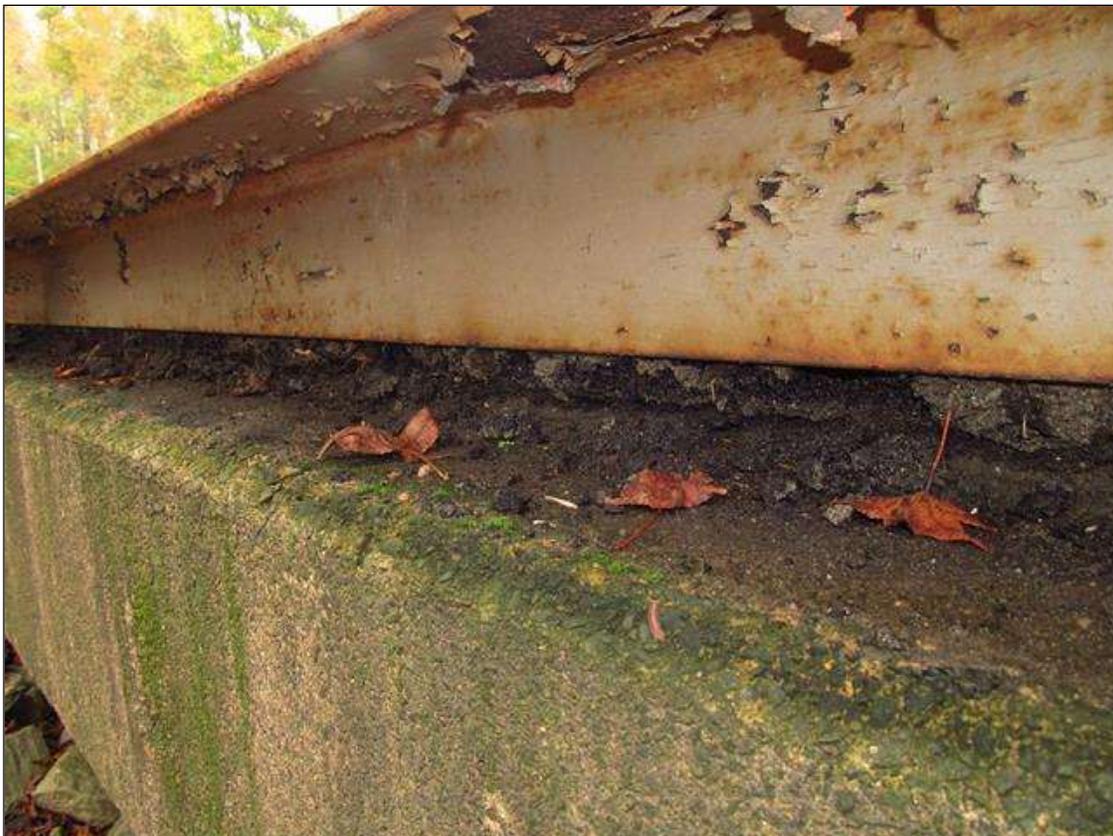
Drainage along the Left side wheelguard blocked by Sediment and asphalt
