Subject: **Application for Section 404 Nationwide Permit, Section 401 Water Quality Certification** for the Proposed Replacement of Bridge No. 79 on NC 9 over the Broad River in Buncombe County; TIP BR-0009, Division 13, Debit \$240 from WBS Element 67009.1.1

Replacement of Bridge #100079 on NC9 over the Broad River

LOCATION: BRIDGE NO. 100079 OVER BROAD RIVER ON NC 9

WETLAND AND SURFACE WATER IMPACTS PERMIT

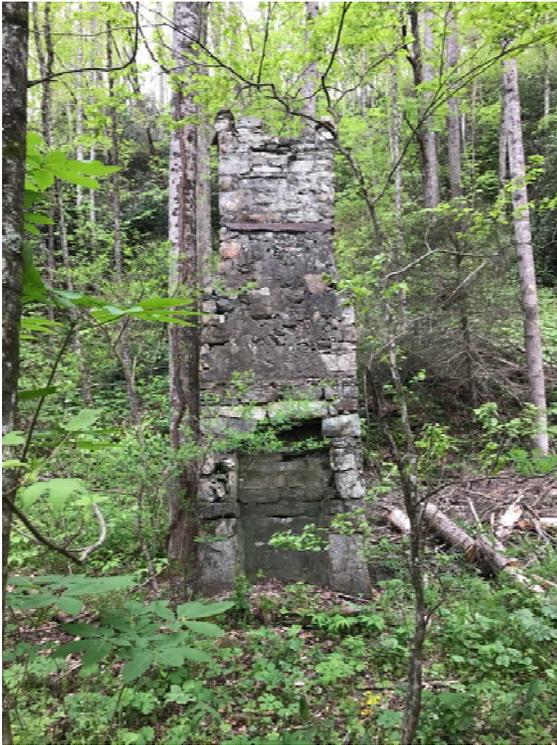
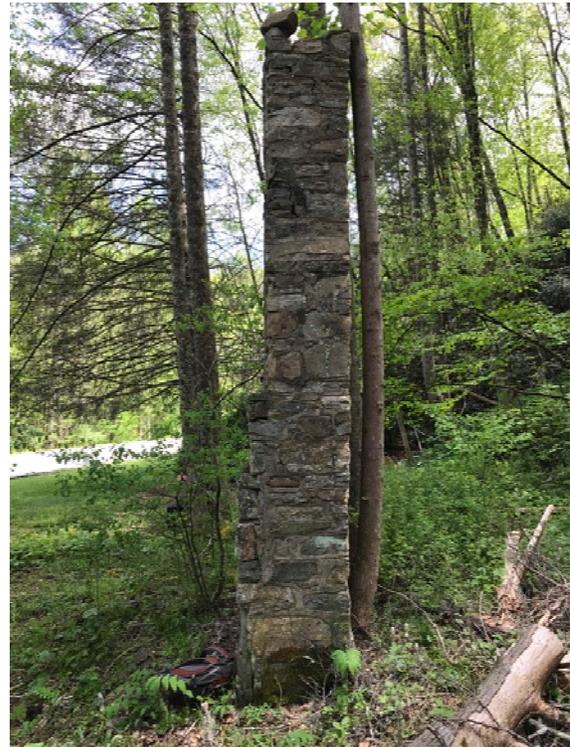
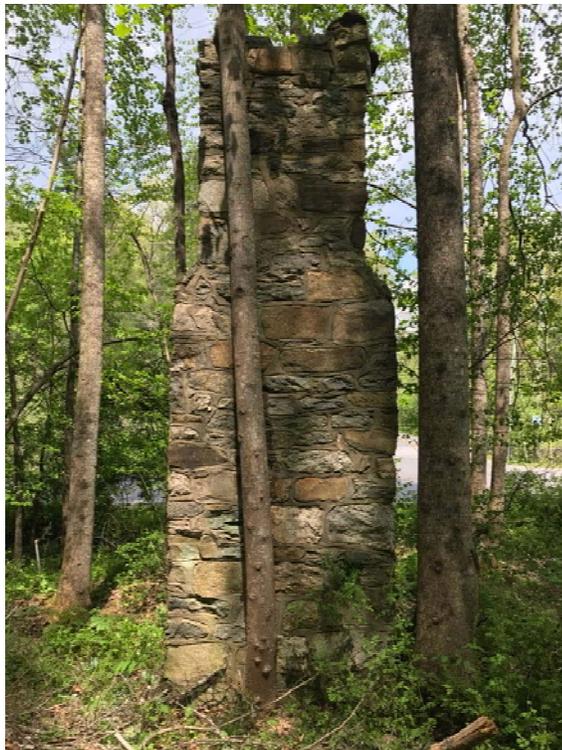
Figure 9. Chimney at Site 31BN1035

The chimney measured 80x160 centimeters in plan and was constructed of stone and mortar (Figure 9). The east-facing fireplace included an elevated stone hearth. A horizontal piece of standing seam metal roofing was embedded in the upper chimney, and mortar present on the interior (eastern) chimney face. No foundation or pier supports were located during the site evaluation. The position of the chimney suggests the house extended into the NC 9 right of way, and it is highly probable that standing structural elements in the area were demolished during road construction. Though survey testing did not locate any artifacts near the chimney, five 7.5-meter interval shovel tests were excavated during the site evaluation (Figures 10 and 11). These tests revealed 30 centimeters of brown (7.5YR 3/4) silty clayey loam overlying reddish yellow (7.5YR 7/8) silty clay subsoil. One test, at N507.5 E500, produced seven historic artifacts from a depth of 0-30 centimeters below the ground surface. This test location and the chimney location indicate the site measures 15 meters in diameter.

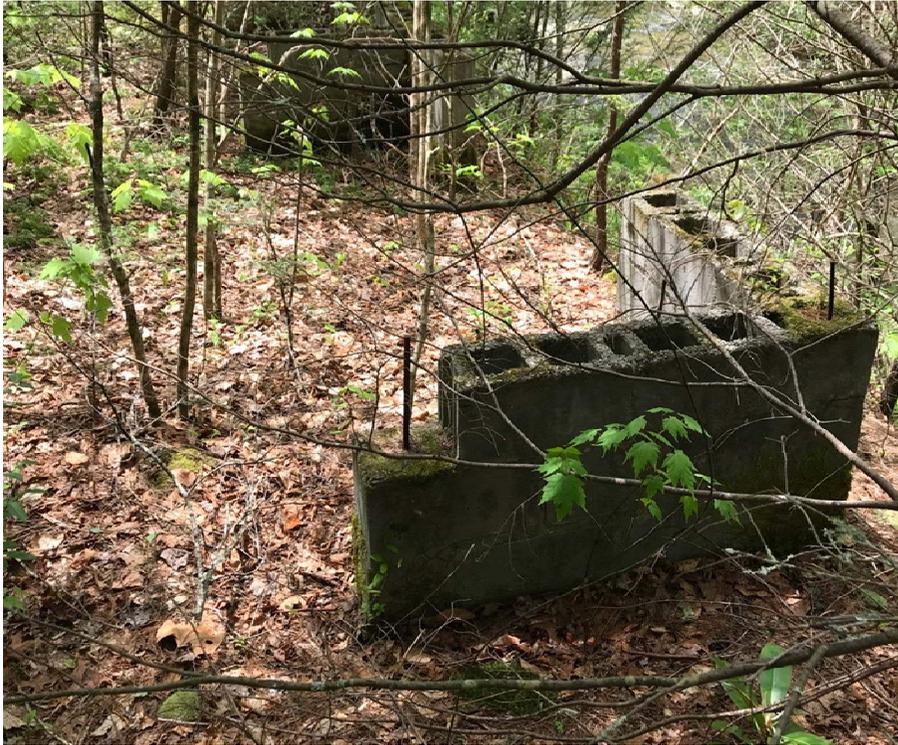
Figure 22. Partially Demolished Building Constructed in the Early 1970s

A) Concrete Block Corner

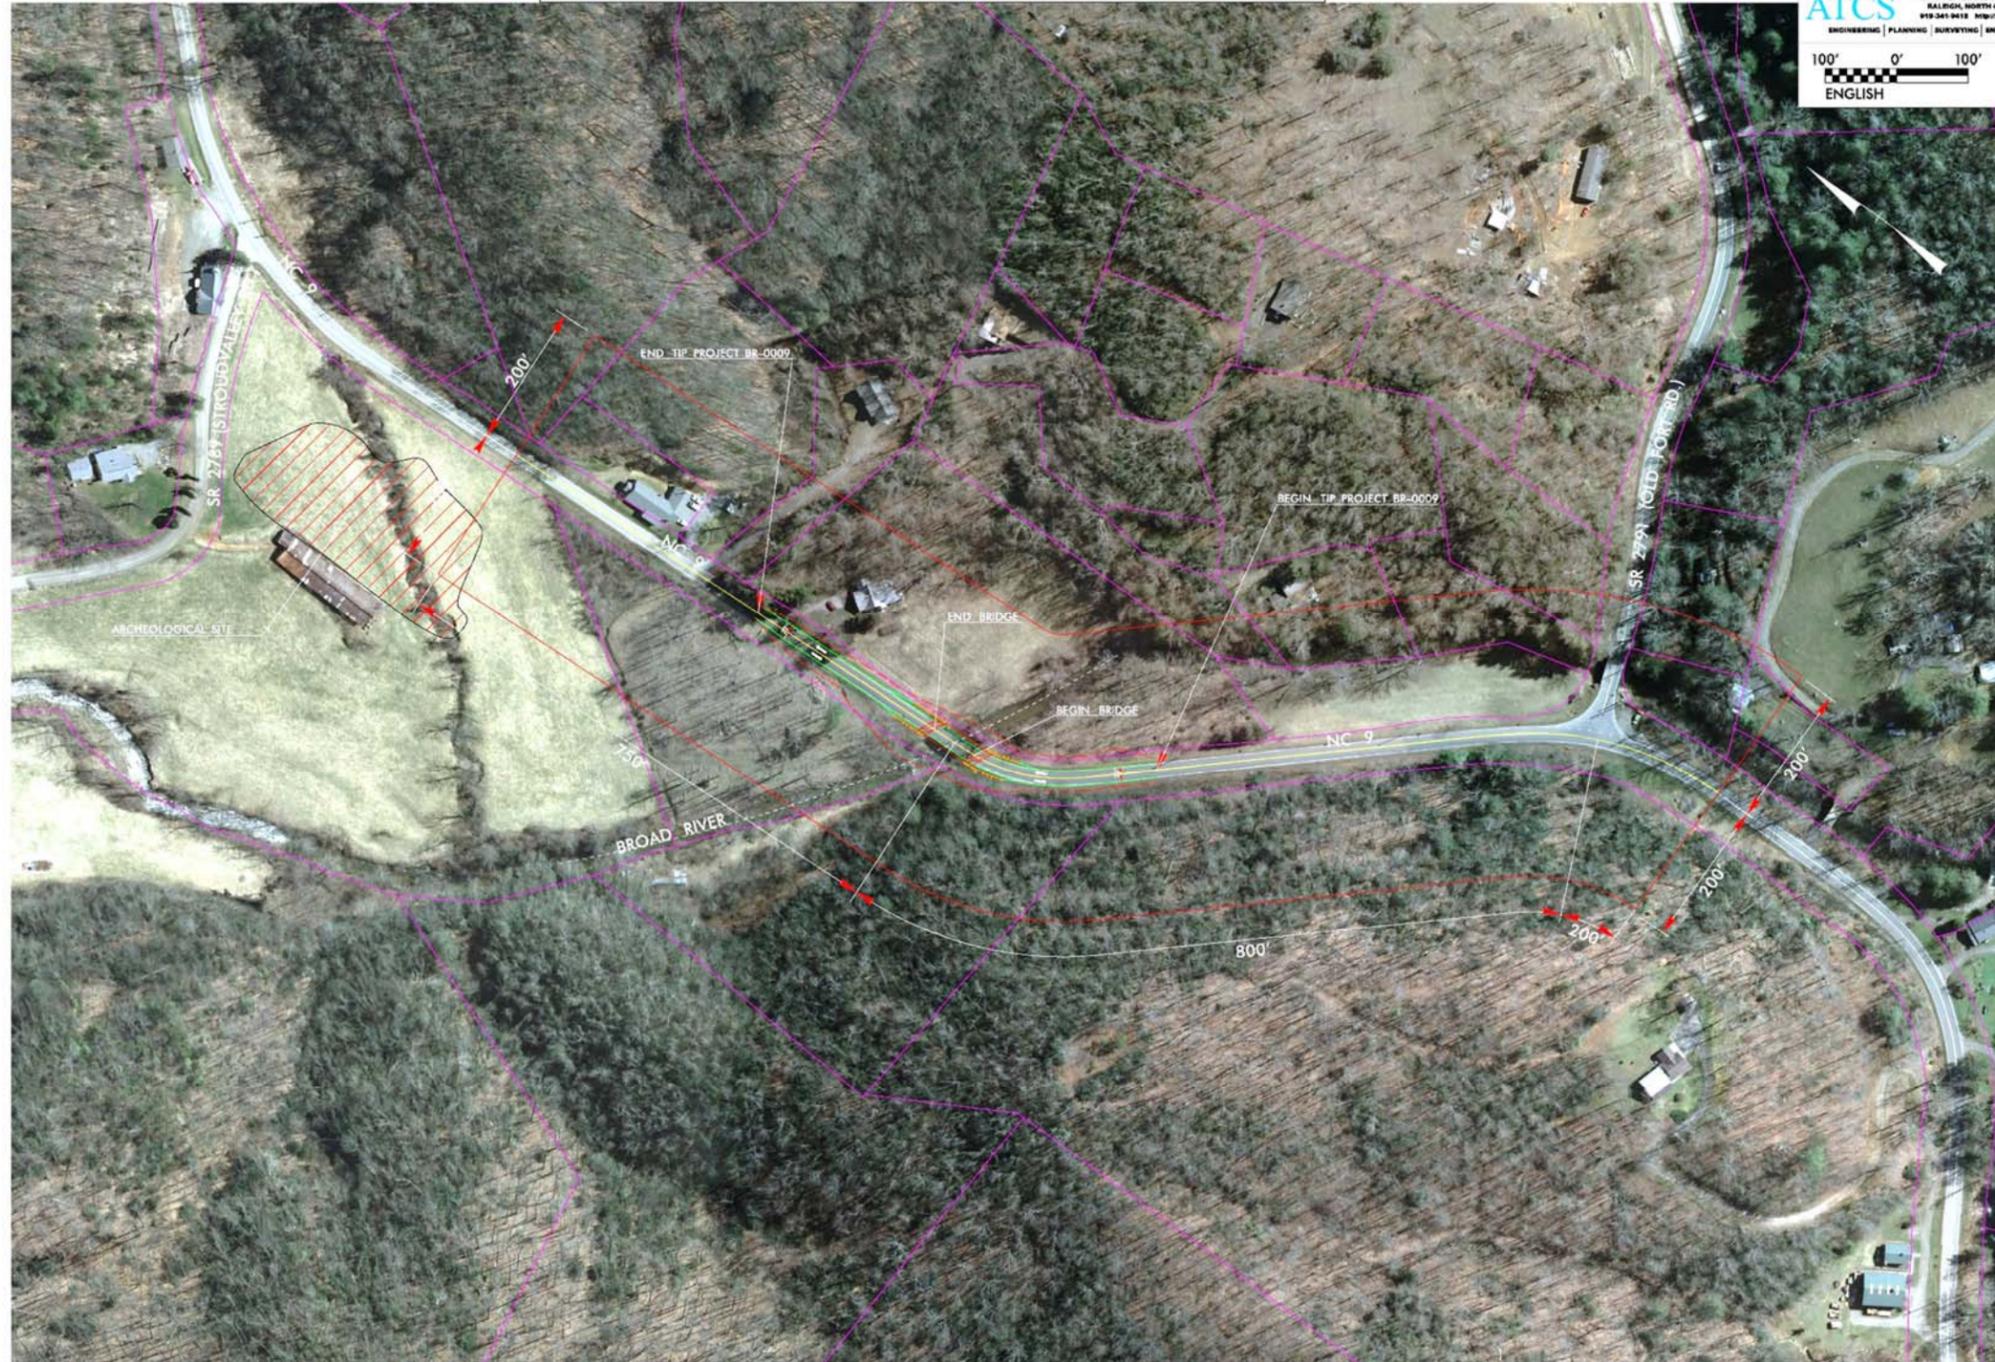
Plan sheet showing avoidance of site 31BN1036 with the proposed replacement of Bridge 79 in Buncombe County.

Preservation through avoidance is recommended. If the proposed bridge replacement project cannot avoid direct impacts to the site, a data recovery plan may be necessary.
