Subject: **Application for Section 404 Nationwide Permit 14, and 401 Water Quality Certification** Replacement of Bridge No. 580084 on SR 1234 (Parker Padgett Rd) over I-40 in McDowell County, North Carolina, Division 13, TIP No. BR-0033. Debit \$240 from WBS Element No. 67033.1.1

Replacement of Bridge No. 580084 on SR 1234 (Parker Padgett Rd) over I-40 in McDowell County

**PERMIT DRAWING  
SHEET 1 OF 5**

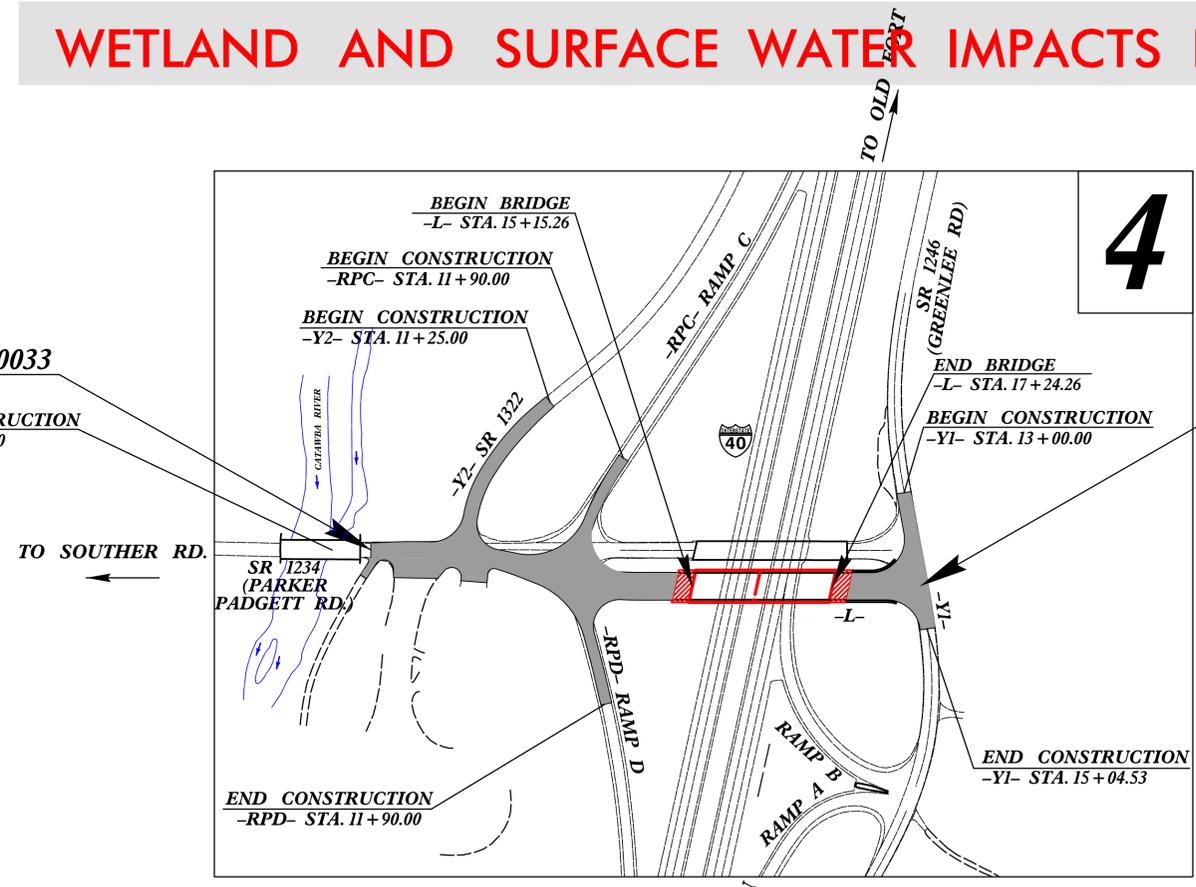
**WETLAND AND SURFACE WATER IMPACTS PERMIT**

**BEGIN TIP PROJECT BR-0033**  
-L- POT STA. 10 + 30.00  
BEGIN CONSTRUCTION  
-L- STA. 9 + 70.00

**END TIP PROJECT BR-0033**  
-L- POT STA. 18 + 54.66

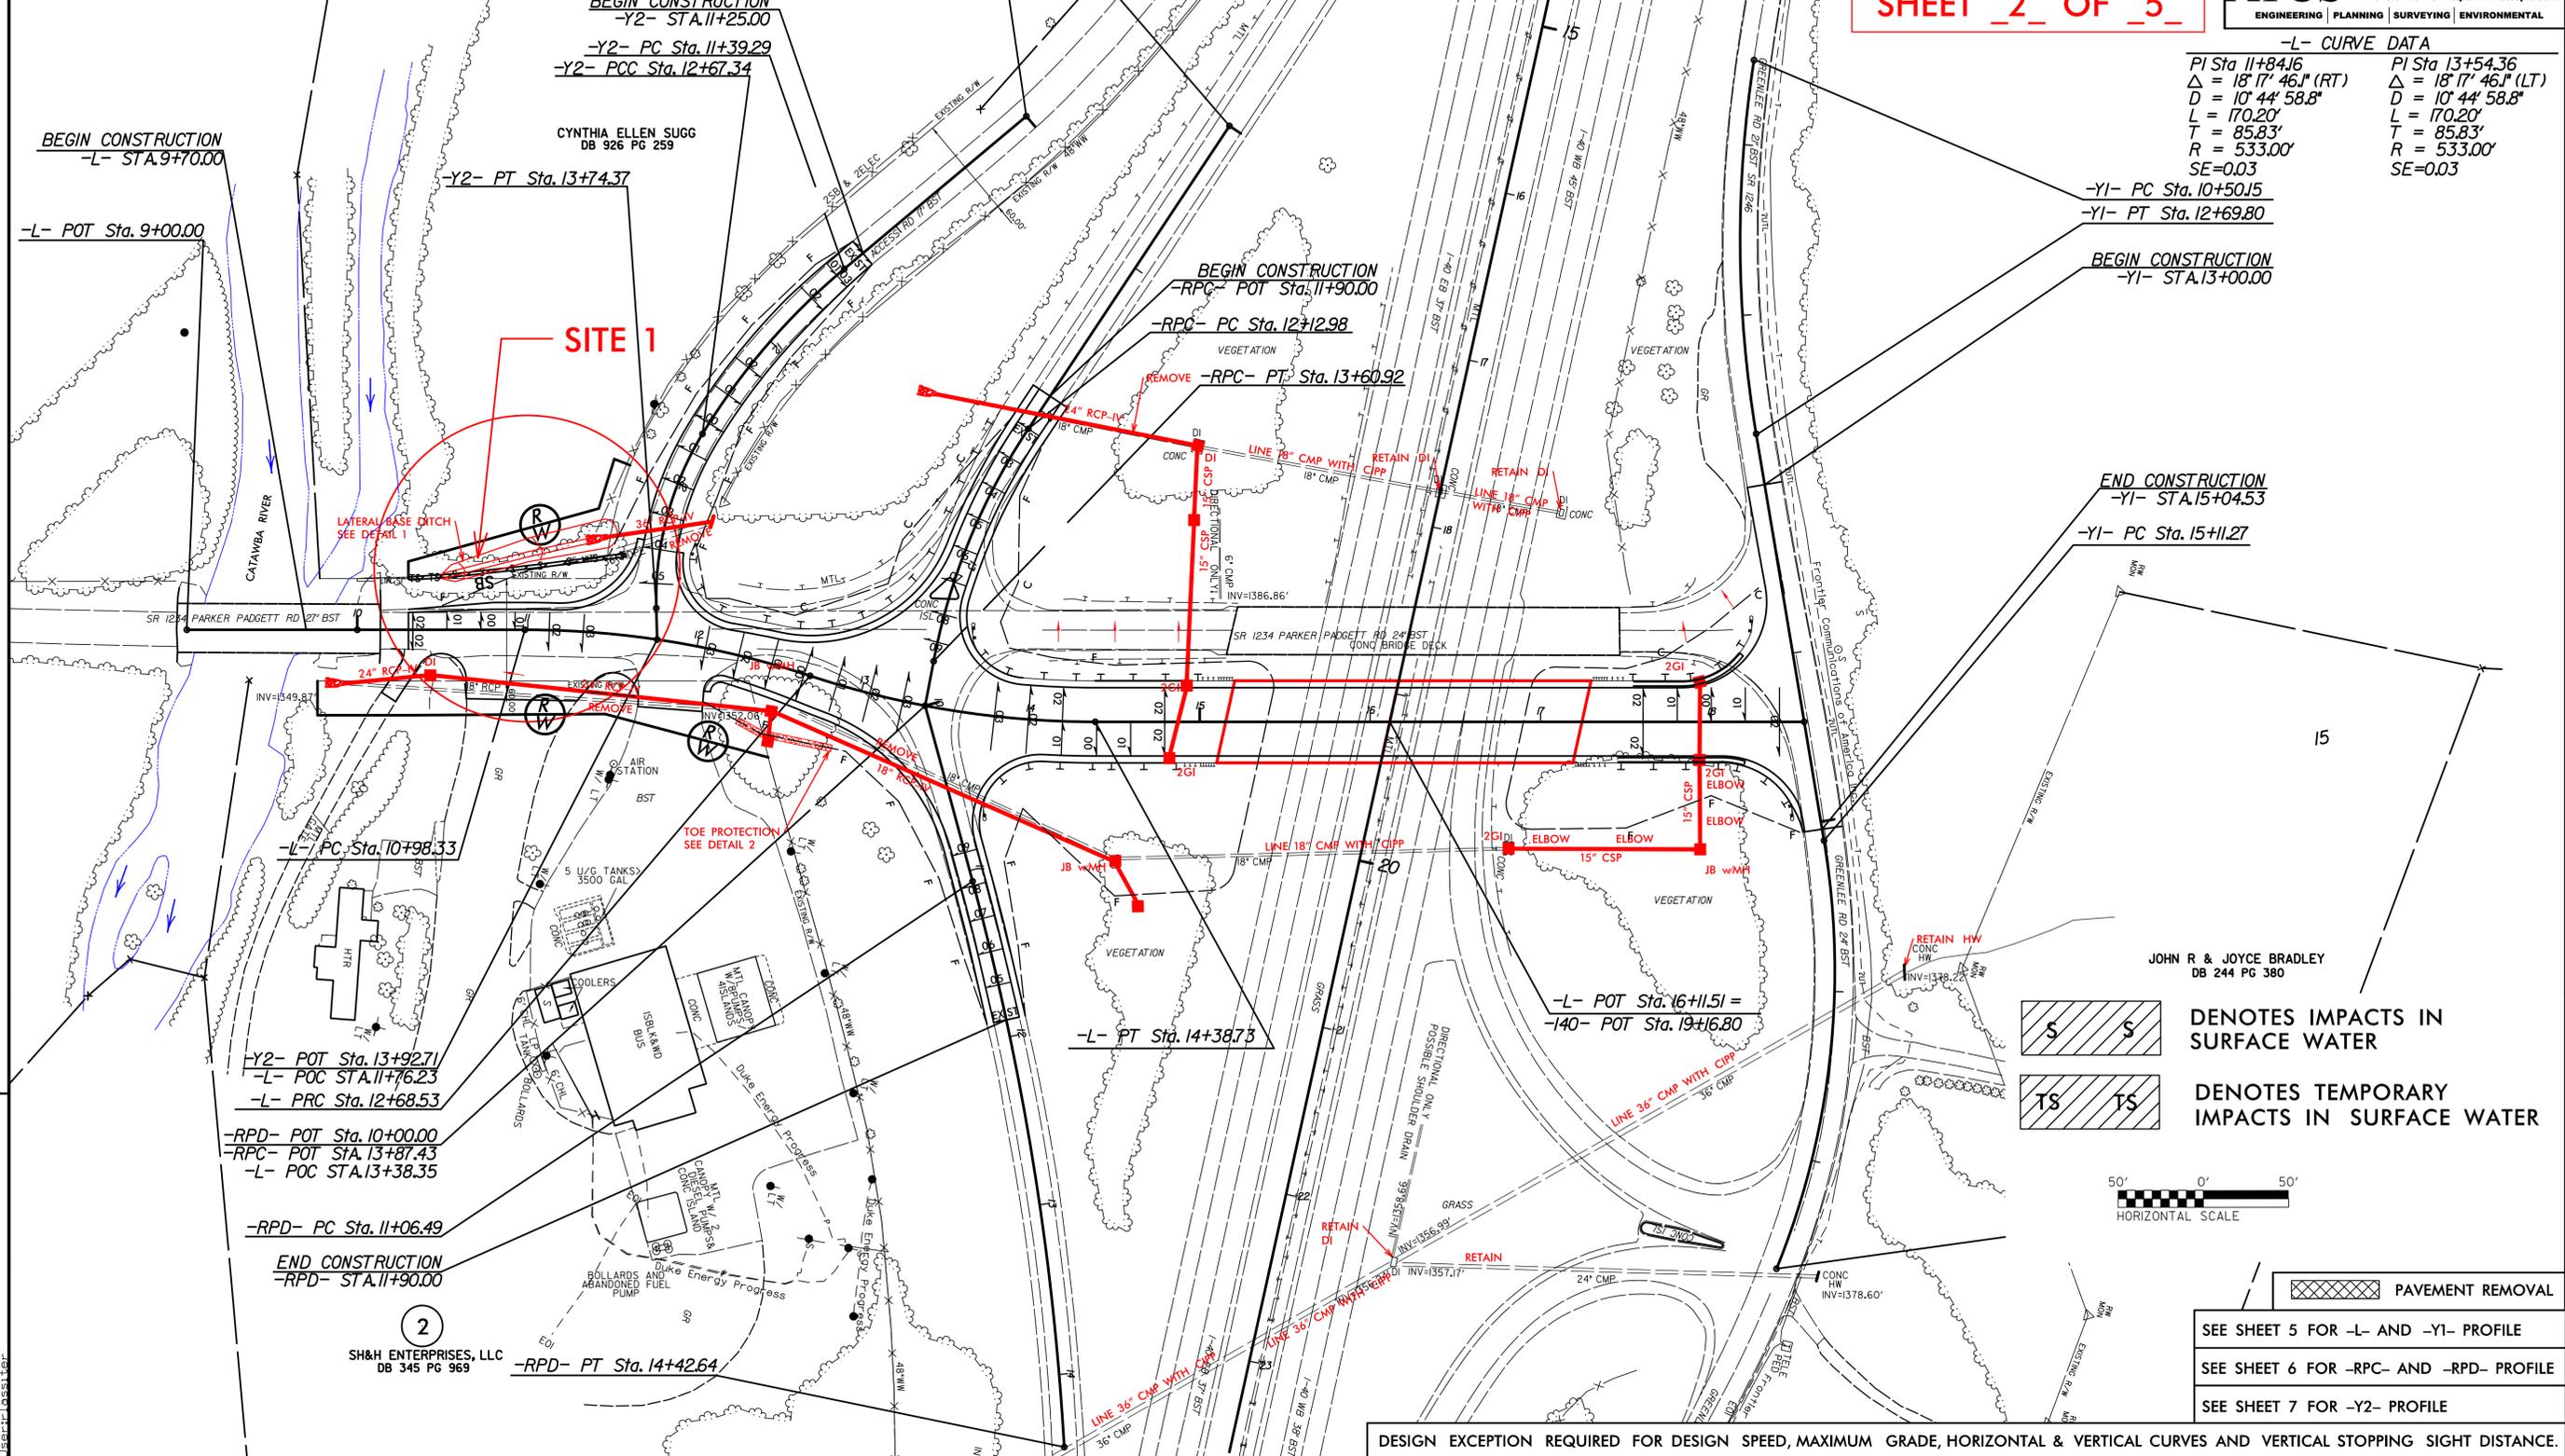
PS - PAVED SHOULDER  
SKETCH SHOWING BRIDGEROADWAY RELATIONSHIP

**S** DENOTES IMPACTS IN SURFACE WATER  
**TS** DENOTES TEMPORARY IMPACTS IN SURFACE WATER

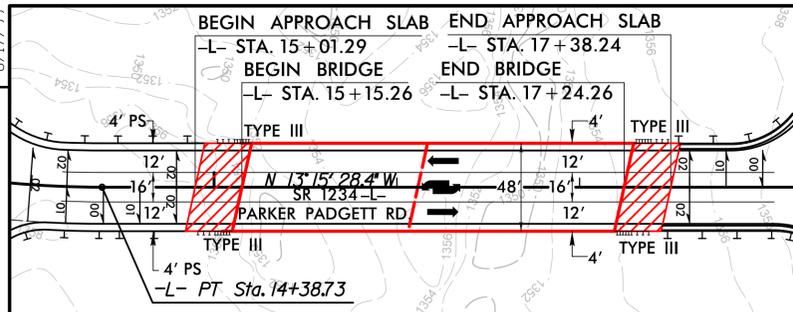
PS = PAVED SHOULDER  
SKETCH SHOWING BRIDGEROADWAY RELATIONSHIP

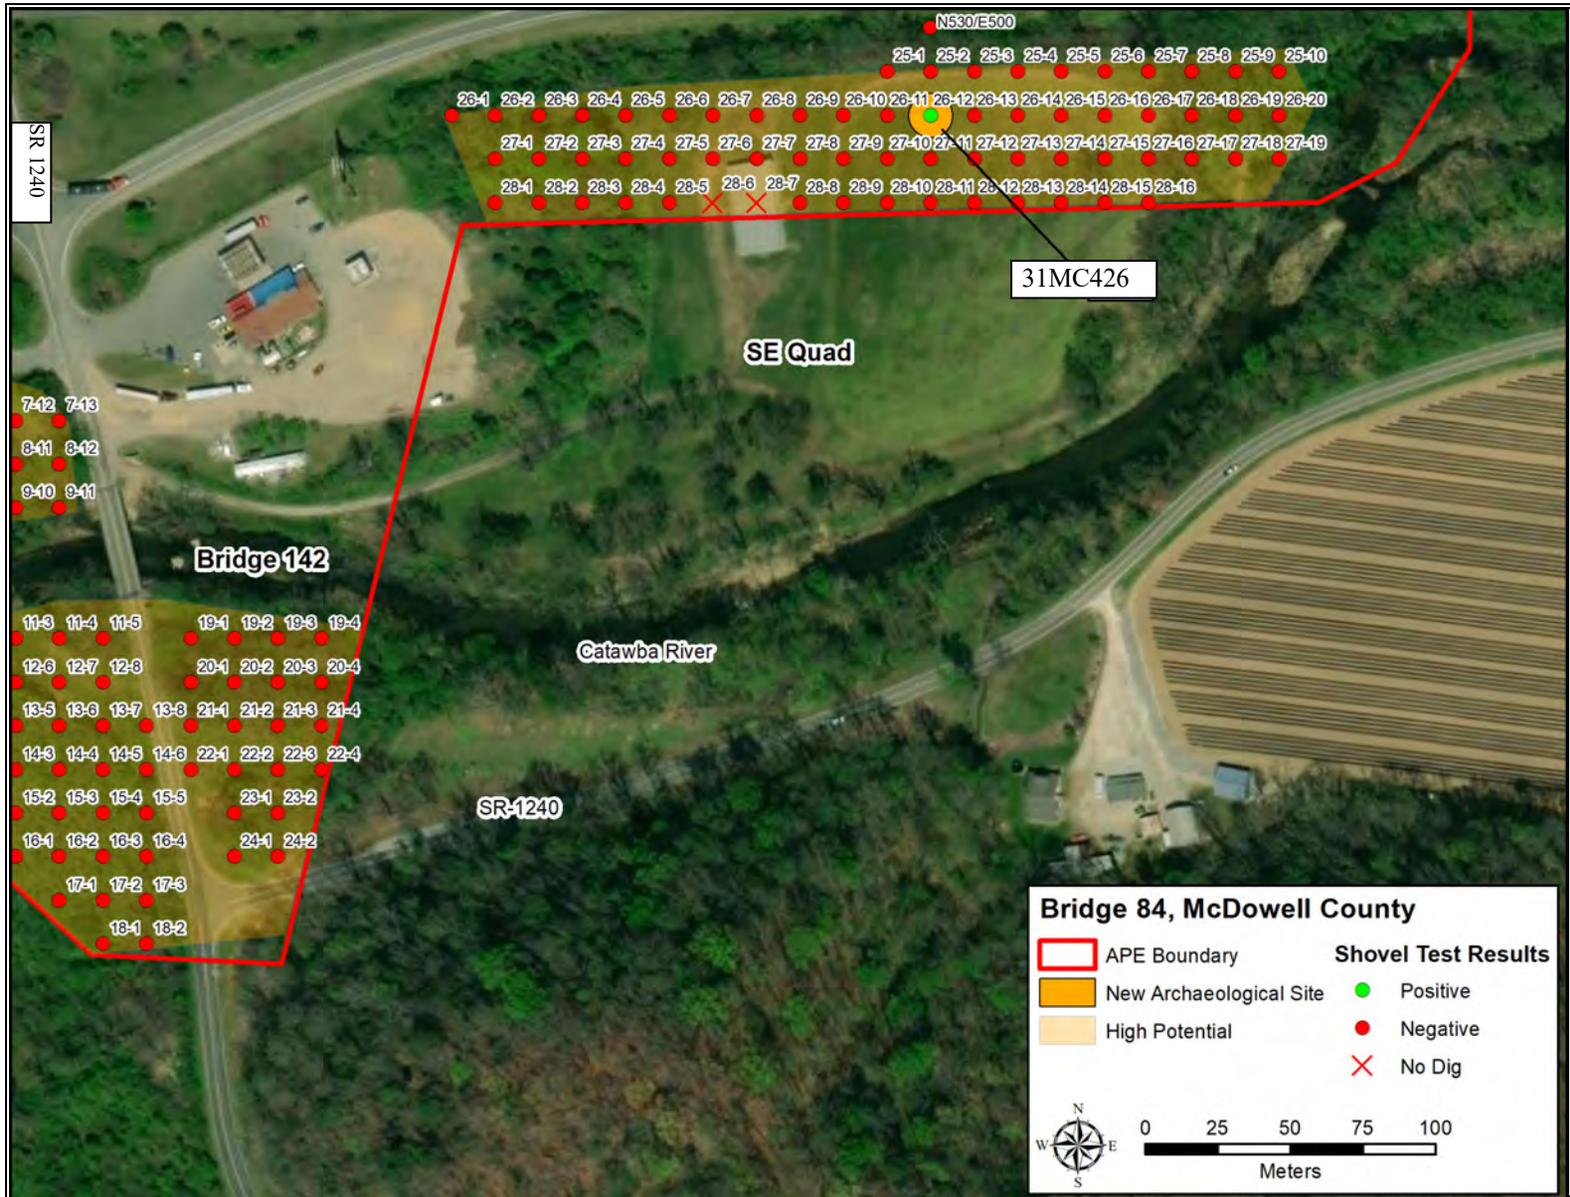
Figure 7. Aerial image of the southeast quadrant showing the locations of shovel tests and site 31MC426.

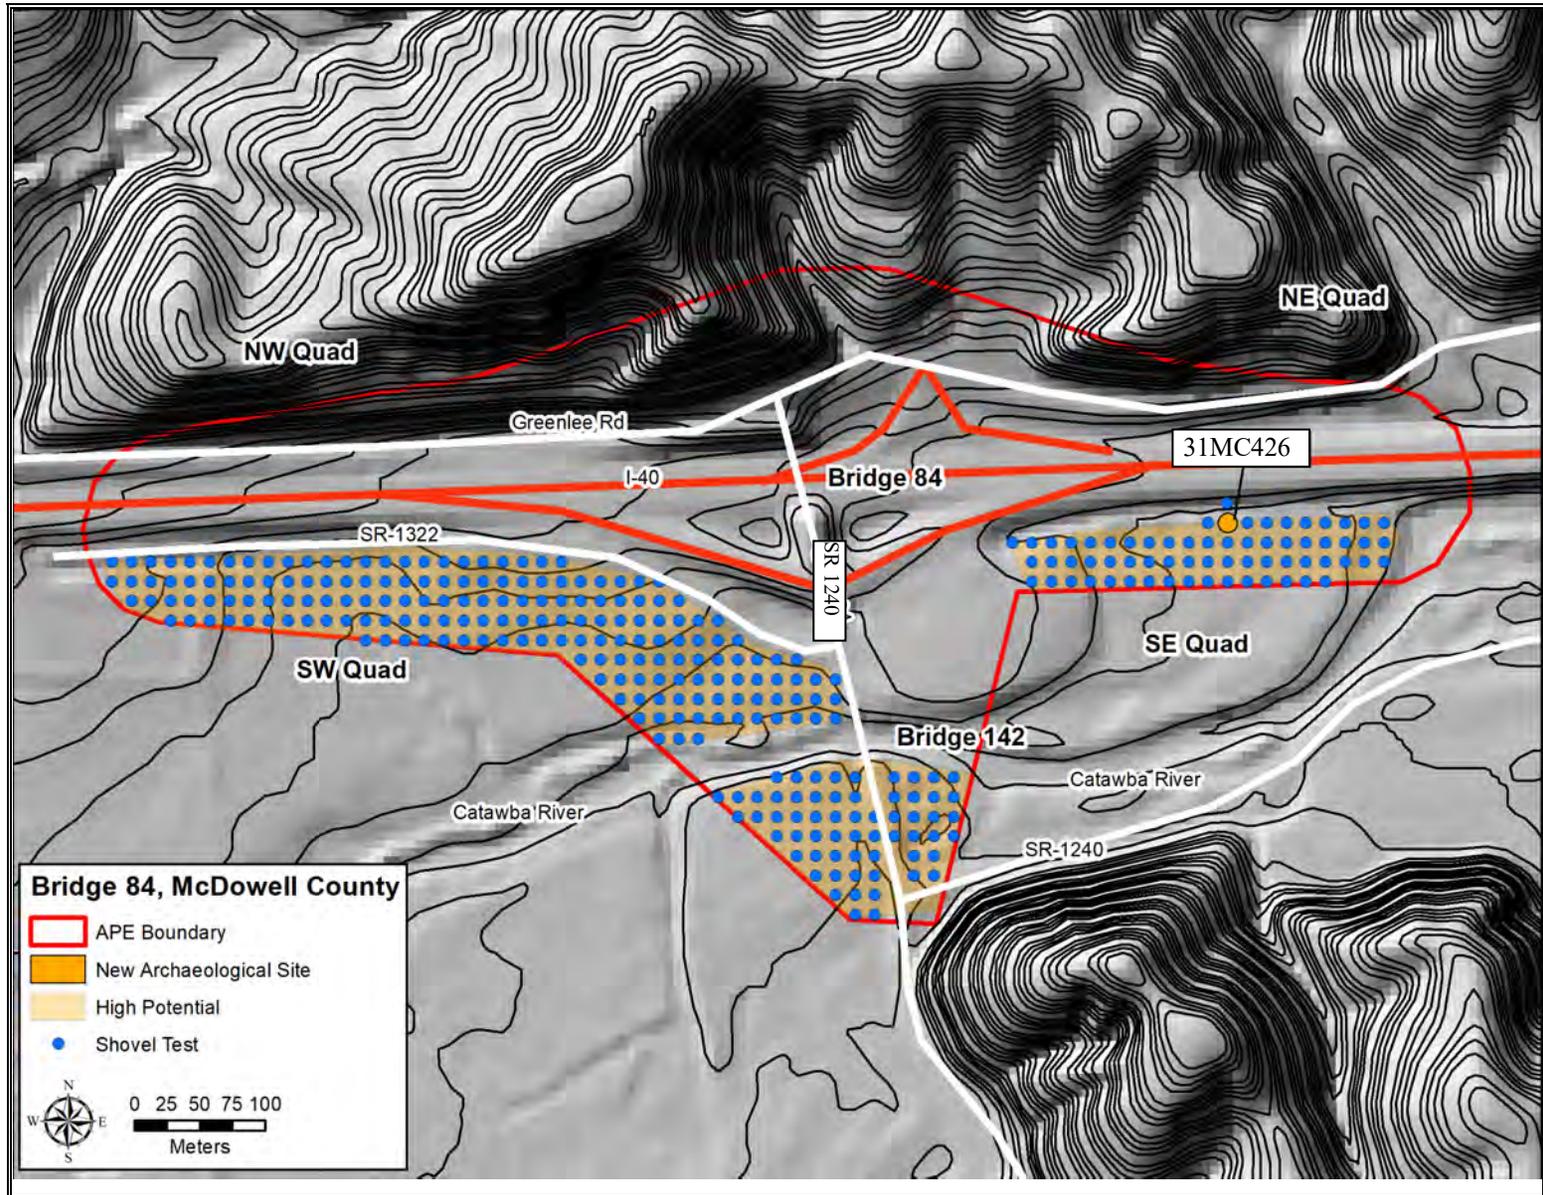
Figure 8. LiDAR map of the Bridge No. 84 APE showing shovel test locations and site 31MC426 (Jones 2010).

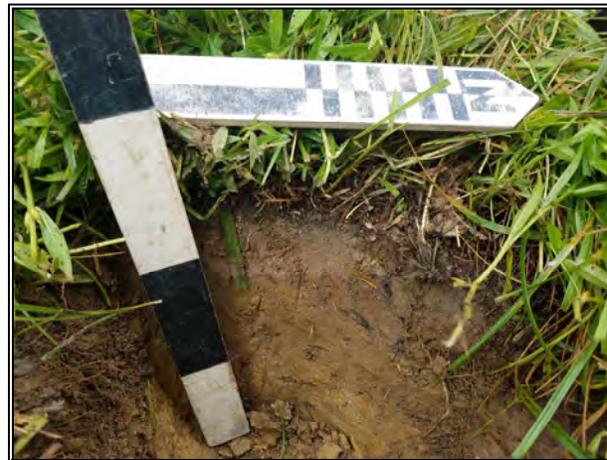
**Figure 12.** Representative shovel test (3-3) profile from pasture in southwest quadrant, looking west.

Shovel test profiles varied throughout the quadrant. In the pasture, shovel test profiles generally exposed 10 centimeters (3.9 in) of dark grayish brown (10YR4/2) sandy loam overlying 10 centimeters (3.9 in) of yellowish brown (10YR5/6) sandy clay loam (Figure 12). These shovel test profiles generally concur with the expected profile for the area (USDA 2018). Shovel test profiles from the wooded area featured 25 centimeters (9.8 in) of dark brown (10YR3/3) sandy loam overlying 10 centimeters (3.9 in) of brownish yellow (10YR6/8) sandy clay loam (Figure 13). The shovel tests excavated in the transmission line corridor in the southern portion of the quadrant exposed profiles indicative of disturbance. These profiles were characterized by 30 centimeters (11.8 in) of dark yellowish brown (10YR4/4) rocky sandy loam overlying 10 centimeters (3.9 in) of dark yellowish brown (10YR4/4) sand mixed with impenetrable gravel (Figure 14). The soil profiles from the wooded area and transmission line corridor differ in soil texture and strata from those recorded for the area. The recorded soil profile is 203 centimeters (80 in) of sand (USDA 2018). This difference may be an indication of disturbance from road and transmission line construction and erosion. None of the excavated shovel tests in the southwest quadrant yielded cultural material.

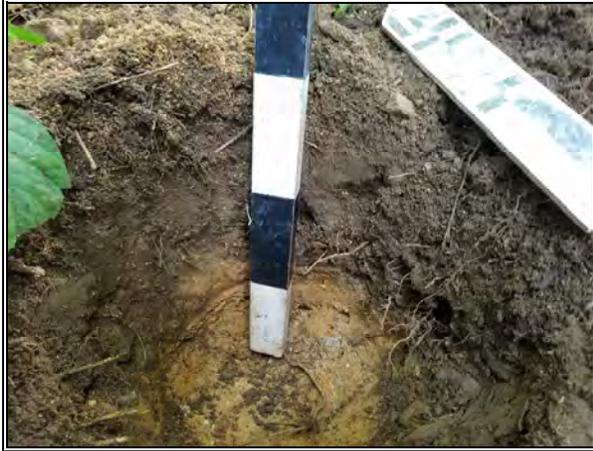
**Figure 13.** Representative shovel test (15-3) profile from wooded area in southwest quadrant, looking west.

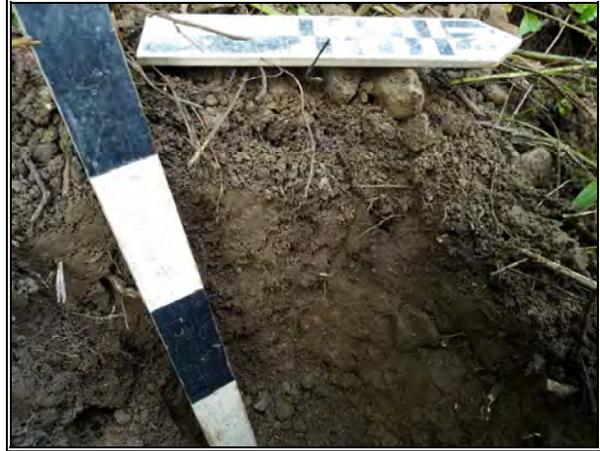
**Figure 14.** Representative shovel test (12-8) profile from transmission line corridor in southwest quadrant, looking west.

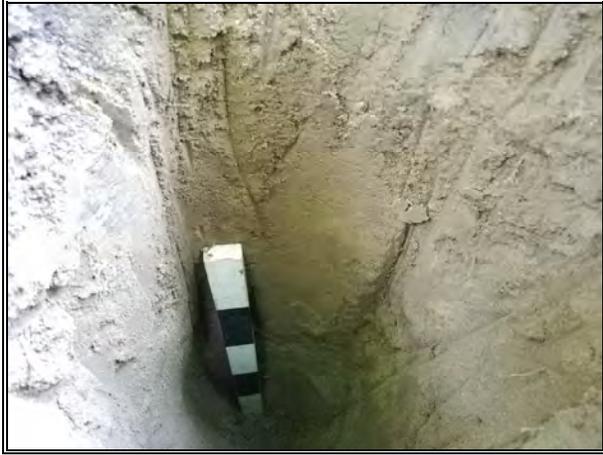
**Figure 19.** Representative shovel test (26-12) profile from floodplain terrace in southeast quadrant, looking east.

Shovel test profiles differed between the grassy and wooded floodplain terrace in the northern portion of the quadrant, wooded floodplain in the southern portion of the quadrant, and the transmission line corridor. A typical shovel test soil profile in the northern floodplain terrace exhibited 60 centimeters (23.6 in) of very dark grayish brown (10YR3/2) sandy loam overlying 10 centimeters (3.9 in) of dark yellowish brown (10YR4/4) sandy loam (Figure 19). In the wooded floodplain south of the Catawba River, shovel test profiles generally exposed 50 centimeters (19.7 in) of dark brown (10YR3/3) sandy loam overlying 10 centimeters (3.9 in) of yellowish brown (10YR5/4) sandy loam (Figure 20). The shovel test soil profiles from both of these portions of the southeast quadrant are similar to those expected for the area (USDA 2018).

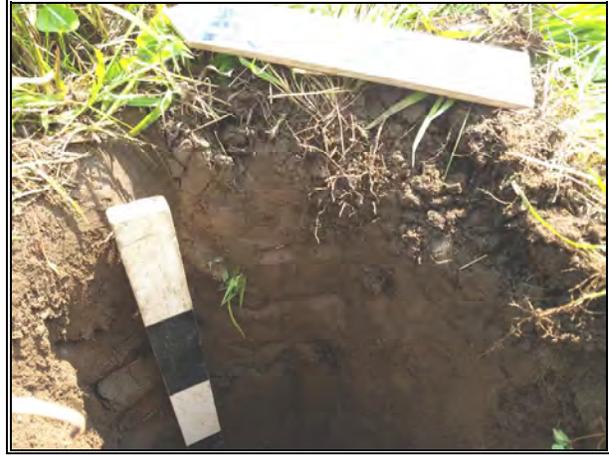
**Figure 20.** Representative shovel test (19-1) profile from wooded floodplain in southern portion of southeast quadrant, looking east.

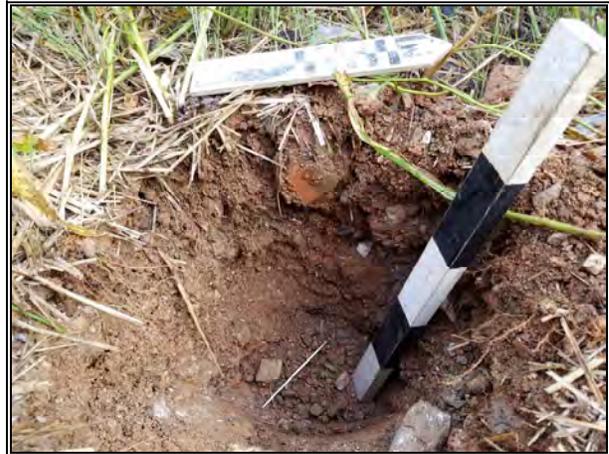
**Figure 21.** Representative shovel test (21-1) profile from transmission line corridor in southeast quadrant, looking west.

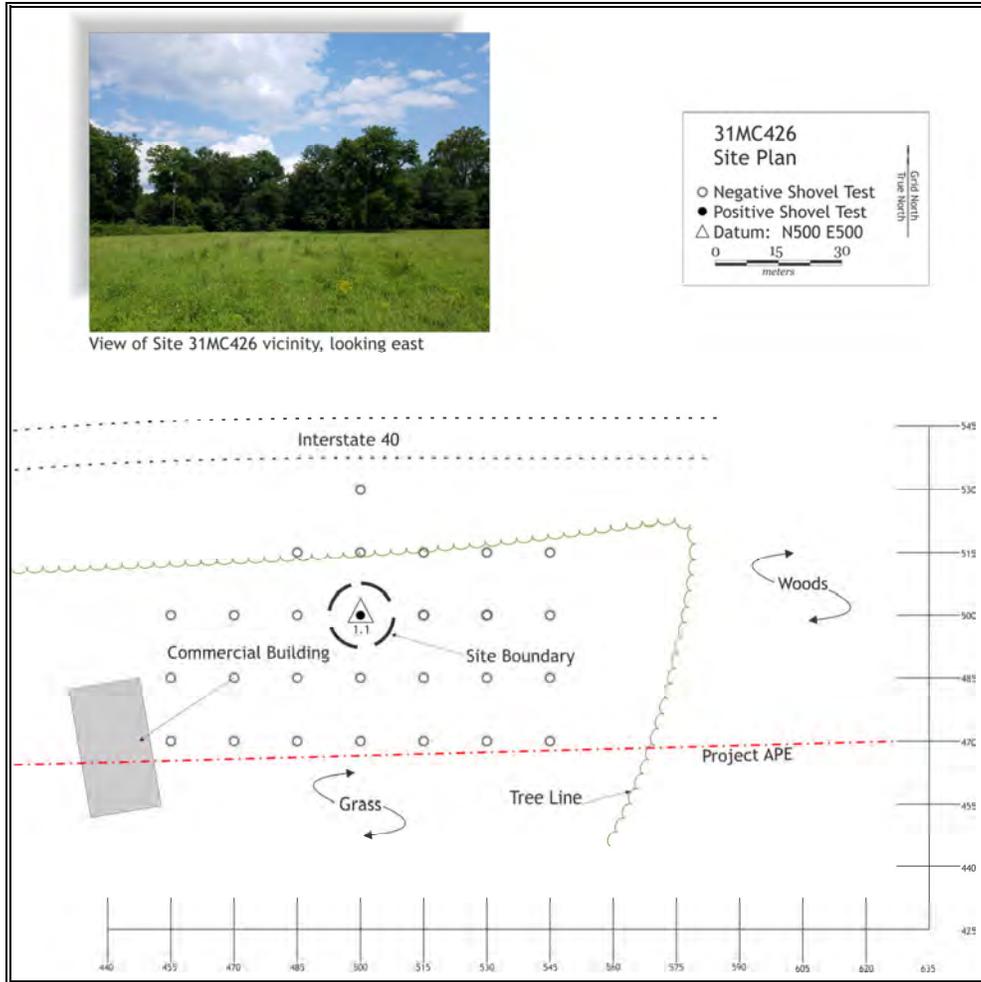
Figure 22. Plan map of site 31MC426

commercial building is located west of the site. Site dimensions of 15 by 15 meters (49.21 X49.21 ft) were determined based on the single positive shovel test (Figure 22). This shovel test contained two ceramic sherds in the plow zone in the upper 30 centimeters (11.8 in) of soil. One of these ceramic sherds exhibits medium sand temper and has been identified as Pisgah Complicated Stamped (John Cable, pers. Comm; Figure 23). This ceramic type is diagnostic of the Mississippian Period (Keel 1976). The other sherd is a residual and too small to identify with confidence.
