NC DEPARTMENT OF TRANSPORTATION
DIVISION OF HIGHWAYS
STRUCTURE MANAGEMENT UNIT

ATTENTION: HURRICANE HELENE
BRIDGE FAILURE, ROADWAY CLOSED

Structure Safety Report

High Water Supplemental

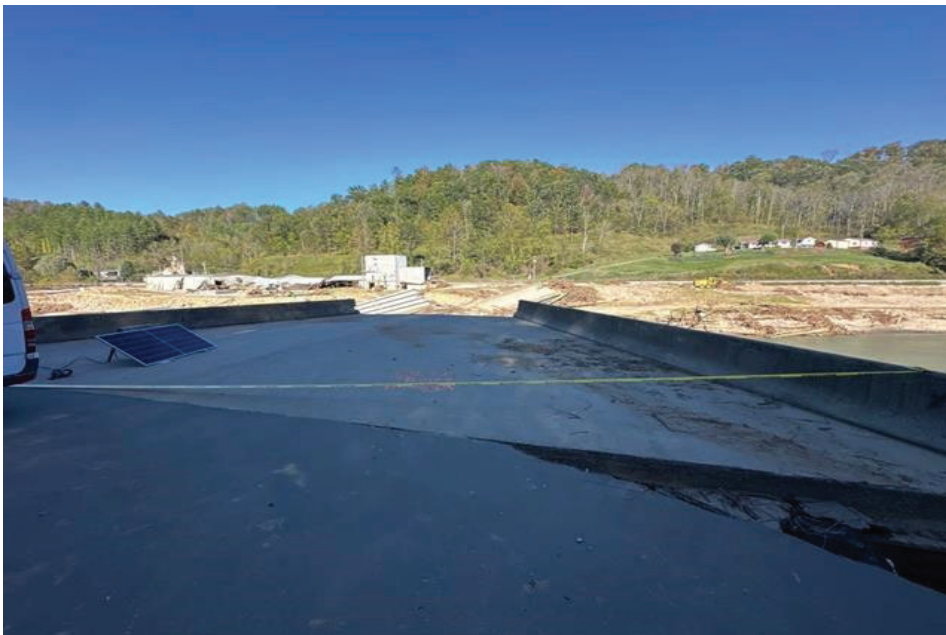
south approach looking north

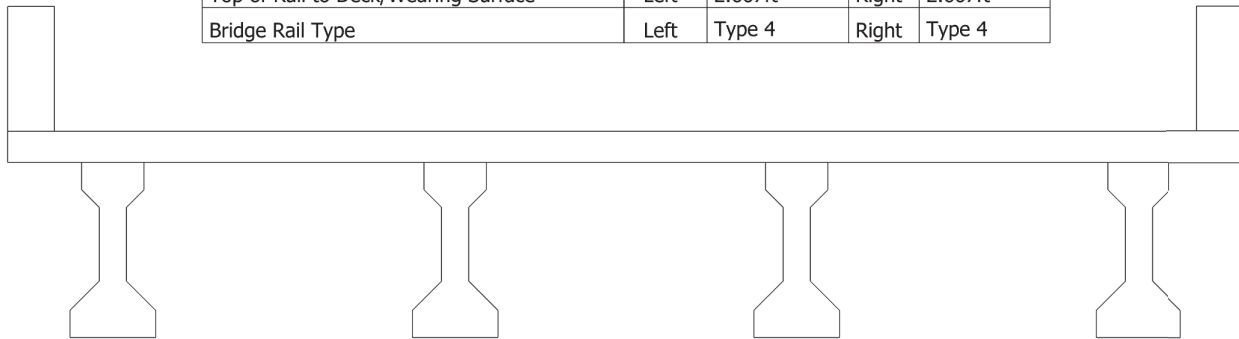
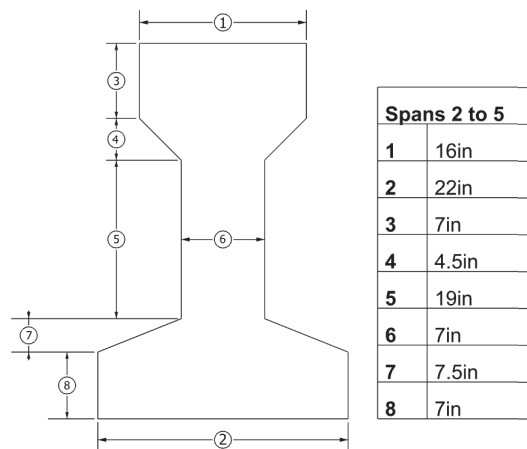
Title
TYPICAL SECTION (SPANS 2 TO 5)

Deck Width/Out to Out	26.5ft	Between Rails		24.667ft
Clear Roadway	24ft	Wearing Surface		
Median Width		Median Height		
Curb Height		Left		Right
Sidewalk Width		Left		Right
Clear Roadway (Rail to Median)		Left		Right
Guardrail Width		Left	15in	Right 15in
Top of Rail to Deck/Wearing Surface		Left	2.667ft	Right 2.667ft
Bridge Rail Type		Left	Type 4	Right Type 4

Measurements for Span #	2 to 5		
Deck Thickness	8.00in	Left Overhang	2.25ft
Top of Rail to Bottom of Beam (Avg)	7.250ft	Right Overhang	2.25ft

Beam #	Beam Type	Width	Height	Spacing	From
1	Prestressed Concrete Girder	22in	45in	2.25ft	Left Edge of Deck
2	Prestressed Concrete Girder	22in	45in	7.33ft	Beam 1
3	Prestressed Concrete Girder	22in	45in	7.33ft	Beam 2
4	Prestressed Concrete Girder	22in	45in	7.33ft	Beam 3

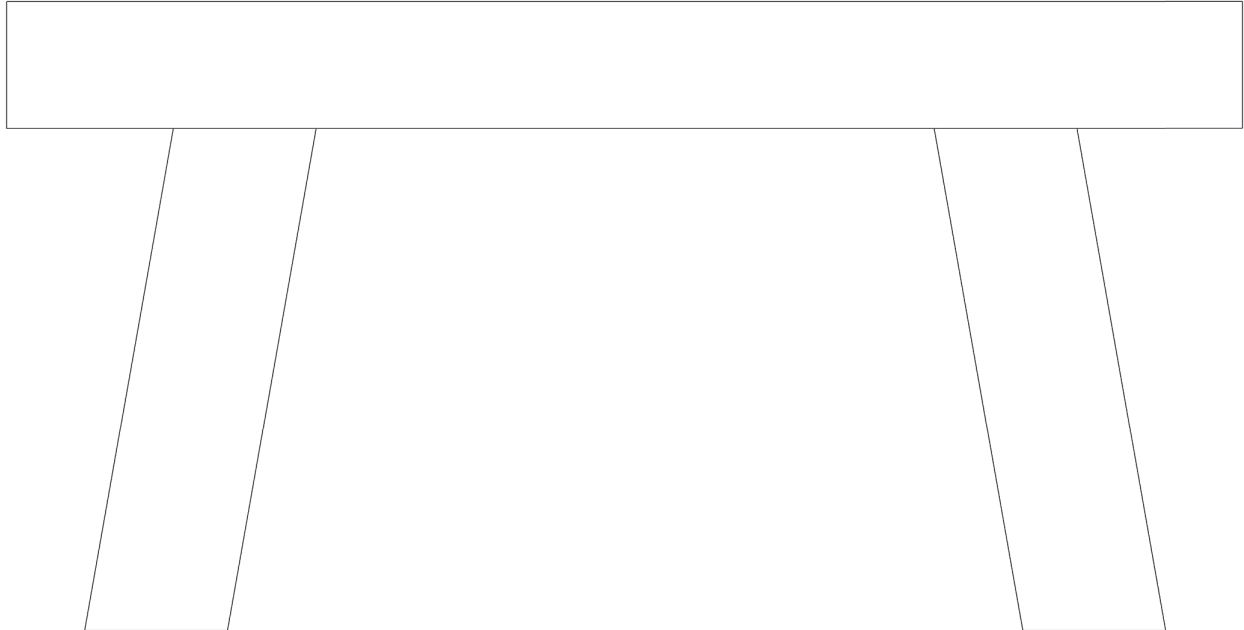
Title INTERIOR BENTS (1 TO 3)			Description SUBSTRUCTURE		
Structure No: 600229	Drawn By: ZK		Date: 10/27/2023	Filename: S001170000432.wes

Caps

#	Name	Type	Length	Width	Height	Left Beam to End of Cap	Right Beam to End of Cap
1	Cap 1	Reinforced Concrete Pier Cap	25.5ft	36in	24in	2ft	2.040ft

Piles

#	Name	Type	Spacing	From	Height/Diam.	Width	Length
1	Pile 1	Reinforced Concrete Column	4.5ft	Left End of Bent	36in		23ft
2	Pile 2	Reinforced Concrete Column	16.5ft	Pile 1	36in		23ft

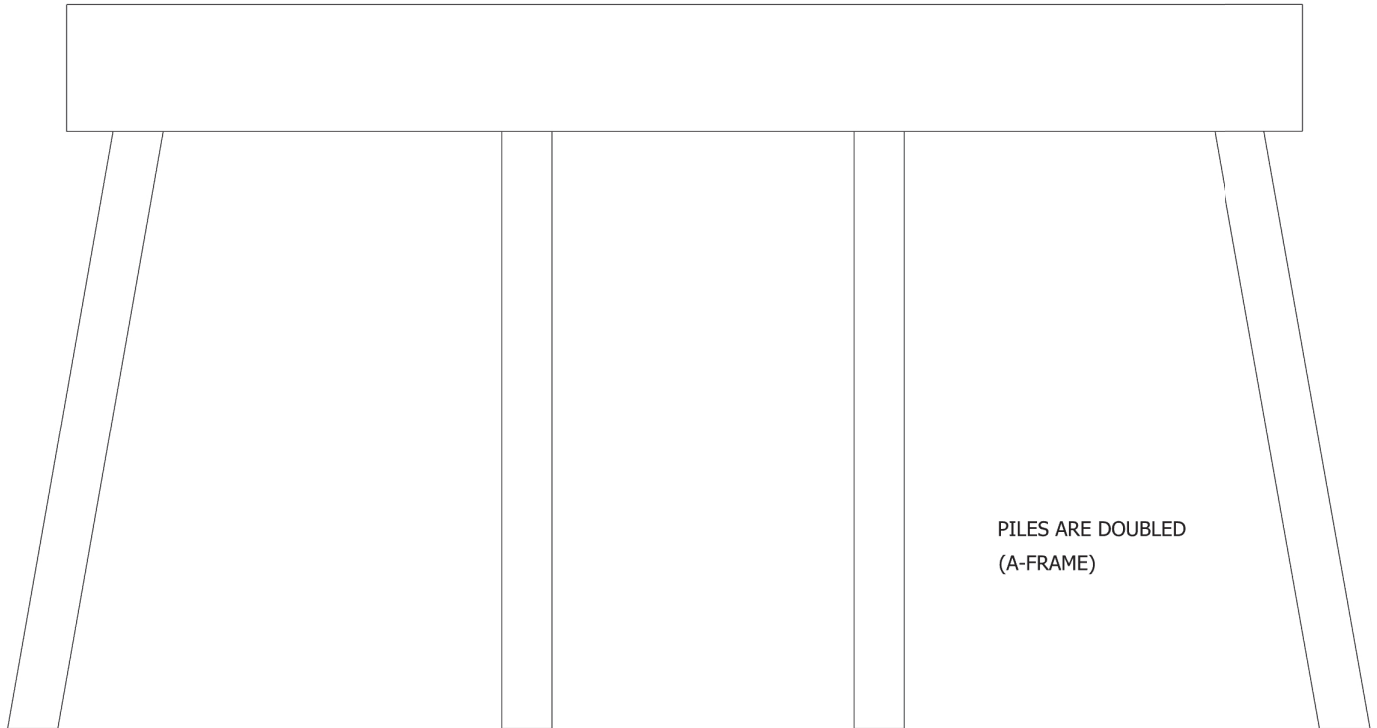
Title INTERIOR BENT 4			Description SUBSTRUCTURE		
Structure No: 600229		Drawn By: ZK		Date: 10/27/2023	Filename: S001170000433.wes

Caps							
#	Name	Type	Length	Width	Height	Left Beam to End of Cap	Right Beam to End of Cap
1	Cap 1	Reinforced Concrete Pier Cap	26.2ft	44in	33in	2ft	1.970ft
Piles							
#	Name	Type	Spacing	From	Height/Diam.	Width	Length
1	Row 2 Pile 1	Steel Pile	1.5ft	Left End of Bent	12.65in		10ft
1	Row 1 Pile 1	Steel Pile	1.5ft	Left End of Bent	12.65in		10ft
2	Row 2 Pile 2	Steel Pile	8.167ft	Row 2 Pile 1	12.65in		10ft
2	Row 1 Pile 2	Steel Pile	8.167ft	Row 1 Pile 1	12.65in		10ft
3	Row 2 Pile 3	Steel Pile	7.417ft	Row 2 Pile 2	12.65in		10ft
3	Row 1 Pile 3	Steel Pile	7.417ft	Row 1 Pile 2	12.65in		10ft
4	Row 2 Pile 4	Steel Pile	7.583ft	Row 2 Pile 3	12.65in		10ft
4	Row 1 Pile 4	Steel Pile	7.583ft	Row 1 Pile 3	12.65in		10ft

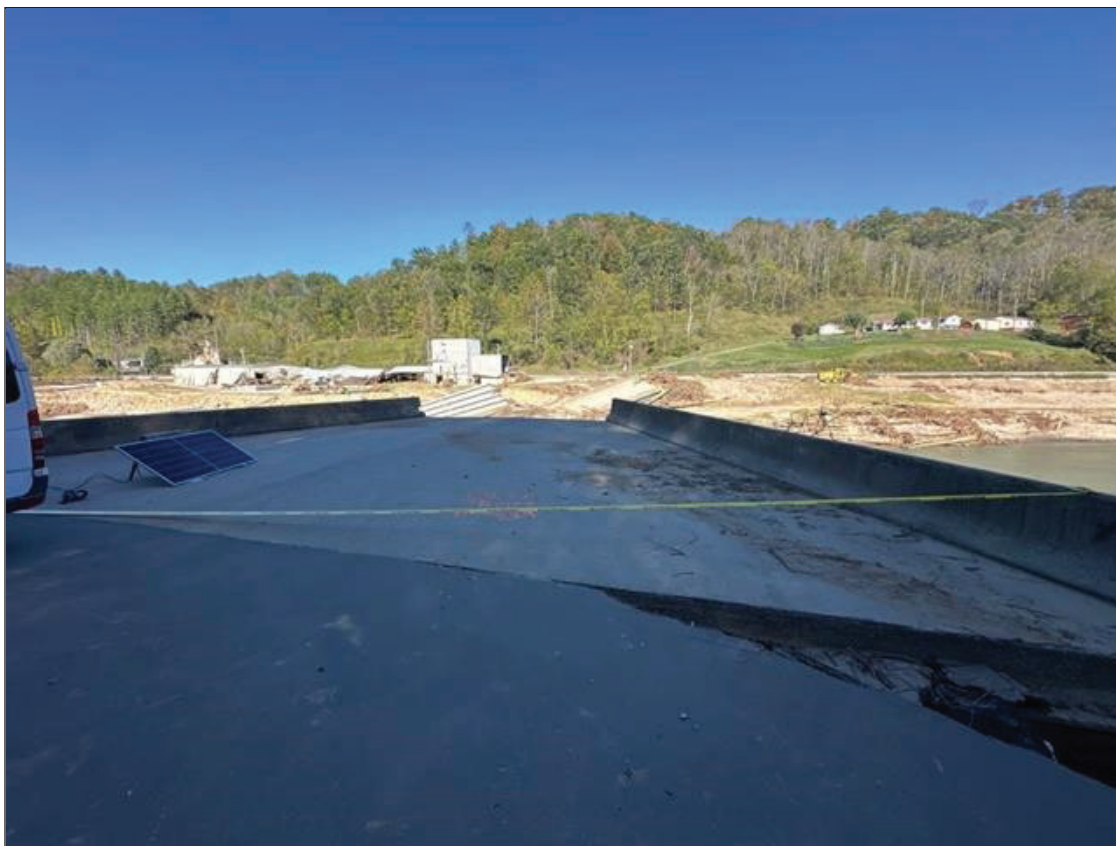
south approach looking north

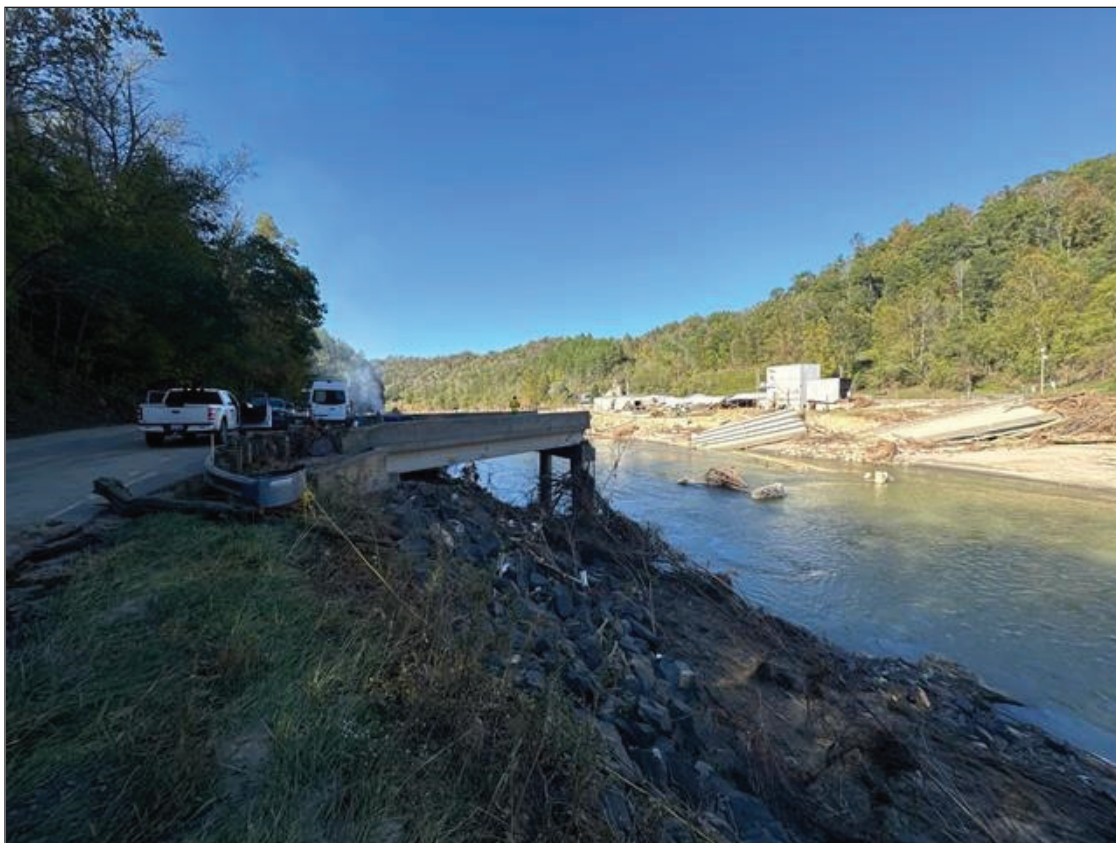
east profile, looking west
