# Bridge and Approach Investigation Checklist

Project 17BP.1.PE.1  
Description Structure #710030 across Perquimans River  
Route SR 1202  
Division 1  
County Perquimans

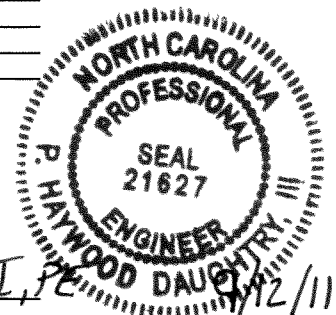
Existing Speed Limit 55 ☐ Posted ☒ Statutory  
Reasonable & Comfortable  
Passenger Car Speed \* 45  
Speed Data \_\_\_\_\_  
Ball Bank Speed Study < 10 @ 45 mph WB approach  
EB approach is tangent  
Warning Signs at Bridge 4 Delineators  
Roadside Development Woods, agriculture, church  
ADT History 690  
Pedestrian/Bicycle Traffic None observed  
Bridge and Approach  
Digital Photos Attached  
Approach Lane Width 8.5'  
Approach Shoulder Width: 6'  
Shoulder Type Soil  
Lane Width (existing bridge) 8'  
Shoulder width (existing bridge) 4'  
Strategic Corridor / Thoroughfare  
Designation and Recommended  
Cross Section Local secondary  
Crash History and  
Safety Considerations SEE ATTACHED TEAAS REPORT  
Comments Road posted 6 1/2 tons  
Structure posted 12 Tons SV/20 Tons TTST  
\* Due to narrow lanes and curved alignment on each side of tangent  
section at bridge.

Reasonable Bridge Speed \* 45

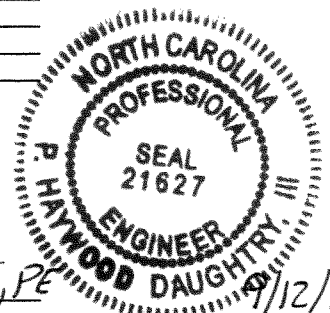
Existing Speed Limit 55 ☐ Posted ☒ Statutory  
Reasonable & Comfortable  
Passenger Car Speed 55  
Speed Data N/A  
Ball Bank Speed Study N/A  
Warning Signs at Bridge 3 Delineators  
Roadside Development Agriculture, residential  
ADT History 570 (2010 AADT MAPS)  
Pedestrian/Bicycle Traffic None observed  
Bridge and Approach  
Digital Photos Attached  
Approach Lane Width 9'  
Approach Shoulder Width: 5'  
Shoulder Type Soil  
Lane Width (existing bridge) 9'  
Shoulder width (existing bridge) 5.5'  
Strategic Corridor / Thoroughfare  
Designation and Recommended  
Cross Section Local secondary  
Crash History and  
Safety Considerations SEE ATTACHED TEAAS REPORT  
Comments 24 tons SV/30 tons TTST

Reasonable Bridge Speed 55
