# BRIDGE INSPECTION REPORT

INSPECTION TYPE: Routine Inspection

BRIDGE NUMBER 600084

ROUTE SR1349

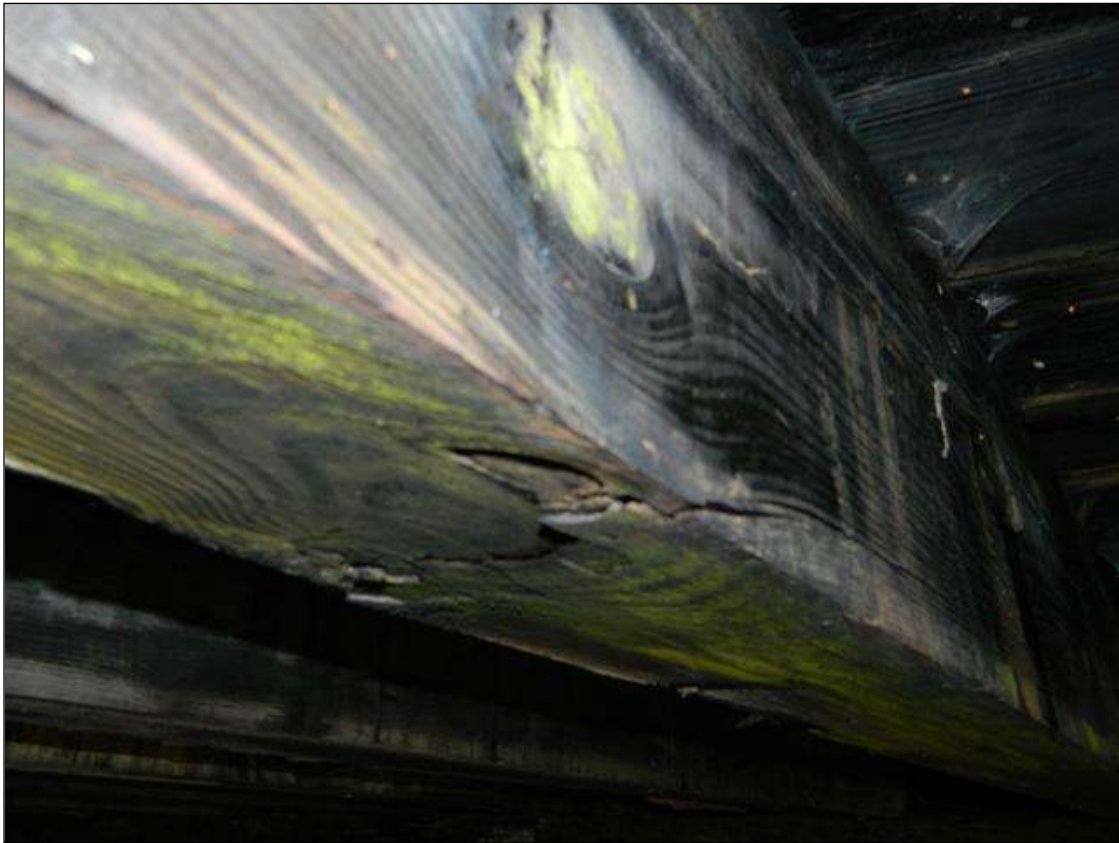
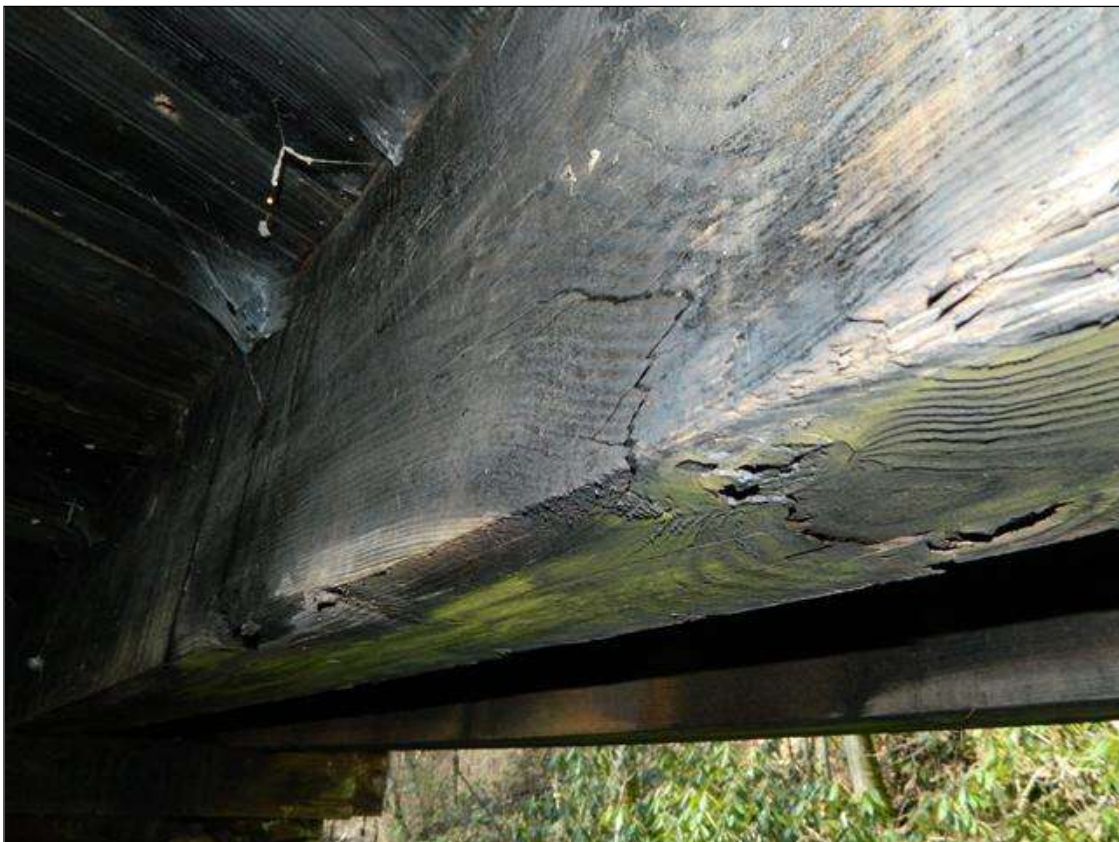
| Bridge I&A Form 1(82)H<br>State of North Carolina<br>Dept. of Transportation<br>Division of Highways | | <h1>FIELD INSPECTION REPORT</h1> <h2><u>Bridge Inspection &amp; Analysis</u></h2> | |
|---|---|---|--|
| 11 | C | TOP OF JOISTS SOFT AND DECAYING. JOIST 10 SUPPLEMENTED. FAR HALF OF JOIST 2 HEAVILY FUNGUS STAINED, IS DULL AND HOLLOW SOUNDING BECOMING MORE SO TOWARD THE BEARING. STRESS FRACTURING IN BOTTOM OF JOIST 2 AT MID AND 3/4 SPAN AND IN BOTTOM AT MID JOIST 5, SEE PHOTOS. BRIDGE ON SLIGHT POSITIVE GRADE. PRIORITY MAINTENANXCE WILL BE REQUESTED ON FRACTURED JOISTS. | |

FRACTURE AT MID JOIST 2 IN BOTTOM AT KNOT DEFECT

| MMS Code | Description of Function | Unit | Quantity | Remarks | Est. Cost |
|---|---|---|---|---|---|
| 3304 | Maintain/Replace Timber Superstructure Components | LF | 17 | Stress fractures in bottom of joist 2 at mid and 3/4 span around knot defects. Fractures follow grain 10" to 12" and run up from bottom 2" to 3". Bridge is posted. | |

| MMS Code | MMS Description | Quantity |
|---|---|---|
| Stress fractures in bottom of joist 2 at mid and 3/4 span around knot defects. Fractures follow grain 10" to 12" and run up from bottom 2" to 3". Bridge is posted. | | |

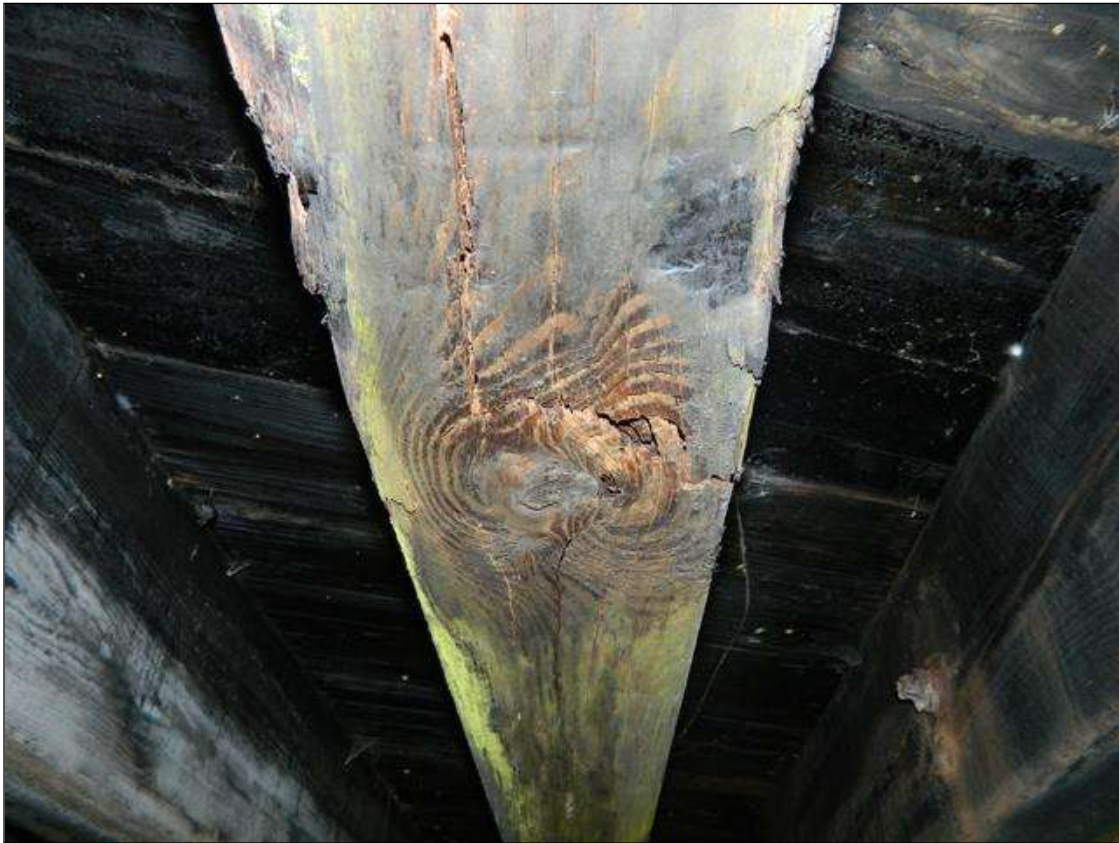
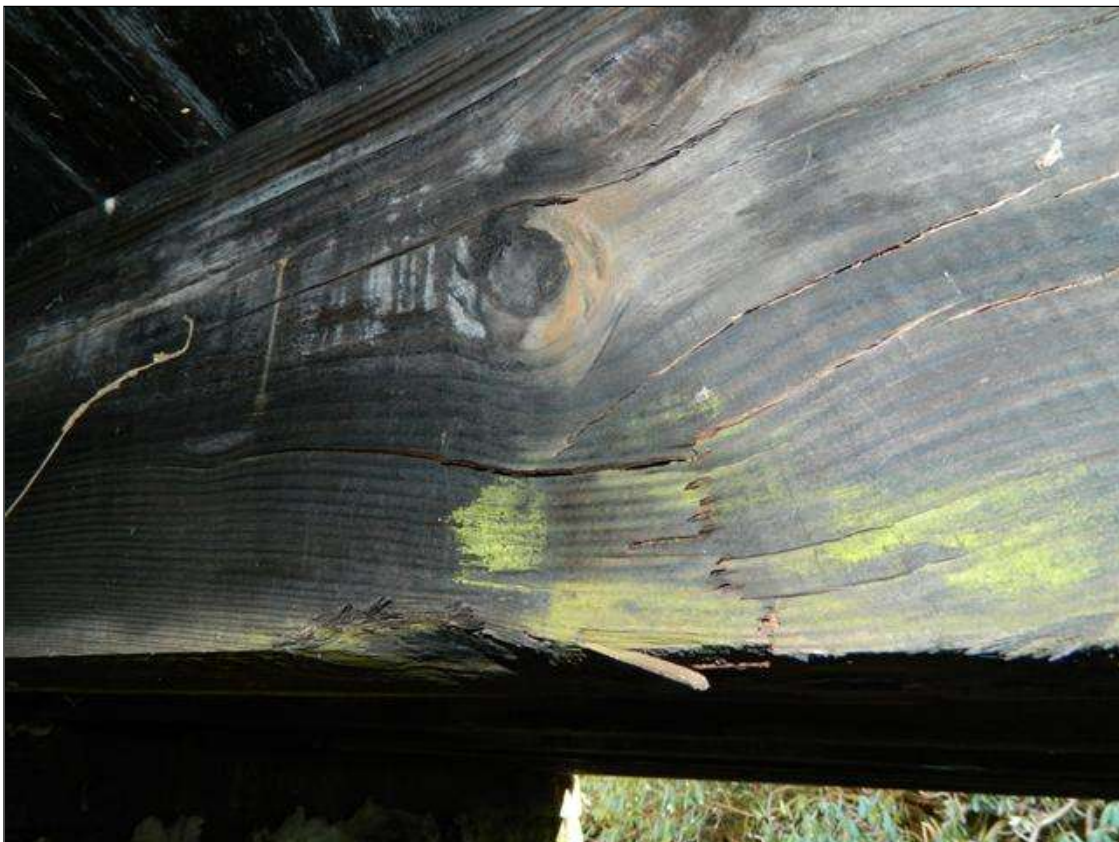
FRACTURE AT 3/4 SPAN JOIST 2 IN BOTTOM AT KNOT DEFECT

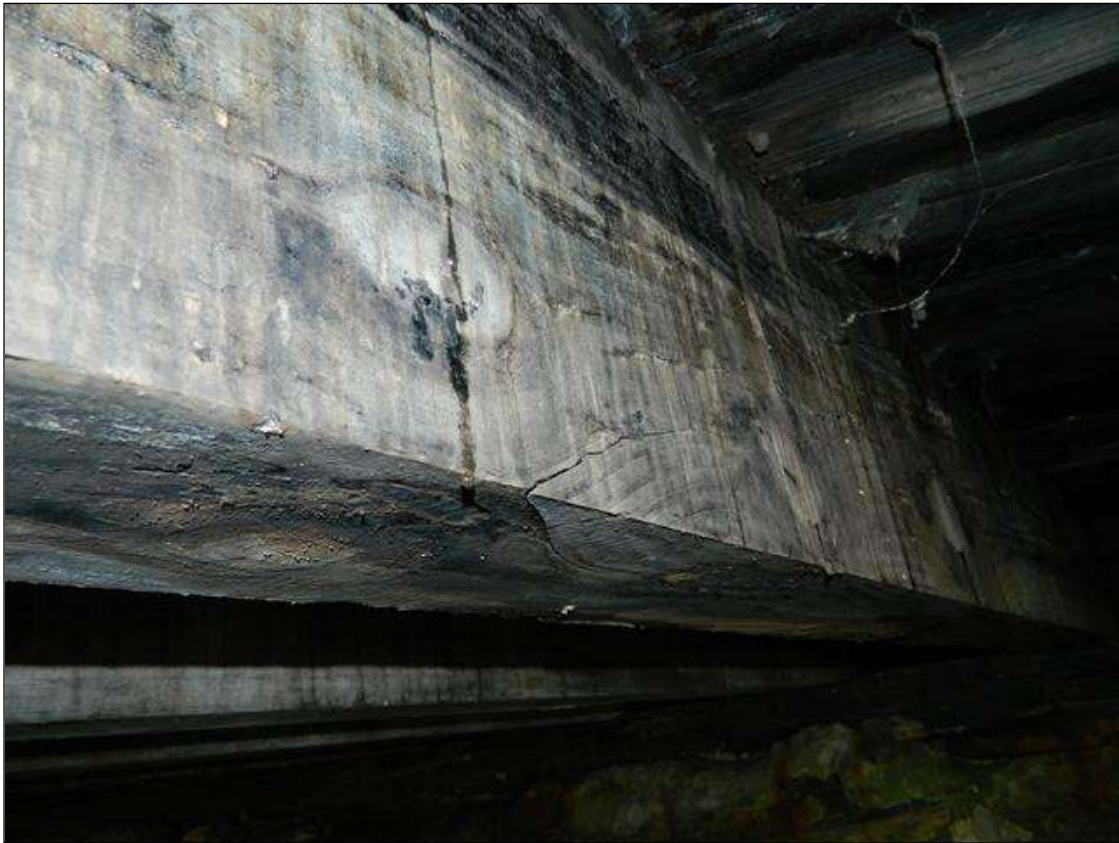
FRACTURE AT MID JOIST 5 IN BOTTOM AT KNOT DEFECT

| MMS Code | Description of Function | Unit | Quantity | Remarks | Est. Cost |
|---|---|---|---|---|---|
| 3304 | Maintain/Replace Timber Superstructure Components | LF | 17 | Stress fracture in bottom of joist 5 at mid span around knot defect. Fracture follows grain 4" to 6" and runs up from bottom 2" to 3". Bridge is posted. | |

| MMS Code | MMS Description | Quantity |
|---|---|---|
| Stress fracture in bottom of joist 5 at mid span around knot defect. Fracture follows grain 4" to 6" and runs up from bottom 2" to 3". Bridge is posted. | | |

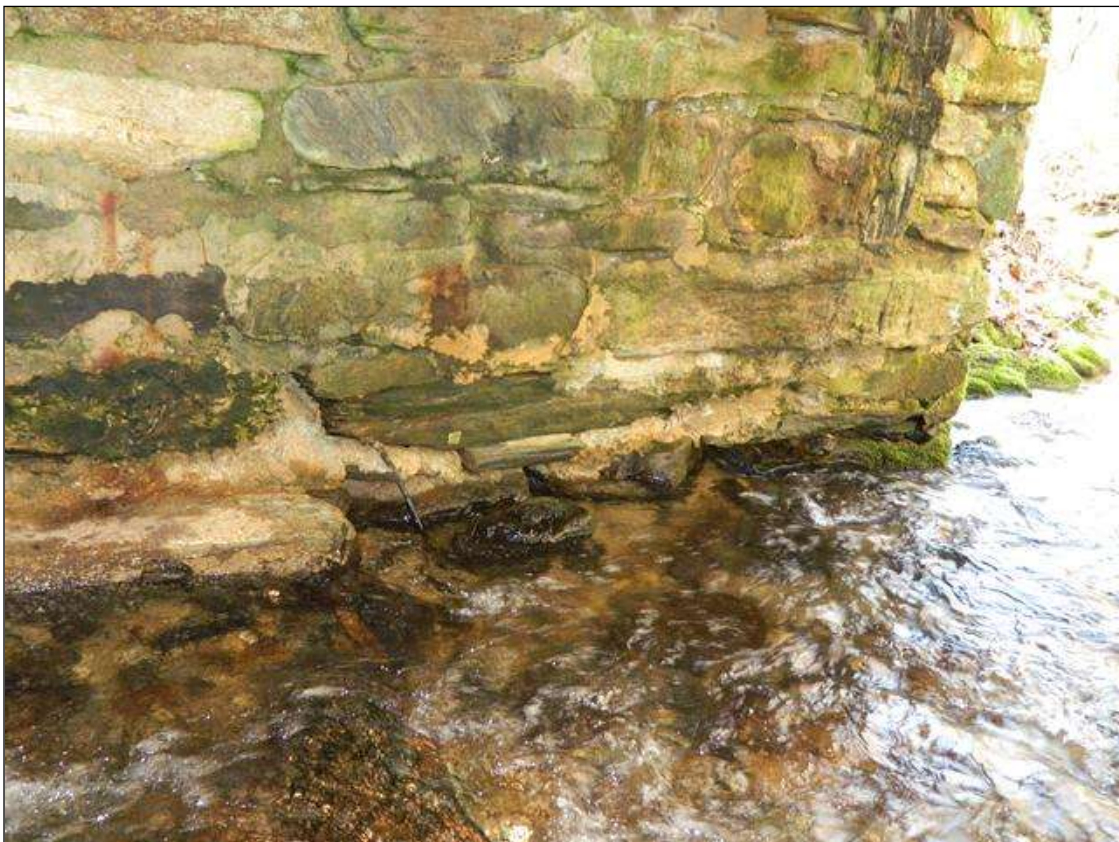
| Bridge I&A Form 1(82)H<br>State of North Carolina<br>Dept. of Transportation<br>Division of Highways | | <h1>FIELD INSPECTION REPORT</h1> <h2><u>Bridge Inspection &amp; Analysis</u></h2> | |
|---|---|---|--|
| 36b | F | LOOSE STONES AND ERODED JOINT GROUT IN BASE OF DOWNSTREAM END ABUTMENT 1, SEE PHOTOS. NO SETTLEMENT NOTICED AT THIS INSPECTION. | |

LOOSE MASONRY AND ERODED GROUT IN DOWNSTREAM END ABUTMENT 1

| MMS Code | Description of Function | Unit | Quantity | Remarks | Est. Cost |
|---|---|---|---|---|---|
| 3348 | Maintain Concrete Substructure Components | LF | 100 | LOOSE MASONRY IN BASE OF ABUTMENT 1 | |

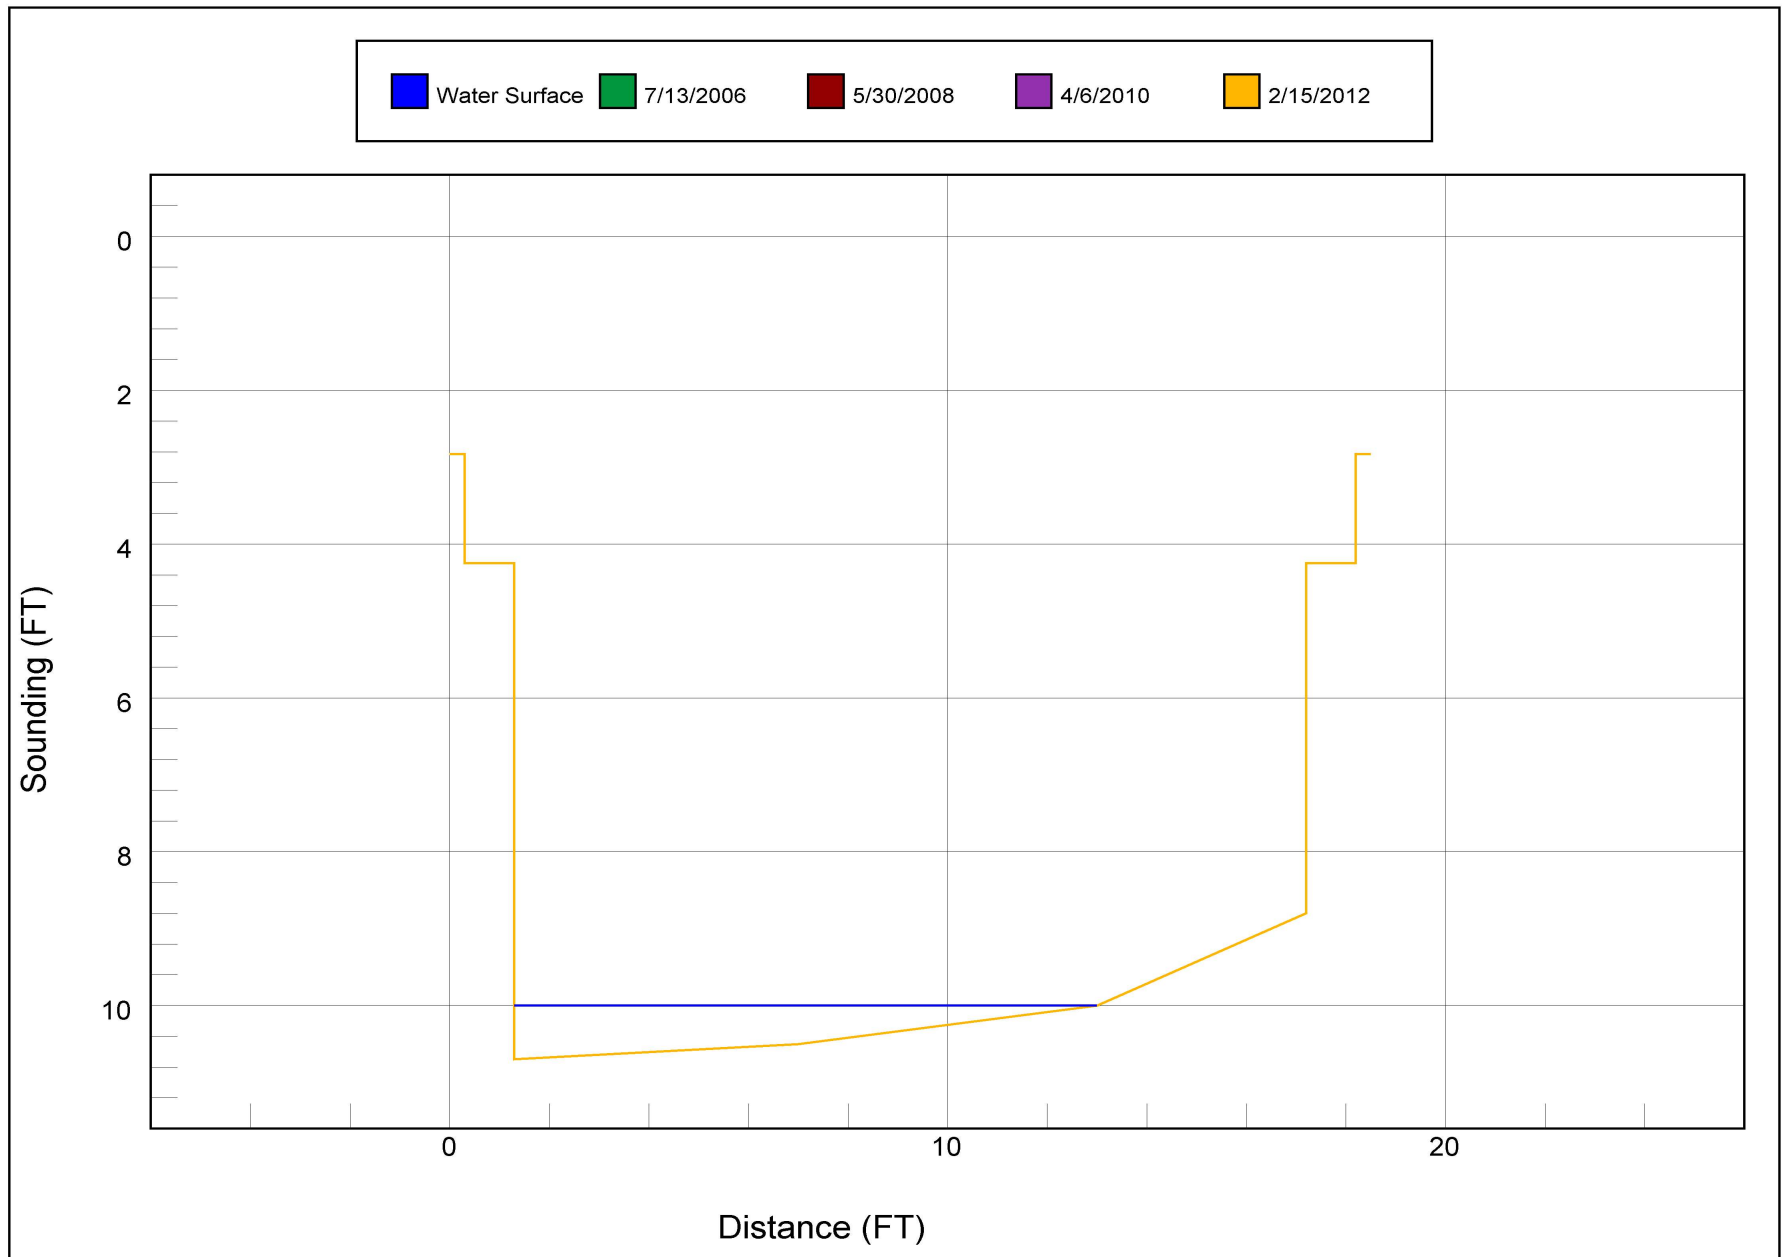
**STREAMBED PROFILE (Downstream)**

Top of Rail = 0 FT (Sounding)

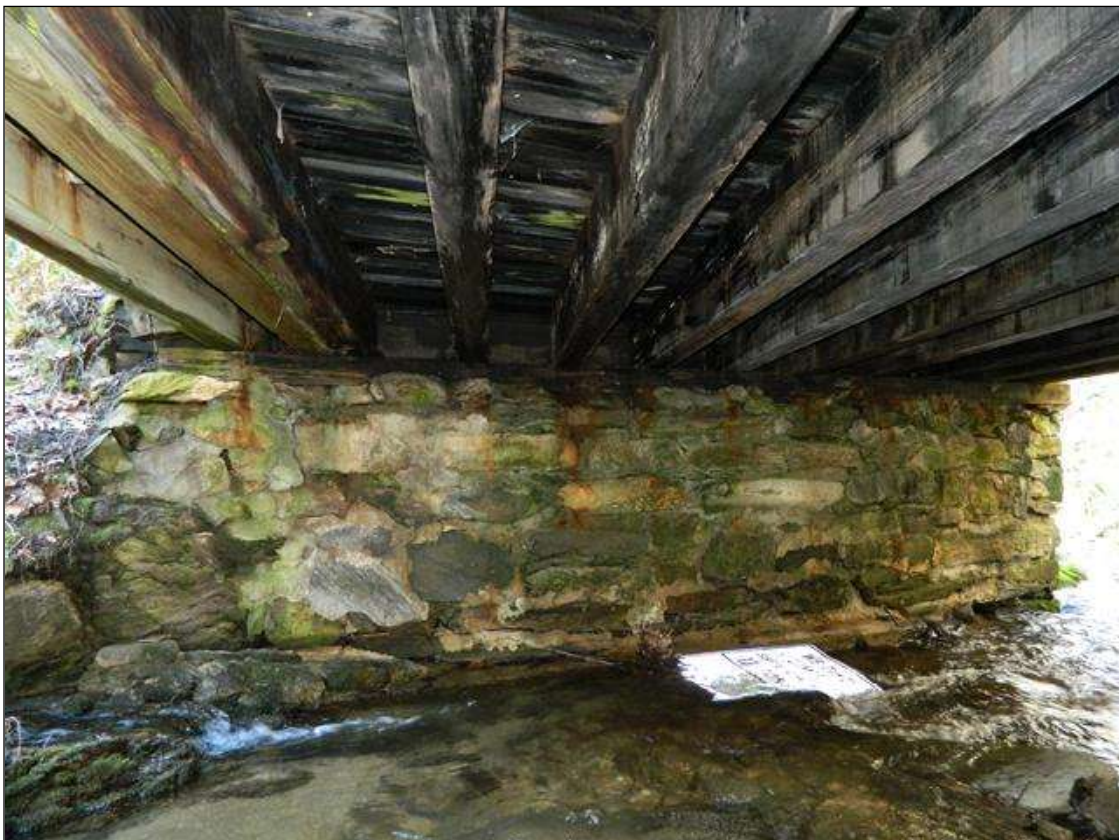
| Bridge I&A Form 1(82)H<br>State of North Carolina<br>Dept. of Transportation<br>Division of Highways | | <h1>FIELD INSPECTION REPORT</h1> <h2><u>Bridge Inspection &amp; Analysis</u></h2> | |
|---|---|---|--|
| 35a | F | TIMBER BEARING BOLSTERS WEATHERED AND SOFT PRIMARILY ON ENDS. DECAY IN TOP on OUTSIDE of EXTERIOR JOISTS. ABUTMENT 1 BOLSTER EXTREMELY SOFT, JOISTS CRUSHING INTO BRIDGE SEAT. BRIDGE ON SLIGHT POSITIVE GRADE, JOISTS CRUSHING INTO FRONT EDGE OF BOLSTER TIMBER AT ABUTMENT 2. | |
