**NO NATIONAL REGISTER OF HISTORIC PLACES  
ELIGIBLE OR LISTED ARCHAEOLOGICAL SITES  
PRESENT OR AFFECTED FORM**

Project No: **Str# 850019** County: **Surry**  
 WBS No: **17BP.11.R.71** Document: **Minimum Criteria**  
 F.A. No: **n/a** Funding: ☒ State ☐ Federal  
 Federal Permit Required? ☒ Yes ☐ No Permit Type: **NWP #3 or14**

*This project calls for the replacement Bridge No. 19 on SR 1307 (Mountain Park Road) over the South Fork Mitchell River in Surry County. The archaeological Area of Potential Effects (APE) for the project is defined as a 720-foot (219.46 meter) long corridor running 360 feet (109.73 meters) northeast and 360 feet southwest along Mountain Park Road from the center of Bridge No. 19. The corridor is approximately 150 feet (45.72 meters) wide extending 75 feet (22.86 meters) on either side of the road from its present center.*

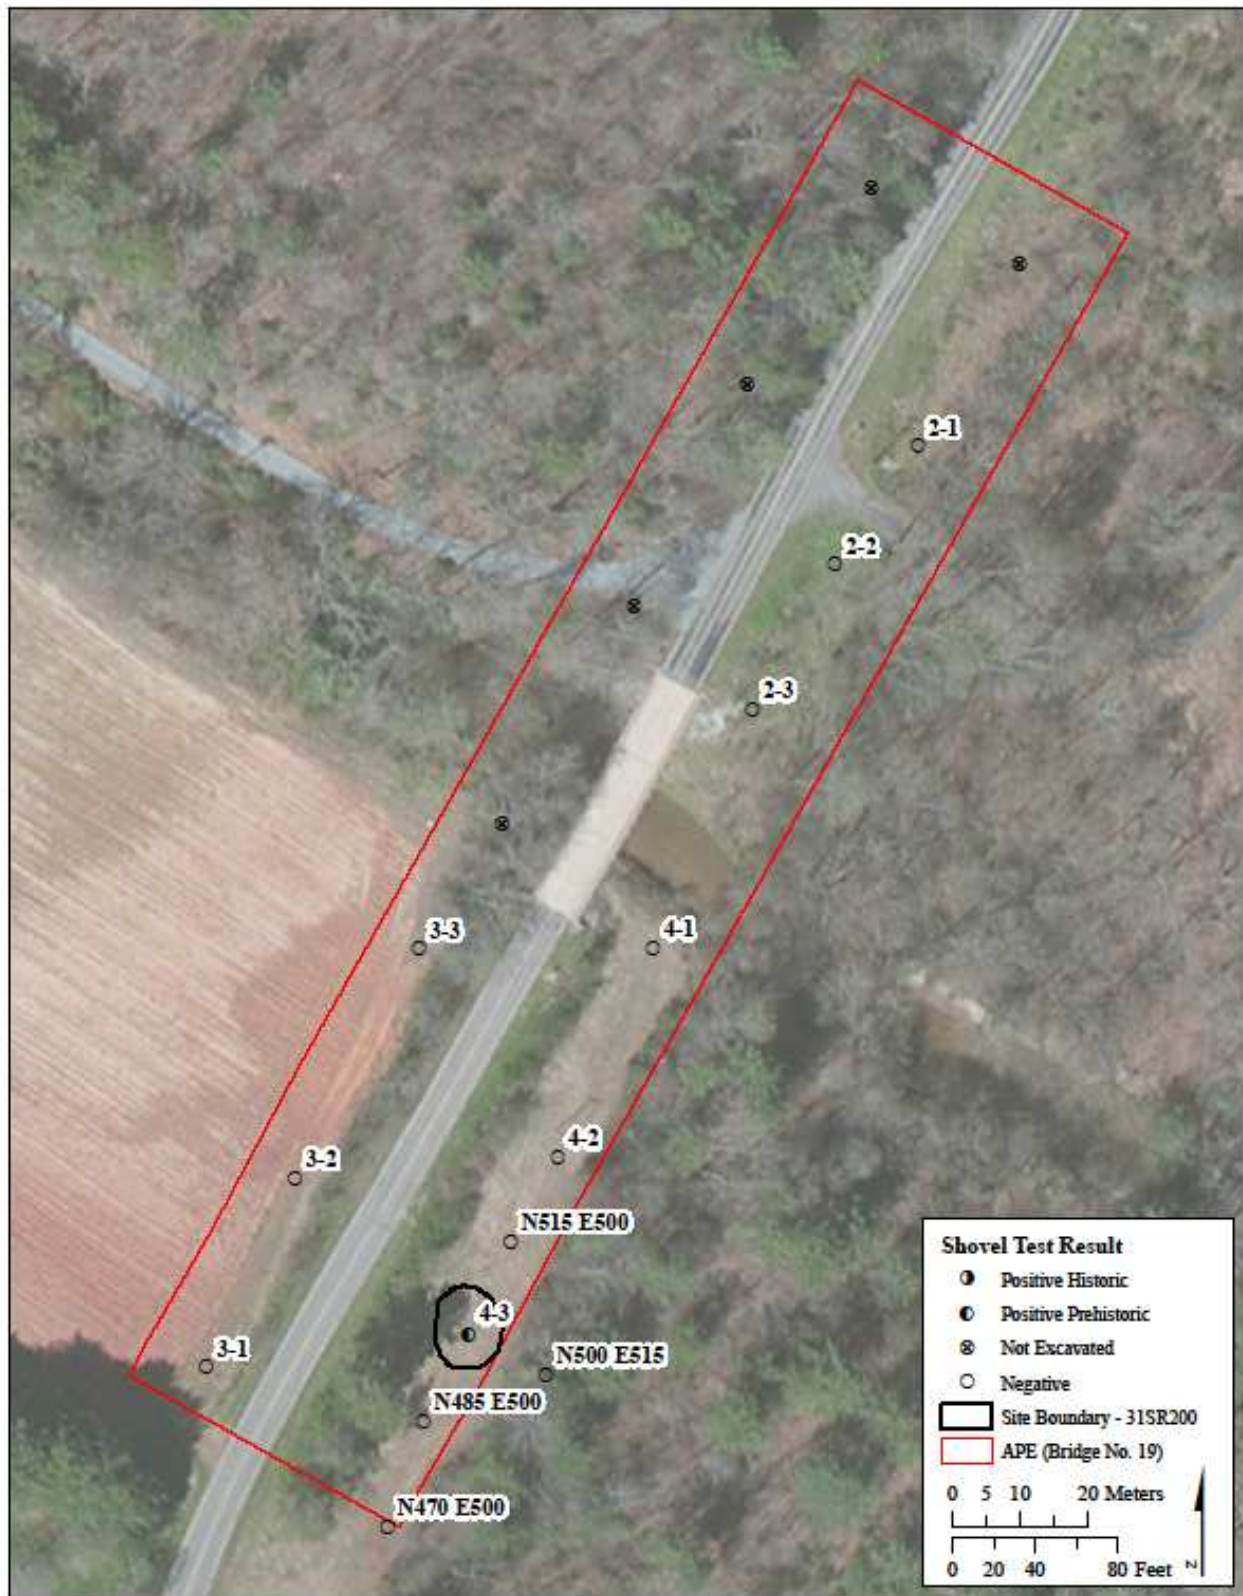
Figure 3. Aerial View of the Project Area showing Shovel Test Results.

The intensive archaeological survey excavated a total of nine shovel tests at 30-meter intervals (98.43 feet) along two transects, one located on either side of the existing road within the APE (Figure 3). Four shovel tests could not be excavated due to the presence of steep slope on the northwest and northeast section of the APE. Three radial shovel tests were excavated around the single positive shovel test at 15-meter (49.21 feet) intervals with an additional radial 30 meters southwest of the original positive. All shovel tests measured at least 30-centimeters (12 inches) in diameter and were excavated to at least 10 centimeters (4 inches) into sterile subsoil. All excavated soils and sediments were screened through mesh screen (0.64 centimeter, 0.25 inch), and all shovel tests were backfilled. A visual inspection of the surface was also done in conjunction with subsurface testing. A typical soil profile in the southeast quadrant, at the positive shovel test, was 0 to 5 centimeters of brown (7.5YR4/4) loam (Stratum I) and 5 to 10 centimeters of brown (7.5YR4/4) silt (Stratum II), and 10-15 centimeters of red (2.5YR4/8) clay (Stratum III). In the southwest quadrant, a typical profile contained red (2.5YR4/6) sandy clay from the surface.

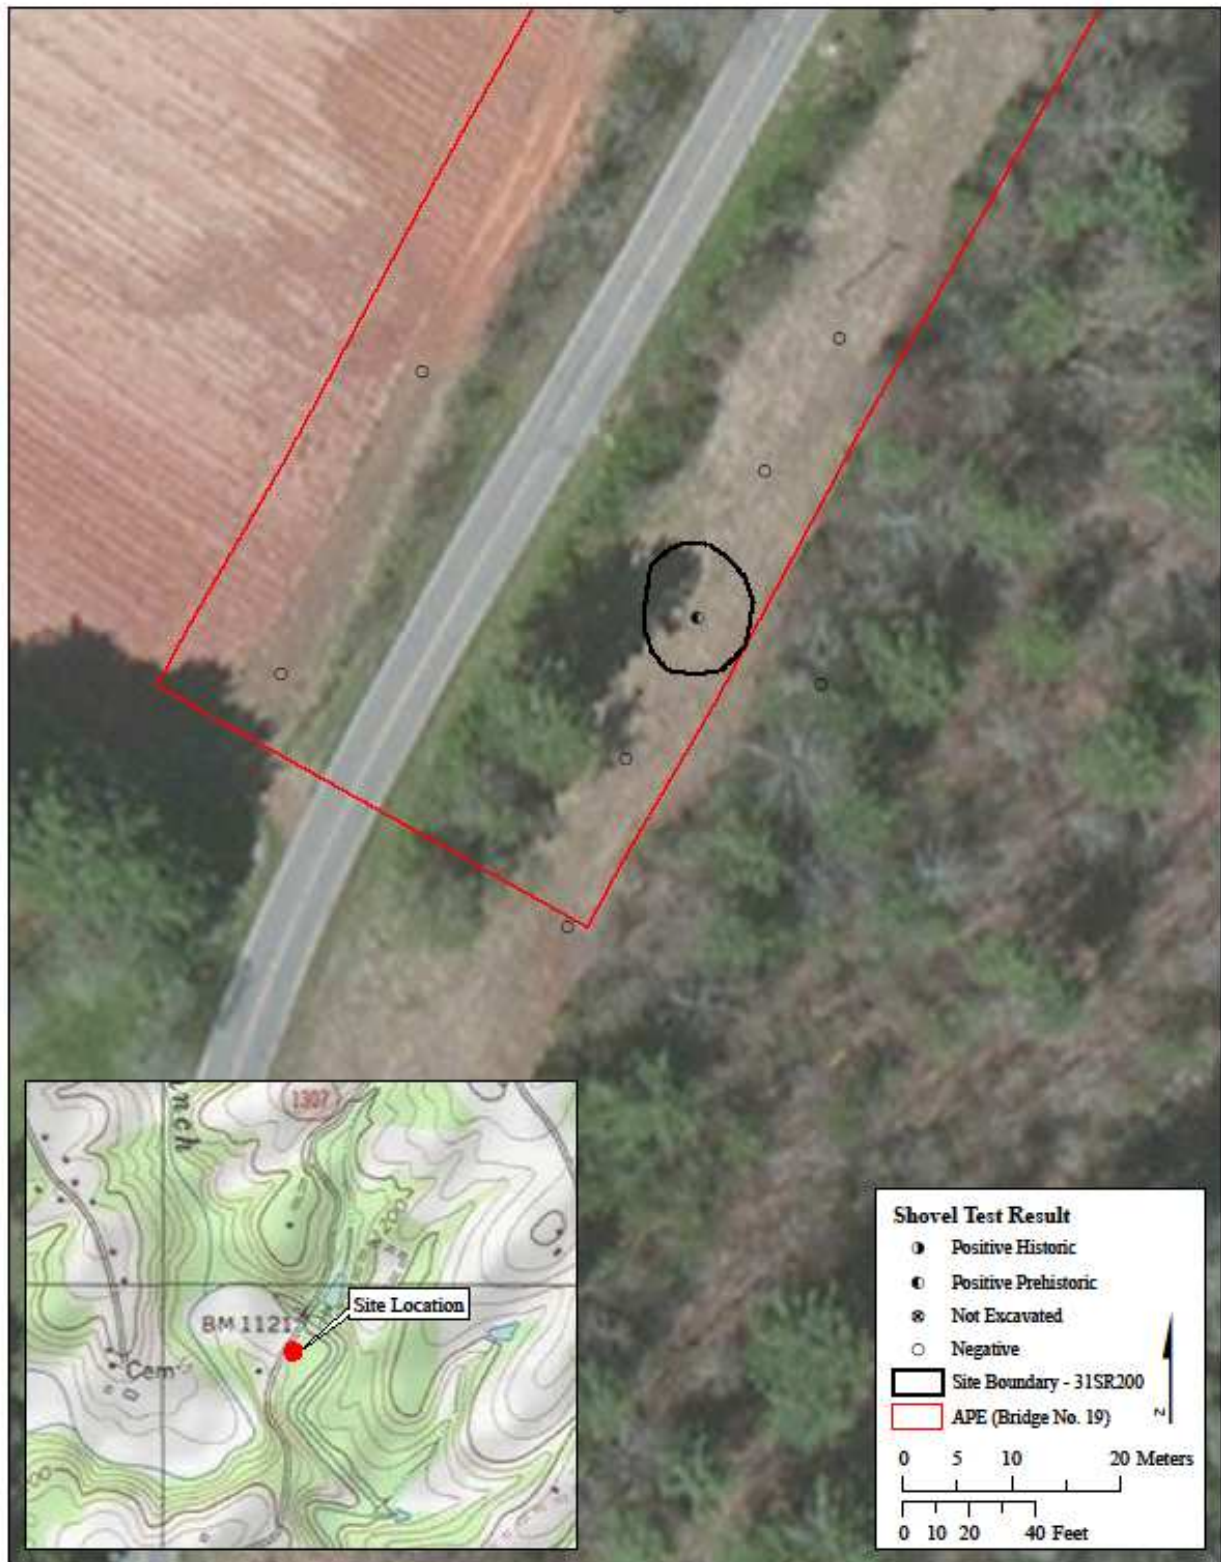
Figure 4. 31SR200 Site Map.

Isolated find 31SR200 was identified during regular interval shovel testing on the south side of the South Fork Mitchell River in the southeast quadrant of the APE. It consists of single metavolcanic flake located in shovel test 4-3 (Figures 4). Radial shovel tests were excavated at 15-meter intervals to the north, south, and east. No radials could be excavated to the west due to the presence of the road. The isolated find is located underneath a power line corridor; the ground has been cleared with signs of extensive erosion. No evidence of features was identified, and none are expected. Isolated find 31SR200 has no potential to provide further important information beyond that which has already been documented. New South recommends that 31SR200 is not eligible for listing in the NRHP under any of the four criteria. No further work is recommended for this site.
