**NO NATIONAL REGISTER OF HISTORIC PLACES  
ELIGIBLE OR LISTED ARCHAEOLOGICAL SITES  
PRESENT OR AFFECTED FORM**

Project No: **Str# 850094** County: **Surry**  
 WBS No: **17BP.11.R.87** Document: **Minimum Criteria**  
 F.A. No: **n/a** Funding: ☒ State ☐ Federal  
 Federal Permit Required? ☒ Yes ☐ No Permit Type: **NWP #3 or14**

*This project calls for the replacement of Bridge No. 94 on SR 1727 (Linville Road) over the Ararat River in Surry County. The archaeological Area of Potential Effects (APE) for the project is defined as a 780-foot (237.74) long corridor running 390 feet (118.87 meters) northwest and 390 feet southeast along Linville Road from the center of Bridge No. 94. The corridor is approximately 150 feet (45.72 meters) wide extending 75 feet (22.86 meters) on either side of the road from its present center.*

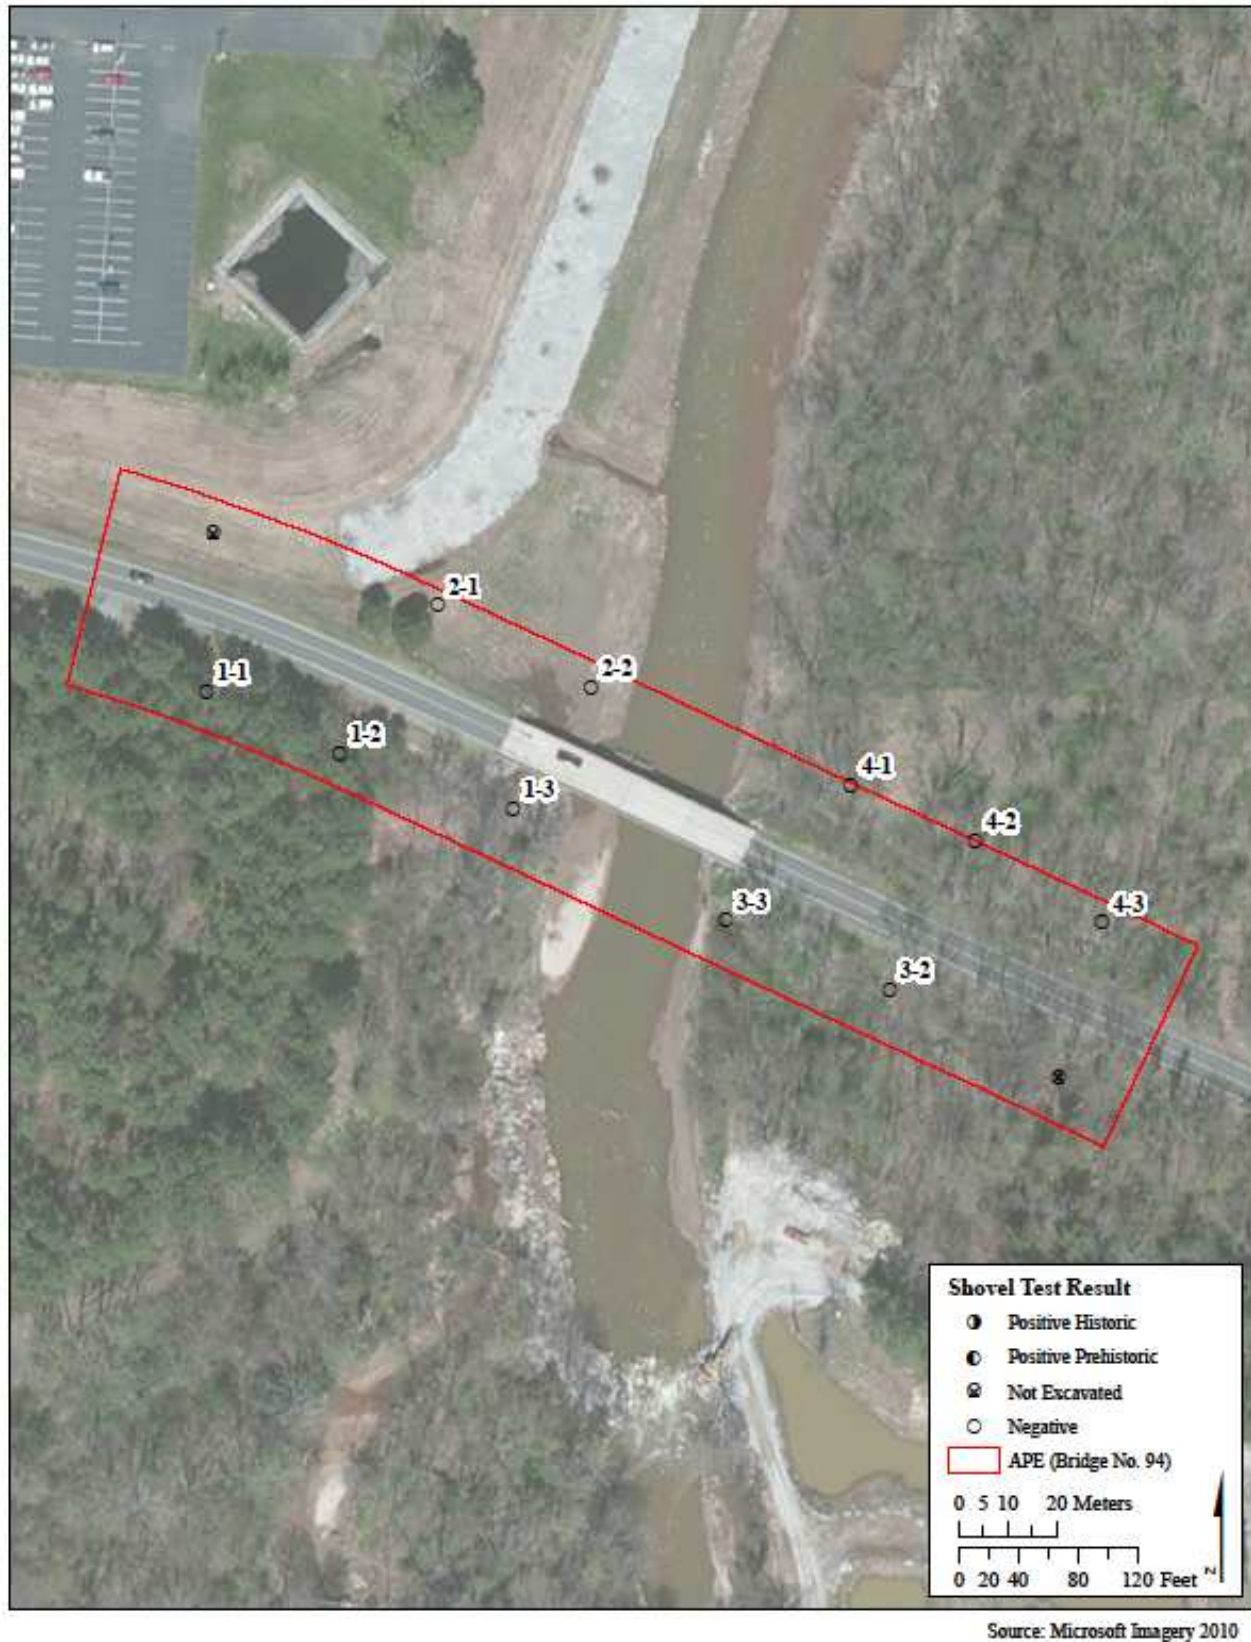
Figure 4. Aerial View of the Project Area showing Shovel Test Results.

The intensive archaeological survey excavated a total of ten shovel tests at 30-meter intervals (98.43 feet) along two transects, one located on either side of the existing road within the APE (Figure 4). Two shovel tests could not be excavated due slope and disturbances in the northwest and southeast quadrants. All shovel tests measured at least 30-centimeters (12 inches) in diameter and were excavated to at least 10 centimeters (4 inches) into sterile subsoil. All excavated soils and sediments were screened through mesh screen (0.64 centimeter, 0.25 inch) and all shovel tests were backfilled. A visual inspection of the surface was also done in conjunction with subsurface testing. A typical soil profile in the floodplain of the Ararat River was 0 to 10 centimeters of brown (7.5YR4/4) loam (Stratum I), 10 to 40 centimeters of brown (7.5YR4/4) sandy loam (Stratum II), and 40-50 centimeters of brown (7.5YR4/4) sandy clay (Stratum III). On the stream terraces, a typical profile contained 0 to 15 centimeters of brown (7.5YR4/4) loam (Stratum I) and 15 to 25 centimeters reddish brown (5YR4/4) sandy clay (Stratum II). Shovel tests on the east side of the Ararat River generally consisted of loose, unconsolidated sediments that are consistent with active stream environments.
