**NO NATIONAL REGISTER OF HISTORIC PLACES  
ELIGIBLE OR LISTED ARCHAEOLOGICAL SITES  
PRESENT OR AFFECTED FORM**

***Project Description:*** Replace Bridge 91 on SR 1599 (Mt. Carmel Church Rd.) over Forbush Creek. Area of Potential Effects (A.P.E.) is approximately 91 meters (300 ft.) from each end of the bridge and 23 meters (75 ft.) from the centerline on each side of the road. No design plans provided. This is a "design-build" project, and the bridge will be replaced in-place with an off-site detour. State-funded; federal permits required; temporary and permanent easements required.

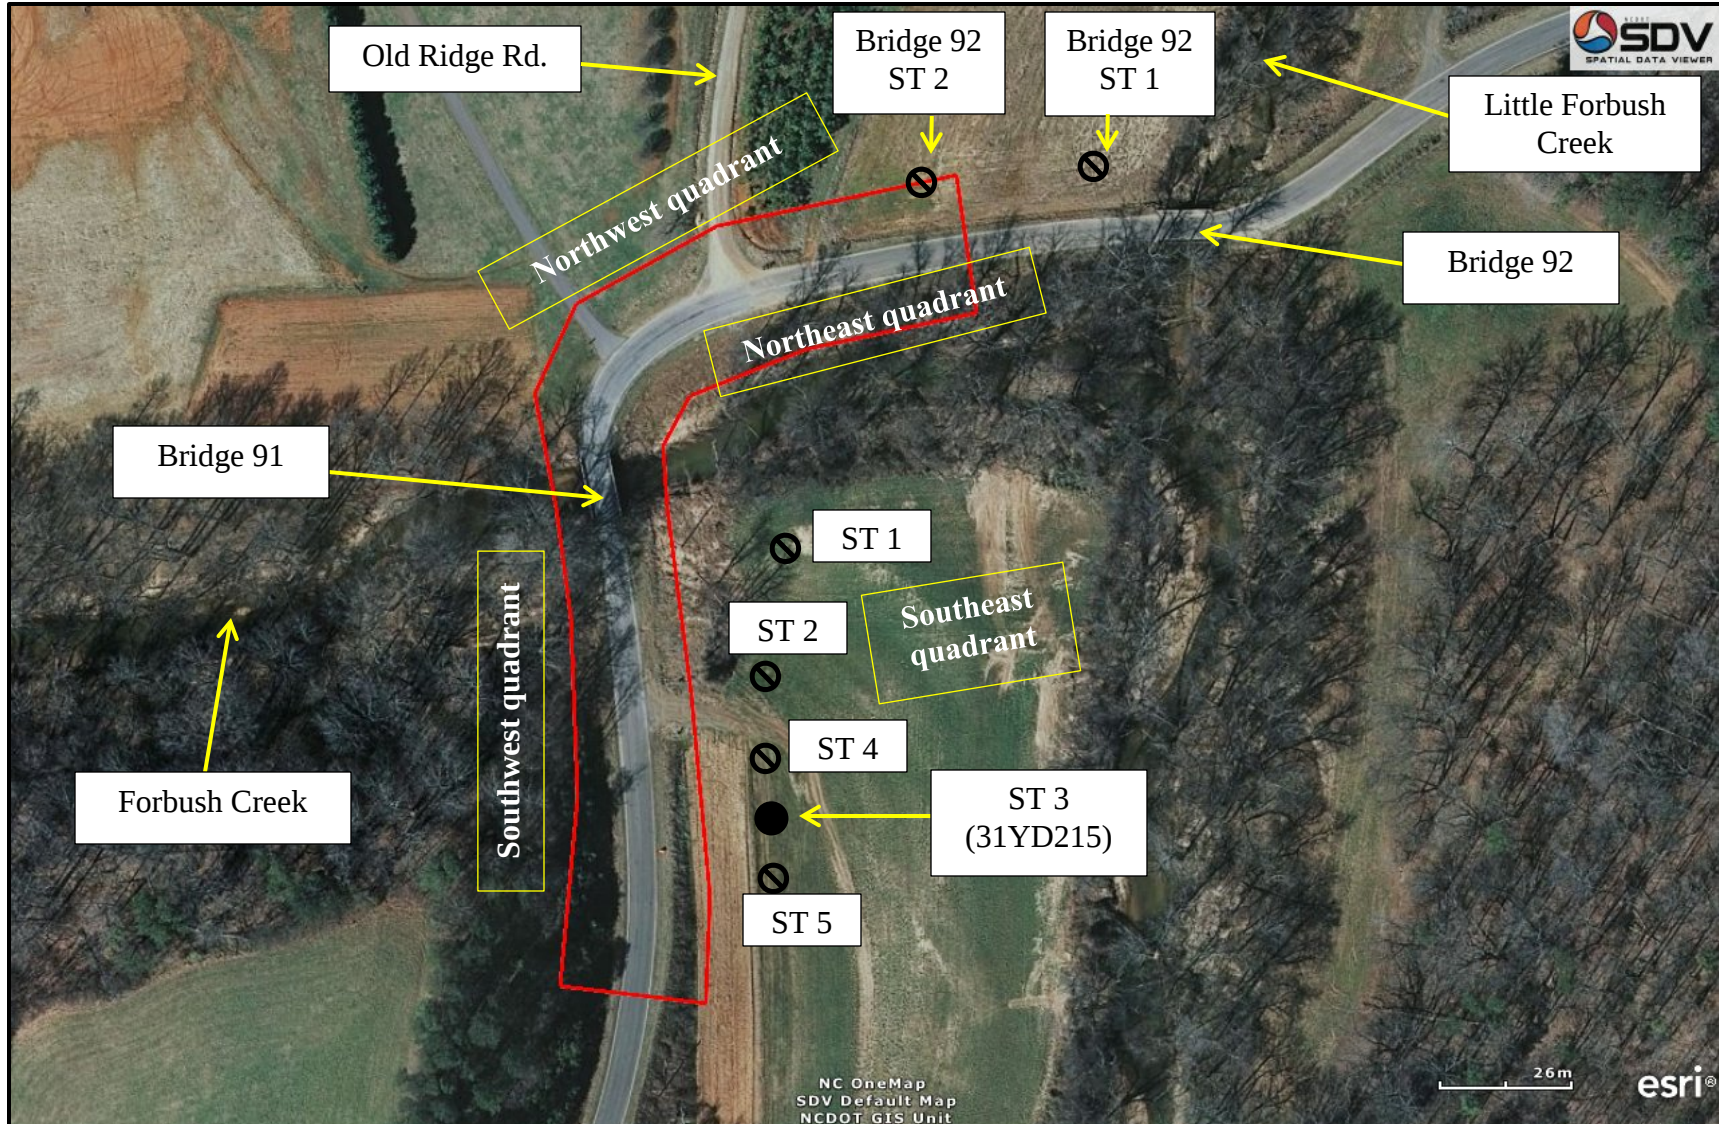
Figure 3: Aerial photograph of Bridge 91.

The archaeological survey was conducted on 11/5/2013 by NCDOT archaeologists Caleb Smith and Dr. Gary Glover. The aerial photograph in Figure 3 shows the locations of the shovel tests excavated in this project's southeast quadrant, as well as the shovel tests excavated in Bridge 92's northwest quadrant. Table 1 describes each shovel test. No shovel tests were excavated in the southwest or northeast quadrants.

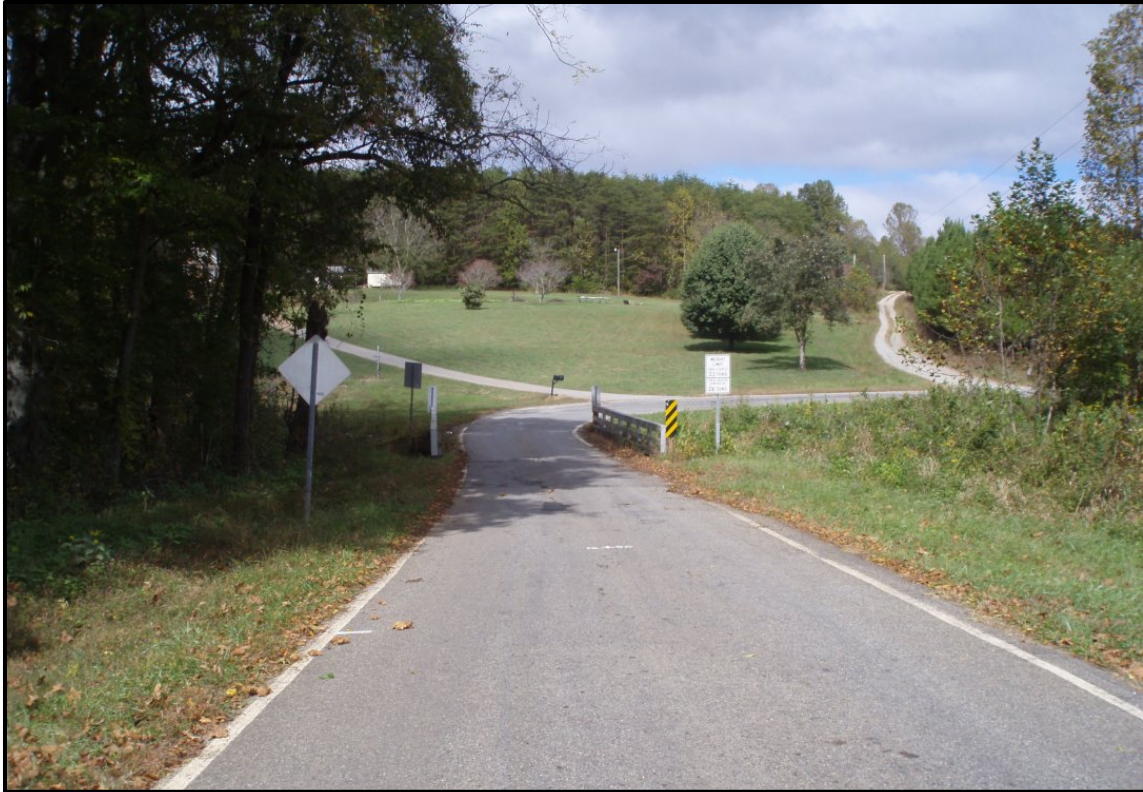
Figure 4: North view of Bridge 91.

The visual reconnaissance was conducted by NCDOT archaeologists Matt Wilkerson and Caleb Smith on 10/14/2013. Figure 4 is a photograph of Bridge 91. The reconnaissance verified that the landforms in the northeast and southwest quadrants had little potential for prehistoric archaeological sites. It also found that the northwest quadrant had a low potential, and confirmed the southeast quadrant had some potential for prehistoric sites.

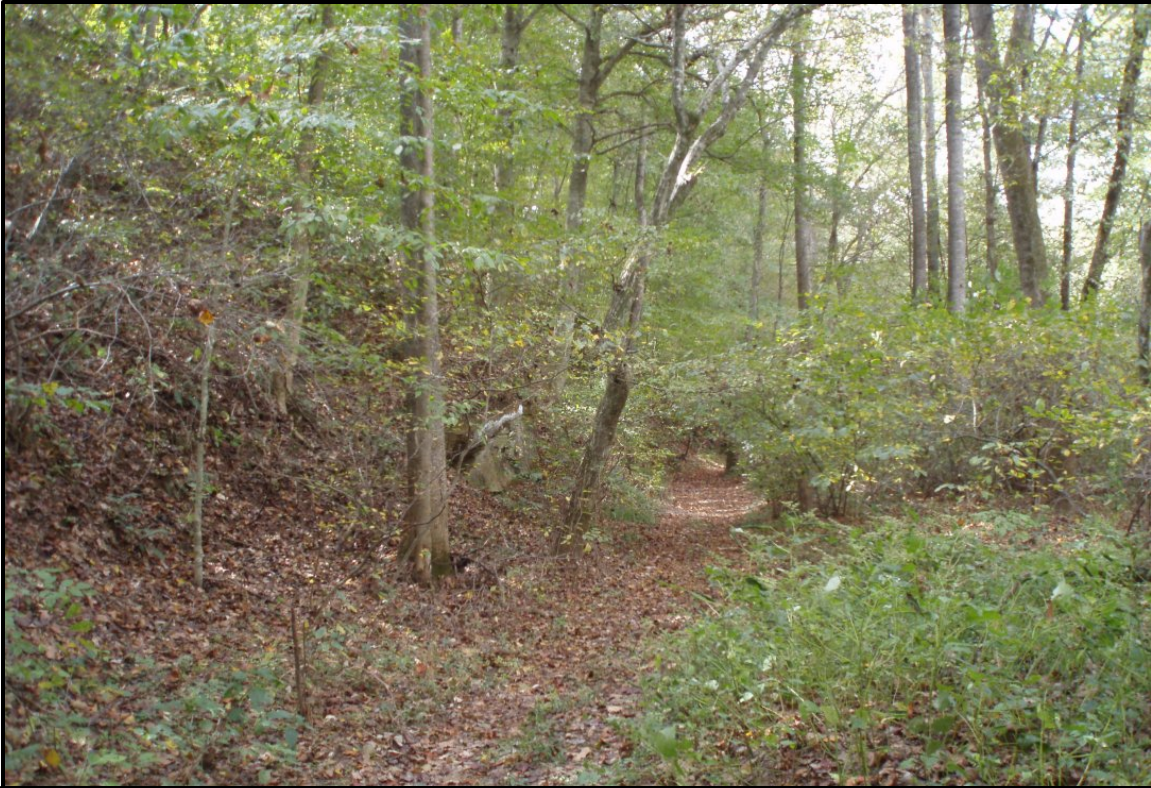
Figure 8: West view of the southwest quadrant.

The landform in the southwest quadrant is a narrow, flat area from the bridge north for 30 meters (100 ft.), then a steep slope up to the west. There appears to be an old road or driveway that runs from SR 1599 west along the south side of Forbush Creek (Figure 8).
