NC DEPARTMENT OF TRANSPORTATION  
DIVISION OF HIGHWAYS  
BRIDGE MANAGEMENT UNIT

# BRIDGE INSPECTION REPORT

COUNTY ALLEGHANY BRIDGE NUMBER 020057 INSPECTION CYCLE 0 YRS  
ROUTE SR1193 ACROSS WATERFALL CREEK M.P. 0

STRUCTURE TYPE TIMBER FLOOR SALVAGED I-BEAMS

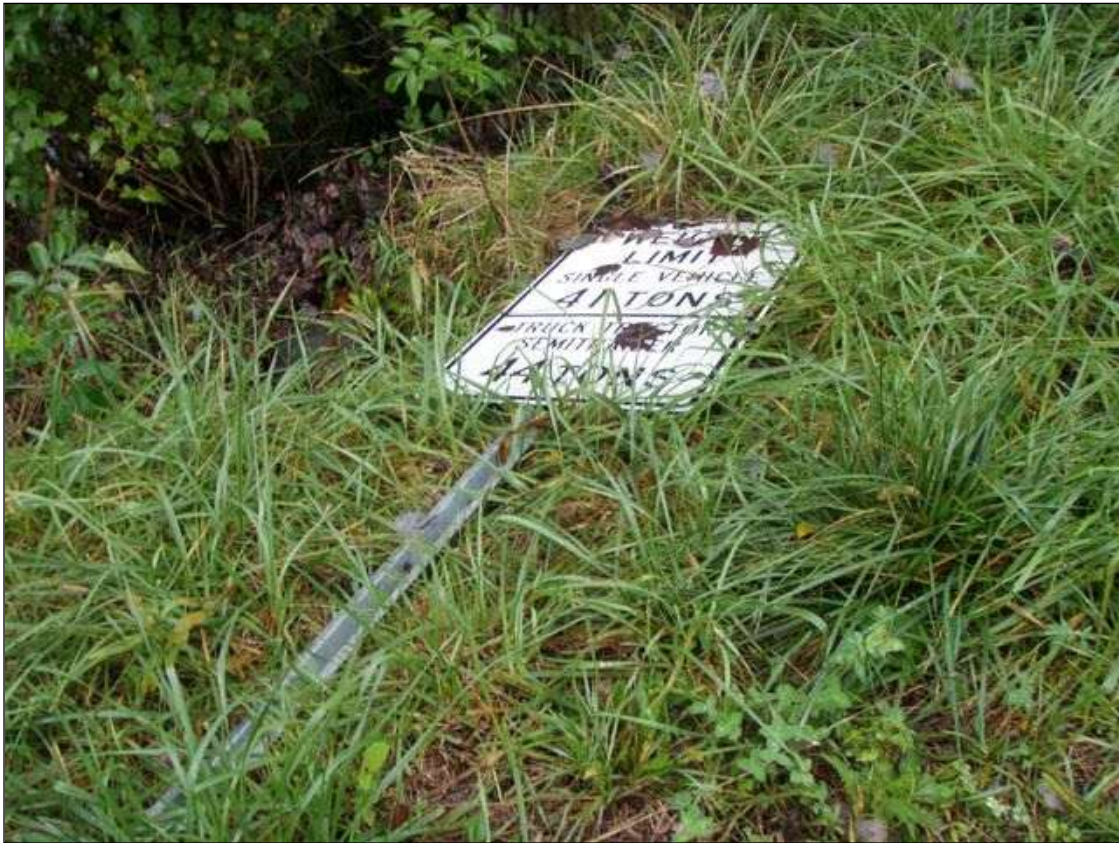
| <b>60</b> | <b>YES</b> | NORTHWEST POSTING SIGN IS KNOCKED DOWN [SEE PHOTO]. | |
| <b>62</b> | <b>YES</b> | SEVERE 41; TTST 44. NORTHWEST POSTING SIGN IS KNOCKED DOWN [PRIORITY MAINTENANCE, SEE PHOTO]. | |

NORTHWEST POSTING SIGN KNOCKED DOWN [PRIORITY MAINTENANCE]

| MMS Code | Description of Function | Unit | Quantity | Remarks | Est. Cost |
|---|---|---|---|---|---|
| 3250 | Install or Replace Ground Mounted Signs | SF | 2 | NORTHWEST POSTING SIGN KNOCKED DOWN [PRIORITY MAINTENANCE]. | |

| MMS Code | MMS Description | Quantity |
|---|---|---|
| NORTHWEST POSTING SIGN KNOCKED DOWN [PRIORITY MAINTENANCE]. | | |

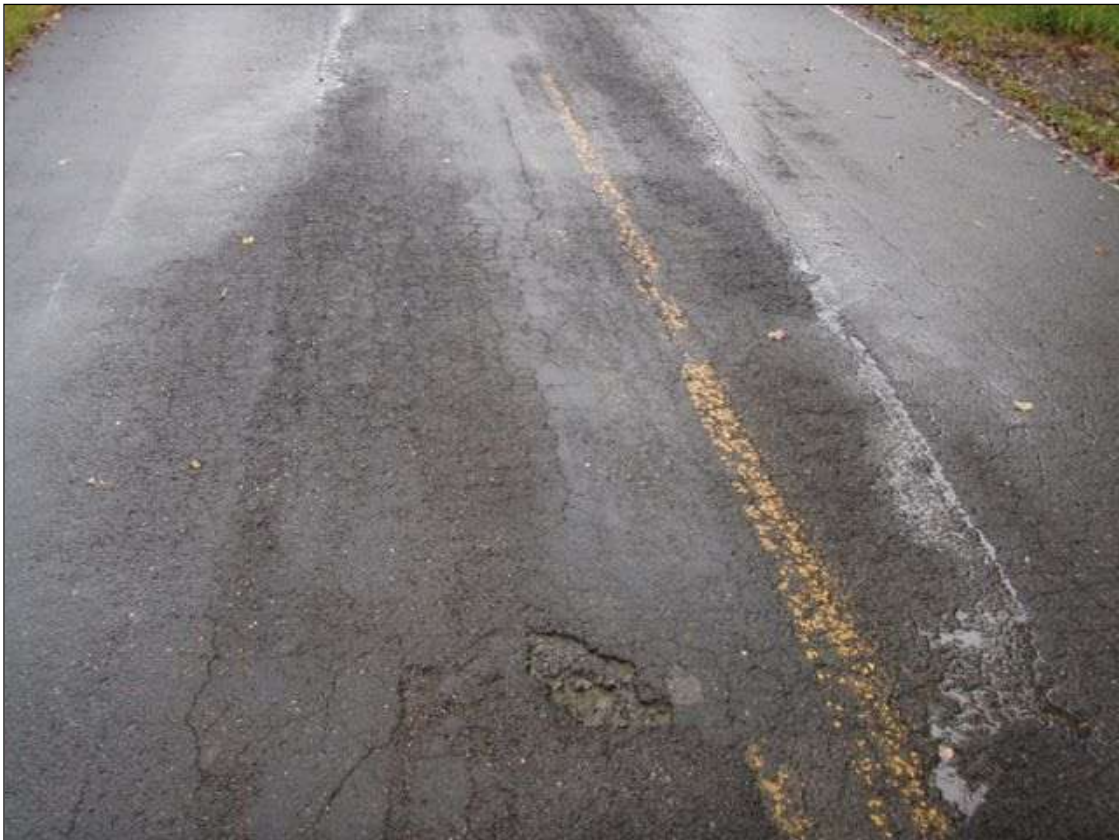
| <b>50</b> | <b>F</b> | BOTH APPROACHES HAVE MAP CRACKING UP TO 1/8" WIDE AND HAVE 1" OF SETTLEMENT [SEE PHOTOS]. THE NORTH APPROACH HAS A 10" LONG X 10" WIDE X 1" DEEP POT HOLE AND A 8' WIDE PATCH AT CENTERLINE [SEE PHOTO]. THERE ARE NO PAVEMENT MARKERS AT THE SOUTH APPROACH. THERE IS A FULL WIDTH TRANSVERSE CRACK UP TO 1/8" WIDE ADJACENT TO ABUTMENT 1 AND FULL WIDTH TRANSVERSE CRACKS UP TO 1/16" WIDE WITH PATCHES ADJACENT TO ABUTMENT 2 [SEE PHOTOS].<br><br>NORTHWEST POSTING SIGN IS KNOCKED DOWN [PRIORITY MAINTENANCE, SEE PHOTO]. REMOVE NARROW BRIDGE SIGNS APPROACH SLAB THE APPROACH ROADWAY WIDTH DOES NOT EXCEED MORE THAN 2' BELOW THE CLEAR BRIDGE ROADWAY WIDTH. | |

MAP CRACKING UP TO 1/8" WIDE WITH A 10" LONG X 10" WIDE X 1" DEEP POT HOLE AND A 8' WIDE PATCH ALONG THE CENTERLINE OF THE NORTH APPROACH

| MMS Code | Description of Function | Unit | Quantity | Remarks | Est. Cost |
|---|---|---|---|---|---|
| 2816 | Asphalt Surface Repair or Replacement | SY | 193 | MAP CRACKING UP TO 1/8" WIDE IN BOTH APPROACHES AND A 10" LONG X 10" WIDE X 1" DEEP POT HOLE IN THE NORTH APPROACH. FULL WIDTH TRANSVERSE CRACK UP TO 1/8" WIDE ALONG ABUTMENT 1 IN THE SOUTH APPROACH. NO PAVEMENT MARKERS. WATER PONDING THROUGHOUT THE BRIDGE. FULL WIDTH TRANSVERSE CRACKS UP TO 1/8" WIDE ALONG THE DECK BOARDS. | |

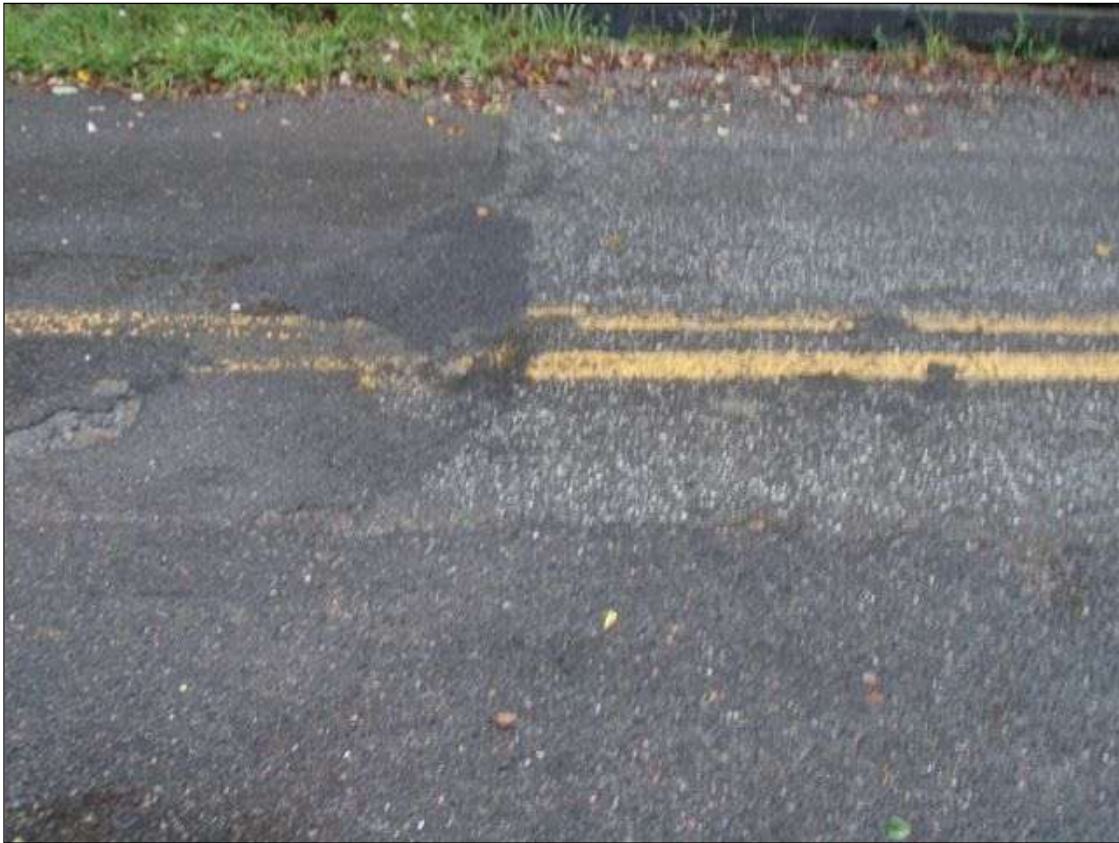
FULL WIDTH TRANSVERSE CRACKS UP TO 1/16" WIDE WITH PATCHES AND 1" SETTLEMENT ADJACENT TO ABUTMENT 2 AT THE NORTH APPROACH

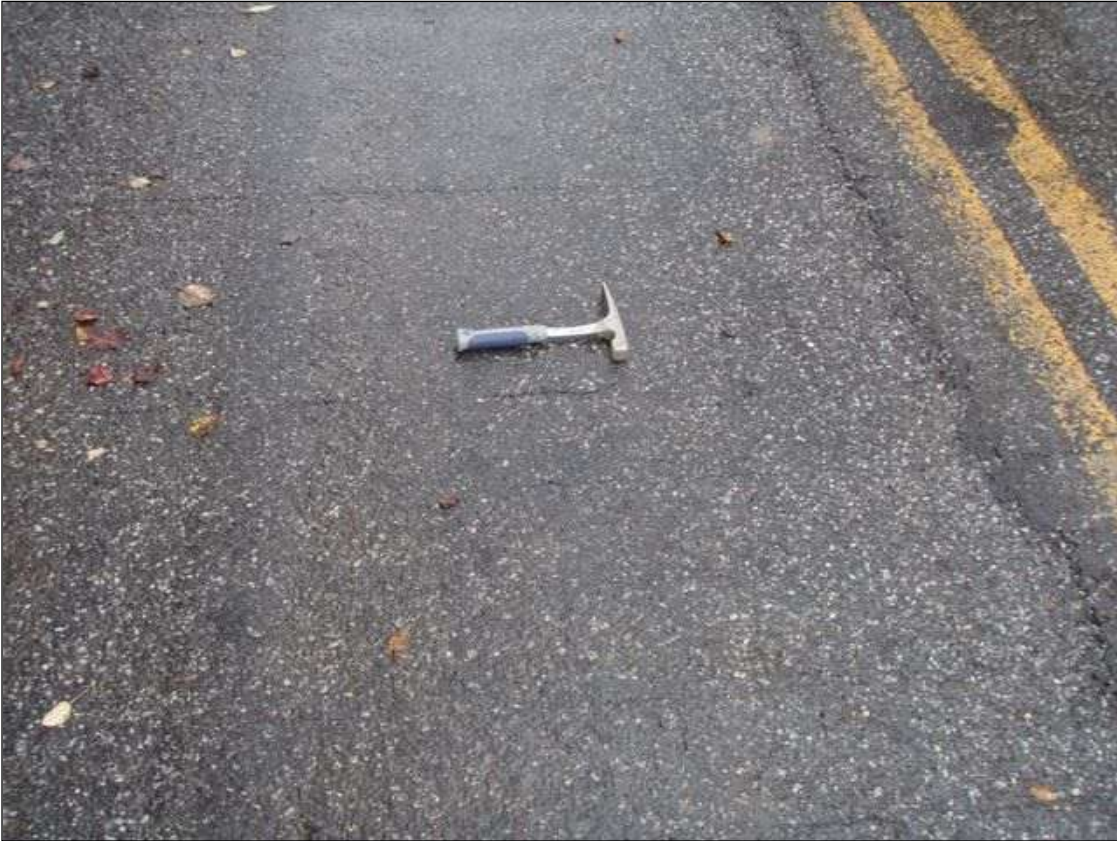
| Bridge I&A Form 1(82)H<br>State of North Carolina<br>Dept. of Transportation<br>Division of Highways | | <h2 style="text-align: center;">FIELD INSPECTION REPORT</h2> <p style="text-align: center;"><u>Bridge Inspection &amp; Analysis</u></p> | |
|---|---|---|--|
| 1 | F | FULL WIDTH TRANSVERSE CRACKS UP TO 1/8" WIDE ALONG THE DECK BOARDS AND WATER PONDING THROUGHOUT THE BRIDGE [SEE PHOTOS]. | |

FULL WIDTH TRANSVERSE CRACKS UP TO 1/8" WIDE IN ASPHALT WEARING SURFACE ALONG THE DECK BOARDS

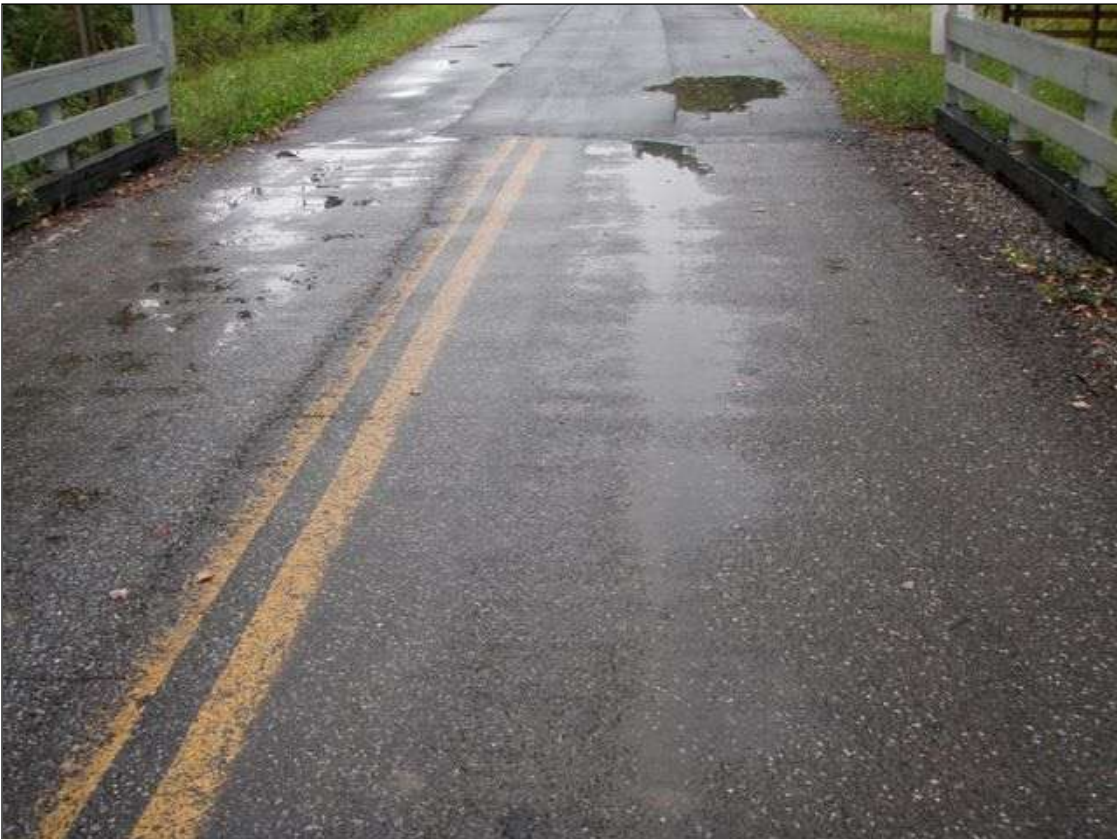
WATER PONDING THROUGHOUT THE BRIDGE

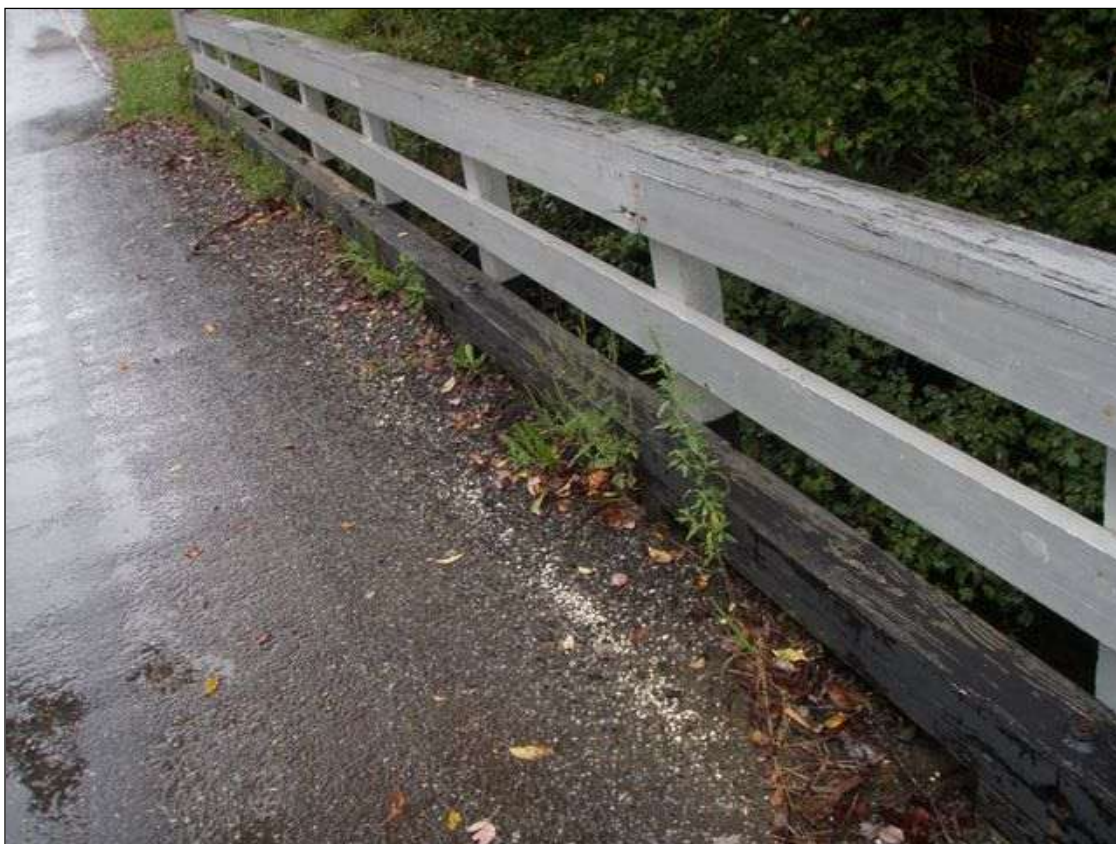
| Bridge I&A Form 1(82)H<br>State of North Carolina<br>Dept. of Transportation<br>Division of Highways | | <h2 style="text-align: center;">FIELD INSPECTION REPORT</h2> <p style="text-align: center;"><u>Bridge Inspection &amp; Analysis</u></p> | |
|---|---|---|--|
| 7 | F | VEGETATION GROWTH ALONG THE EAST CURB [SEE PHOTO]. | |

VEGETATION GROWTH ALONG THE EAST CURB

| MMS Code | Description of Function | Unit | Quantity | Remarks | Est. Cost |
|---|---|---|---|---|---|
| 3376 | Clean/Wash Bridge Decks | SF | 80 | VEGETATION GROWTH ALONG THE EAST CURB. | |

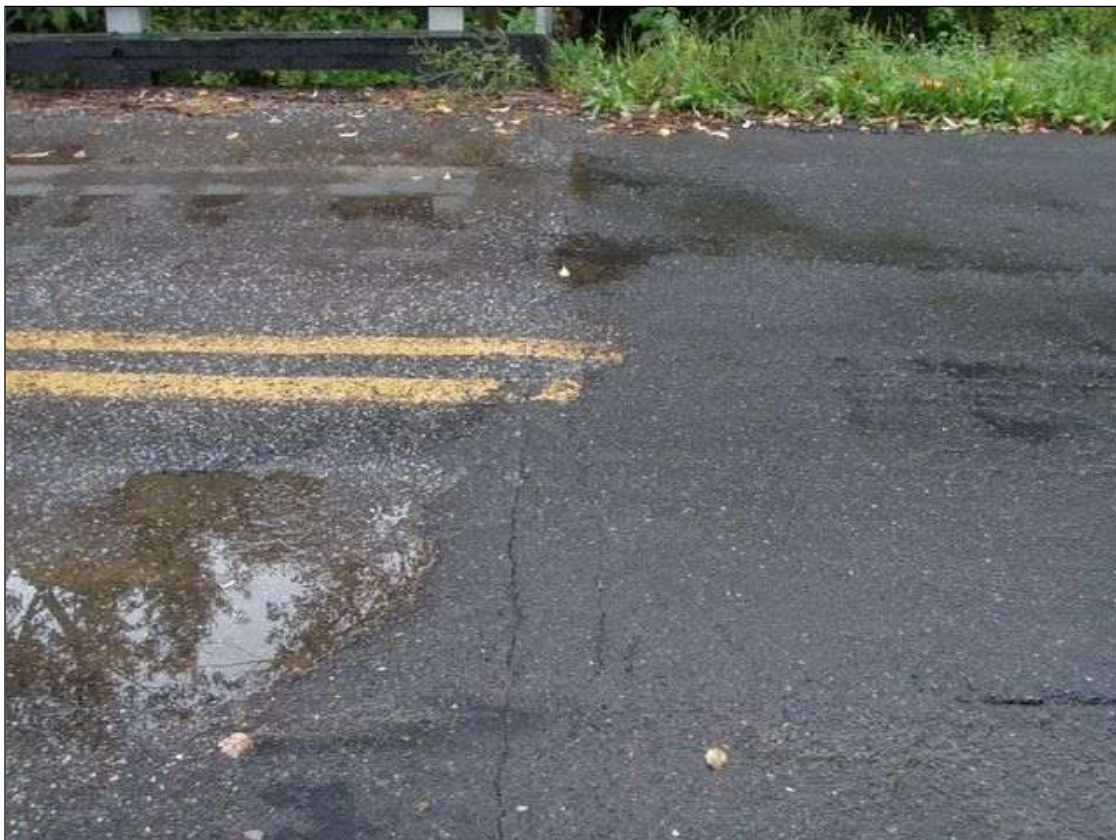
FULL WIDTH TRANSVERSE CRACK UP TO 1/8" WIDE WITH 1" SETTLEMENT ALONG ABUTMENT 1 OF THE SOUTH APPROACH

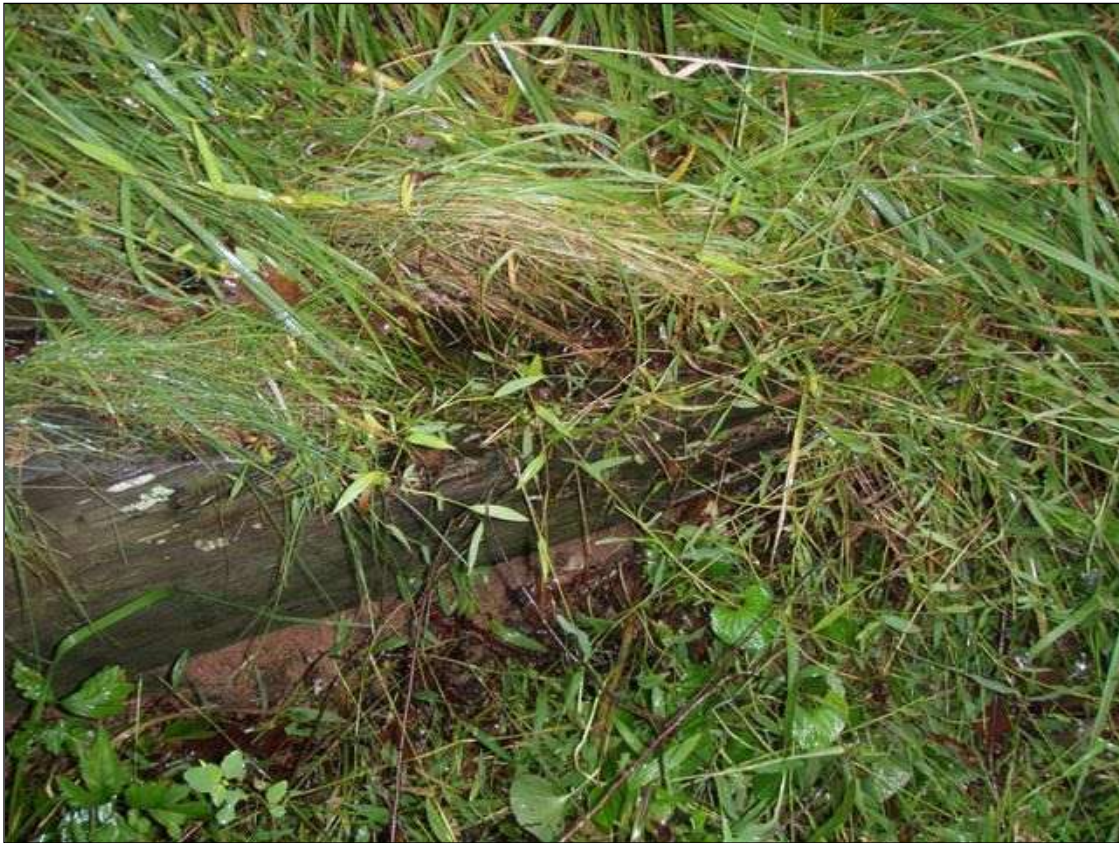
| Bridge I&A Form 1(82)H<br>State of North Carolina<br>Dept. of Transportation<br>Division of Highways | | <h2 style="text-align: center;">FIELD INSPECTION REPORT</h2> <p style="text-align: center;"><u>Bridge Inspection &amp; Analysis</u></p> | |
|---|---|---|--|
| 39 | G | THE EXTERIOR 3' OF TOP BOARD OF THE SOUTHWEST WINGWALL HAS DECAY WITH 1" OUTER SHELL REMAINING [SEE PHOTO]. THE BOTTOM BOARD IS MISSING AT THE SOUTHWEST WINGWALL. THE TOP THREE BOARDS OF THE SOUTHEAST WINGWALL HAVE UP TO 1" OF HORIZONTAL MISALIGNMENT. THE NORTHWEST WINGWALL HAS A 2' LONG X 6 1/2" HIGH X 3" DEEP DECAYED AREA [SEE PHOTO].<br>RIPRAP UP AGAINST ABUTMENT 2 AND MAKES MOST OF THE BULKHEAD NOT VISIBLE. | |

EXTERIOR 3' OF TOP BOARD OF THE SOUTHWEST WINGWALL HAS DECAY WITH 1" OUTER SHELL  
REMAINING

| MMS Code | Description of Function | Unit | Quantity | Remarks | Est. Cost |
|---|---|---|---|---|---|
| 3346 | Repair / Maintain Timber Wings & Blkhds | SF | 7 | EXTERIOR 3' OF THE SOUTHWEST WINGWALL TOP BOARD HAS DECAY WITH 1" OUTER SHELL REMAINING. BOTTOM BOARD IS MISSING AT THE SOUTHWEST WINGWALL. 1'-6" LONG X 4" HIGH X 3" WIDE DECAYED AREA IN THE THIRD BOARD FROM THE TOP AT THE WEST END OF ABUTMENT 1. 11" LONG X 8" HIGH X 3" WIDE DECAYED AREA IN THE EAST END OF ABUTMENT 1 BULKHEAD. 2' LONG X 6 1/2" HIGH X 3" DEEP DECAYED AREA IN THE NORTHWEST WINGWALL. | |

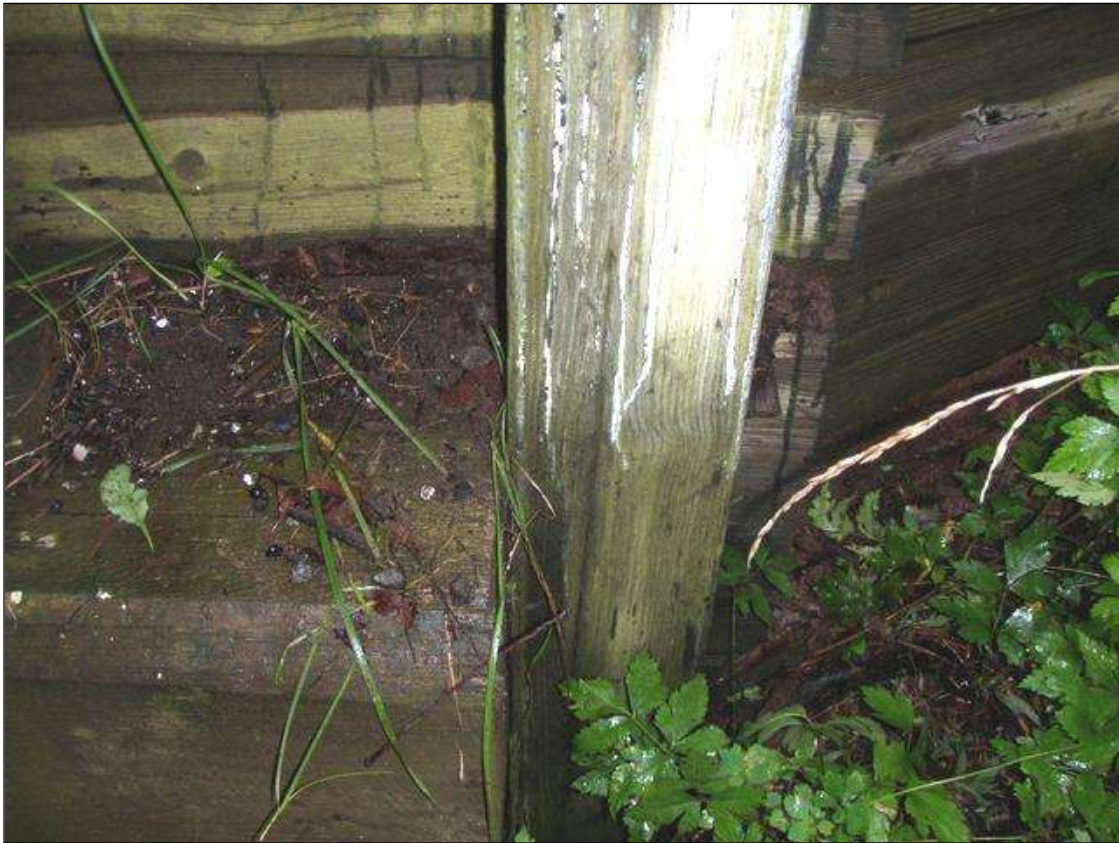
| Bridge I&A Form 1(82)H<br>State of North Carolina<br>Dept. of Transportation<br>Division of Highways | | <h2 style="text-align: center;">FIELD INSPECTION REPORT</h2> <p style="text-align: center;"><u>Bridge Inspection &amp; Analysis</u></p> | |
|---|---|---|--|
| 35c | F | THE THIRD BOARD FROM THE TOP AT THE WEST END OF ABUTMENT 1 BULKHEAD HAS A 1'-6" LONG X 4" HIGH X 3" WIDE DECAYED AREA [SEE PHOTO]. THE EAST END OF ABUTMENT 1 BULKHEAD HAS AN 11" LONG X 8" HIGH X 3" WIDE DECAYED AREA [SEE PHOTO]. | |

1'-6" LONG X 4" HIGH X 3" WIDE DECAYED AREA IN THE THIRD BOARD FROM THE TOP AT THE WEST END OF ABUTMENT 1

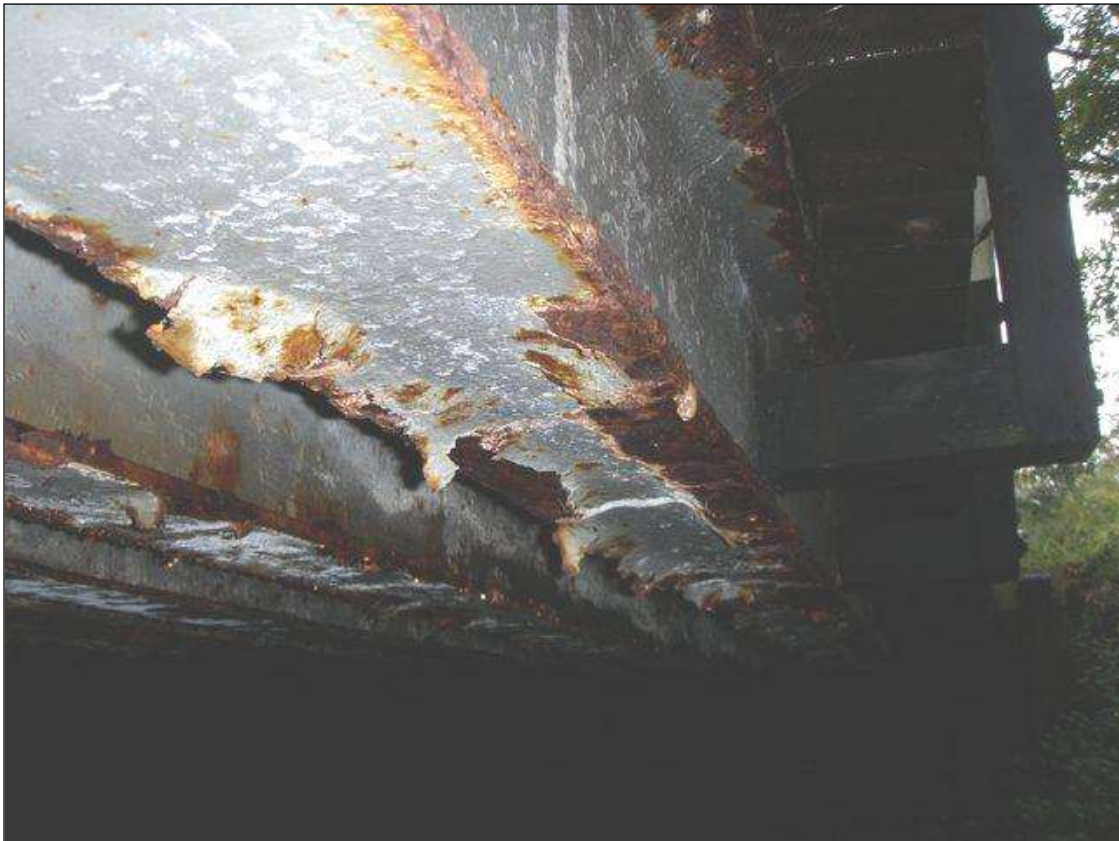
| Bridge I&A Form 1(82)H<br>State of North Carolina<br>Dept. of Transportation<br>Division of Highways | | <h2 style="text-align: center;">FIELD INSPECTION REPORT</h2> <p style="text-align: center;"><u>Bridge Inspection &amp; Analysis</u></p> | |
|---|---|---|--|
| 10 | F | PEELING PAINT AND SURFACE RUST ALONG THE TOP AND BOTTOM FLANGES OF ALL BEAMS [SEE PHOTOS]. THERE IS DELAMINATING STEEL WITHOUT MEASUREABLE SECTION LOSS ALONG THE BOTTOM FLANGE OF BEAM 13 NEAR ABUTMENT 1 [SEE PHOTO]. THE SALVAGED BEAMS HAVE AREAS OF SURFACE PITTING THROUGHOUT THE BOTTOM FLANGE. | |

PEELING PAINT AND SURFACE RUST ALONG THE BOTTOM FLANGE OF BEAM 13 (OTHERS SIMILAR)

| MMS Code | Description of Function | Unit | Quantity | Remarks | Est. Cost |
|---|---|---|---|---|---|
| 5603 | Partial Cleaning and Painting of Structural Steel | SF | 1100 | PEELING PAINT AND SURFACE RUST ALONG THE TOP AND BOTTOM FLANGES OF ALL BEAMS AND INTERMEDIATE DIAPHRAGMS. | |

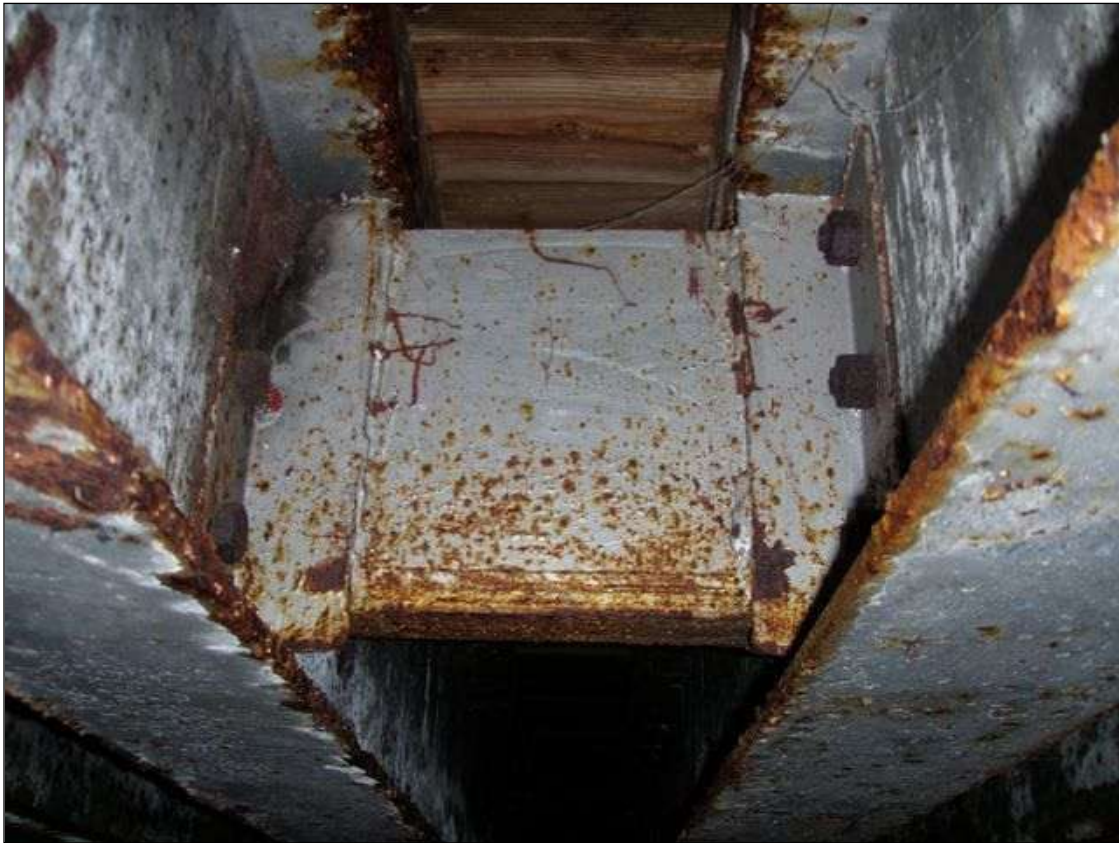
| Bridge I&A Form 1(82)H<br>State of North Carolina<br>Dept. of Transportation<br>Division of Highways | | <h2 style="text-align: center;">FIELD INSPECTION REPORT</h2> <p style="text-align: center;"><u>Bridge Inspection &amp; Analysis</u></p> | |
|---|---|---|--|
| 12 | G | SURFACE RUST ON THE INTERMEDIATE DIAPHRAGMS [SEE PHOTO]. | |
| 52 | F | PEELING PAINT ALONG THE TOP AND BOTTOM FLANGES OF ALL BEAMS AND FRECKLED RUST THROUGHOUT THE INTERMEDIATE DIAPHRAGMS [SEE PHOTOS]. | |

FRECKLED RUST ON THE INTERMEDIATE DIAPHRAGMS (BAY 2 SHOWN)

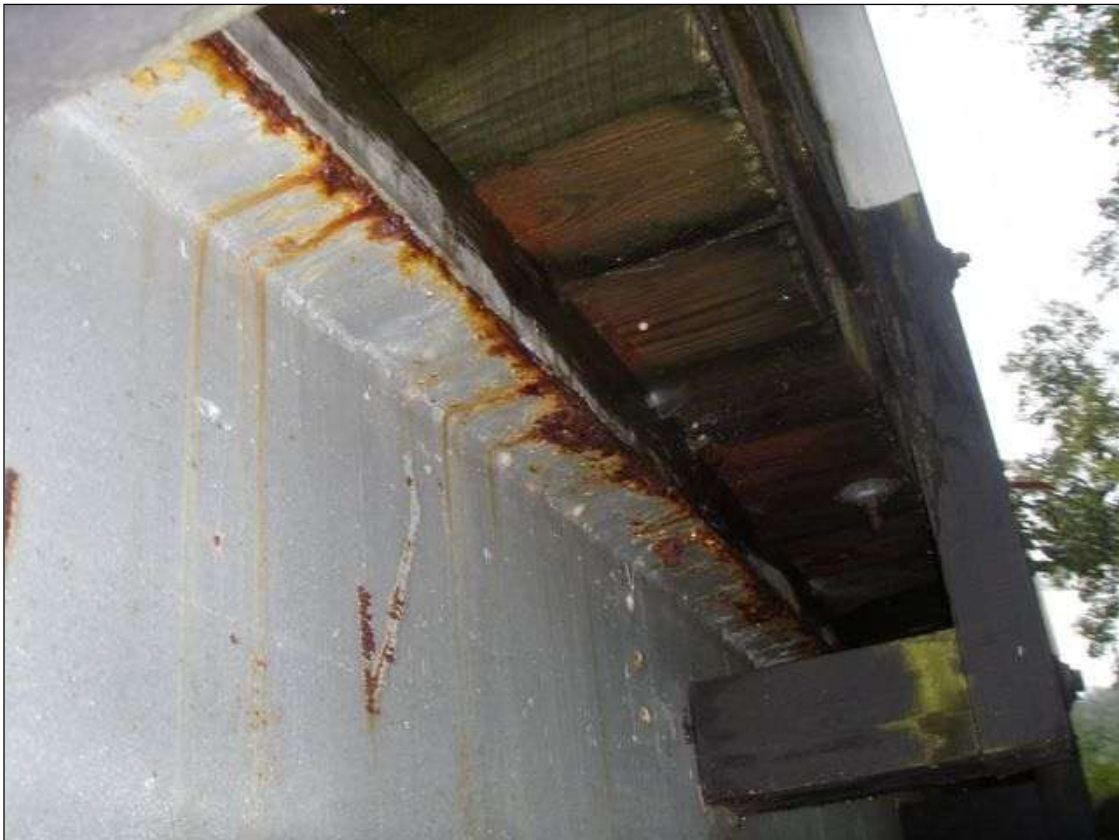
SURFACE RUST AND PEELING PAINT ALONG THE TOP FLANGE OF BEAM 1 (OTHERS SIMILAR)

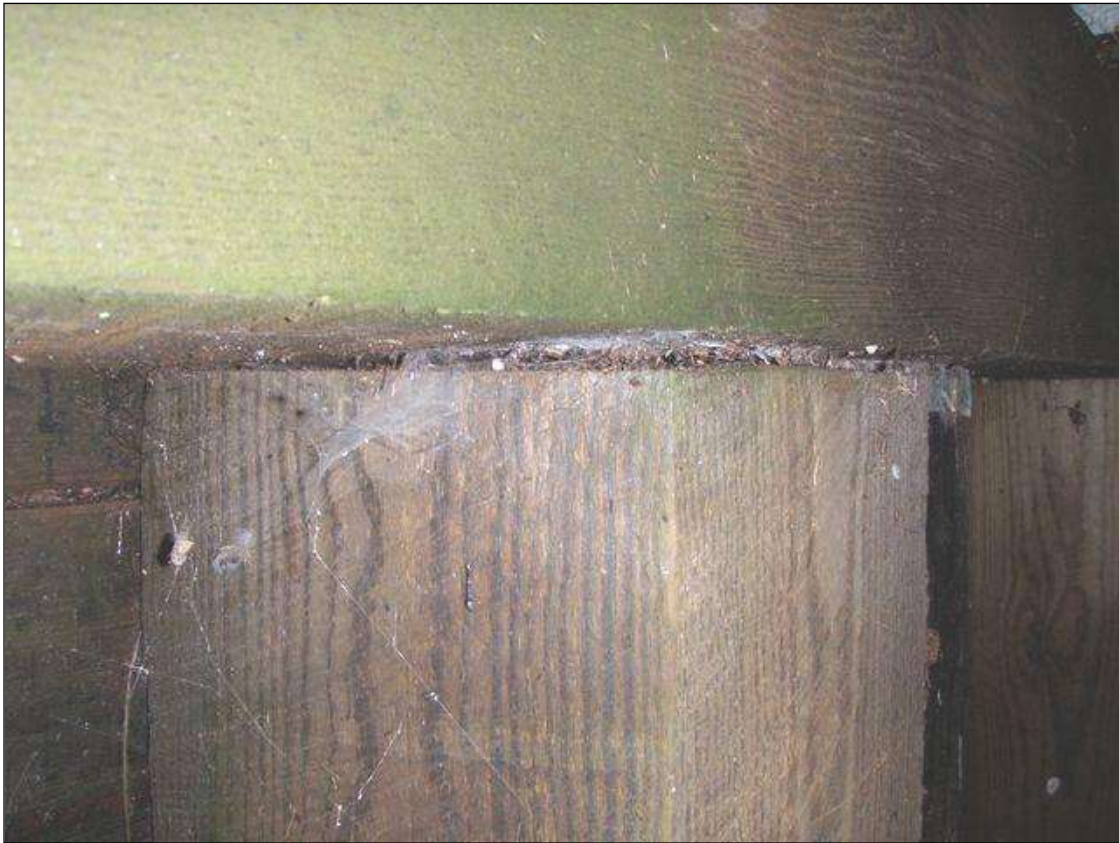
| Bridge I&A Form 1(82)H<br>State of North Carolina<br>Dept. of Transportation<br>Division of Highways | | <h2 style="text-align: center;">FIELD INSPECTION REPORT</h2> <p style="text-align: center;"><u>Bridge Inspection &amp; Analysis</u></p> | |
|---|---|---|--|
| 35b | G | DISCOLORATION, CHECKS AND SPLITS UP TO 1/16" WIDE IN THE ORIGINAL PILES. THERE IS 3/4" GAP WITH LOSS OF BEARING BETWEEN PILE 9 AND ABUTMENT 1 CAP [SEE PHOTO]. | |

UP TO 3/4" HIGH LOSS OF BEARING BETWEEN ABUTMENT 1 CAP AND PILE 9

| MMS Code | Description of Function | Unit | Quantity | Remarks | Est. Cost |
|---|---|---|---|---|---|
| 3344 | Repair / Replace Timber Substructure Components | LF | 5 | UP TO 3/4" HIGH LOSS OF BEARING BETWEEN ABUTMENT 1 CAP AND PILE 9. | |

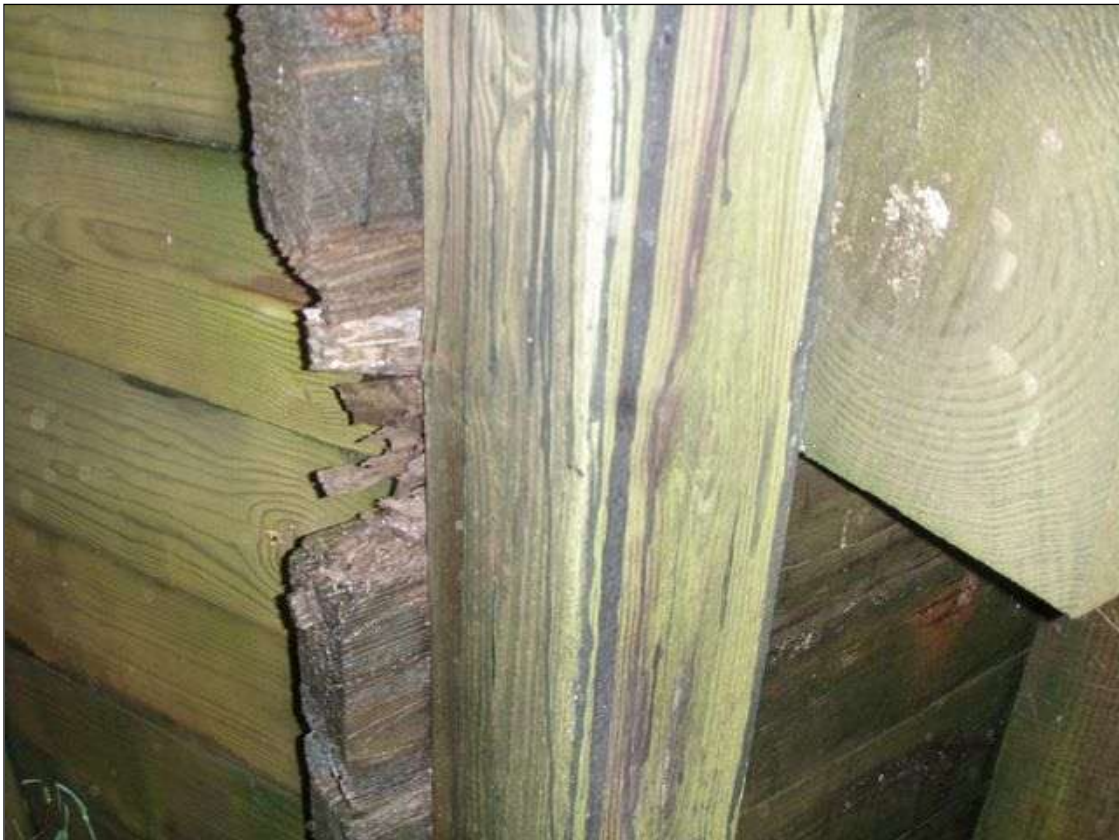
11" LONG X 8" HIGH X 3" WIDE DECAYED AREA IN THE EAST END OF ABUTMENT 1 BULKHEAD

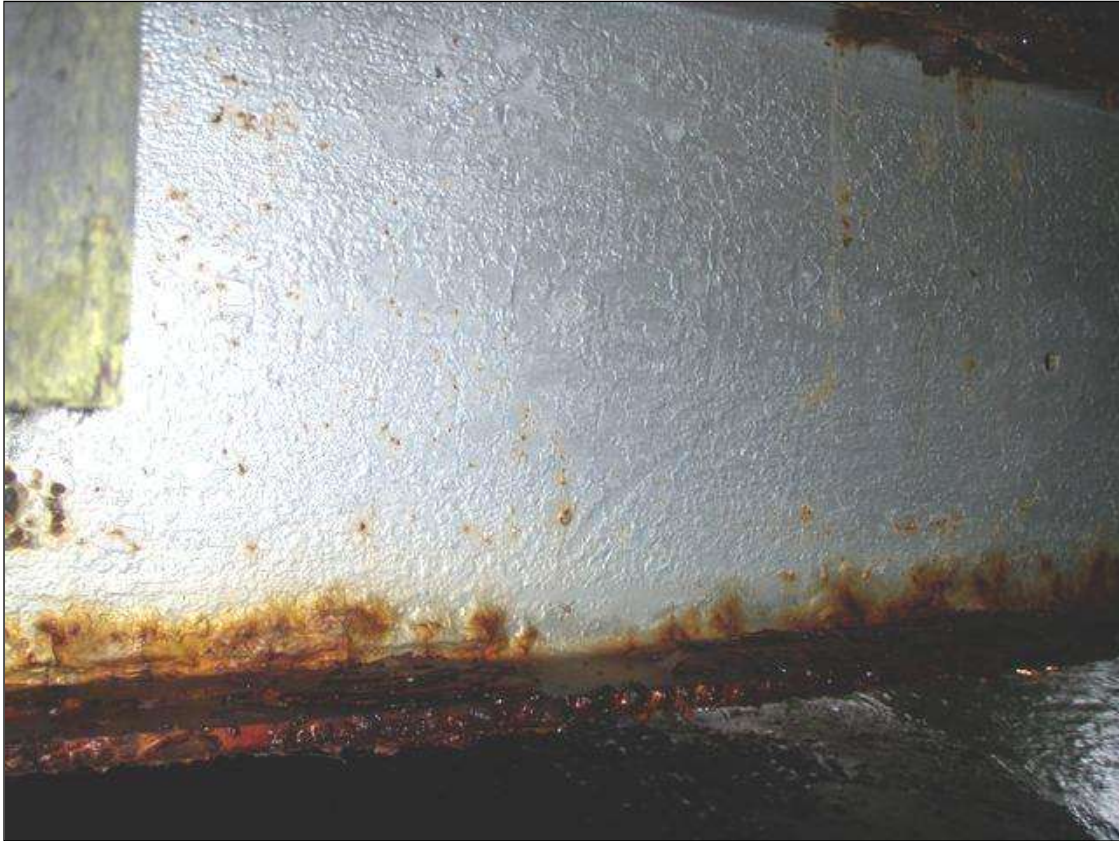
DELAMINATING STEEL WITHOUT MEASUREABLE SECTION LOSS ALONG THE BOTTOM FLANGE OF BEAM 13  
NEAR ABUTMENT 1

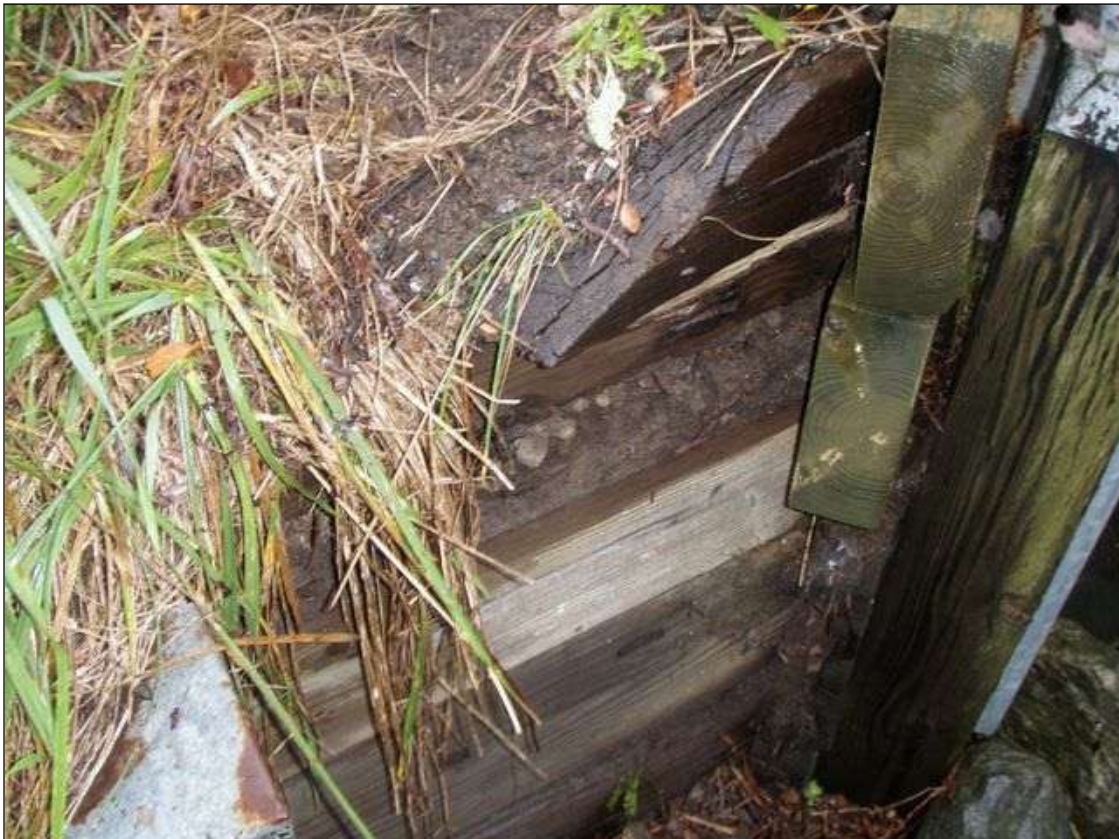
2' LONG X 6 1/2" HIGH X 3" DEEP DECAYED AREA IN THE NORTHWEST WINGWALL

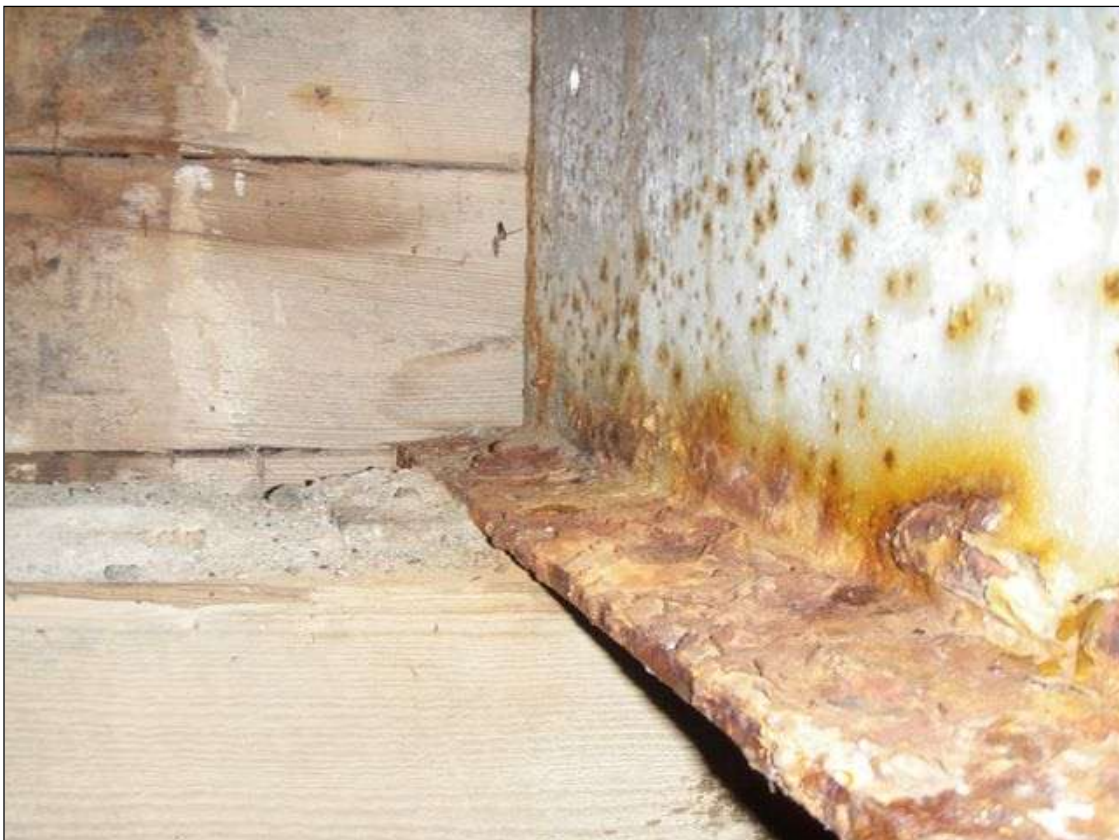
BEAM 4 BEARING AT ABUTMENT 1 (OTHERS SIMILAR)

| Bridge I&A Form 1(82)H<br>State of North Carolina<br>Dept. of Transportation<br>Division of Highways | | <h2 style="text-align: center;">FIELD INSPECTION REPORT</h2> <p style="text-align: center;"><u>Bridge Inspection &amp; Analysis</u></p> | |
|---|---|---|--|
| 15 | F | SURFACE RUST THROUGHOUT THE ANCHOR BOLTS. | |
