# BRIDGE INSPECTION REPORT

INSPECTION TYPE: Routine Inspection - Contract

COUNTY WILKES BRIDGE NUMBER 960143 INSPECTION CYCLE 0 YRS

ROUTE SR1737 ACROSS CREEK M.P. 0

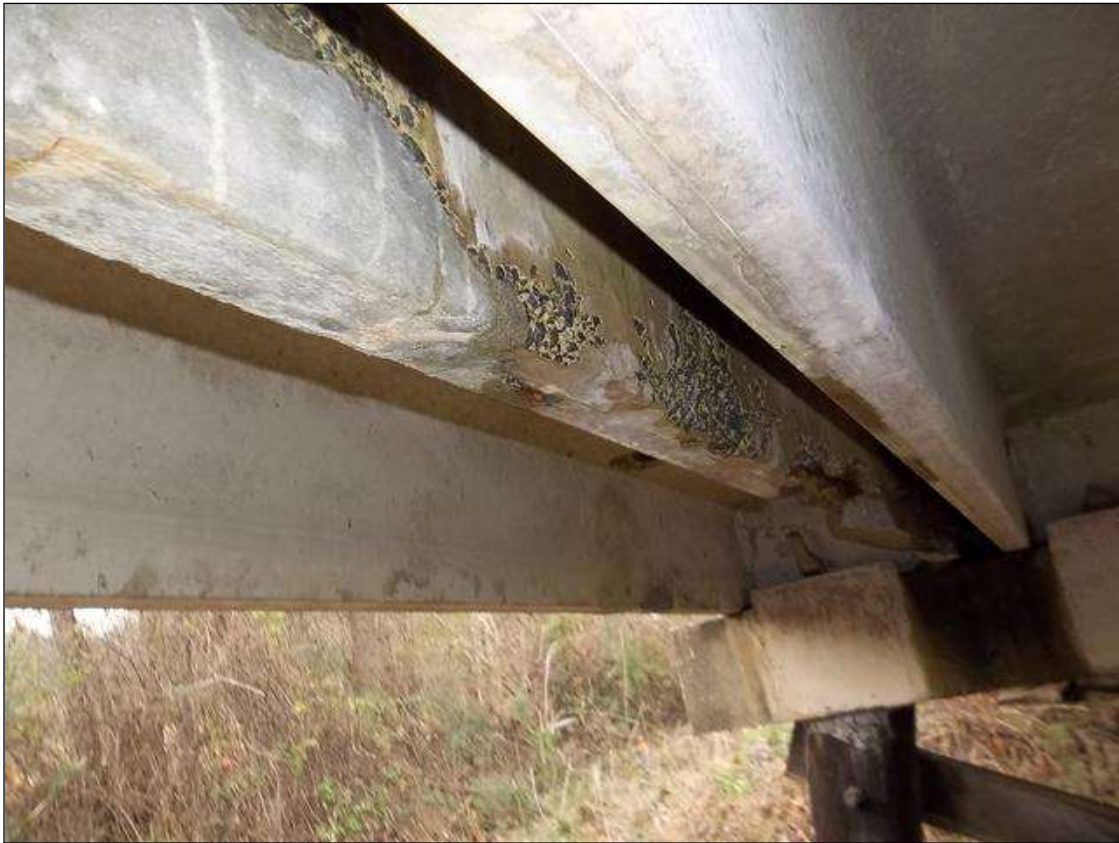
9' X 4" X 3" SPALL / DELAMINATION WITH EXPOSED REINFORCING ON NORTH LEG, CHANNEL 10 AT BENT 1, SPAN 2. (WITH PREVIOUS REPAIR) (PRIORITY MAINTENANCE)

| MMS Code | Description of Function | Unit | Quantity | Remarks | Est. Cost |
|---|---|---|---|---|---|
| 3306 | Maintain Concrete Superstructure Components | SF | <del>10 TSC</del> | 9' X 4" X 3" SPALL / DELAMINATION WITH EXPOSED ON NORTH LEG, CHANNEL 10 AT BENT 1, SPAN 2. (WITH PREVIOUS REPAIR) | |

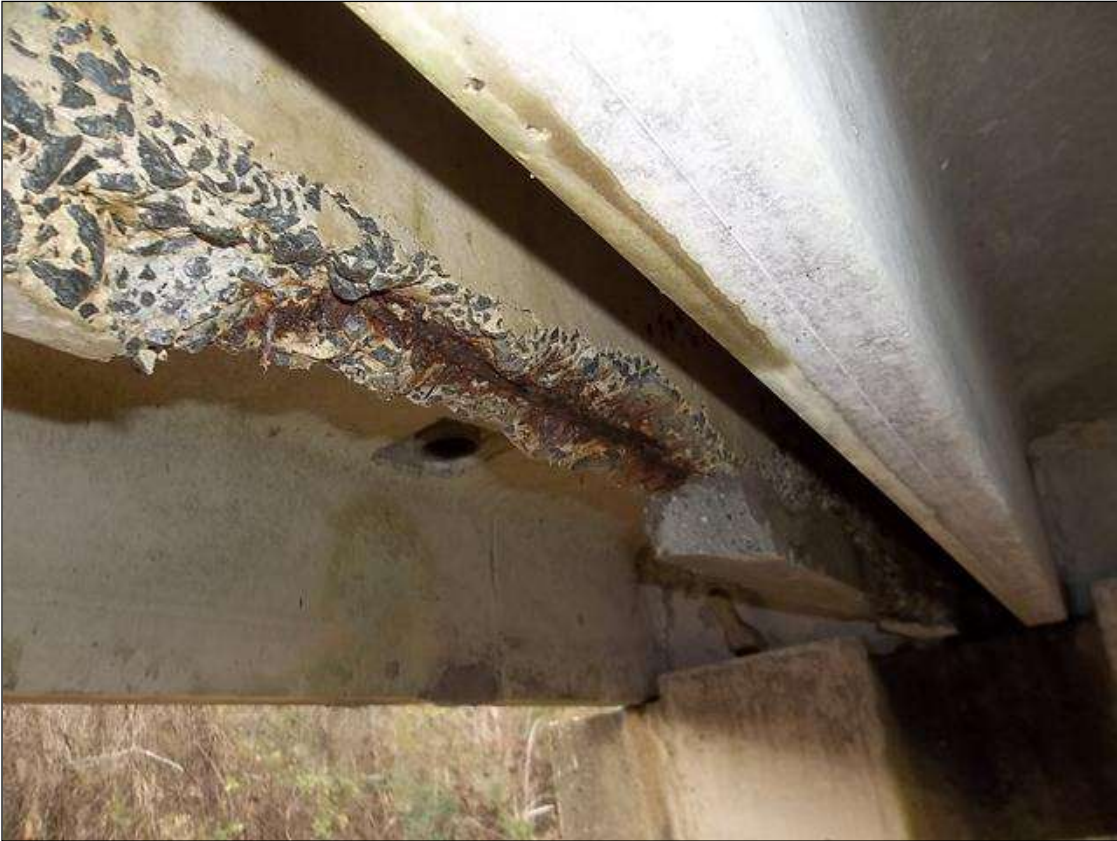
9' X 4" X 3" SPALL / DELAMINATION WITH EXPOSED REINFORCING ON NORTH LEG, CHANNEL 10 AT BENT 1, SPAN 2. (WITH PREVIOUS REPAIR) (PRIORITY MAINTENANCE)

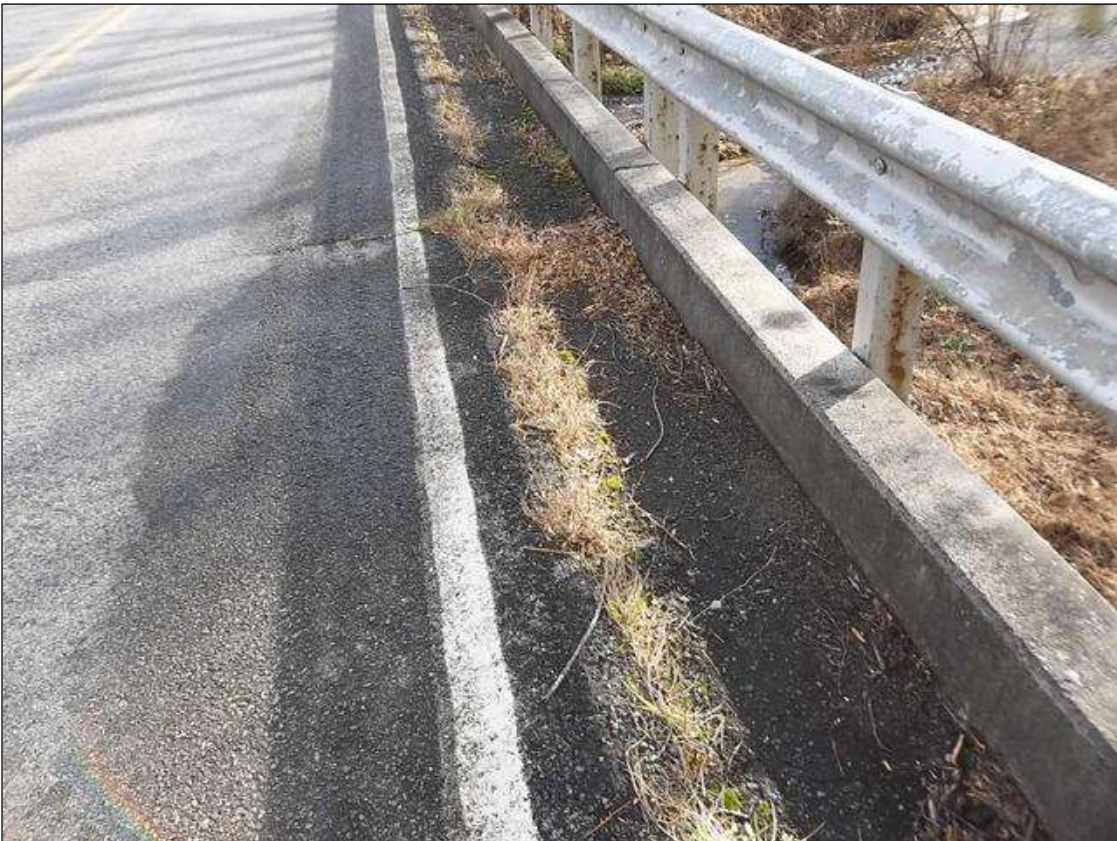
| Bridge I&A Form 1(82)H<br><b>State of North Carolina</b><br><b>Dept. of Transportation</b><br><b>Division of Highways</b> | | <h1 style="text-align: center;">FIELD INSPECTION REPORT</h1> <p style="text-align: center;"><u>Bridge Inspection &amp; Analysis</u></p> | |
|---|---|---|--|
| 7 | F | VEGETATION AND DEBRIS ALONG BOTH CURBS. | |

VEGETATION AND DEBRIS ALONG BOTH CURBS.

| MMS Code | Description of Function | Unit | Quantity | Remarks | Est. Cost |
|---|---|---|---|---|---|
| 3376 | Clean/Wash Bridge Decks | SF | 300 | REMOVE VEGETATION AND DEBRIS ALONG BOTH CURBS. | |

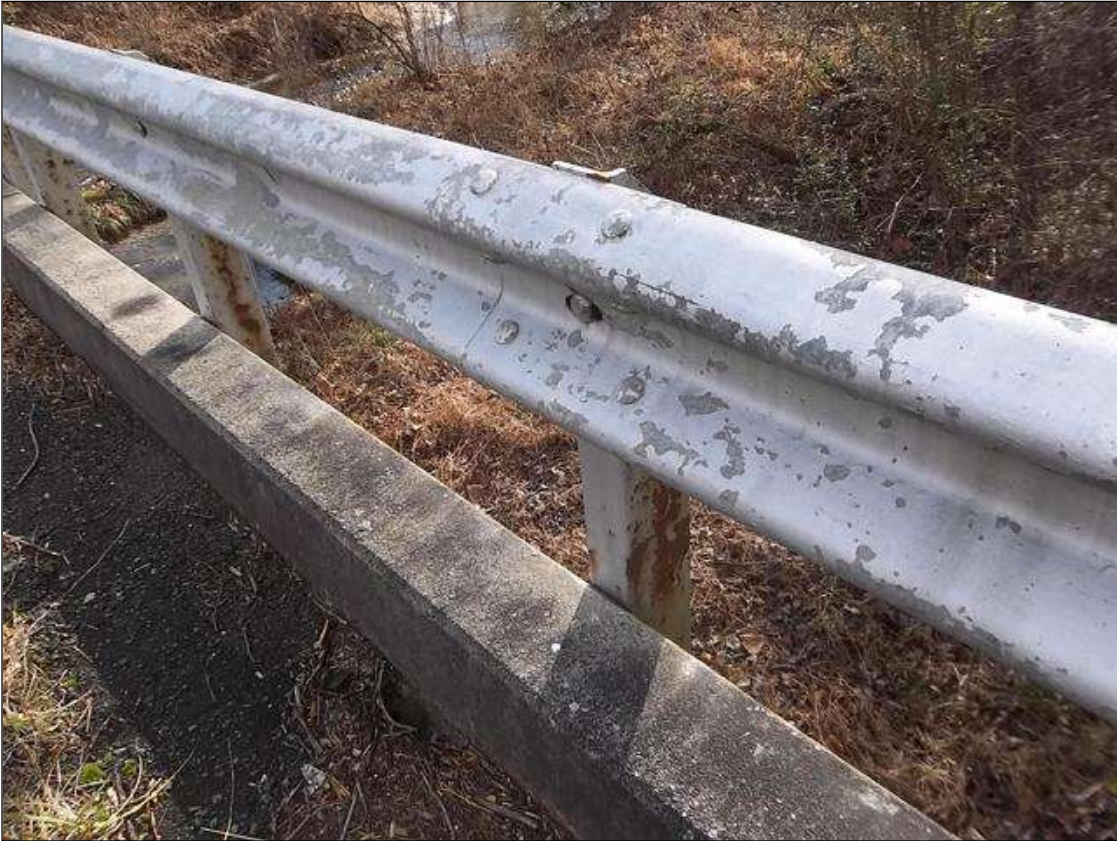
| Bridge I&A Form 1(82)H<br><b>State of North Carolina</b><br><b>Dept. of Transportation</b><br><b>Division of Highways</b> | | <h1 style="text-align: center;">FIELD INSPECTION REPORT</h1> <p style="text-align: center;"><u>Bridge Inspection &amp; Analysis</u></p> | |
|---|---|---|--|
| 3d | F | RANDOM PAINT PEELING AND FLAKING THROUGHOUT BOTH BRIDGE RAILS UP TO 50%.<br>BRIDGE RAIL ENDS HAVE IMPACT DAMAGE AT ALL FOUR CORNERS. | |

RANDOM PAINT PEELING AND FLAKING THROUGHOUT BOTH BRIDGE RAILS UP TO 50%.

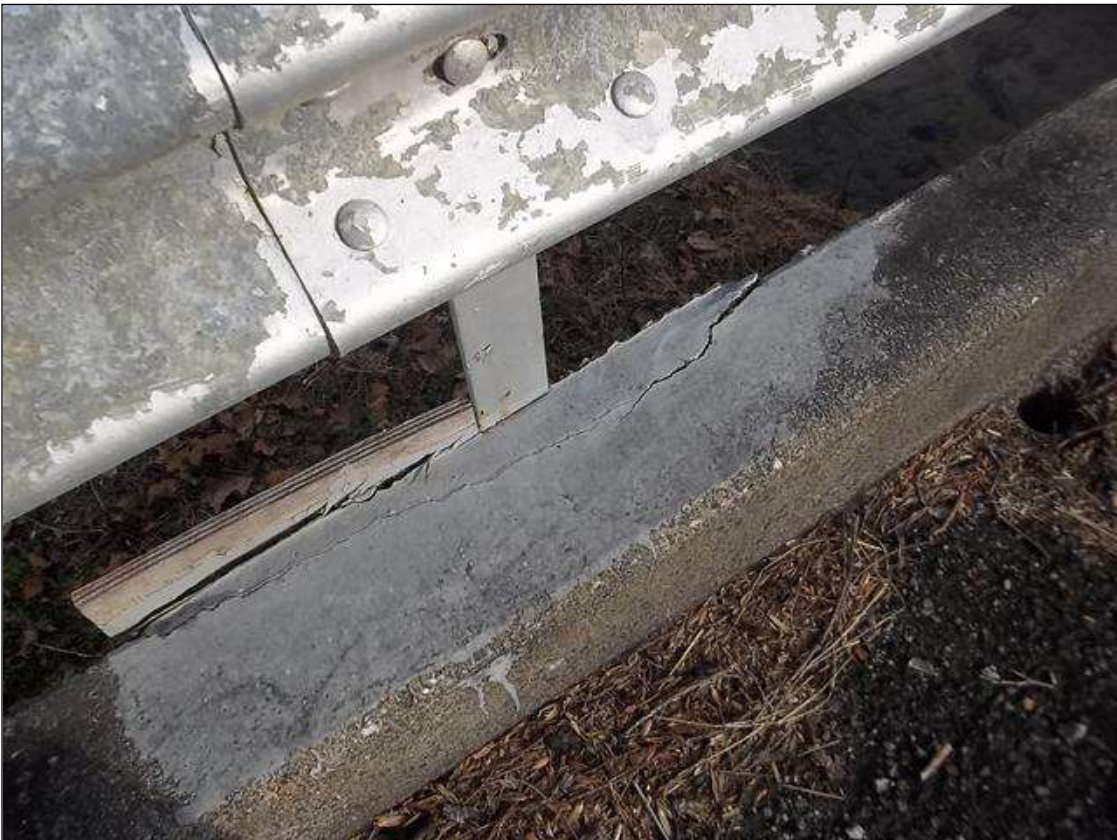
| Bridge I&A Form 1(82)H<br><b>State of North Carolina</b><br><b>Dept. of Transportation</b><br><b>Division of Highways</b> | | <h1 style="text-align: center;">FIELD INSPECTION REPORT</h1> <p style="text-align: center;"><u>Bridge Inspection &amp; Analysis</u></p> | |
|---|---|---|--|
| 4 | F | BOTH CURBS HAVE RANDOM TRANSVERSE HAIRLINE CRACKS, SOME WITH EFFLORESCENCE.<br>CONCRETE EPOXY REPAIRS IN NORTH CURB ARE DELAMINATED / SPALLING IN SPAN 2.<br>BOTH CURBS ARE WEATHERED WITH EXPOSED AGGREGATE. | |

CONCRETE EPOXY REPAIRS IN NORTH CURB ARE DELAMINATED / SPALLING IN SPAN 2.

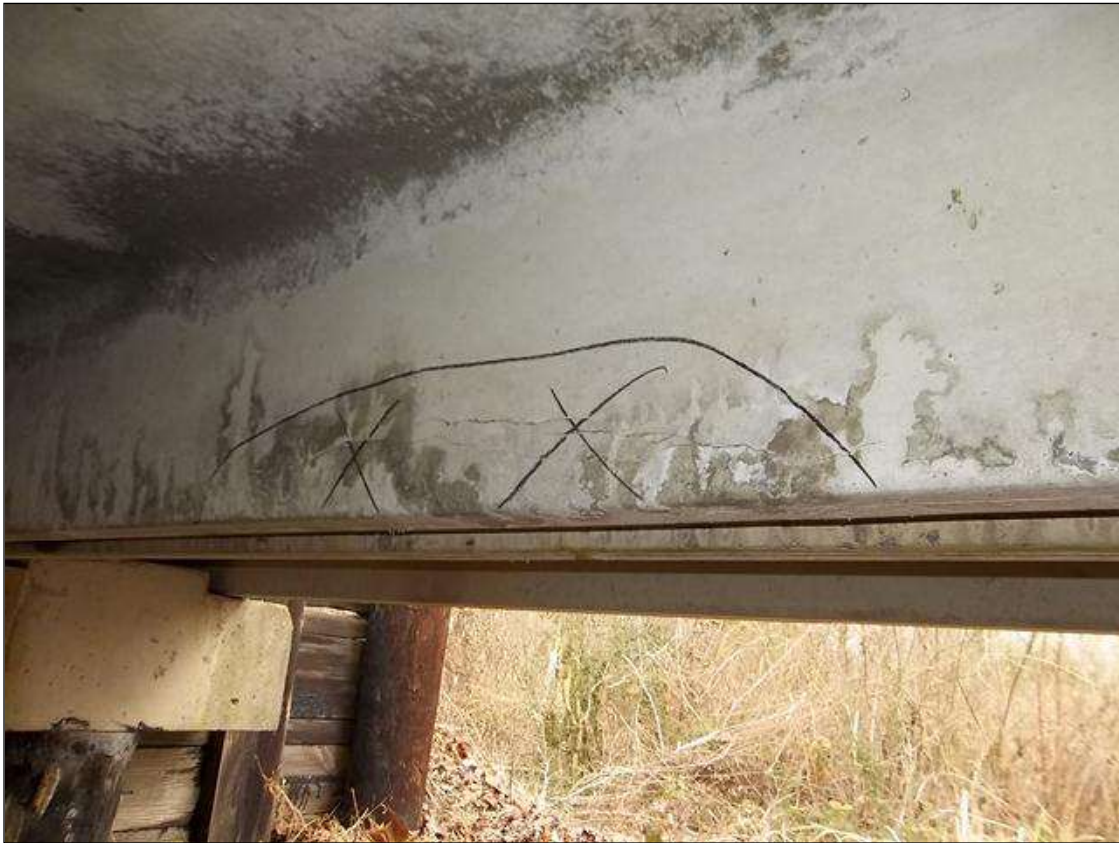
2' X 4" DELAMINATION IN BOTTOM OF NORTH LEG OF CHANNEL 2, 5' FROM END BENT 1, SPAN 1.

| MMS Code | Description of Function | Unit | Quantity | Remarks | Est. Cost |
|---|---|---|---|---|---|
| 3306 | Maintain Concrete Superstructure Components | SF | 20 | REPAIR SPALLS AND DELAMINATIONS TO CHANNELS. | |

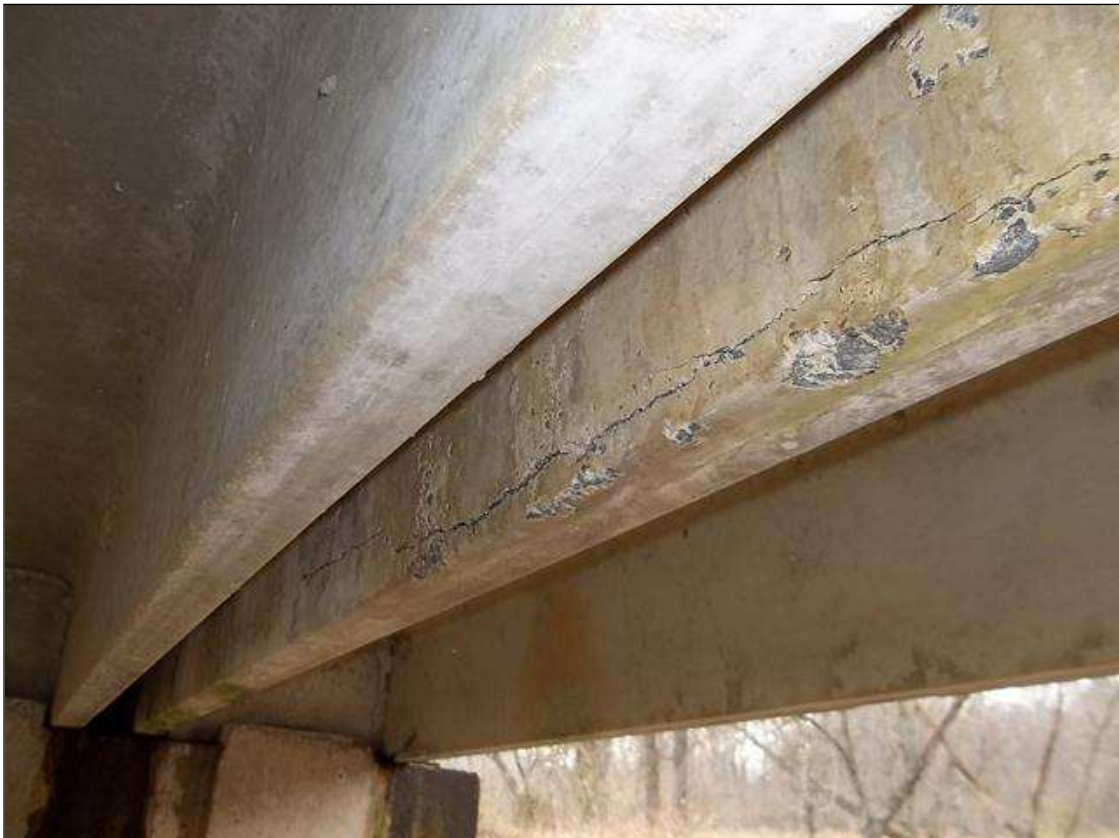
5' X 3" X 3" DELAMINATION IN BOTTOM OF NORTH LEG OF CHANNEL 10, 6' FROM BENT 1, SPAN 2.

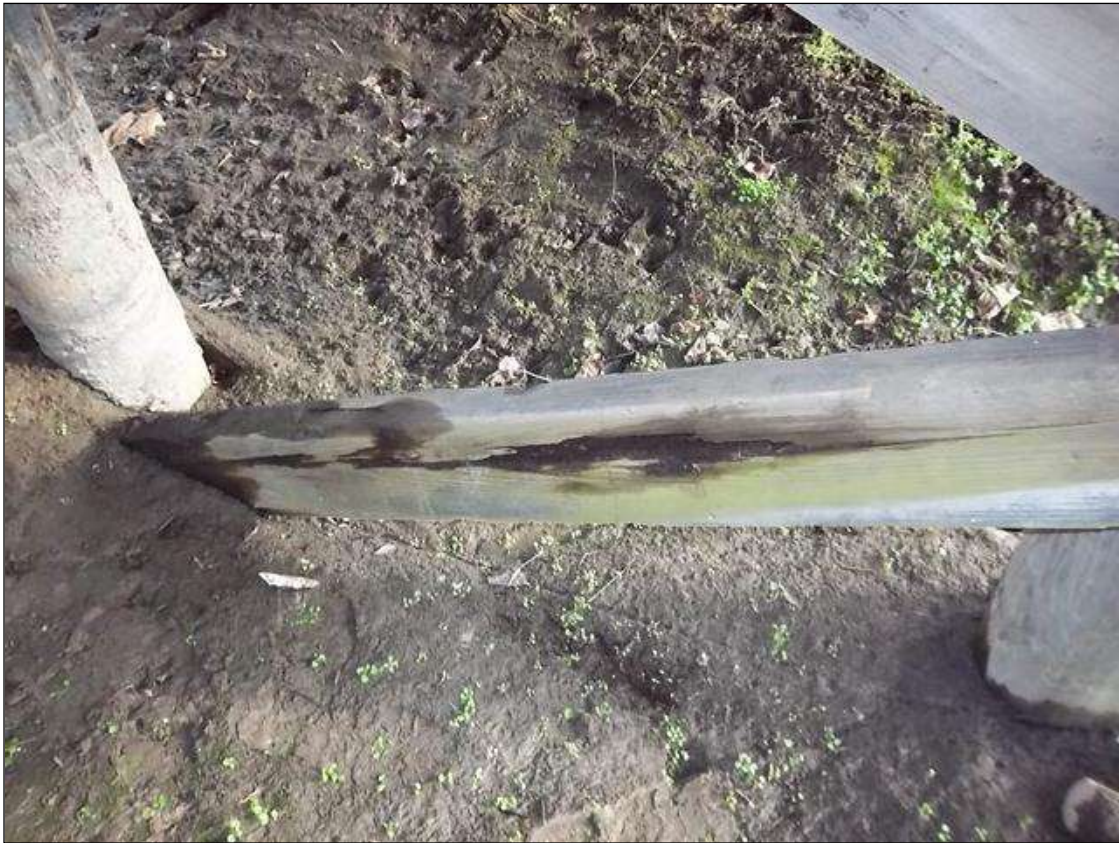
| Bridge I&A Form 1(82)H<br><b>State of North Carolina</b><br><b>Dept. of Transportation</b><br><b>Division of Highways</b> | | <h1 style="text-align: center;">FIELD INSPECTION REPORT</h1> <p style="text-align: center;"><u>Bridge Inspection &amp; Analysis</u></p> | |
|---|---|---|--|
| 35b | F | 4' X 4" AREA OF DECAY IN BENT 1 CROSS BRACE BETWEEN PILES 3 & 4. | |

4' X 4" AREA OF DECAY IN BENT 1 CROSS BRACE BETWEEN PILES 3 & 4.

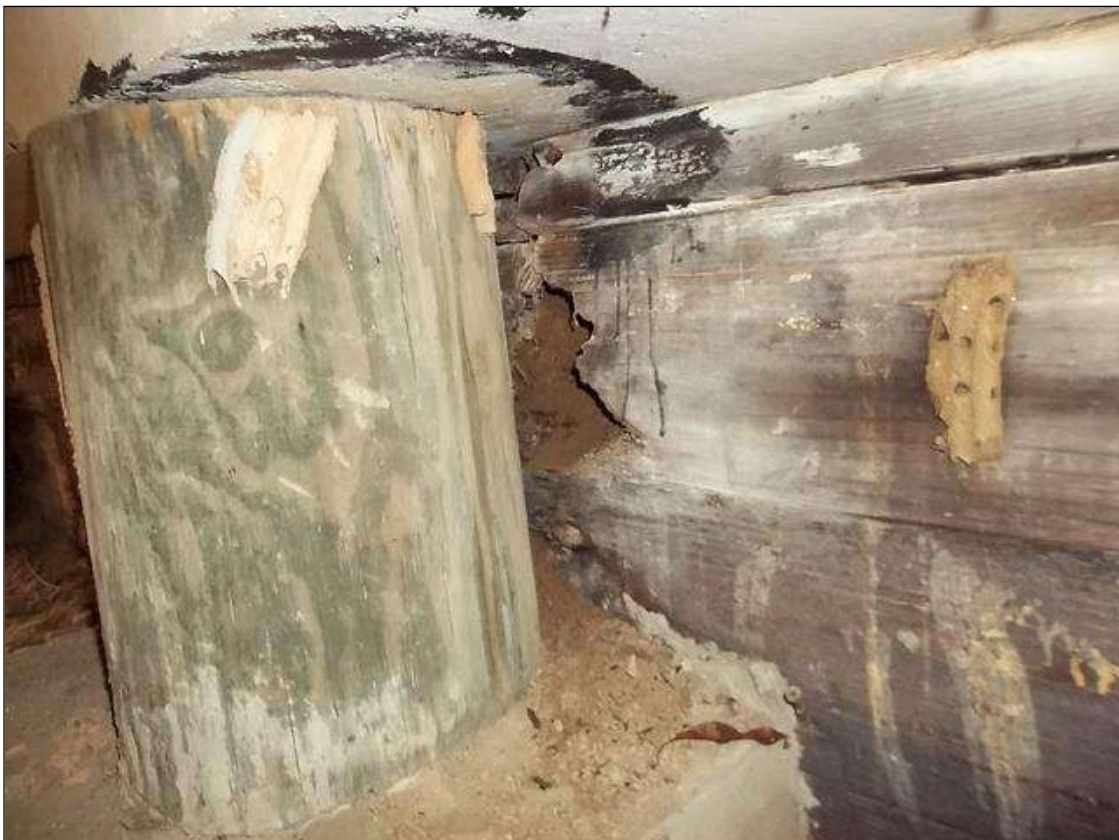
8" X 8" AREA OF DECAY IN END BENT 2 BULKHEAD BEHIND PILE 3.

| MMS Code | Description of Function | Unit | Quantity | Remarks | Est. Cost |
|---|---|---|---|---|---|
| 3346 | Repair / Maintain Timber Wings & Blkhds | SF | 20 | REPAIR DECAY IN END BENT BULKHEADS. | |

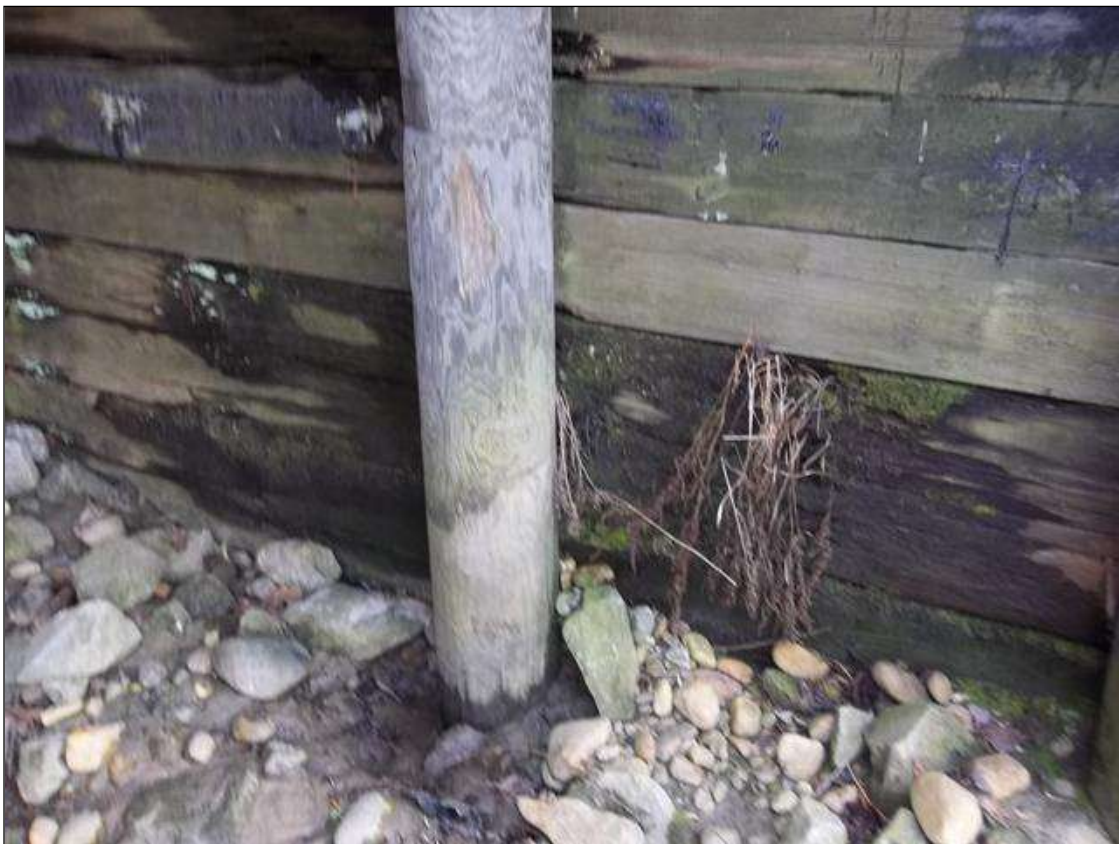
5' X 16" AREA OF RANDOM DECAY IN BOTTOM OF END BENT 2 BULKHEAD BEHIND PILE 5.

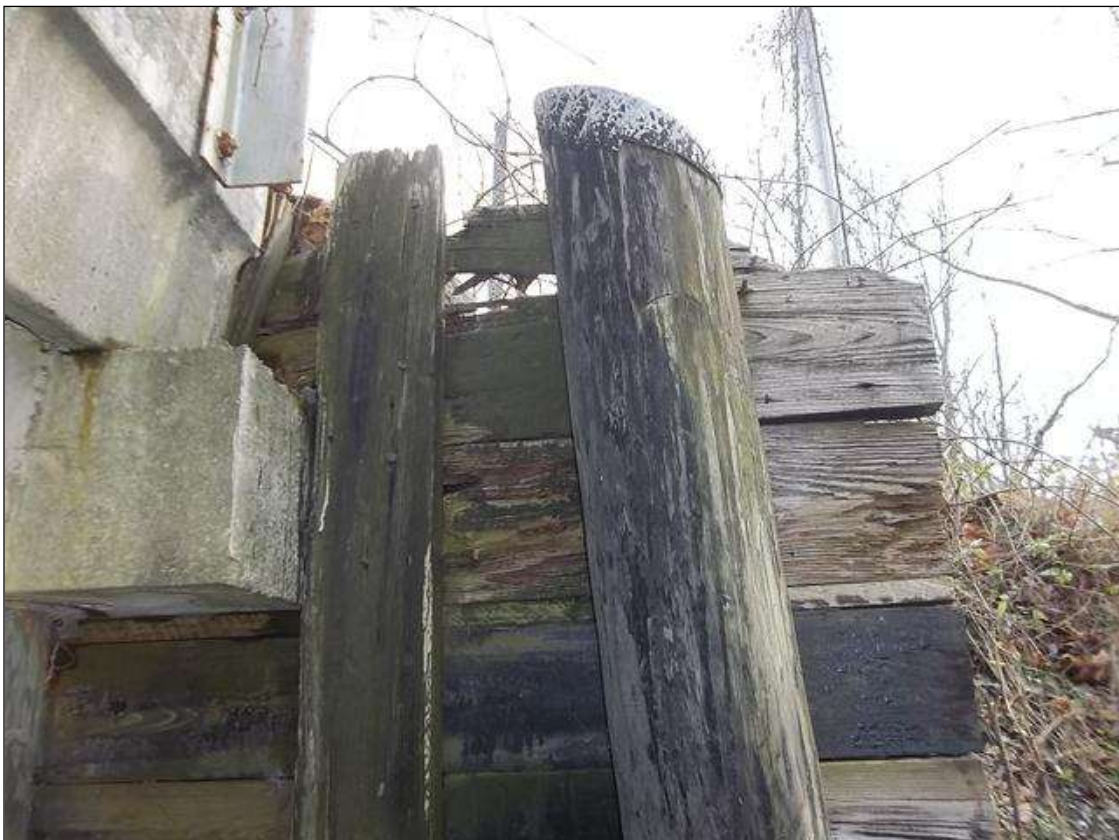
TOP 3 BOARDS ARE DECAYED IN TOP OF END BENT 2 BULKHEAD OUTSIDE CHANNEL 10.

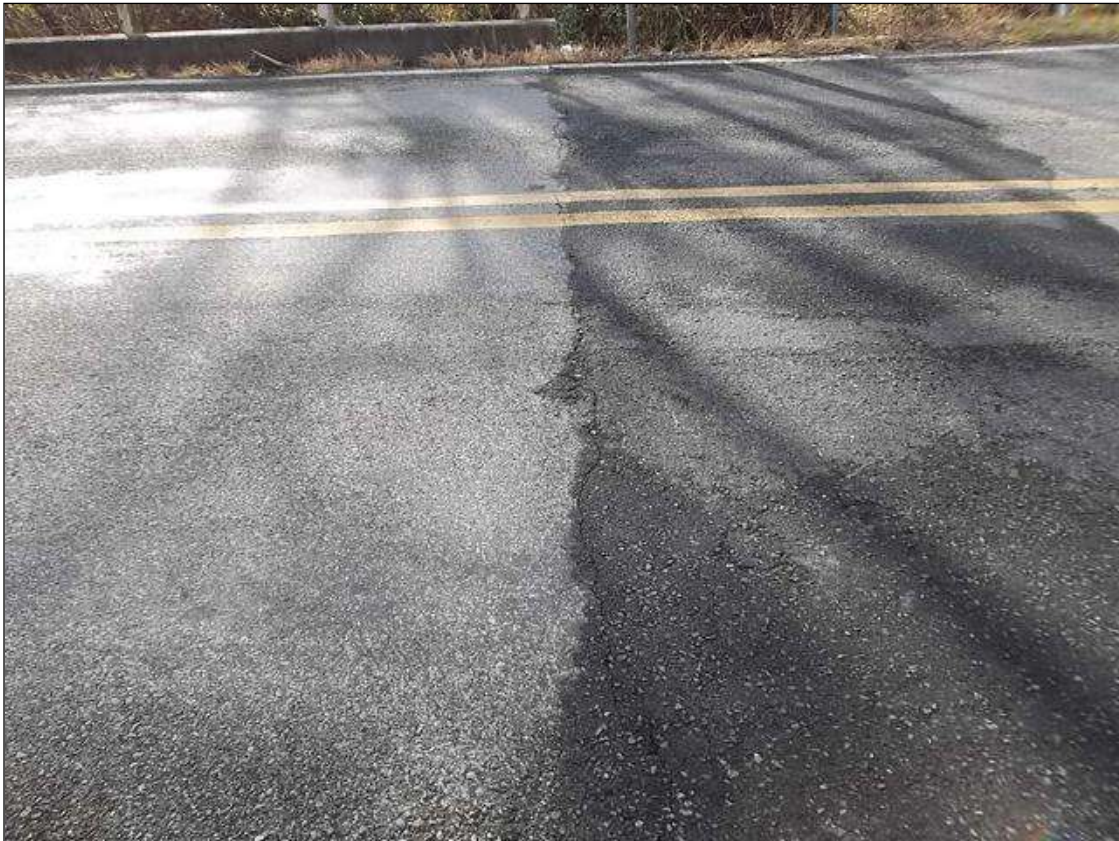
| Bridge I&A Form 1(82)H<br><b>State of North Carolina</b><br><b>Dept. of Transportation</b><br><b>Division of Highways</b> | | <h1 style="text-align: center;">FIELD INSPECTION REPORT</h1> <p style="text-align: center;"><u>Bridge Inspection &amp; Analysis</u></p> | |
|---|---|---|--|
| 1 | G | FULL WIDTH TRANSVERSE CRACKS UP TO 1/4" IN ASPHALT WEARING SURFACE OVER ALL BENTS AND END BENTS. | |

CRACK IN ASPHALT WEARING SURFACE OVER END BENT 1, LOOKING SOUTH

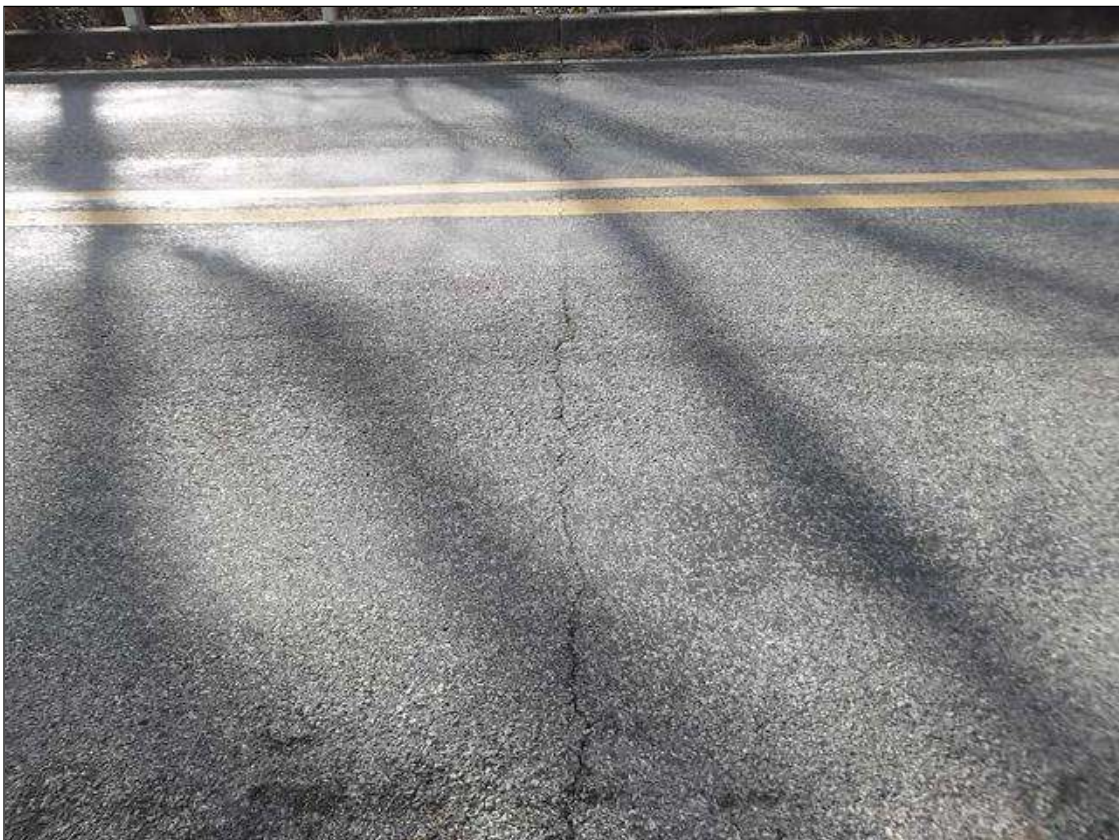
CRACK IN ASPHALT WEARING SURFACE OVER BENT 1, LOOKING SOUTH

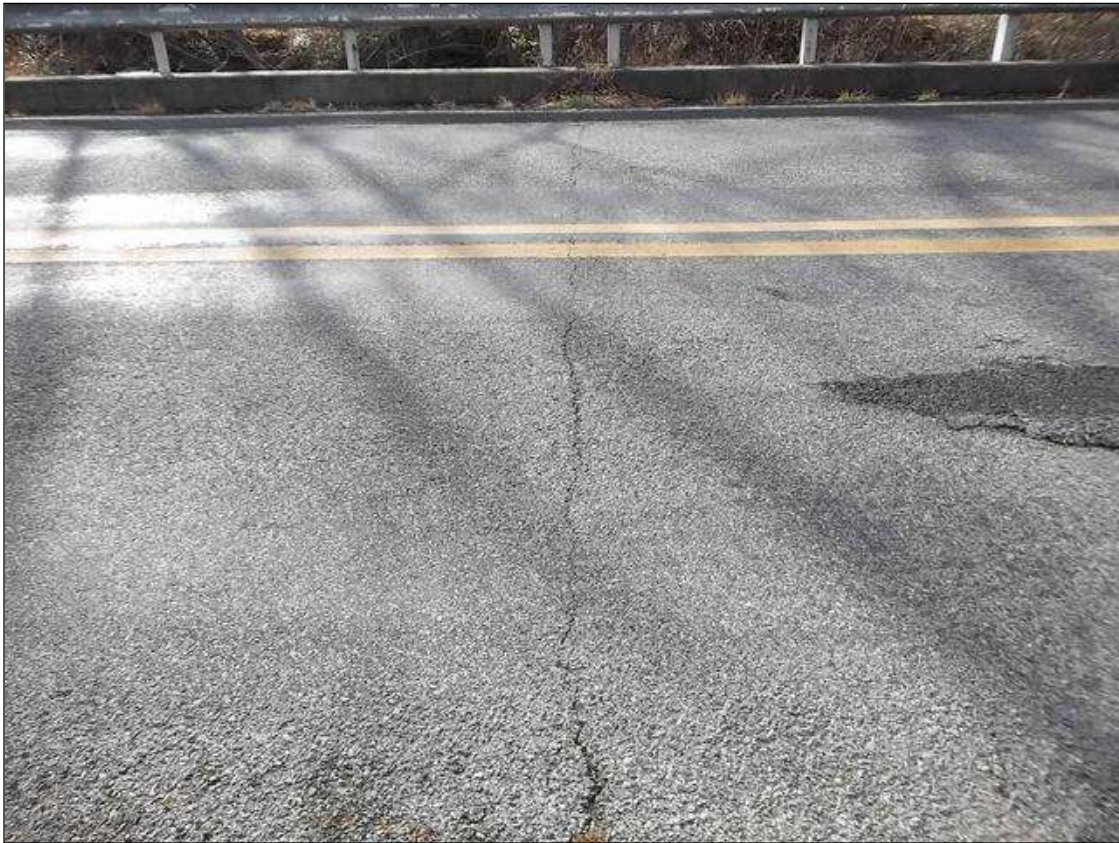
CRACK IN ASPHALT WEARING SURFACE OVER BENT 2, LOOKING SOUTH

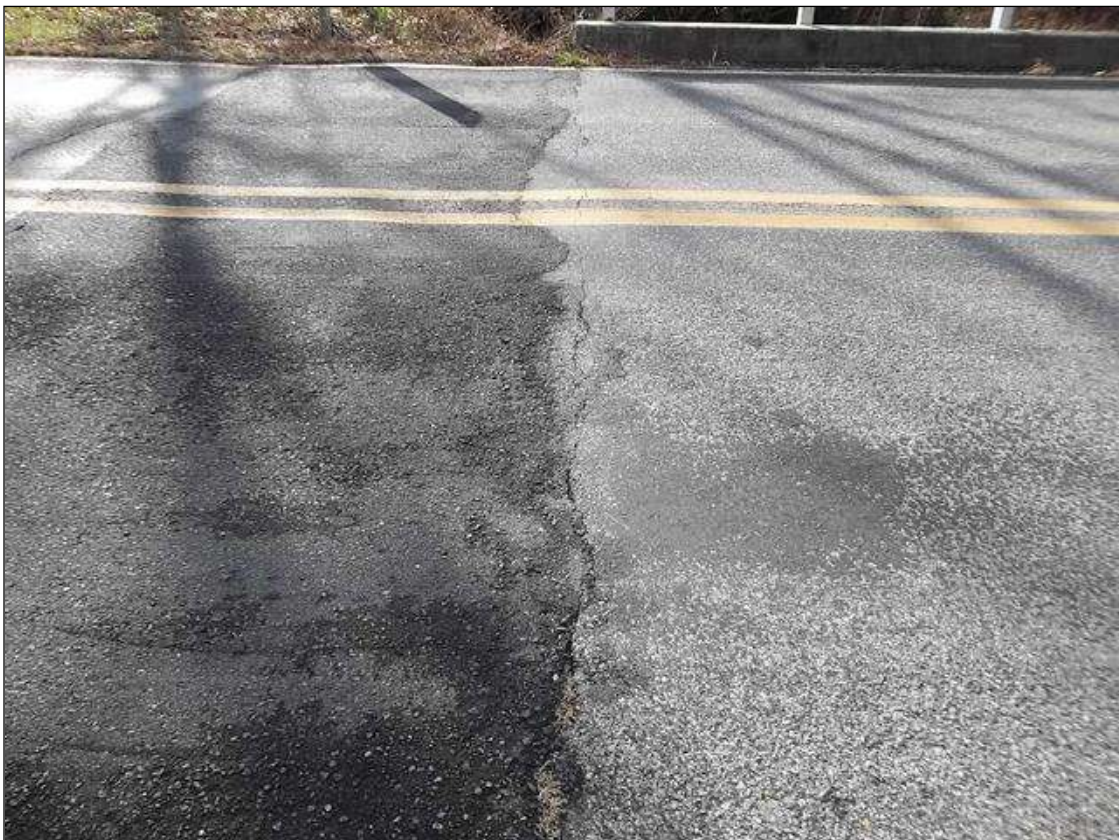
CRACK IN ASPHALT WEARING SURFACE OVER END BENT 2, LOOKING SOUTH
