**NO NATIONAL REGISTER OF HISTORIC PLACES  
ELIGIBLE OR LISTED ARCHAEOLOGICAL SITES  
PRESENT OR AFFECTED FORM**

Project No: **Structure 110060** County: **Burke**  
 WBS No: **17BP.13.R.133** Document: **LIBR Data Sheet (PCE) or Minimum Criteria Checklist**  
 F.A. No: **N/A** Funding: ☒ State ☐ Federal  
 Federal Permit Required? ☒ Yes ☐ No Permit Type: **NWP 3 / NWP 14 TVA**

**Project Description:** NCDOT intends to replace Bridge No. 60 on SR 1240, Fish Hatchery Road, over Russell Creek. The bridge will be replaced on the existing alignment and in the same location; an off-site detour will be utilized during construction. The archaeological Area of Potential Effects (APE) for the project is defined as extending 75 feet (22.9 m) from the existing centerline, and 300 feet (91.4 m) from each end of the existing bridge.

## CULTURAL RESOURCES REVIEW

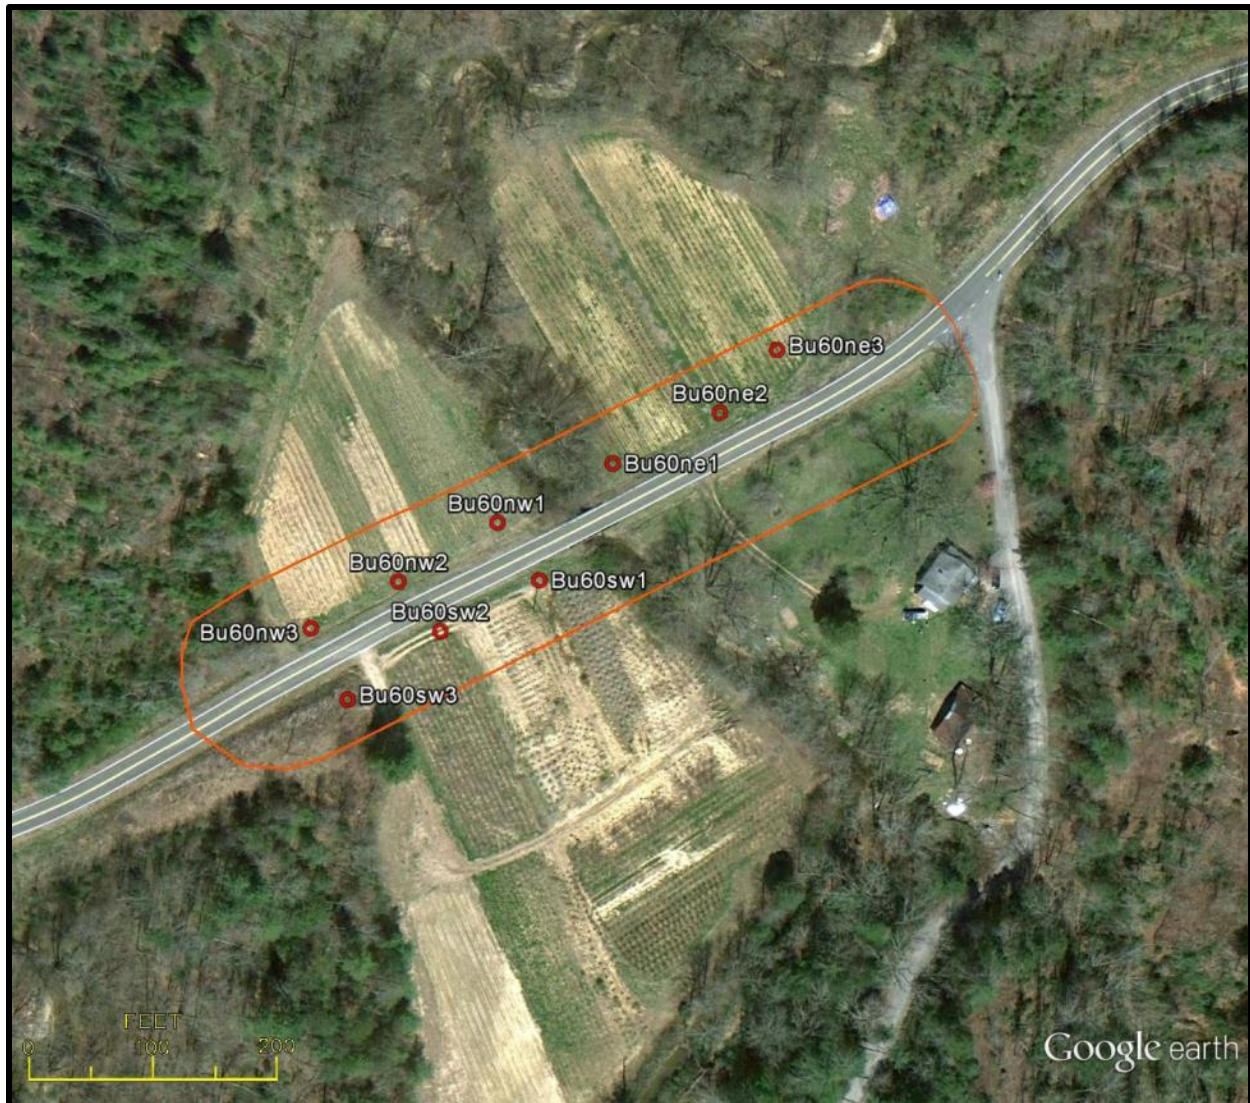
Figure 2. Aerial Photograph of Project Area Depicting Area of Potential Effects (Source: Google Earth 2013).

A field inspection was made by URS archaeologists on October 23, 2013. Three of the four quadrants were subjected to systematic survey (FIGURE 2). The southeast quadrant consists of slope with a residence located uphill, outside the APE (FIGURE 3). No shovel testing was conducted in the southeast quadrant. The northeast quadrant was subjected to a combination of systematic surface inspection and shovel testing. Recent plowing in the northeast quadrant offered surface visibility in excess of 90% (FIGURE 4). Surface inspection of the entire plowed area within the APE failed to identify cultural materials. In addition, three shovel tests at 30 meter intervals were excavated; no cultural materials were recovered from the STPs. Soils in the northeast quadrant consisted of dark yellowish brown (10YR 4/4) sandy loam overlying strong brown (7.5YR 5/8) sandy clay loam. Similarly, the southwest quadrant was subjected to both surface inspection and shovel testing (FIGURE 5). Surface visibility in much of the southwest quadrant was 90% or greater; no cultural materials were observed during the inspection. Three STPs at 30 meter intervals were excavated. Proceeding away from Russell Creek, the first two STPs were located on a lower floodplain within the plowed area while the third was excavated on a slightly higher T1 terrace within an overhead utility corridor. The lower two STPs exhibited soils identical to those described above for the northeast quadrant. The higher STP on the T1 terrace consisted of strong brown (7.5YR 5/8) gravelly sand overlying strong brown (7.5 YR 5/6) silty sand with very light gravel, which was in turn underlain by light gray (10YR 7/2) clayey sand. No cultural materials were recovered from the STPs in the southwest quadrant. The northwest quadrant was covered with rows of immature trees being grown for a nursery (FIGURE 6). Three STPs at 30 meter intervals were excavated in the northwest

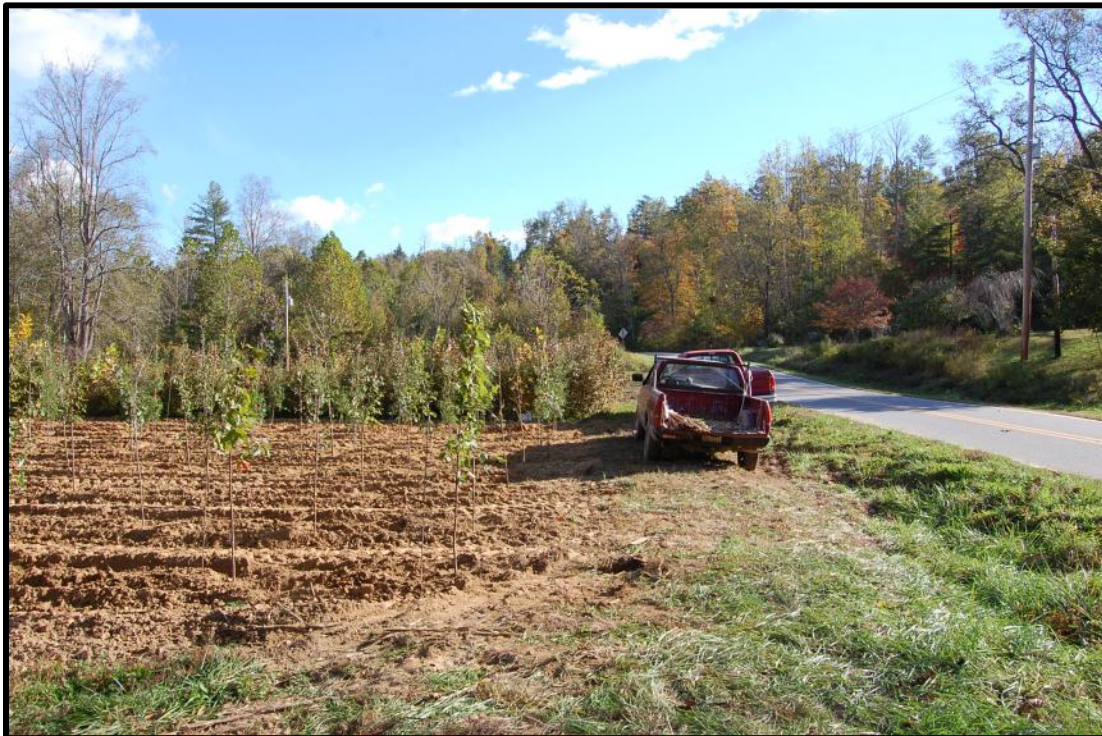
Figure 4. Northeast quadrant of APE, View East.

Based on the field inspection, it was determined that the northeast quadrant of the APE was heavily sloped; this portion was not subjected to systematic subsurface testing. Systematic archaeological survey was performed on the remaining three quadrants of the APE. No cultural materials were recovered. No significant archaeological sites are situated within the APE.

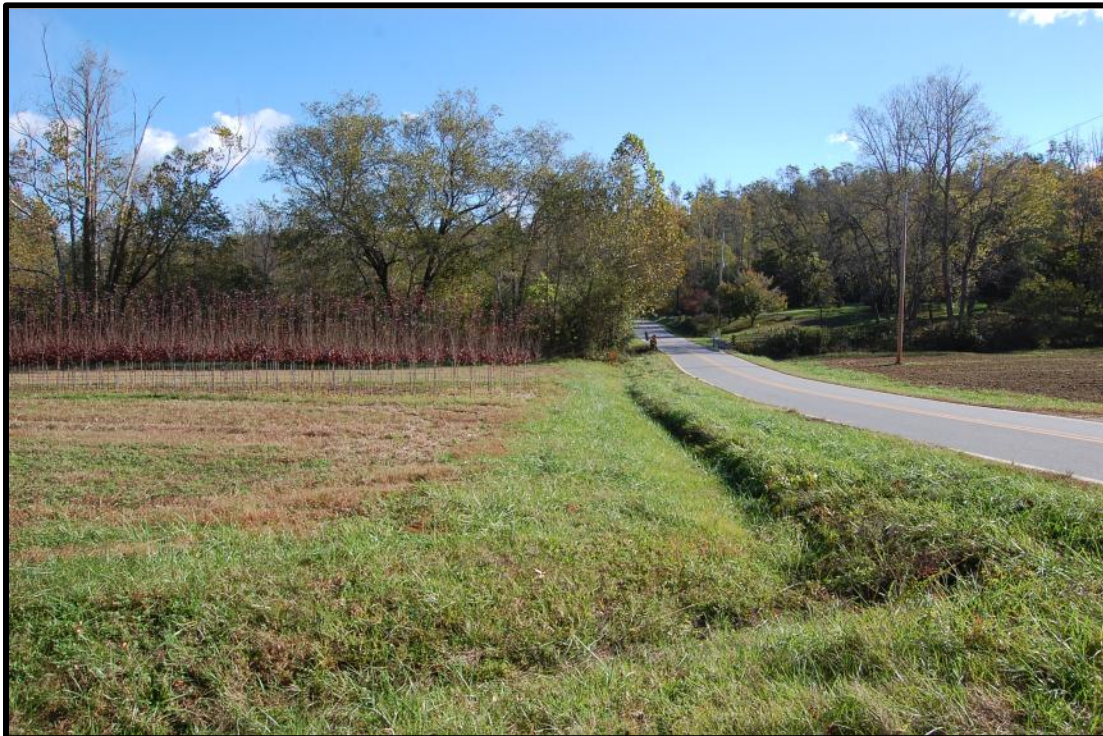
Figure 6. Northwest quadrant of APE, View East.

quadrant. No cultural materials were recovered from these STPs. Soils in all three STPs were identical to those described above for the northeast quadrant.
