NC DEPARTMENT OF TRANSPORTATION  
DIVISION OF HIGHWAYS  
BRIDGE MANAGEMENT UNIT

# BRIDGE INSPECTION REPORT

INSPECTION TYPE: Routine Inspection

COUNTY ORANGE BRIDGE NUMBER 670073 INSPECTION CYCLE 2 YRS  
ROUTE SR1115 ACROSS CANE CREEK M.P. 0

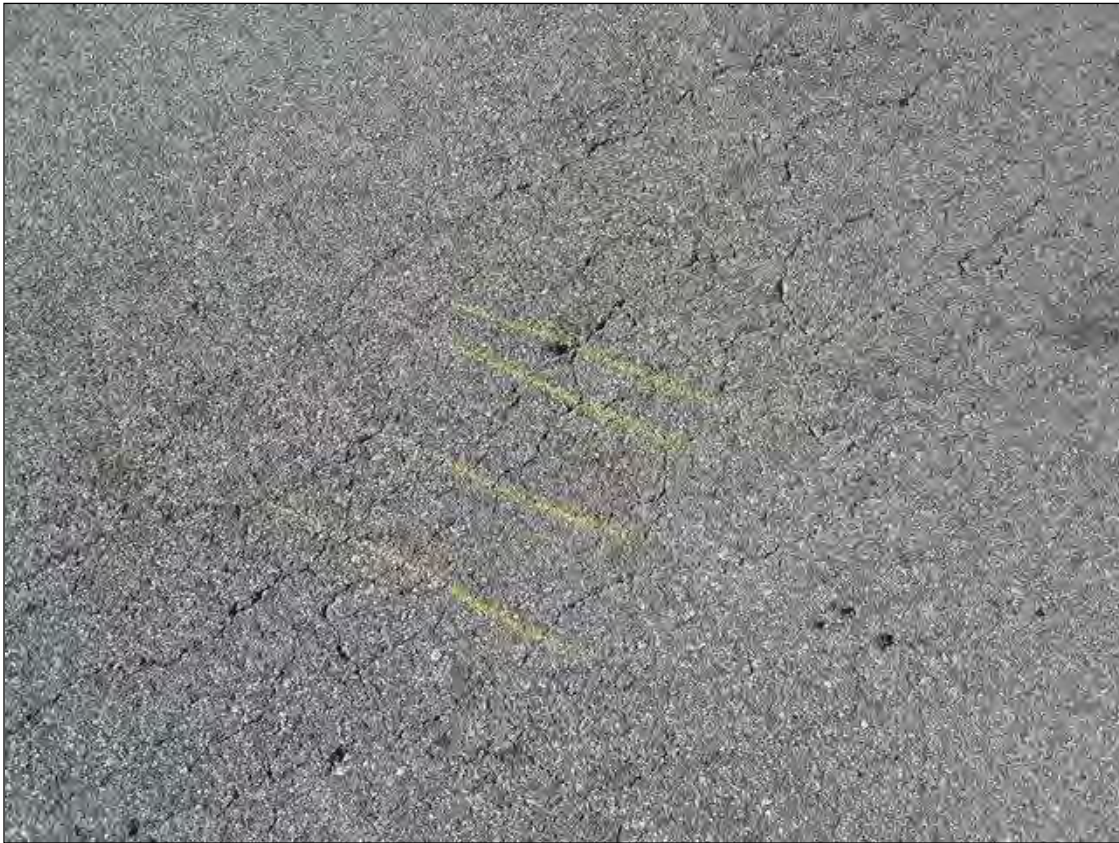
| Bridge I&A Form 1(82)H<br>State of North Carolina<br>Dept. of Transportation<br>Division of Highways | | <h1>FIELD INSPECTION REPORT</h1> <p><u>Bridge Inspection &amp; Analysis</u></p> | |
|---|---|---|--|
| 50 | G | ASPHALT ON APPROACHES HAS CRACKING, NO SETTLEMENT. | |

CRACKING ON WEST END APPROACH

| MMS Code | Description of Function | Unit | Quantity | Remarks | Est. Cost |
|---|---|---|---|---|---|
| 2816 | Asphalt Surface Repair or Replacement | SY | 100 | AWS CRACKED AND BREAKING UP | |

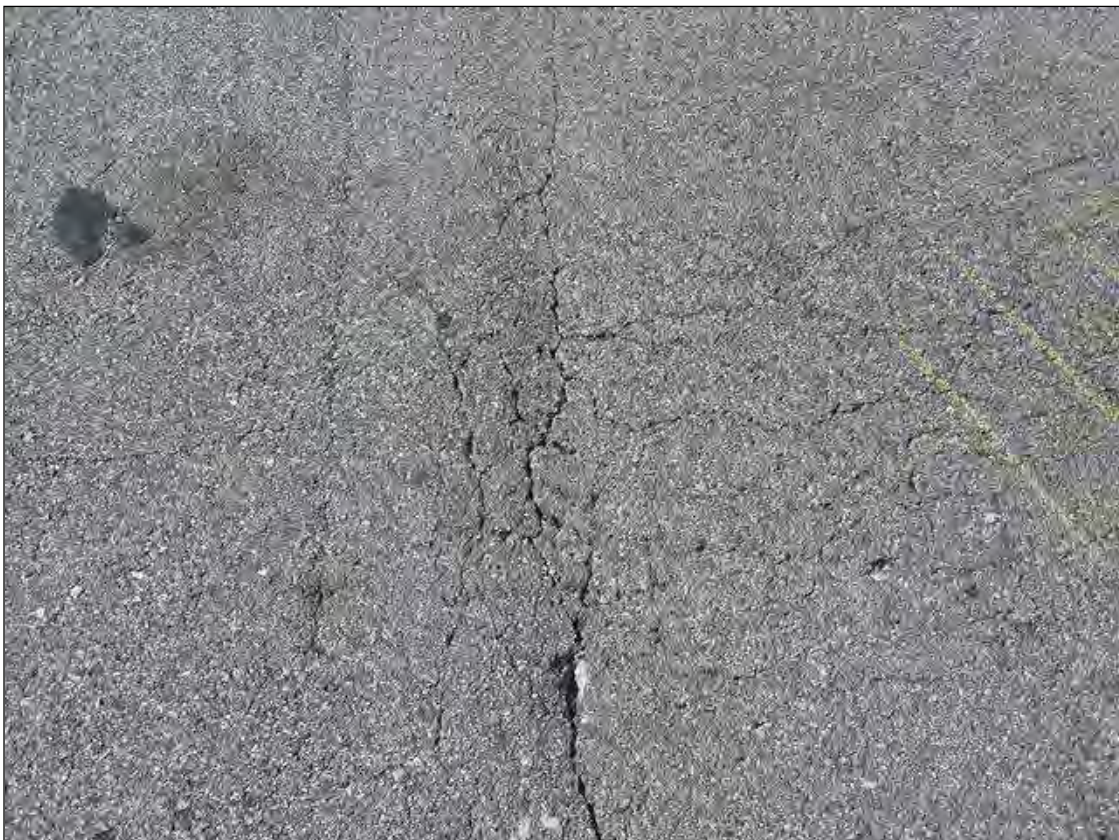
| Bridge I&A Form 1(82)H<br>State of North Carolina<br>Dept. of Transportation<br>Division of Highways | | <h1>FIELD INSPECTION REPORT</h1> <p><u>Bridge Inspection &amp; Analysis</u></p> | |
|---|---|---|--|
| 1 | F | AWS CRACKED ALONG TIMBER DECKING EDGES, 52 SQUARE FOOT OF PATCHED AREAS WITH OTHER AREA CRACKING STARTING TO BREAK OUT. | |

WEAR SURFACE CRACKING AT END BENT 1

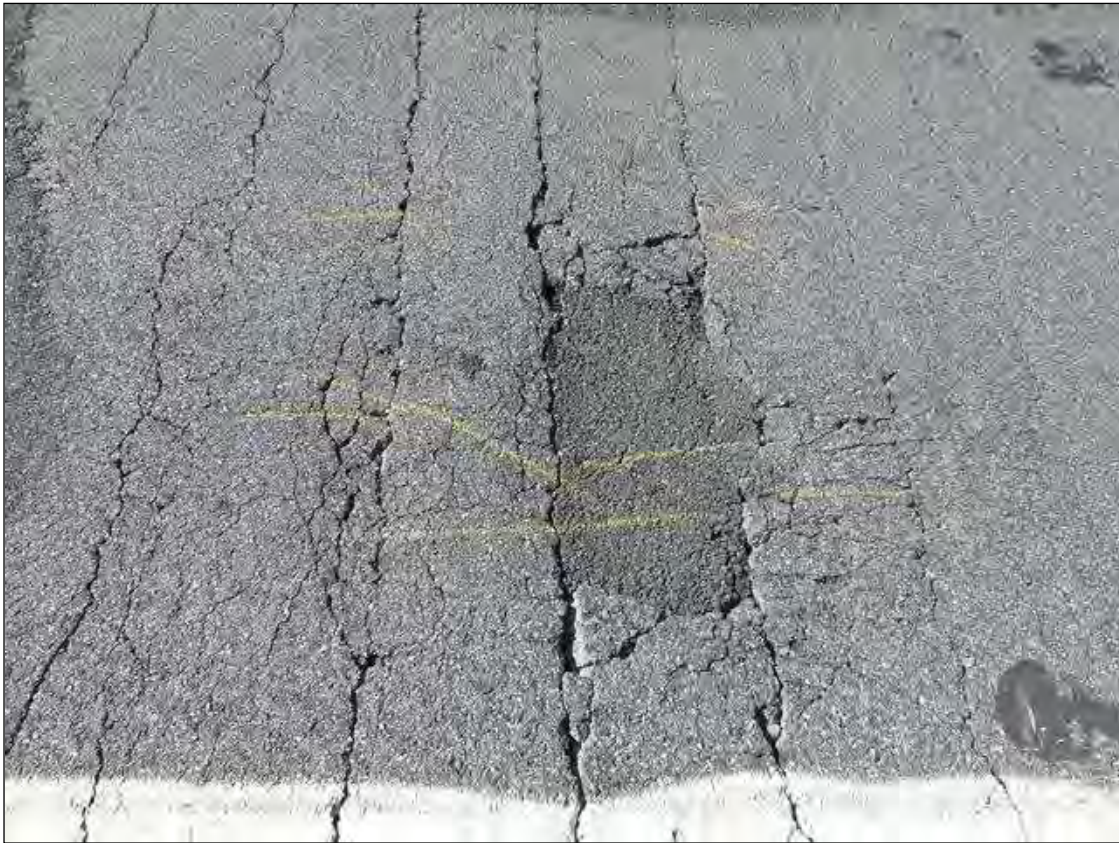
WEAR SURFACE CRACKING ON DECK AT TIMBER DECKING BOARD JOINTS

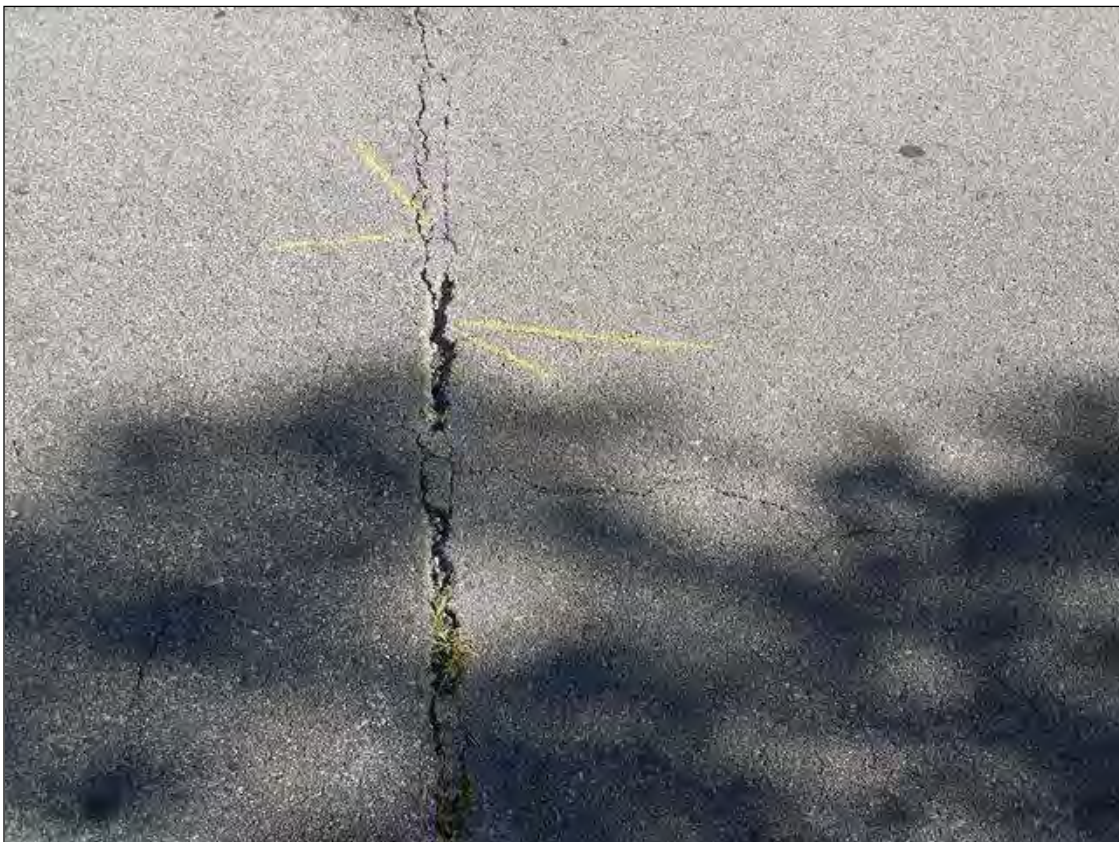
WEAR SURFACE CRACKING AT END BENT 2

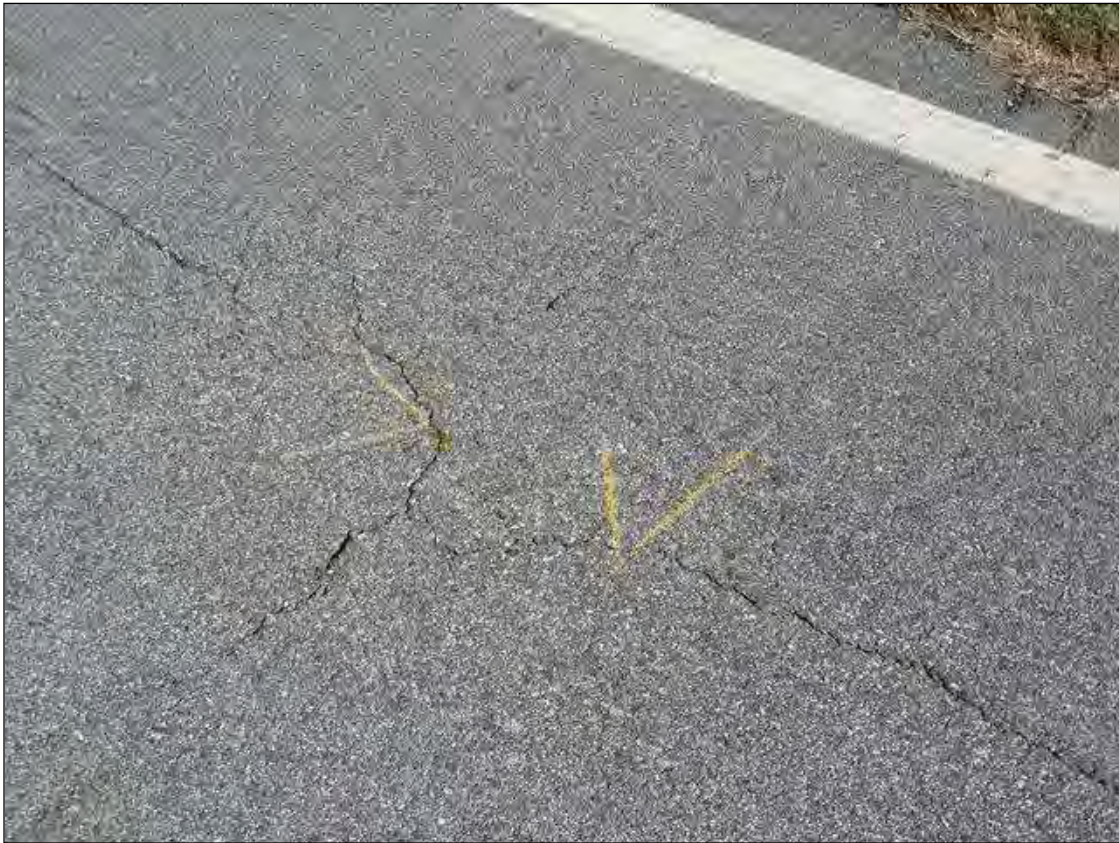
CRACKING ON EAST END APPROACH

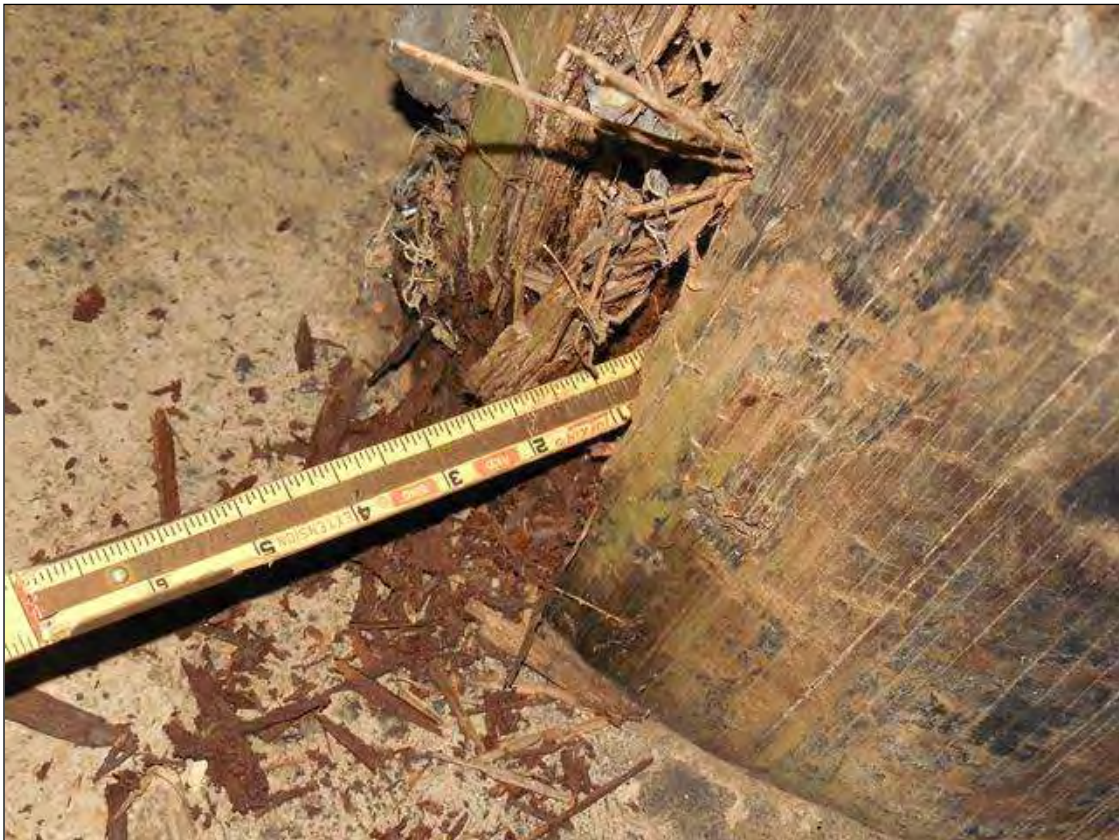
| Bridge I&A Form 1(82)H<br>State of North Carolina<br>Dept. of Transportation<br>Division of Highways | | <h1>FIELD INSPECTION REPORT</h1> <p><u>Bridge Inspection &amp; Analysis</u></p> | |
|---|---|---|--|
| 35b | P | TIMBER POSTS ARE WEATHERED AND CHECKED WITH DELAM AROUND CHECK CRACKS.<br>END BENT 1, PILE 3, DECAY AREA AT BASE, 5"DEEP X 6" WIDE X 16"HIGH.<br>PIER 1, PILE 4, DECAY AREA AT BASE, AREA IS 2"DEEP X 8"WIDE X 20"HIGH. PM ISSUED.<br>PILE 5, DECAY AREA ALONG BASE, 5"WIDE X 6" DEEP X 20" HIGH PM ISSUED.<br>END BENT 2, PILE 8 DECAY AREA AT BASE, AREA IS 3"DEEP X 3"WIDE X 4"HIGH. | |

DECAY ON BOTTOM OF PILE 4 AT PIER

| MMS Code | Description of Function | Unit | Quantity | Remarks | Est. Cost |
|---|---|---|---|---|---|
| 3344 | Repair / Replace Timber Substructure Components | LF | <del>6</del> <i>TSE</i><br><i>12/4/13</i> | PILE 4 AT PIER, DECAY ALONG BASE AT SILL, AREA IS 2"DEEP X 8"WIDE X 20"HIGH. | |

| MMS Code | MMS Description | Quantity |
|---|---|---|
| PILE 4 AT PIER, DECAY ALONG BASE AT SILL, AREA IS 2"DEEP X 8"WIDE X 20"HIGH. | | |

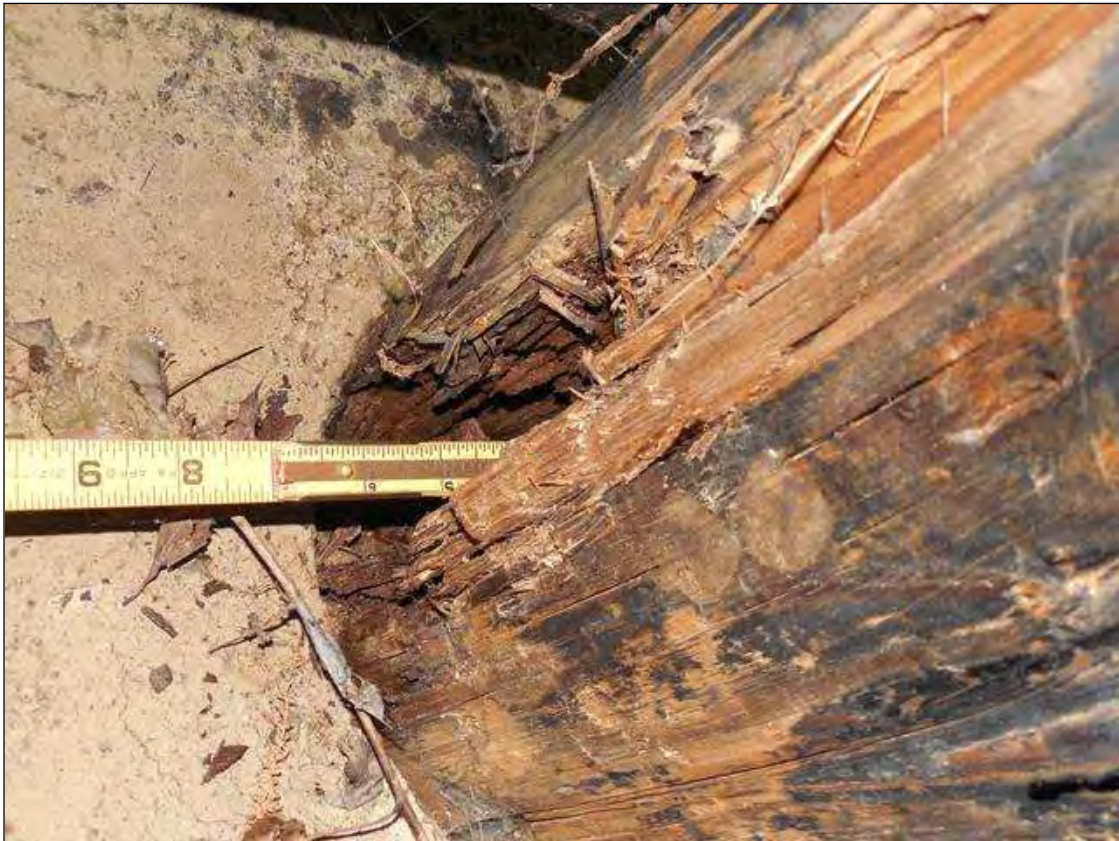
DECAY ON BOTTOM OF PILE 5 AT PIER

| MMS Code | Description of Function | Unit | Quantity | Remarks | Est. Cost |
|---|---|---|---|---|---|
| 3344 | Repair / Replace Timber Substructure Components | LF | <del>6</del> <i>TSE</i> | PILE 5 AT PIER, DECAY ALONG BASE AT SILL, AREA IS 5"WIDE X 6"DEEP X 20"TALL. | |

| MMS Code | MMS Description | Quantity |
|---|---|---|
| PILE 5 AT PIER, DECAY ALONG BASE AT SILL, AREA IS 5"WIDE X 6"DEEP X 20"TALL. | | |

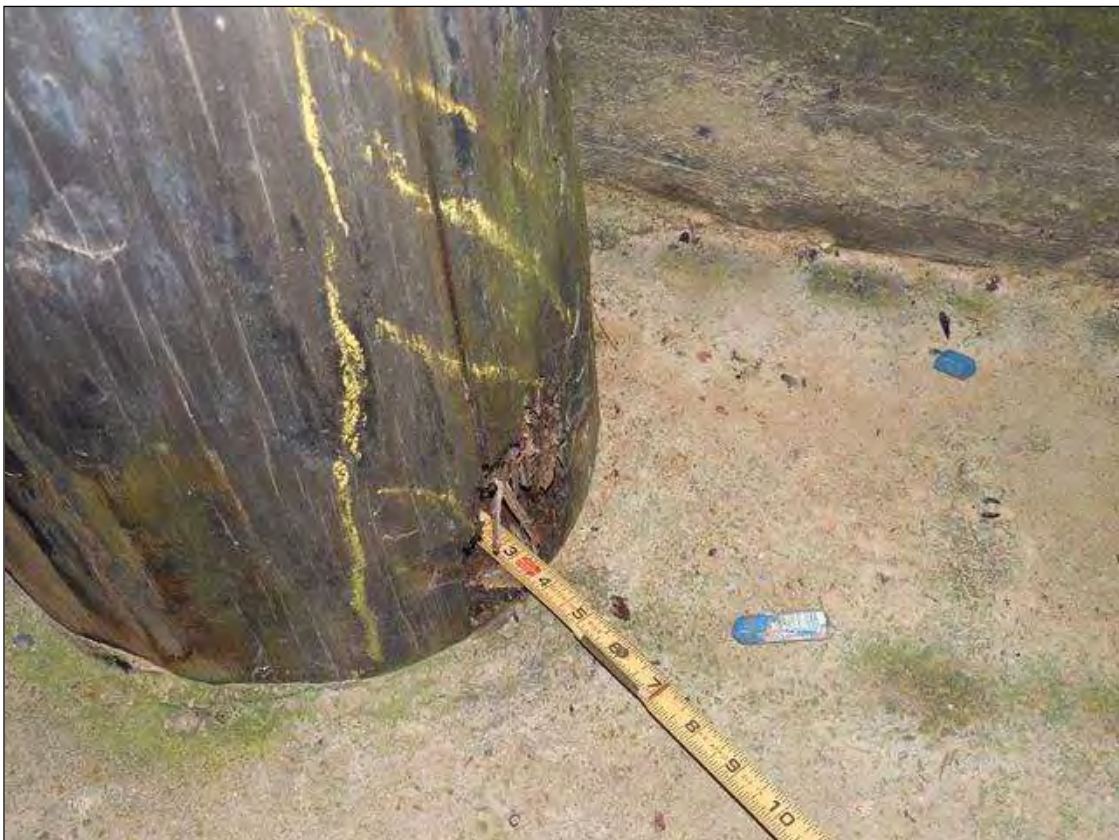
DECAY ON BOTTOM OF PILE 8 AT END BENT 2

| MMS Code | Description of Function | Unit | Quantity | Remarks | Est. Cost |
|---|---|---|---|---|---|
| 3344 | Repair / Replace Timber Substructure Components | LF | 12 | DECAY ON PILES AT EB 1, P3 AND EB2, P8 | |

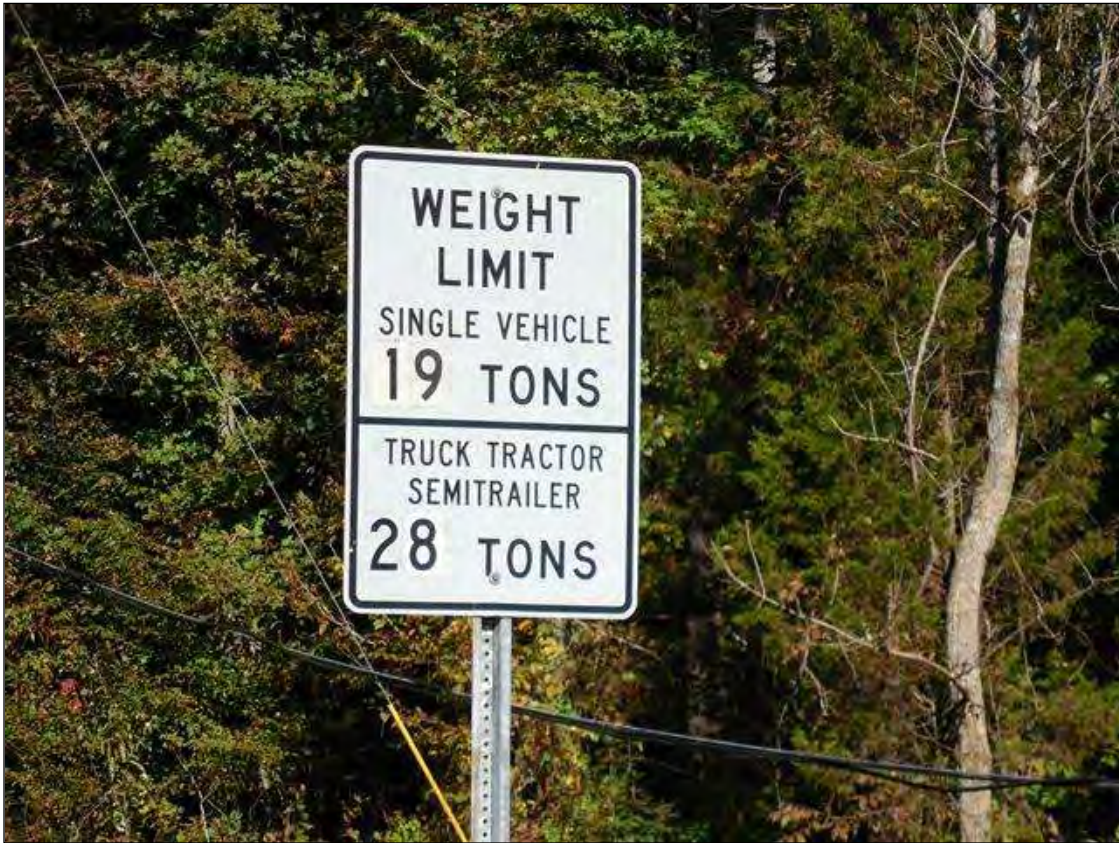
PRESENT POSTING SV 20 TTST 30 SV 19 TTST 28

WEIGHT LIMIT SIGN

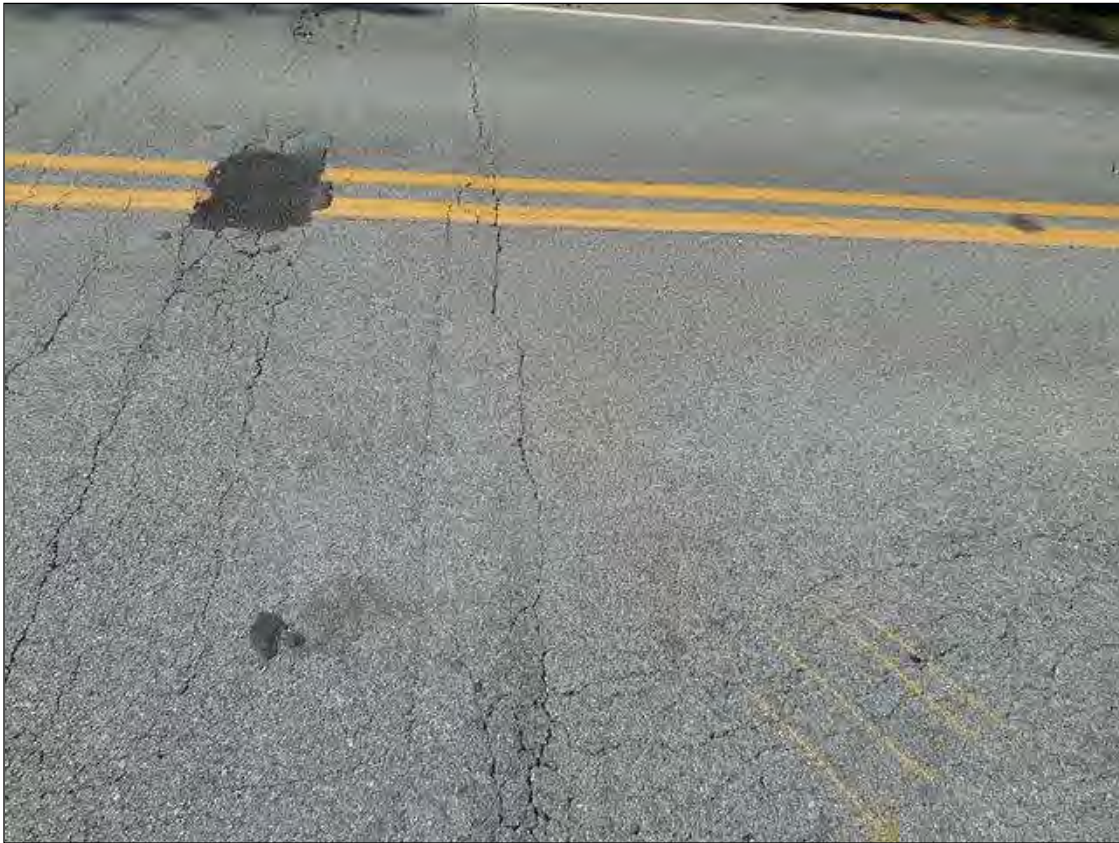
WEAR SURFACE AT END BENT 1

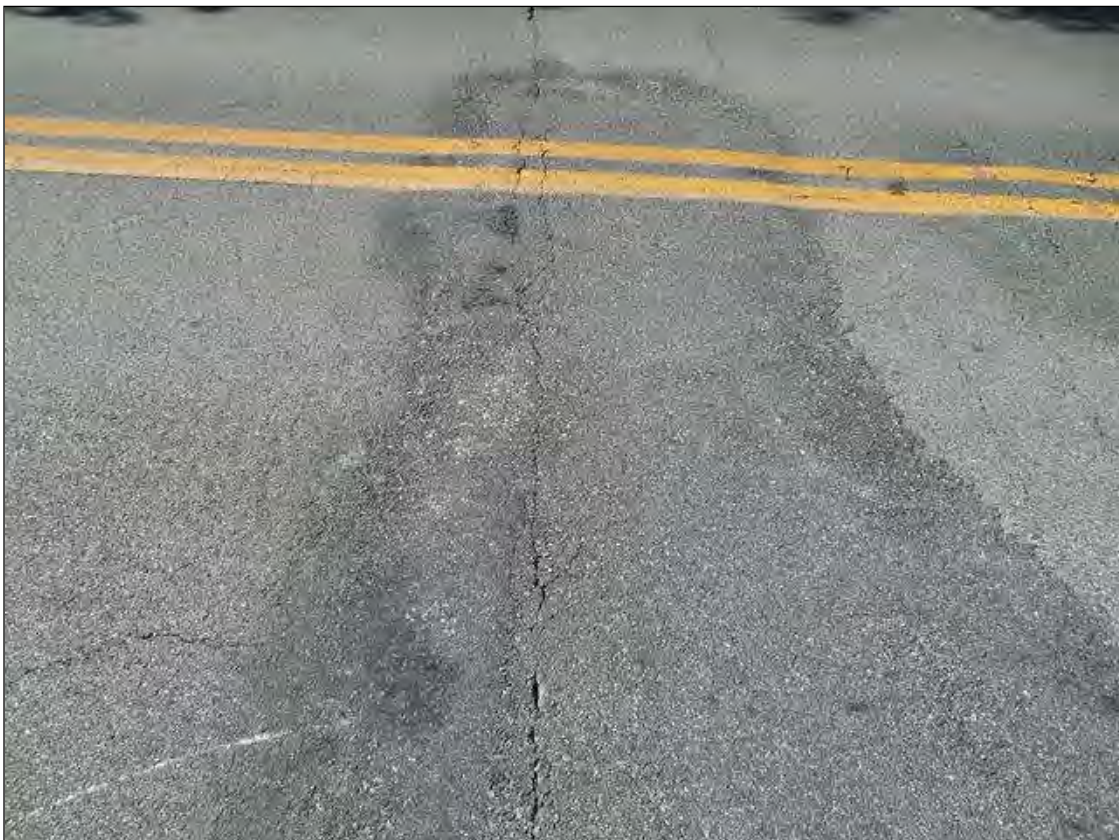
WEAR SURFACE AT END BENT 2

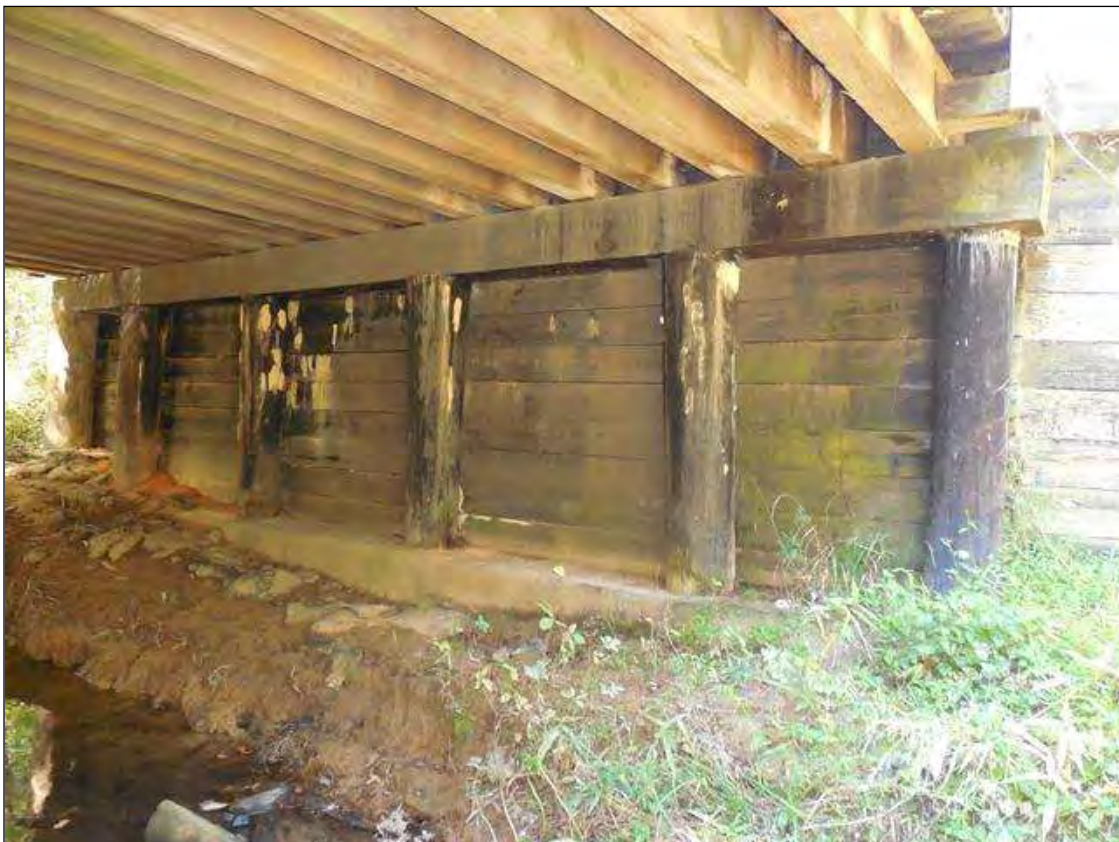
END BENT 1

| Bridge I&A Form 1(82)H<br>State of North Carolina<br>Dept. of Transportation<br>Division of Highways | | <h1>FIELD INSPECTION REPORT</h1> <p><u>Bridge Inspection &amp; Analysis</u></p> | |
|---|---|---|--|
| 35c | F | BULKHEADS AND WING TIMBERS HAVE AREAS OF DECAY, SE WING HAS FULL DEPTH DECAY EXPOSING FILL, YELLOW JACKET NEST BEHIND WING.<br>WING POST HAVE HOLLOW SOUNDINGS ALONG TOP PORTIONS. | |

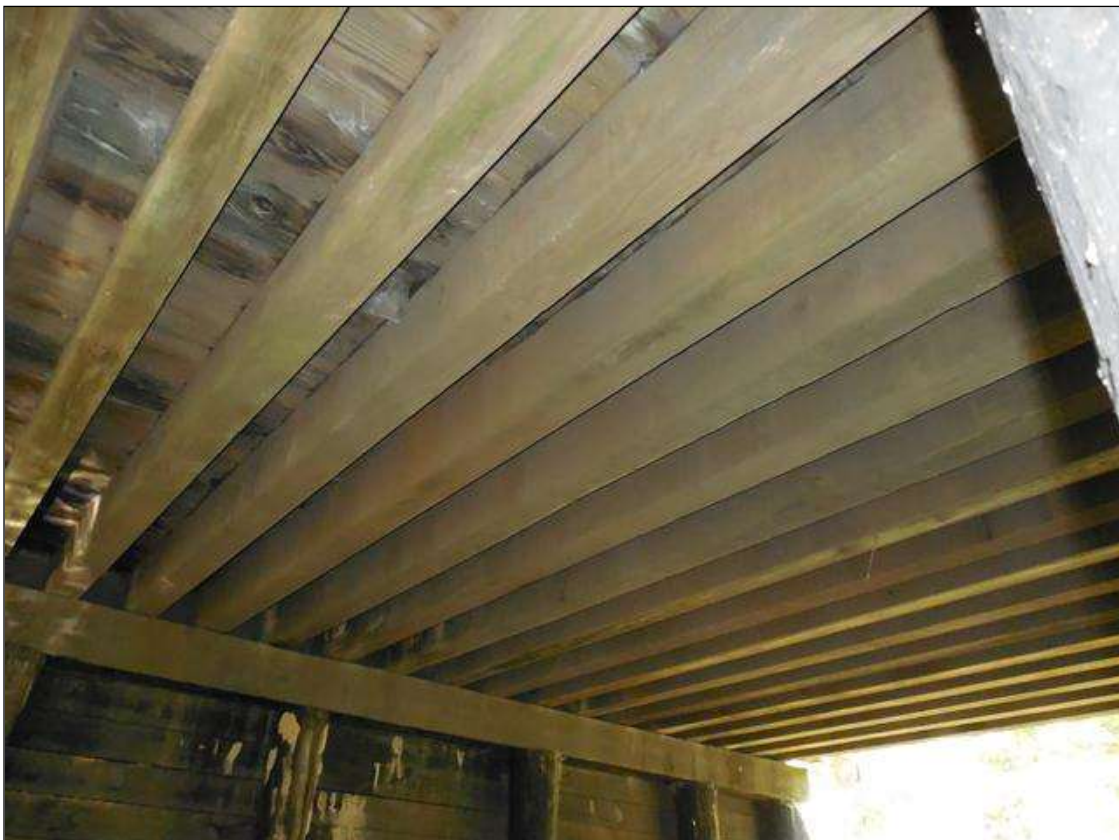
| Bridge I&A Form 1(82)H<br>State of North Carolina<br>Dept. of Transportation<br>Division of Highways | | <h1>FIELD INSPECTION REPORT</h1> <p><u>Bridge Inspection &amp; Analysis</u></p> | |
|---|---|---|--|
| 2b | F | TIMBER DECKING LOOSE AND REBOUNING, DISCOLORATION ALONG UNDERSIDE WITH ENDS SOFT ON OLDER TIMBERS, DECAY UP TO 3"DEEP. | |

UNDERSIDE OF DECK

| MMS Code | Description of Function | Unit | Quantity | Remarks | Est. Cost |
|---|---|---|---|---|---|
| 3324 | Maint / Repair / Replace Timber Deck Components | SF | 900 | TIMBER DECKING LOOSE | |

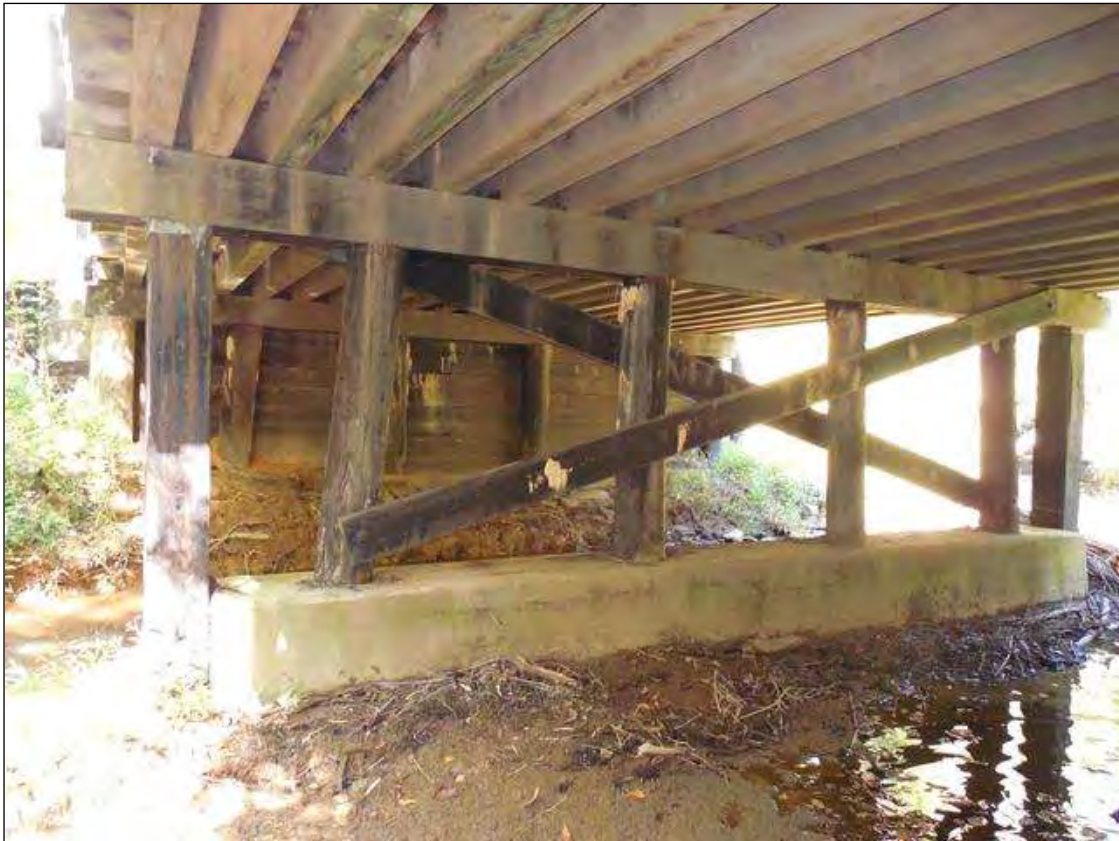
| Bridge I&A Form 1(82)H<br>State of North Carolina<br>Dept. of Transportation<br>Division of Highways | | <h1>FIELD INSPECTION REPORT</h1> <p><u>Bridge Inspection &amp; Analysis</u></p> | |
|---|---|---|--|
| 36e | F | PIER FOOTING HAS FULL HEIGHT CRACK AT PILE 4 ON SPAN 2 FACE, CRACK IS 1/16" WIDE RUNNING FROM TIMBER PILE DOWN TO MUD LINE | |

PIER
