NC DEPARTMENT OF TRANSPORTATION  
DIVISION OF HIGHWAYS  
BRIDGE MANAGEMENT UNIT

# BRIDGE INSPECTION REPORT

INSPECTION TYPE: Routine Inspection

COUNTY ORANGE BRIDGE NUMBER 670173 INSPECTION CYCLE 2 YRS  
ROUTE SR1353 ACROSS PRONG ENO RIVER M.P. 0

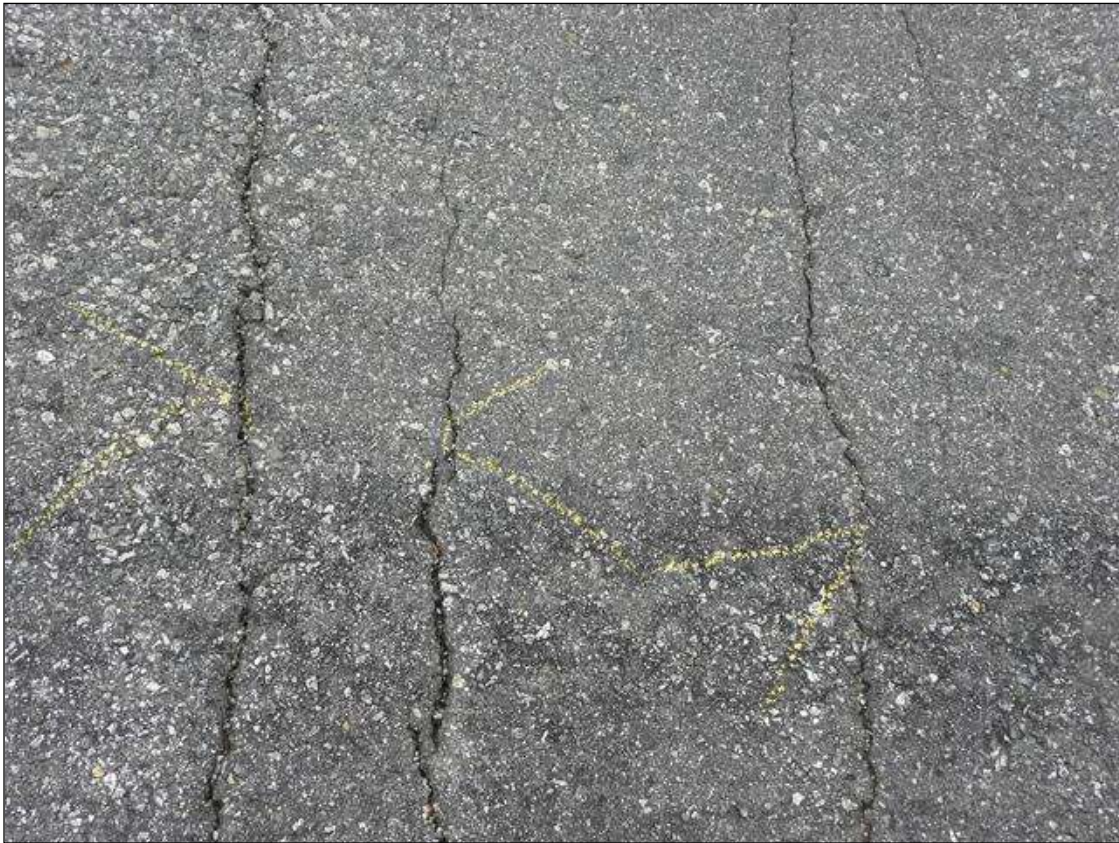
| Bridge I&A Form 1(82)H<br>State of North Carolina<br>Dept. of Transportation<br>Division of Highways | | <b>FIELD INSPECTION REPORT</b><br><u>Bridge Inspeccion &amp; Analysis</u> | |
|---|---|---|--|
| 1 | F | AWS CRACKED ALONG TIMBER DECKING EDGES THROUGH OUT SURFACE. AWS CRACKING AND STARTING TO BUST UP OVER END BENTS. | |

WEAR SURFACE CRACKING AT TIMBER DECKING BOARD JOINTS

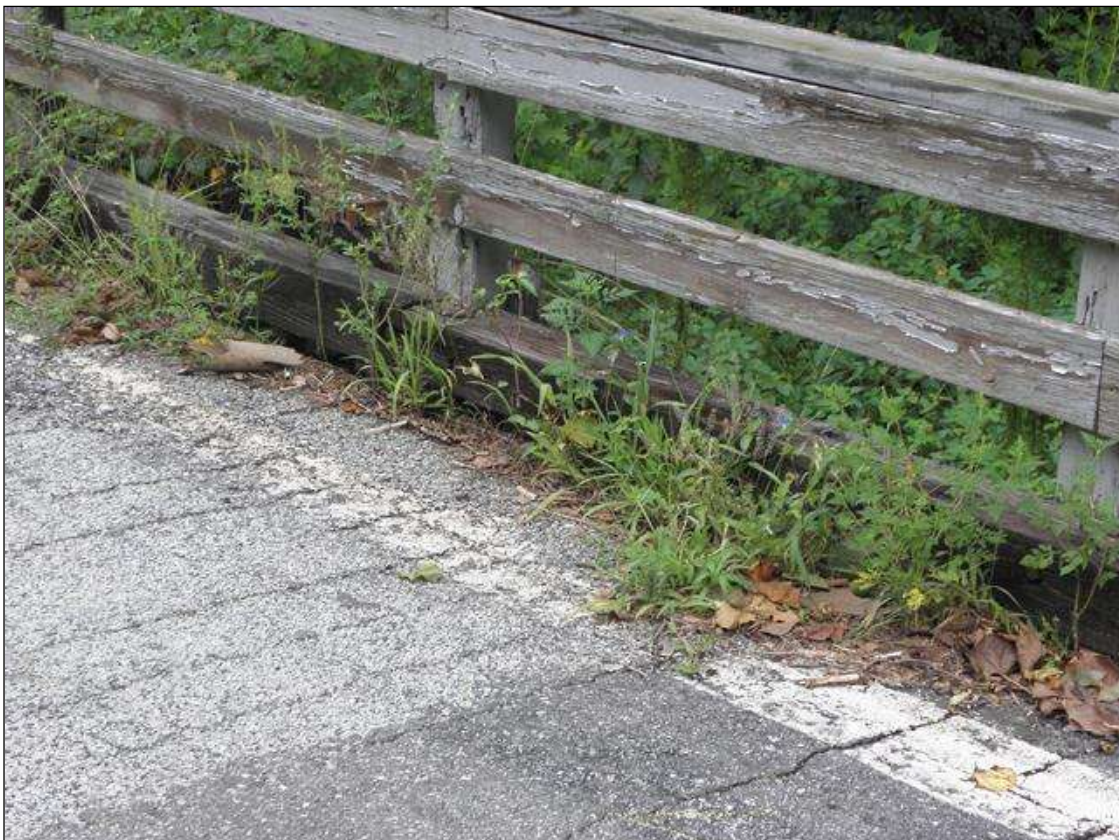
| Bridge I&A Form 1(82)H<br>State of North Carolina<br>Dept. of Transportation<br>Division of Highways | | <b>FIELD INSPECTION REPORT</b><br><u>Bridge Inspeccion &amp; Analysis</u> | |
|---|---|---|--|
| 7 | F | VEGETATION GROWING ALONG CURBS | |

VEGETATION GROWING ON BOTH SIDES OF DECK

| MMS Code | Description of Function | Unit | Quantity | Remarks | Est. Cost |
|---|---|---|---|---|---|
| 2910 | Manual Brush and Tree Control | LF | 100 | VEGETATION HEAVY AROUND OPENINGS | |

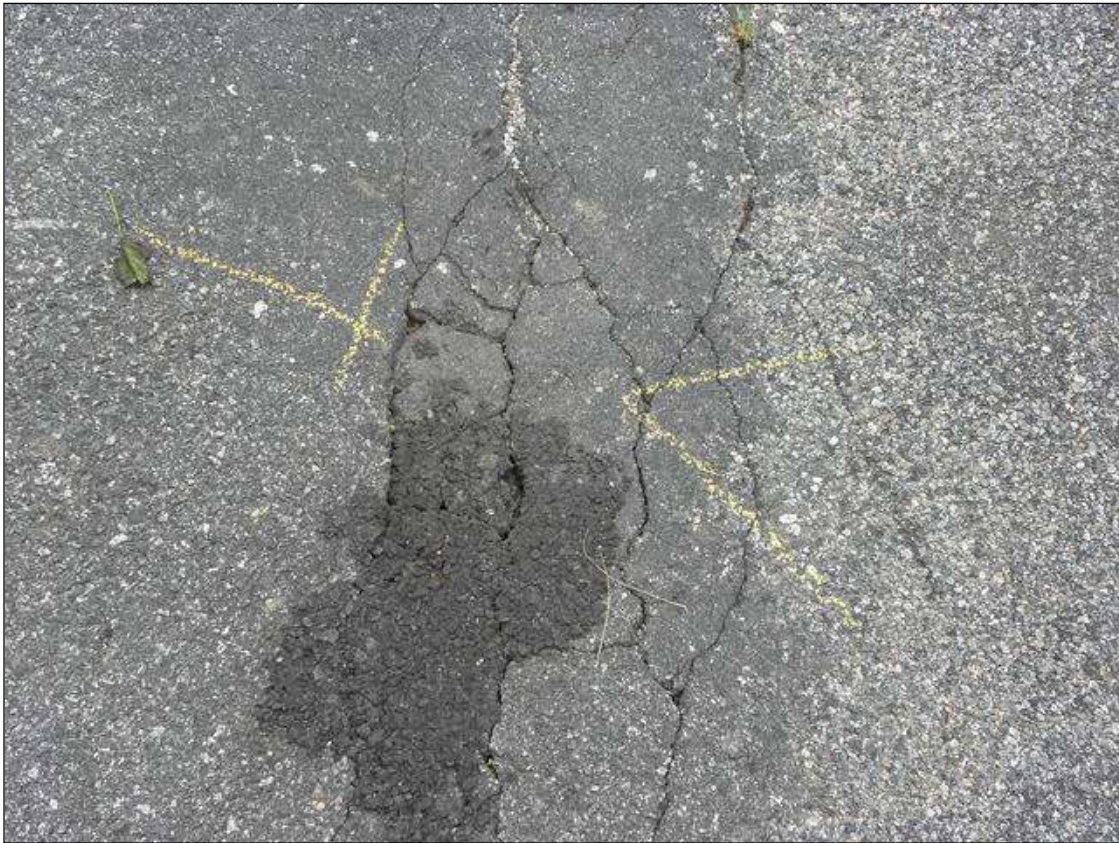
WEAR SURFACE CRACKING AT END BENT 1

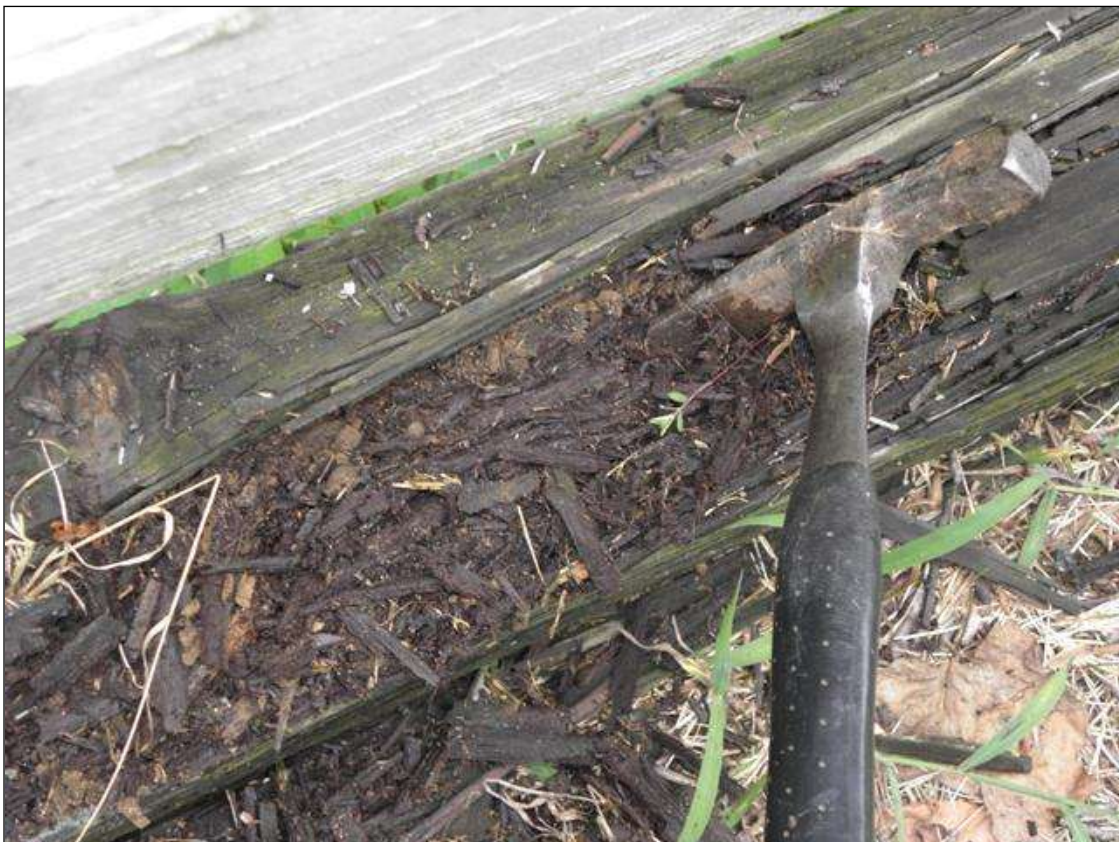
| Bridge I&A Form 1(82)H<br>State of North Carolina<br>Dept. of Transportation<br>Division of Highways | | <b>FIELD INSPECTION REPORT</b><br><u>Bridge Inspeccion &amp; Analysis</u> | |
|---|---|---|--|
| 4 | F | SECTION OF CURB ON RIGHT SIDE HAS DECAY ALONG TOP, UP TO 3" DEEP, SECTION IS 7' LONG. OTHER TIMBERS WEATHERED AND CHECKED. | |

WHEEL GUARD DECAYED ON EAST SIDE OF DECK

| MMS Code | Description of Function | Unit | Quantity | Remarks | Est. Cost |
|---|---|---|---|---|---|
| 3316 | Maint to Timber Handrail | LF | 7 | WHEEL GUARD HAS DECAY | |

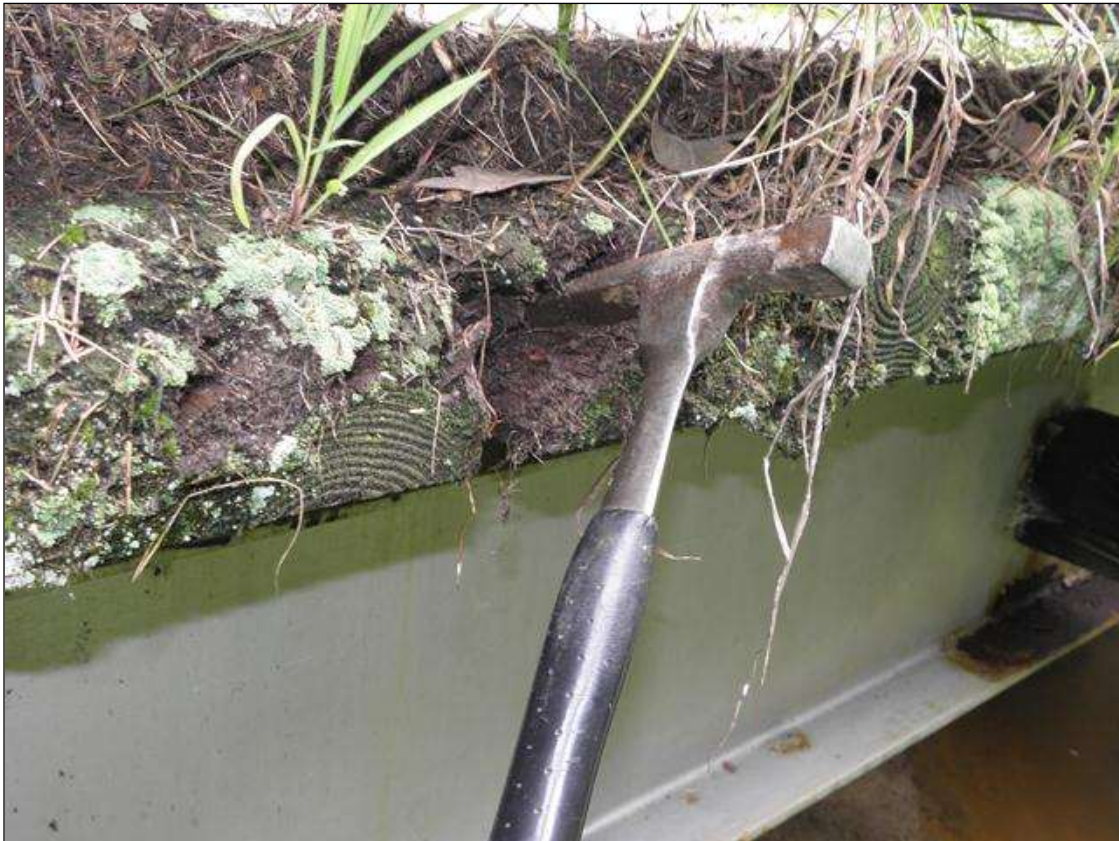
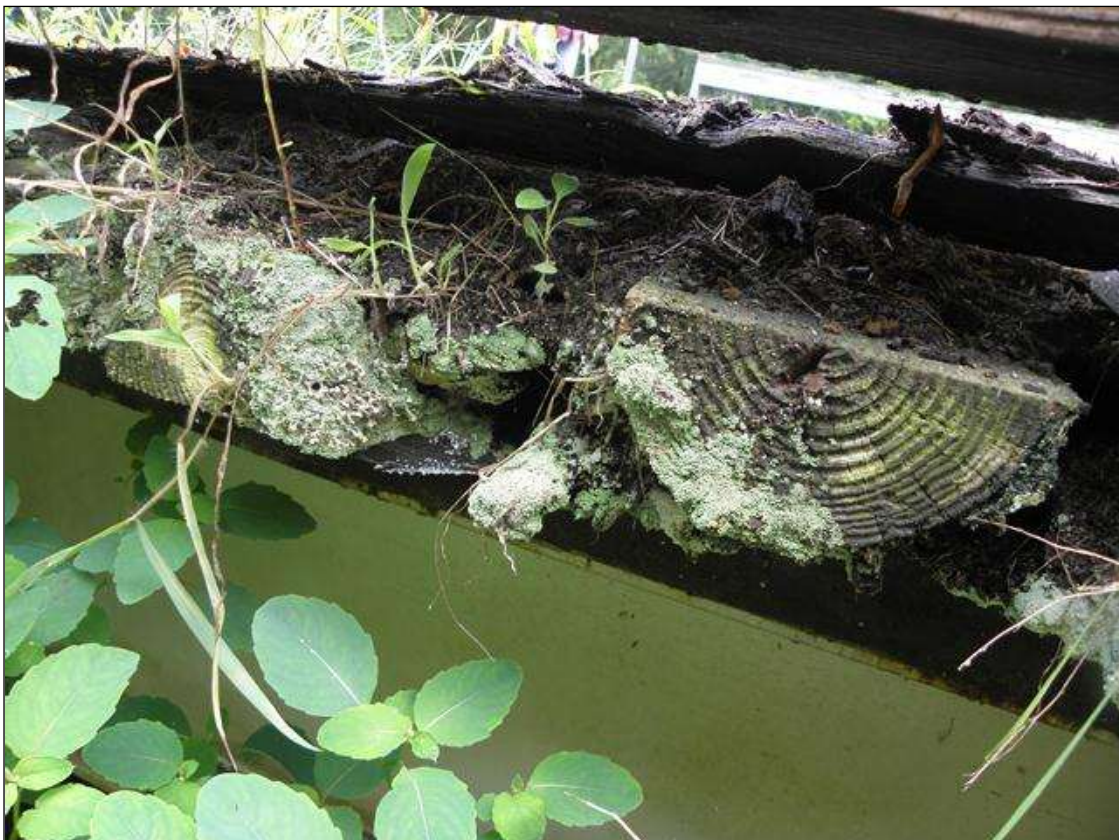
| Bridge I&A Form 1(82)H<br>State of North Carolina<br>Dept. of Transportation<br>Division of Highways | | <b>FIELD INSPECTION REPORT</b><br><u>Bridge Inspeccion &amp; Analysis</u> | |
|---|---|---|--|
| 2b | P | DECKING TIMBERS HAVE DECAY ALONG ENDS UP TO 4" DEEP ALONG BOTH SIDES. TIMBERS WEATHERED AND DISCOLORED ALONG UNDERSIDE DUE TO DRAINAGE THROUGH DECK. NAILERS MOISTURE SOAKED AND CHECKED. DECKING LOOSE AND REBOUNDED UNDER SMALL LOADS. | |

DECAY ON END OF TIMBER DECKING BOARDS THROUGHOUT

| MMS Code | Description of Function | Unit | Quantity | Remarks | Est. Cost |
|---|---|---|---|---|---|
| 3324 | Maint / Repair / Replace Timber Deck Components | SF | 840 | DECKING TIMBER SHOWING DECAY ALONG ENDS | |

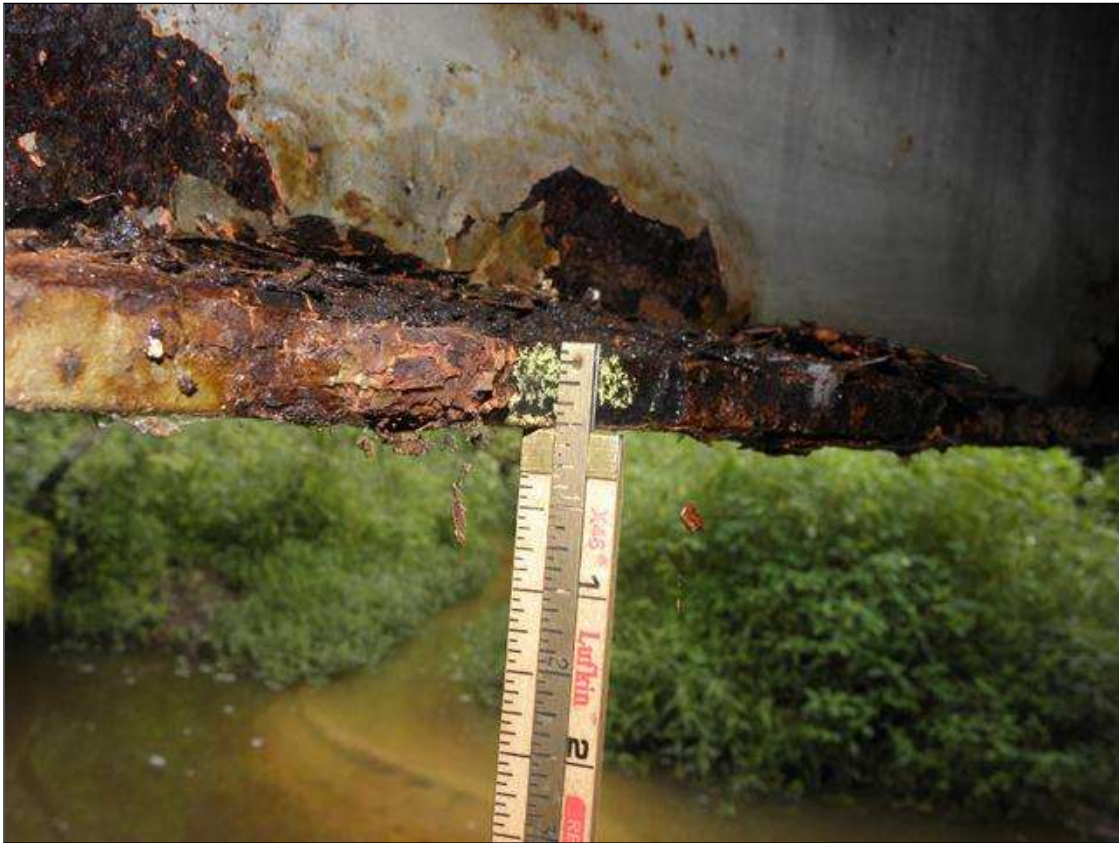
| Bridge I&A Form 1(82)H<br>State of North Carolina<br>Dept. of Transportation<br>Division of Highways | | <b>FIELD INSPECTION REPORT</b><br><u>Bridge Inspeccion &amp; Analysis</u> | |
|---|---|---|--|
| 10 | F | BEAMS SHOWING RUST SCALE ALONG TOP AND BOTTOM FLANGES, AND UP 4"ALONG LOWER WEB SECTIONS. BEAMS HAVE UP TO 1/32"SECTION LOSS TO FLANGE EDGES IN SPOTS. | |

RUST SCALE ON BOTTOM FLANGE OF BEAM 1 WITH NO SECTION LOSS

| MMS Code | Description of Function | Unit | Quantity | Remarks | Est. Cost |
|---|---|---|---|---|---|
| 5603 | Partial Cleaning and Painting of Structural Steel | SF | 300 | BEAMS SHOWING RUST SCALE ALONG TOP AND BOTTOM FLANGES | |

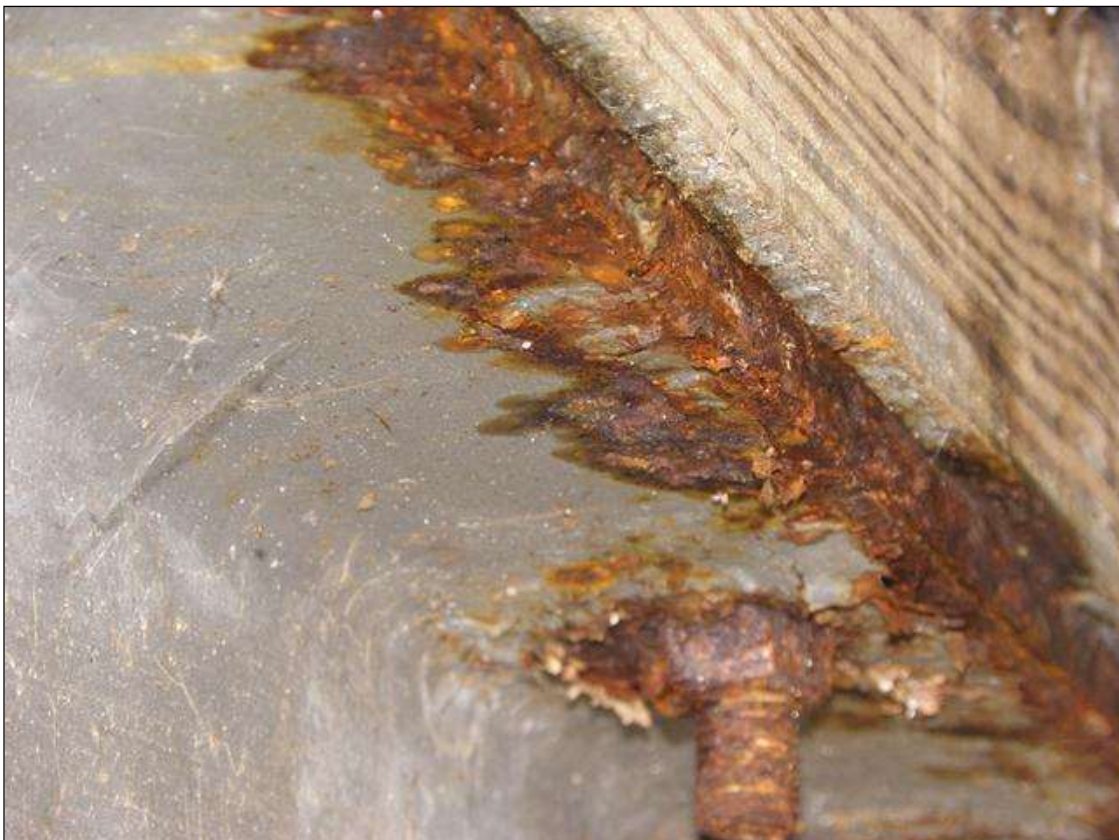
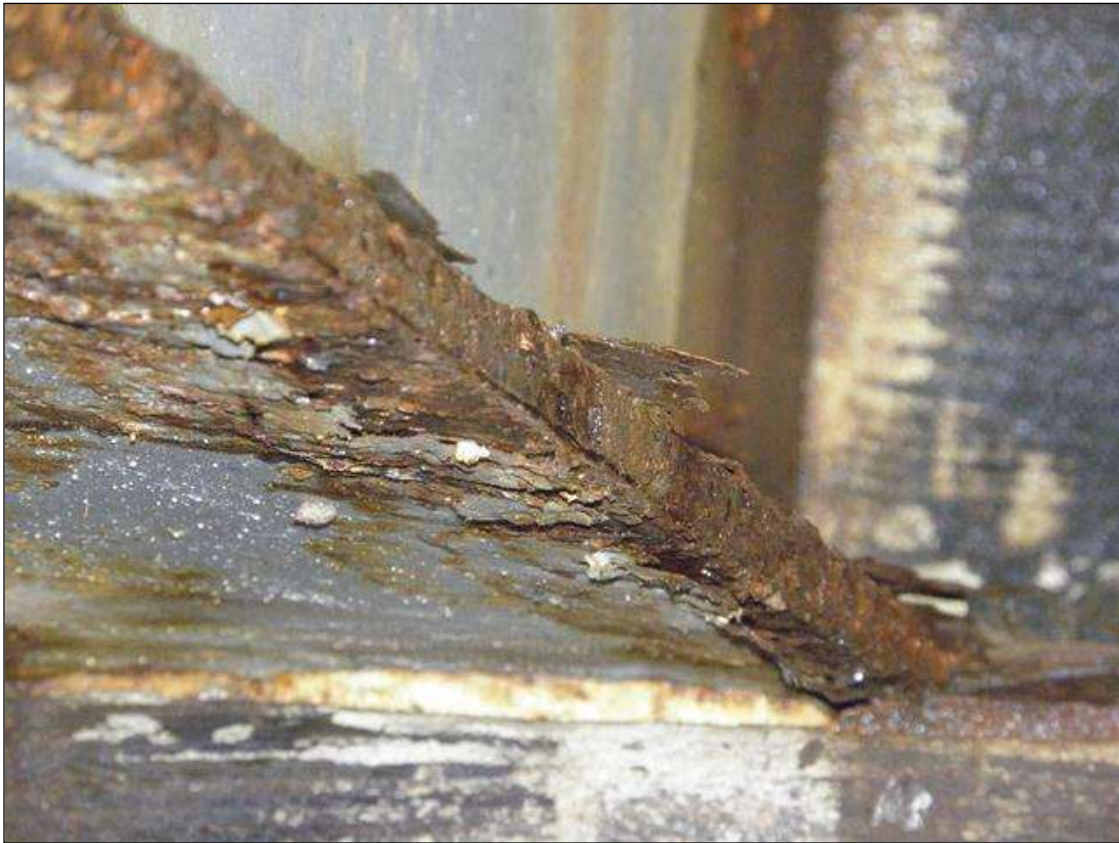
RUST SCALE ON BEAMS THROUGHOUT

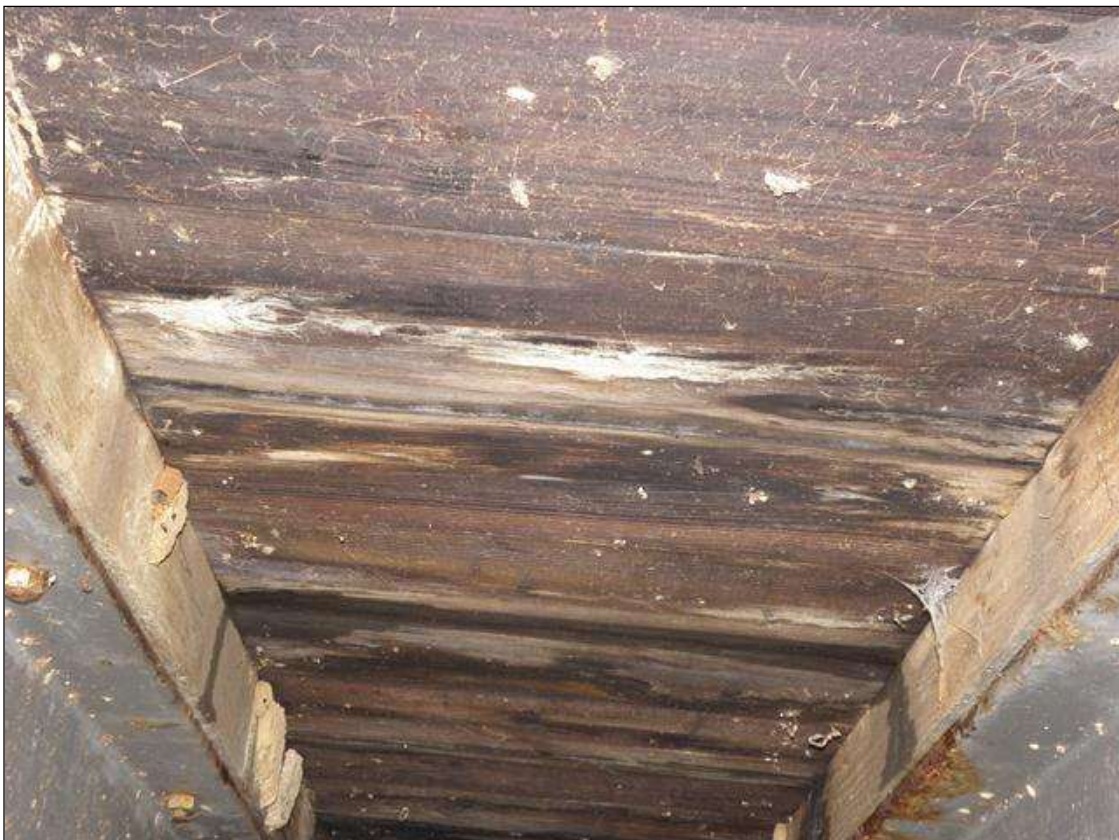
DISCOLORATION ON UNDERSIDE OF DECK

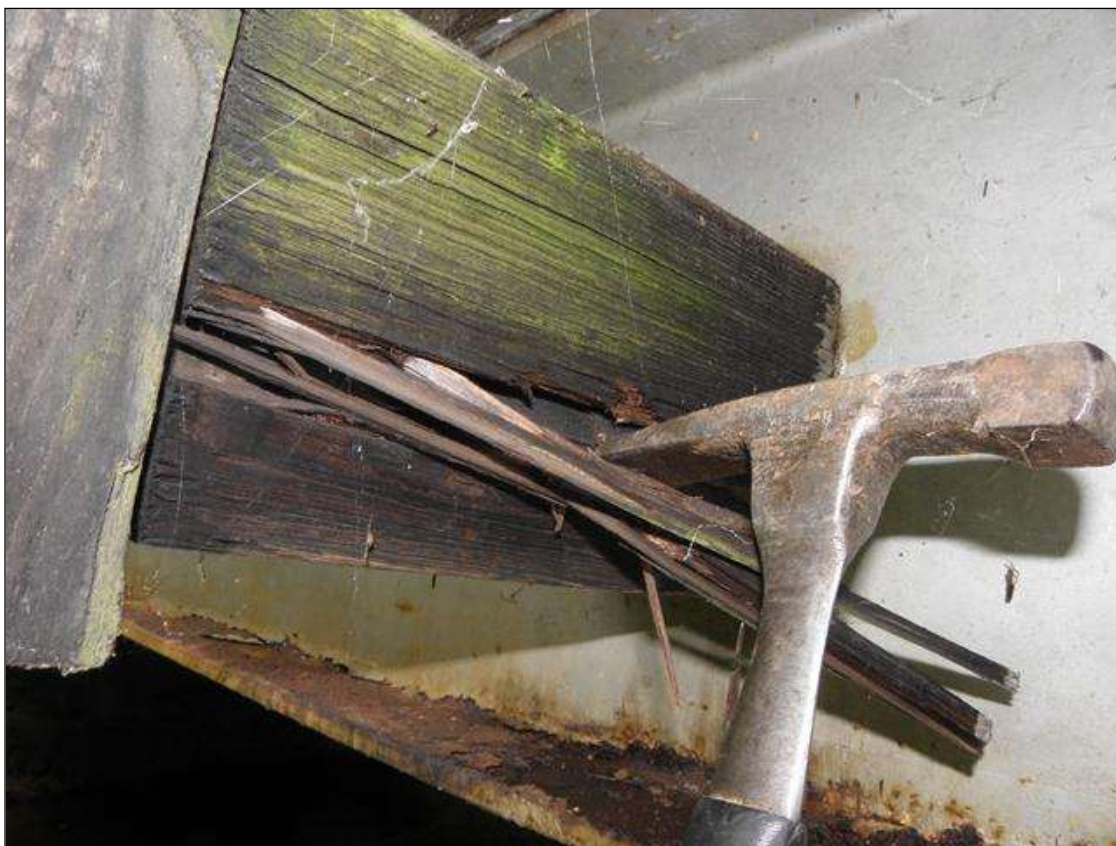
| Bridge I&A Form 1(82)H<br>State of North Carolina<br>Dept. of Transportation<br>Division of Highways | | <b>FIELD INSPECTION REPORT</b><br><u>Bridge Inspeccion &amp; Analysis</u> | |
|---|---|---|--|
| 3b | F | TIMBERS WEATHERED AND CHECKED, TOP BOARDS WARPING AND PULLING NAILS OUT. RAIL SUPPORT BLOCKS CHECKED AND SPLIT. | |

DECAY ON RAIL SUPPORT POST ON EAST SIDE

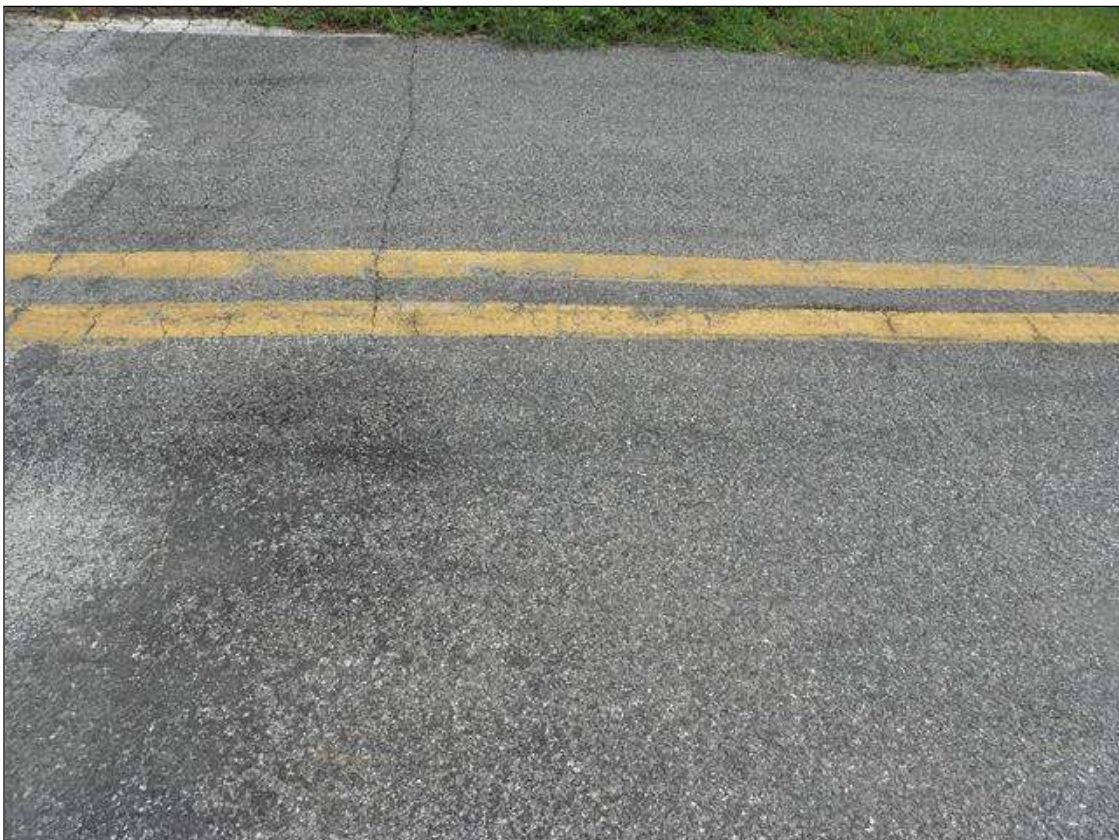
WEAR SURFACE AT END BENT 2

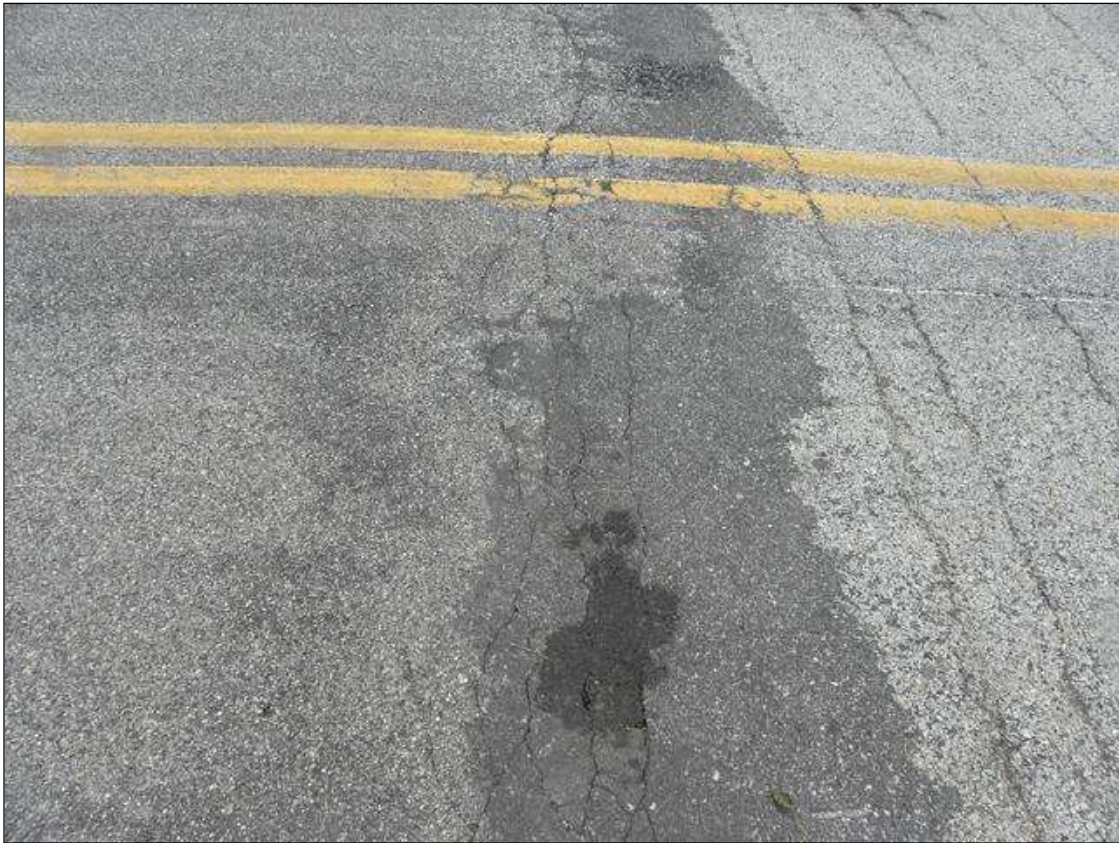
WEAR SURFACE AT END BENT 1

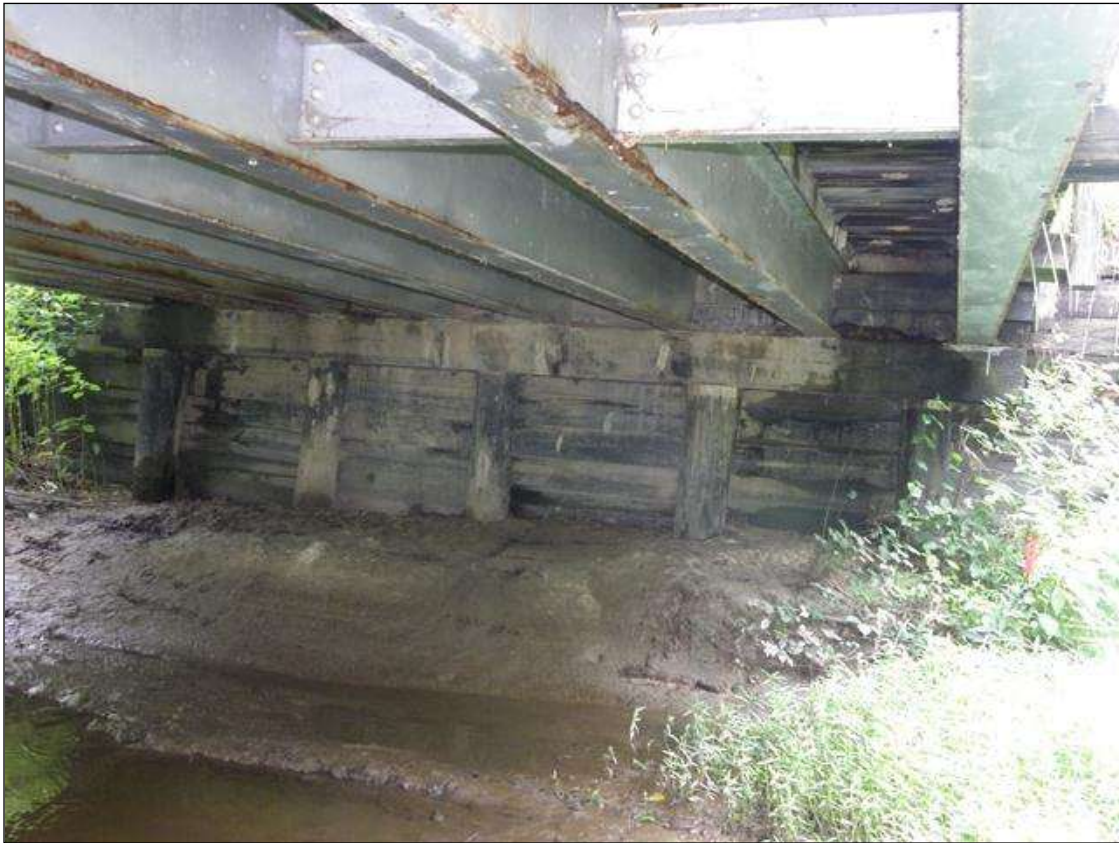
| Bridge I&A Form 1(82)H<br>State of North Carolina<br>Dept. of Transportation<br>Division of Highways | | <b>FIELD INSPECTION REPORT</b><br><u>Bridge Inspeccion &amp; Analysis</u> | |
|---|---|---|--|
| 35c | F | BULKHEAD TIMBERS WEATHERED AND SOFT WITH SCATTERED DECAY AREAS. | |

END BENT 2

| MMS Code | Description of Function | Unit | Quantity | Remarks | Est. Cost |
|---|---|---|---|---|---|
| 3346 | Repair / Maintain Timber Wings & Blkhds | SF | 500 | BULK HEAD TIMBERS HAVE SCATTERED DECAY | |

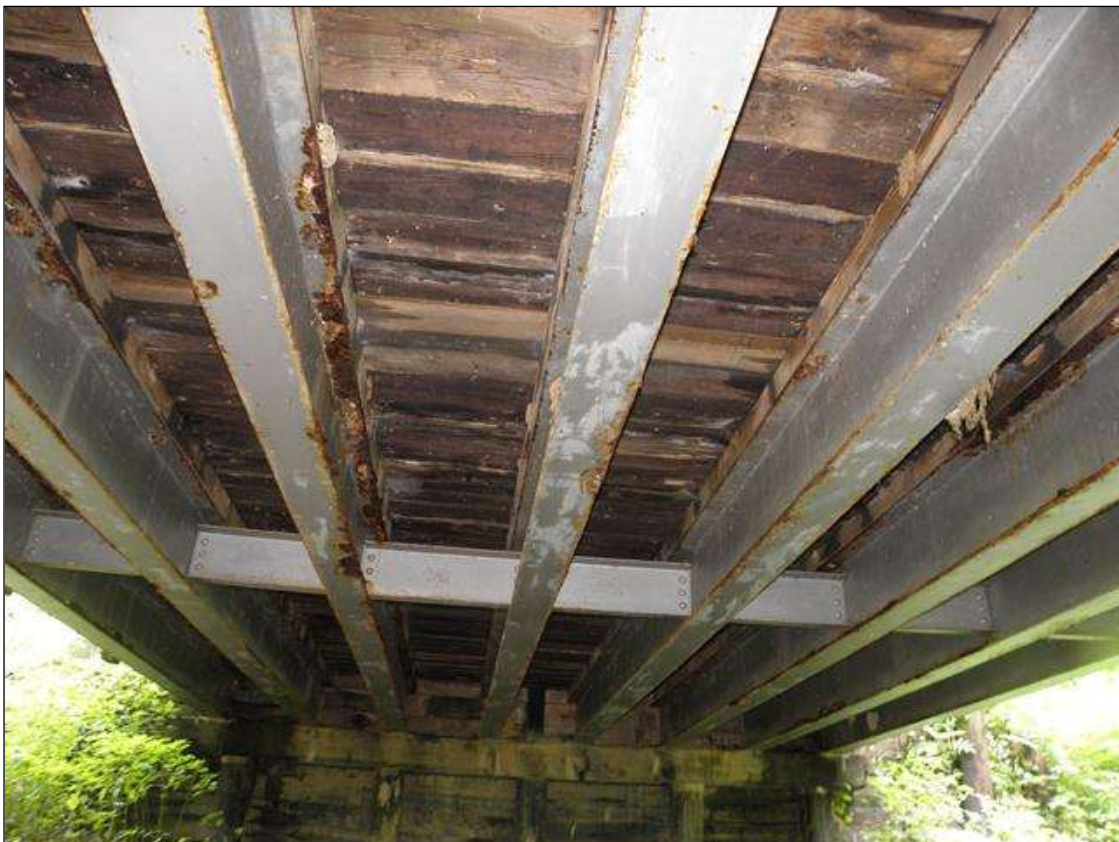
UNDERSIDE OF DECK

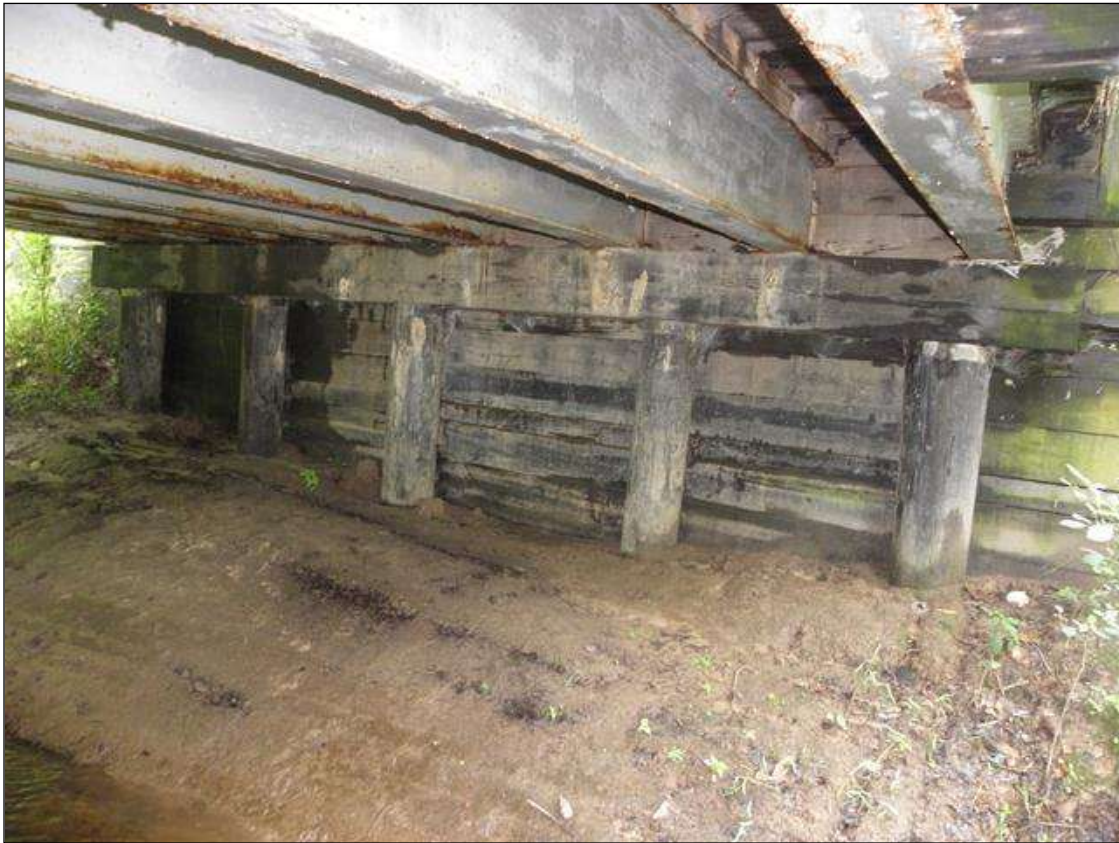
END BENT 1

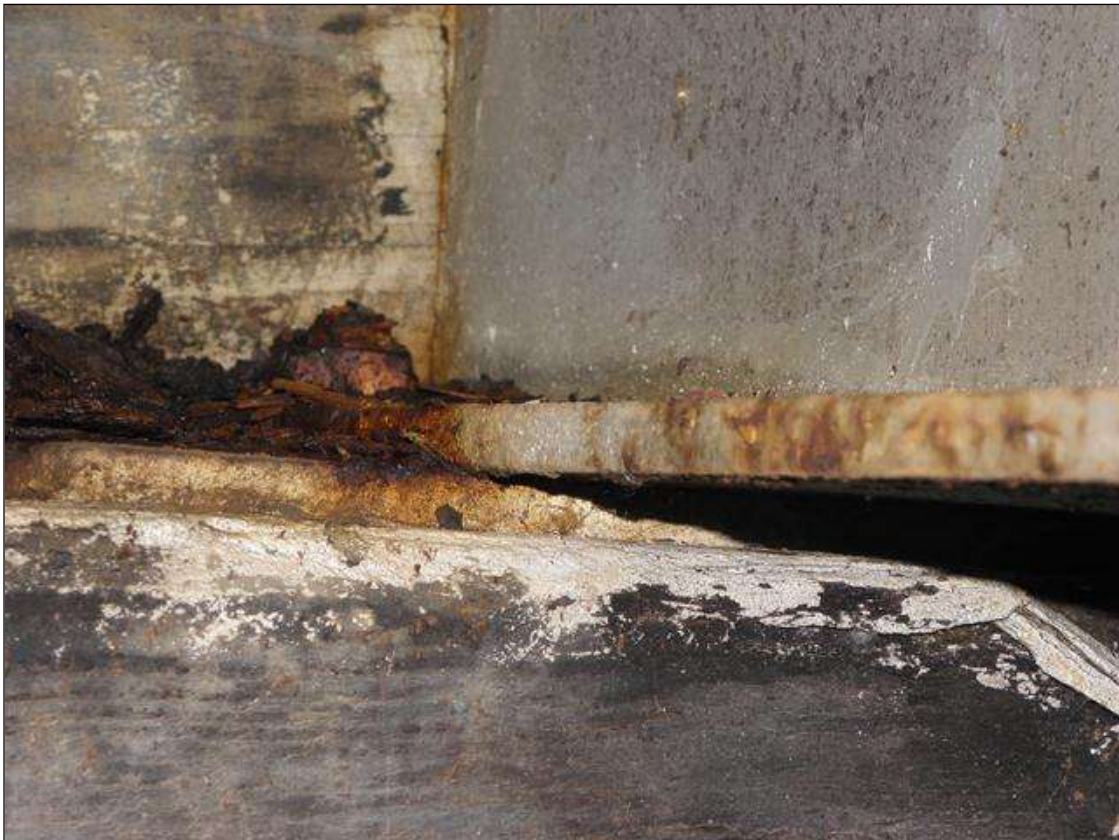
BEARING ON BEAMS
