# BRIDGE INSPECTION REPORT

INSPECTION TYPE: Routine Inspection

COUNTY ROWAN BRIDGE NUMBER 790315 INSPECTION CYCLE 2 YRS  
ROUTE SR1225 ACROSS GRANTS CREEK M.P. 0

SUPERSTRUCTURE TIMBER DECK ON I-BEAMS

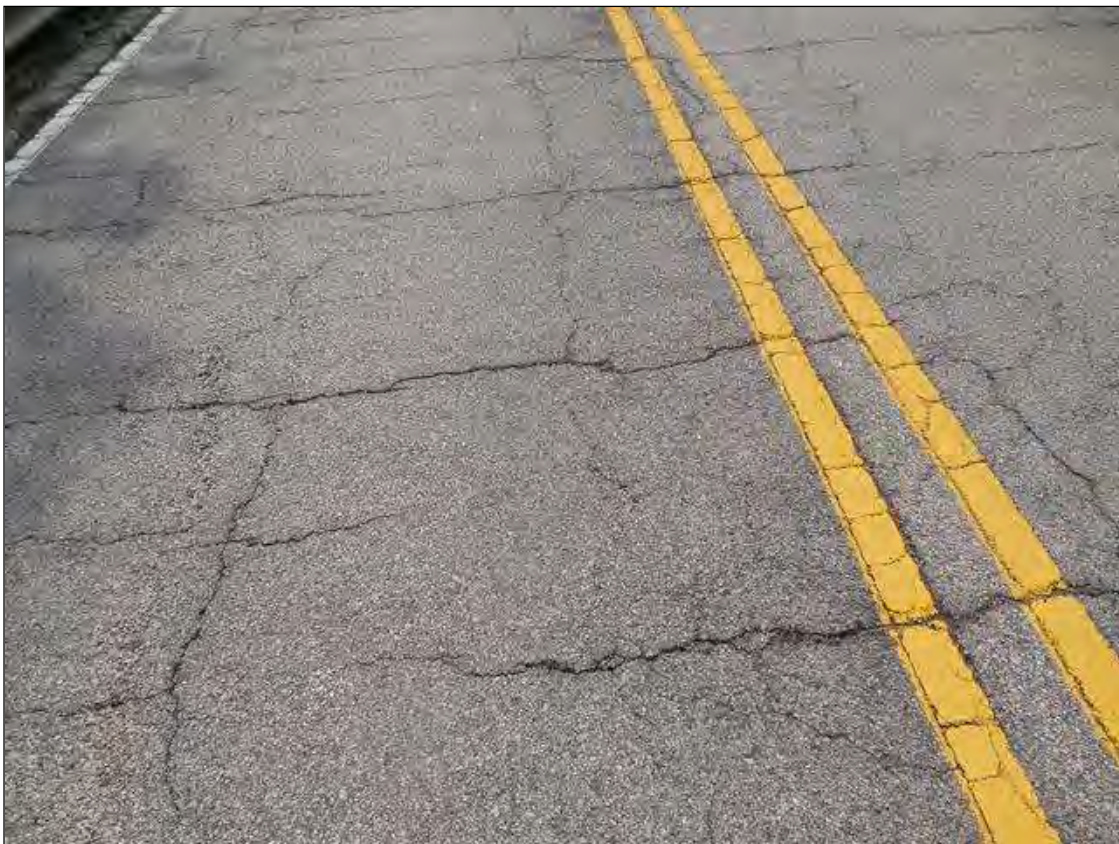
| Bridge I&A Form 1(82)H<br>State of North Carolina<br>Dept. of Transportation<br>Division of Highways | | <b>FIELD INSPECTION REPORT</b><br><u>Bridge Inspection &amp; Analysis</u> | |
|---|---|---|--|
| 1 | F | AWS HAS TRANSVERSE CRACKING AT TIMBER DECKING BOARD JOINTS | |

WEAR SURFACE CRACKING ON DECK AT TIMBER DECKING BOARD JOINTS

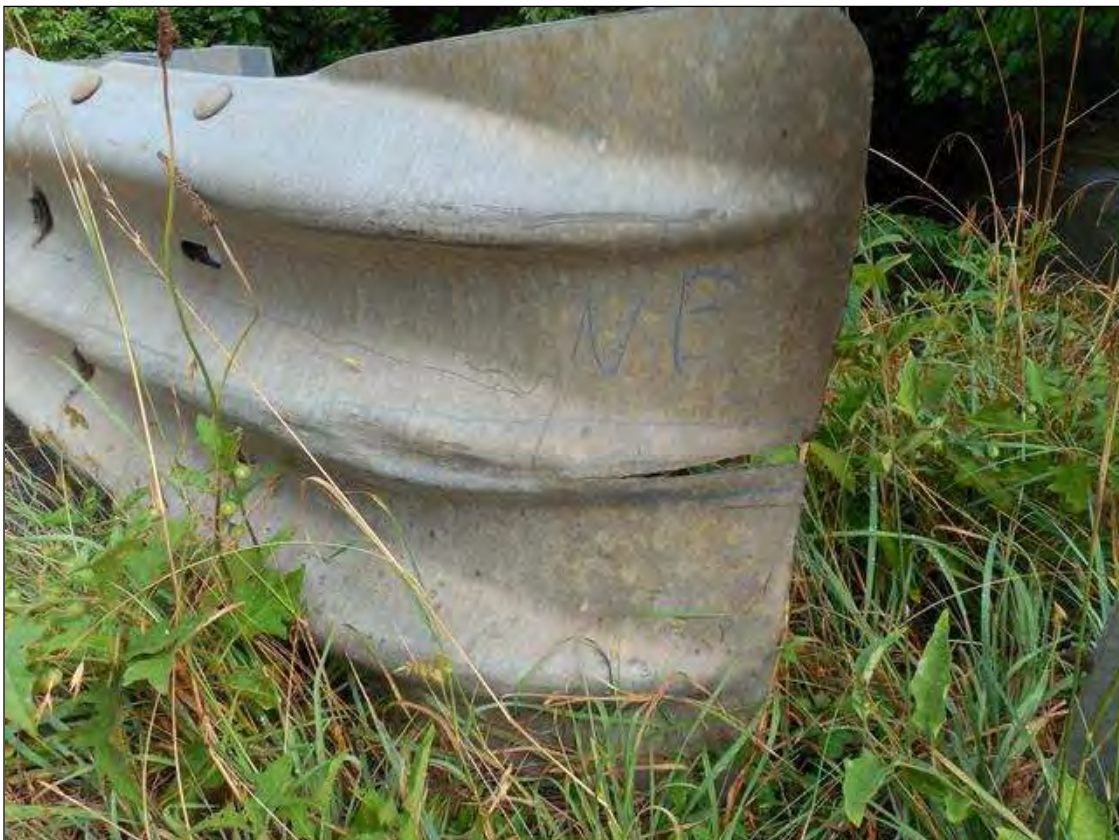
| Bridge I&A Form 1(82)H<br>State of North Carolina<br>Dept. of Transportation<br>Division of Highways | | <b>FIELD INSPECTION REPORT</b><br><u>Bridge Inspection &amp; Analysis</u> | |
|---|---|---|--|
| 3d | G | 6" SPLIT ON RAIL AT NE CORNER | |

NORTHEAST CORNER RAIL HAS A 6" SPLIT

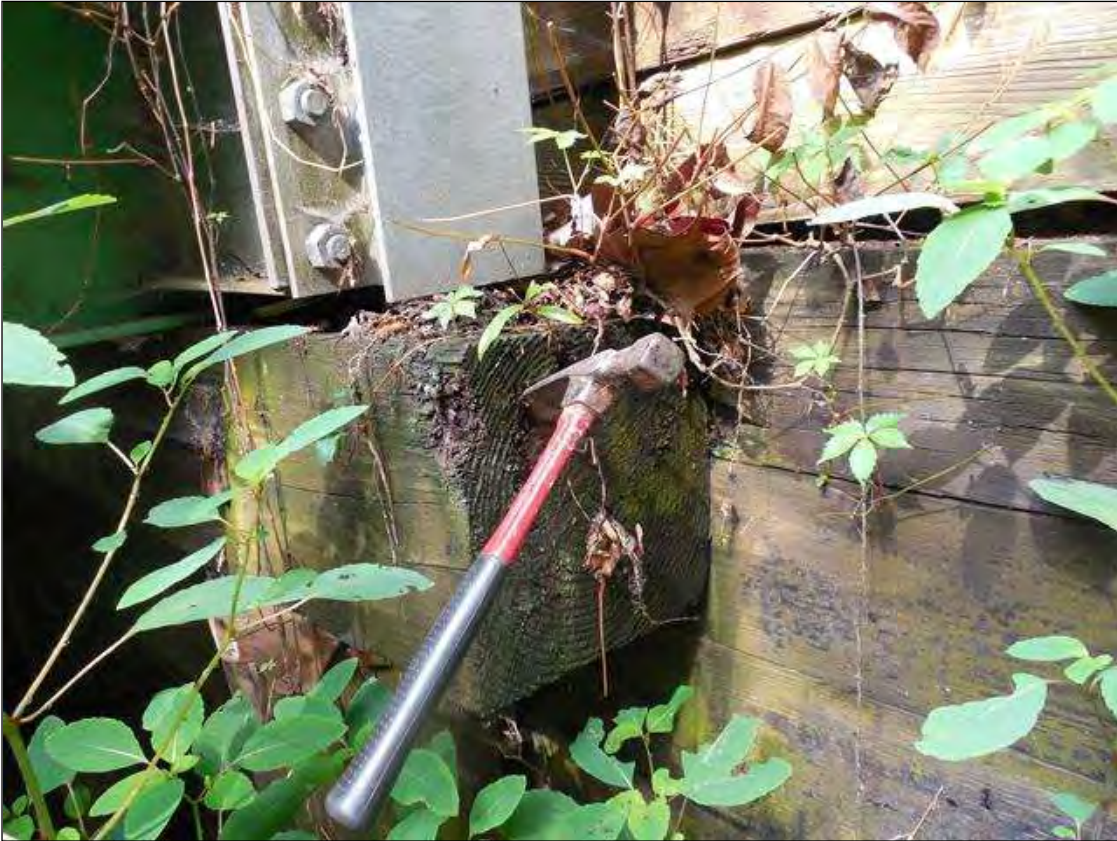
| Bridge I&A Form 1(82)H<br>State of North Carolina<br>Dept. of Transportation<br>Division of Highways | | <b>FIELD INSPECTION REPORT</b><br><u>Bridge Inspection &amp; Analysis</u> | |
|---|---|---|--|
| 35a | F | END BENT 1 HAS 3, 1" DIAMETER DECAY HOLES, UP TO 10"DEEP ON SOUTH END.<br>END BENT 1 HAS AN 1" DIAMETER DECAY HOLE 2" DEEP | |

NORTH END OF END BENT 1 CAP HAS SOFT AREA WITH A 1" WIDE X 2" HIGH X 2" DEEP DECAY AREA

| MMS Code | Description of Function | Unit | Quantity | Remarks | Est. Cost |
|---|---|---|---|---|---|
| 3344 | Repair / Replace Timber Substructure Components | LF | 3 | | |

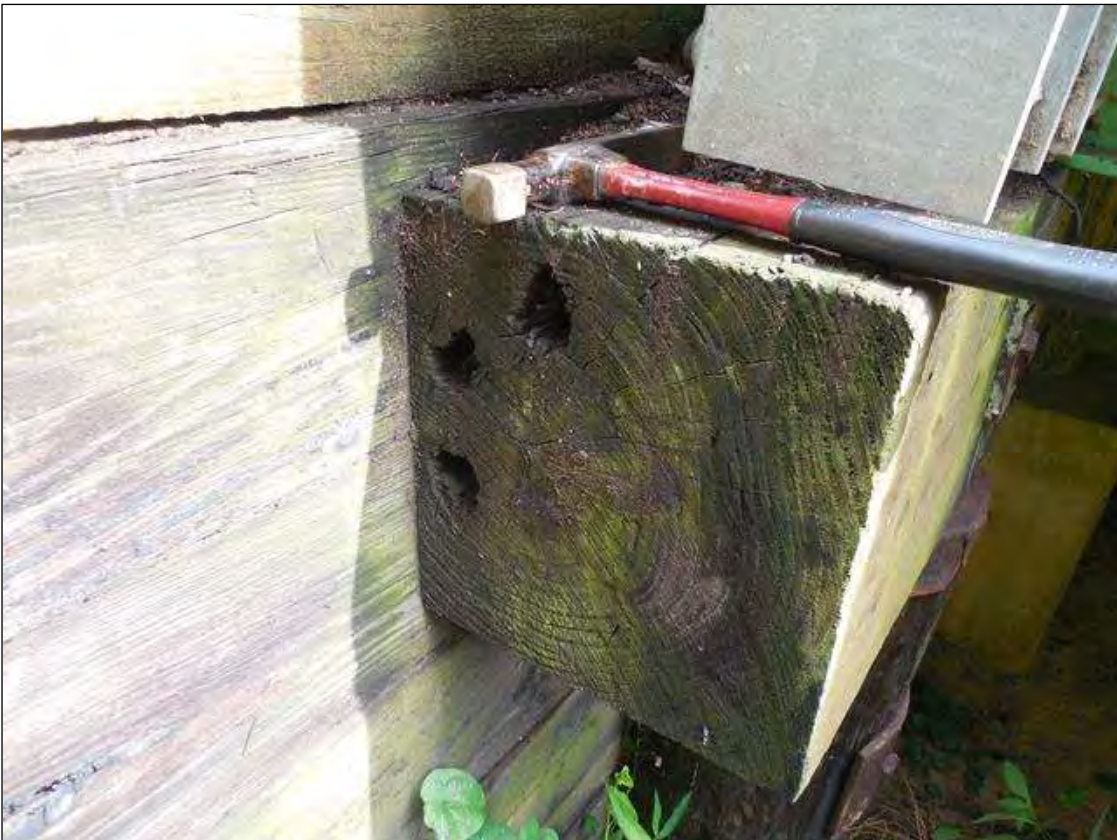
SOUTH END OF END BENT 1 CAP HAS 3 DECAY HOLES 1" DIAMETER UP TO 10" DEEP

| MMS Code | Description of Function | Unit | Quantity | Remarks | Est. Cost |
|---|---|---|---|---|---|
| 3342 | Clean and Paint Structural Steel | SF | 20 | SURFACE RUST ON TOP FLANGES OF BEAMS 6 AND 7 NEAR END BENT 2, AND BOTTM FLANGES AT MID SPAN<br>DECAY ON ENDS OF END BENT 1 CAP,<br>DECAY ON PILE 3 AT END BENT 2 | |

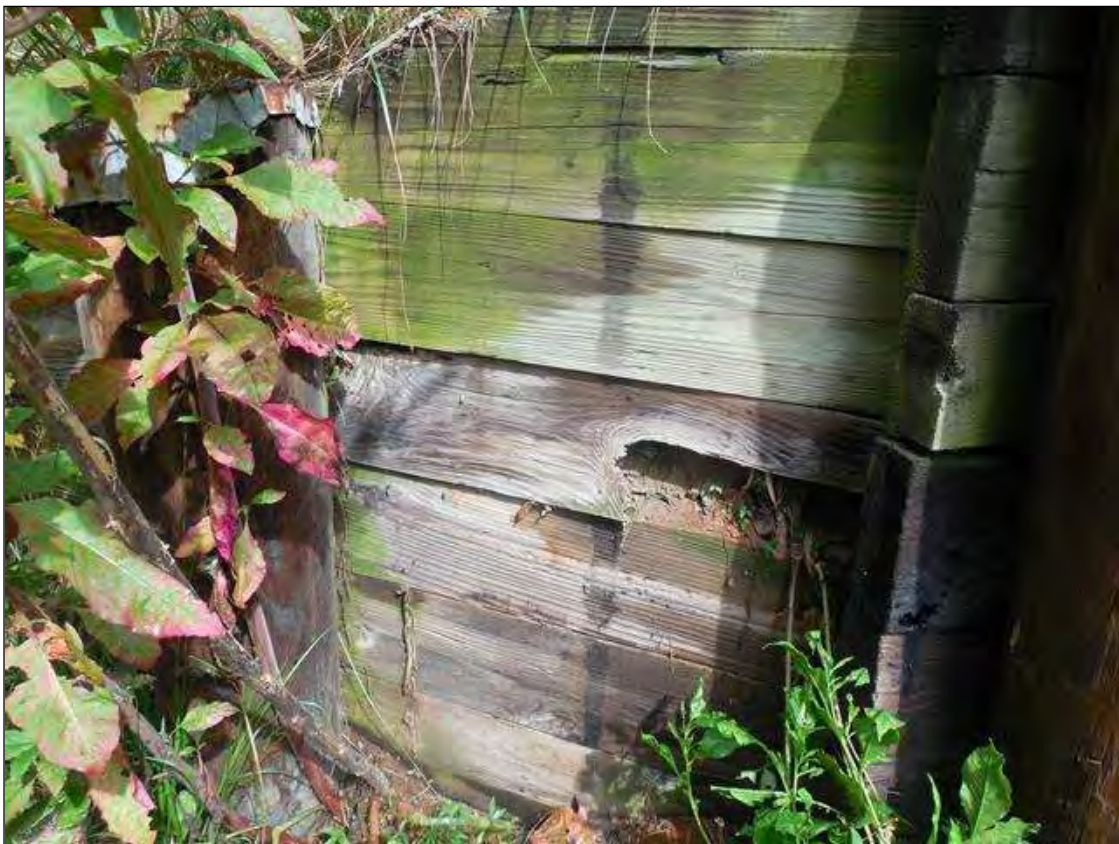
| Bridge I&A Form 1(82)H<br>State of North Carolina<br>Dept. of Transportation<br>Division of Highways | | <b>FIELD INSPECTION REPORT</b><br><u>Bridge Inspection &amp; Analysis</u> | |
|---|---|---|--|
| 35c | F | DECAY ON BULKHEADS AT WINGS WITH FILL EXPOSED | |

WING WALL DECAYED AT END BENT 1 SOUTHWEST CORNER

| MMS Code | Description of Function | Unit | Quantity | Remarks | Est. Cost |
|---|---|---|---|---|---|
| 3346 | Repair / Maintain Timber Wings & Blkhds | SF | 160 | | |

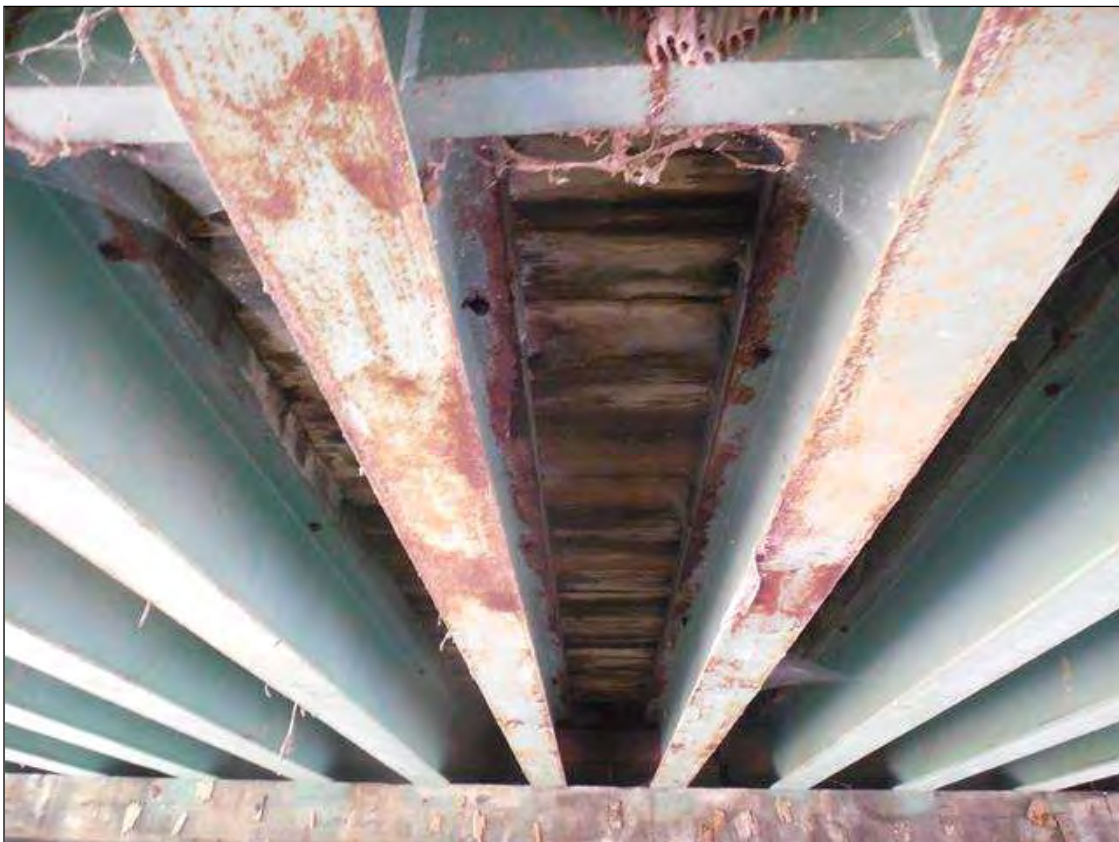
| Bridge I&A Form 1(82)H<br>State of North Carolina<br>Dept. of Transportation<br>Division of Highways | | <b>FIELD INSPECTION REPORT</b><br><u>Bridge Inspection &amp; Analysis</u> | |
|---|---|---|--|
| 10 | G | SURFACE RUST ON BOTTOM FLANGE OF BEAMS 6 AND 7 MID SPAN<br>SURFACE RUST ON TOP FLANGE OF BEAMS 6 AND 7 AT END BENT 2 | |

SURFACE RUST ON BOTTOM FLANGE OF BEAMS 6 AND 7 MID SPAN

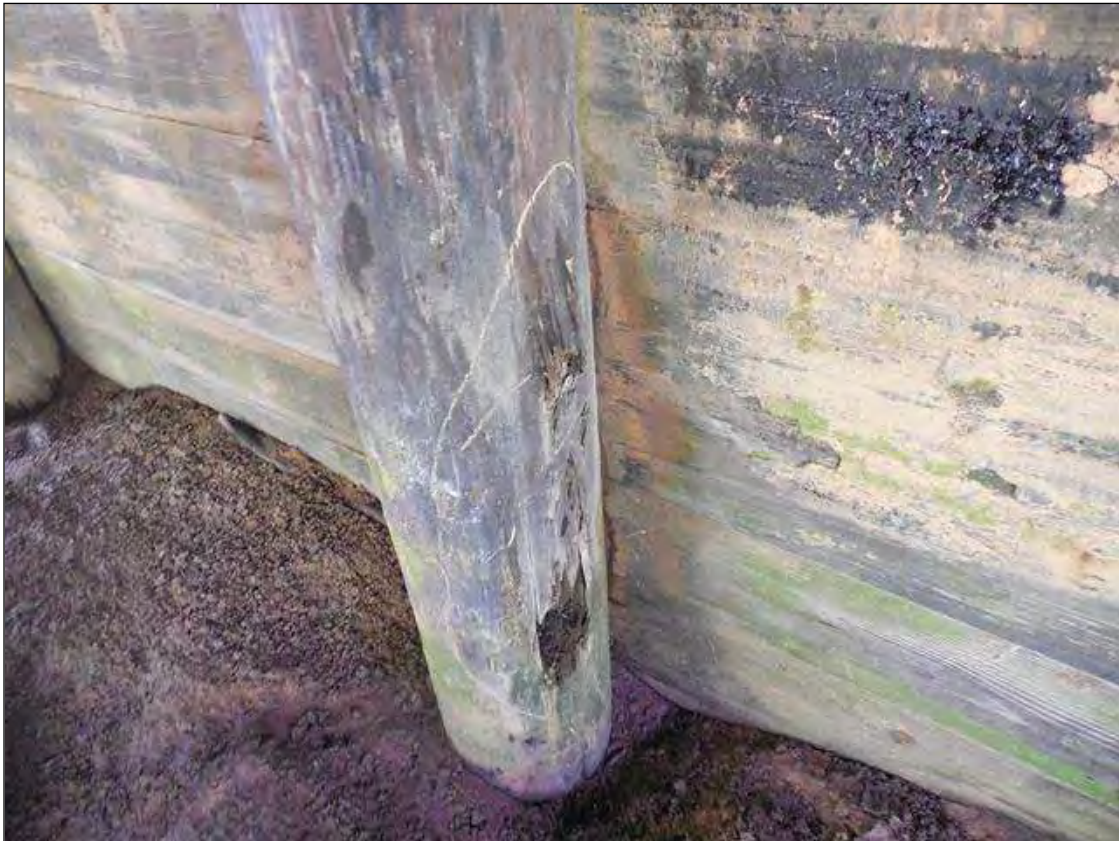
| Bridge I&A Form 1(82)H<br>State of North Carolina<br>Dept. of Transportation<br>Division of Highways | | <b>FIELD INSPECTION REPORT</b><br><u>Bridge Inspection &amp; Analysis</u> | |
|---|---|---|--|
| 35b | F | TIMBERS WEATHERED AND CHECKED WITH DELAM AROUND CHECK CRACKS.<br>END BENT 2 PILE 3 DECAY 24IN HIGH X 10IN WIDE X 2IN DEEP.<br>PILES 3 AND 4 AT END BENT 1 HAVE BEEN TEMPORARY SHORED UP WITH<br>ENCASED CONCRETE | |

PILE 3 AT END BENT 2 HAS DECAY AREA 24" X 10" HIGH X 2" DEEP

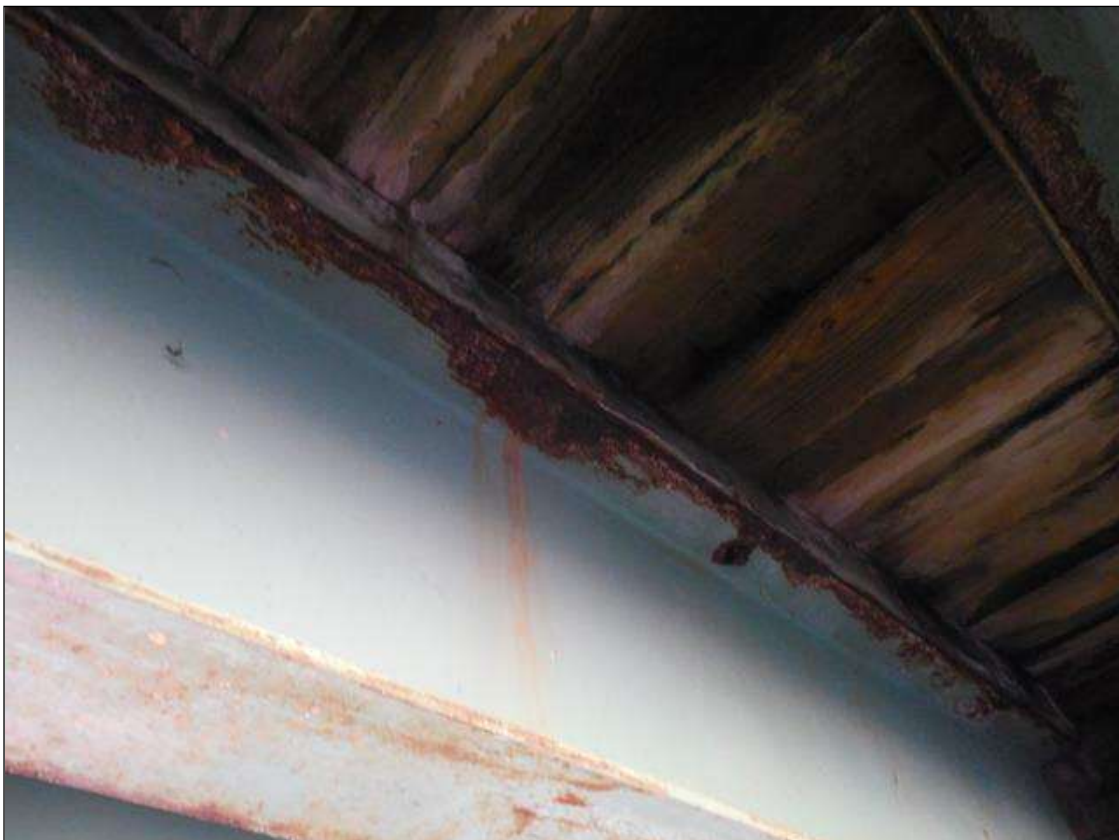
SURFACE RUST ON TOP FLANGE OF BEAMS 6 AND 7 NEAR END BENT 2

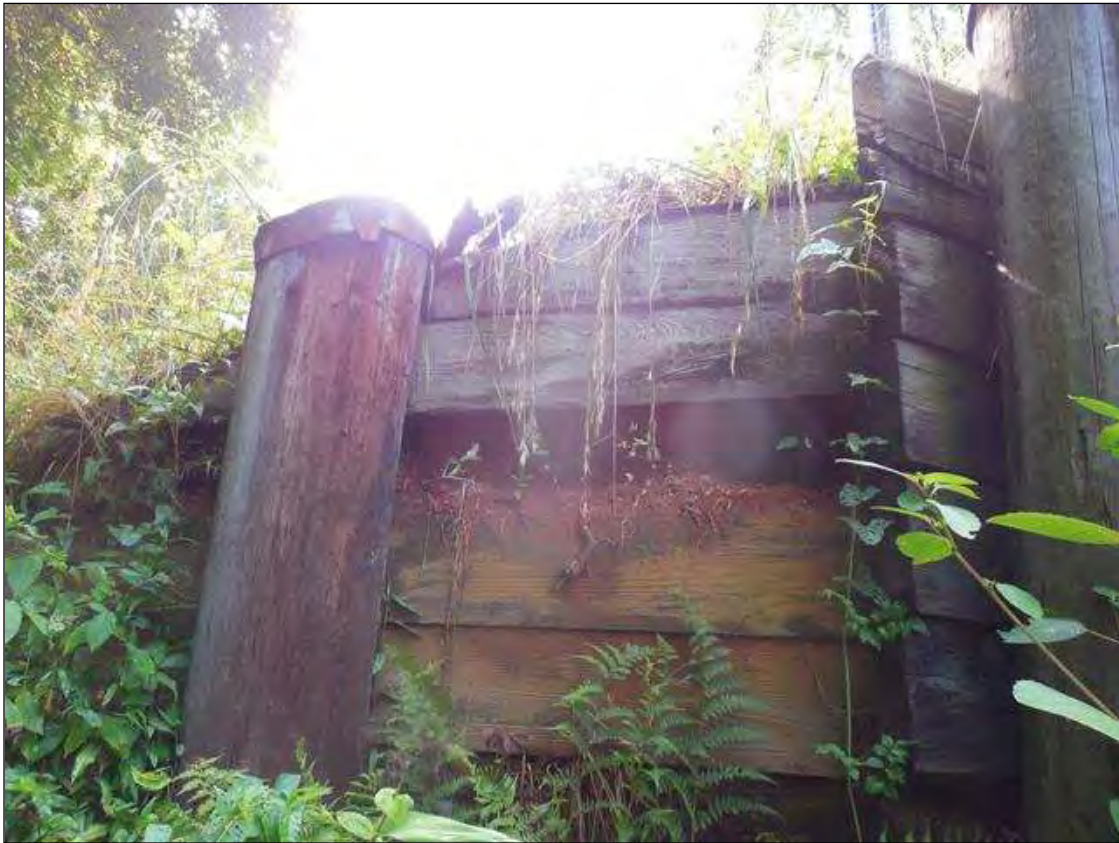
WING WALL DECAY AT NORTHEAST CORNER WITH FILL EXPOSED

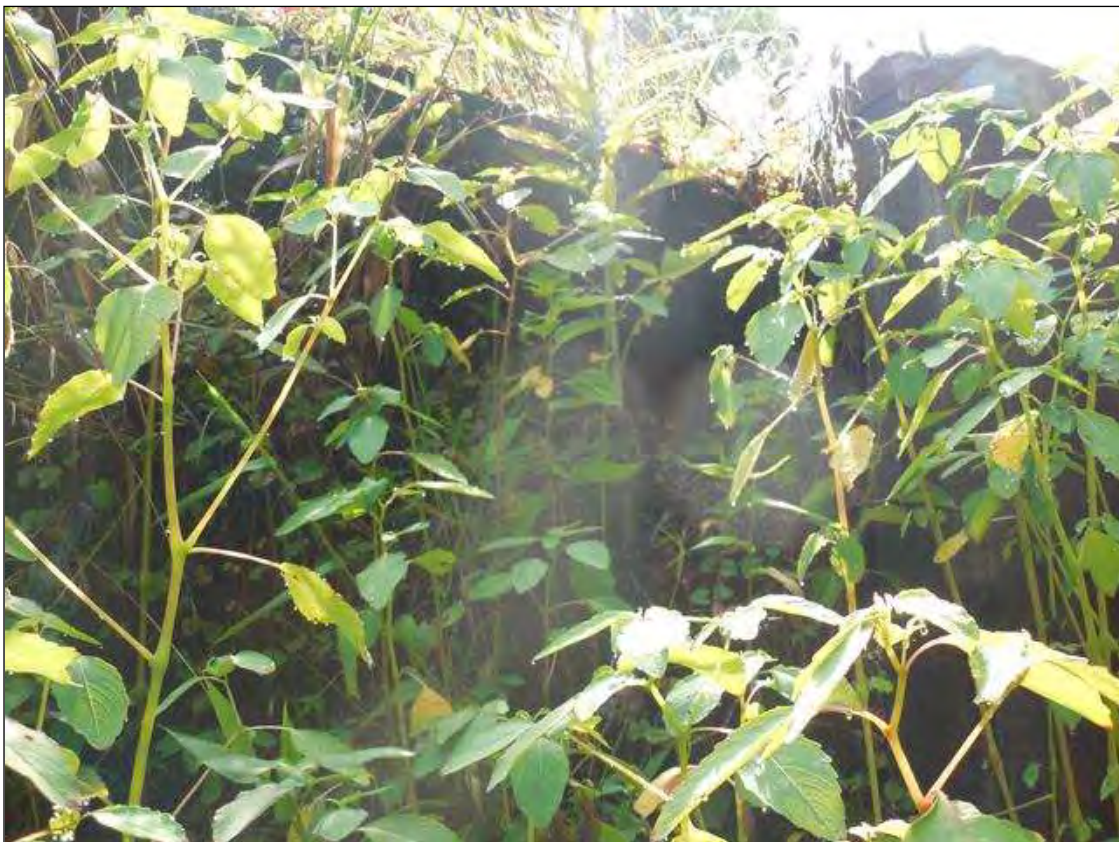
SOUTHWEST WING DECAYED WITH FILL EXPOSED

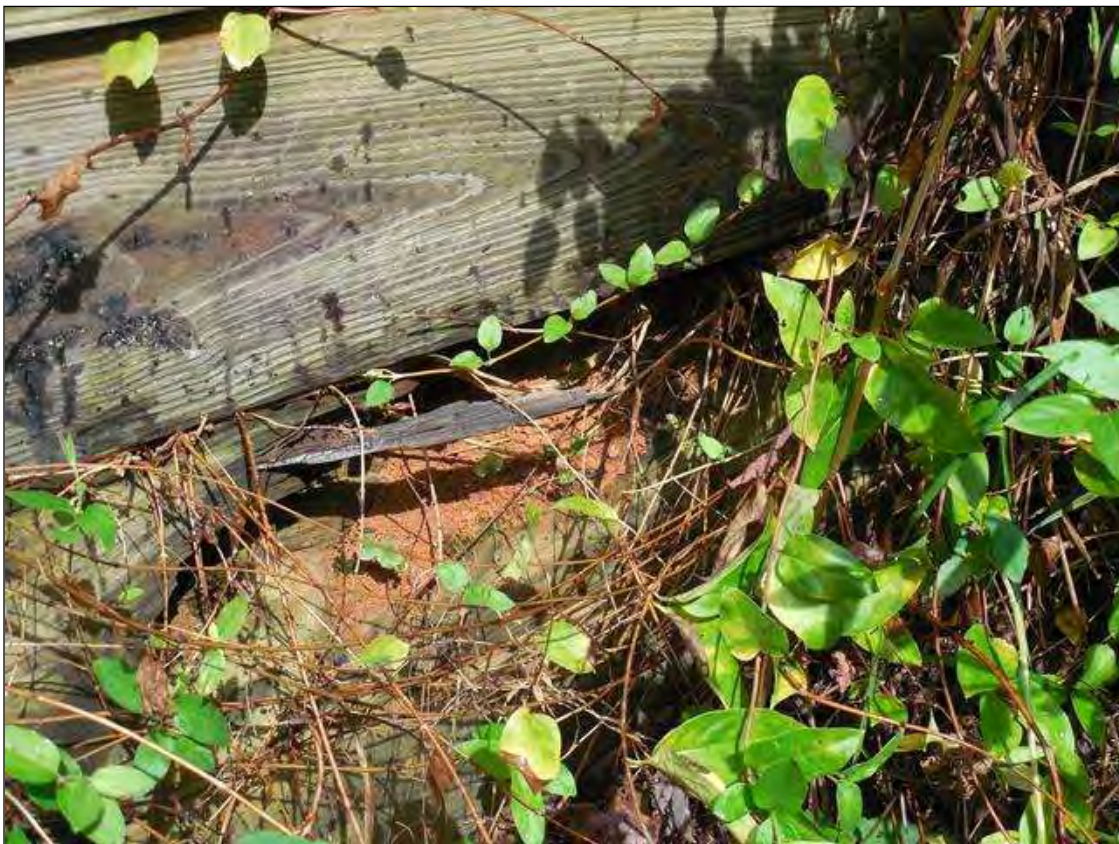
NORTHEAST WING DECAYED WITH FILL EXPOSED
