**NO NATIONAL REGISTER OF HISTORIC PLACES  
ELIGIBLE OR LISTED ARCHAEOLOGICAL SITES  
PRESENT FORM**

Project No: B-5700 County: Cumberland  
WBS No: 45654.1.1 Document: Minimum Criteria Checklist  
F.A. No: Funding: ☒ State ☐ Federal

**Project Description:** Replace Bridge 45 on SR 2030 (Hollow Bridge Rd.) over the South River in Cumberland and Sampson Counties. The Area of Potential Effects (A.P.E.) is approximately 183 meters (600 ft.) long and 46 meters (150 ft.) wide. This A.P.E. includes the area within 92 meters (300 ft.) from each end of the bridge and 23 meters (75 ft.) from centerline on each side of the road. No design plans were provided.

## **Archaeological Survey for the Proposed Replacement of Bridge No. 45 on SR 2030 (Hollow Bridge Road) over the South River, Cumberland County, North Carolina**

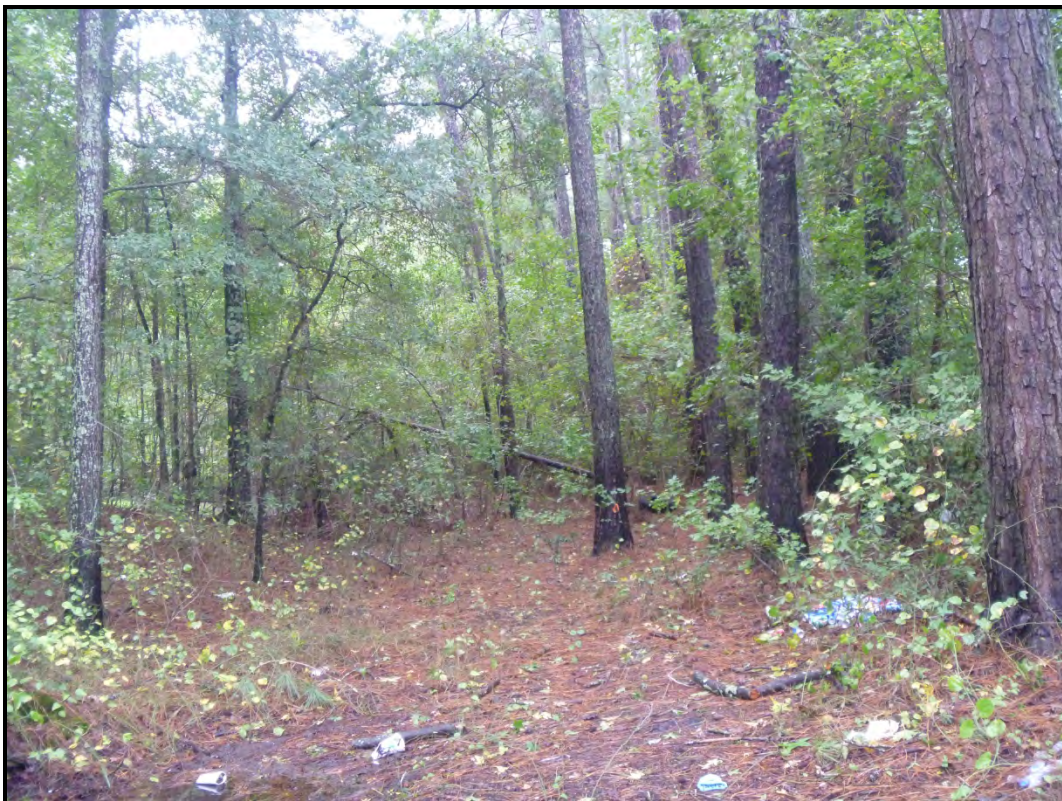
The southwest quadrant of the APE was wooded (mixed pine and hardwood), with evidence of modern surface disturbance from roadside trash dumping (see **Figure 9**). Surface visibility in this portion of the APE was poor due to groundcover; a general visual inspection of this portion of the APE revealed no surface artifacts or evidence of historic or prehistoric cultural activity. Three shovel tests (see **Figure 3**) were excavated in this portion of the APE (Shovel tests [STs] 1–3).

**Figure 9: Southwest Quadrant of APE, facing South.**

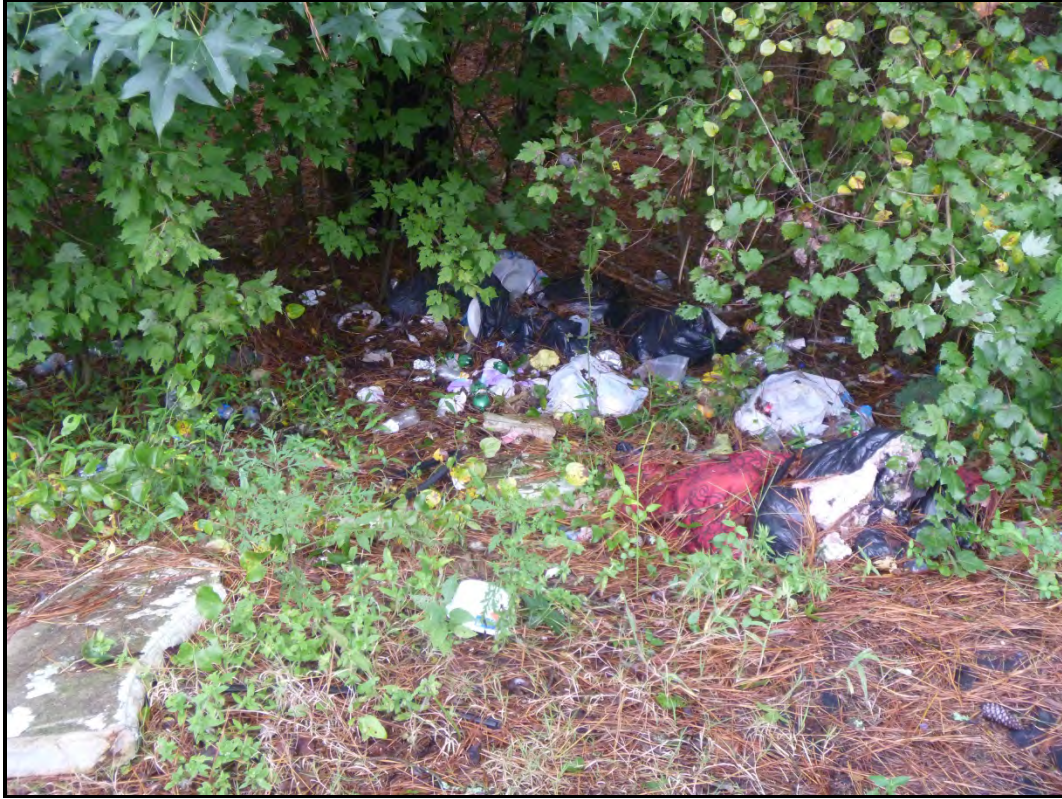
The majority of the southeast quadrant of the APE was wooded. Surface visibility in this quadrant was poor due to ground cover; however, a general visual inspection of this portion of the APE was undertaken to look for above ground structural remains, surface artifacts, or other evidence of past cultural activity. No surface artifacts or other signs of historic cultural activity were noted; however, modern trash piles (primarily aluminum cans and plastic bottles) littered the side of the paved road (see **Figures 10 and 11**). Although the soils in this portion of the APE are mapped as moderately well drained, several areas of standing water were observed just outside of the APE boundaries (**Figure 12**).

**Figure 11: Modern Trash Dumping within the Southeast Quadrant of the APE, facing East.**

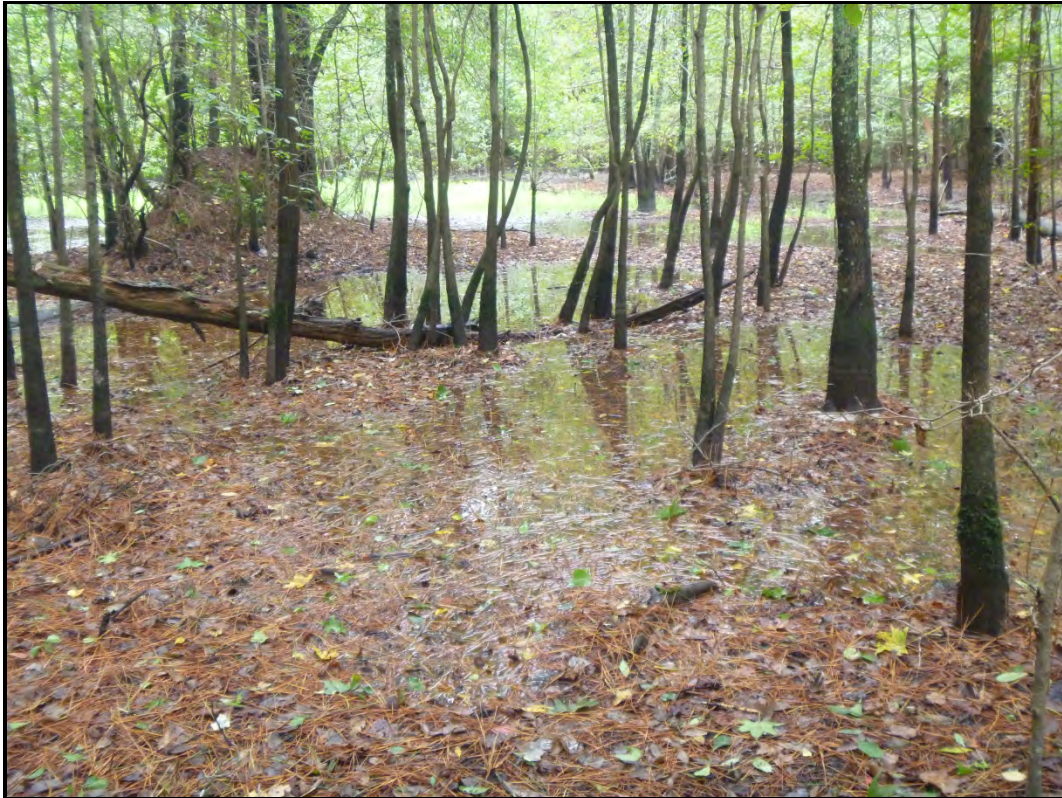
**Figure 12: Standing Water Adjacent to the Southeast Quadrant of the APE, facing East.**

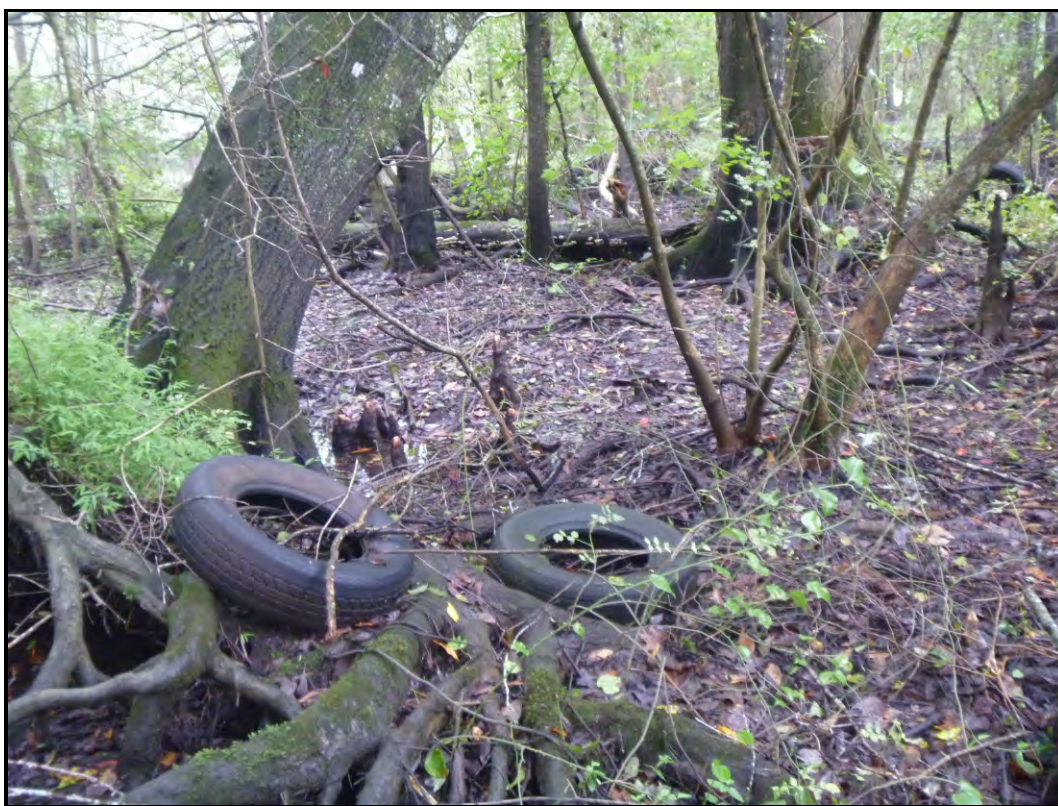
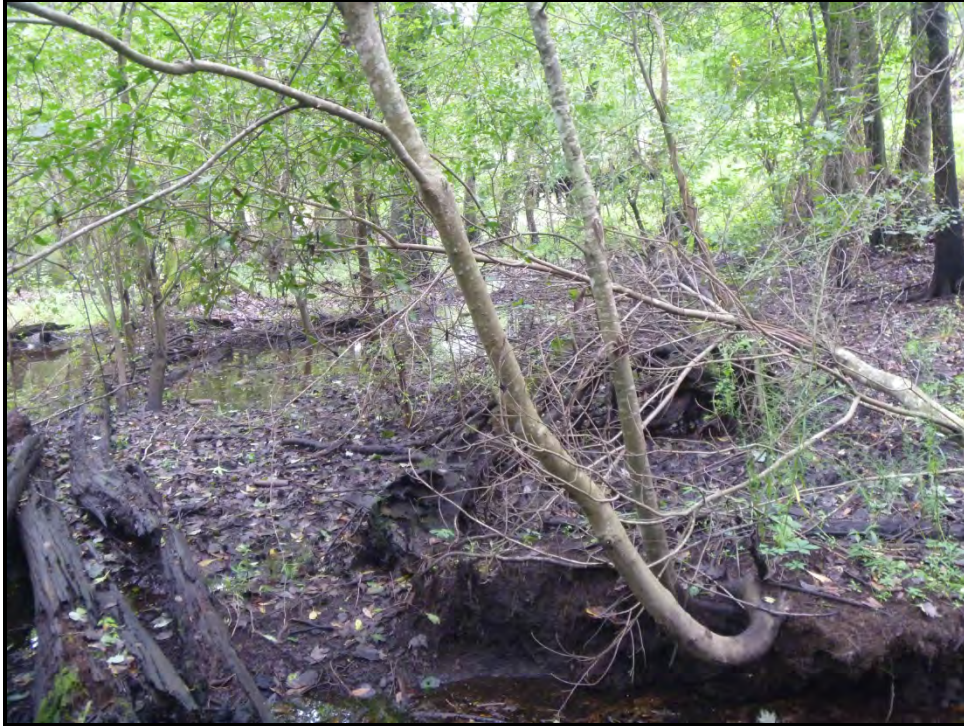
The northeast quadrant of the APE was very poorly drained, with standing water observed during the investigation (**Figures 13 and 14**). Surface visibility in this portion of the APE was poor due to standing water, vegetation, or flood-deposited organic debris; however, a general visual inspection of this portion of the APE revealed no surface artifacts or evidence of historic or prehistoric cultural activity. No shovel tests were excavated in this portion of the APE.

**Figure 13: Northeast Quadrant of the APE, facing South.**

**Figure 14: Standing Water in the Northeast Quadrant of the APE, facing Southeast.**

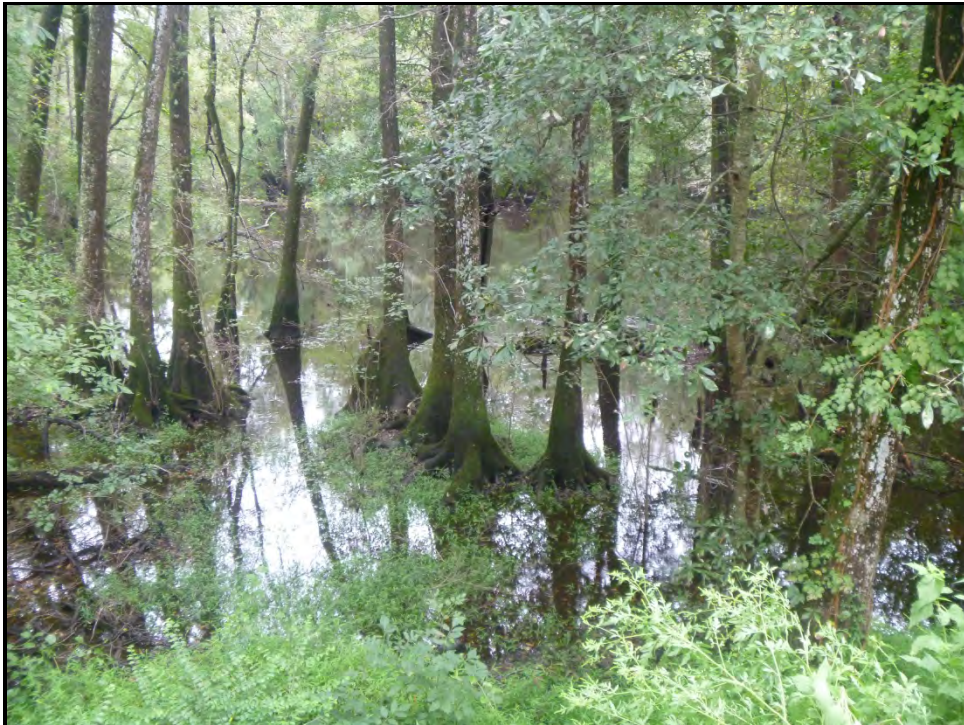
Like the northeast quadrant of the APE, the northwest quadrant was very poorly drained, with standing water observed across the majority of the APE during the investigation (**Figure 15**). Surface visibility in this portion of the APE was poor due to standing water, vegetation, or flood-deposited organic debris; however, a general visual inspection of this portion of the APE revealed no surface artifacts or evidence of historic or prehistoric cultural activity. No shovel tests were excavated in this portion of the APE.

**Figure 15: Standing Water in the Northwest Quadrant of the APE, facing West.**
