# Bridge and Approach Investigation Checklist

Project 17BP.11.R.118  
Description Bridge 136  
Route SR 1533  
Division 11  
County Watauga

**17BP.11.R.118**

Bridge 136 on SR 1533 Watauga Co.

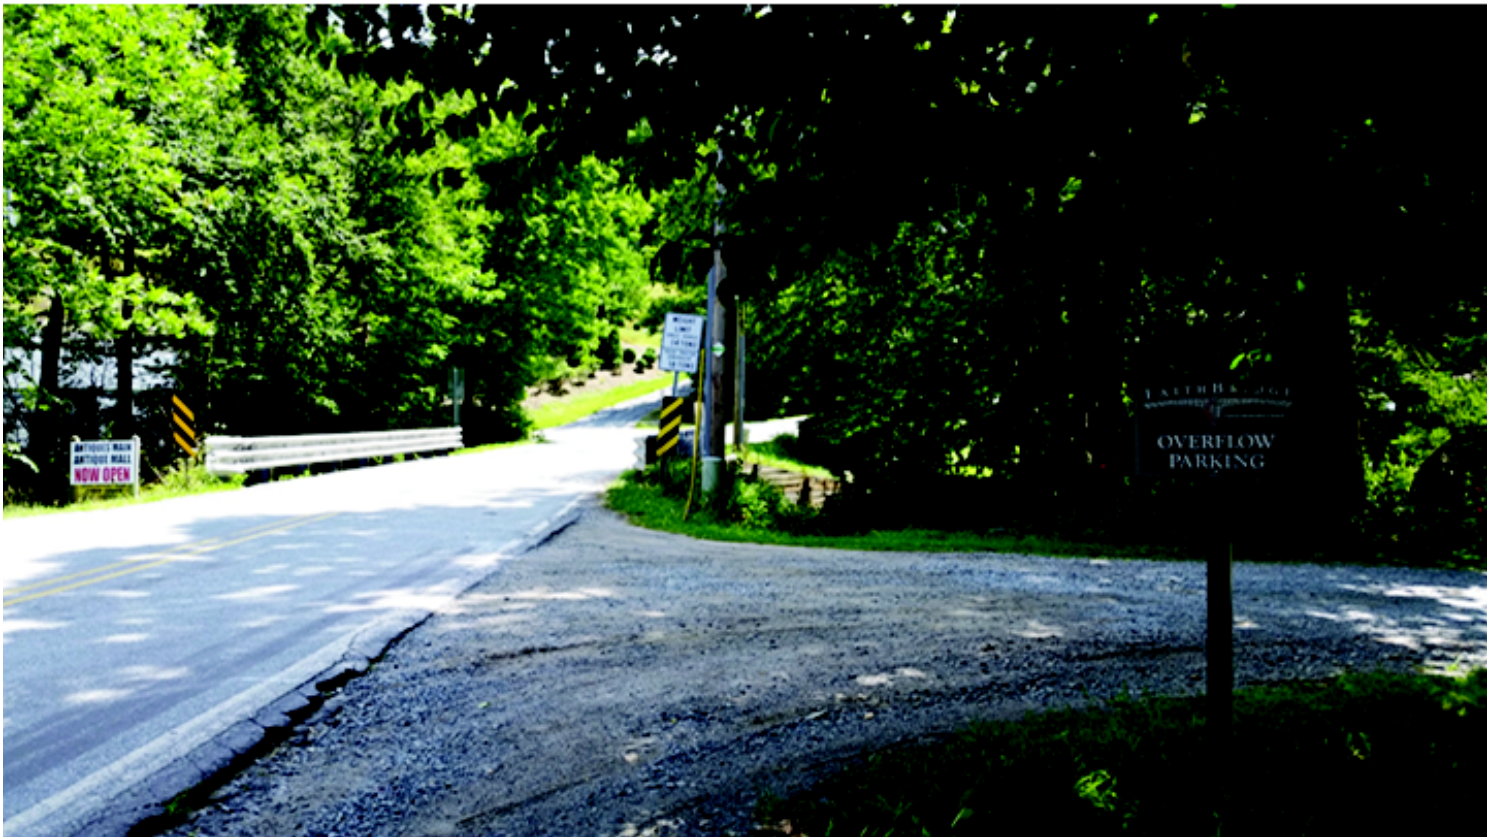
Faith Bridge church has overflow parking across the stream from the main campus and utilizes the bridge to walk to and from the parking lot.

Relation of church parking drive to bridge
