# Hydraulics Unit Pre-Design Report (Pre-Scoping) for Structure #: 100536

PREDESIGN-SCOPING REPORT

Bridge# 100536  
Road# SR 1296 ✓ Brooks Branch Rd  
Stream Newfound Creek ✓

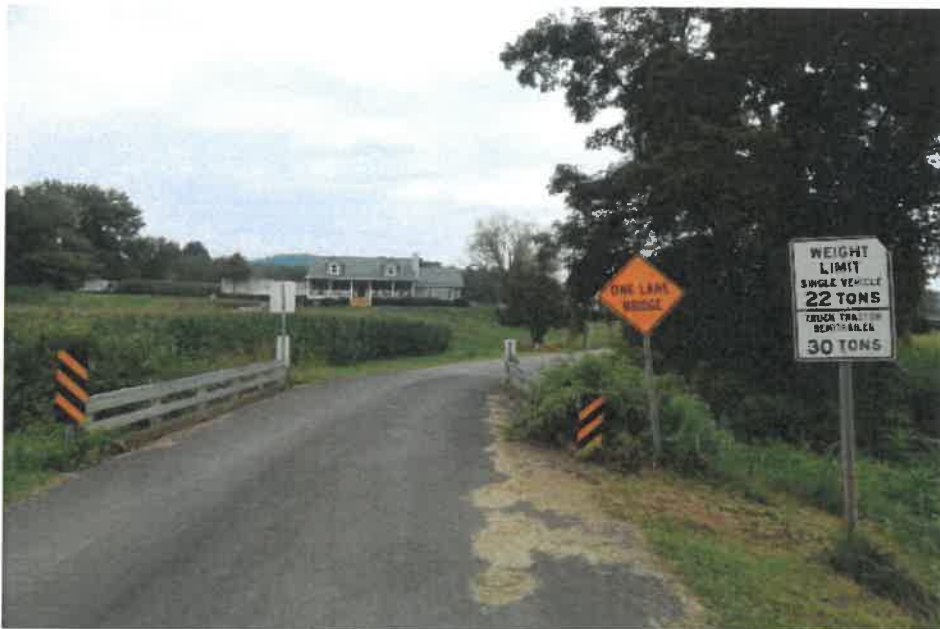
SOUTH APPROACH LOOKING NORTH

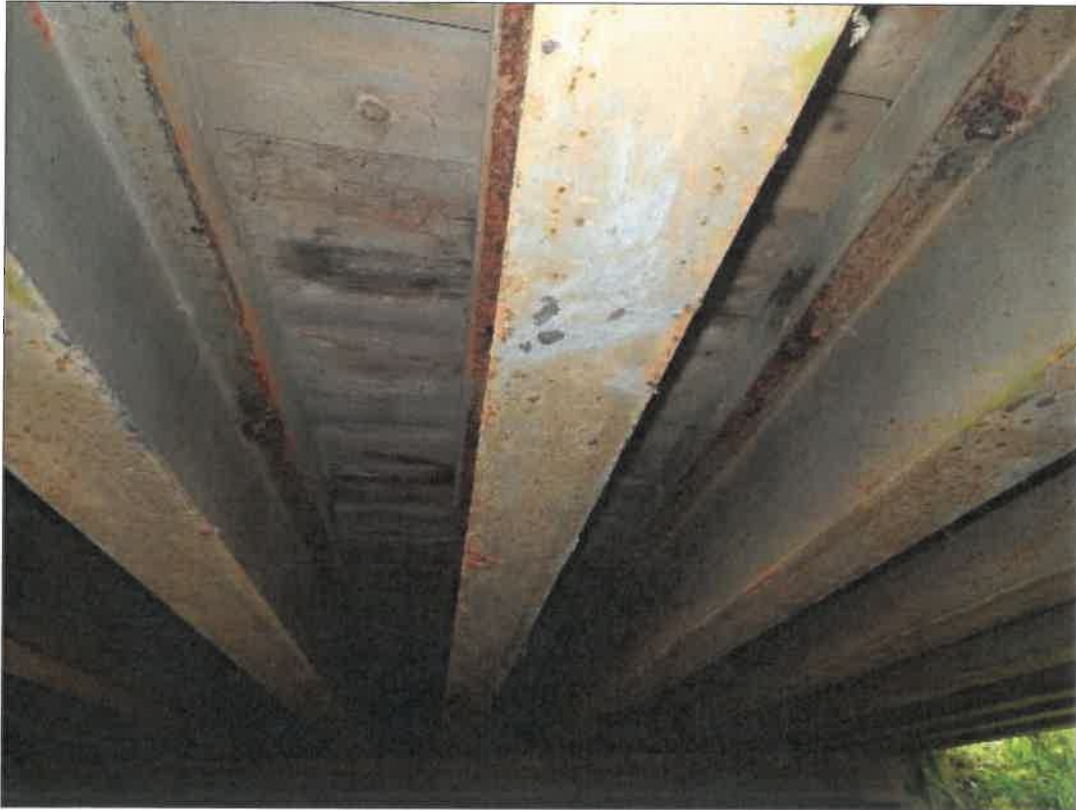
DECK UNDERSIDE

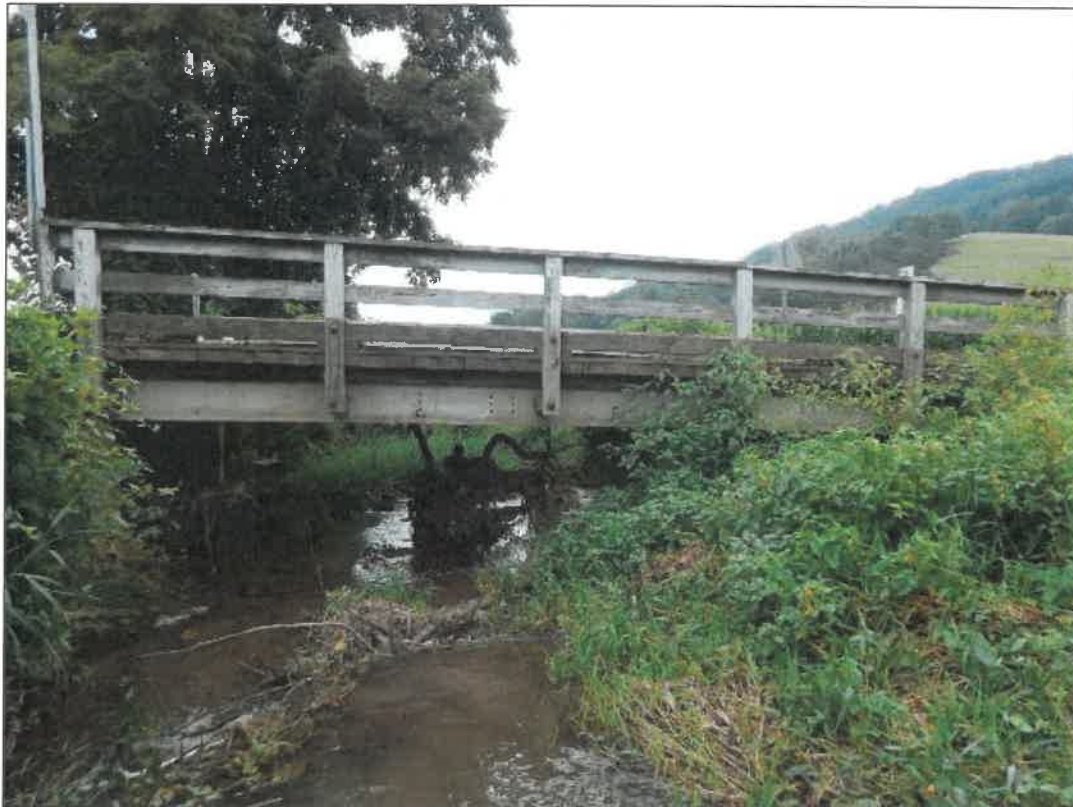
UPSTREAM PROFILE

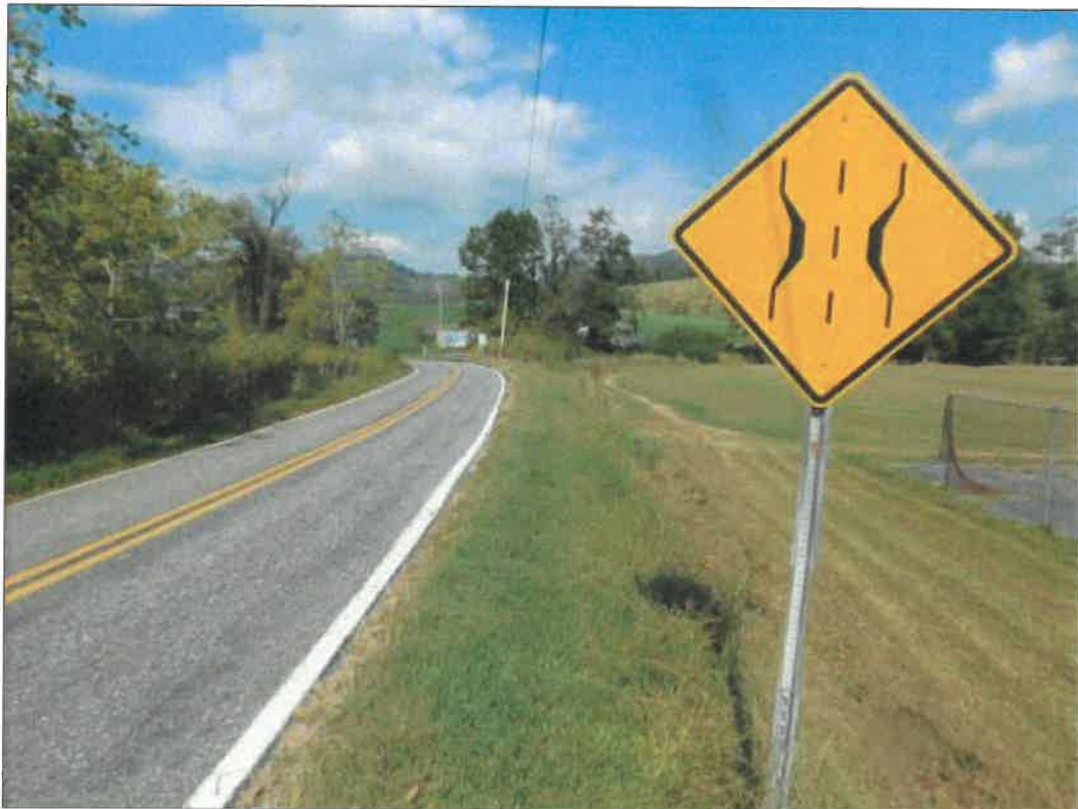
SOUTH APPROACH "NARROW BRIDGE" SIGN AT 150' FROM THE BRIDGE. NORTH APPROACH SIGN IS AT 300'.
