## Hydraulics Unit Pre-Design Report (Pre-Scoping) for Structure #: 110237

County: Burke Stream: Rock Creek  
Road #: SR 1913 Road Name: Sugar Loaf Rd  
Division: 13 Location: 0.1 MI. E JCT. SR 1914  
Latitude: 35.63327 Longitude: -81.57493 Decimal degrees, a min of 5 decimal points

## Structure Safety Report

COUNTY: BURKE STRUCTURE NUMBER: 110237 FREQUENCY: 24 MONTHS

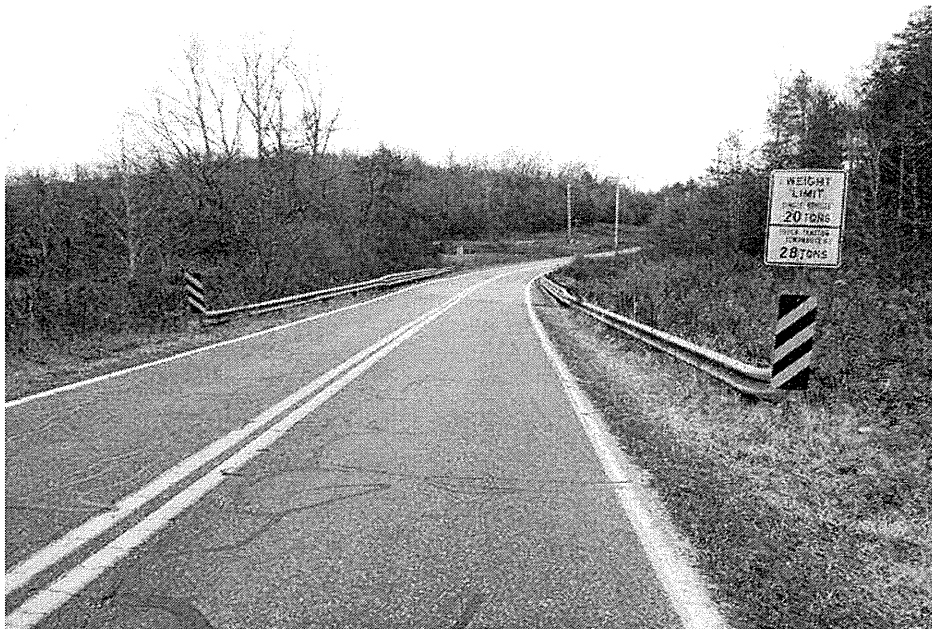
WEST APPROACH LOOKING EAST.
