## NO ARCHAEOLOGICAL SURVEY REQUIRED FORM

Project No: **Bridge 156** County: **Wayne**  
 WBS No: **DF15004.2096128** Document: **PCE**  
 F.A. No: **DF15004.2096128** Funding: ☐ State ☒ Federal

**Project Description:** Replacement of Bridge No. 156 over Raynor Mill Branch on SR 1101 (Raynor Mill Road) in Wayne County, North Carolina. The archaeological Area of Potential Effects (APE) measures 600ft in length (300ft from each bridge end-point) and 150ft in width (75ft from each side of the SR1101 center-line).

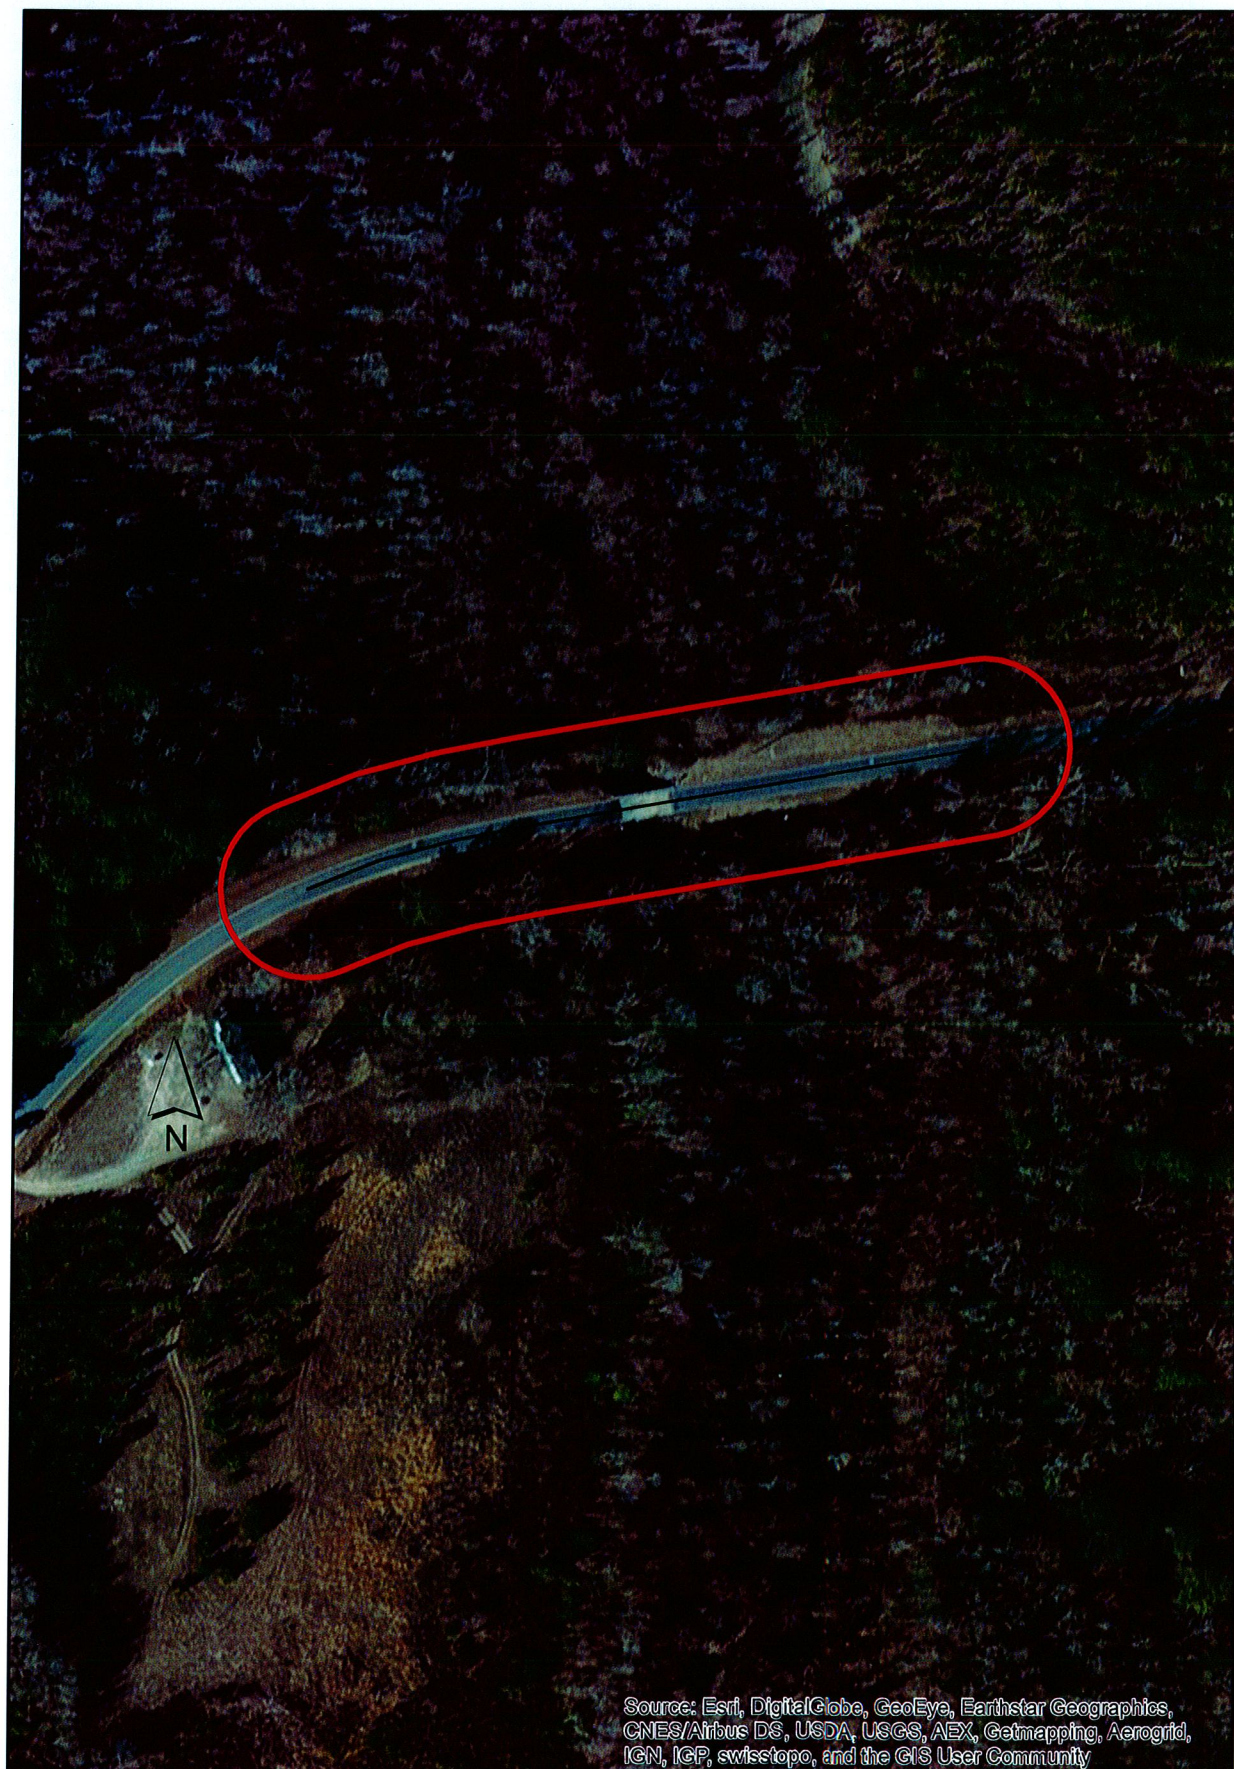
ARC-GIS image depicting the boundaries and location of the APE in Wayne County, North Carolina.
