**NO NATIONAL REGISTER OF HISTORIC PLACES  
ELIGIBLE OR LISTED ARCHAEOLOGICAL SITES  
PRESENT FORM**

Project No: **Bridge 310** County: **Surry**  
WBS No: **17BP.11.R.128** Document: **Minimum Criteria**  
F.A. No: **na** Funding: ☒ State ☐ Federal

**Project Description:**

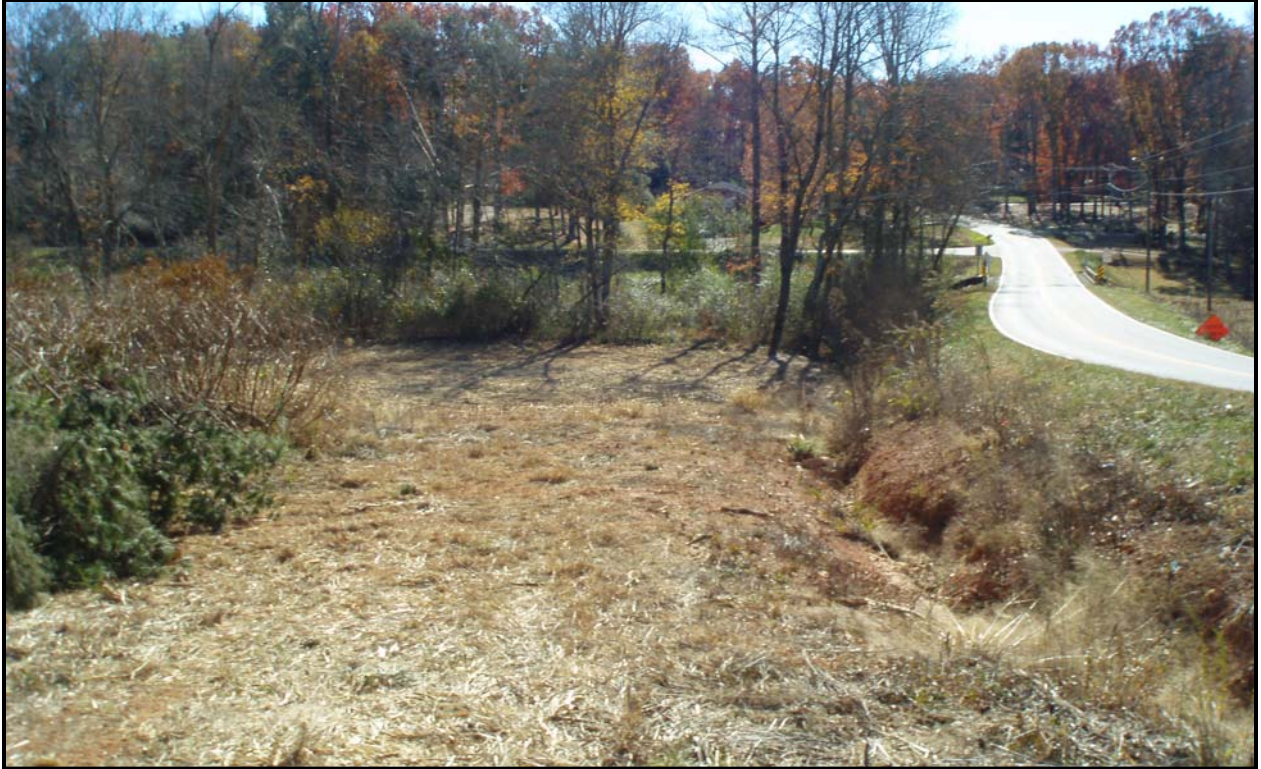
Figure 3. General View of floodplain in the northeast quadrant showing a portion of the agricultural property looking south.

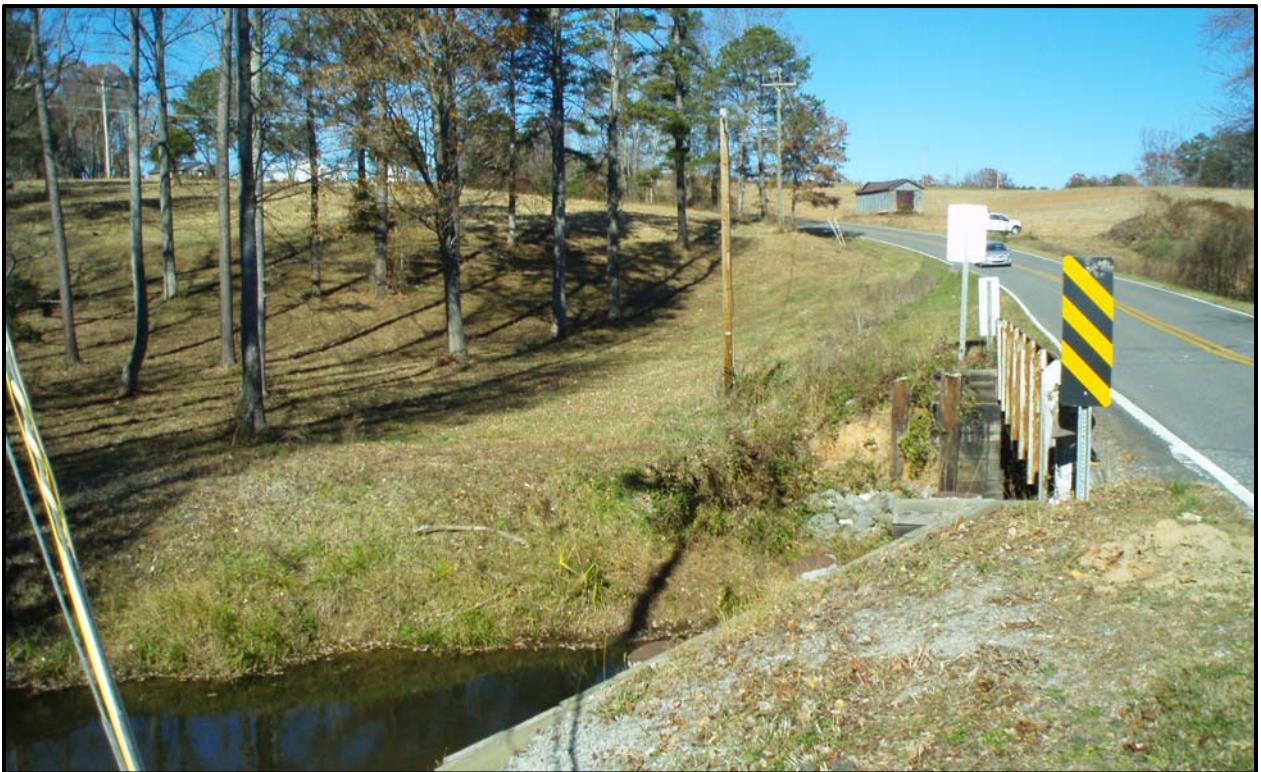
Figure 4. General View of floodplain and hillside slope in the northwest quadrant looking north.

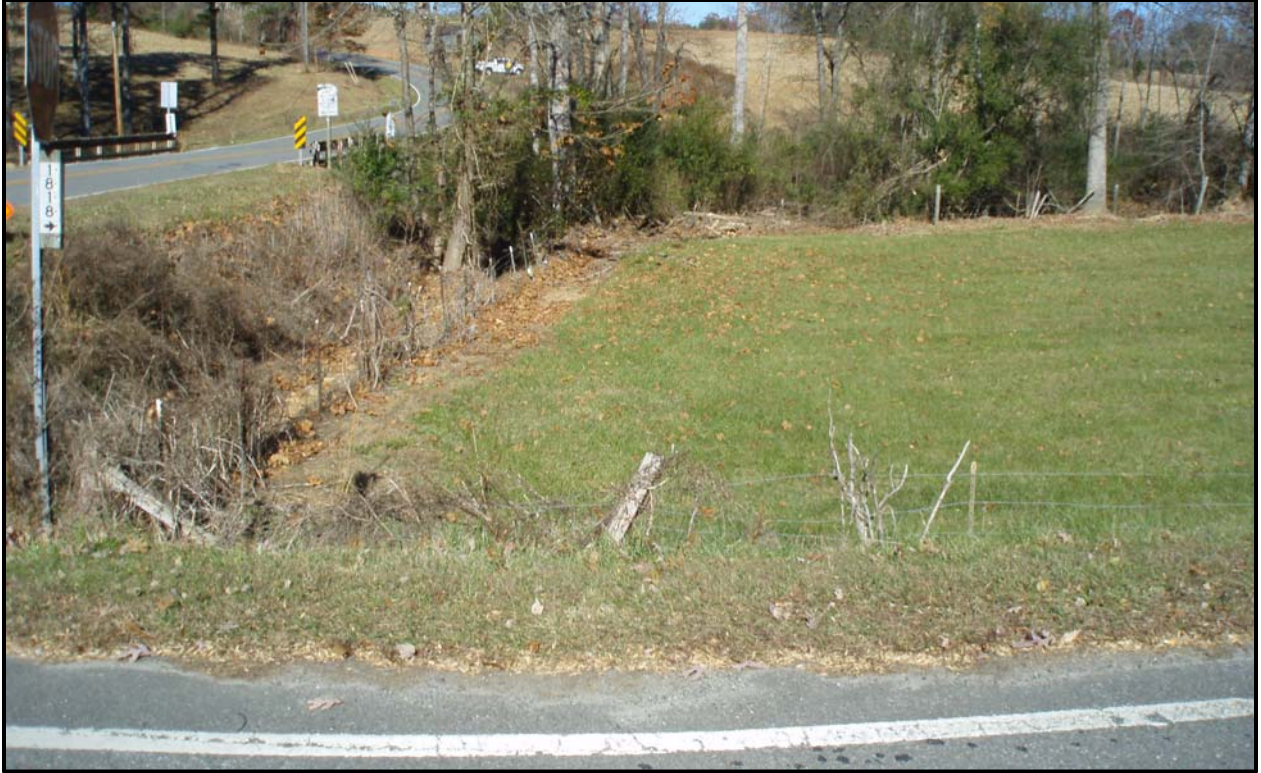
Figure 5. General View of floodplain in the southeast quadrant showing the pasture looking north.

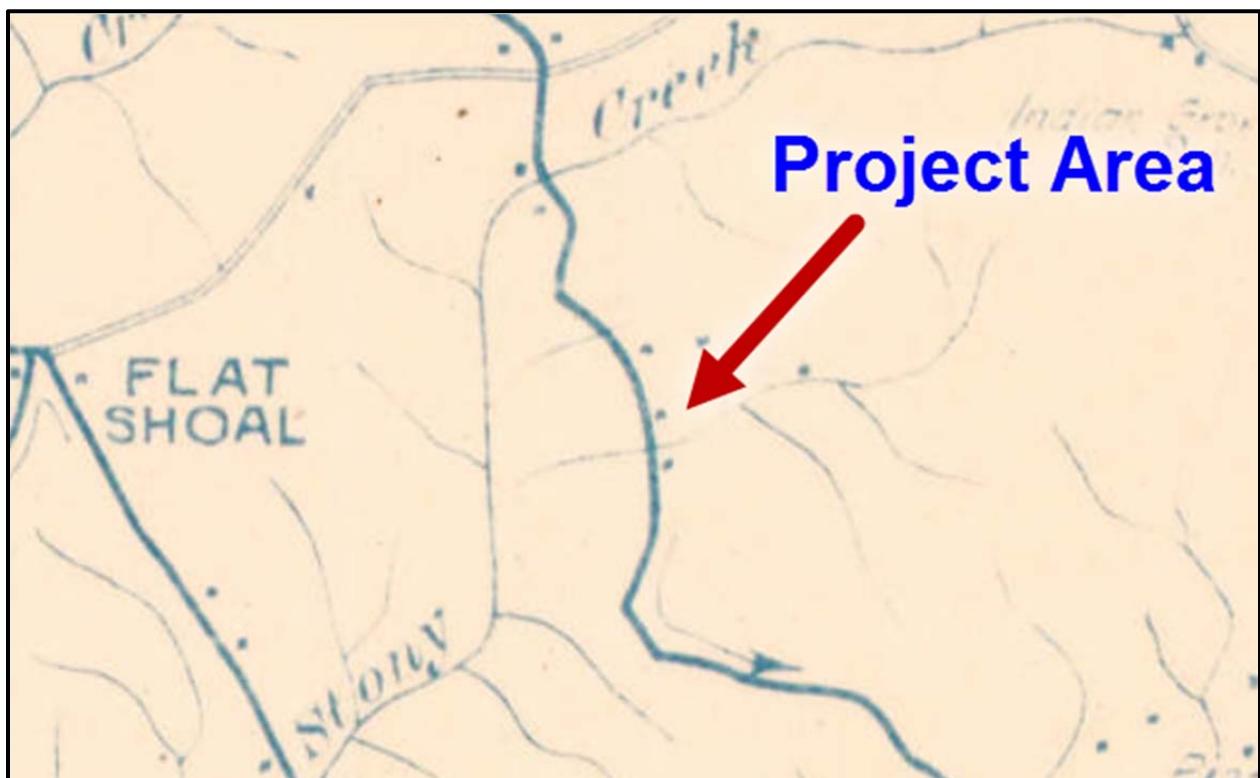
Figure 8. The 1912 Rural Delivery Route for Surry County showing the approximate location of the project area.
