## NO ARCHAEOLOGICAL SURVEY REQUIRED FORM

Project No: **Bridge 309** County: **Caldwell**  
 WBS No: **17BP.11.R.129** Document: **MCC**  
 F.A. No: Funding: ☒ State ☐ Federal

**Project Description:** Replacement of Bridge No. 309 over Mulberry Creek on SR 1338 (Valley View Circle) in Caldwell County, North Carolina. The archaeological Area of Potential Effects (APE) measures 600ft in length (300ft from each bridge end-point) and 150ft in width (75ft from each side of the SR1338 center-line).

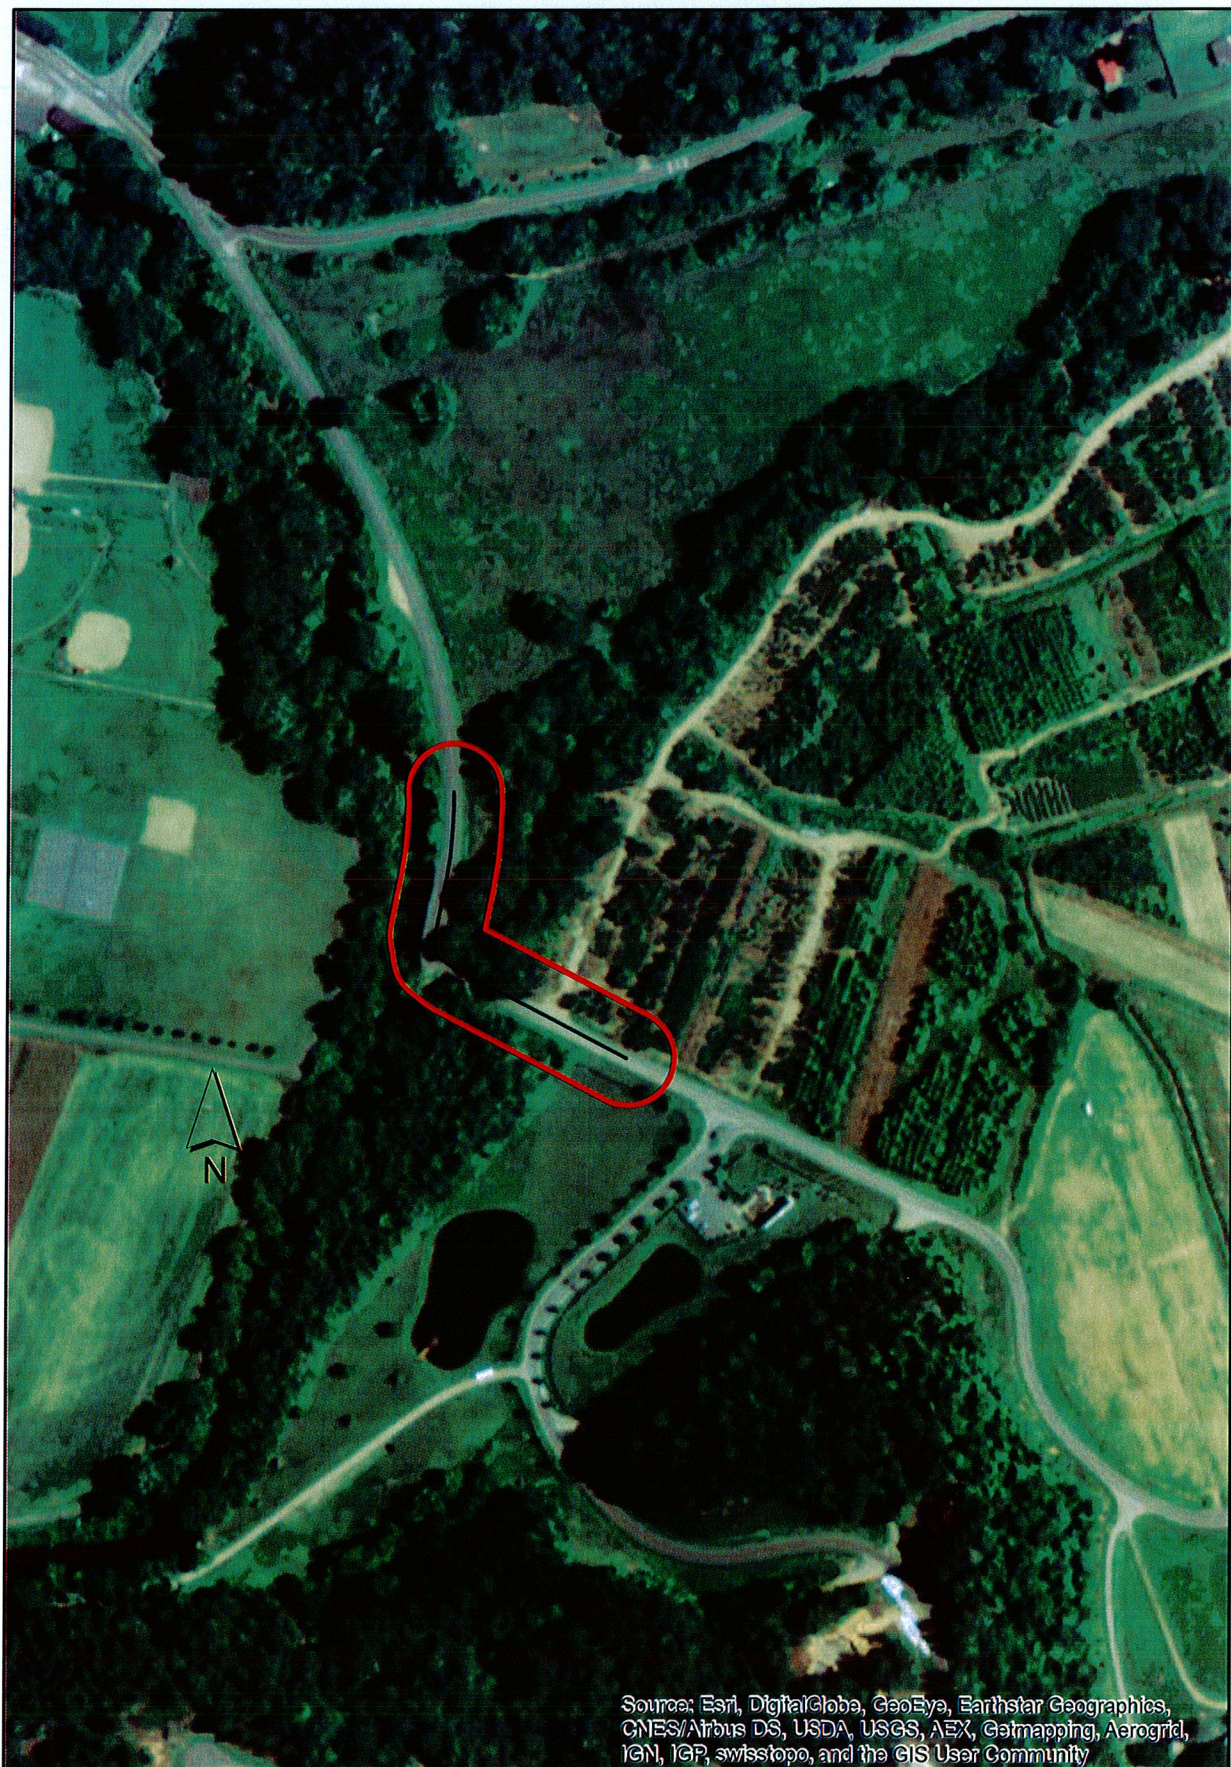
ARC-GIS aerial map depicting the location and boundaries of the APE in Caldwell County, North Carolina.
