## Bridge Approach Speed Investigation

Bridge # 050117 over Henson Creek on SR 1127 (Little Henson Creek Rd)  
Avery County  
Project Number 17BP.11.R.138

## Division 11 - Avery County Design Build Year 6/7 Bridge Program

Bridge and Approach Investigation Checklist

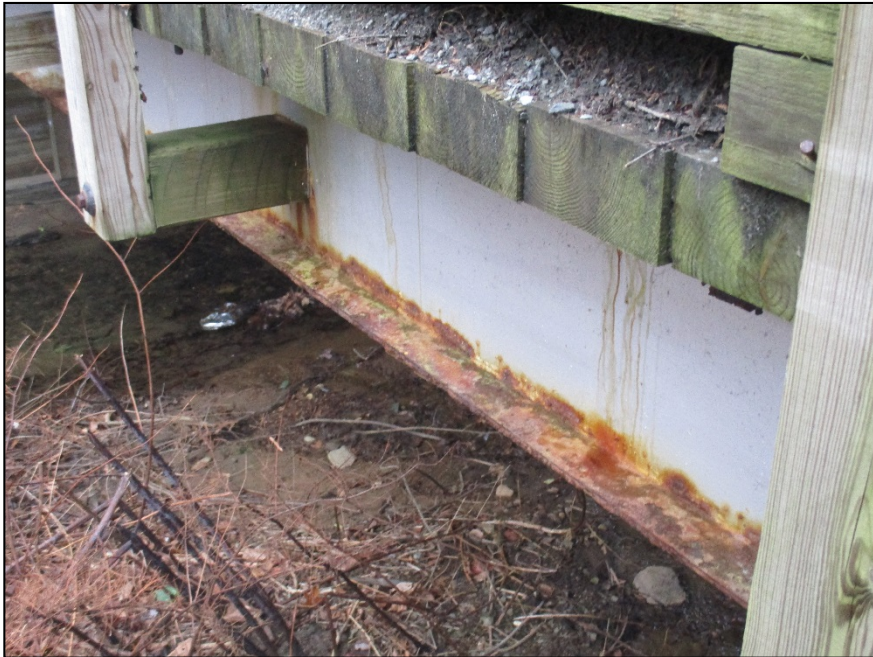
Comments Bridge directly adjacent to three-leg stop-controlled intersection. EB approach must stop on bridge.  
No pavement markings on bridge or NB approach.  
Residential driveway on each approach. Cars and shacks on NB approach.  
Steel supports beneath bridge show signs of rust.

Bridge shows signs of rust
