PROJECT: 33037.1.1 ID: B-3406

# STRUCTURE SUBSURFACE INVESTIGATION

STATE PROJECT 33037.1.1 I.D. NO. B-3406  
 F.A. PROJECT BRZ-1321(1)  
 COUNTY AVERY  
 PROJECT DESCRIPTION BRIDGE No. 28  
OVER CURTIS CREEK ON SR 1321(CURTIS CREEK RD.)

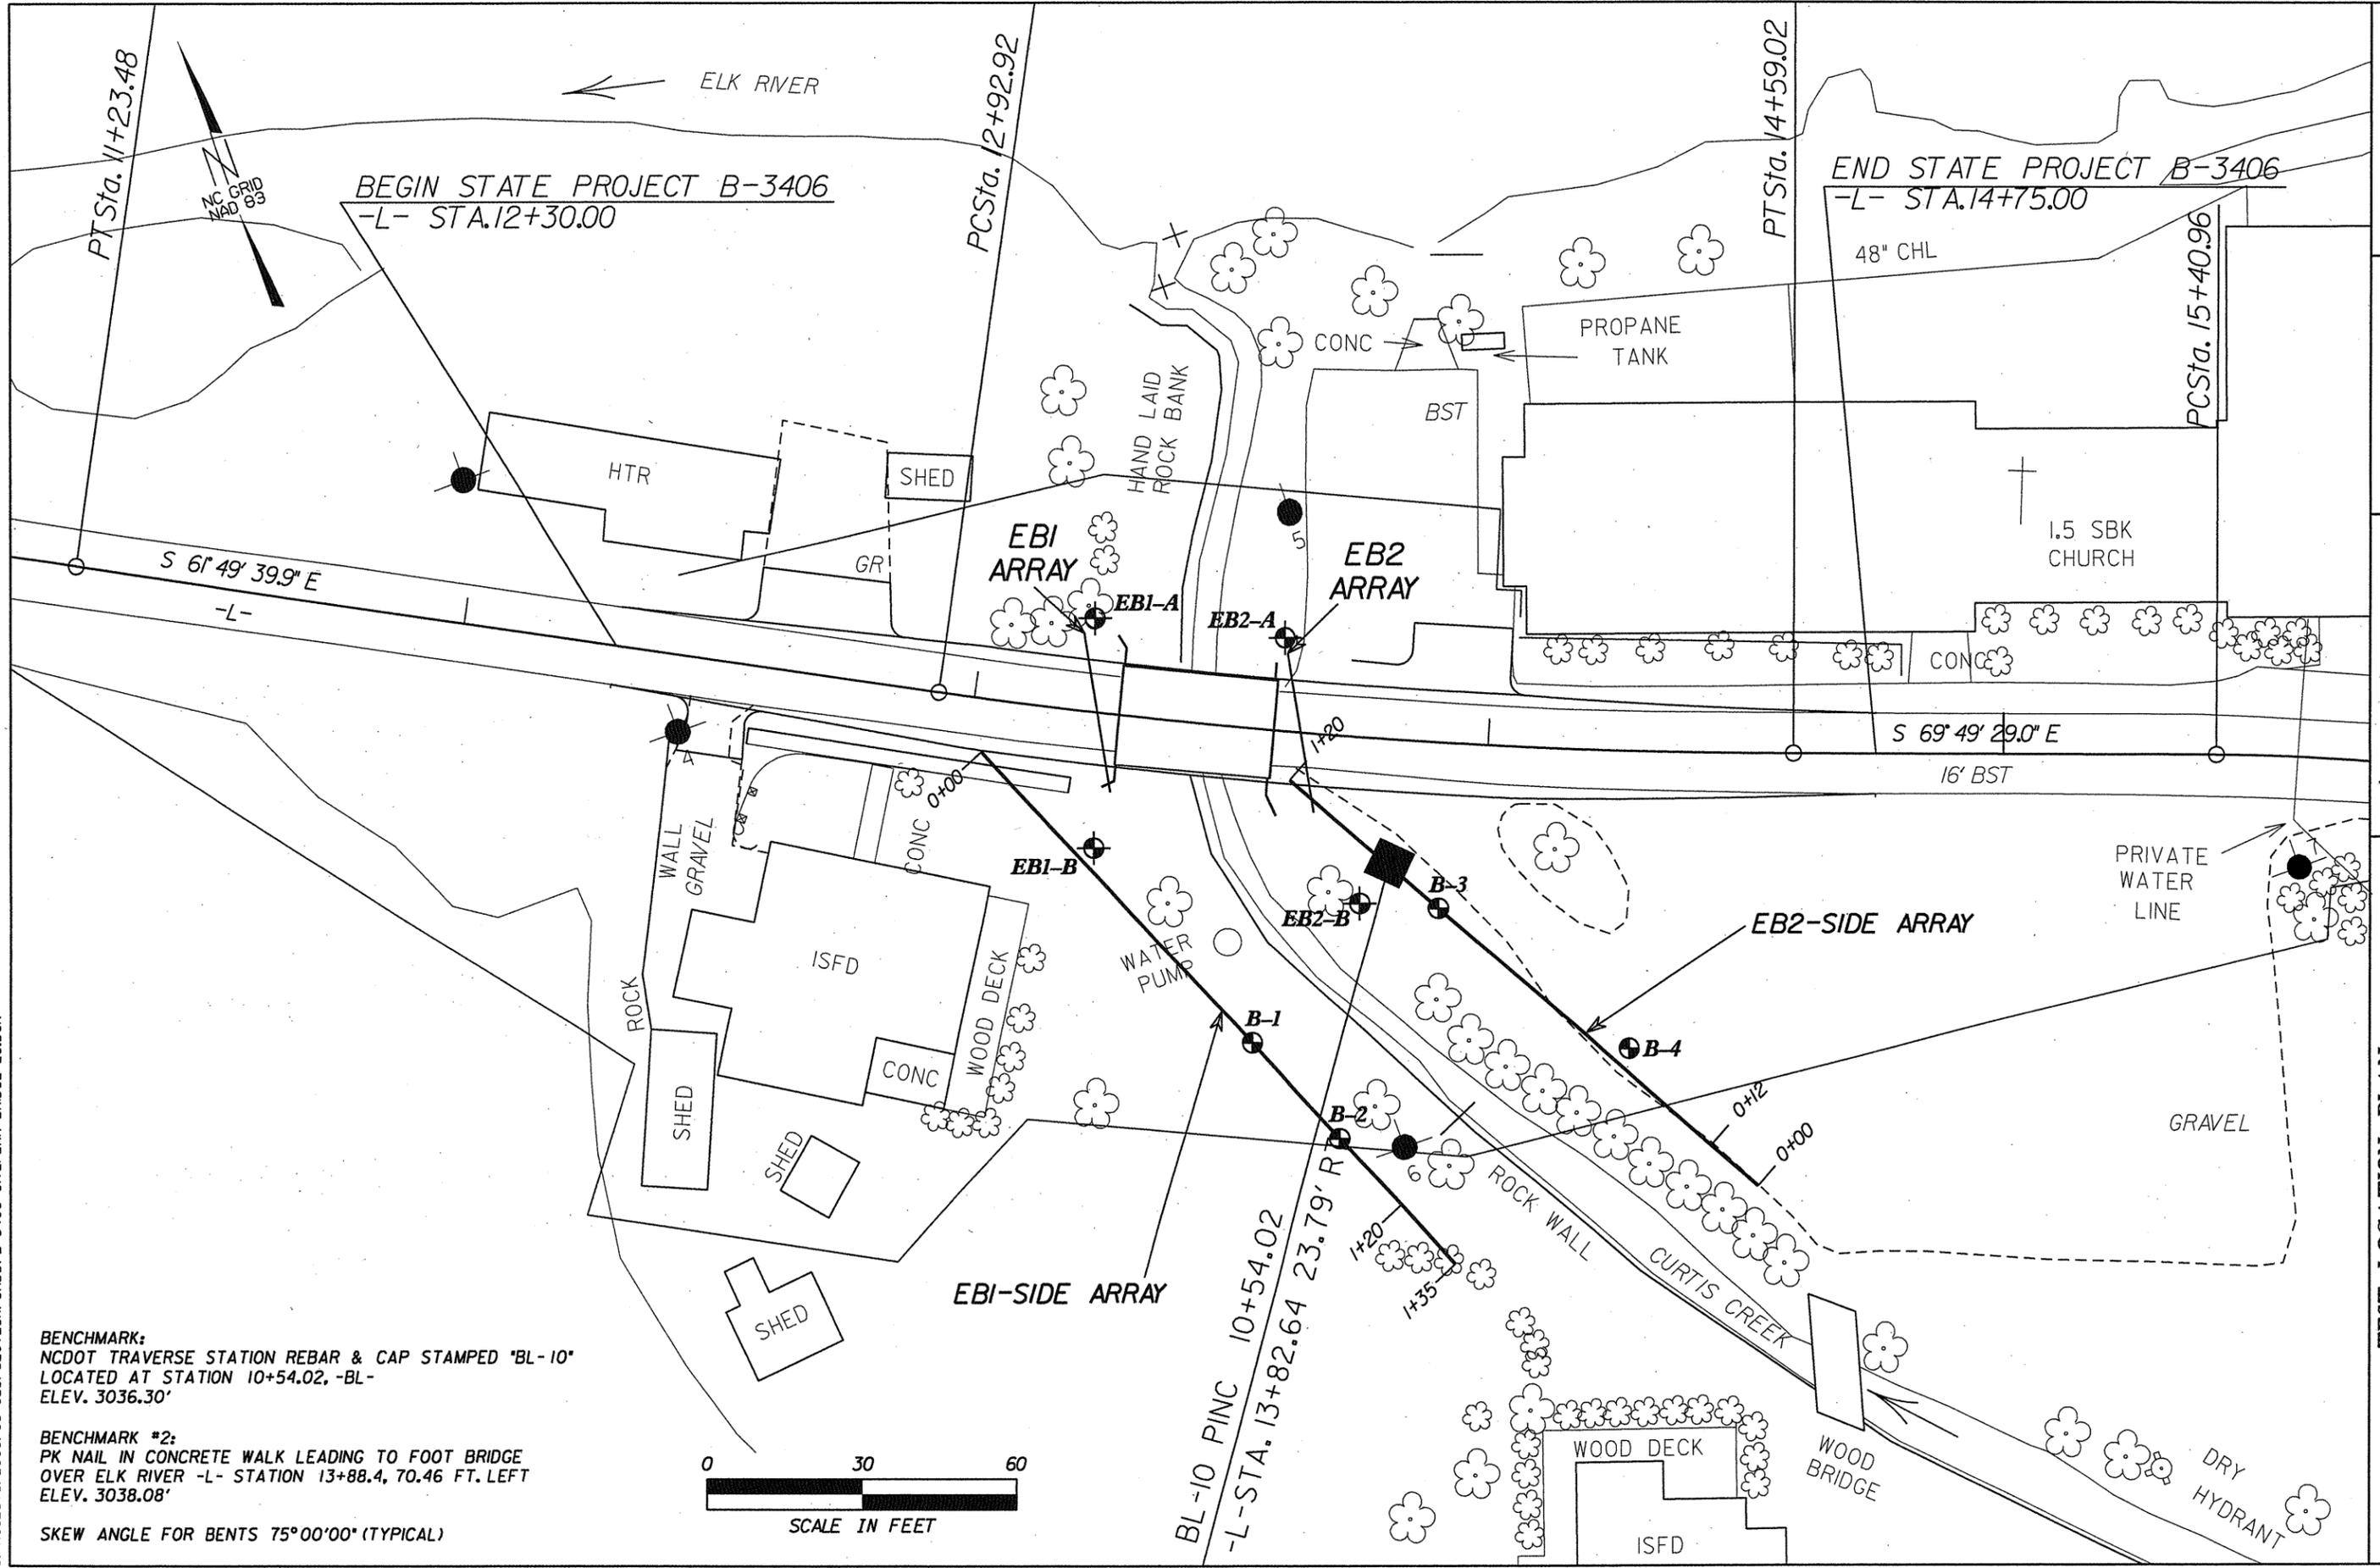
**BENCHMARK:**  
 NCDOT TRAVERSE STATION REBAR & CAP STAMPED "BL-10"  
 LOCATED AT STATION 10+54.02, -BL-  
 ELEV. 3036.30'

**BENCHMARK #2:**  
 PK NAIL IN CONCRETE WALK LEADING TO FOOT BRIDGE  
 OVER ELK RIVER -L- STATION 13+88.4, 70.46 FT. LEFT  
 ELEV. 3038.08'

<b>TEST LOCATION PLAN</b> BRIDGE No. 28		APPROVED BY: AFR
REPLACEMENT OF BRIDGE No. 28 OVER CURTIS CREEK ON SR 1321		DRAWN BY: TRP
TIP No. B-3406 WBS No. 33037.1.1 FEDERAL I.D. BRZ-1321(I)		SHEET 7 OF 44
AVERY COUNTY, NORTH CAROLINA		JOB NO. 1051-06-023
ENVIRONMENTAL SERVICES ENGINEERING TESTING		DATE: MAY 2006
S&ME		SCALE: 1" = 30'

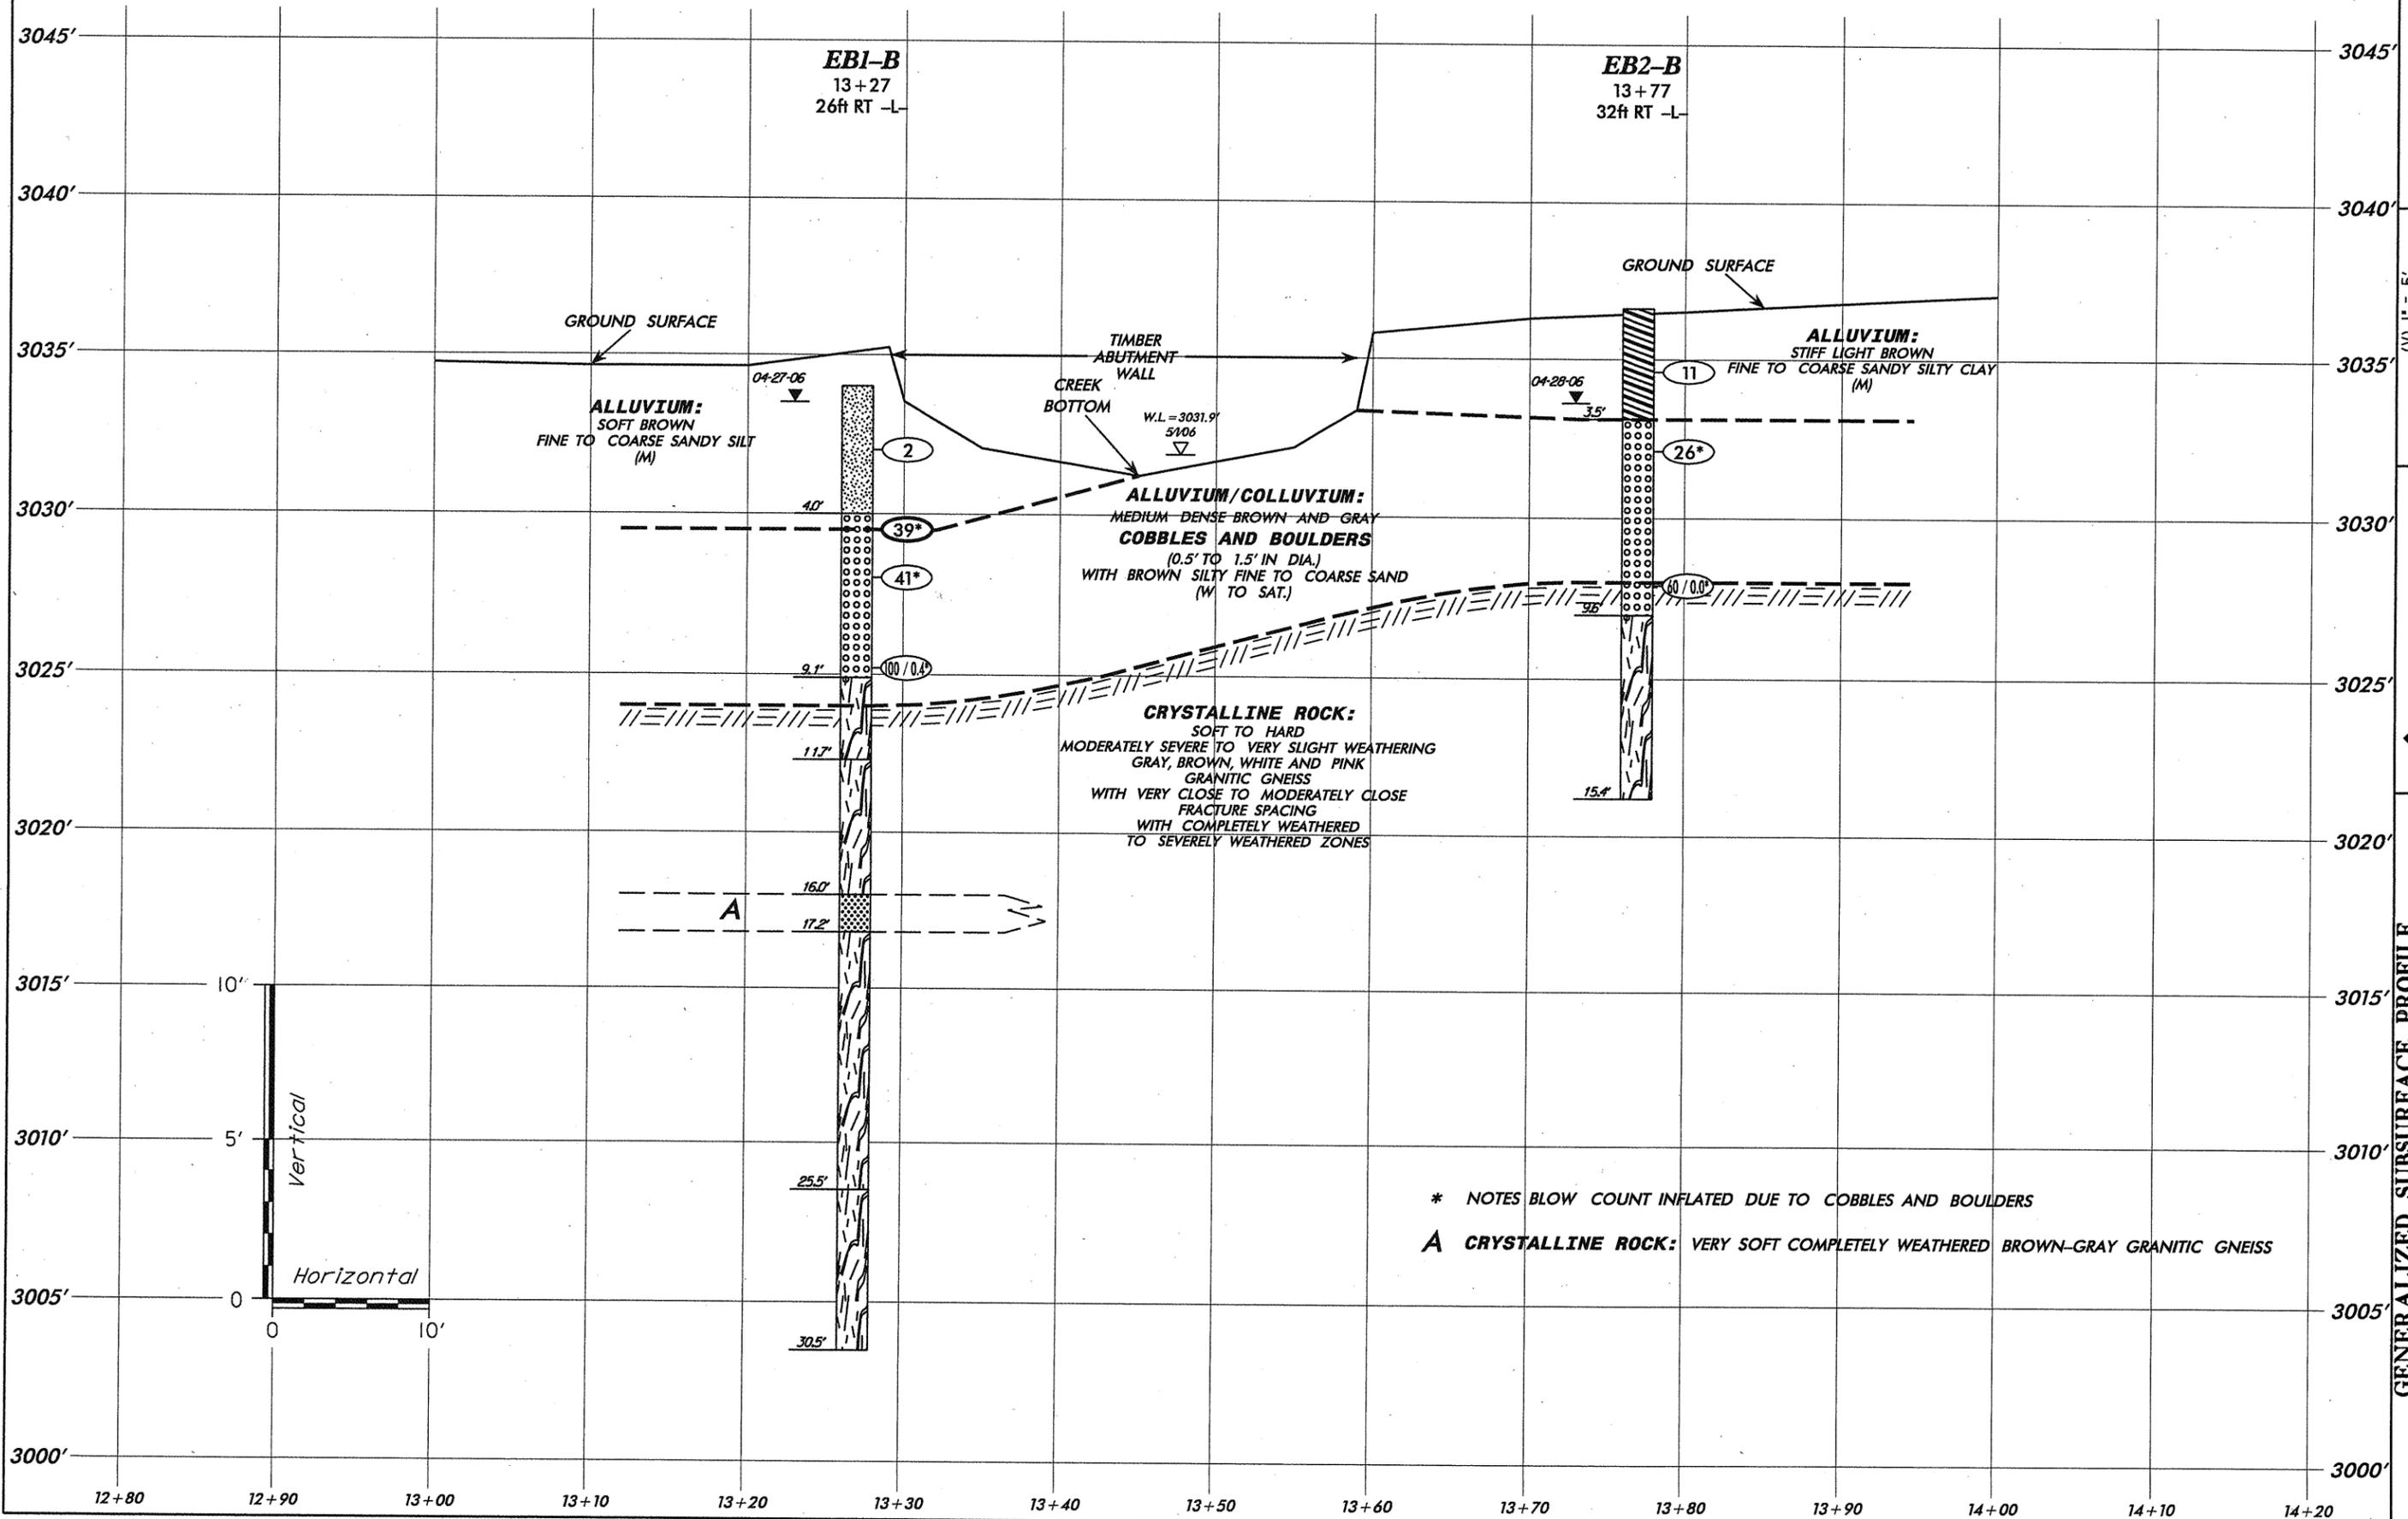
\* NOTES BLOW COUNT INFLATED DUE TO COBBLES AND BOULDERS

**A** CRYSTALLINE ROCK: VERY SOFT COMPLETELY WEATHERED BROWN-GRAY GRANITIC GNEISS

**GENERALIZED SUBSURFACE PROFILE**  
BRIDGE No. 28 - 10.0 FT. RIGHT OF -L-  
REPLACEMENT OF BRIDGE No. 28  
OVER CURTIS CREEK ON SR 1321  
TIP No. B-3406 STATE PROJECT No. 33037.1.1 FEDERAL I.D. BRZ-132 (1.1)  
AVERY COUNTY, NORTH CAROLINA

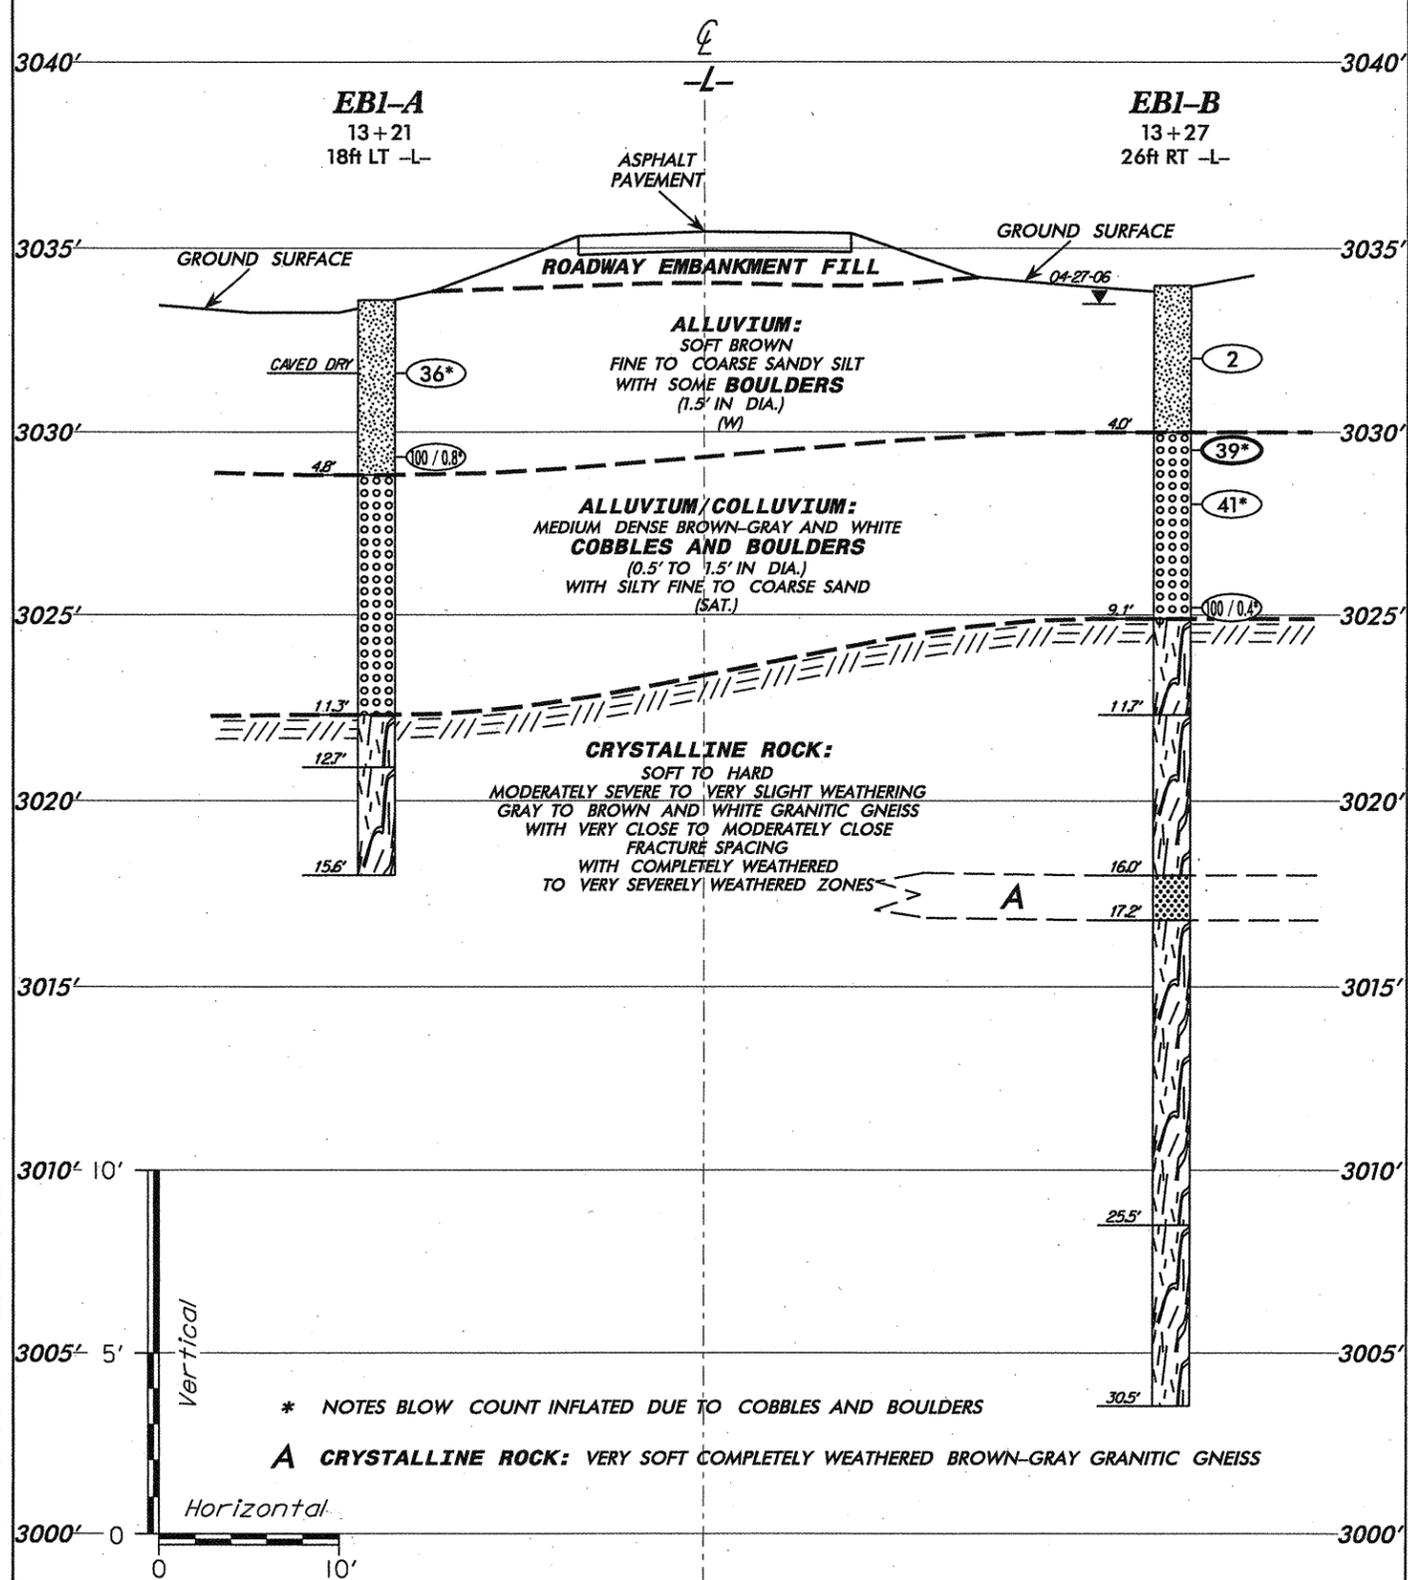
GENERALIZED SUBSURFACE CROSS SECTION THROUGH BRIDGE No.28 - END BENT No.1

\* NOTES BLOW COUNT INFLATED DUE TO COBBLES AND BOULDERS  
**A** CRYSTALLINE ROCK: VERY SOFT COMPLETELY WEATHERED BROWN-GRAY GRANITIC GNEISS

GENERALIZED SUBSURFACE CROSS SECTION  
 THROUGH BRIDGE No. 28 - END BENT No. 1  
 REPLACEMENT OF BRIDGE No. 28  
 OVER CURTIS CREEK ON SR 1321  
 TIP No. B-3406 STATE PROJECT No. 33037.1.1  
 FEDERAL ID No. BRZ-1321(I)  
 AVERY COUNTY, NORTH CAROLINA

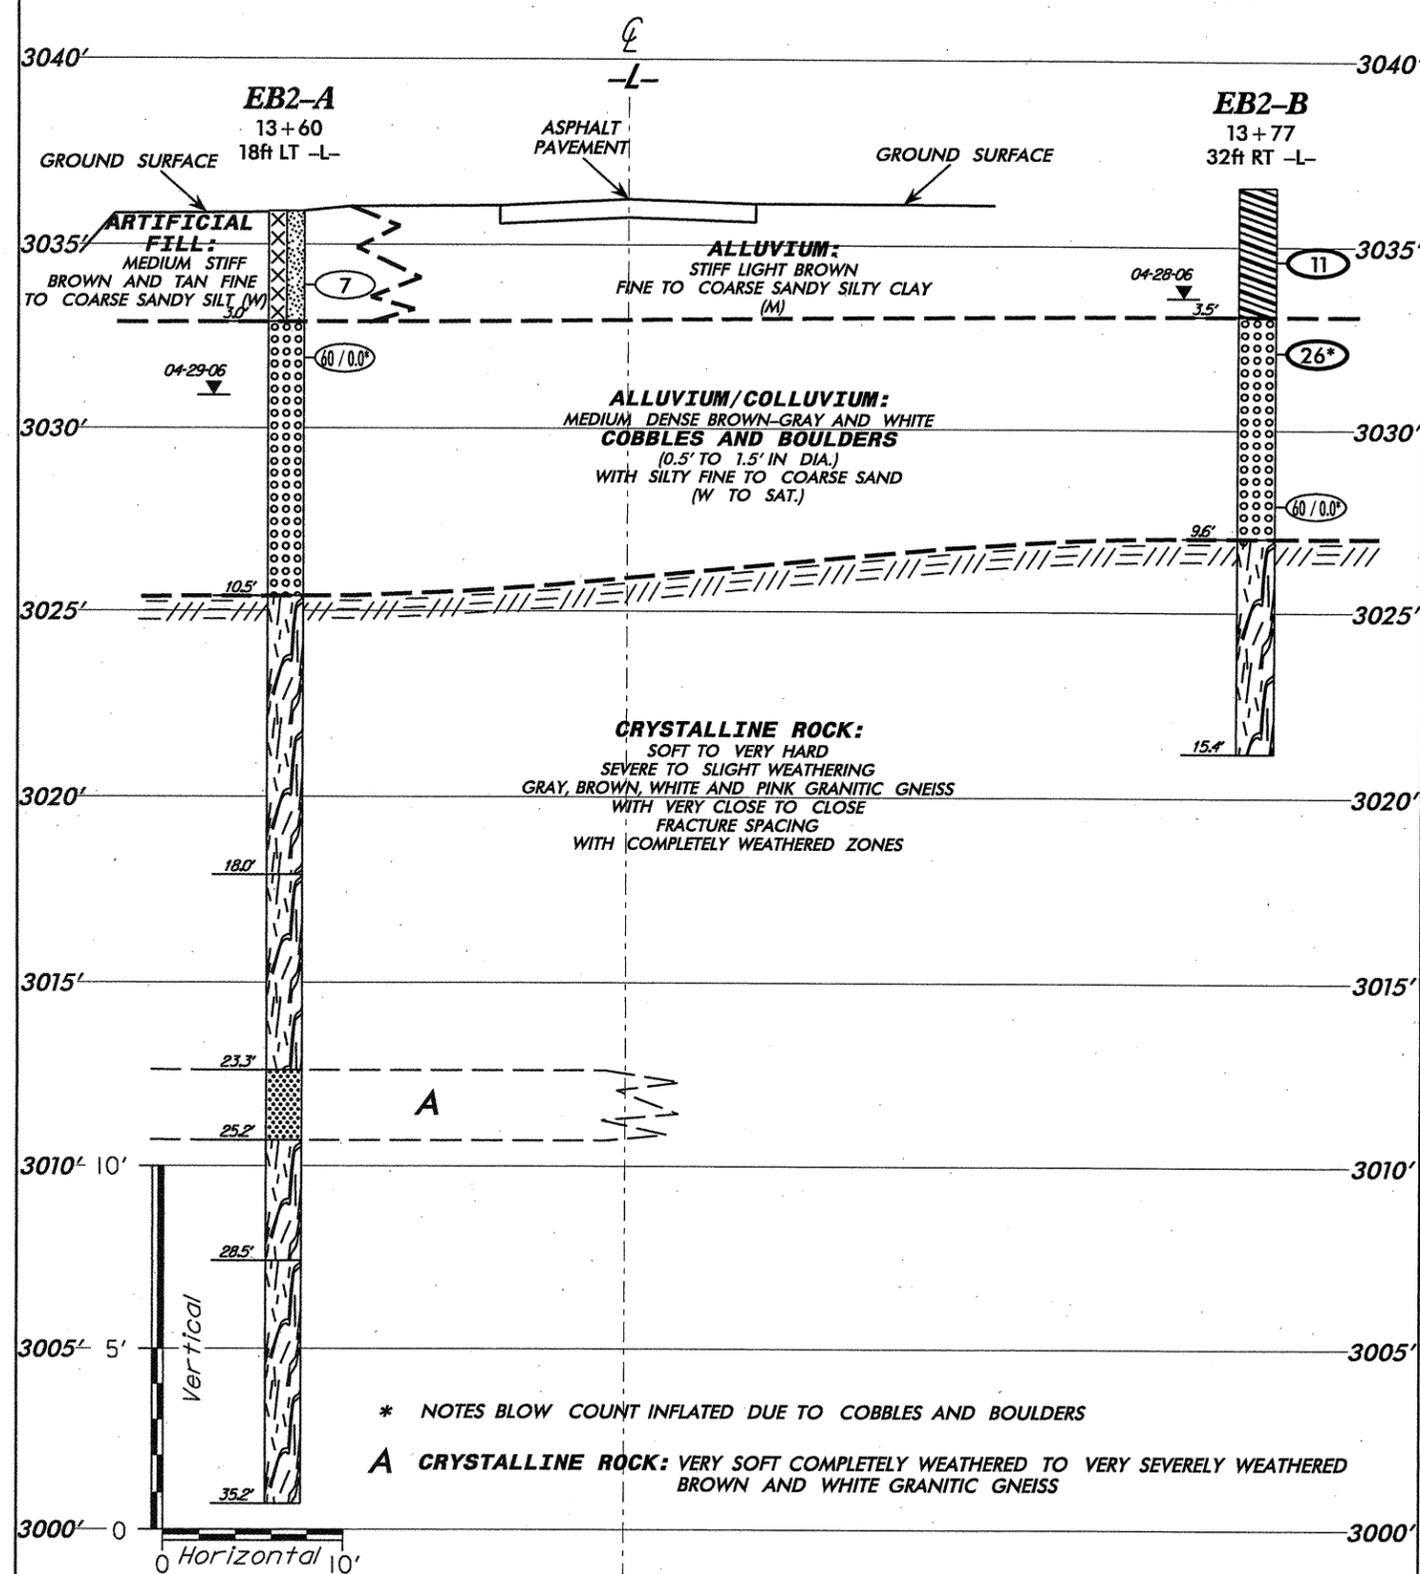
GENERALIZED SUBSURFACE CROSS SECTION THROUGH BRIDGE No.28 - END BENT No.2

\* NOTES BLOW COUNT INFLATED DUE TO COBBLES AND BOULDERS  
**A** CRYSTALLINE ROCK: VERY SOFT COMPLETELY WEATHERED TO VERY SEVERELY WEATHERED BROWN AND WHITE GRANITIC GNEISS

GENERALIZED SUBSURFACE CROSS SECTION  
 THROUGH BRIDGE No. 28 - END BENT No. 2  
 REPLACEMENT OF BRIDGE No. 28  
 OVER CURTIS CREEK ON SR 1321  
 TIP No. B-3406 STATE PROJECT No. 33037.1.1  
 FEDERAL ID No. BRZ-1321(I)  
 AVERY COUNTY, NORTH CAROLINA

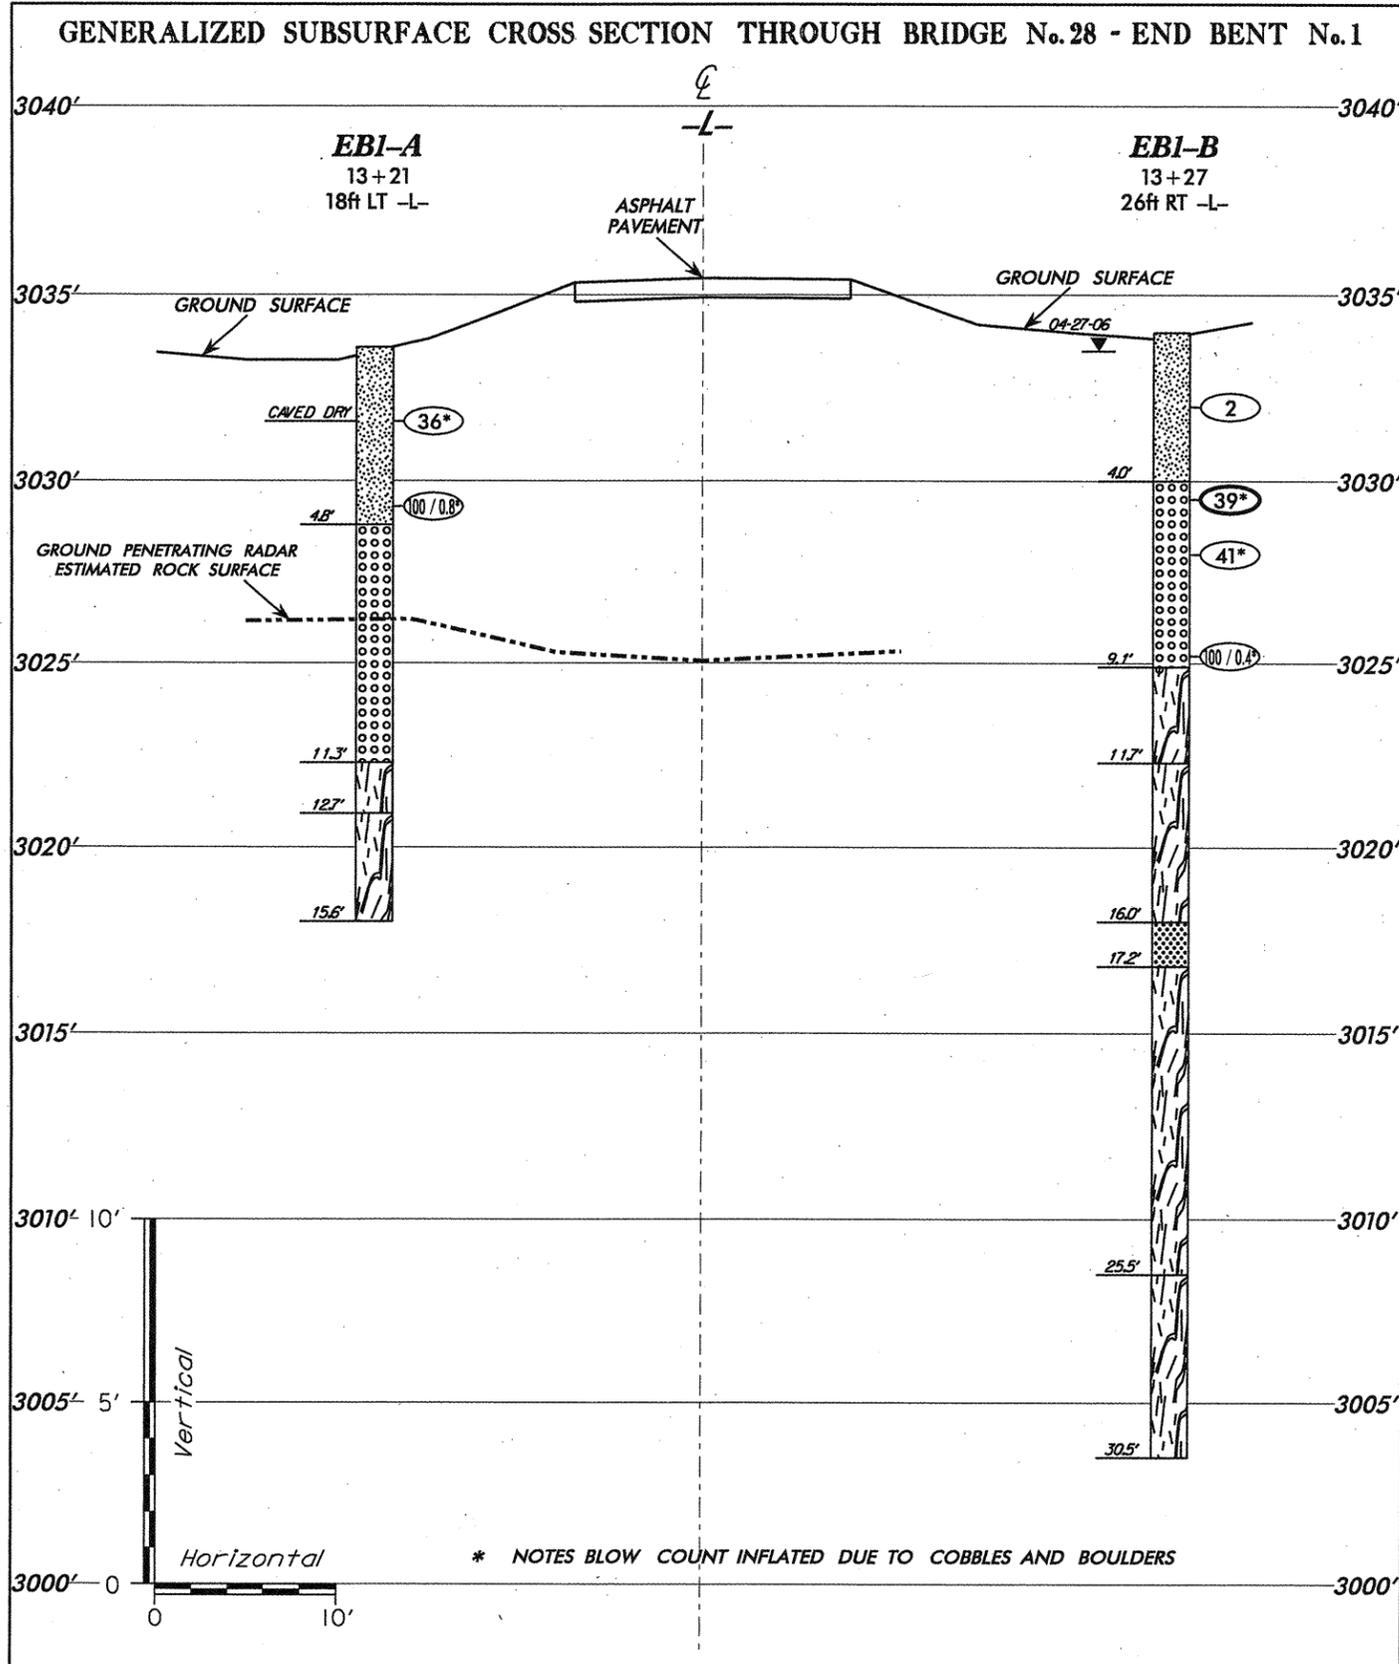
**GENERALIZED SUBSURFACE CROSS SECTION**  
 THROUGH BRIDGE No. 28 - END BENT No. 1  
 REPLACEMENT OF BRIDGE No. 28  
 OVER CURTIS CREEK ON SR 132 I  
 TIP No. B-3406 STATE PROJECT No. 33037.1.1  
 FEDERAL ID No. BRZ-132 I(1)  
 AVERY COUNTY, NORTH CAROLINA

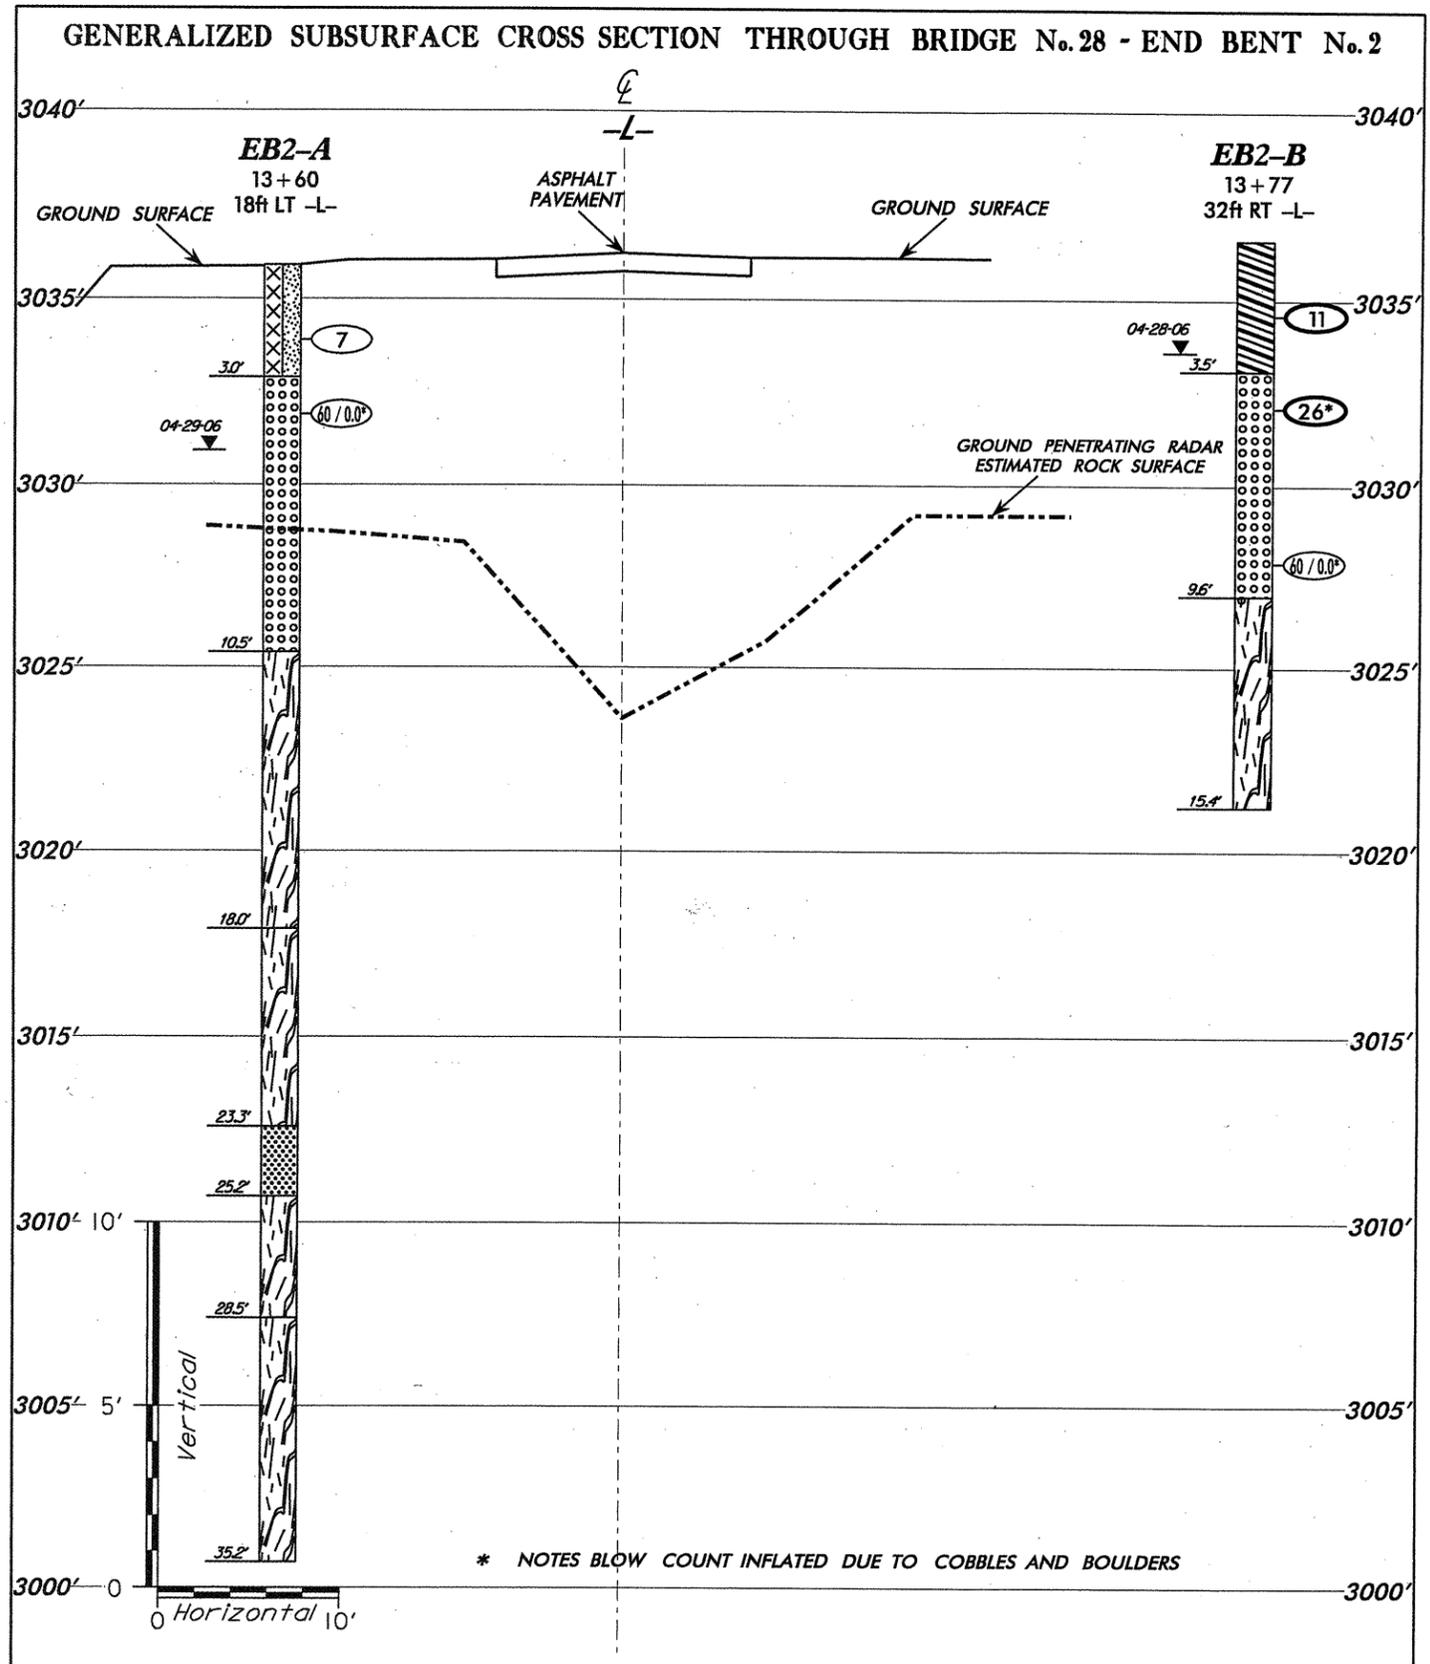
**GENERALIZED SUBSURFACE CROSS SECTION**  
 THROUGH BRIDGE No. 28 - END BENT No. 2  
 REPLACEMENT OF BRIDGE No. 28  
 OVER CURTIS CREEK ON SR 132 I  
 TIP No. B-3406 STATE PROJECT No. 33037.1.1  
 FEDERAL ID No. BRZ-132 I(1)  
 AVERY COUNTY, NORTH CAROLINA

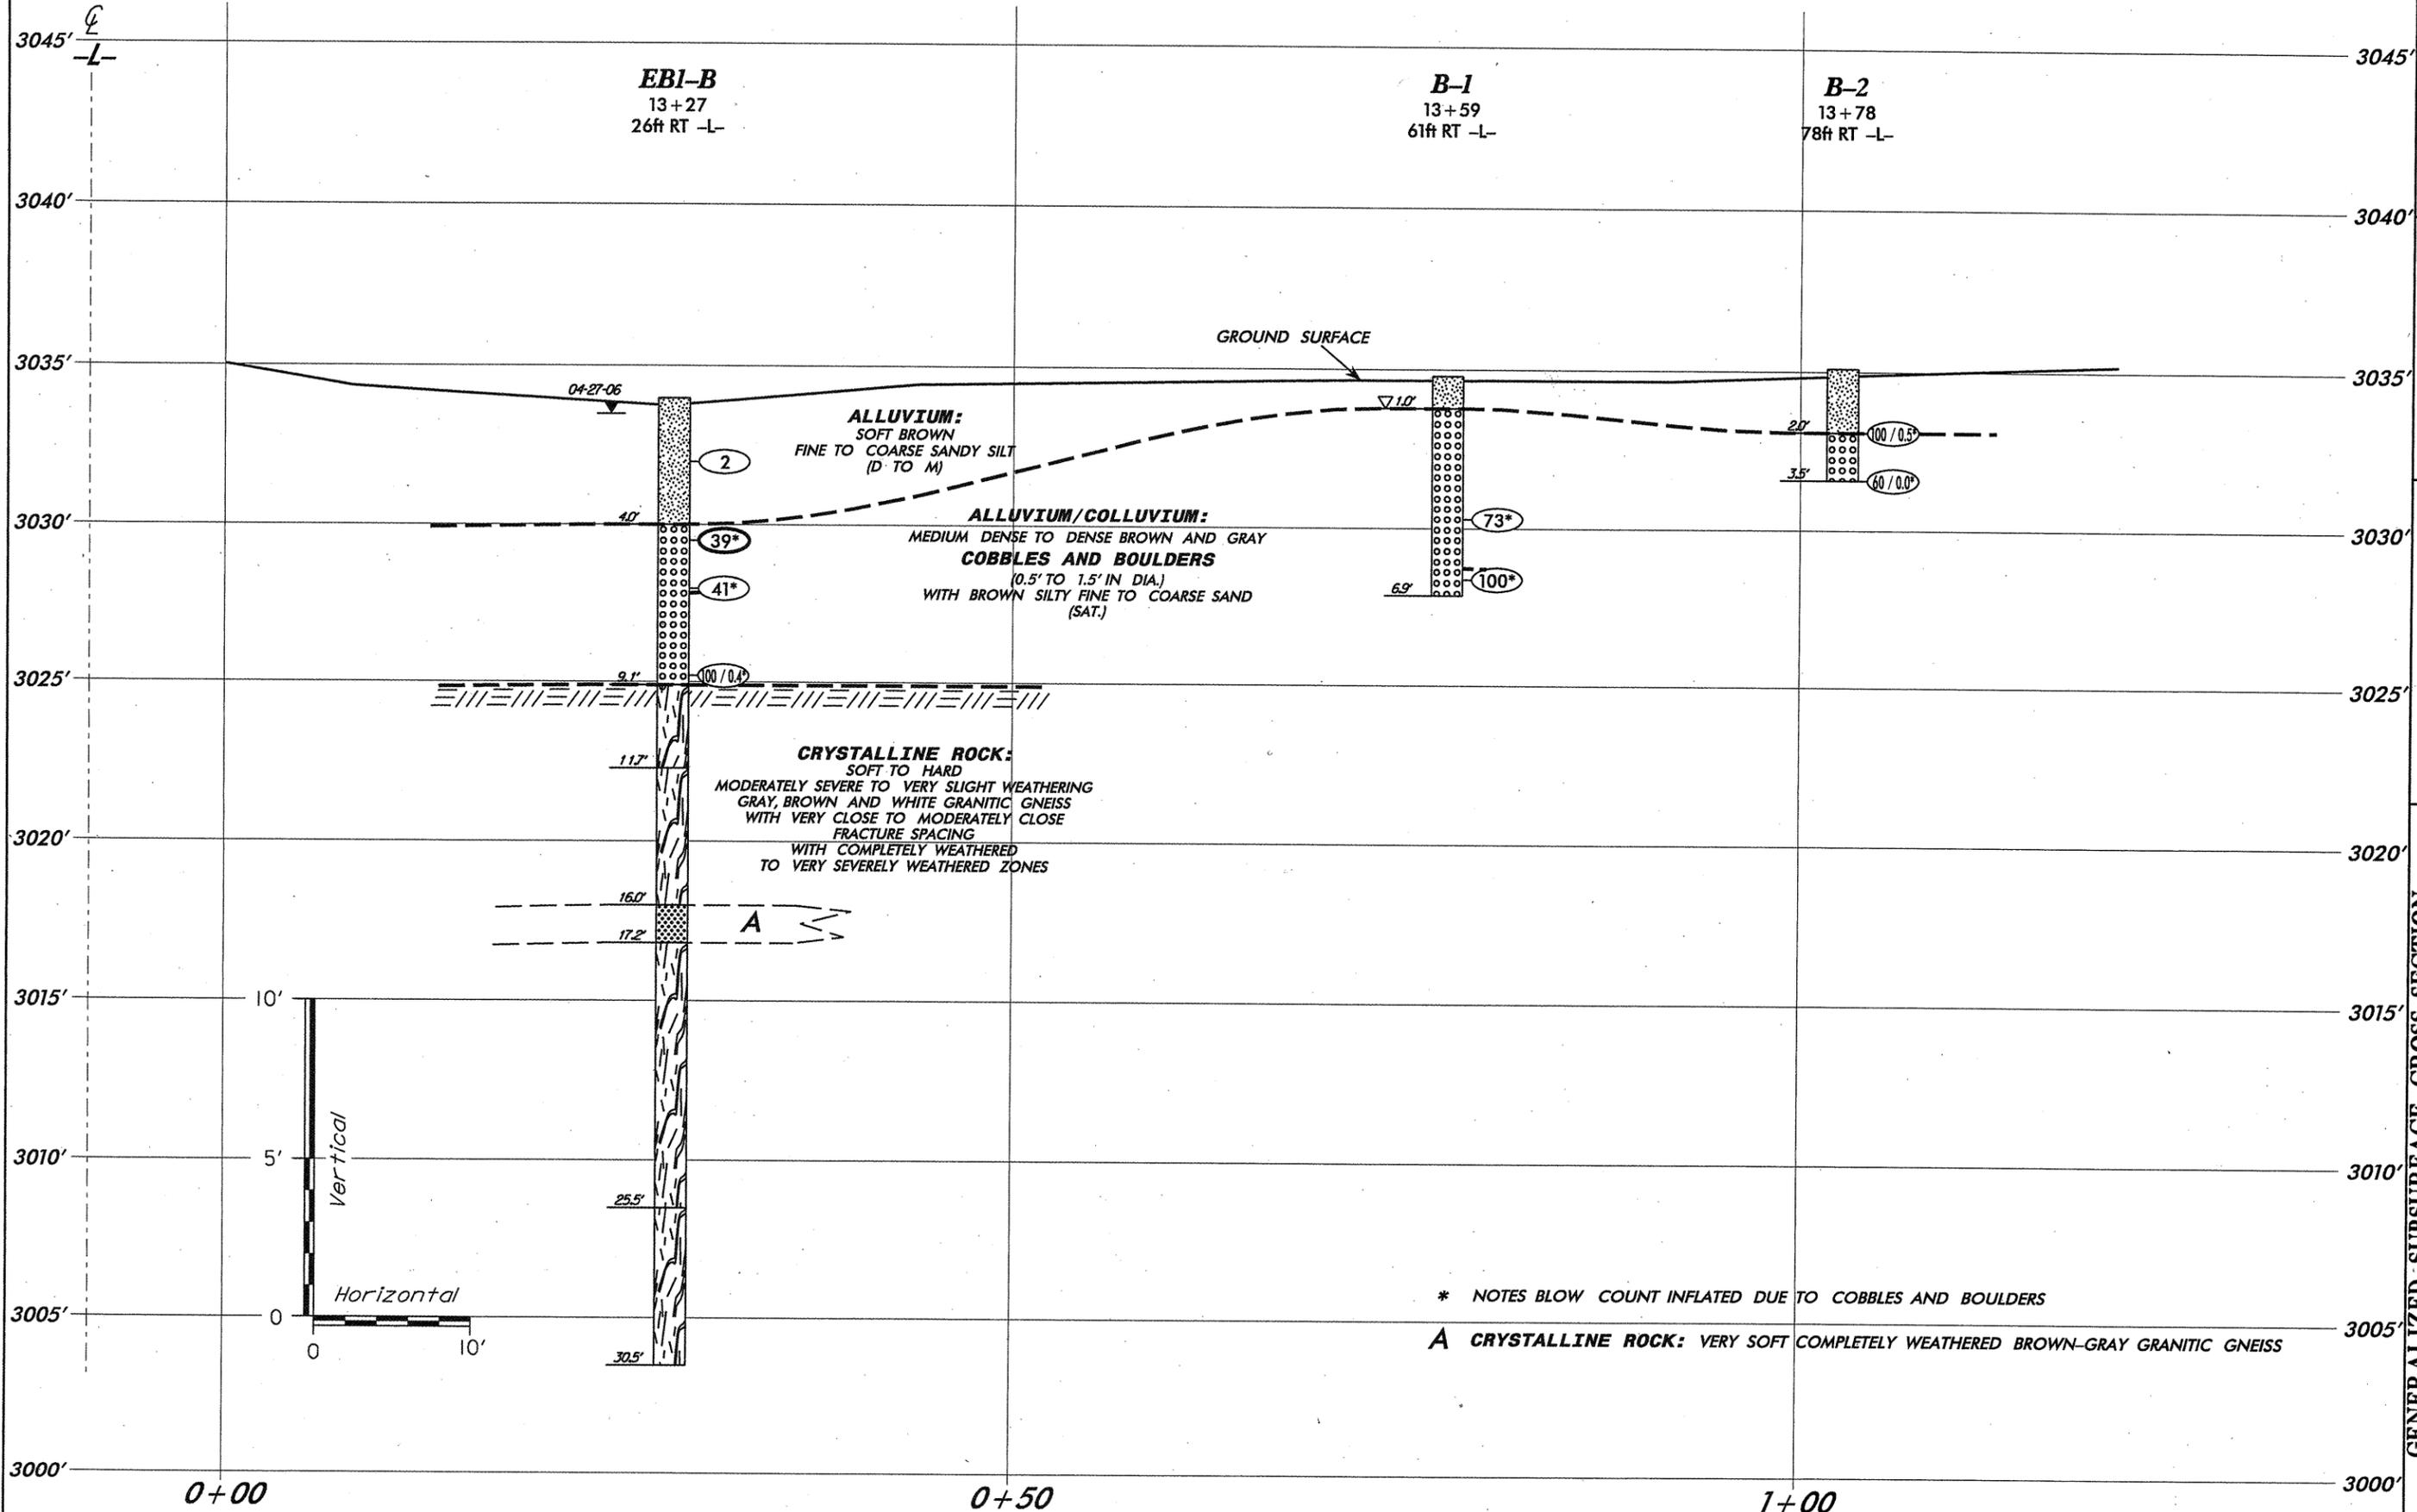
# GENERALIZED SUBSURFACE CROSS SECTION ALONG EB1-SIDE ARRAY

\* NOTES BLOW COUNT INFLATED DUE TO COBBLES AND BOULDERS

**A** CRYSTALLINE ROCK: VERY SOFT COMPLETELY WEATHERED BROWN-GRAY GRANITIC GNEISS

ALONG EB1-SIDE ARRAY  
REPLACEMENT OF BRIDGE No. 28  
OVER CURTIS CREEK ON SR 132 I  
TIP No. B-3406 WBS No. 33037-1-1 FEDERAL I.D. BRZ-132 (1)  
AVERY COUNTY, NORTH CAROLINA

- In addition, the resistivity scale is also skewed due to a very high resistance value being produced by the inversion process. As such, the inverted profile on the EB1 side is likely not a realistic representation of subsurface conditions. There does, however, appear to be a zone of lower resistivity material overlying a higher resistivity material, moving along the profile away from the road.
