PROJECT: 33037.1.1 ID: B-3406

# STRUCTURE SUBSURFACE INVESTIGATION

STATE PROJECT 33037.1.1 I.D. NO. B-3406  
 F.A. PROJECT BRZ-1321(1)  
 COUNTY AVERY  
 PROJECT DESCRIPTION BRIDGE No. 28  
OVER CURTIS CREEK ON SR 1321(CURTIS CREEK RD.)

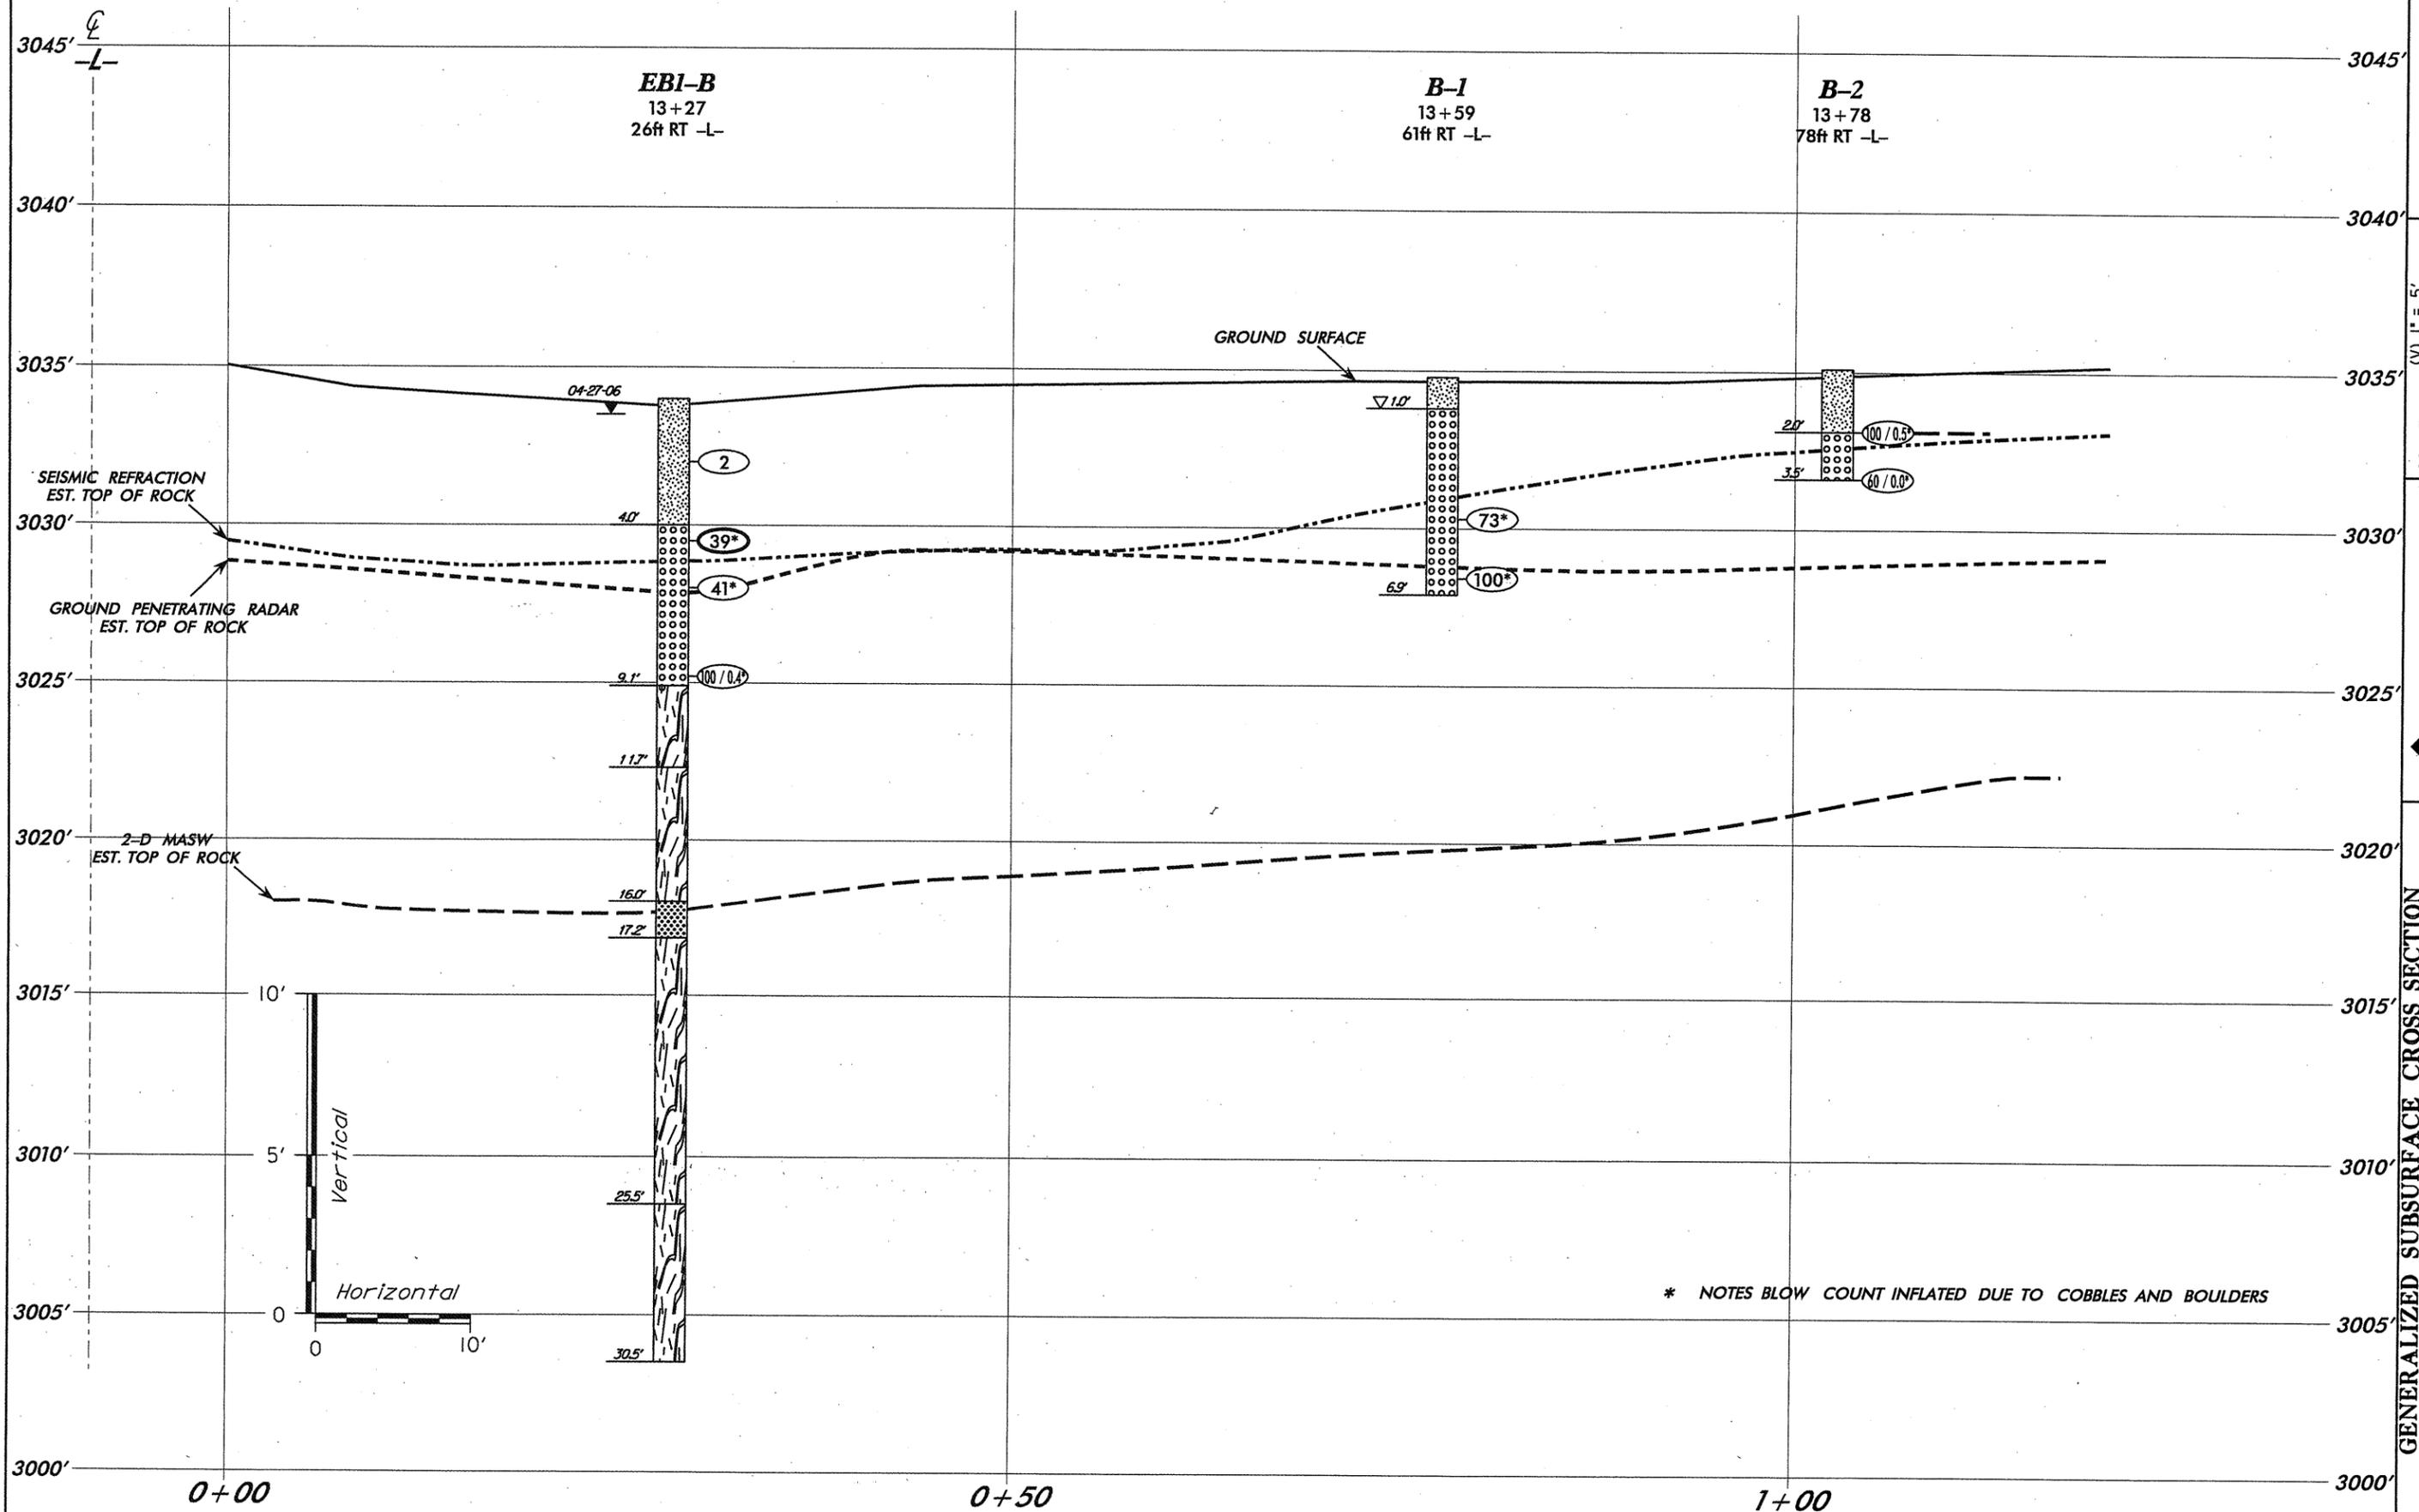
# GENERALIZED SUBSURFACE CROSS SECTION ALONG EBI-SIDE ARRAY

ALONG EBI-SIDE ARRAY  
REPLACEMENT OF BRIDGE No. 28  
OVER CURTIS CREEK ON SR 132 I  
TIP No. B-3406 WBS No. 33037.1.1 FEDERAL I.D. BRZ-132 (1.1)  
AVERY COUNTY, NORTH CAROLINA

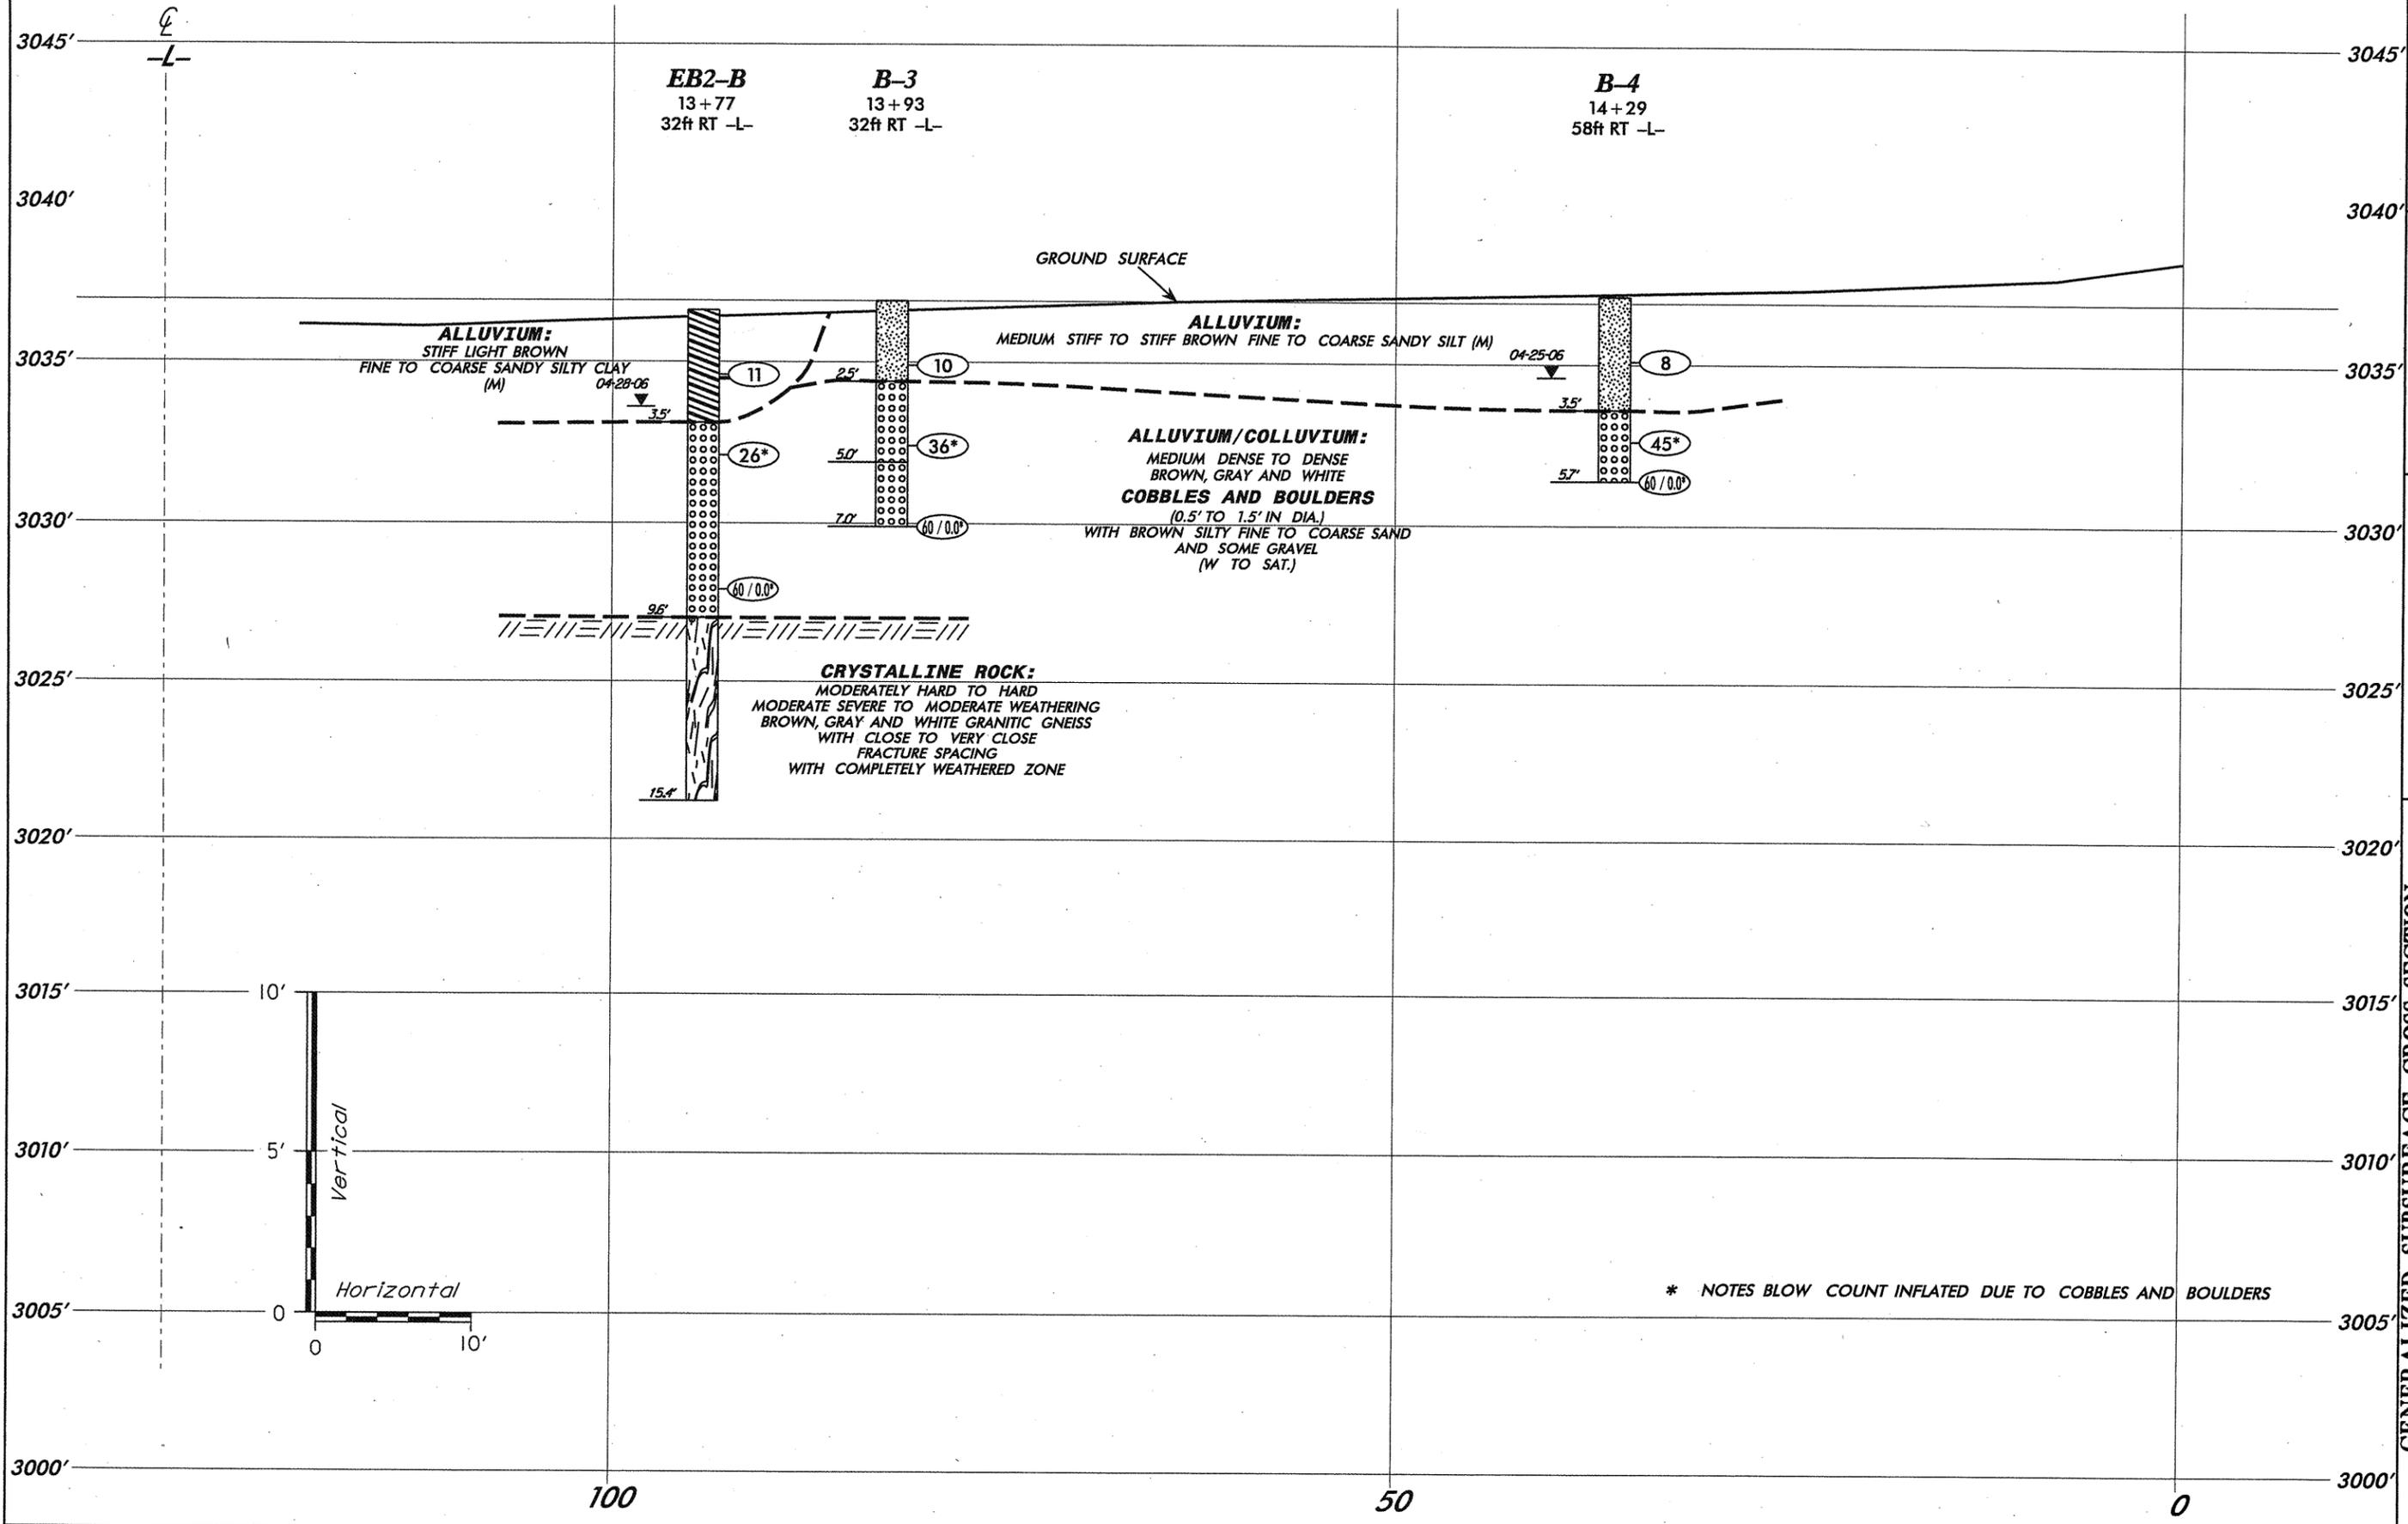
# GENERALIZED SUBSURFACE CROSS SECTION ALONG EB2-SIDE ARRAY

<p style="font-size: 8px; margin: 0;">S&amp;ME ENVIRONMENTAL SERVICES ENGINEERING - TESTING</p>	SCALE: (V) 1" = 5' (H) 1" = 10'	DATE: MAY 2006	JOB NO. 105 I-06-023	APPROVED BY: AFR DRAWN BY: TRP SHEET 13 OF 44
GENERALIZED SUBSURFACE CROSS SECTION ALONG EB2-SIDE ARRAY REPLACEMENT OF BRIDGE No. 28 OVER CURTIS CREEK ON SR 1321 TIP No. B-3406 STATE PROJECT No. 33037-1-1 FEDERAL I.D. BRZ-132 (1) AVERY COUNTY, NORTH CAROLINA

- Reflections indicative of boulders and cobbles were observed in the ground penetration radar survey, particularly on the EB2 side, near the existing bridge and downstream of the Curtis Creek Bridge. In addition, observed reflections could also have been from the water table.

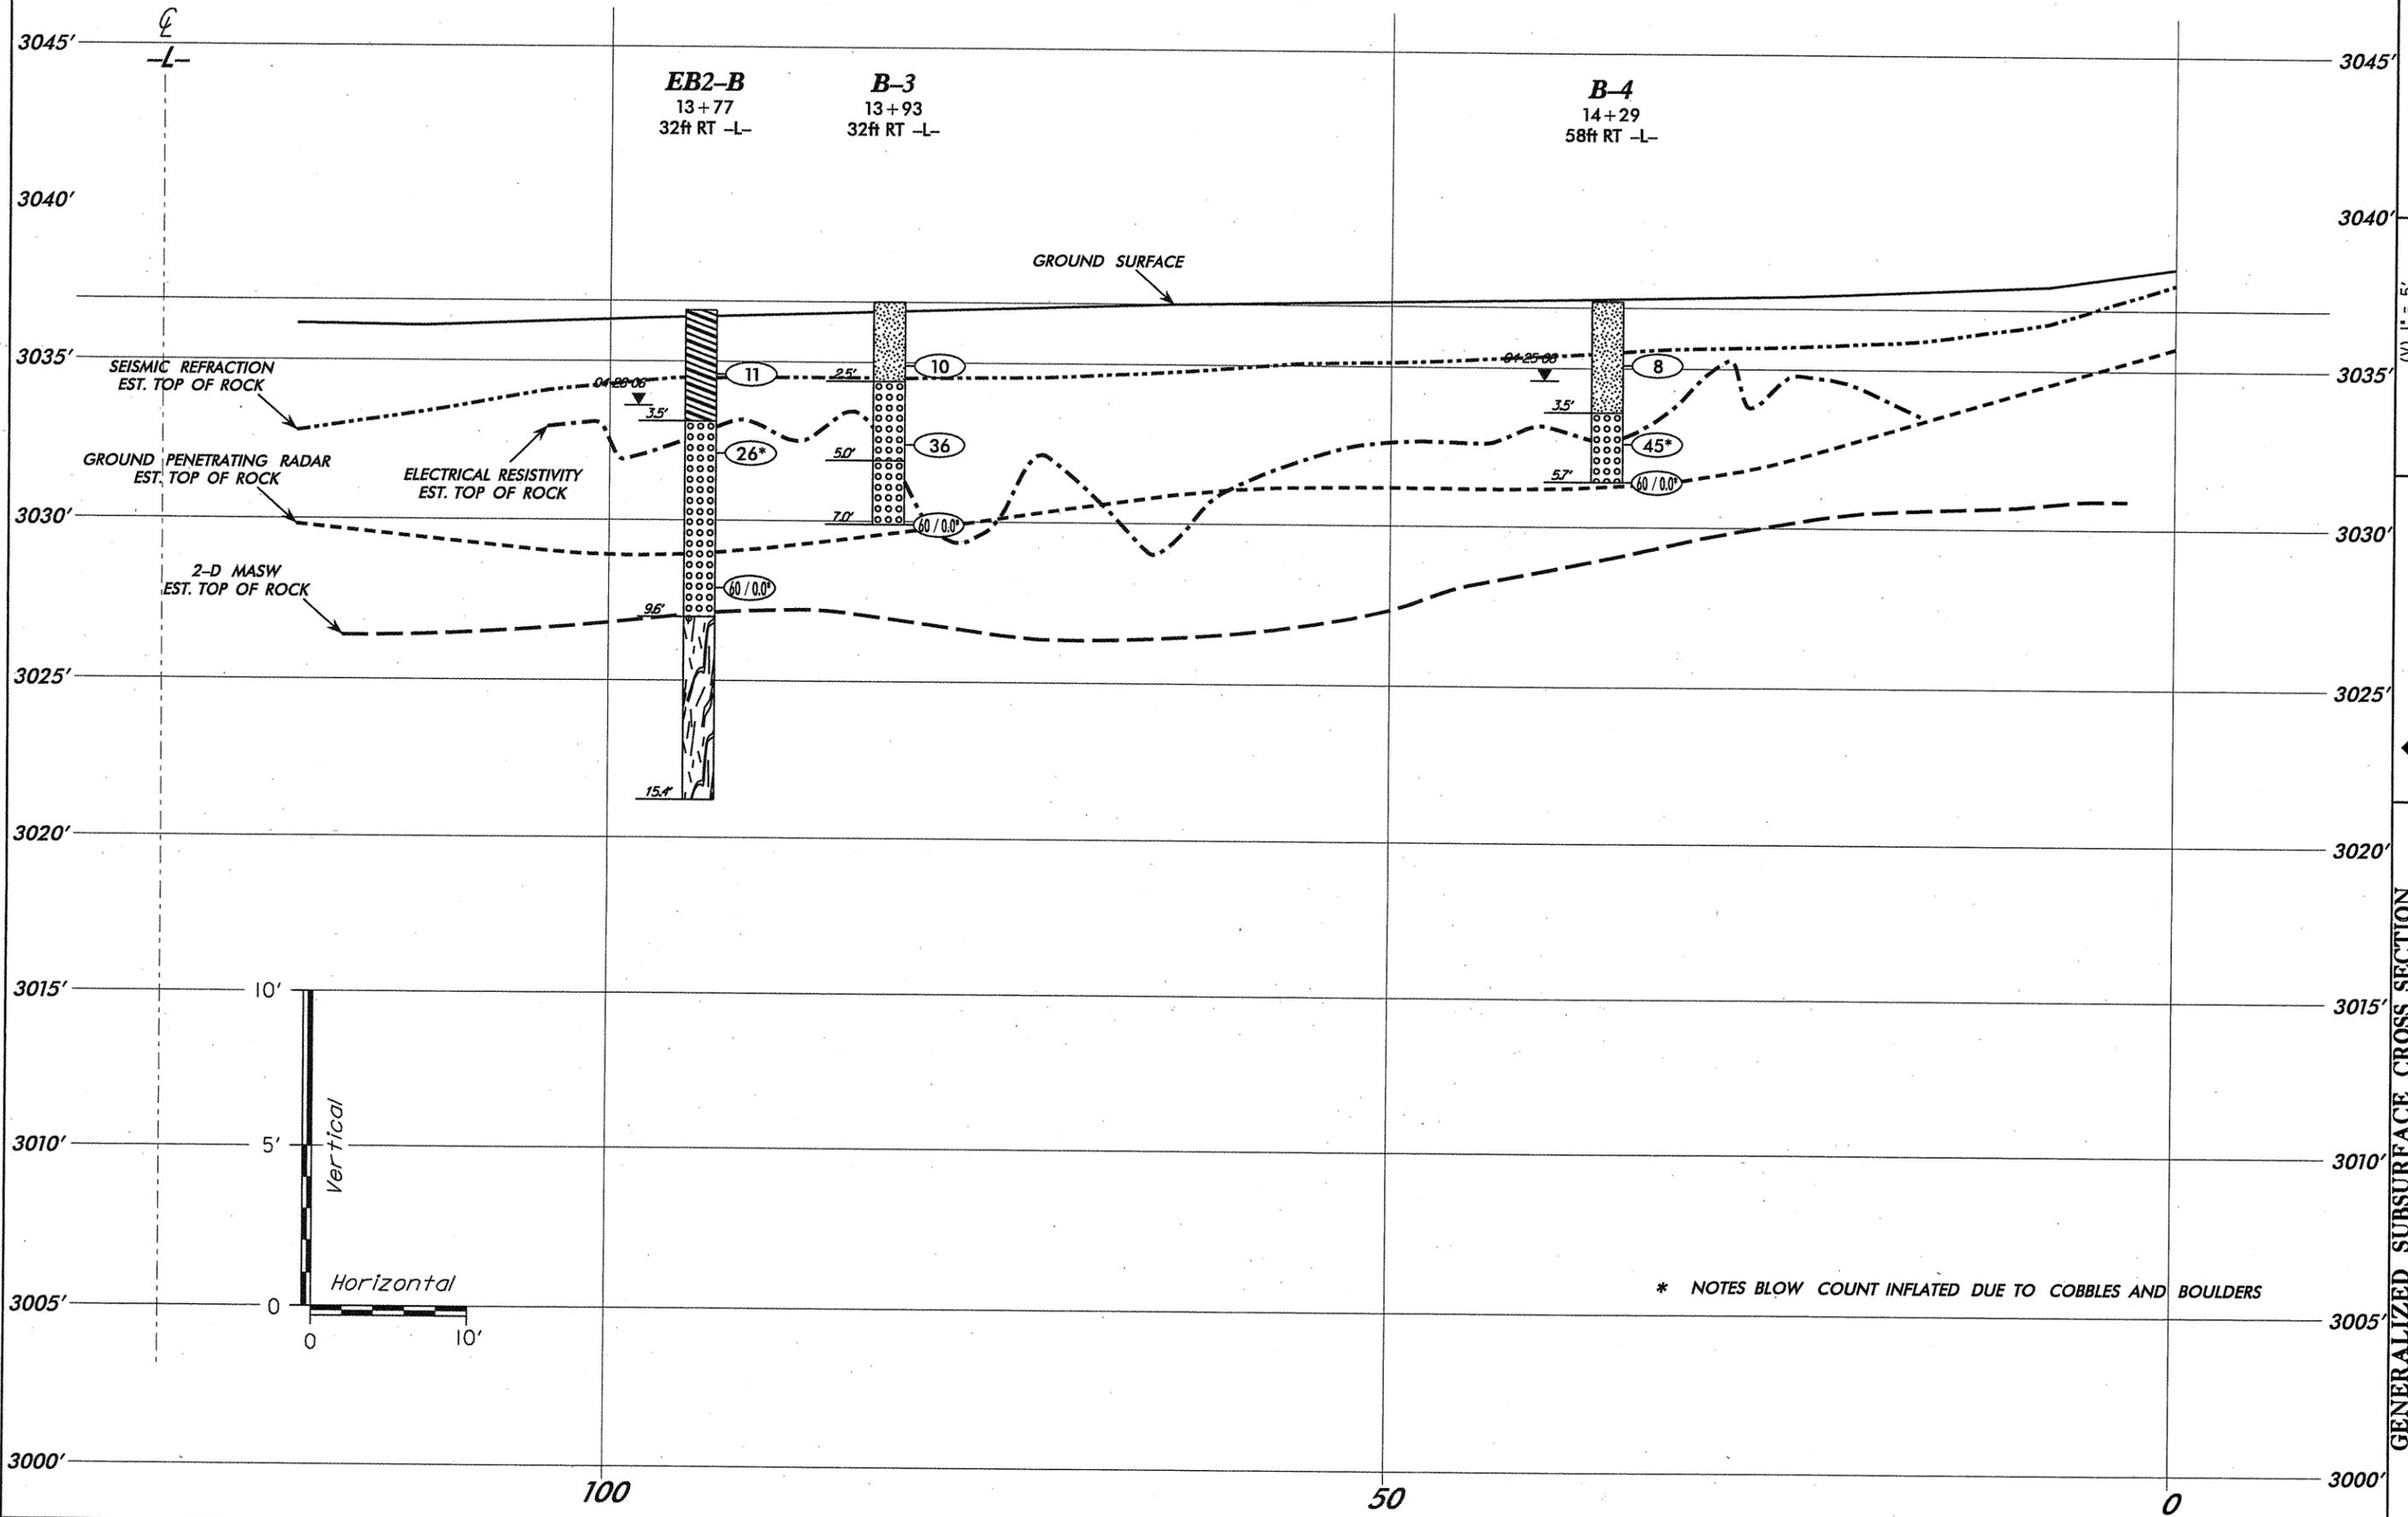
# GENERALIZED SUBSURFACE CROSS SECTION ALONG EB2-SIDE ARRAY

ALONG EB2-SIDE ARRAY  
REPLACEMENT OF BRIDGE No. 28  
OVER CURTIS CREEK ON SR 132 I  
STATE PROJECT No. 33037.1.1 FEDERAL I.D. BRZ-132 (1)  
TIP No. B-3406 AVERY COUNTY, NORTH CAROLINA

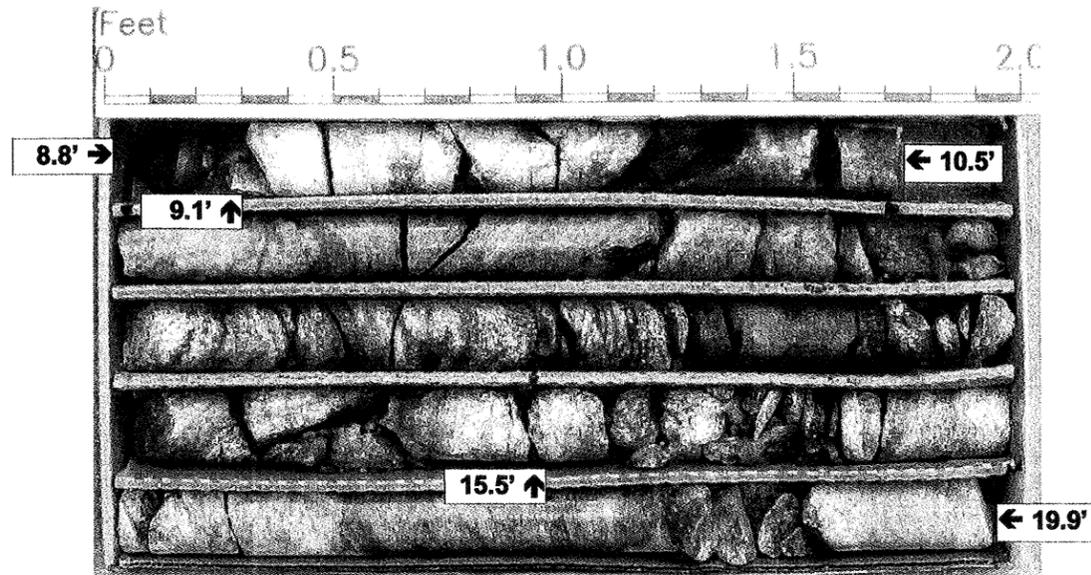
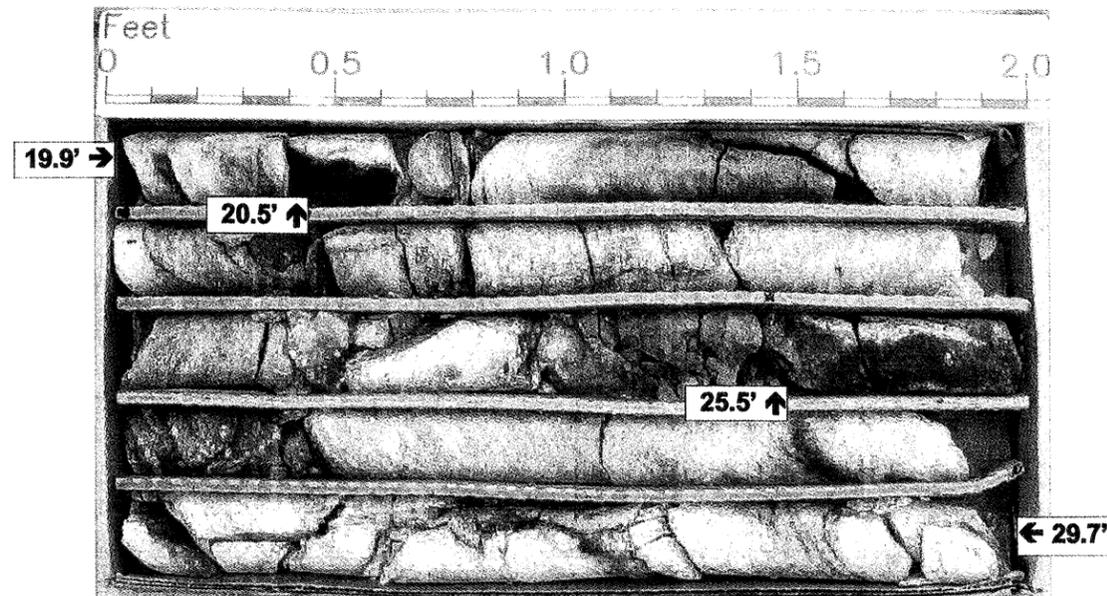
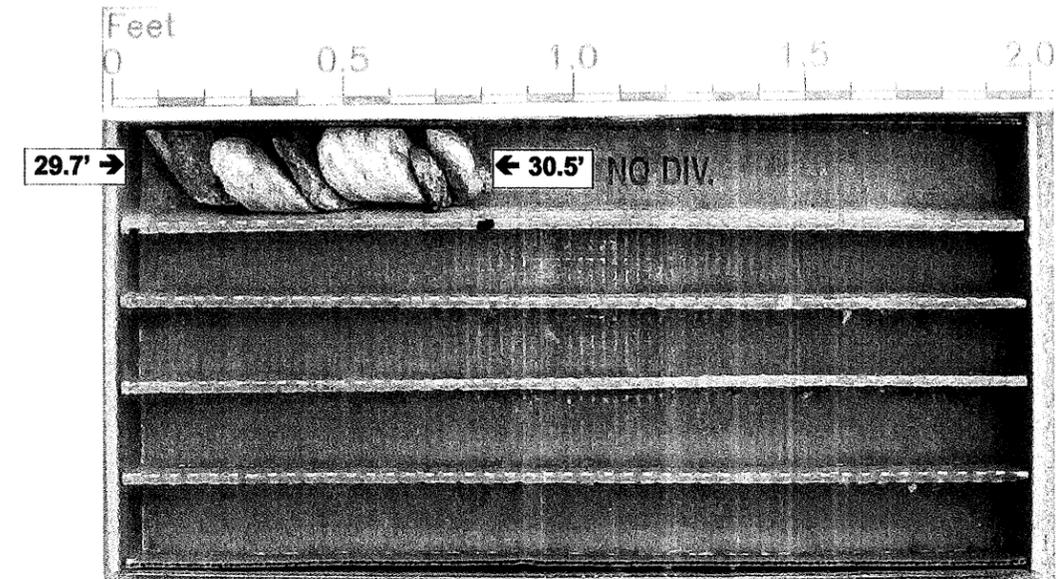
Box 1 of 3  
Top of Box @ 8.8 feet; Bottom of Box @ 19.9 feet

Box 2 of 3  
Top of Box @ 19.9 feet; Bottom of Box @ 29.7 feet

WBS No: 33037.1.1	ID: B-3406	County: Avery	Boring No.: EB1-B
Site Description: Bridge No. 28 over Curtis Creek on SR 1321 (Curtis Creek Rd.)		Driller: L. Shrader	
Collar Elev.: 3034.0 ft.	Core Size: NQ-2	Equipment: Diedrich D-50	Geologist: S. Laney
Elev. at T.D.: 3003.5 ft.	Total Depth: 30.5 ft.	Total Run: 21.7 ft.	Date: 4/26/06

Box 3 of 3  
Top of Box @ 29.7 feet; Bottom of Box @ 30.5 feet

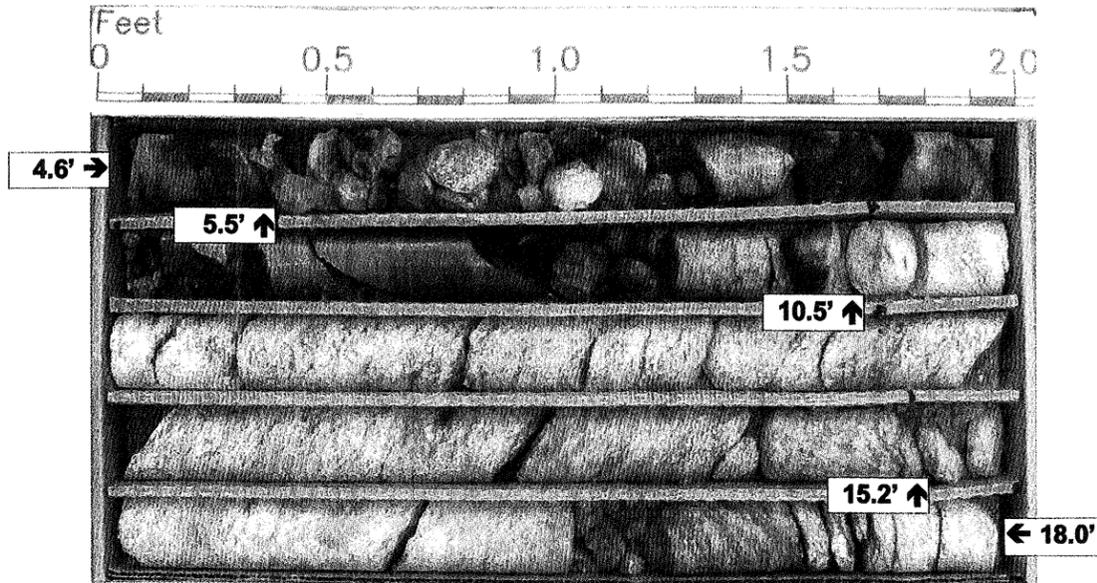
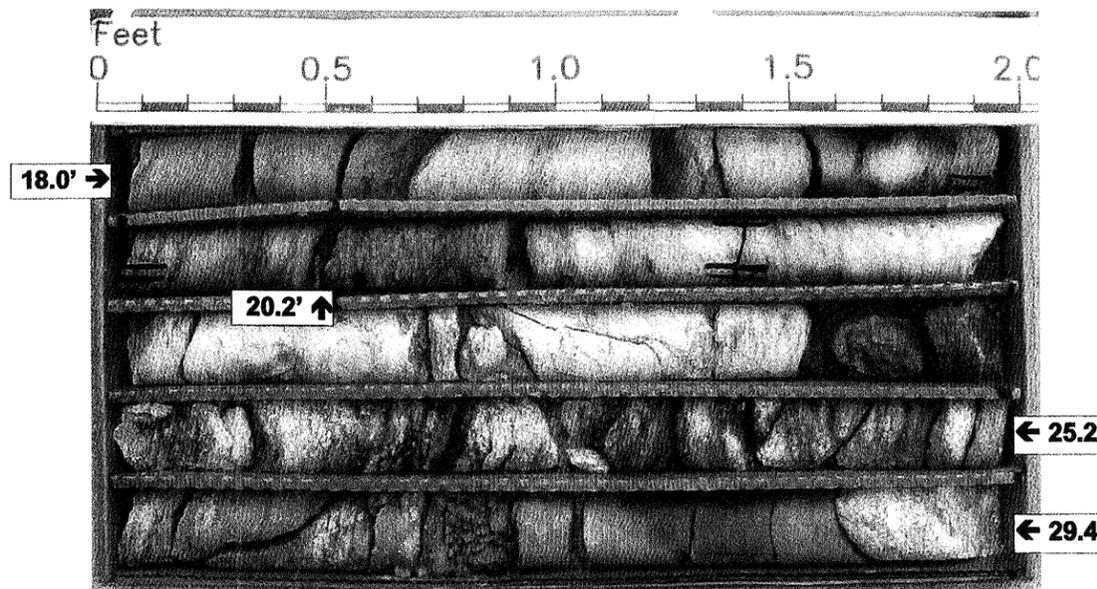
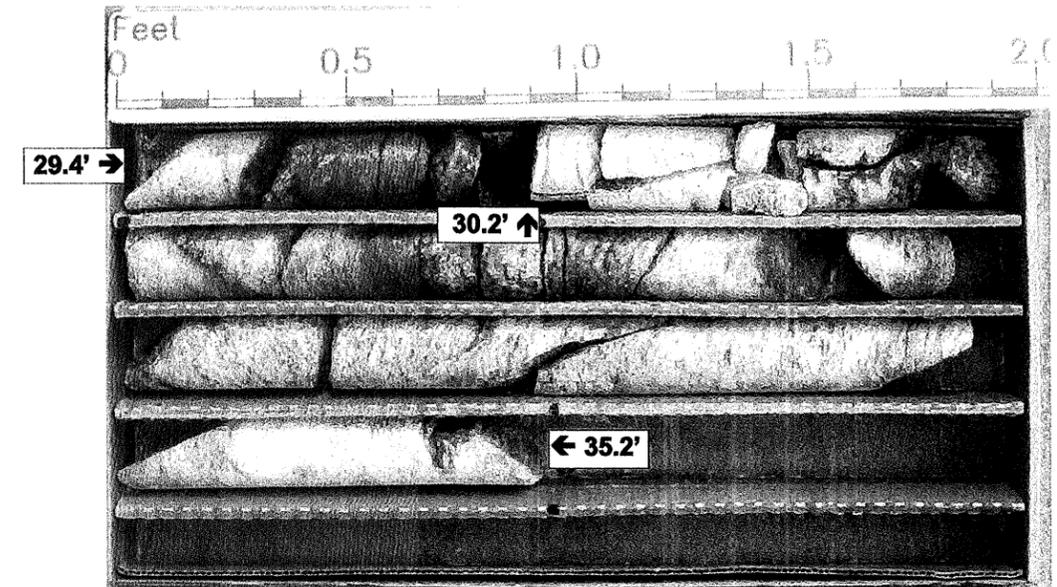
Box 1 of 3  
Top of Box @ 4.6 feet; Bottom of Box @ 18.0 feet

Box 2 of 3  
Top of Box @ 18.0 feet; Bottom of Box @ 29.4 feet

WBS No: 33037.1.1	ID: B-3406	County: Avery	Boring No.: EB2-A
Site Description: Bridge No. 28 over Curtis Creek on SR 1321 (Curtis Creek Rd.)		Driller: L. Shrader	
Collar Elev.: 3035.9 ft.	Core Size: NQ-2	Equipment: Diedrich D-50	Geologist: S. Laney
Elev. at T.D.: 3000.7 ft.	Total Depth: 35.2 ft.	Total Run: 30.6 ft.	Date: 4/25/06

Box 3 of 3  
Top of Box @ 29.4 feet; Bottom of Box @ 35.2 feet

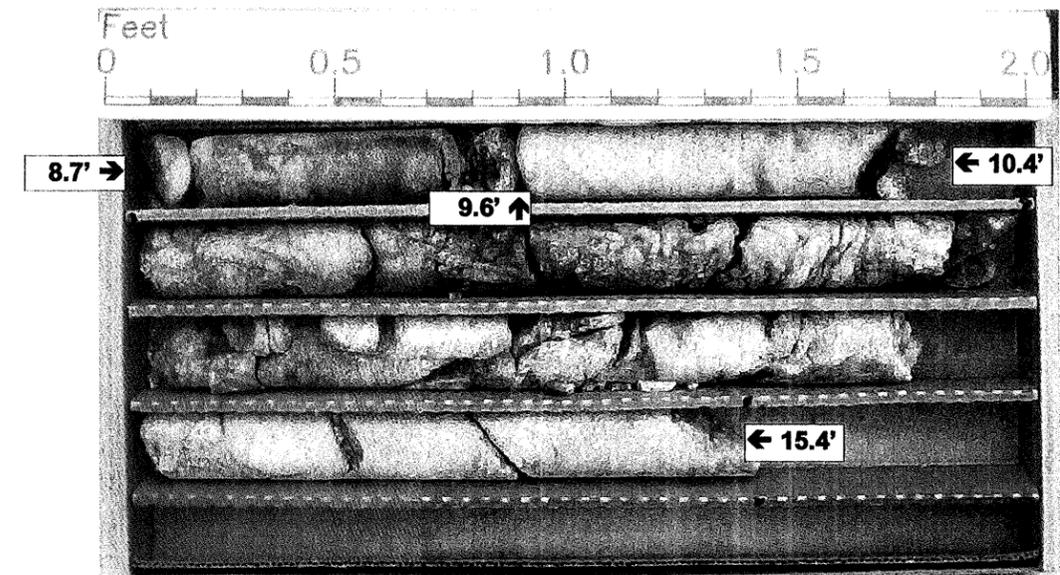
Box 1 of 1  
Top of Box @ 8.7 feet; Bottom of Box @ 15.4 feet

WBS No: 33037.1.1	ID: B-3406	County: Avery	Boring No.: EB2-B
Site Description: Bridge No. 28 over Curtis Creek on SR 1321 (Curtis Creek Rd.)			Driller: L. Shrader
Collar Elev.: 3036.6 ft.	Core Size: NQ-2	Equipment: Diedrich D-50	Geologist: S. Laney
Elev. at T.D.: 3021.2 ft.	Total Depth: 15.4 ft.	Total Run: 6.7 ft.	Date: 4/27/06

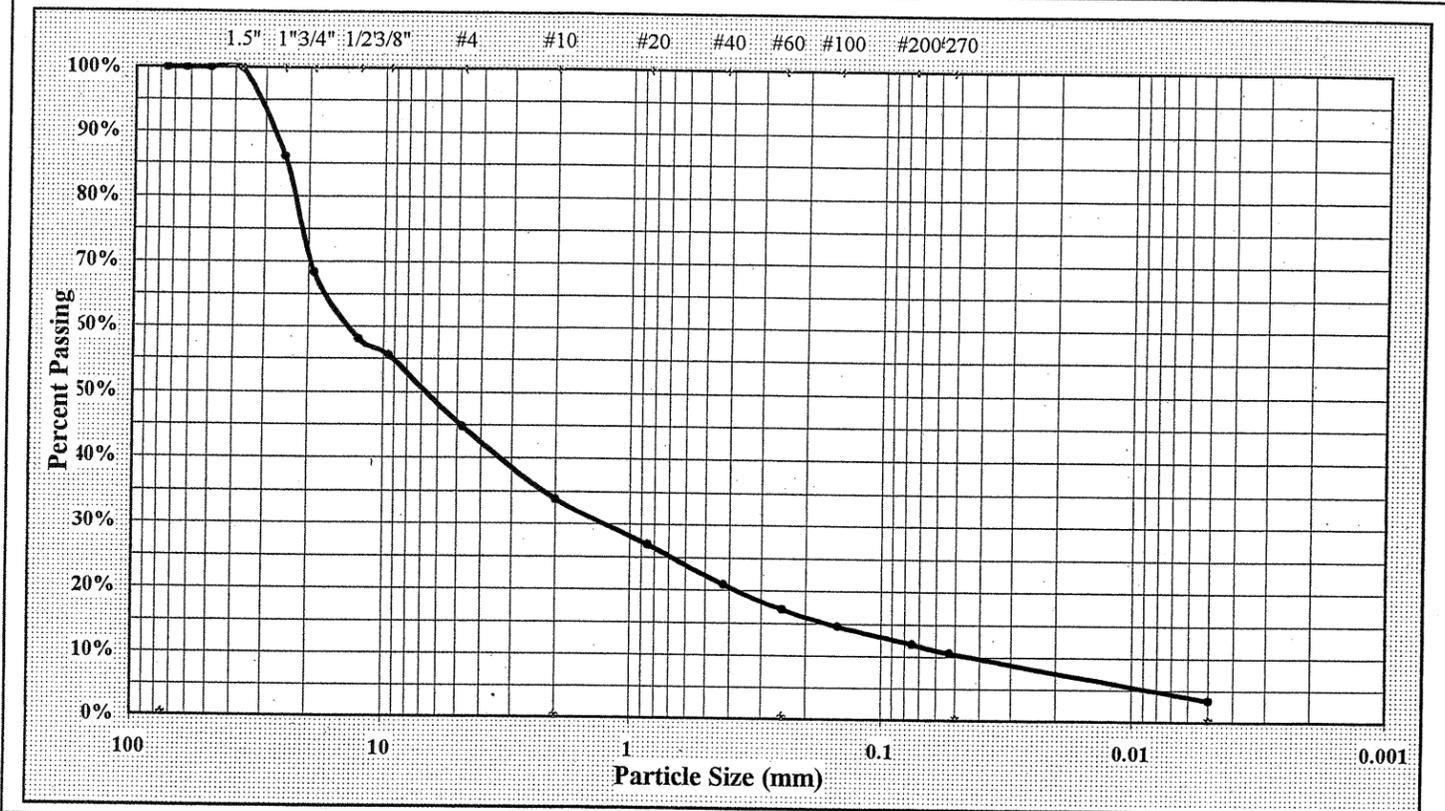
Boring #: EB1-B Sample #: SS-1 Sample Date: 4/24-28/06  
 Location: STA. 13+27 Offset: 26' RT Depth: 4.0-5.0  
 Sample Description: BROWN COBBLES AND BOULDERS WITH SILTY F. TO CSE. SAND (A-1-a)

As Defined by NCDOT			
Gravel	< 75 mm and > 2.00 mm	Fine Sand	< 0.25 mm and > 0.05 mm
Coarse Sand	< 2.00 mm and > 0.25 mm	Silt	< 0.05 and > 0.005 mm
		Clay	< 0.005 mm
Maximum Particle Size	1.5"	Coarse Sand	16.6%
		Fine Sand	6.7%
Gravel	66.2%	Silt	7%
		Clay	3%
Apparent Relative Density	2.650	Moisture Content	% Passing #200 11.9%
Liquid Limit	N.A.	Plastic Limit	N.A.
		Plastic Index	N.A.

Soil Mortar (-#10 Sieve)			
Coarse Sand	49.2%	Fine Sand	19.7%
		Silt	21%
		Clay	10%
Description of Sand & Gravel Particles:	Rounded <input type="checkbox"/>	Angular <input type="checkbox"/>	Hard & Durable <input type="checkbox"/>
	Soft <input type="checkbox"/>	Weathered & Friable <input type="checkbox"/>	
Mechanical Stirring Apparatus (A)	Length of Dispersion Period: 1 min.	Dispersing Agent:	Sodium Hexametaphosphate: 40 g./ Liter

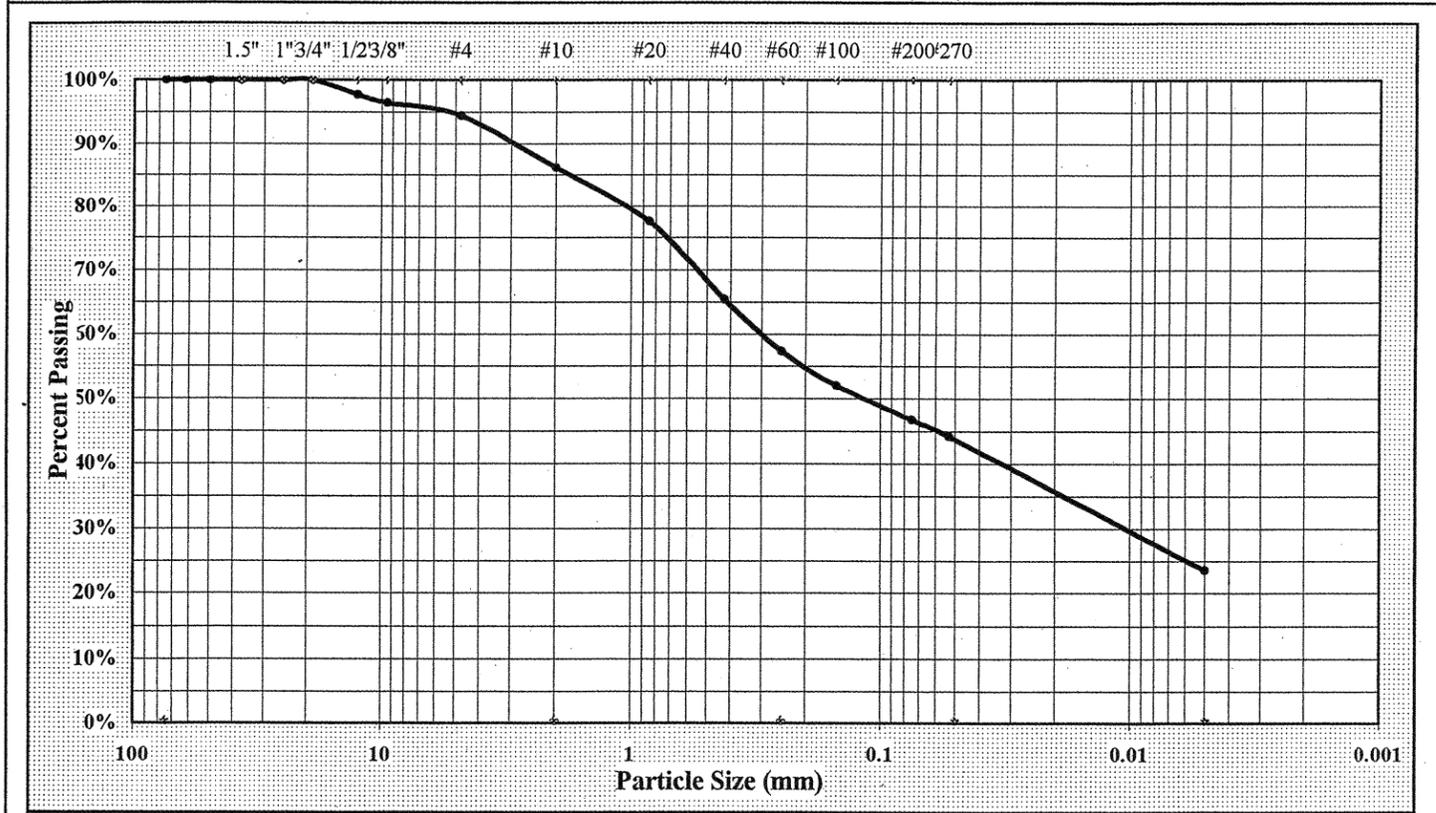
Boring #: EB2-B	Sample #: SS-2	Sample Date: 4/24-28/06
Location: STA. 13+77	Offset: 32' RT	Depth: 1.0-2.5'
Sample Description: BROWN FINE TO COARSE SANDY SILTY CLAY (A-6)

As Defined by NCDOT		Fine Sand	< 0.25 mm and > 0.05 mm
Gravel	< 75 mm and > 2.00 mm	Silt	< 0.05 and > 0.005 mm
Coarse Sand	< 2.00 mm and > 0.25 mm	Clay	< 0.005 mm

Maximum Particle Size	3/4"	Coarse Sand	28.9%	Silt	21%
Gravel	13.8%	Fine Sand	13.1%	Clay	24%
Apparent Relative Density	2.650	Moisture Content		% Passing #200	46.7%
Liquid Limit	38	Plastic Limit	26	Plastic Index	12

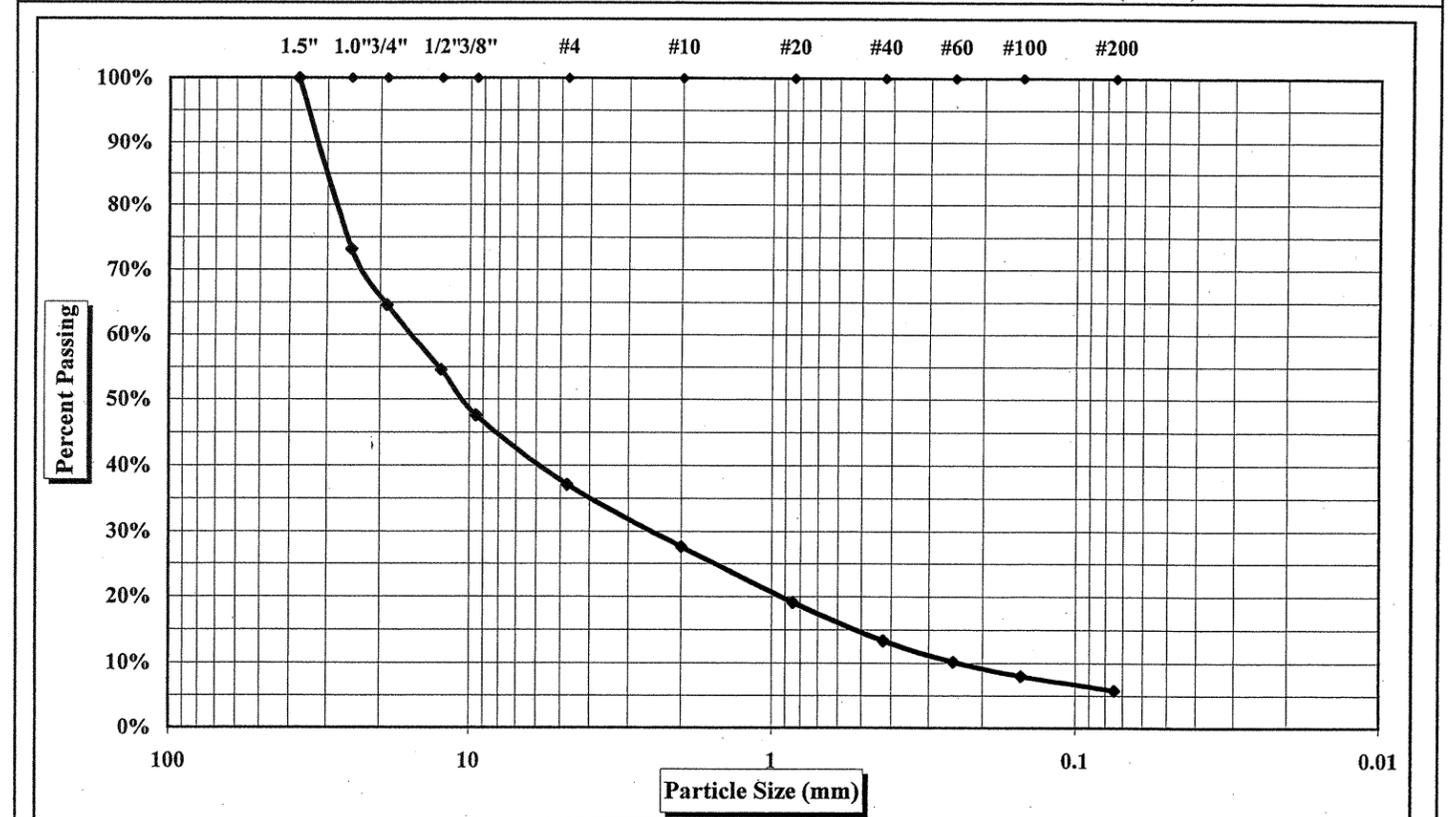
Boring #: EB2-B	Sample #: SS-3	Sample Date: 4/24-28/06
Location: STA.13+77	Offset: 32' RT	Depth: 3.5-5.0'
Sample Description: BROWN COBBLES AND BOULDERS WITH F. TO CSE. SAND (A-1-a)

Cobbles	< 300 mm (12") and > 75 mm (3")	Fine Sand	< 0.425 mm and > 0.075 mm (#200)
Gravel	< 75 mm and > 4.75 mm (#4)	Silt	< 0.075 and > 0.005 mm
Coarse Sand	< 4.75 mm and > 2.00 mm (#10)	Clay	< 0.005 mm
Medium Sand	< 2.00 mm and > 0.425 mm (#40)	Colloids	< 0.001 mm

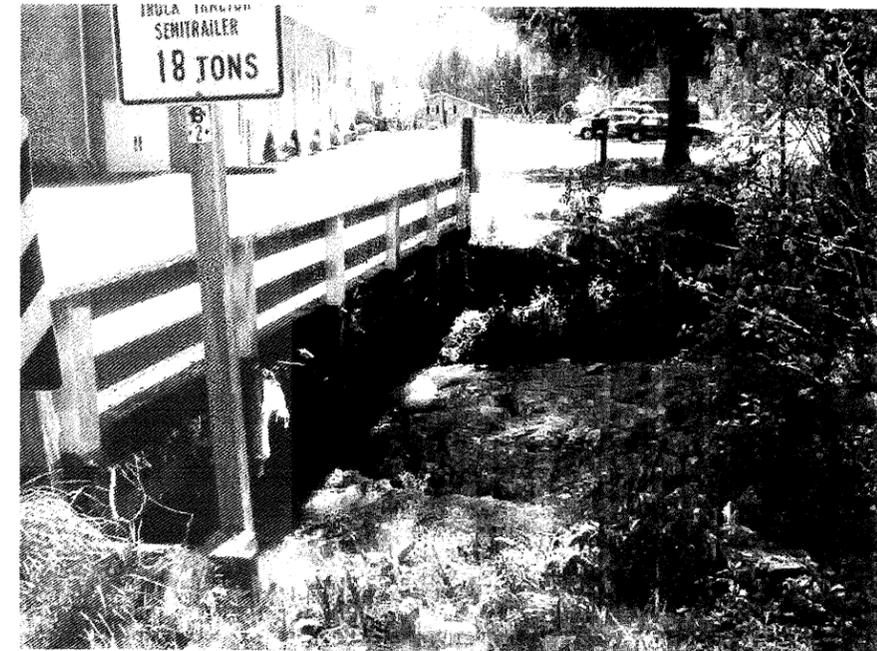
**Photograph No. 3:**  
This photograph was taken from the right side of the -L- alignment, looking east, along the existing bridge.

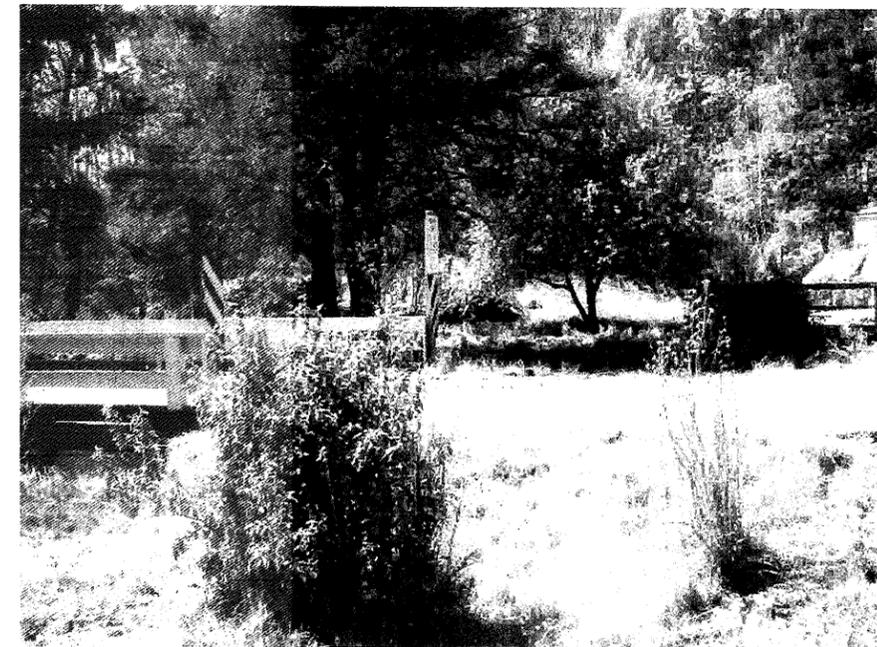
**Photograph No. 4:**  
This photograph was taken from the left side of the -L- alignment, looking south, across proposed End Bent No. 1 of the replacement bridge.

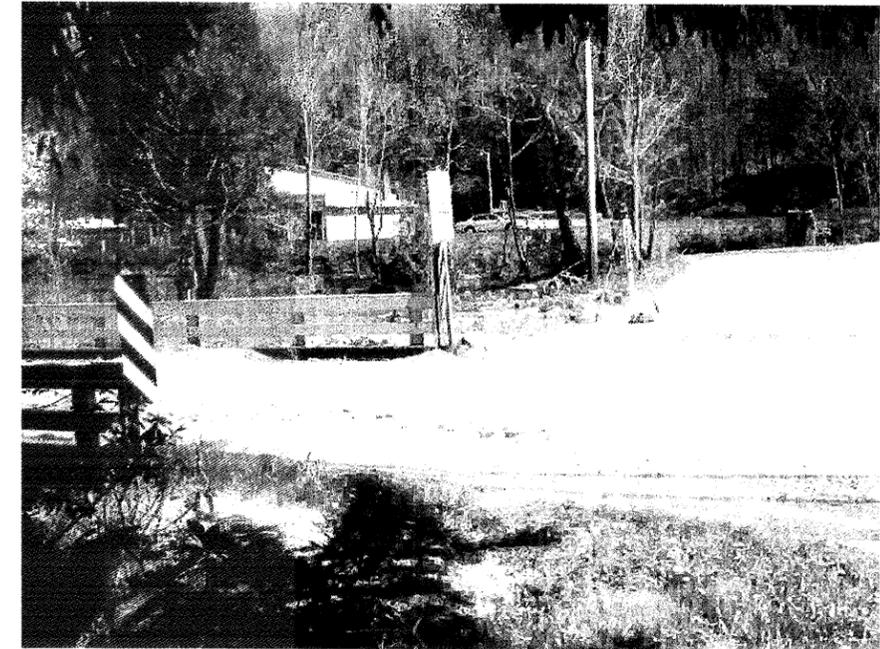
**Photograph No. 7:**  
This photograph was taken from the right side of the -L- alignment, looking north, across proposed End Bent No. 2 of the replacement bridge.

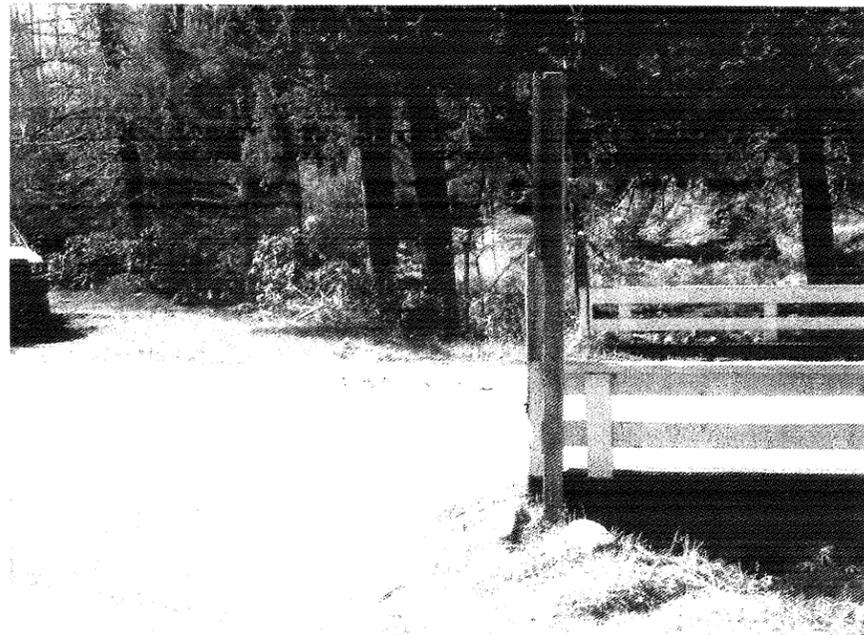
**Photograph No. 6:**  
This photograph was taken from the left side of the -L- alignment, looking south, across proposed End Bent No. 2 of the replacement bridge.
