PROJECT: 33037.1.1 ID: B-3406

# STRUCTURE SUBSURFACE INVESTIGATION

STATE PROJECT 33037.1.1 I.D. NO. B-3406  
 F.A. PROJECT BRZ-1321(1)  
 COUNTY AVERY  
 PROJECT DESCRIPTION BRIDGE No. 28  
OVER CURTIS CREEK ON SR 1321(CURTIS CREEK RD.)

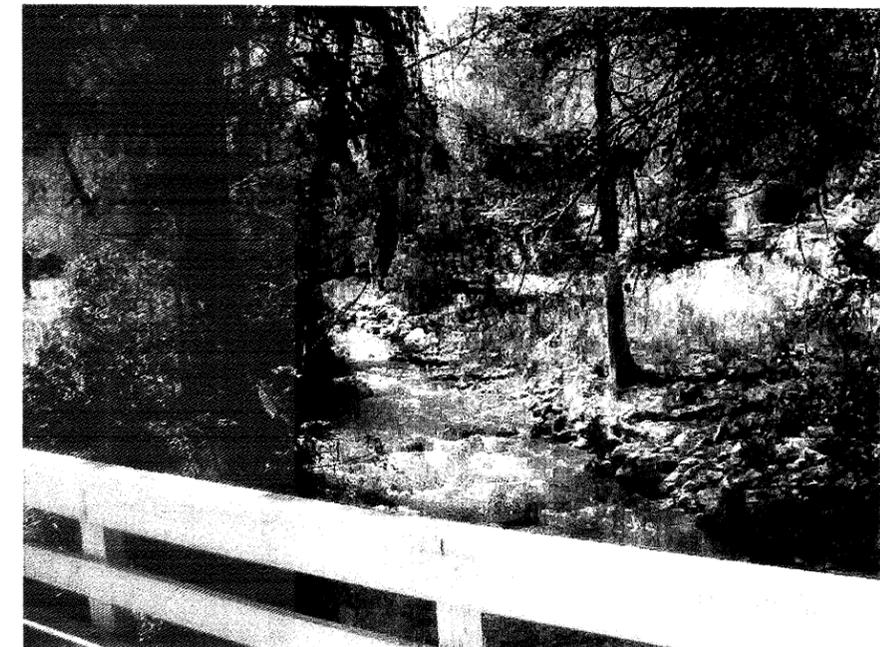
**Photograph No. 8:**  
This photograph was taken from the existing bridge, looking south (upstream) at Curtis Creek.

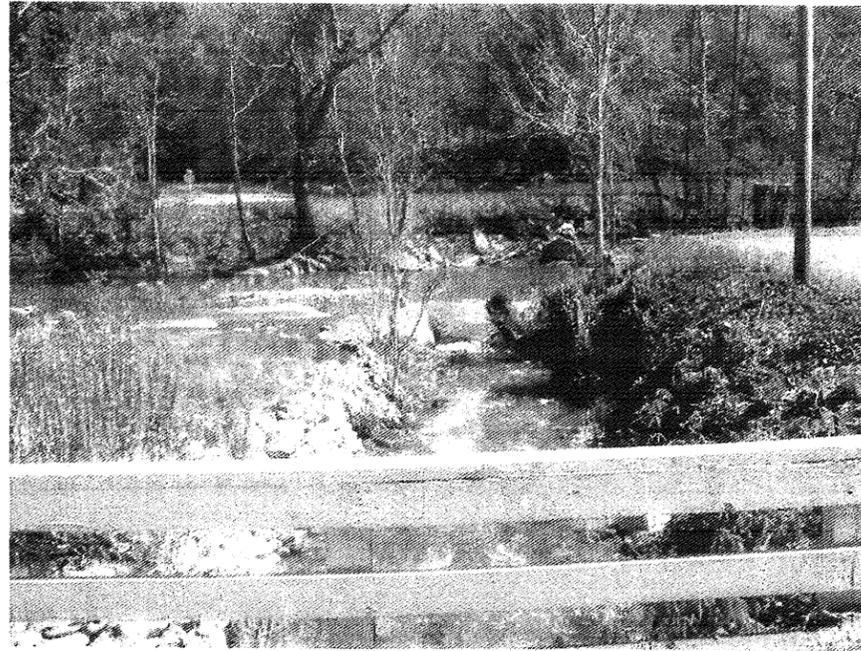
**Photograph No. 9:**  
This photograph was taken from the existing bridge, looking north (downstream) at Curtis Creek.

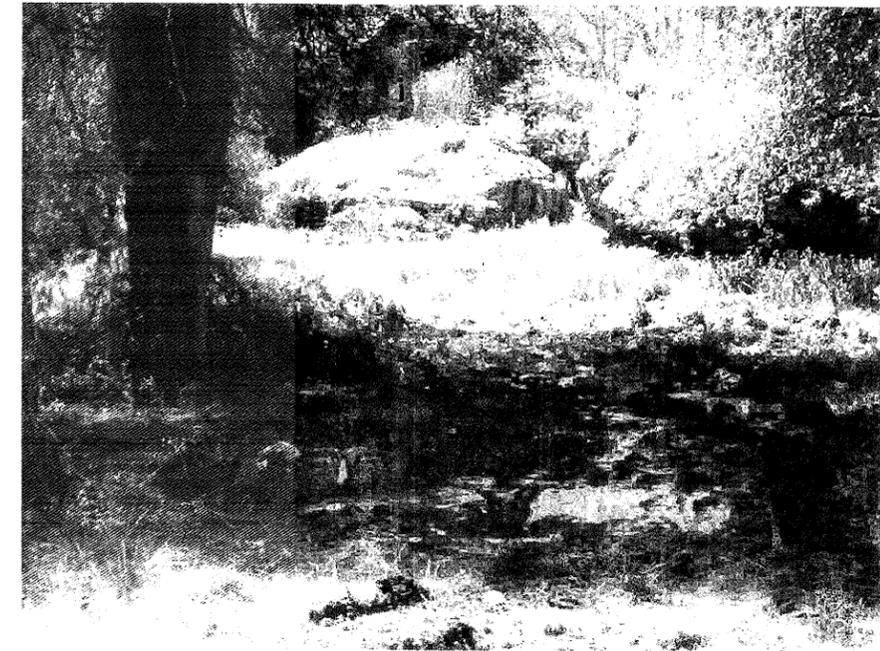
**Photograph No. 11:**  
This photograph was taken from the right side of the -L- alignment, looking south, along the EB1-side MASW array line.

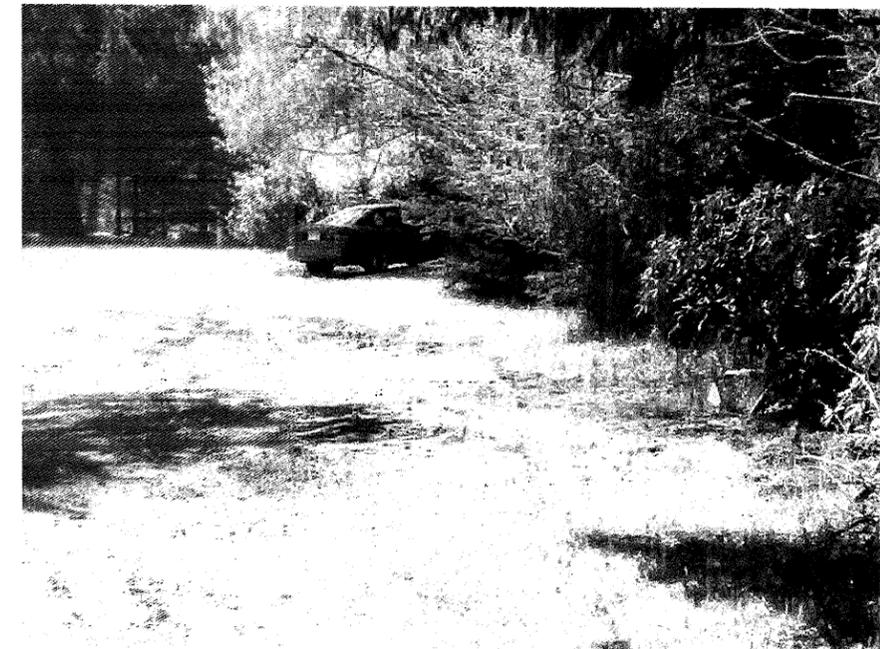
**Photograph No. 12:**  
This photograph was taken from the right side of the -L- alignment, looking south, along the EB2-side MASW array line.

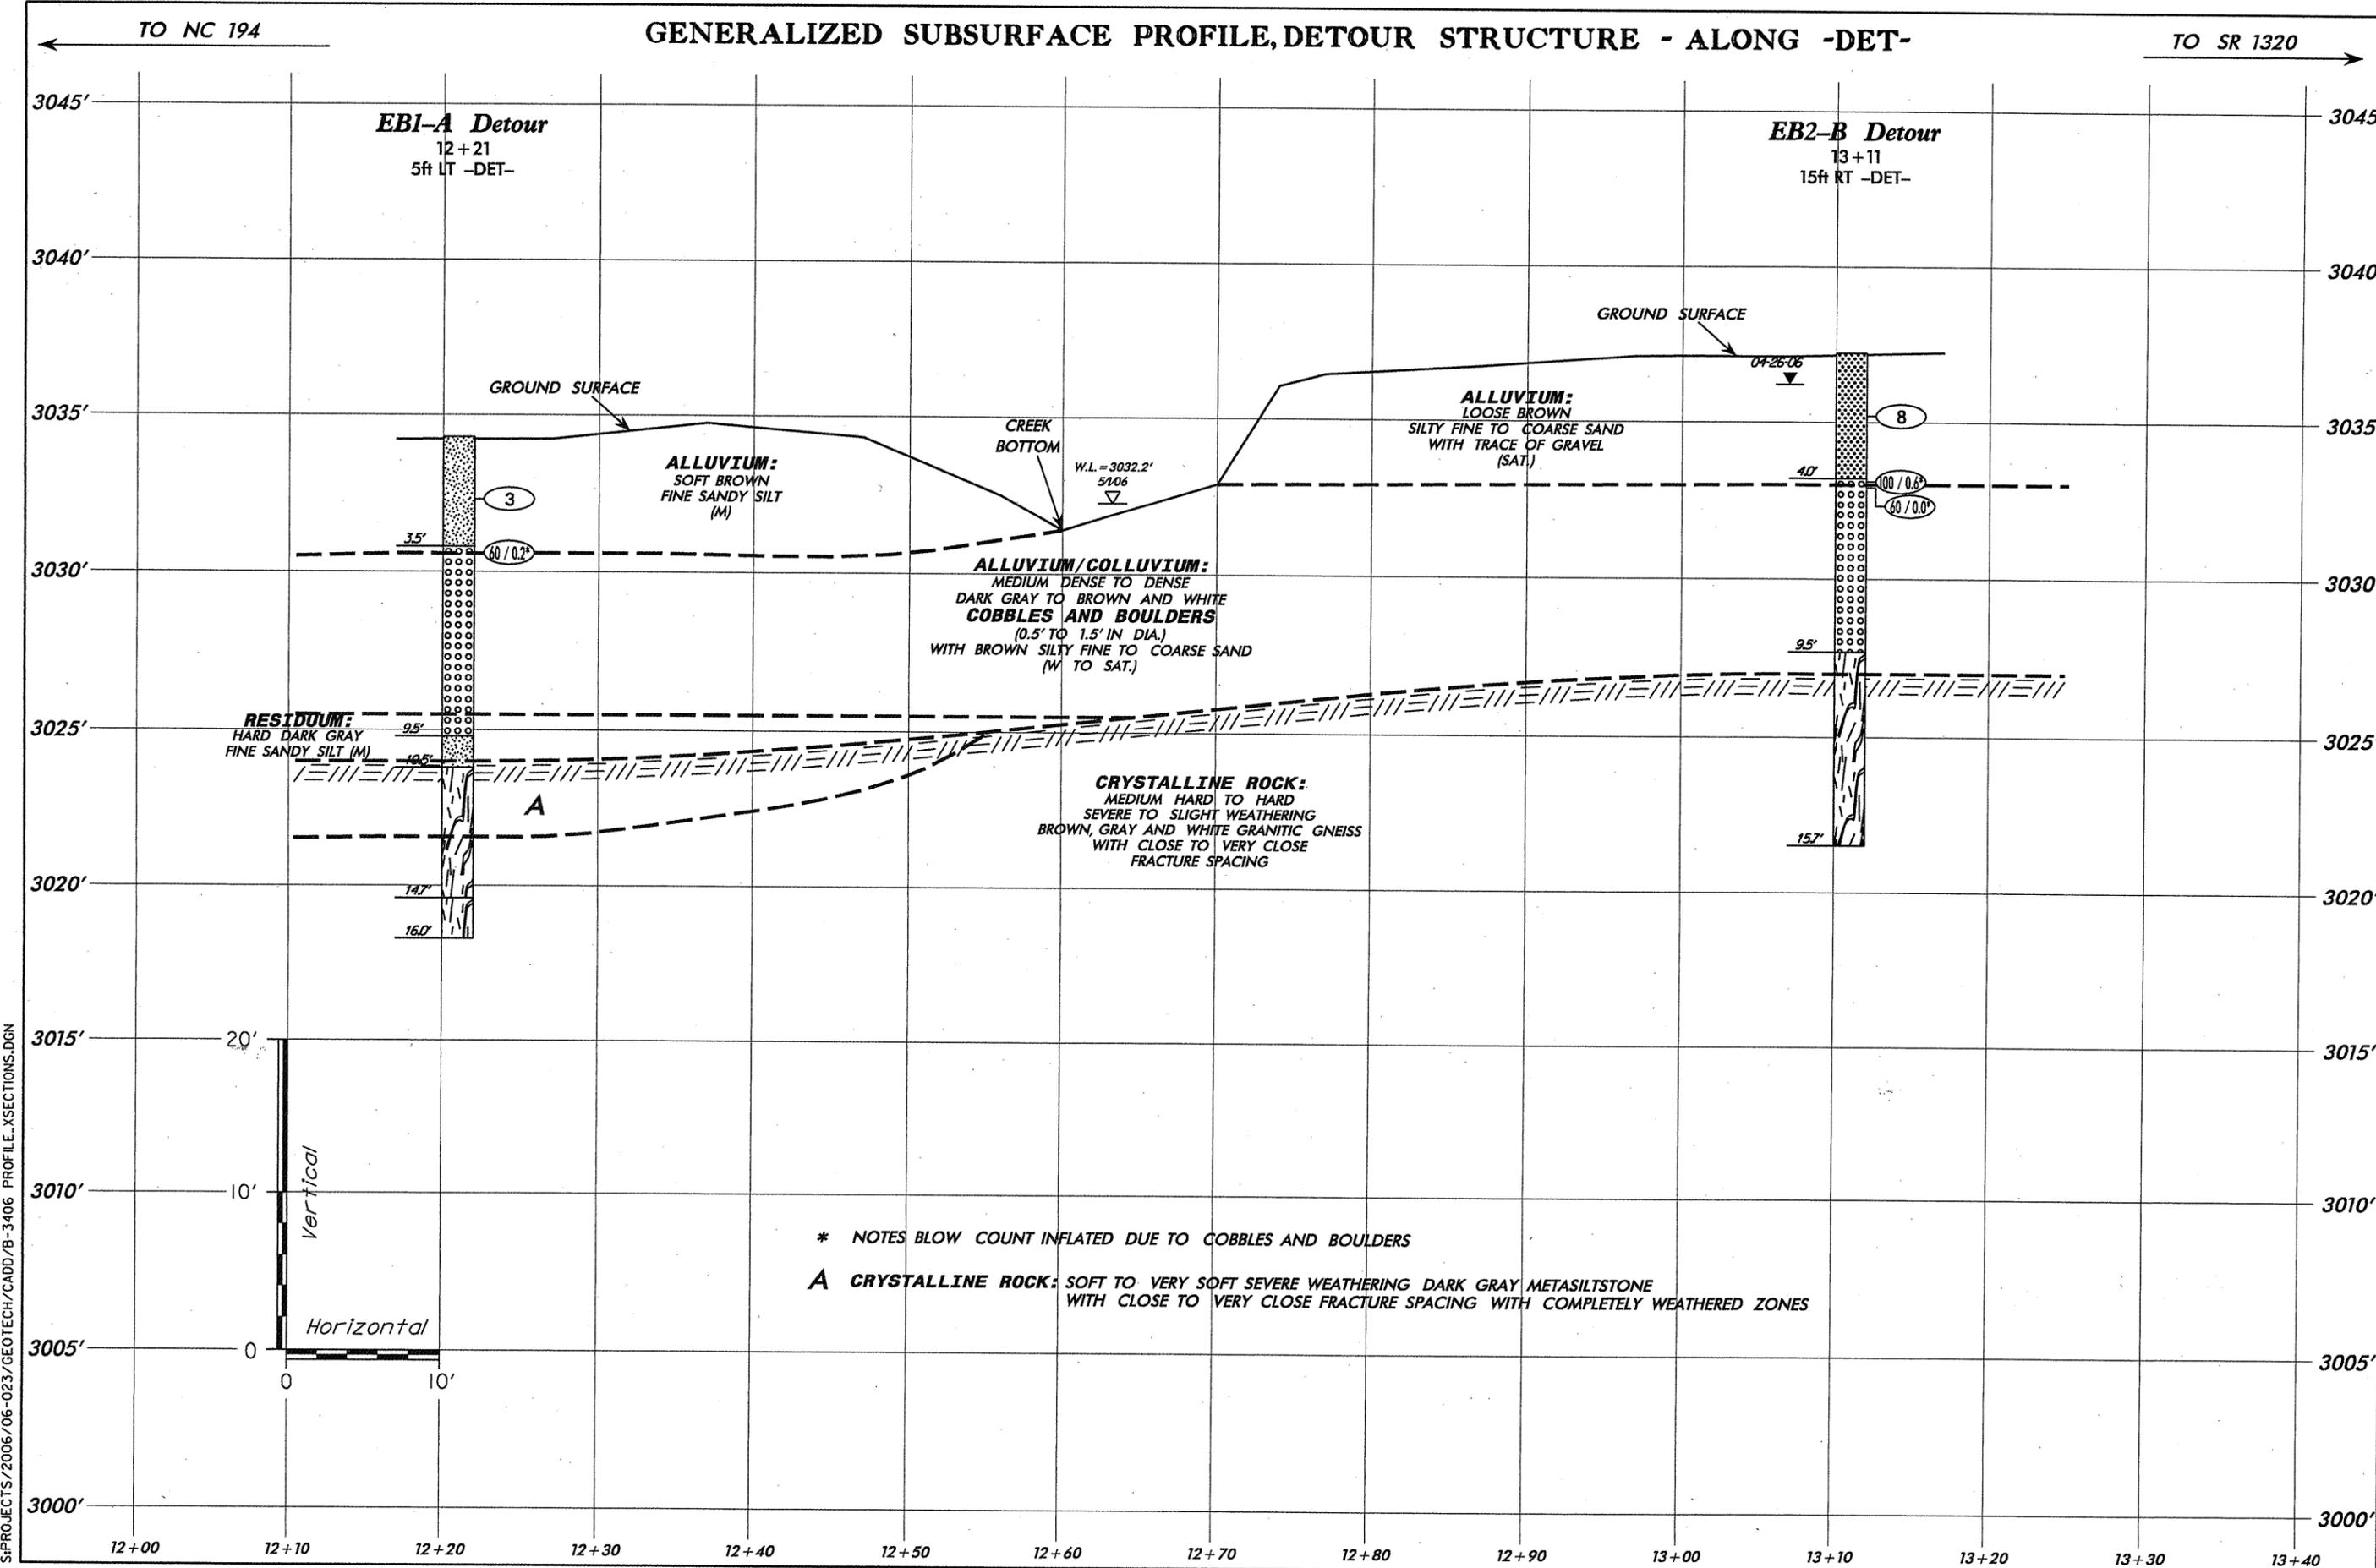
\* NOTES BLOW COUNT INFLATED DUE TO COBBLES AND BOULDERS

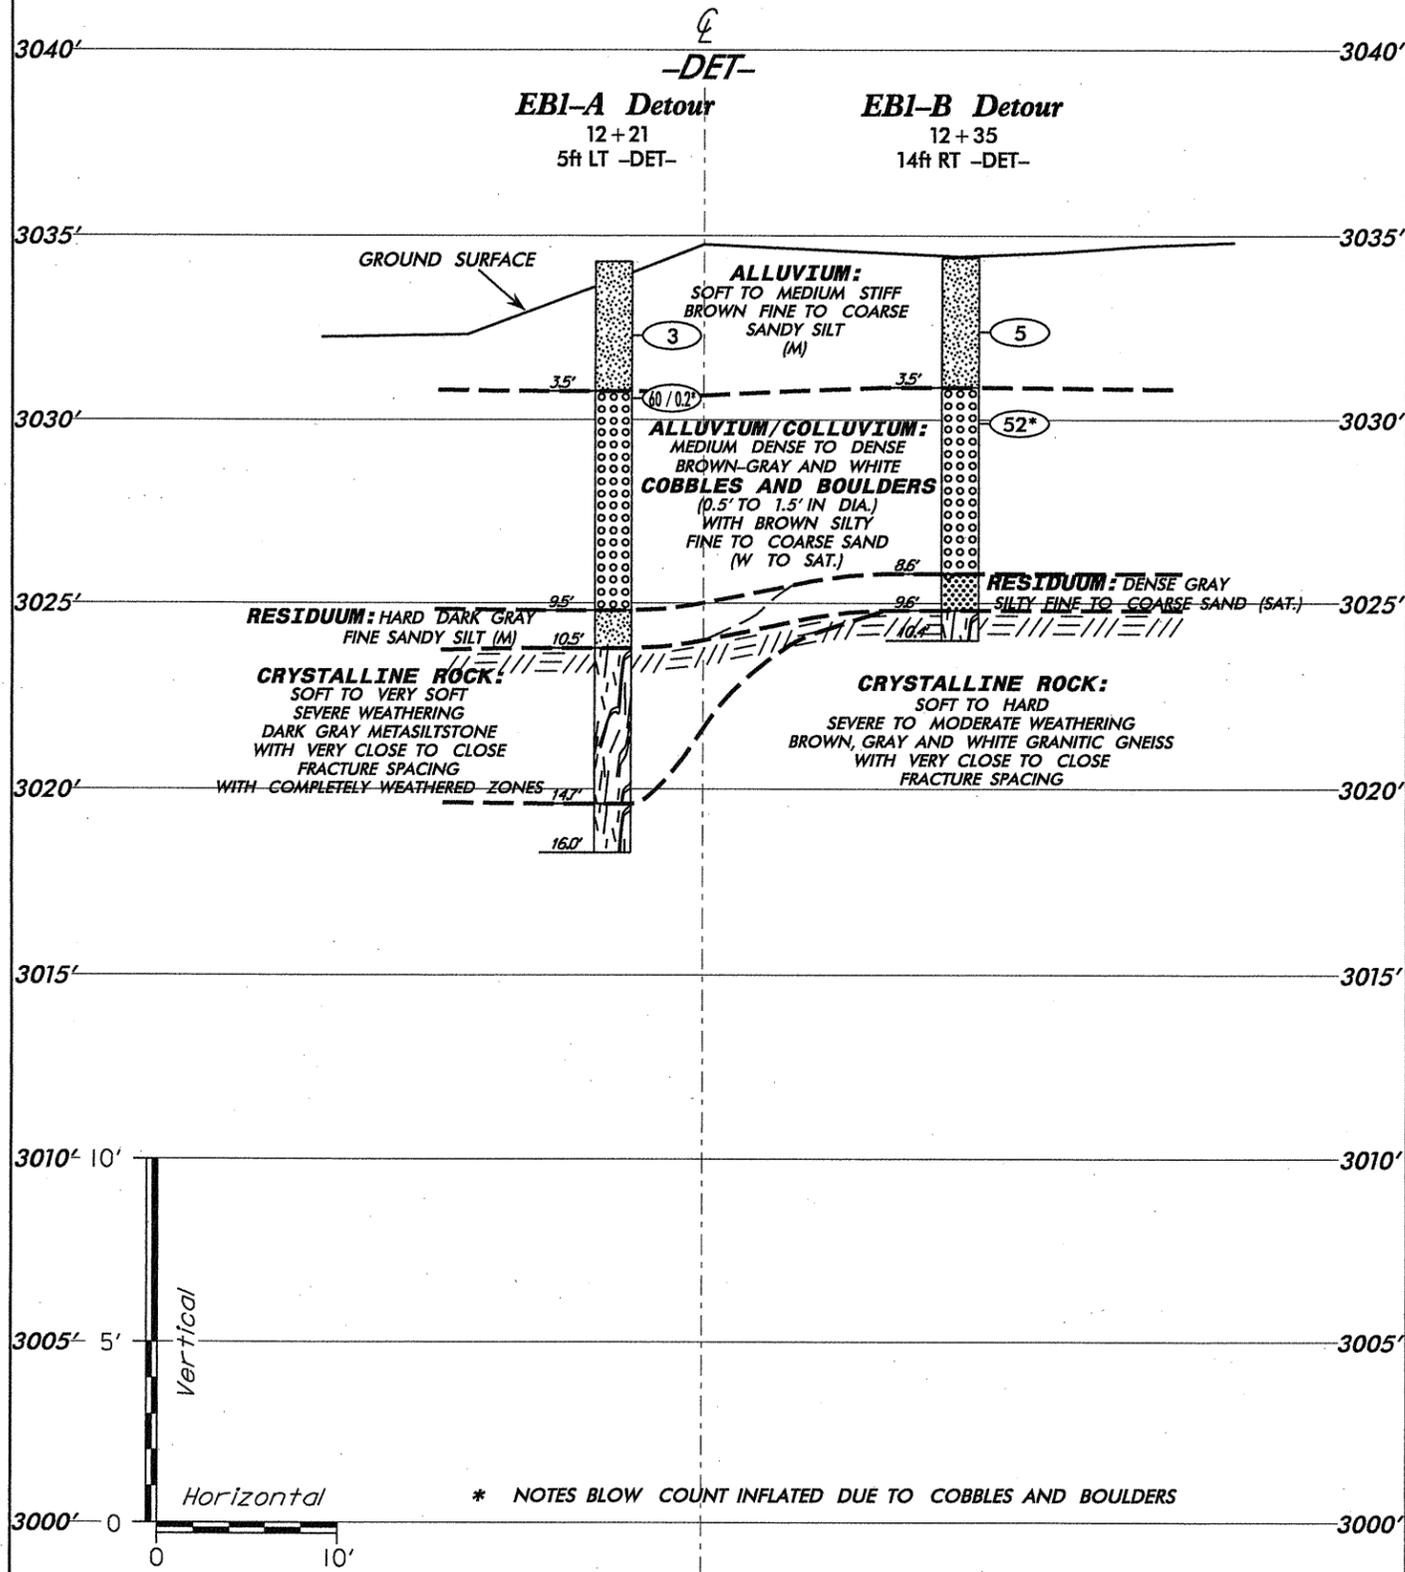
GENERALIZED SUBSURFACE CROSS SECTION THROUGH DETOUR STRUCTURE - END BENT No.1

SCALE: (V) 1"=5' (H) 1"= 10'  
 CHECKED BY: AFR  
 DRAWN BY: TRP  
 DATE: MAY 2006  
 JOB NO. 1051-06-023

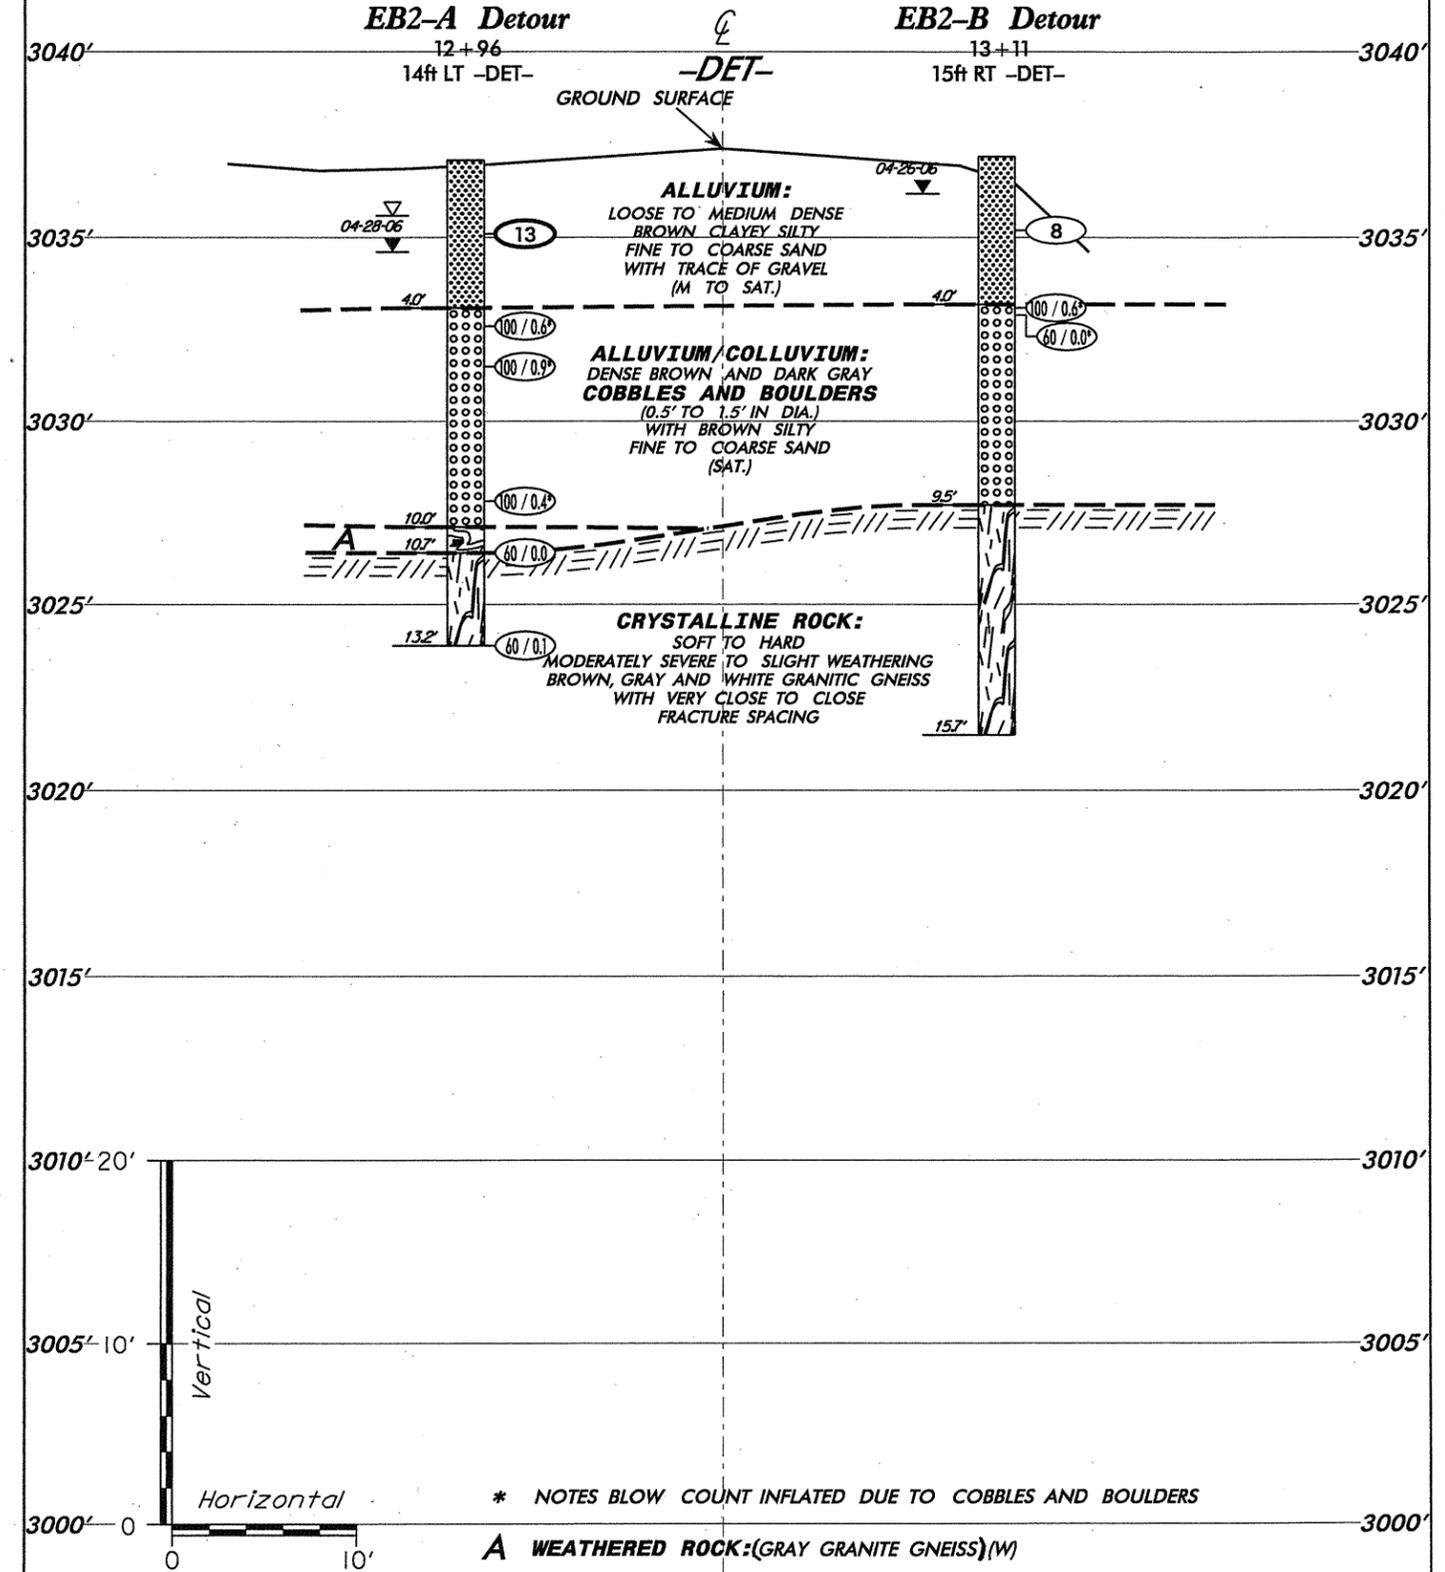
GENERALIZED SUBSURFACE CROSS SECTION THROUGH DETOUR STRUCTURE - END BENT No.2

SCALE: (V) 1"=5' (H) 1"= 10'  
 CHECKED BY: AFR  
 DRAWN BY: TRP  
 DATE: MAY 2006  
 JOB NO. 1051-06-023

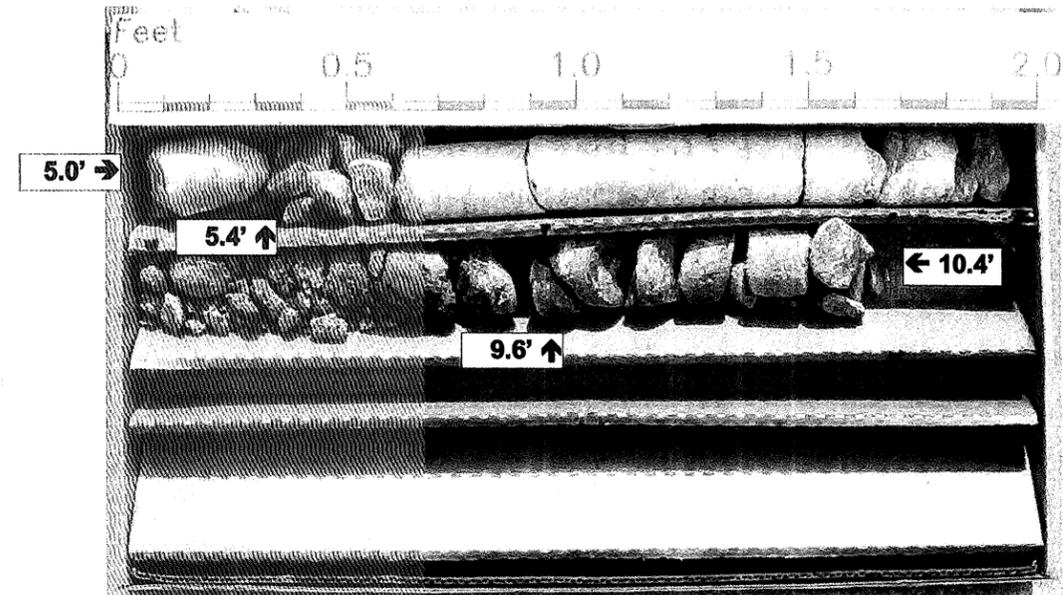
Box 1 of 1  
Top of Box @ 5.0 feet; Bottom of Box @ 10.4 feet

ELEV. (ft)	DEPTH (ft)	RUN (ft)	DRILL RATE (Min/ft)	RUN		SAMP. NO.	STRATA		LOG	DESCRIPTION AND REMARKS
				REC. (%)	RQD (%)		REC. (%)	RQD (%)		
										3,029.4 Begin Coring @ 5.0 ft 5.0
3,029.4	5.0	0.4	0:10/0.4	(0.4)	(N/A)					ALLUVIUM/COLLUVIUM DENSE BROWN GRAY AND WHITE COBBLES TO BOULDERS (0.5 TO 1.5 FEET IN DIAMETER) WITH BROWN SILTY FINE TO COARSE SAND (A-1-a) RESIDUUM: DENSE GRAY SILTY FINE TO COARSE SAND (A-2-4) CRYSTALLINE ROCK: SOFT TO MEDIUM HARD, SEVERE WEATHERING, GRAY AND WHITE GRANITIC GNEISS VERY CLOSE TO CLOSE FRACTURE SPACING 2 JOINTS @ 0° TO 10° 1 JOINT @ 45° BORING TERMINATED AT ELEV. 3024.0 FEET IN CRYSTALLINE ROCK: VERY SOFT GRAY AND WHITE GRANITIC GNEISS.
3,029.0	5.4	5.0	0:50	100%	(N/A)					
			1:00	(3.5)						
			0:30	70%						
3,024.0	10.4		0:30	(0.8)	(0.0)					3,024.8 8.6 3,024.8 9.6 3,024.0 10.4

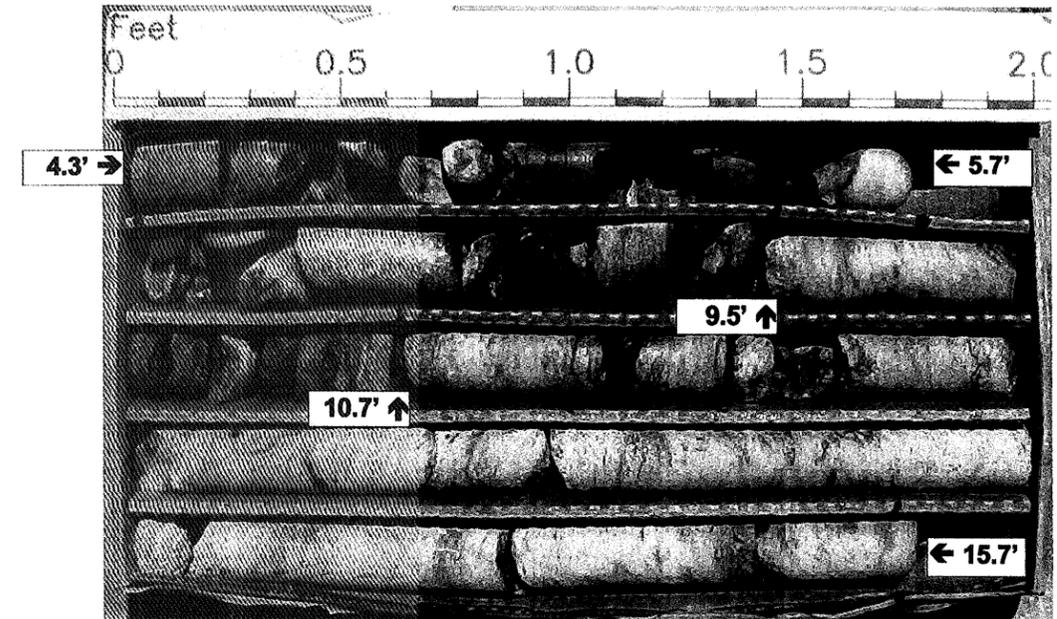
Box 1 of 1  
Top of Box @ 4.3 feet; Bottom of Box @ 15.7 feet

WBS No: 33037.1.1	ID: B-3406	County: Avery	Boring No.: EB2-B (Detour)
Site Description: Bridge No. 28 over Curtis Creek on SR 1321 (Curtis Creek Rd.) Detour			Driller: L. Shrader
Collar Elev.: 3037.2 ft.	Core Size: NQ-2	Equipment: Diedrich D-50	Geologist: S. Laney
Elev. At T.D.: 3021.5 ft.	Total Depth: 15.7 ft.	Total Run: 11.4 ft.	Date: 4/26/06

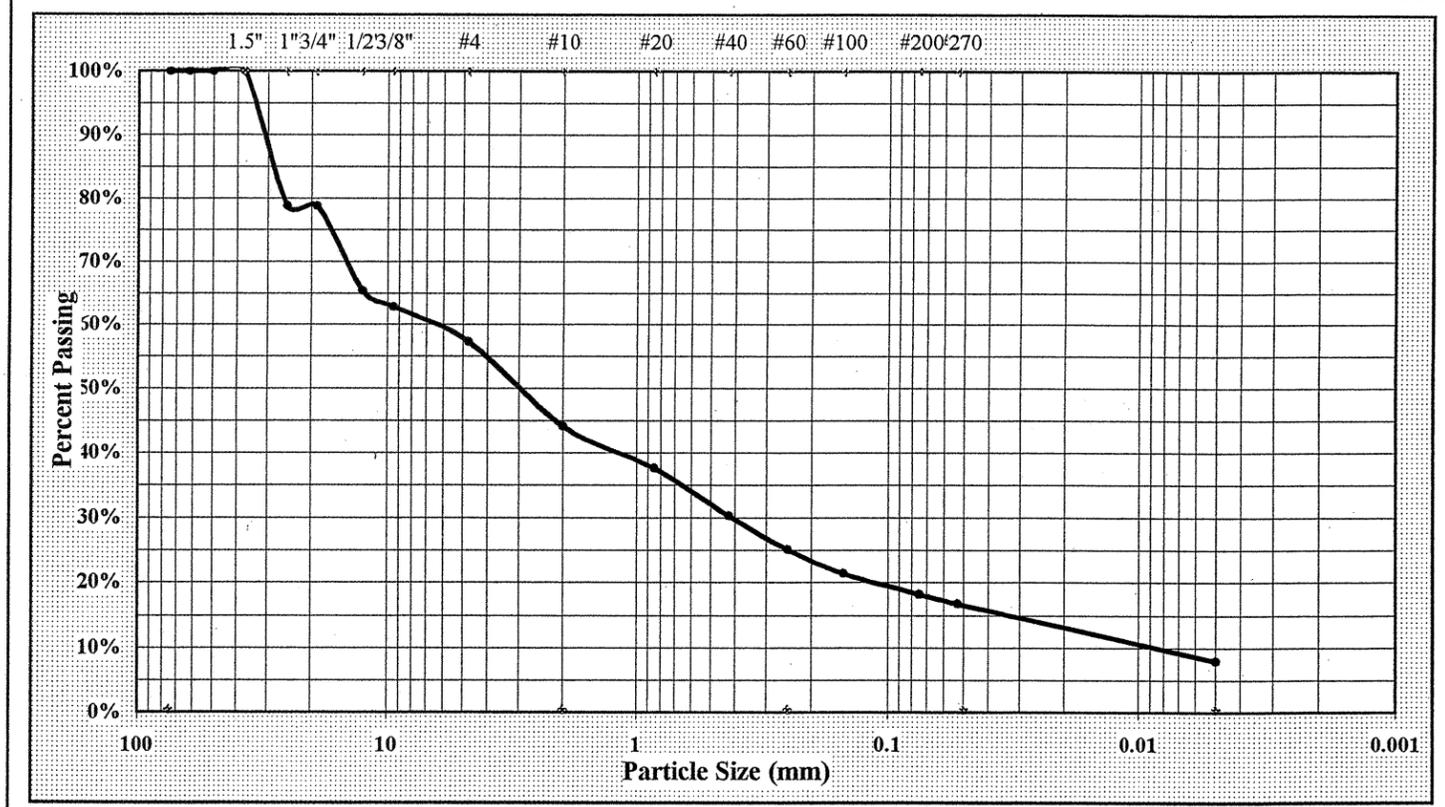
Boring #: EB2-A (DETOUR) Sample #: SS-1 Sample Date: 4/24-28/06  
 Location: STA. 12+96 Offset: 14' LT Depth: 1.0-2.5'  
 Sample Description: BROWN CLAYEY SILTY FINE TO COURSE SAND (A-2-4)

As Defined by NCDOT		Fine Sand	
Gravel	< 75 mm and > 2.00 mm	Silt	< 0.25 mm and > 0.05 mm
Coarse Sand	< 2.00 mm and > 0.25 mm	Clay	< 0.05 and > 0.005 mm
			< 0.005 mm

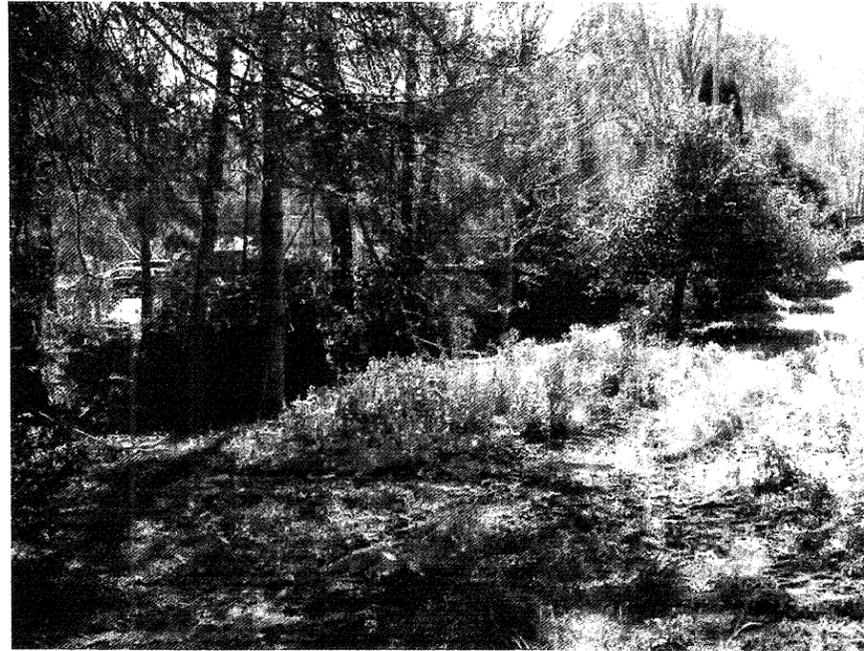
**Photograph No. 1:**  
This photograph was taken from the proposed west approach of the detour bridge, along the -Detour- alignment, looking east.

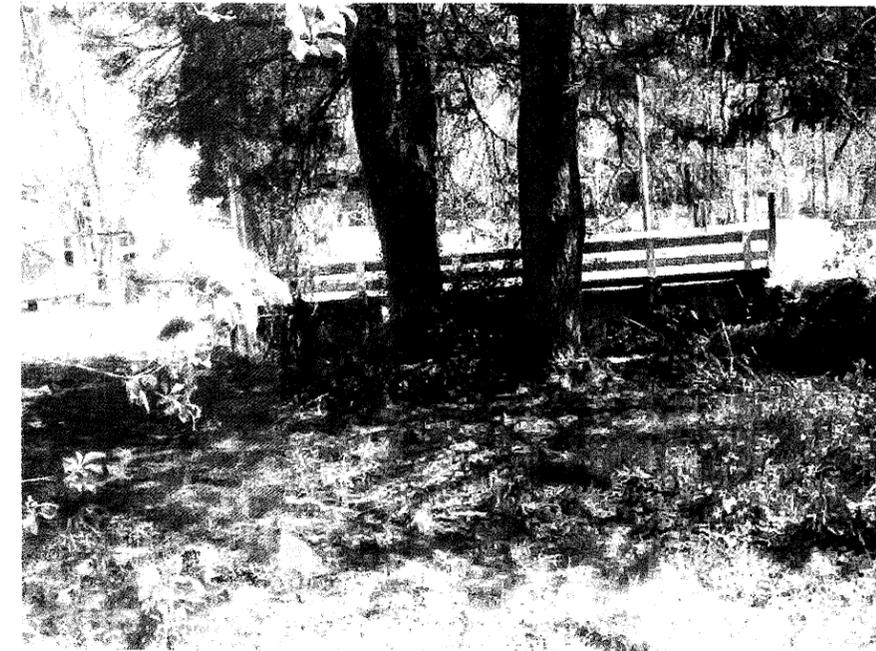
**Photograph No. 3:**  
This photograph was taken from the right side of the detour alignment, looking north, across proposed End Bent No. 1 of the detour bridge.

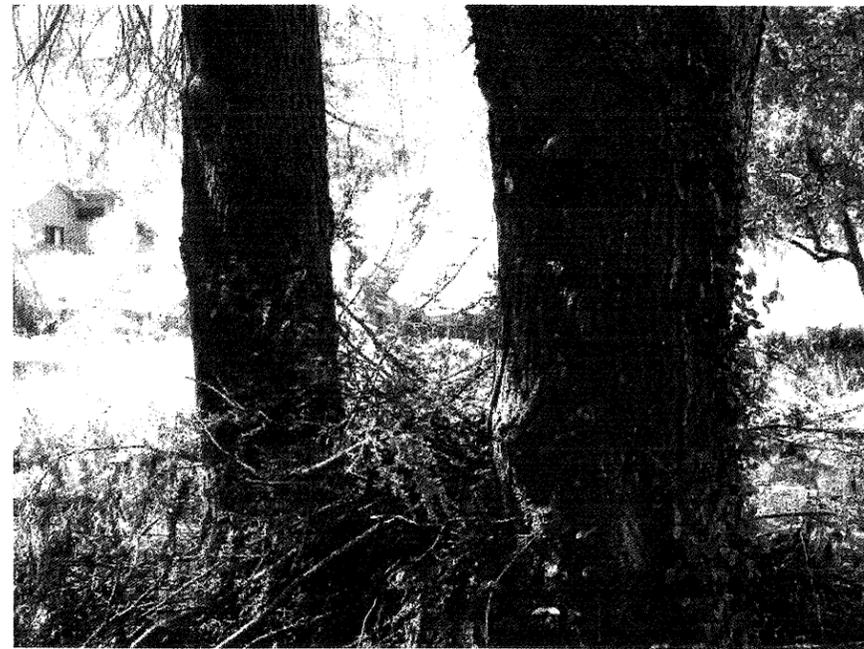
**Photograph No. 2:**  
This photograph was taken from the left side of the detour alignment, looking south, across proposed End Bent No. 1 of the detour bridge.

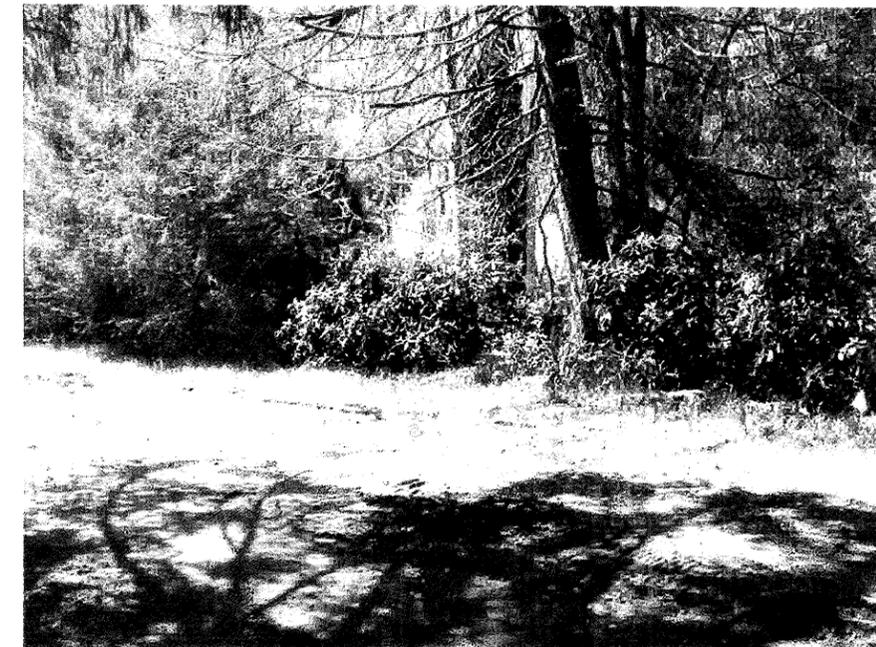
**Photograph No. 4:**  
This photograph was taken from the left side of the detour alignment, looking south, across proposed End Bent No. 2 of the detour bridge.

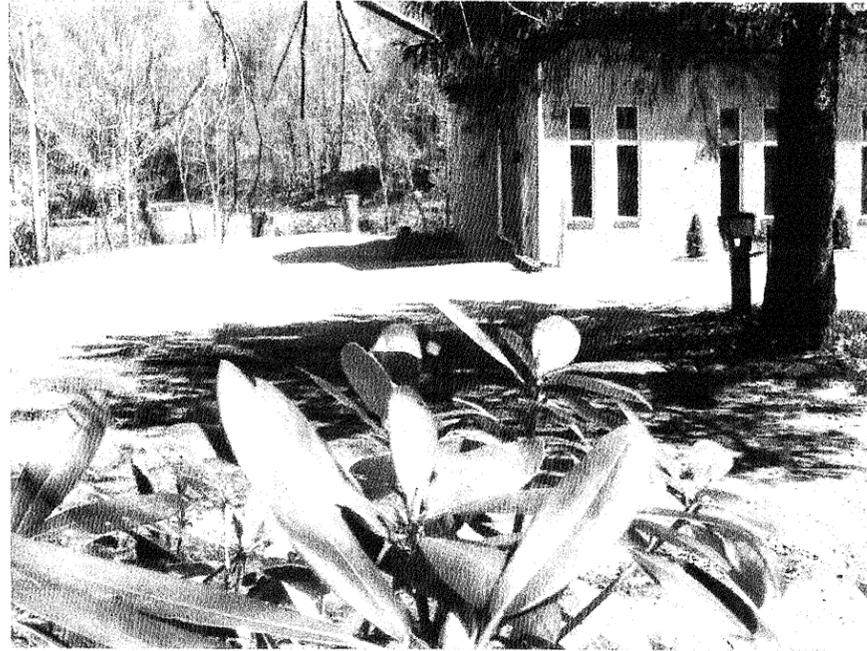
**Photograph No. 5:**  
This photograph was taken from the right side of the detour alignment, looking north, across proposed End Bent No. 2 of the detour bridge.

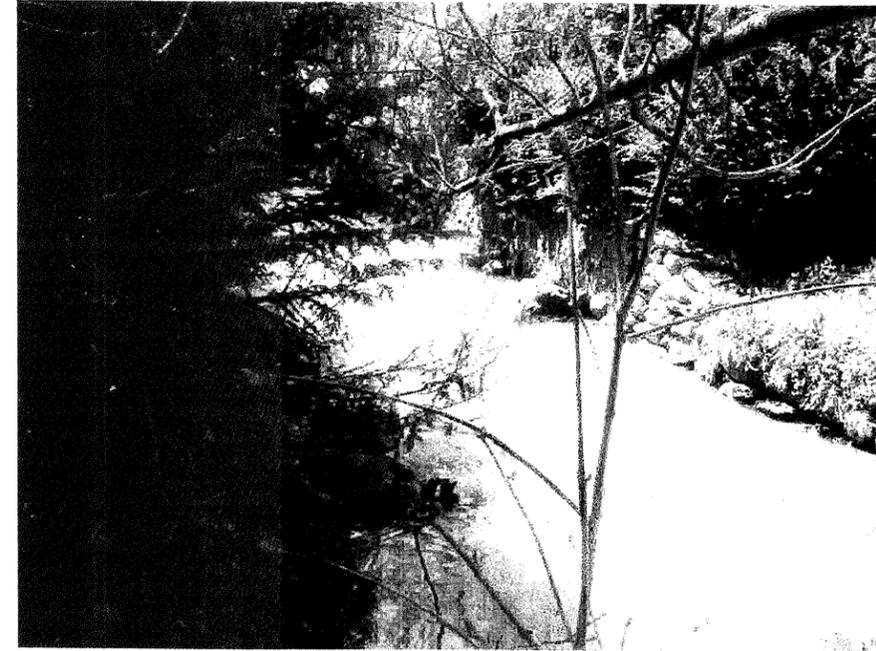
**Photograph No. 7:**  
This photograph was taken from the proposed detour bridge location, looking south (upstream) at Curtis Creek.

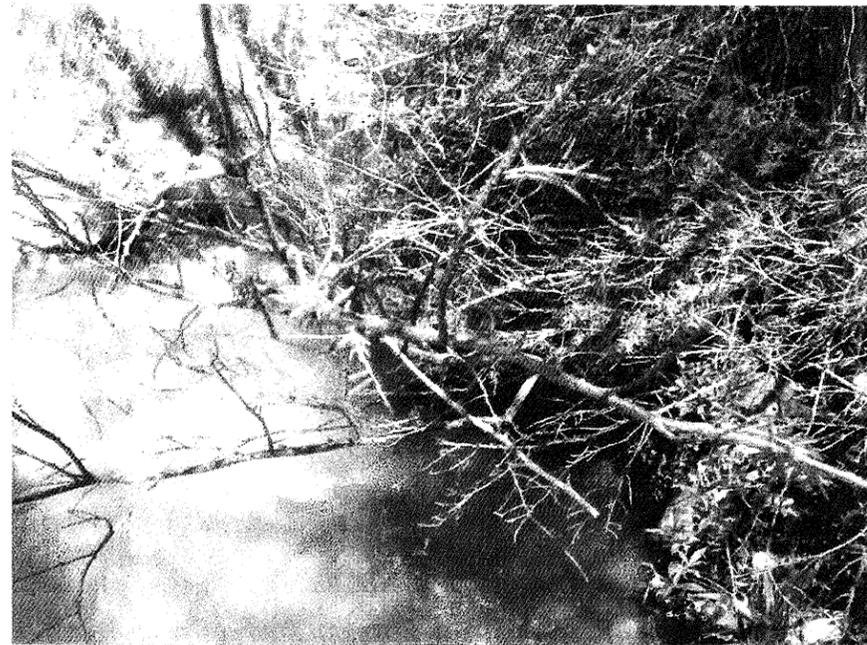
**Photograph No. 6:**  
This photograph was taken from the proposed detour bridge location, looking north (downstream) at Curtis Creek.

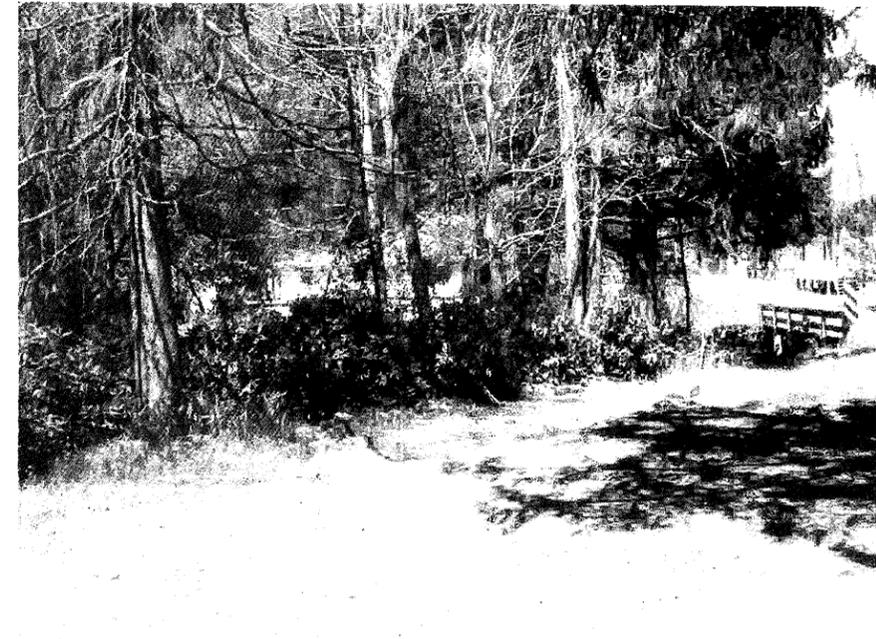
**Photograph No. 8:**  
This photograph was taken from the proposed east approach of the detour bridge, along the -Detour- alignment, looking west.
