**GEOPHYSICAL SURVEY AND
PRELIMINARY SITE ASSESSMENT REPORT**

**Randolph Oil Company
Short Stop 1 Gas Station
Parcel 9
1407 East Dixie Drive
Asheboro, North Carolina
WBS Element # 34935.1.1
State Project U-3401
Randolph County**

North Carolina Dept. of Transportation
Geotechnical Engineering Unit
1589 Mail Service Center
Raleigh, North Carolina 27699-1589

Submittal Date: March 10, 2006

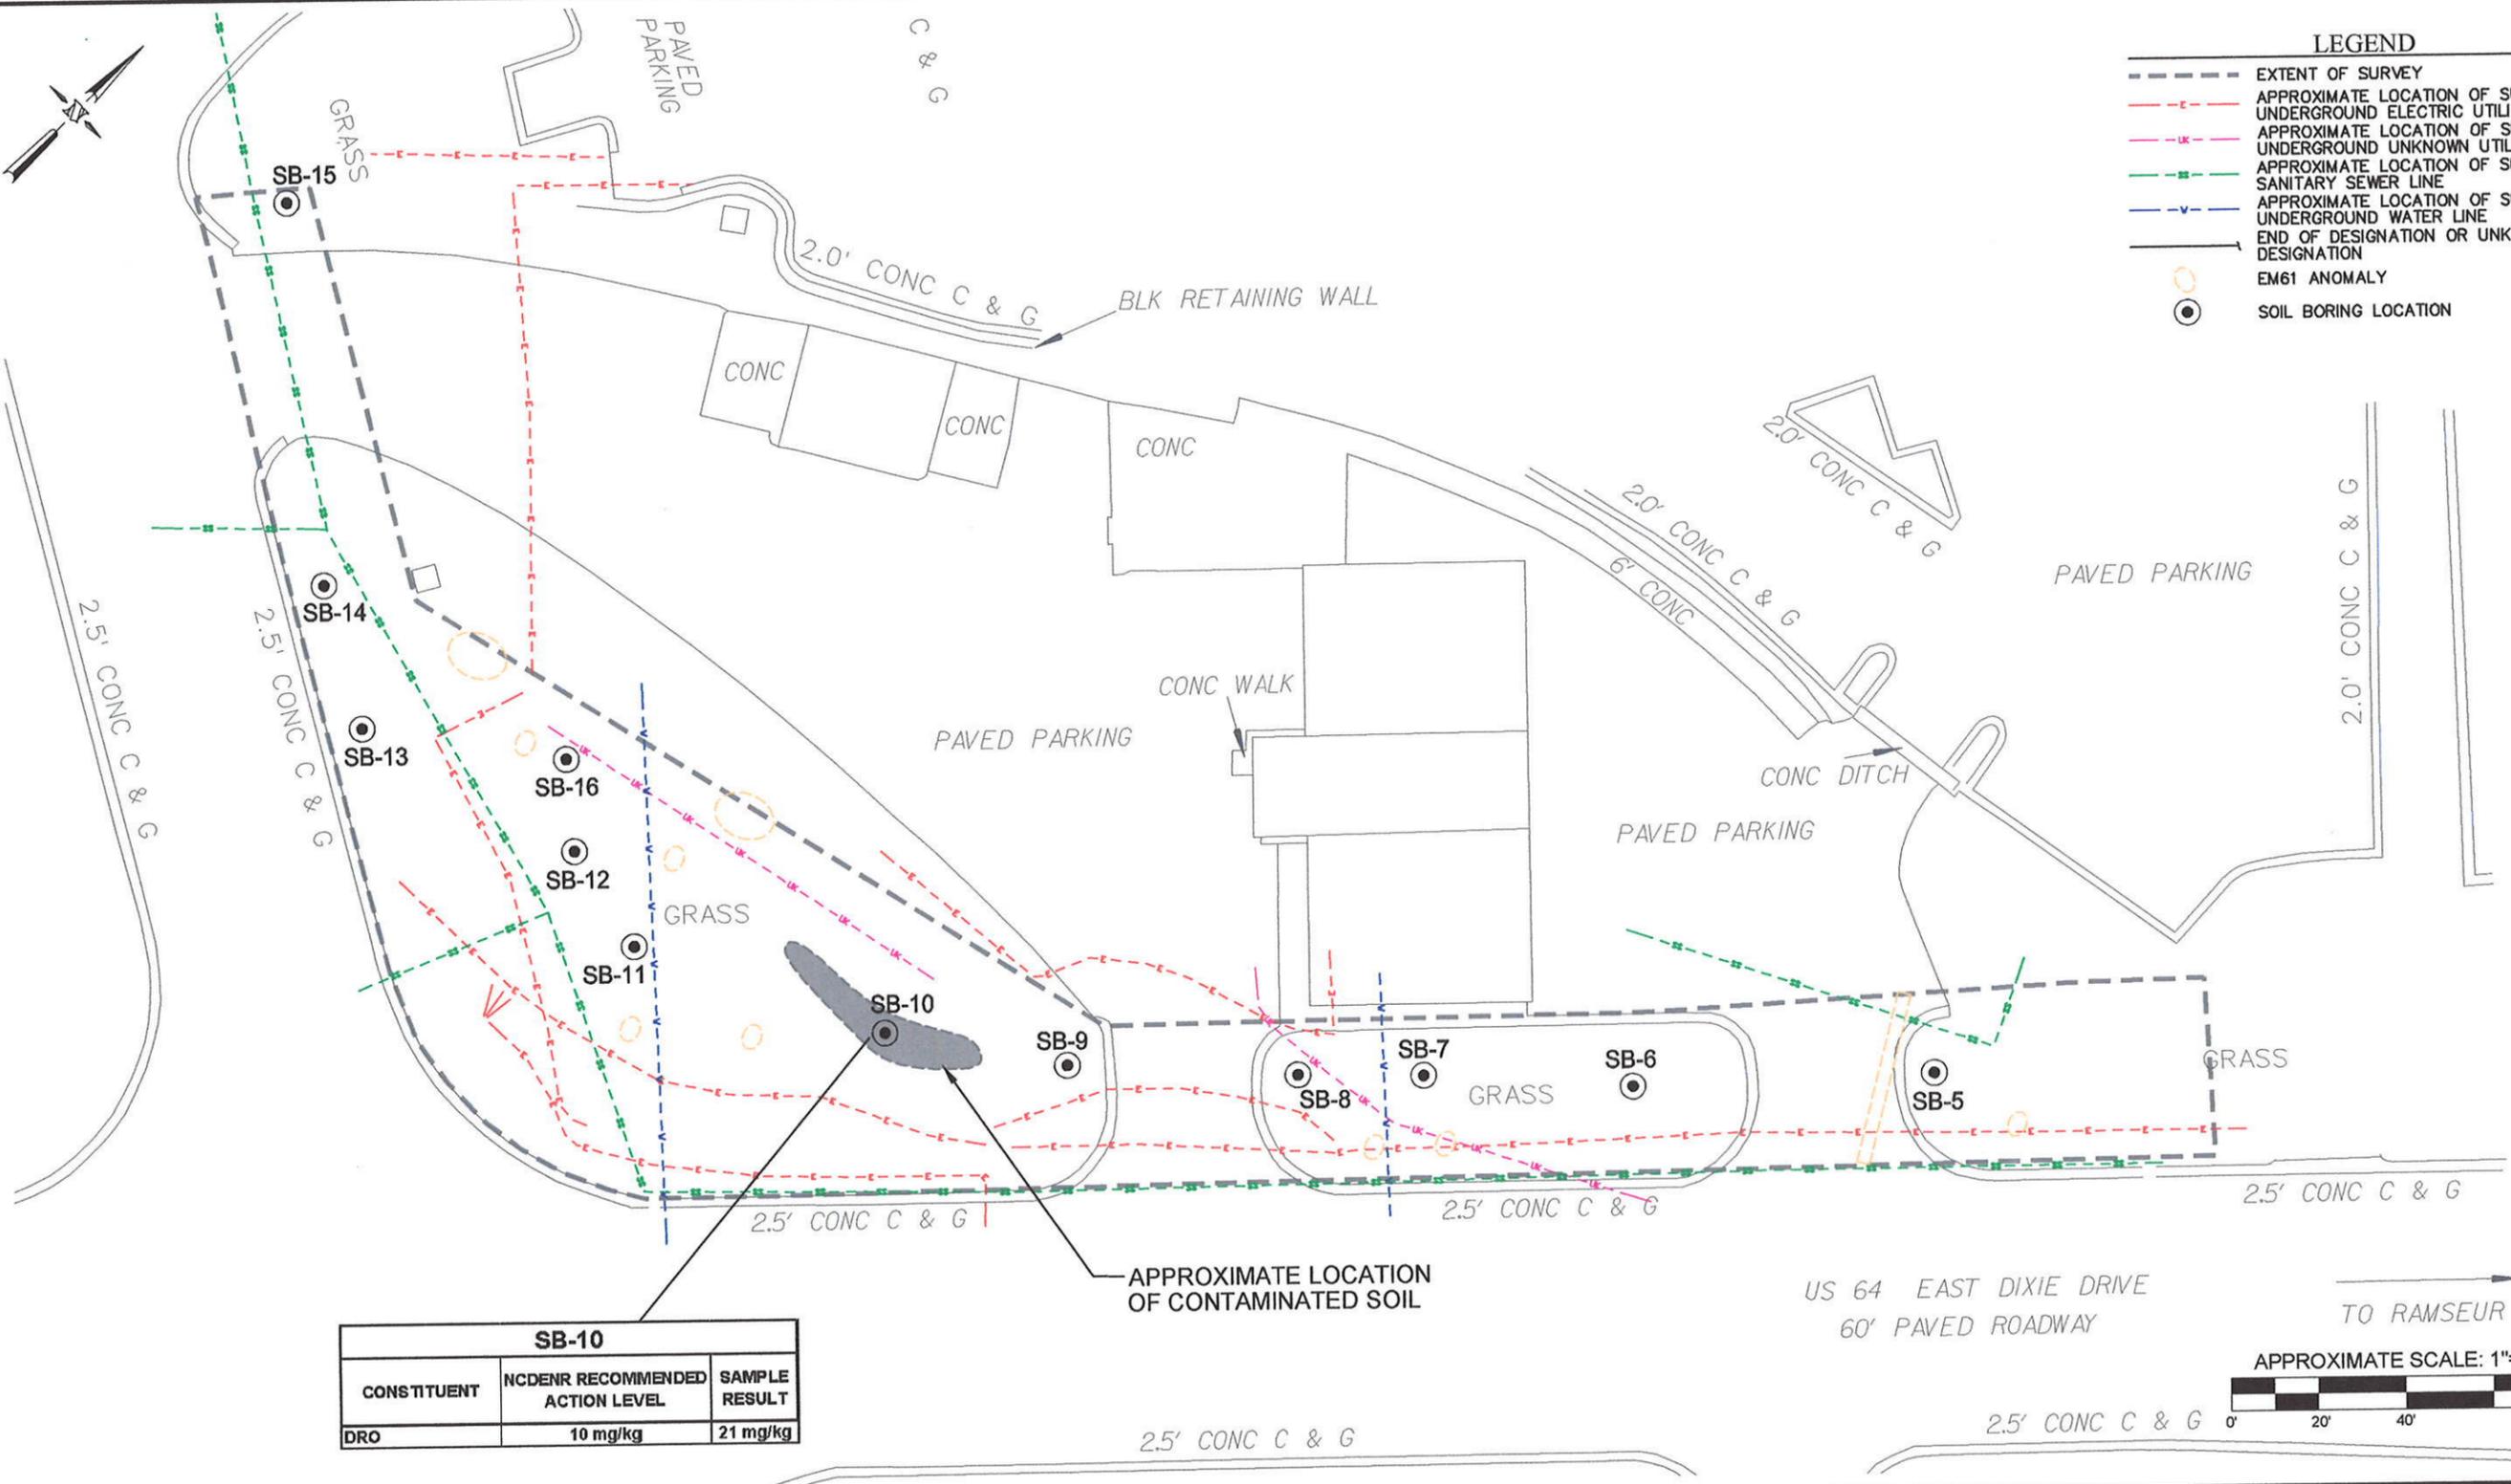
As shown on Figure 2, underground utilities and unknown subsurface anomalies were identified during the survey. The unidentified subsurface anomalies are most likely buried metallic objects. Since the available documentation we reviewed identifies the current locations of the existing USTs, the anomaly is most likely not a UST. Signal penetration with GPR was approximately 3 to 4 feet over the site. Utilities below the maximum penetration depth were not detected with GPR.

DRO and GRO were not detected in 11 of the 12 soil borings. However, the results of the analysis for the soil sample collected from soil boring SB-10 indicate that the DRO concentration was 21 milligrams per kilogram (mg/kg), which is above the recommended DRO action level.

SB-10		
CONSTITUENT	NCDENR RECOMMENDED ACTION LEVEL	SAMPLE RESULT
DRO	10 mg/kg	21 mg/kg

Based on the data generated from this investigation, there is no evidence that a significant release(s) of constituents of concern has occurred at the subject site. No additional environmental investigation of the site soil is recommended at this time.
