# ***Preliminary Site Assessment***

**Omni Supply Company Property, Parcel #1  
Caldwell County, North Carolina**

**NCDOT State Project: 33419.1.1 (B-4054)  
AMEC Project: 549014054**

**November 20, 2006**

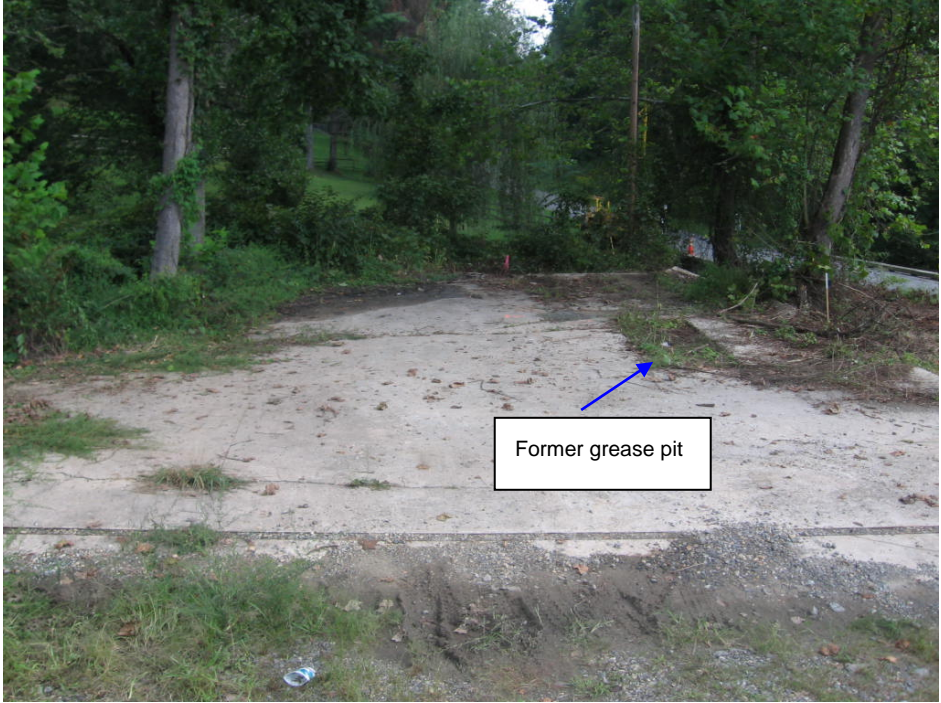
<b>Photo No.</b> 1	<b>Date:</b> 9/6/06

<b>Direction Photo Taken:</b> East		
<b>Description:</b> View of the concrete slab and former grease pit. The entrance of the former garage is in the forefront.

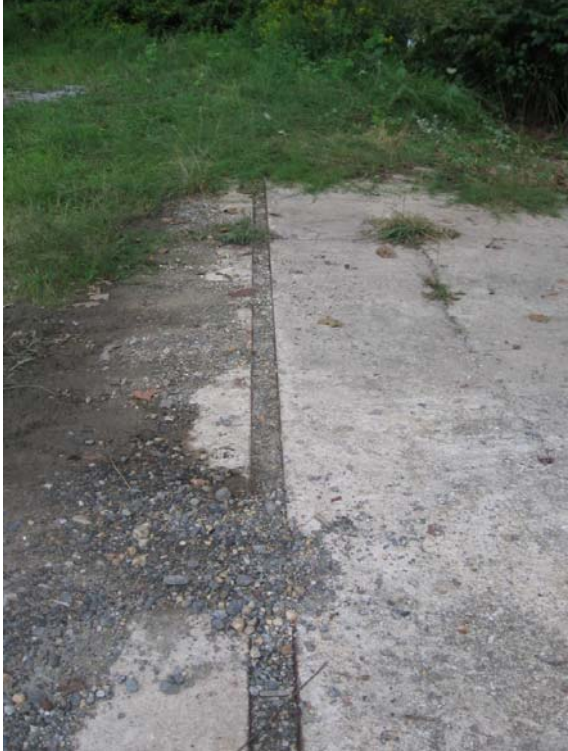
<b>Photo No.</b> 2	<b>Date:</b> 9/6/06

<b>Direction Photo Taken:</b> North		
<b>Description:</b> Front of the former garage and metal catchment that likely held the garage doors.

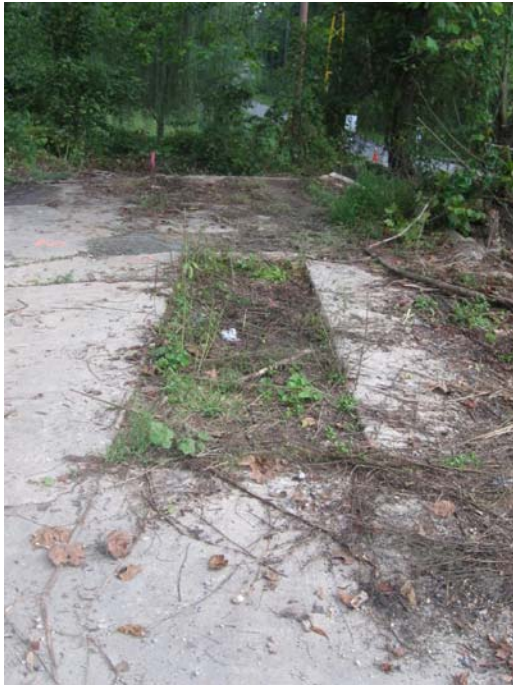
<b>Photo No.</b> 3	<b>Date:</b> 9/6/06

<b>Direction Photo Taken:</b> East		
<b>Description:</b> Former grease pit.

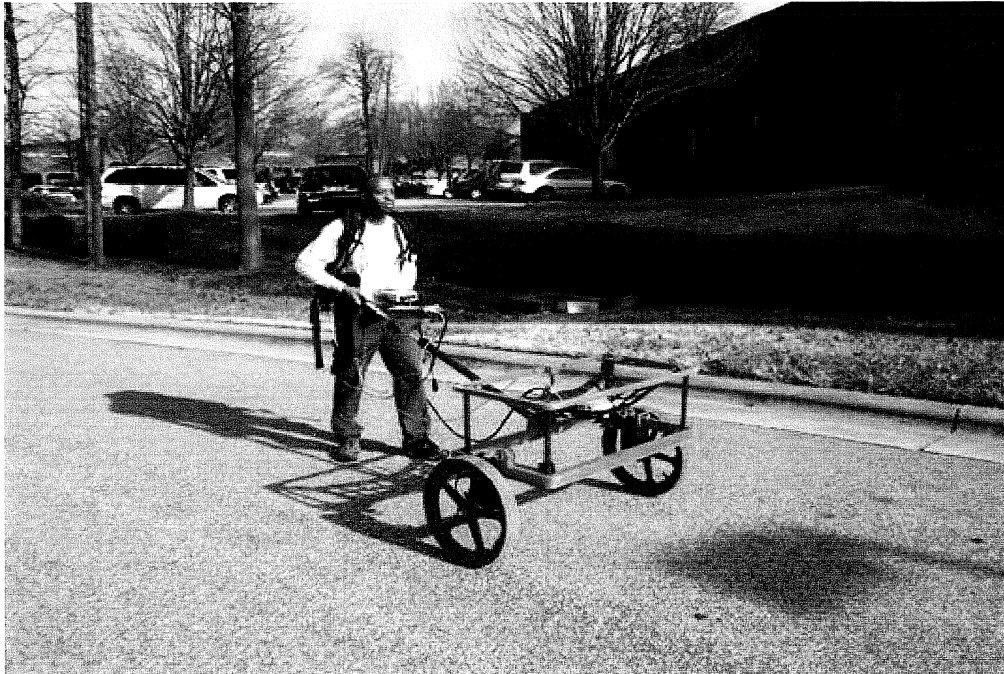
Geonics EM61-MK2

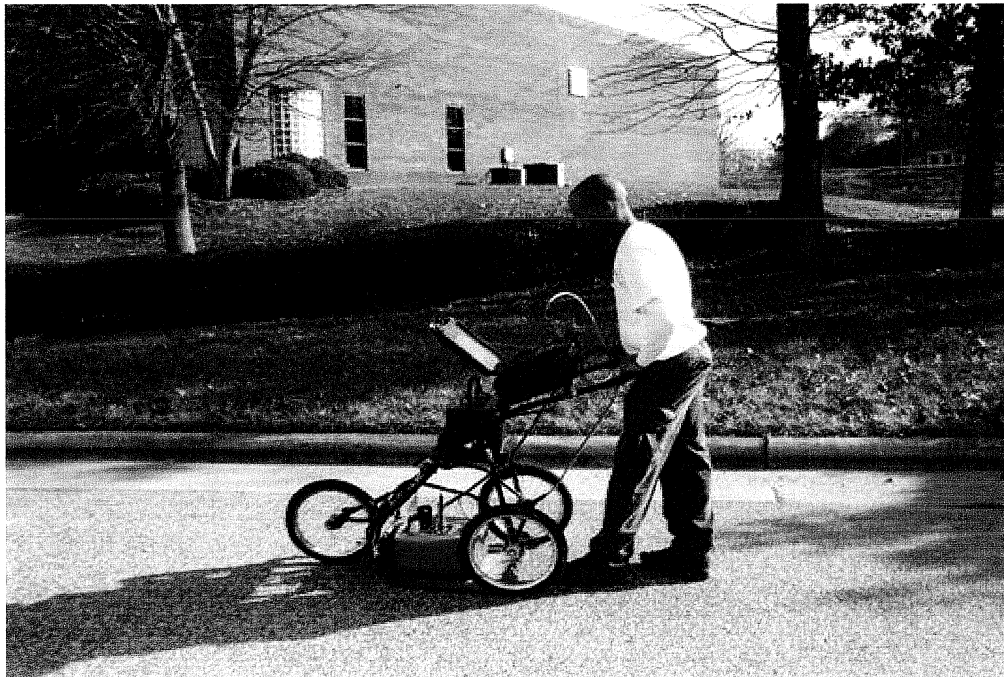
Geophysical Survey Systems SIR-2000 with 400 MHz antenna
