BONNER BRIDGE
Load Test of Spans 186 and 189

Bridge # 270011
Dare County, NC

Final Report
9 June 2006
WJE No. 2005.5426

Prepared by:
WJE Engineers & Architects, PC

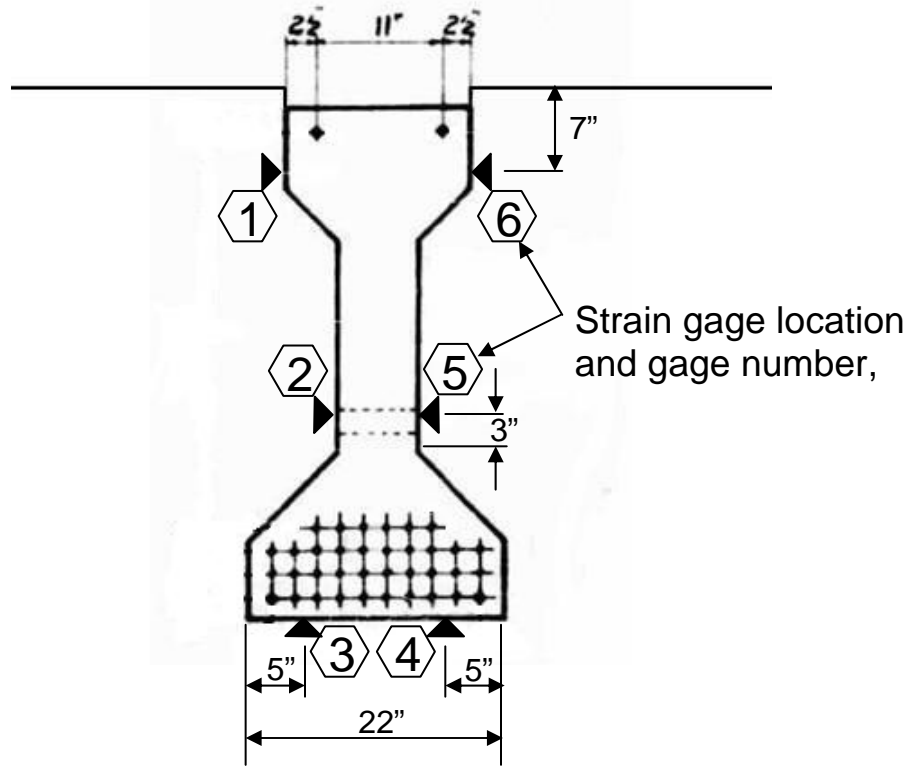
Figure 1. Location and channel numbering for strain gages, lvdt's, string pots.

a) Location of strain gages at mid-span of typical 45" prestressed girder

b) Plan view of Span 189 showing location of strain and deflection gages. Note layout in Span 186 was similar.

1. For girders G2, G3, and G4, a series of six strain gages were installed on the surface of the prestress concrete beams at the mid-span location. The location of the strain gages is shown in Figure 1a and 1b.
2. For girders G2, G3 and G4, a linear variable displacement transducer (LVDT) was installed at the north end of each girder to measure vertical displacement of the girder relative to the pile bent.
3. For girders G2, G3 and G4, a linear motion transducer (or string potentiometer) was installed at mid-span to measure the girder deflection under the truck loading.

The location and channel number for each strain gage, string pot, and LVDT are illustrated in Figures 1a and 1b. The string pots were used to collect mid-span deflections (Figure 4) while the LVDT's were used to measure bearing pad compression (Figure 5). Prior to installing the string pots, WJE installed galvanized reference wires between the bent caps. All data was collected using a Pacific Instruments 660-6000 data acquisition system capable of collecting up to 24 data channels simultaneously. The acquisition system was located on the west fishing pier.

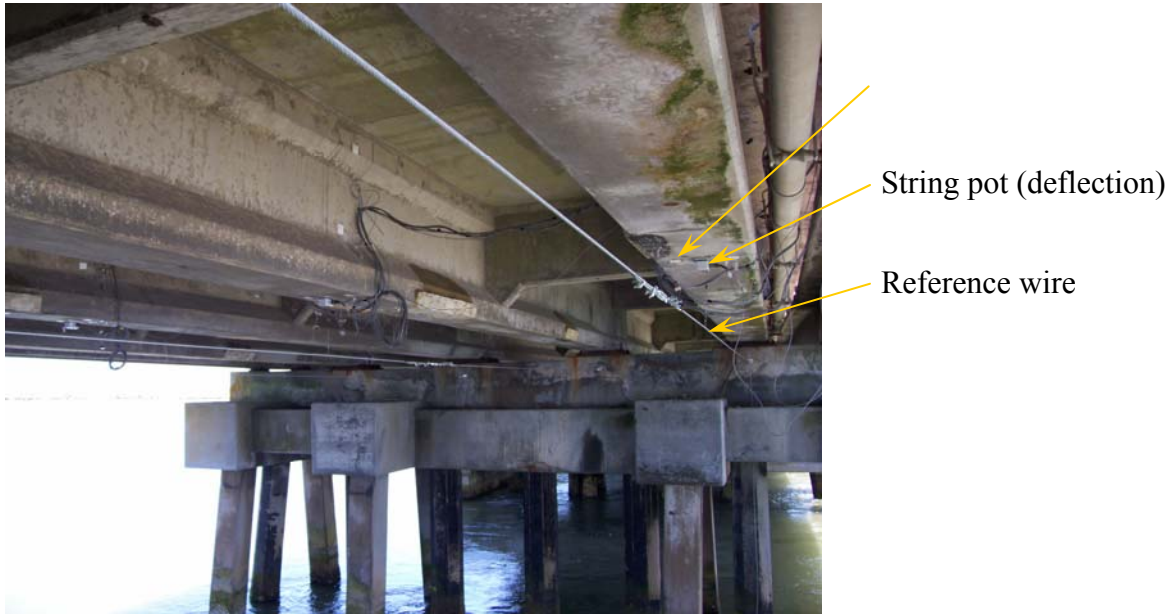
Figure 3. Overall of instrumentation setup.

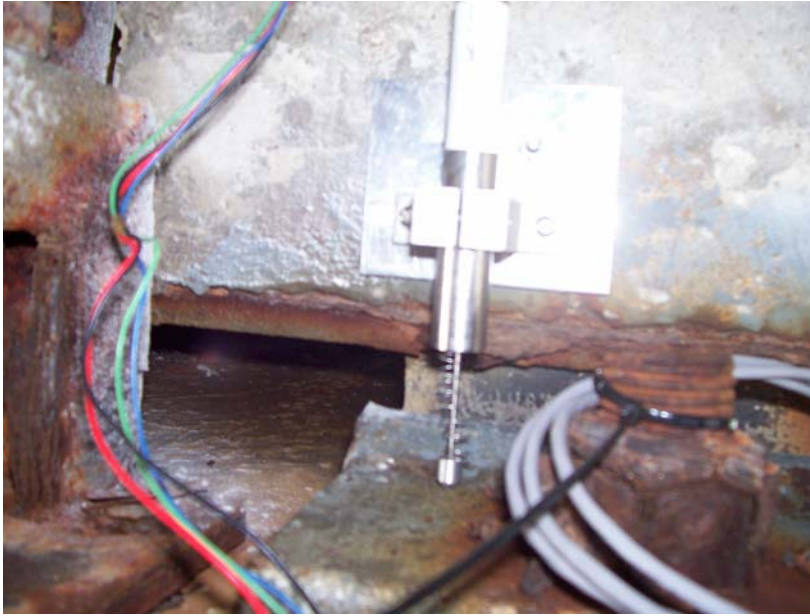
Figure 5. Typical LVDT installation at north end of each girder.

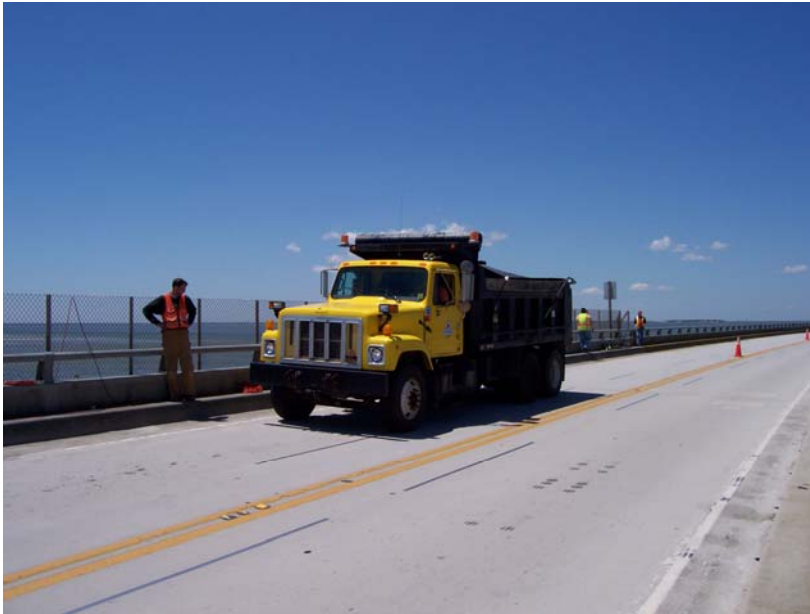
Figure 6. Truck positioned with left wheel over Girder No. 3 (looking north).

For the first three loadings on each span, the truck speed was very slow in order to produce pseudo-static results. For the last three loadings on each span, the truck speed was increased to approximately 35 mph in an attempt to apply impact loadings to the girders. Table 1 provides a brief description of each span loading. Figures 6, 7 and 8 illustrate the three different truck positions.

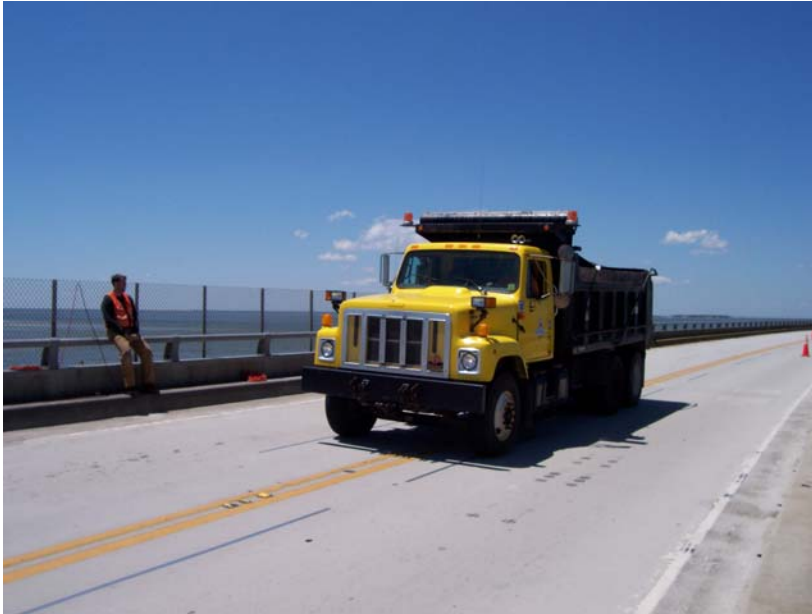
Figure 7. Truck positioned with right wheel over Girder No. 3 (looking north).

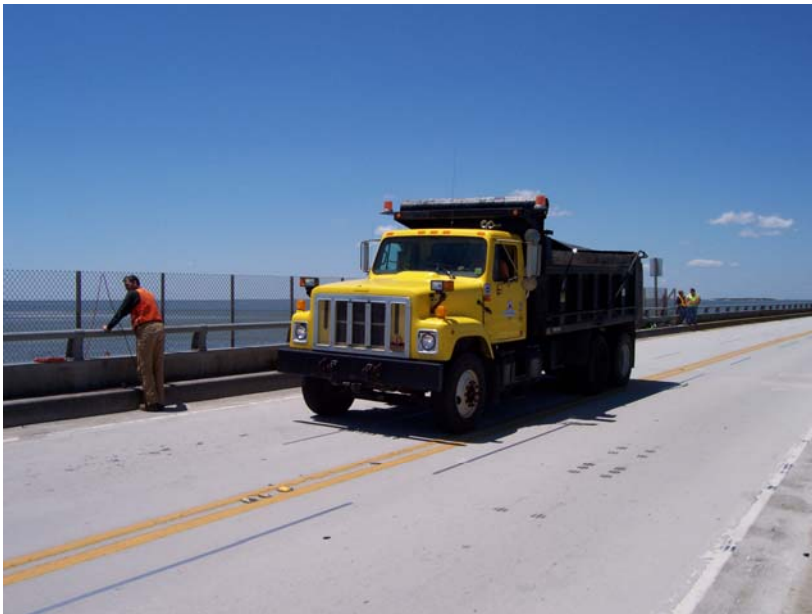
Figure 8. Truck centered over Girder No. 3 (looking north).

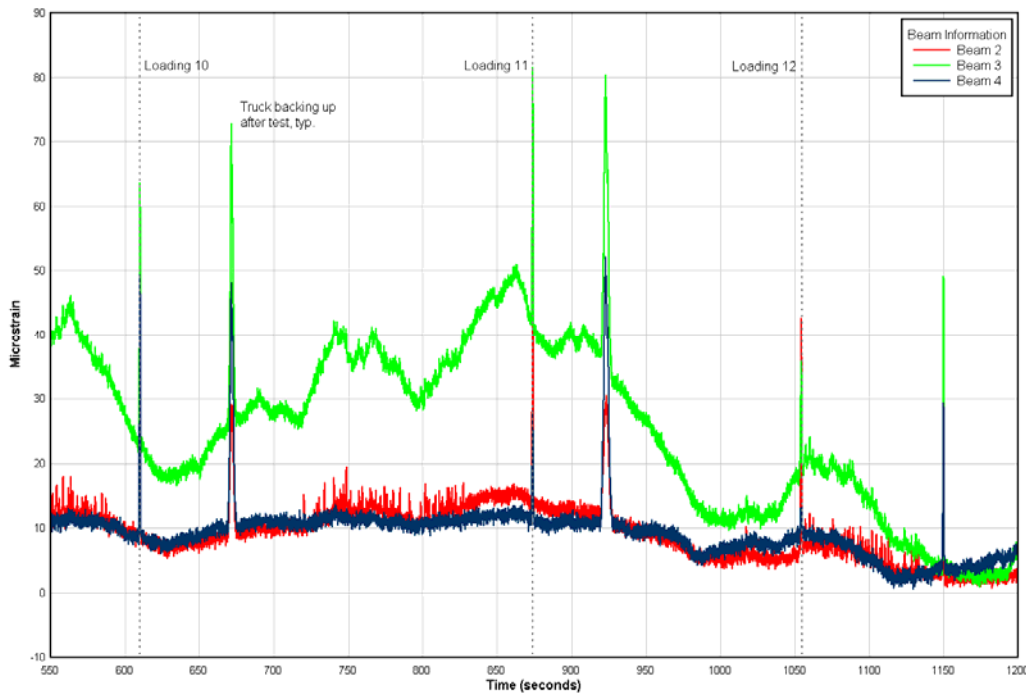
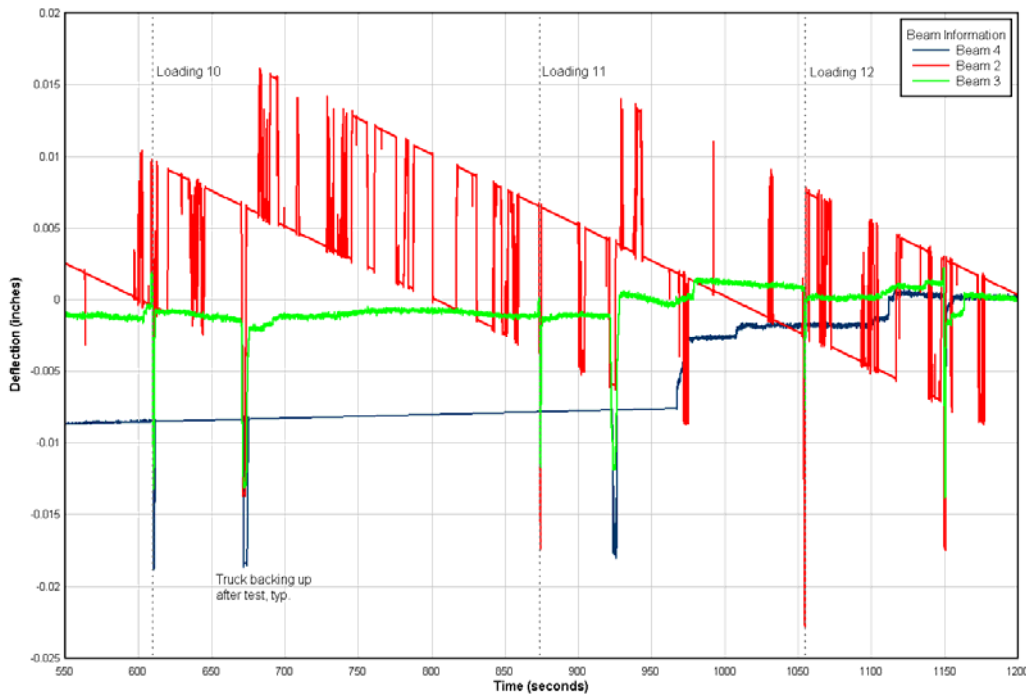
Figure 17. Span 186; loading nos. 10, 11, 12; top strain gage data.

Figure 18. Span 186; loading nos. 10, 11, and 12; middle strain gage data.

Figure 19. Span 186; loading nos. 10, 11, and 12; bottom strain gage data.

Figure 20. Span 186; loading nos. 10, 11, and 12; mid-span deflection data. (Note vertical axis plotted at different scale than scale used in Figure 11.)

Load test results are provided in Figures 9-20. The field data used to create these graphs has been edited slightly. WJE edits include the following.

1. All data curves have been smoothed.
2. All strain gage values are an average of the top, middle, or bottom two strain gages on each girder.
3. The Span 186 data has been separated into static (loadings 7, 8, and 9) and dynamic (loadings 10, 11, 12) segments.
4. Drift was removed from the mid-span displacement curves for Span 186.
5. Drift was removed from the mid-span displacement curve for Girder 4, Span 189.

1. Overall, the measured mid-span deflections of the girders were very small; typically ranging from 0.010 in. to 0.039 in. Measured mid-span deflections in Span 189 were larger than the measured mid-span deflections in Span 186.
2. The overall behavior of Span 189 was comparable to the behavior of Span 186 for each loading condition. For example, for the load cases of the test truck centered on girder G3 (loading 6 and 12), the measured strain at the bottom of girder G3 was 59 $\mu\epsilon$ in Span 189 and 51 $\mu\epsilon$ in Span 186.
3. The transverse distribution of the applied truck load was comparable for Span 189 and 186. For example, for the load cases of the test truck centered on girder G3 (loading 6 and 12), the measured strain at the bottom of girder G2 was 48 $\mu\epsilon$ in Span 189 and 44 $\mu\epsilon$ in Span 186.

Similarly, for the load cases of the test truck centered on girder G3 (loading 6 and 12), the measured strain at the bottom of girder G4 was 32 $\mu\epsilon$ in Span 189 and 32 $\mu\epsilon$ in Span 186.
