STRUCTURE SUBSURFACE INVESTIGATION

PROJECT DESCRIPTION BRIDGE NO. 211 OVER

RICHLAND CREEK ON SR 1519(RICHLAND CREEK RD.)

SUBJECT: Geotechnical Report of Structure Subsurface Investigation

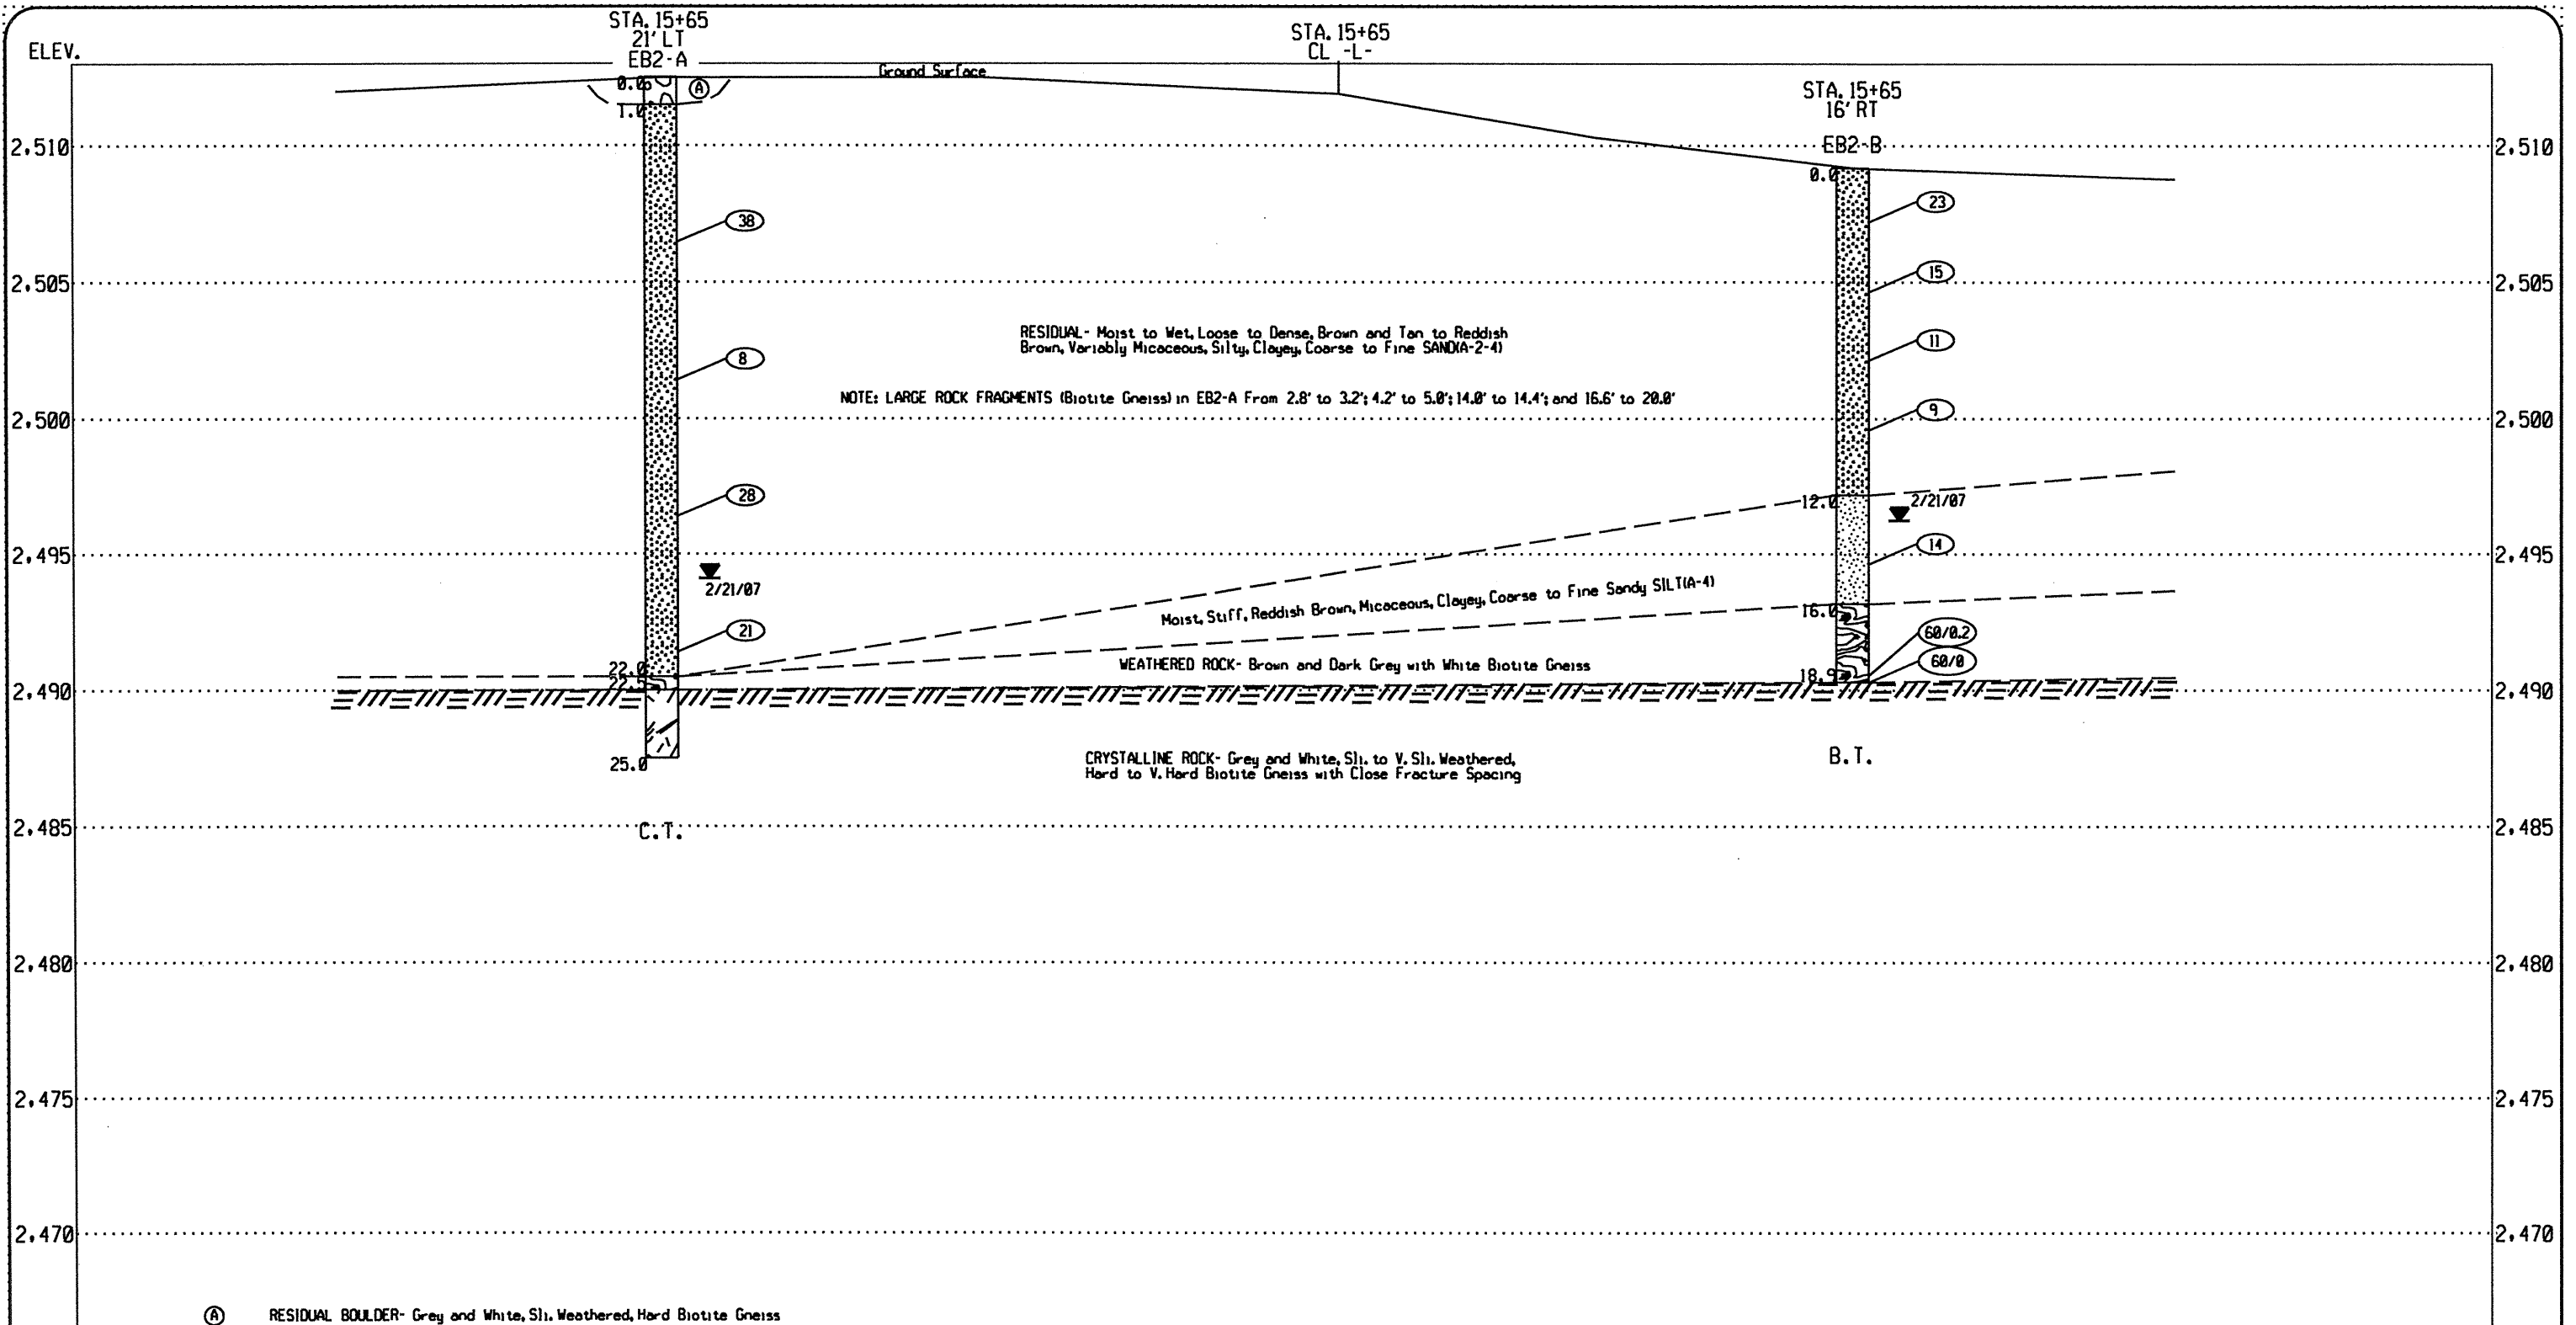
CROSS-SECTION ALONG END BENT-2	
Bridge No. 211 Over Richland Creek on SR 1519 (Richland Creek Rd.)	
Haywood County, North Carolina	
Project No. 33493.1.1	TIP No. B-4144
Federal No. BRZ-1519(2)	Vert. Scale 1" = 6'
Date 3/15/07	Horiz. Scale 1" = 5'
Drawn by DRK	Drawing No. 6

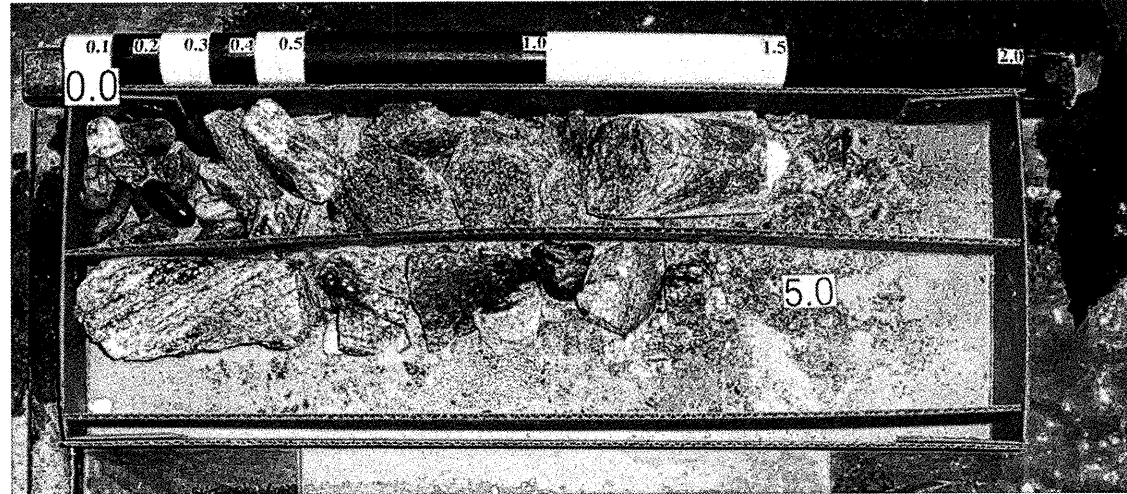
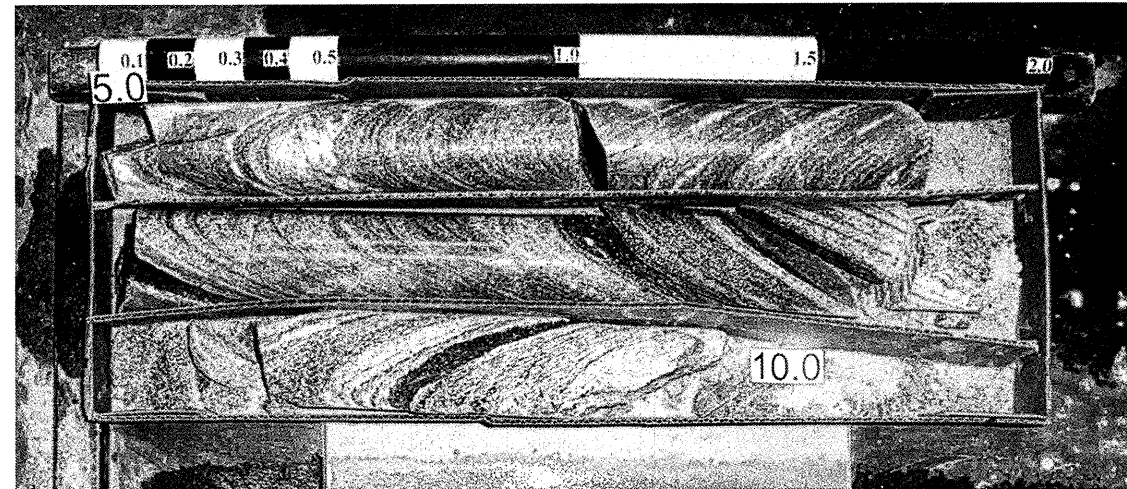
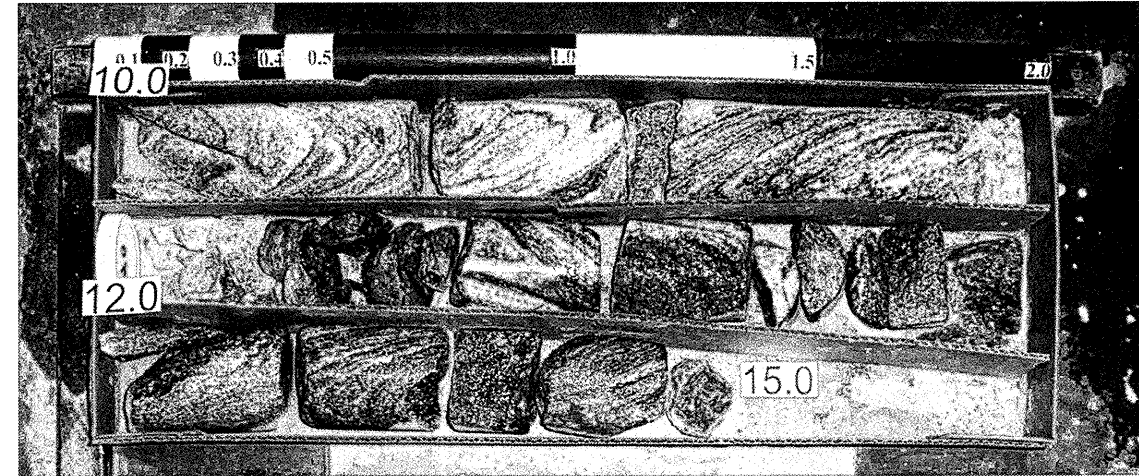
CORE PHOTOGRAPHS

Approximately 15 feet of weathered rock/crystalline rock was cored at Boring B1-A and approximately 24 feet of weathered rock/crystalline rock was cored at Boring B1-B/B1-B2 to evaluate the nature of the refusal materials at Bent-1. A total of approximately 3 feet of weathered rock/crystalline rock was cored at Boring EB2-A to differentiate between the cored residual soil/residual boulders or large rock fragments and the weathered rock/crystalline rock. In general, the cored weathered rock is severely weathered, very soft to medium hard, biotite gneiss with very close fracture spacing. The strata recovery (REC) values within the weathered rock ranged from 0 to 36 percent. In general, the cored crystalline rock is moderately severely to very slightly weathered, moderately hard to very hard biotite gneiss with very close to wide fracture spacing. Strata (REC) values within the crystalline rock ranged from 76 to 100 percent and strata Rock Quality Designation (RQD) values ranged from 52 to 100 percent. The majority of the crystalline rock cored was good to very good in quality.

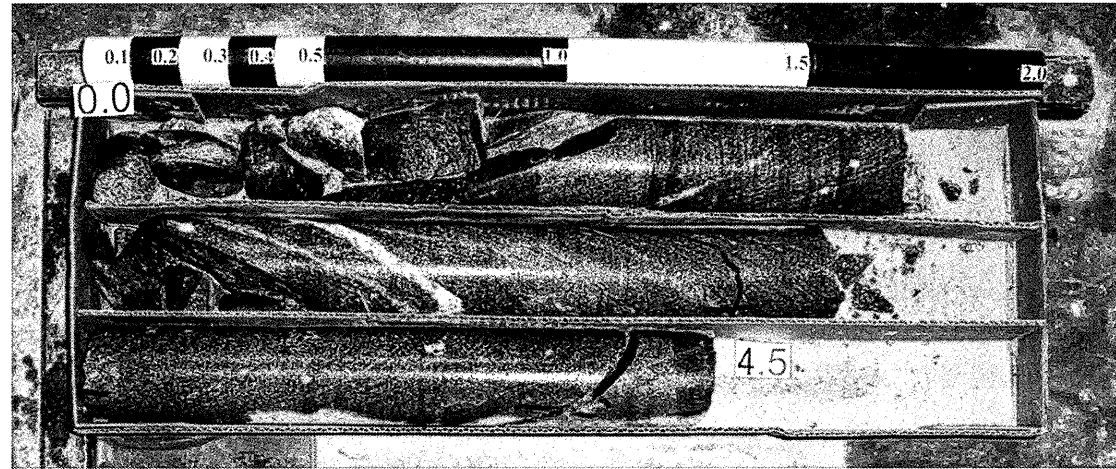
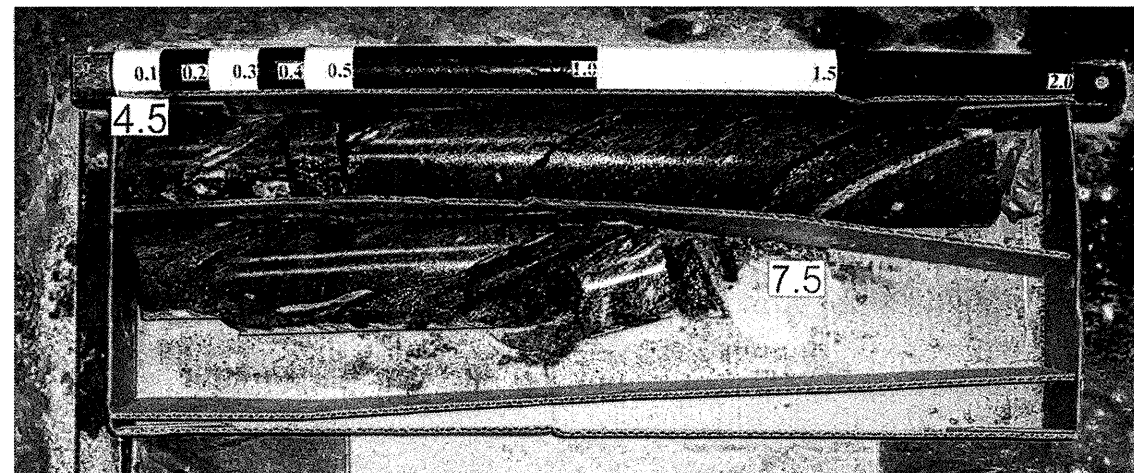
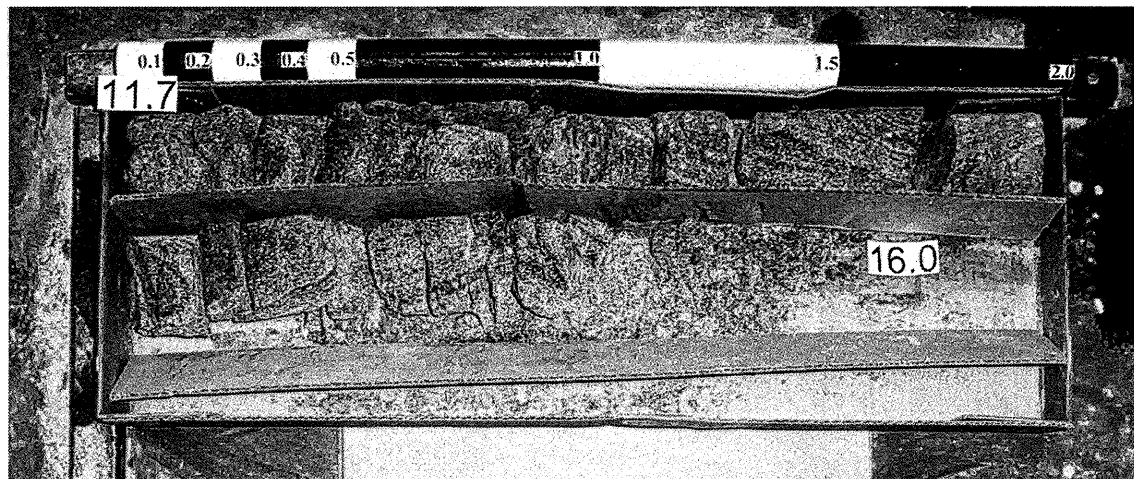
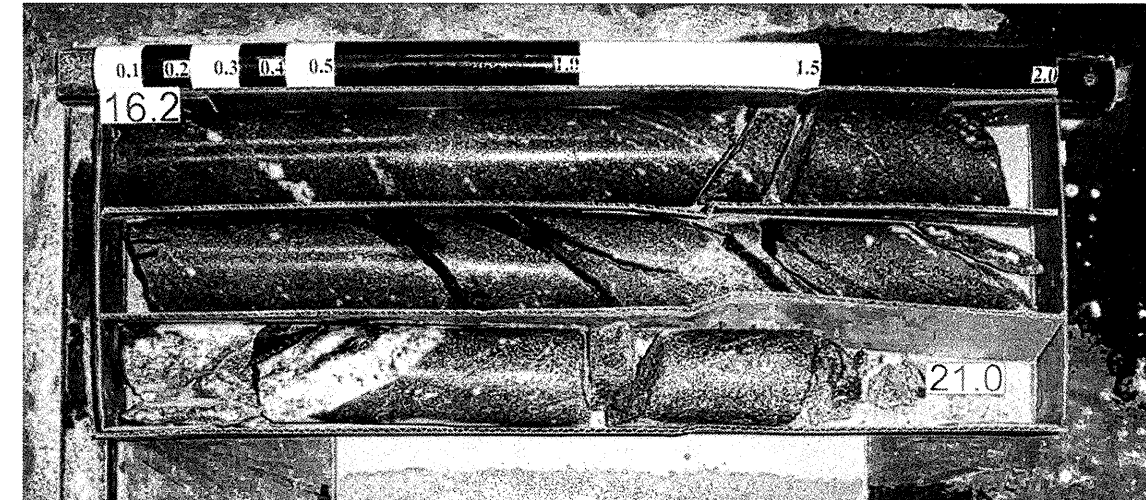
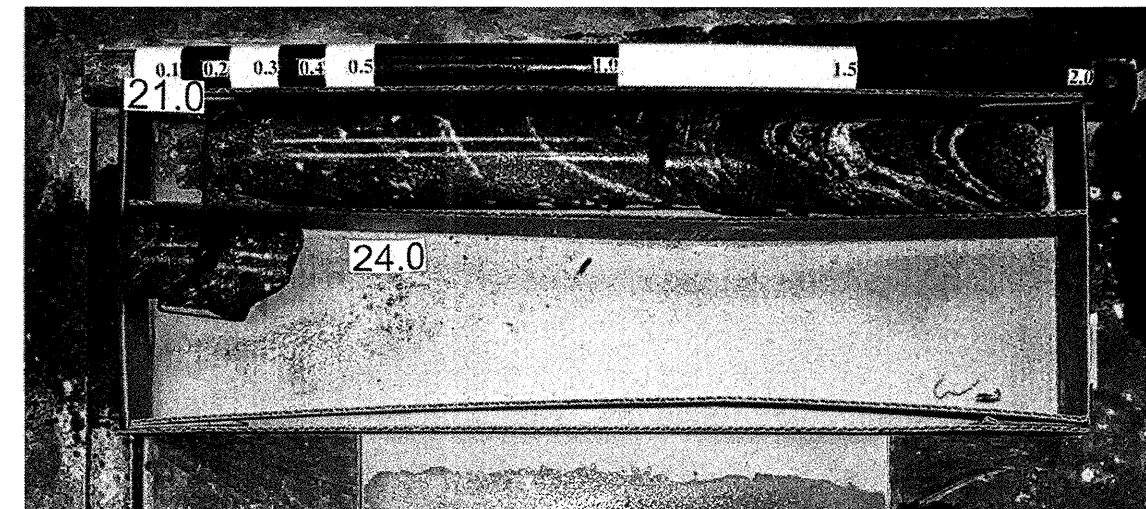
B1-B/B1-B2

CORE PHOTOGRAPHS

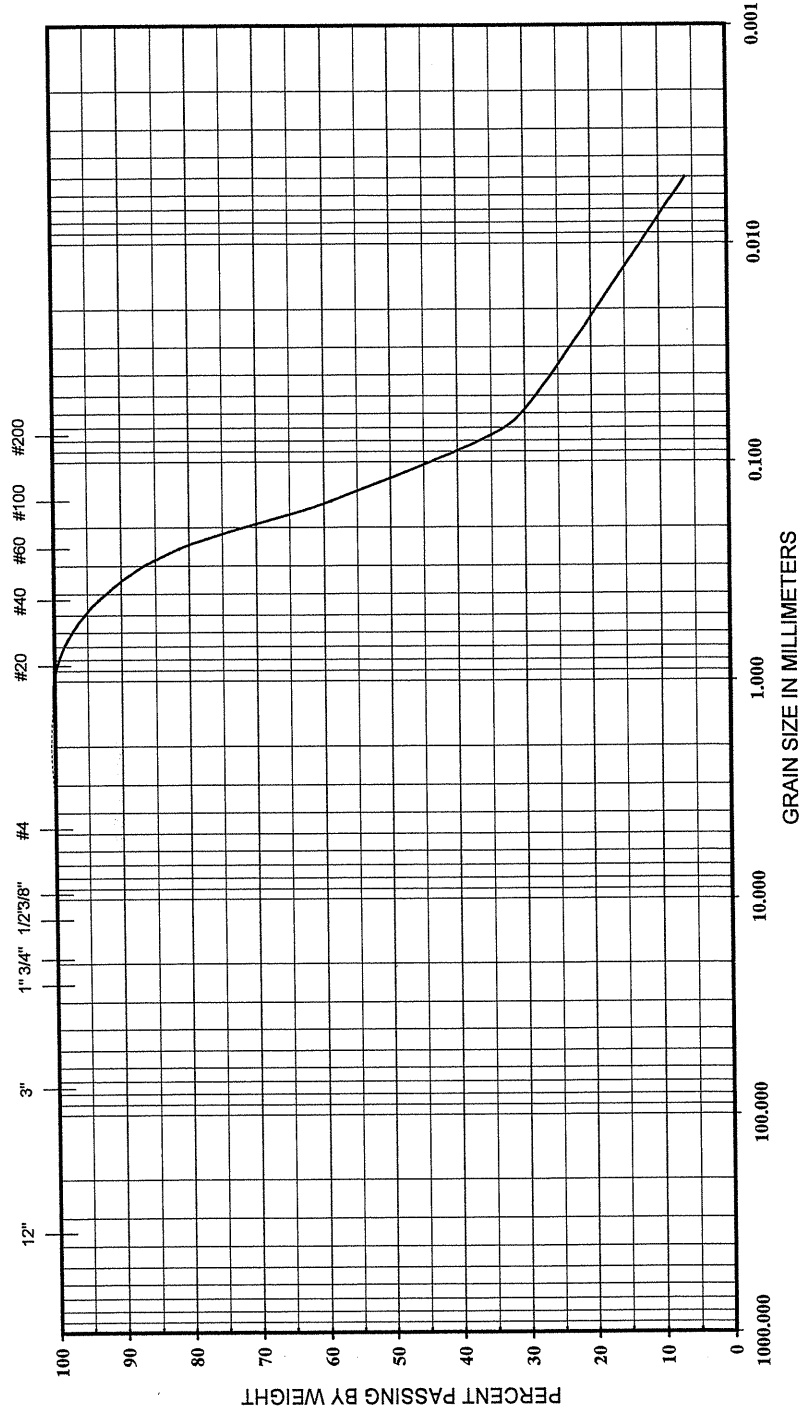
BORING NO.	SAMPLE NO.	ELEVATION OR DEPTH	NMC %	LL	PL	PI
EB1-A	SS-1	1.0-2.5	NA	29	NP	NP

Laboratory soil testing was performed on five representative split-barrel samples and on one grab sample from the stream bank to aid in the assessment of AASHTO soil classification and to provide data for evaluation of engineering properties. The laboratory testing on the samples consisted of Natural Moisture Content, Atterberg Limit, and grain size analysis with hydrometer. In addition, two Unconfined Compressive Strength (Qu only) tests were performed on selected samples of the recovered rock core. Laboratory tests were performed in general accordance with AASHTO and NCDOT specifications. The results of the soil and rock laboratory tests are included on Sheet 22 located behind this report. Laboratory results of the rock testing are also included under separate cover in Appendix A.

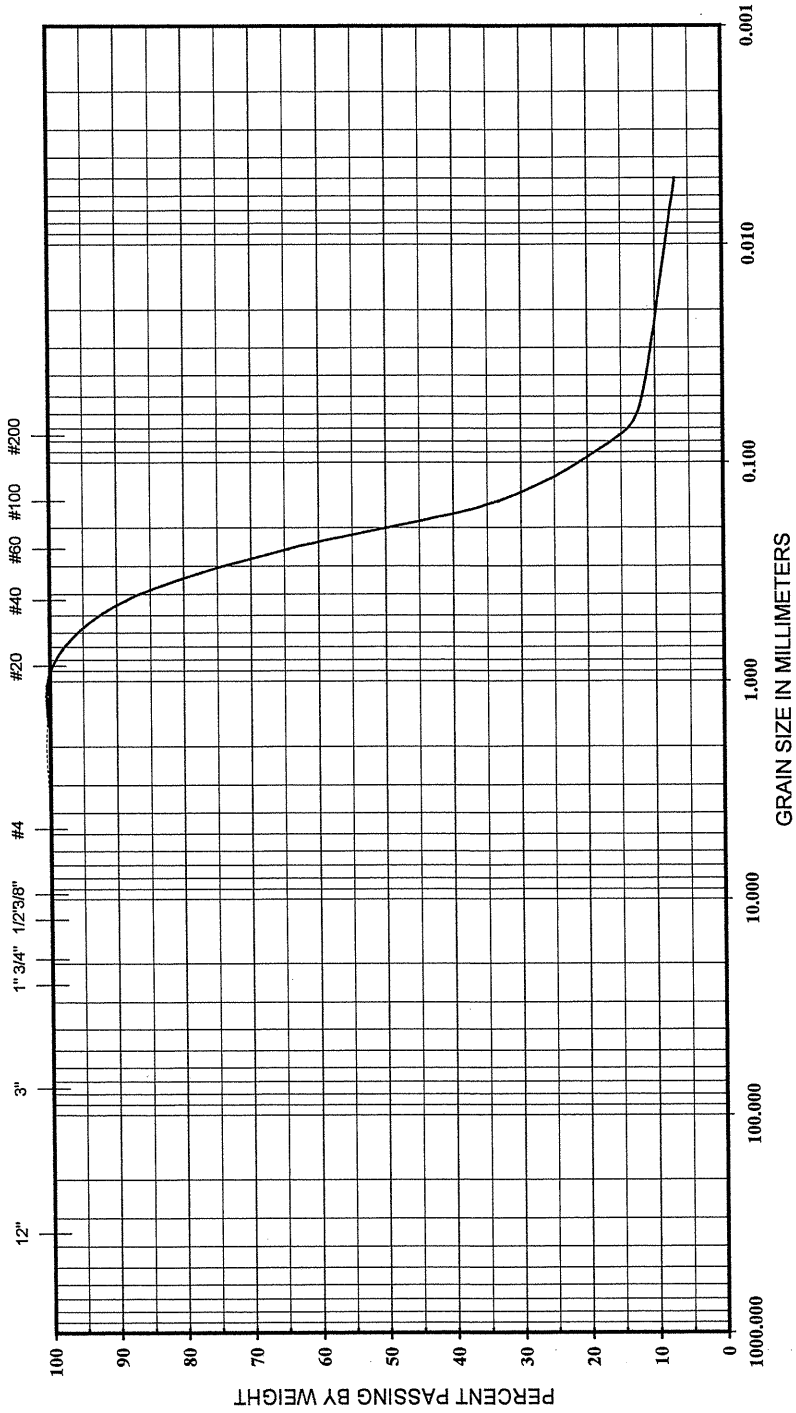
BORING NO.	SAMPLE NO.	ELEVATION OR DEPTH	NMC %	LL	PL	PI
EB1-B	SS-3	3.5-5.0	NA	40	NP	NP

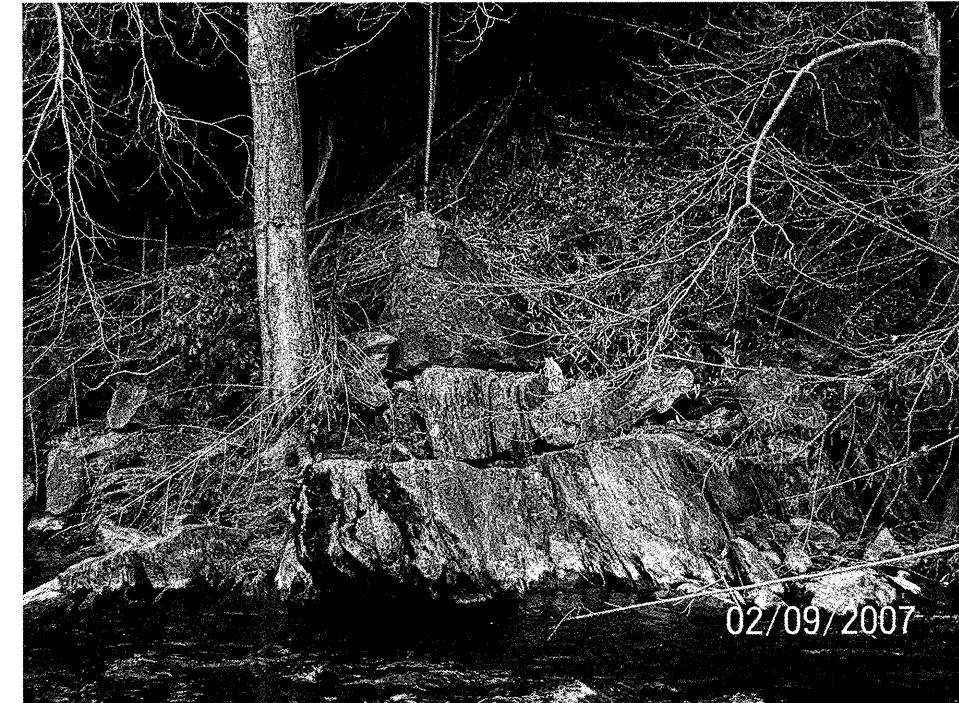
Photograph 8 – View of Rock Outcrop on North Bank at Proposed Location of New Bridge

A large rock outcrop is present on the eastern bank of the creek extending from approximately the left side of the proposed bridge to right of the centerline of the proposed bridge. The strike of this outcrop was measured by Trigon personnel at north 40° east with a dip of 80 ° southeast. Boulders are present along the majority of the eastern bank of the creek extending from the proposed bridge to the existing bridge. In addition, large concrete blocks have been placed along the eastern creek bank approximately 80 feet south of the proposed bridge.

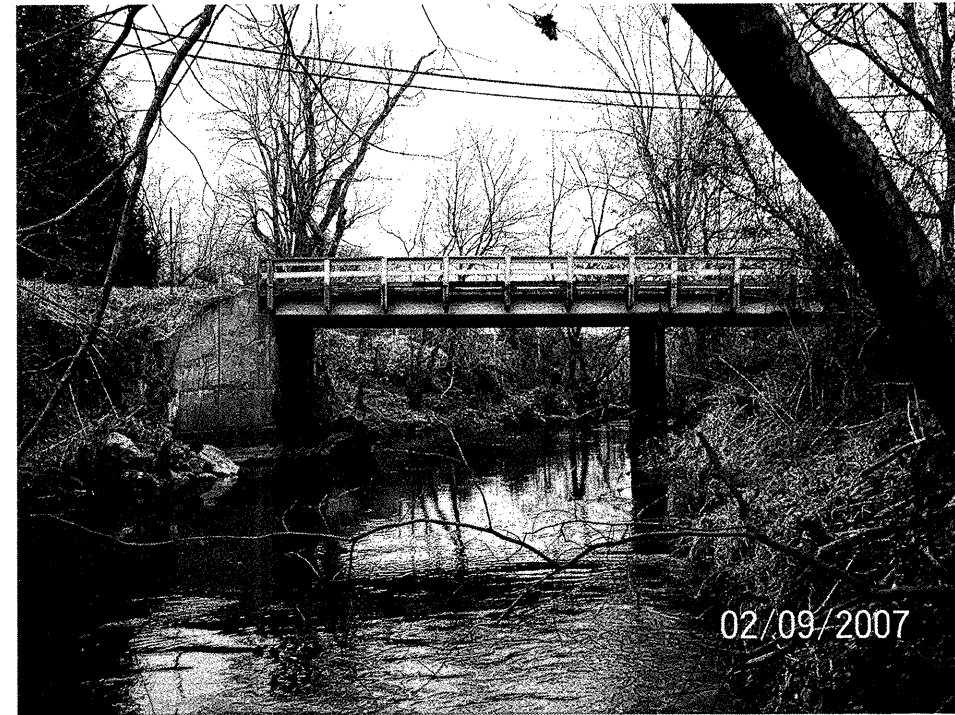
Photograph 11 – View of Existing Bridge Looking Upstream

At the time of this investigation, a two-span bridge (existing Bridge No. 211) was present approximately 180 feet south of the proposed bridge location. The existing bridge consists of a timber deck, I-beams on timber piles, has a timber abutment at End Bent-1, and has a concrete abutment at End Bent-2. The existing bridge is approximately 70 feet in length and approximately 20 feet in width.

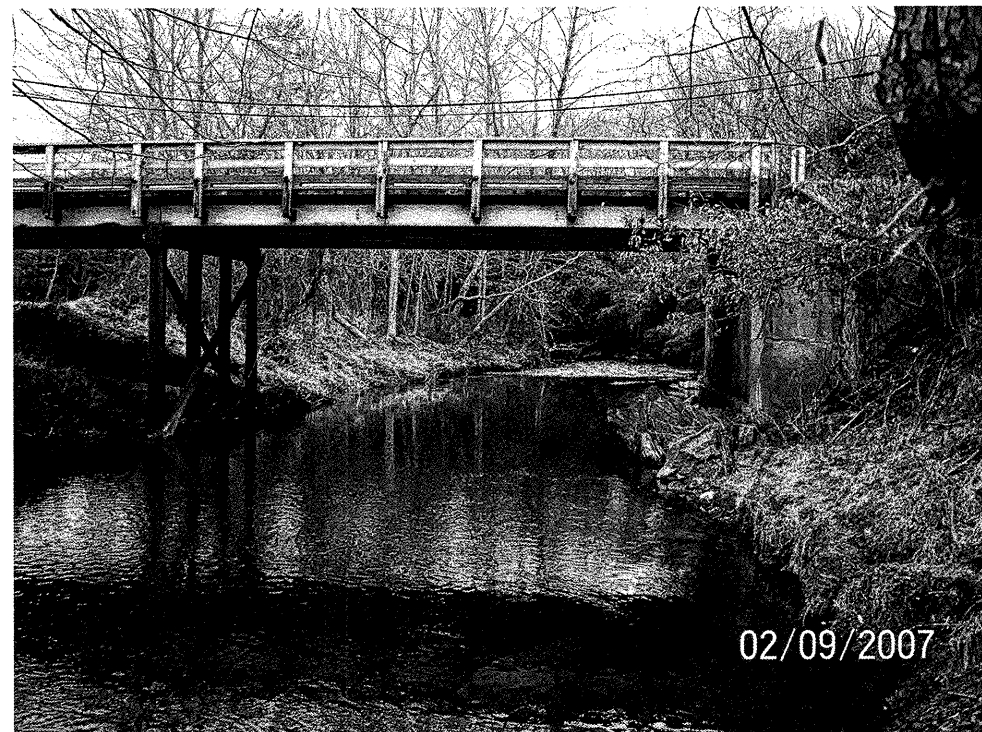
Photograph 10 – View of Existing Bridge Looking Downstream
