**PRELIMINARY SITE ASSESSMENT
PARCEL 9, K. J. LEWIS PROPERTY
2505 US HIGHWAY 1
RICHMOND COUNTY, NORTH CAROLINA
WBS ELEMENT: 34438.1.1; NCDOT PROJECT: R-2502A**

Solutions-IES Project No. 3260.06A3.NDOT

***GEOPHYSICAL SURVEYS FOR THE
DETECTION OF METALLIC USTS***

US 1 from SR 1001 to the Richmond County Line

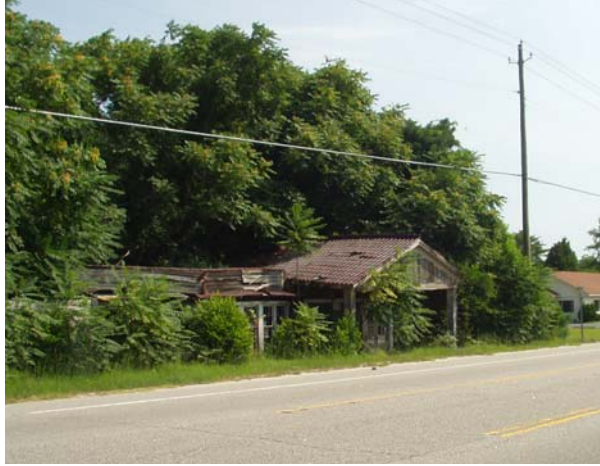
Photograph 1 – Looking north on US Highway 1 at Parcel 9.

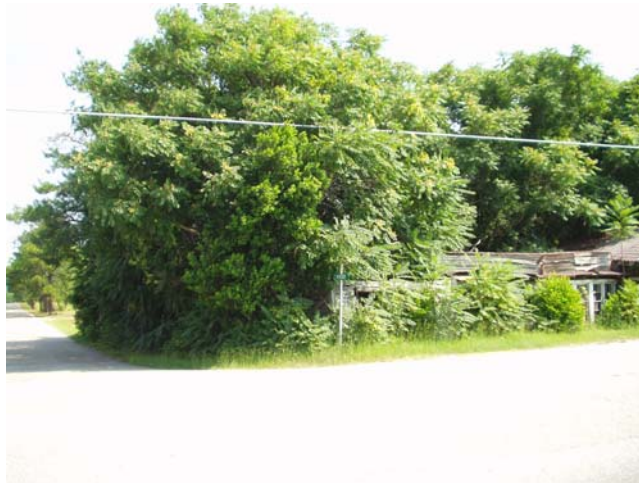
Photograph 2 – View of Parcel from intersection of US Highway 1 and Mercer Street.

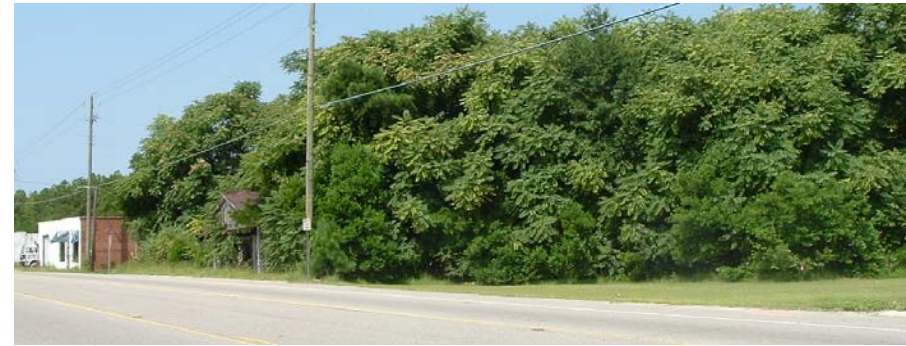
Parcel 9 - K.J. Lewis Property

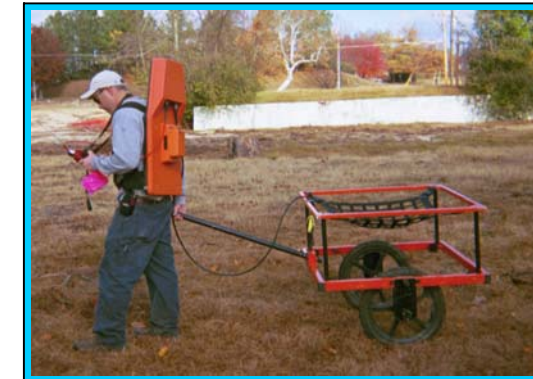
The photo shows the Geonics EM61 metal detector that was used to conduct the metal detection survey at the sites in Richmond County, North Carolina.

The geophysical investigations consisted of electromagnetic (EM) induction-metal detection surveys and ground penetrating radar (GPR) surveys. The EM surveys were performed using a Geonics EM61-MK1 metal detection instrument. According to the instrument specifications, the EM61 can detect a metal drum down to a maximum depth of approximately 8 feet. The EM61 data were digitally collected at each site along parallel northerly-southerly or easterly-westerly trending survey lines spaced five feet apart. The data were downloaded to a computer and reviewed in the field and office using the Geonics DAT61W and Surfer for Windows Version 7.0 software programs.

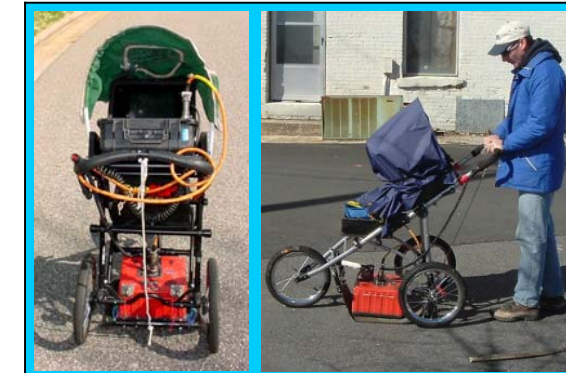
The photos show the SIR-2000 GPR system equipped with a 400 MHz antenna that was used to conduct the ground penetrating radar investigation at the sites in Richmond County, North Carolina.

GPR surveys were conducted across selected EM61 differential anomalies and steel-reinforced concrete using a GSSI SIR-2000 unit equipped with a 400 MHz antenna. Surveys were also performed across several areas where parked vehicles that obstructed the EM 61 survey had since been removed. GPR data were digitally collected in a continuous mode along X and/or Y survey lines, spaced two to five feet apart using a vertical scan of 512 samples, at a rate of 48 scans per second. An 80 MHz high pass filter and an 800 MHz low pass filter were used during data acquisition with the 400 MHz antenna. GPR data were collected down to a maximum depth of approximately five feet, based on an estimated two-way travel time of 9 nanoseconds per foot.

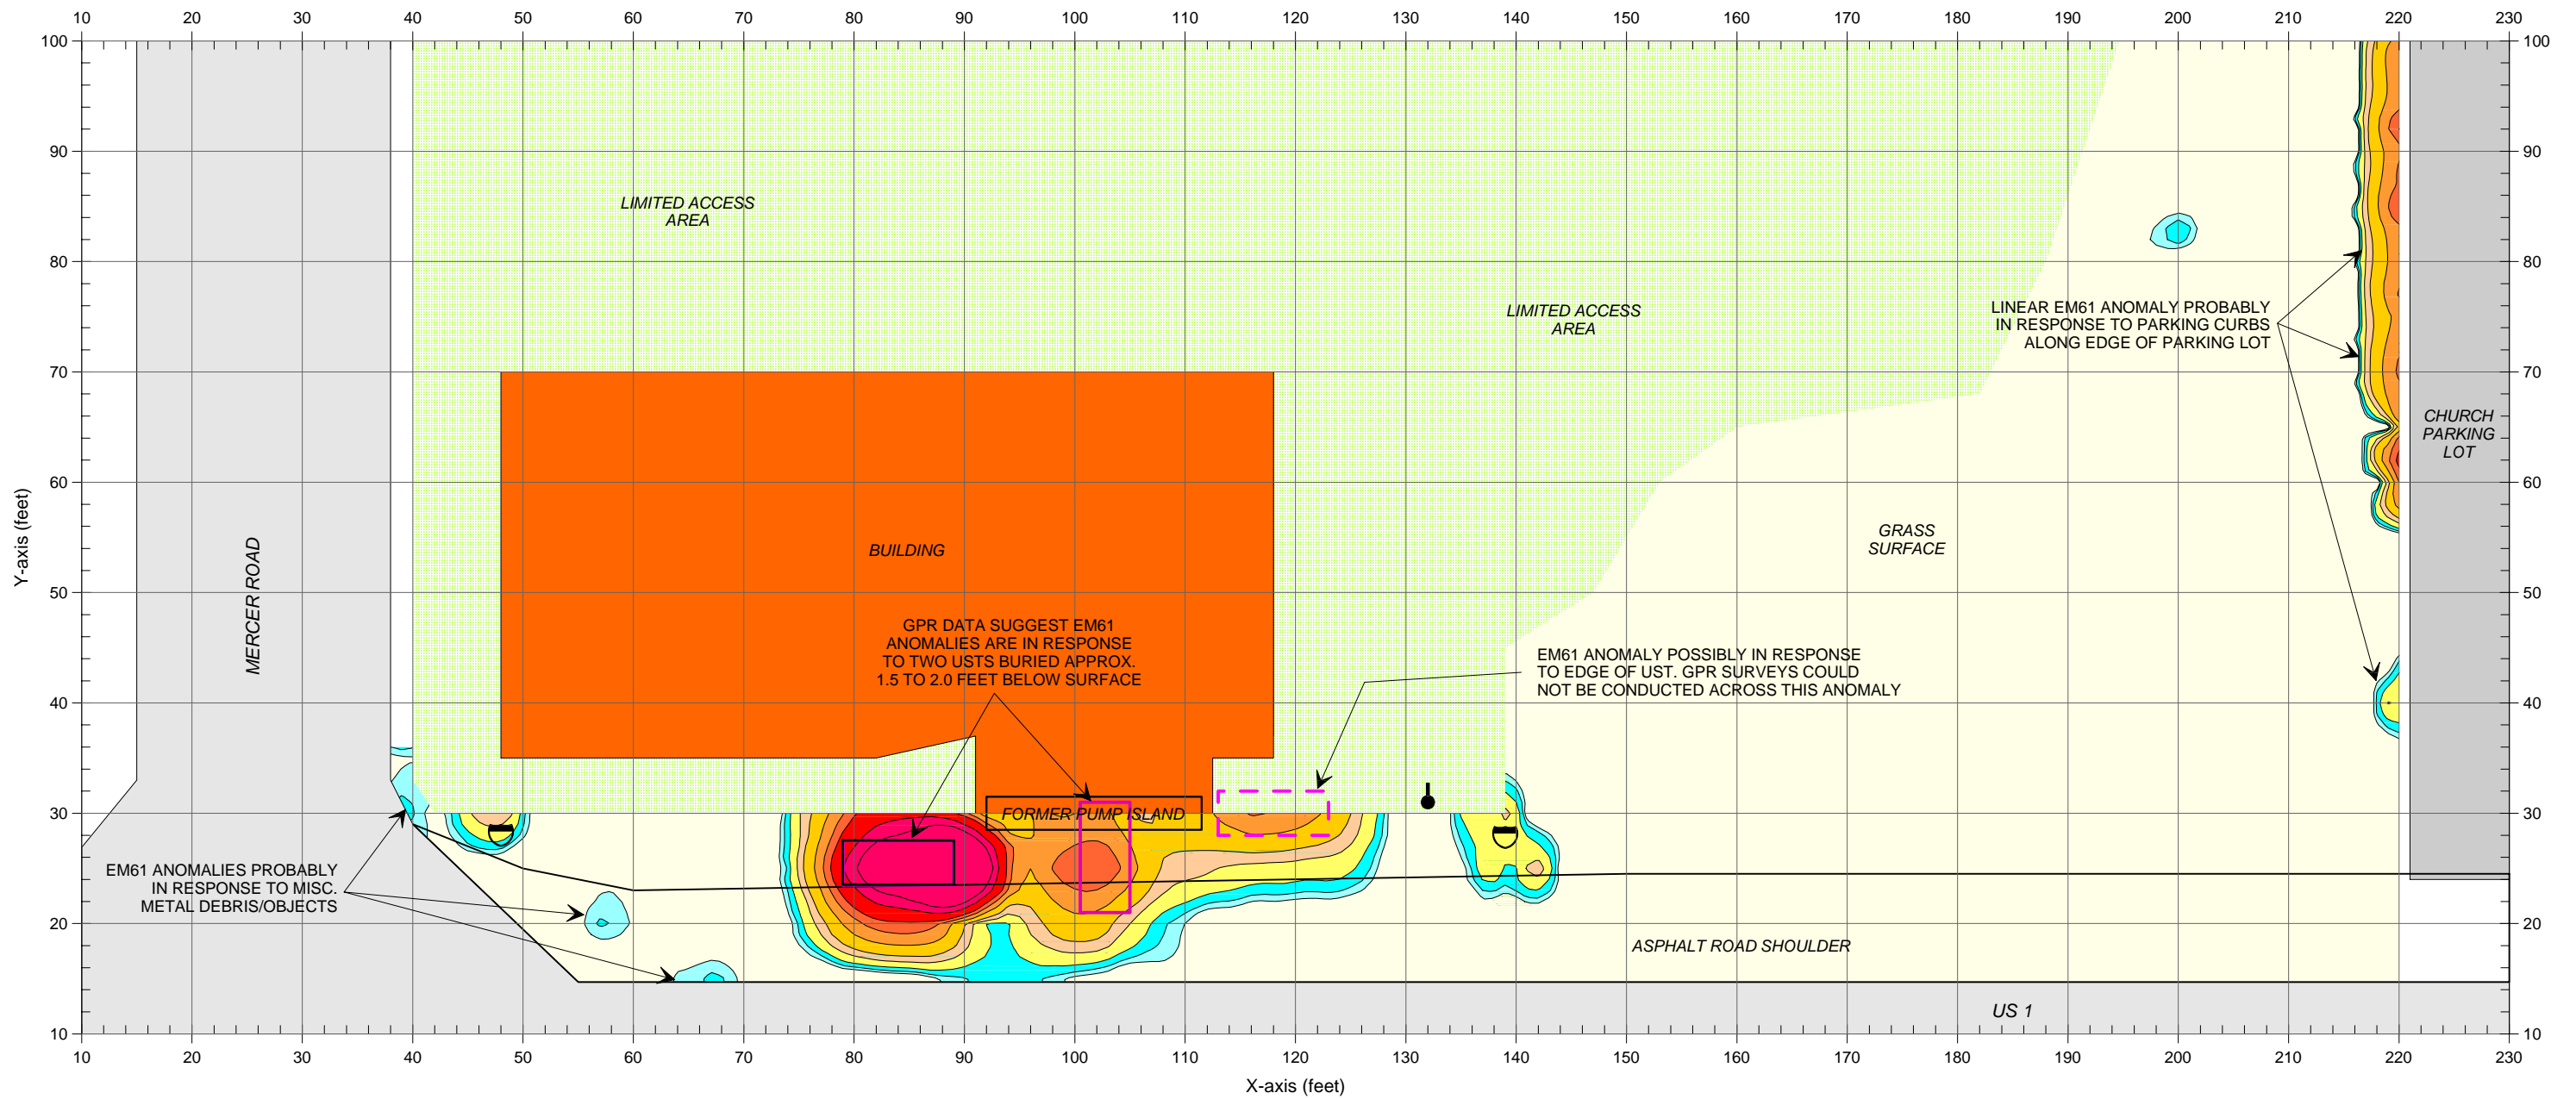
FIGURE 4

EM61 ANOMALIES PROBABLY IN RESPONSE TO MISC. METAL DEBRIS/OBJECTS

GPR DATA SUGGEST EM61 ANOMALIES ARE IN RESPONSE TO TWO USTS BURIED APPROX. 1.5 TO 2.0 FEET BELOW SURFACE

EM61
BOTTOM COIL
RESULTS

The geophysical investigation detected the probable presence of two USTs located adjacent to the pump island area. The first UST is centered near grid coordinates X=84 Y=27, and buried approximately 1.5 feet below surface. The second UST is centered near grid coordinates X=103 Y=27, and is buried approximately 2.0 feet below surface. This latter UST appears to be partially beneath the former pump island area. The approximate locations of the USTs are shown as magenta-colored rectangles in Figures 4 and 5. Based on the GPR results, the probable USTs are approximately 10 feet long and 4 feet wide. A photograph showing the approximate locations of the two probable USTs and the image of GPR survey lines Y=27.5, which intersects the probable USTs, are presented in **Figure 6**.

The EM61 differential anomaly centered near grid coordinates X=118 Y=29, may possibly be in response to a UST or large metal object. However, GPR surveys could not be conducted across this EM anomaly due to the limited access caused by the dense wooded terrain. The approximate location of this possible UST is shown as a dashed, magenta-colored rectangle in Figures 4 and 5, and in the site photograph that is presented in Figure 6.

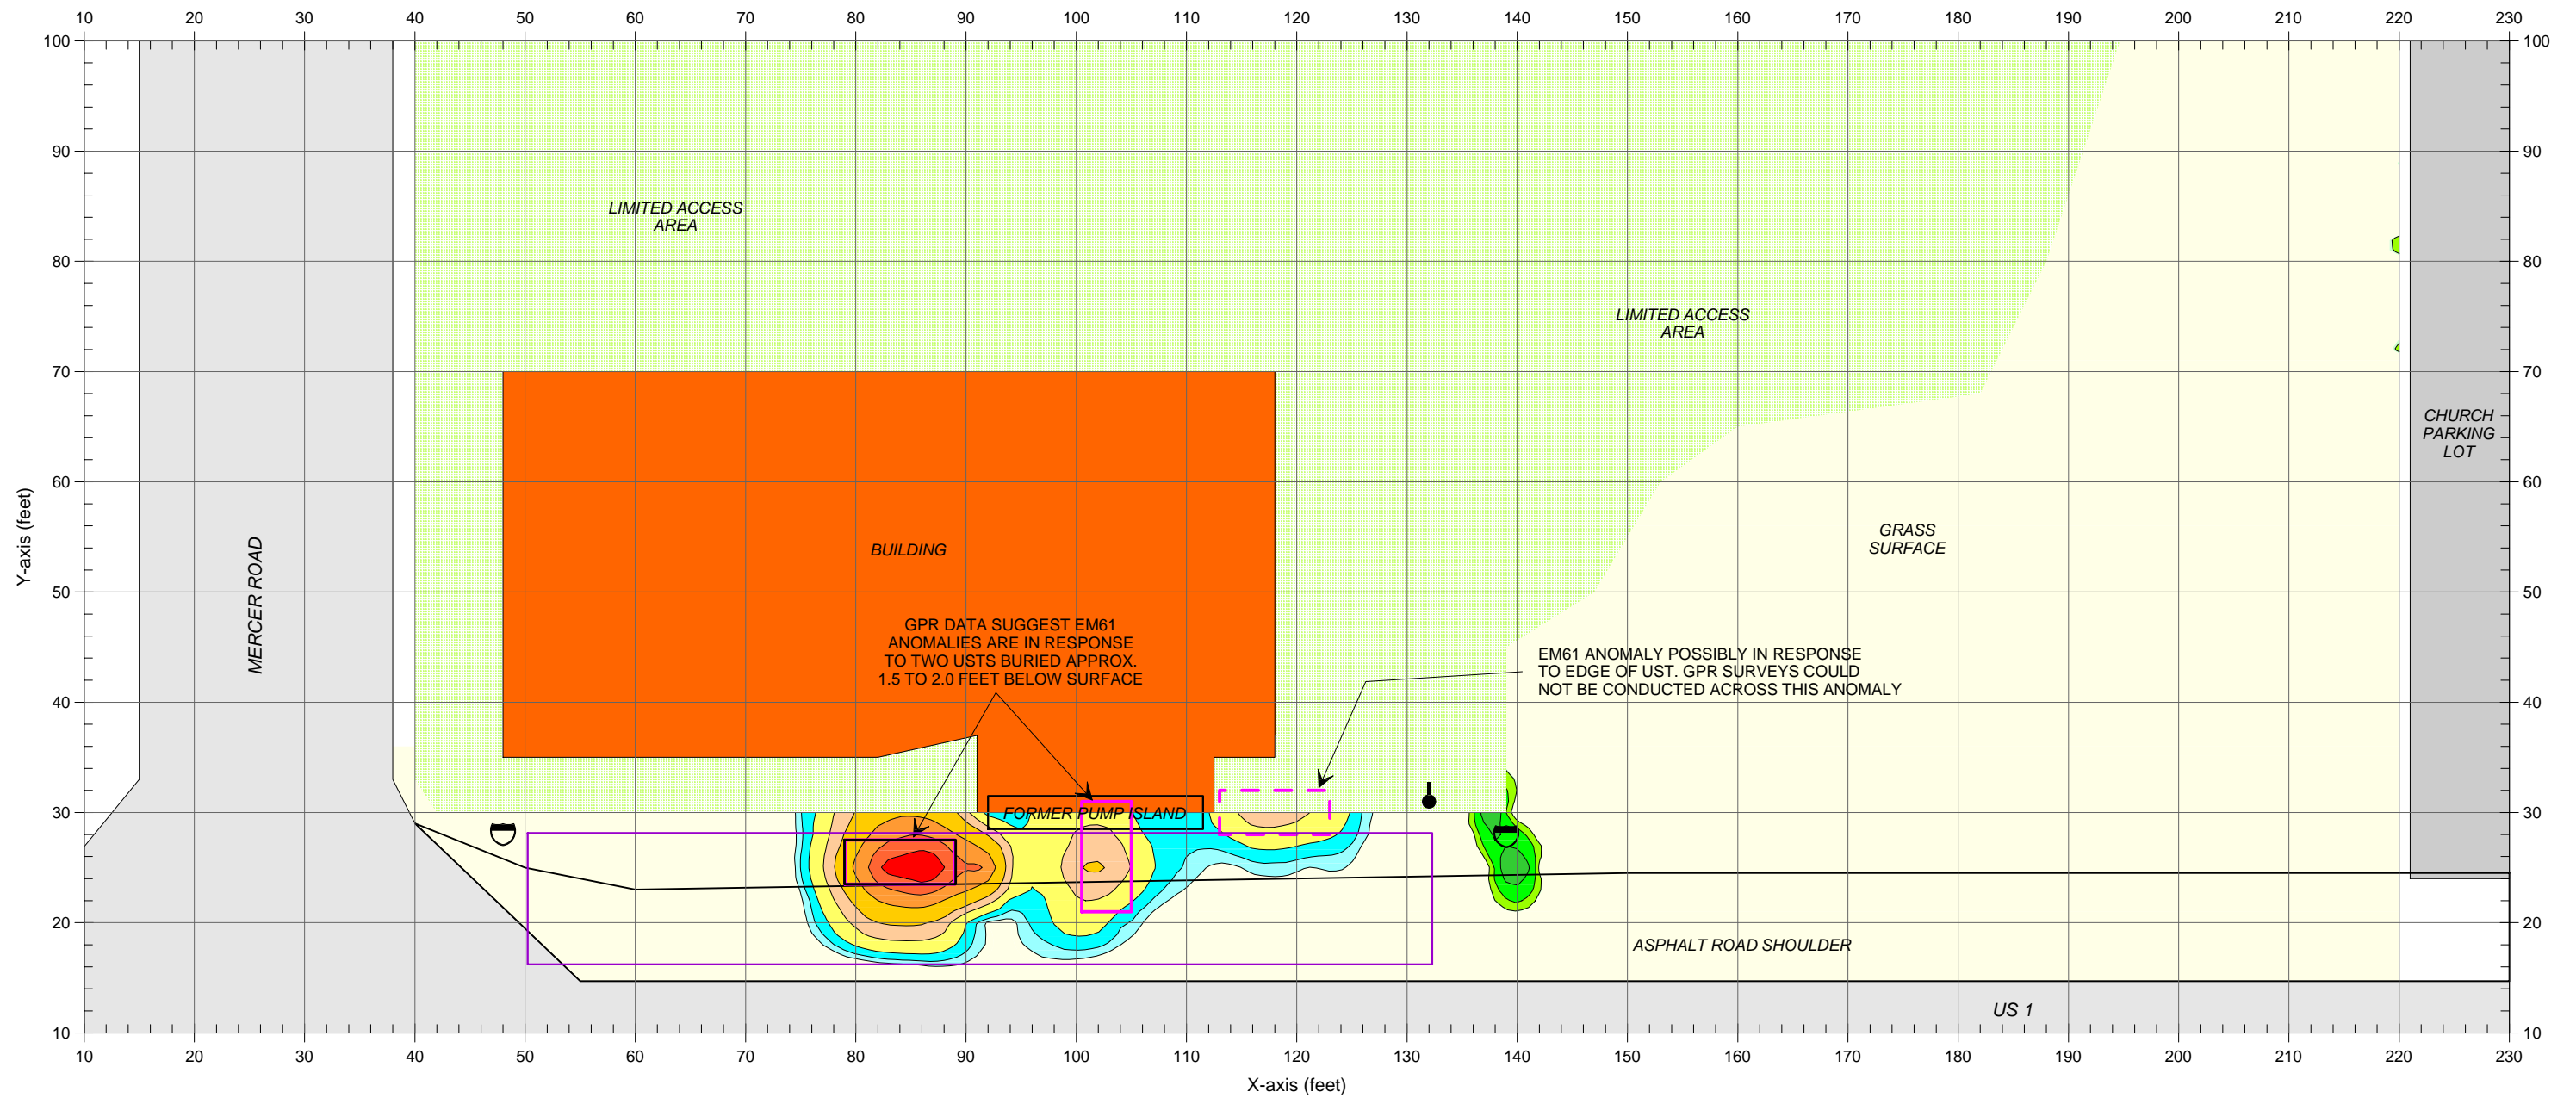
FIGURE 5

Note: The contour plot shows the differential results of the EM61 metal detection survey in millivolts (mV). The differential response focuses on larger, buried metallic objects such as drums and USTs and ignores smaller miscellaneous, buried, metal debris. The EM metal detection data were collected on August 15, 2006 using a Geonics EM61 instrument. Ground penetrating radar (GPR) data were acquired on August 16, 2006 using a Geophysical Survey Systems SIR 2000 instrument with a 400 MHz antenna.

GPR surveys suggest that the EM61 anomalies recorded adjacent to the former pump island area are probably in response to metallic USTs.

**EM61
DIFFERENTIAL
RESULTS**

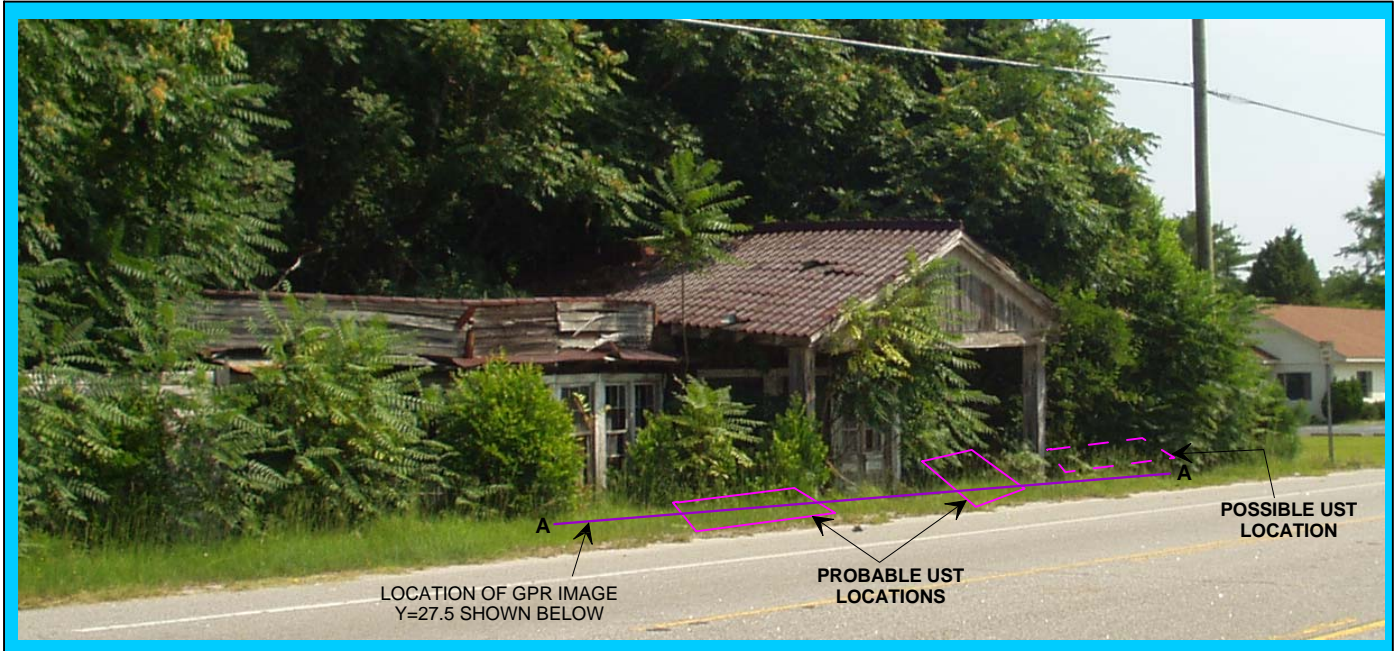
FIGURE 6

The photograph shows the locations of two probable USTs and one possible UST buried 1.5 to 2.0 feet below surface, as suggested by the geophysical results at Parcel 9.

The geophysical survey conducted at the site suggested the presence of two, or possibly three, metallic USTs located in close proximity to the abandoned building. At least two of these USTs are likely located beneath the shoulder of US Highway 1 and extremely close to the abandoned building. The outline of a former pump island was observed in this area as well (**Appendix B**, Figures 4, 5, and 6).

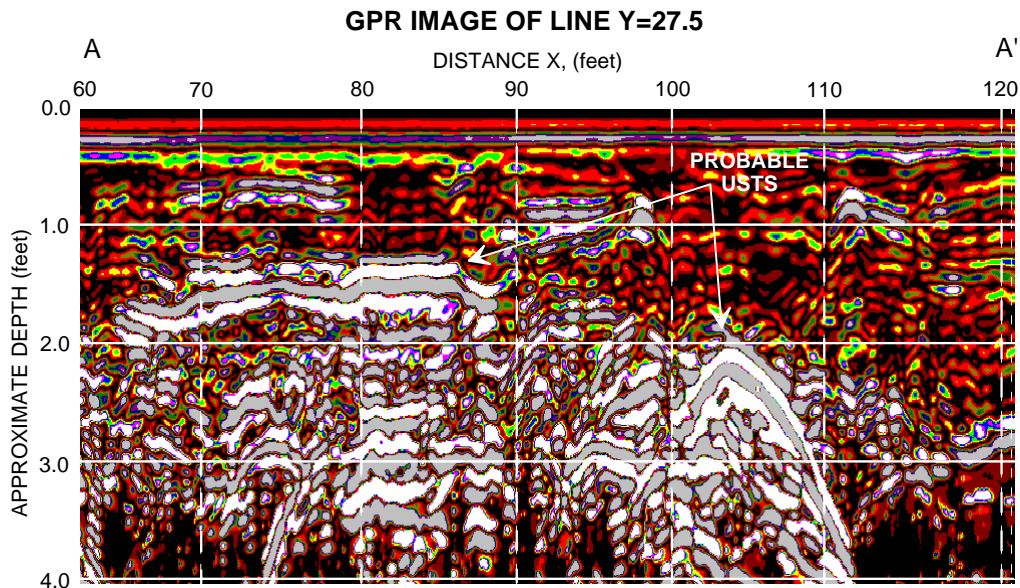
The GPR image obtained along a portion of survey line Y=27.5, shows the anomalies that are probably in response to USTs near X=84 and X=103, and buried approximately 1.5 and 2.0 feet below surface, respectively. The location of this GPR image is shown with a solid purple line in the above photograph.

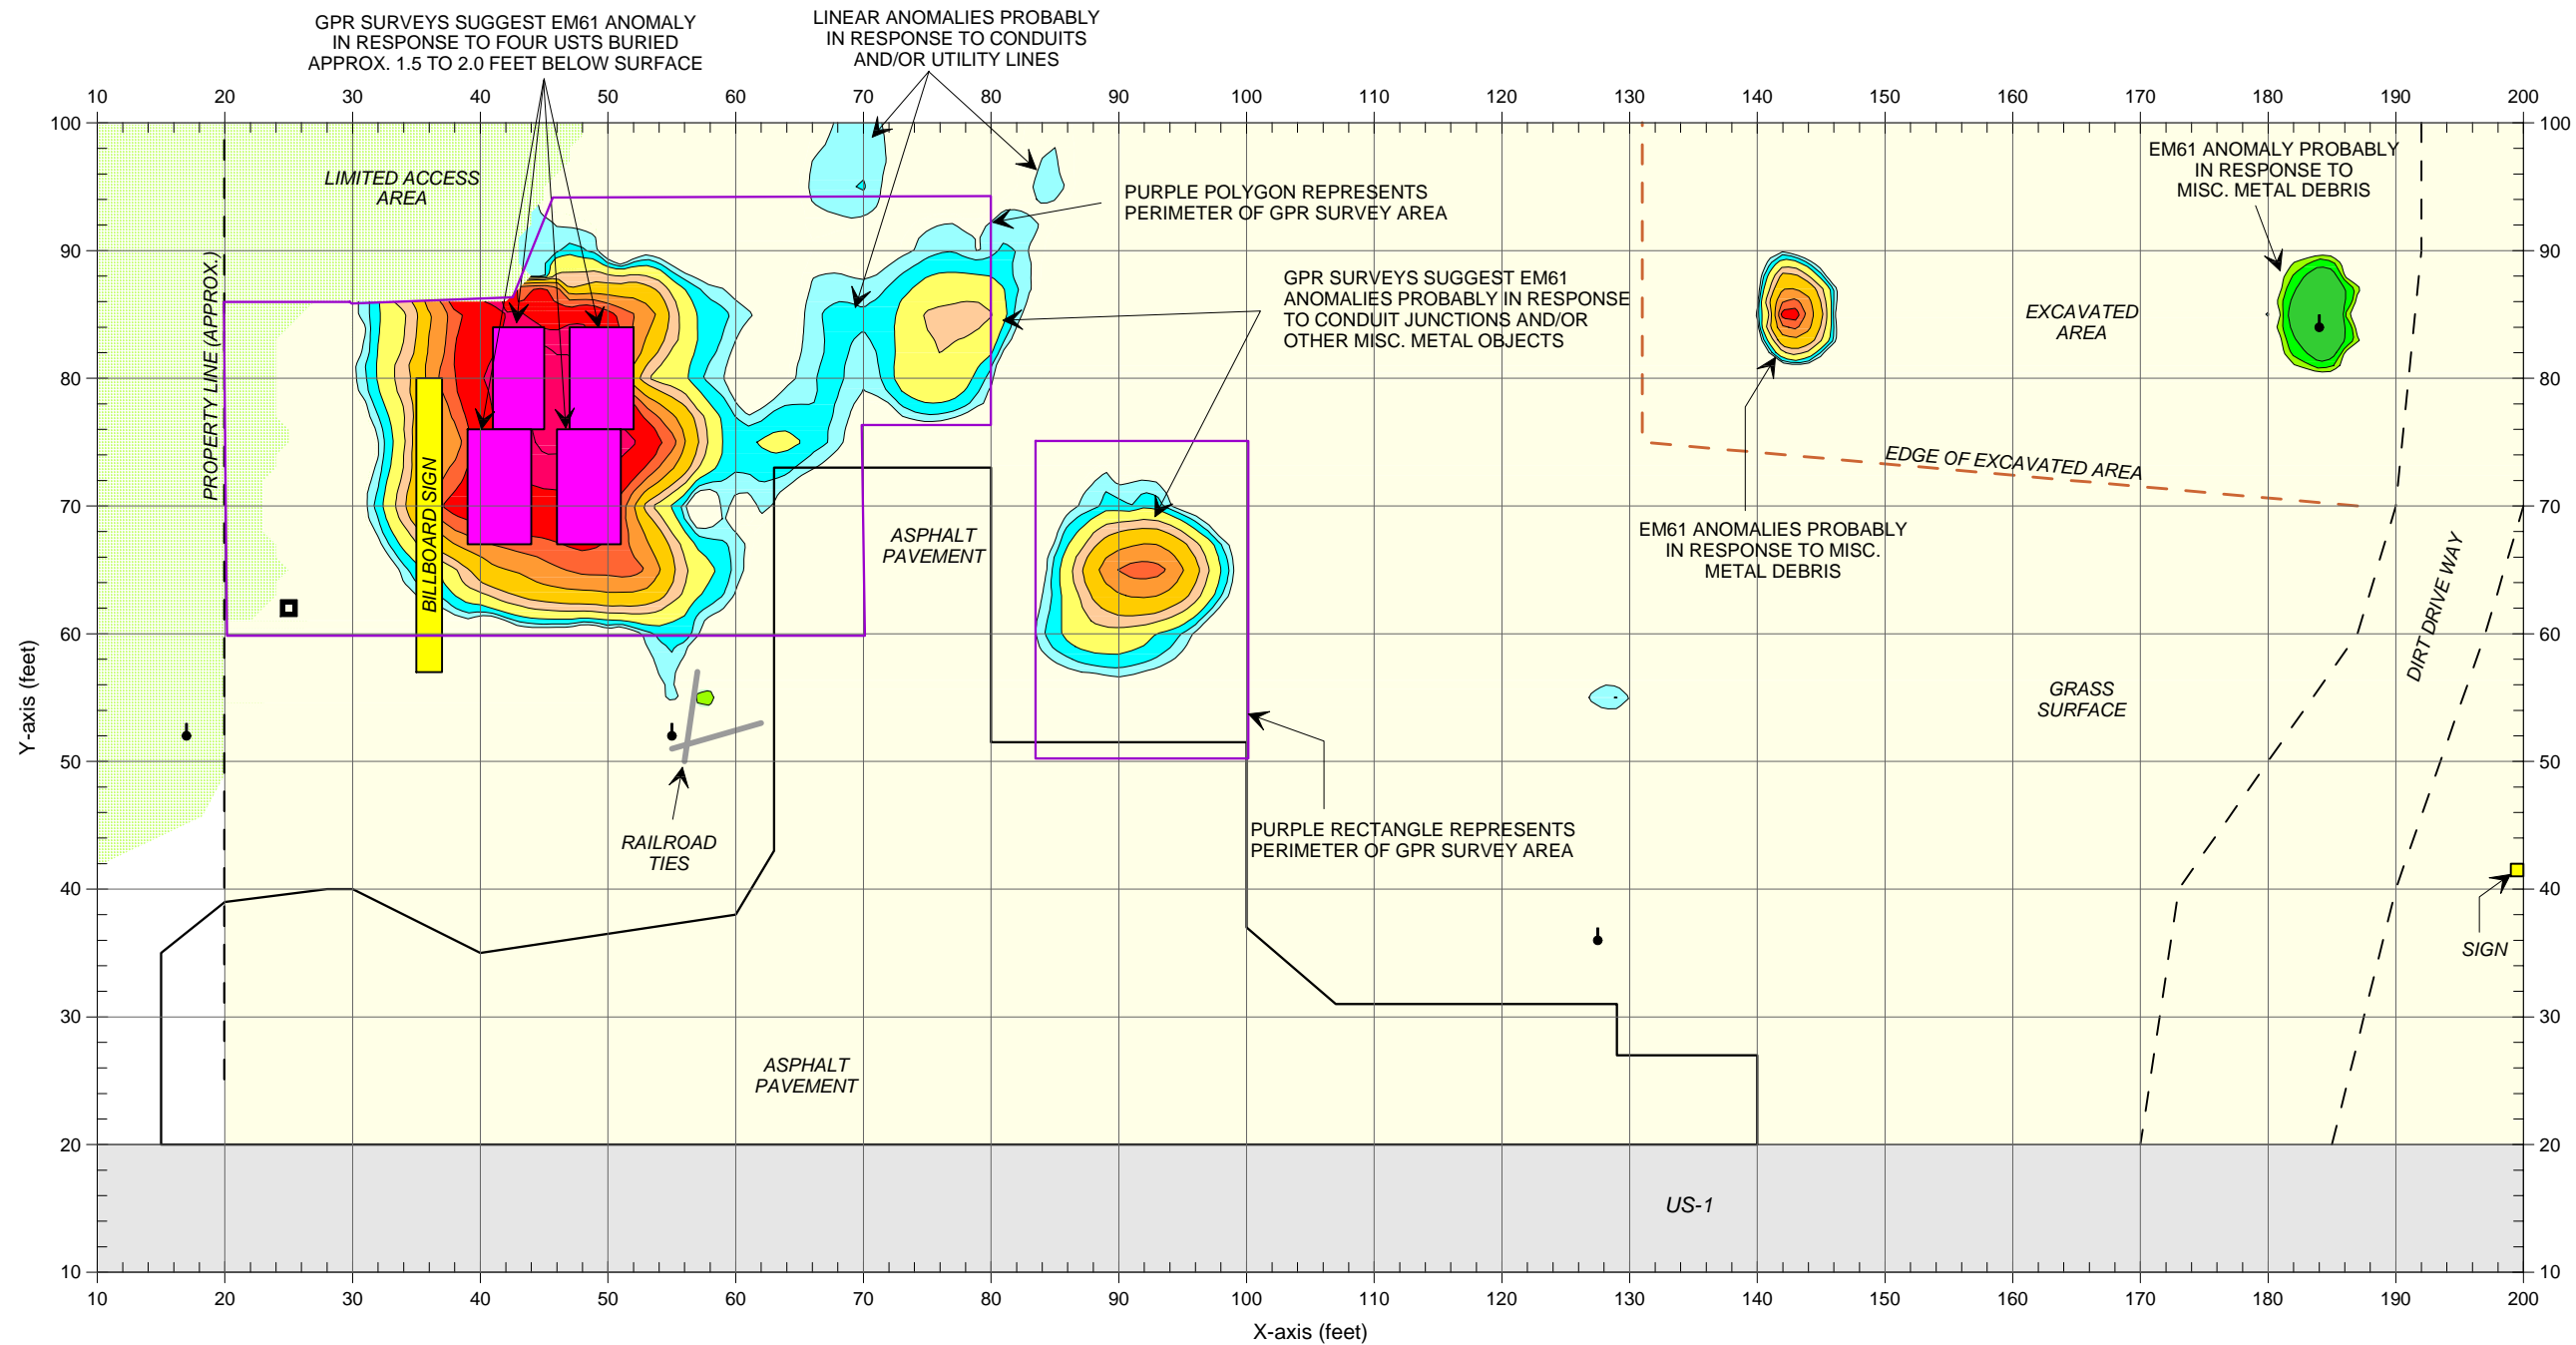
FIGURE 8

EM61 DIFFERENTIAL RESULTS

The James Brigman property (Parcel 21) consists of an open, grass and asphalt-covered lot located along the western side of US 1. The EM61 bottom coil results and the differential results are presented in **Figures 7 and 8**, respectively.

GPR surveys conducted across the linear, EM61 bottom coil anomalies that intersect grid coordinates X=62 Y=70, X=66 Y=94, X=84 Y=94, and X=87.5 Y=75, suggest the anomalies are probably in response to buried utility lines or conduits. GPR data also suggest that the high amplitude anomalies centered near grid coordinates X=77 Y=84, and X=93 Y=66, are probably in response to buried miscellaneous metal objects or junction areas for the conduits or utility lines.

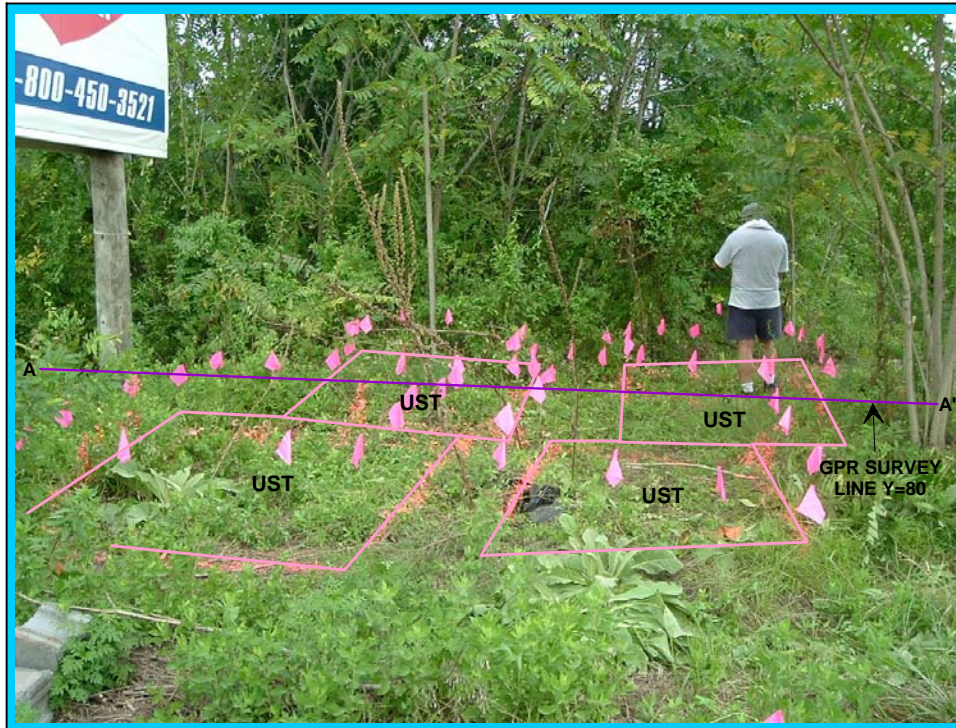
The photograph shows the location of four probable USTs buried 1.75 to 2.0 feet below surface, as suggested by the geophysical results at Parcel 21.

GPR surveys conducted across the large, high amplitude anomaly centered near X=45 Y=75, detected the probable presence of four metallic USTs. The four probable USTs are centered near grid coordinates X=43 Y=80, X=50 Y=80, X=42 Y=73, and X=48 Y=73. Based on the GPR data, the USTs appear to be approximately 9 feet long and 3.5 to 4 feet wide and buried approximately 1.5 to 2.0 feet below surface. The approximate locations of the probable USTs are shown as magenta-colored rectangles in Figures 7 and 8. A photograph showing the approximate locations of the four probable USTs and the image of GPR survey lines Y=80, which intersects the two probable USTs centered near X=43 Y=80, and X=50 Y=80, are presented in **Figure 9**.

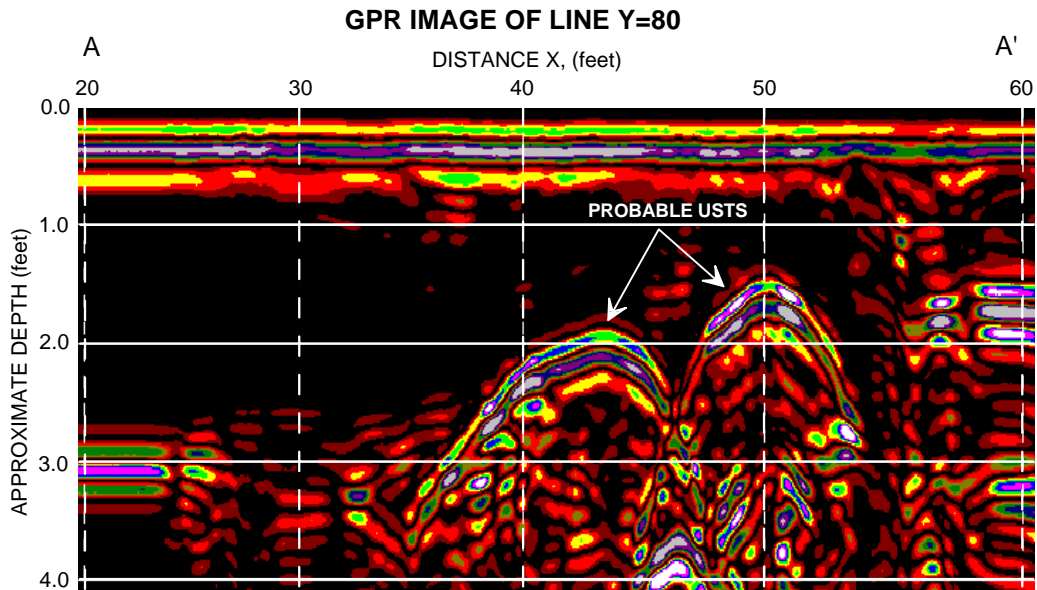
The GPR image obtained along a portion of survey line Y=80, shows the anomalies that are probably in response to USTs near X=43 and X=50, and buried approximately 2.0 and 1.5 feet below surface, respectively. The location of this GPR image is shown with a solid purple line in the above photograph.

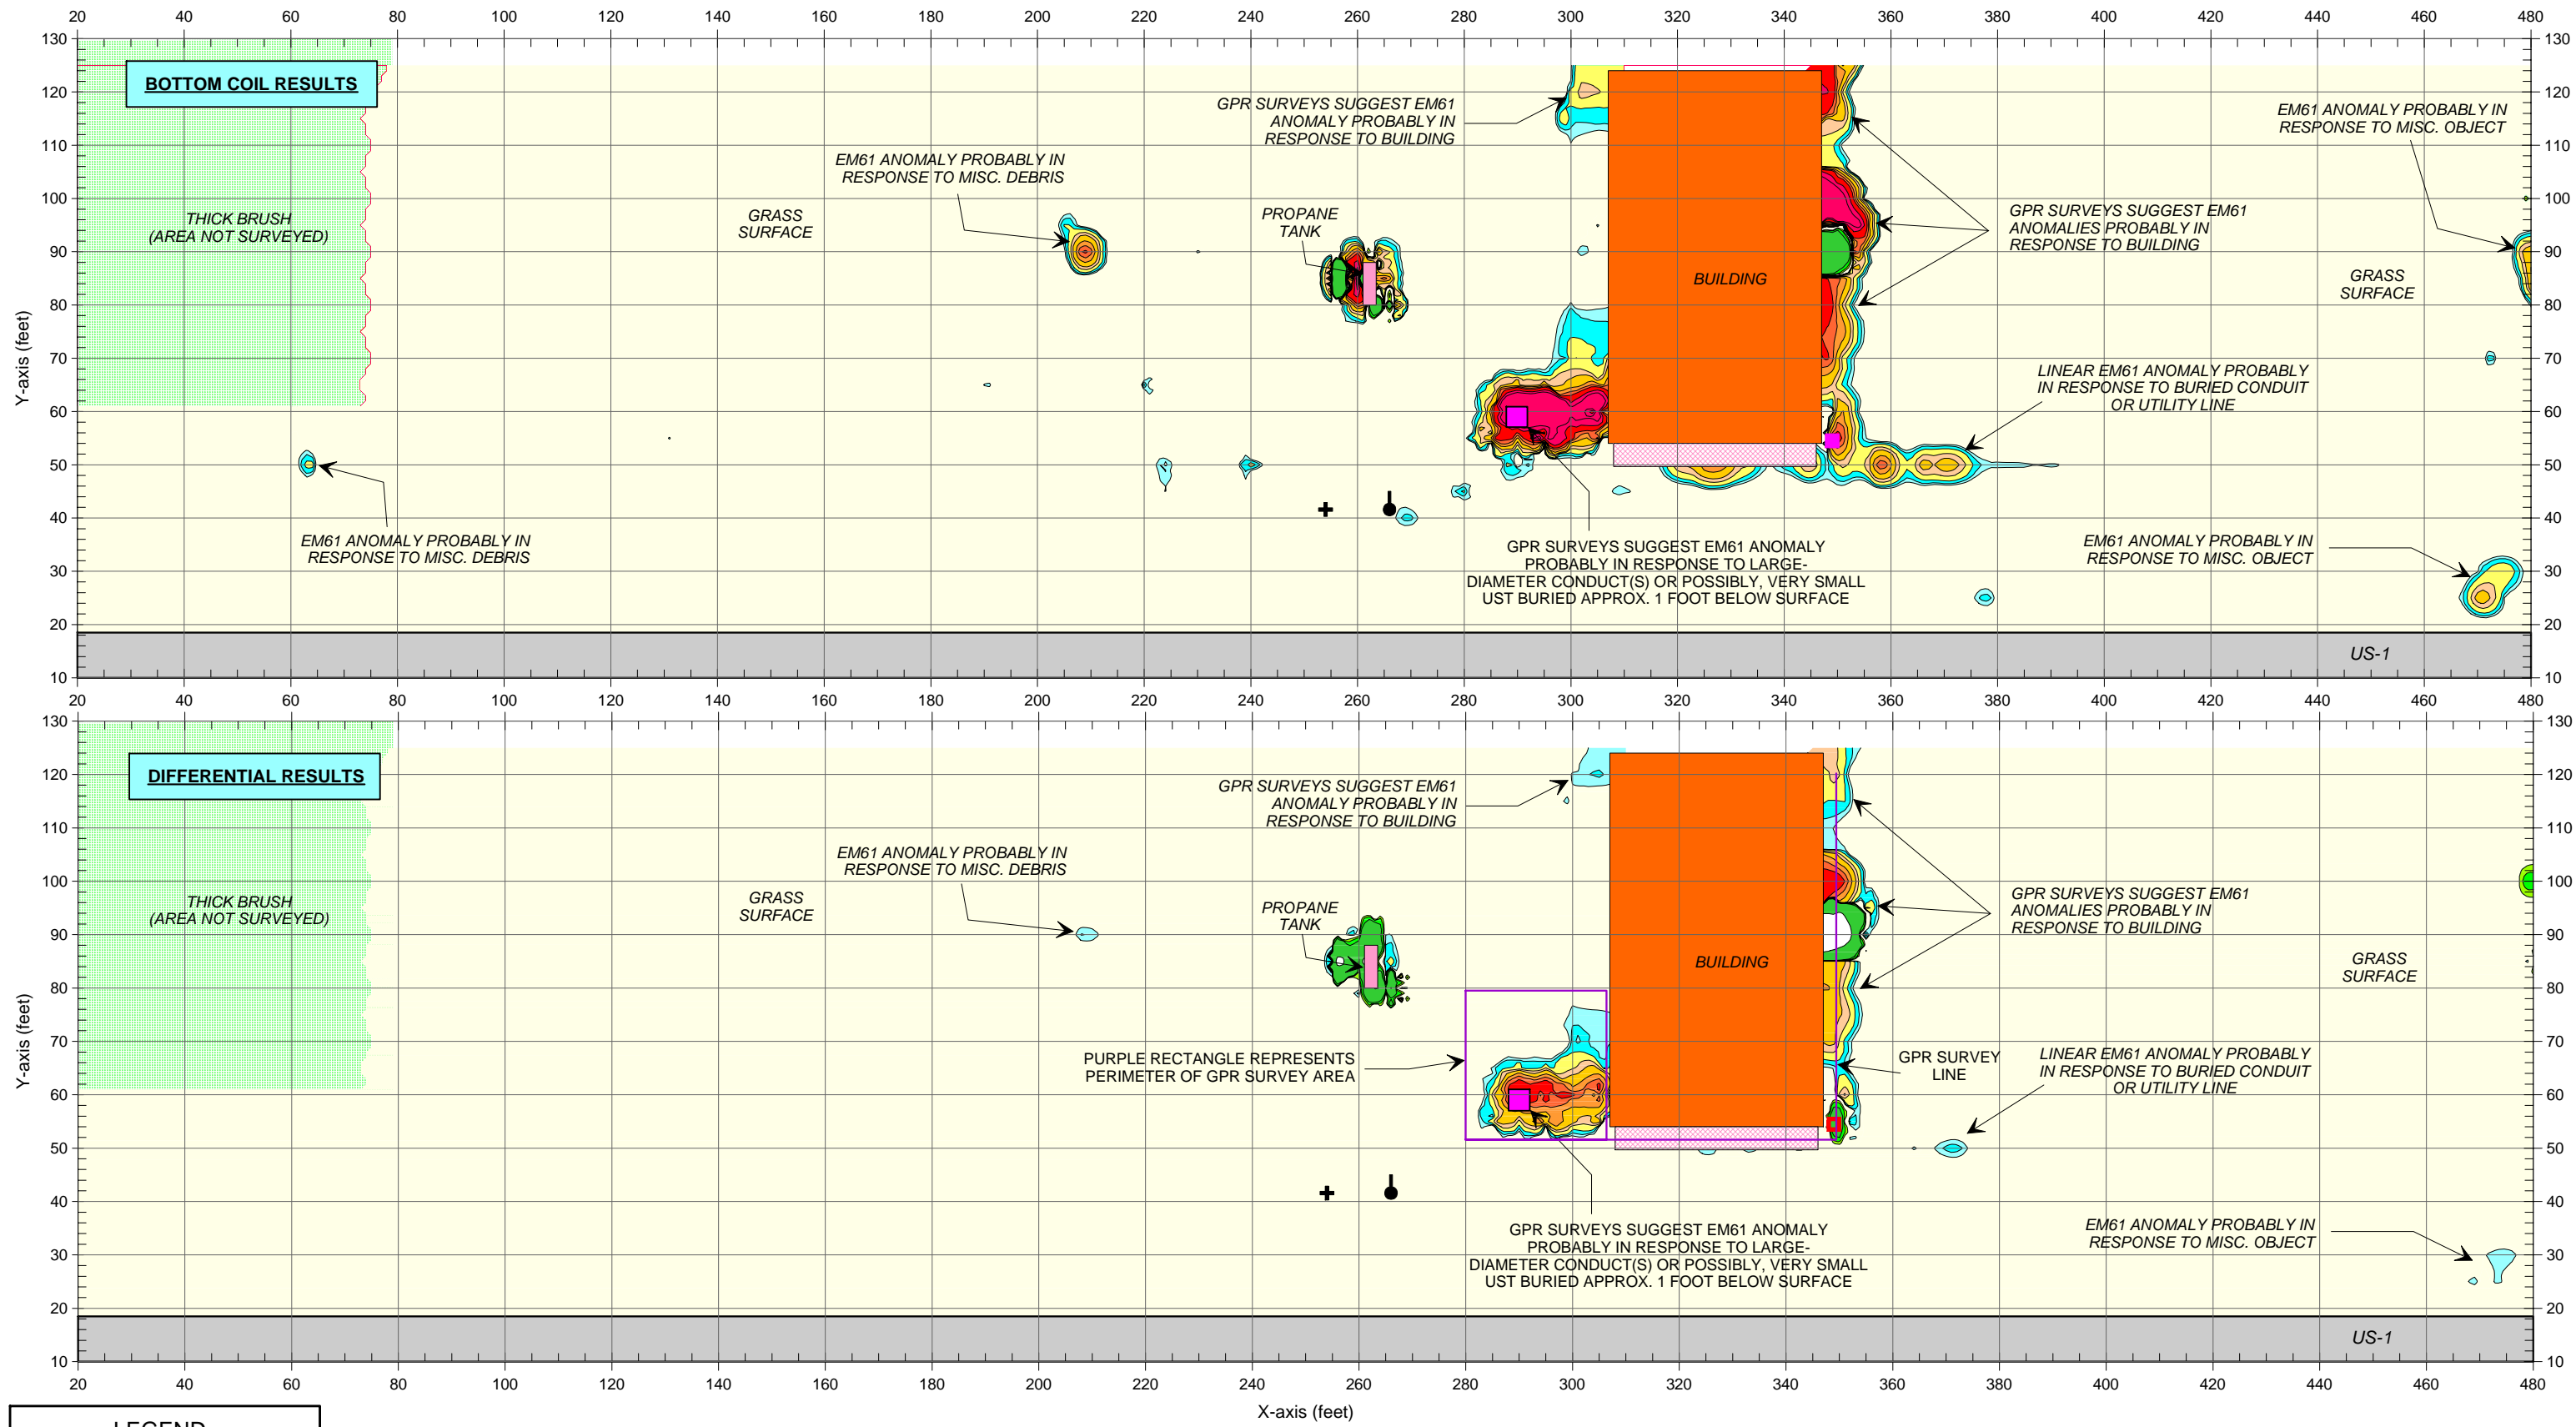
FIGURE 10

EM61 METAL DETECTION RESULTS

GPR surveys conducted across the EM61 anomaly centered near grid coordinates X=295 Y=60, suggest that the anomaly is probably in response to one or more large diameter (12 or more inches) conduits buried approximately 1.0 feet below surface. There is a possibility (although unlikely) that the anomaly may be in response to a very small UST centered near grid coordinates X=290 Y=59. The location of the possible, but unlikely UST is shown as a magenta-colored square in Figure 10.

GPR surveys conducted along the edge of the brick building suggest that the EM61 anomalies recorded in this area are probably in response to the building and/or buried miscellaneous debris. The remaining EM61 anomalies recorded within the proposed ROW area at Parcel 48 are probably in response to known cultural features and/or buried miscellaneous debris.

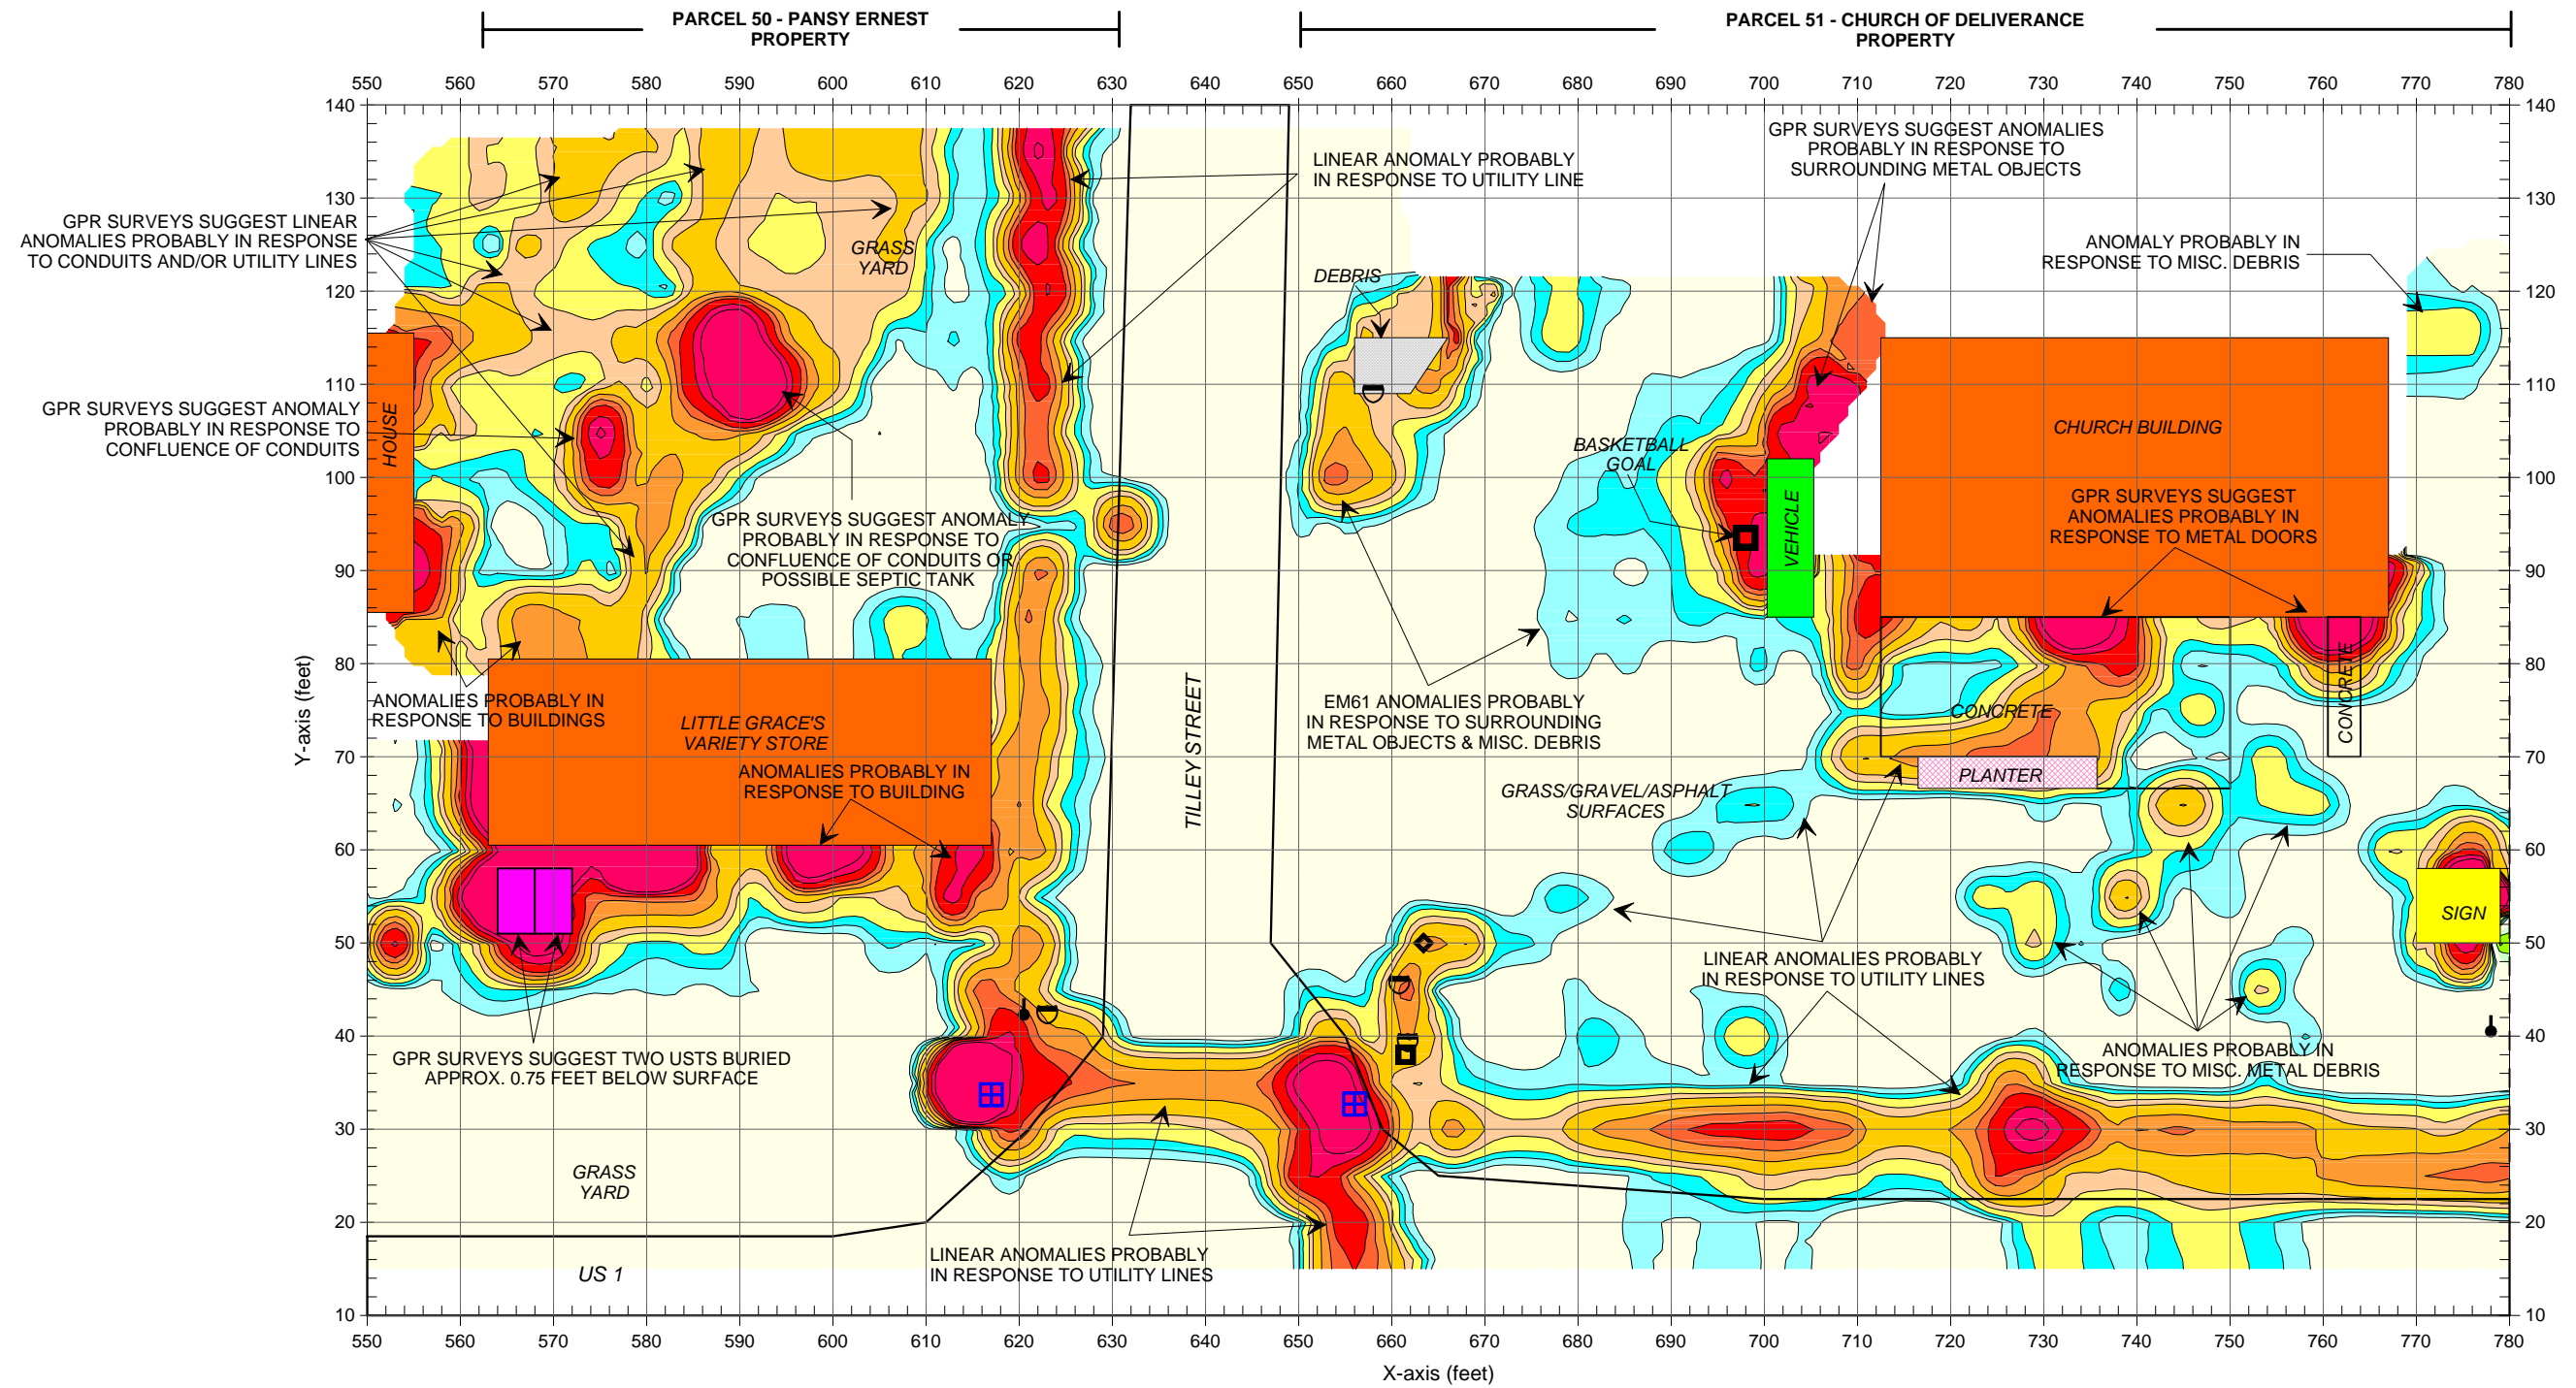
FIGURE 11

Note: The contour plot shows the bottom coil (most sensitive) response of the EM61 instrument in millivolts (mV). The bottom coil response shows buried metallic objects regardless of size. The EM metal detection data were collected on July 26, 2006 using a Geonics EM61 instrument. Ground penetrating radar (GPR) data were acquired on July 28, 2006 using a Geophysical Survey Systems SIR 2000 instrument with a 400 MHz antenna.

The majority of linear EM61 bottom coil anomalies shown above, are probably in response to buried utility lines or conduits. Negative EM anomalies (shaded in green) are probably in response to metallic surface objects. The geophysical investigation detected two probable USTs on Parcel 50.

EM61
BOTTOM COIL
RESULTS
