**PRELIMINARY SITE ASSESSMENT
PARCEL 9, K. J. LEWIS PROPERTY
2505 US HIGHWAY 1
RICHMOND COUNTY, NORTH CAROLINA
WBS ELEMENT: 34438.1.1; NCDOT PROJECT: R-2502A**

Solutions-IES Project No. 3260.06A3.NDOT

***GEOPHYSICAL SURVEYS FOR THE
DETECTION OF METALLIC USTS***

US 1 from SR 1001 to the Richmond County Line

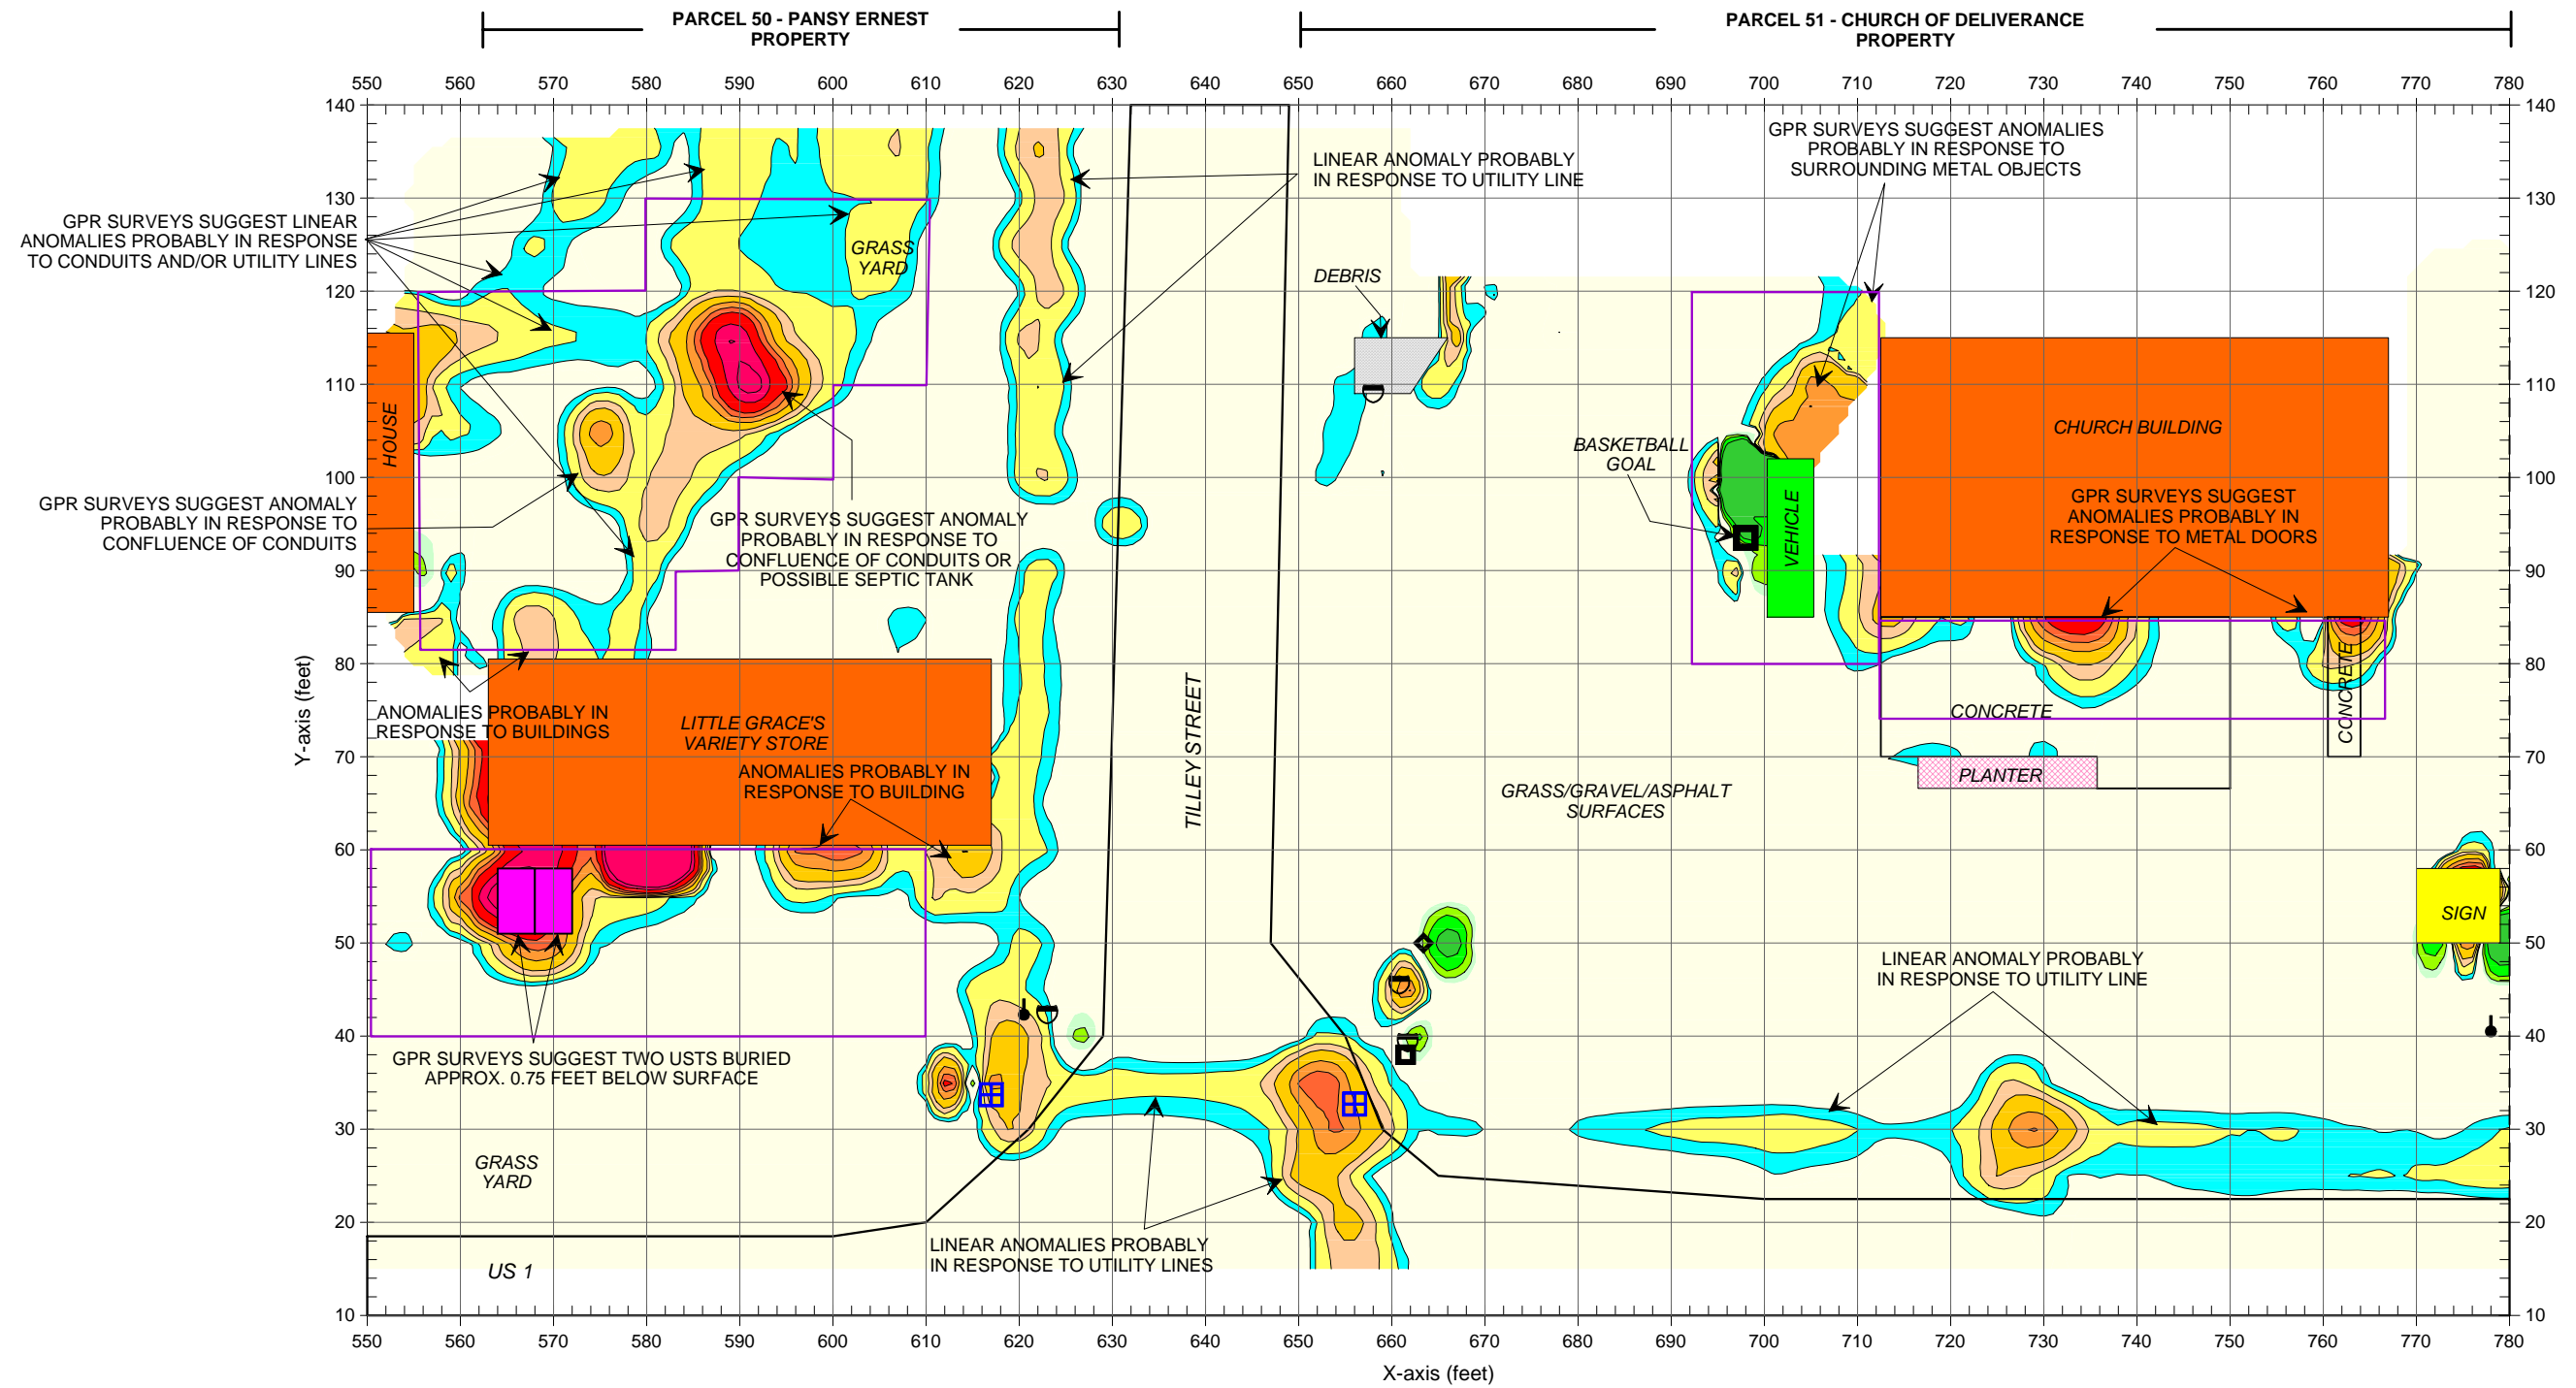
FIGURE 12

Note: The contour plot shows the differential results of the EM61 metal detection survey in millivolts (mV). The differential response focuses on larger, buried metallic objects such as drums and USTs and ignores smaller miscellaneous, buried, metal debris. The EM metal detection data were collected on July 26, 2006 using a Geonics EM61 instrument. Ground penetrating radar (GPR) data were acquired on July 28, 2006 using a Geophysical Survey Systems SIR 2000 instrument with a 400 MHz antenna.

The majority of linear EM61 bottom coil anomalies shown above, are probably in response to buried utility lines or conduits. Negative EM anomalies (shaded in green) are probably in response to metallic surface objects. The geophysical investigation detected two probable USTs on Parcel 50.

**EM61
DIFFERENTIAL
RESULTS**

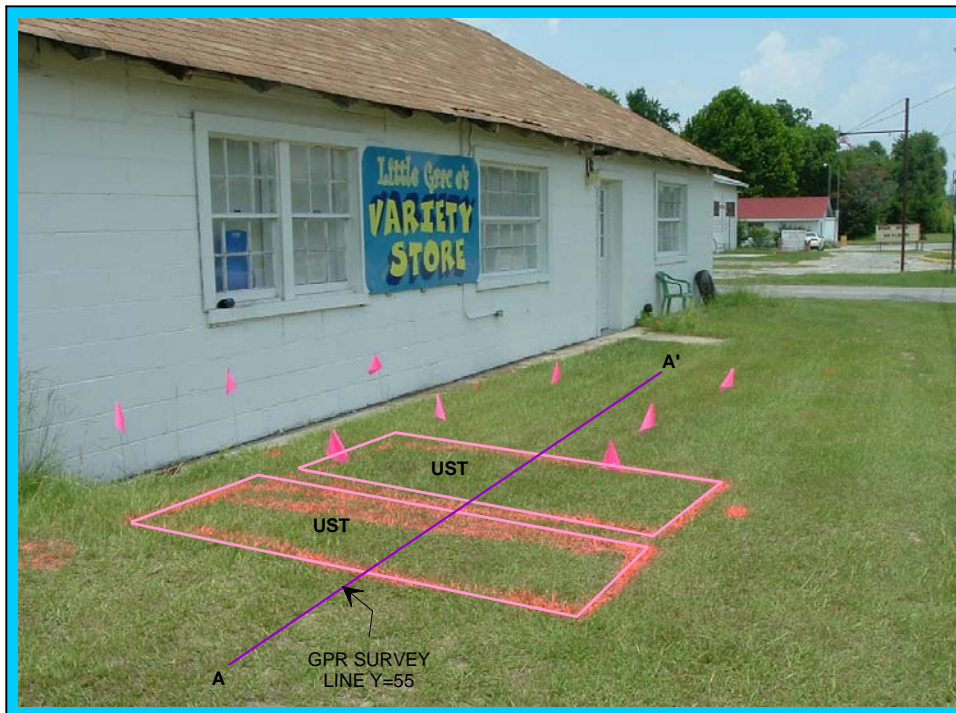
The photograph shows the location of two probable USTs buried approx. 0.75 feet below surface, as suggested by the geophysical results at Parcel 50.

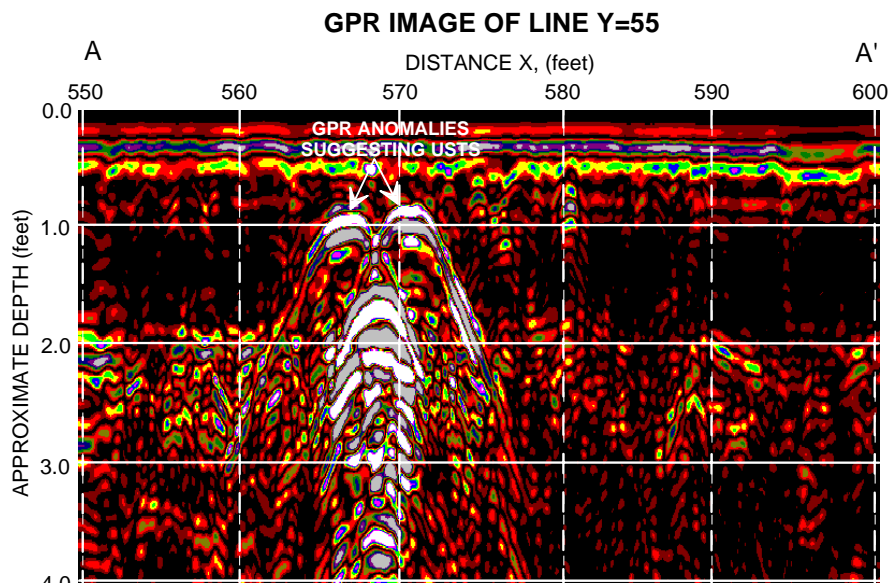
The GPR image obtained along survey line Y=55 shows the anomalies that are probably in response to USTs near X=566 and X=570, and buried approximately 0.75 feet below surface. The location of this GPR image is shown with a solid purple line in the above photograph.

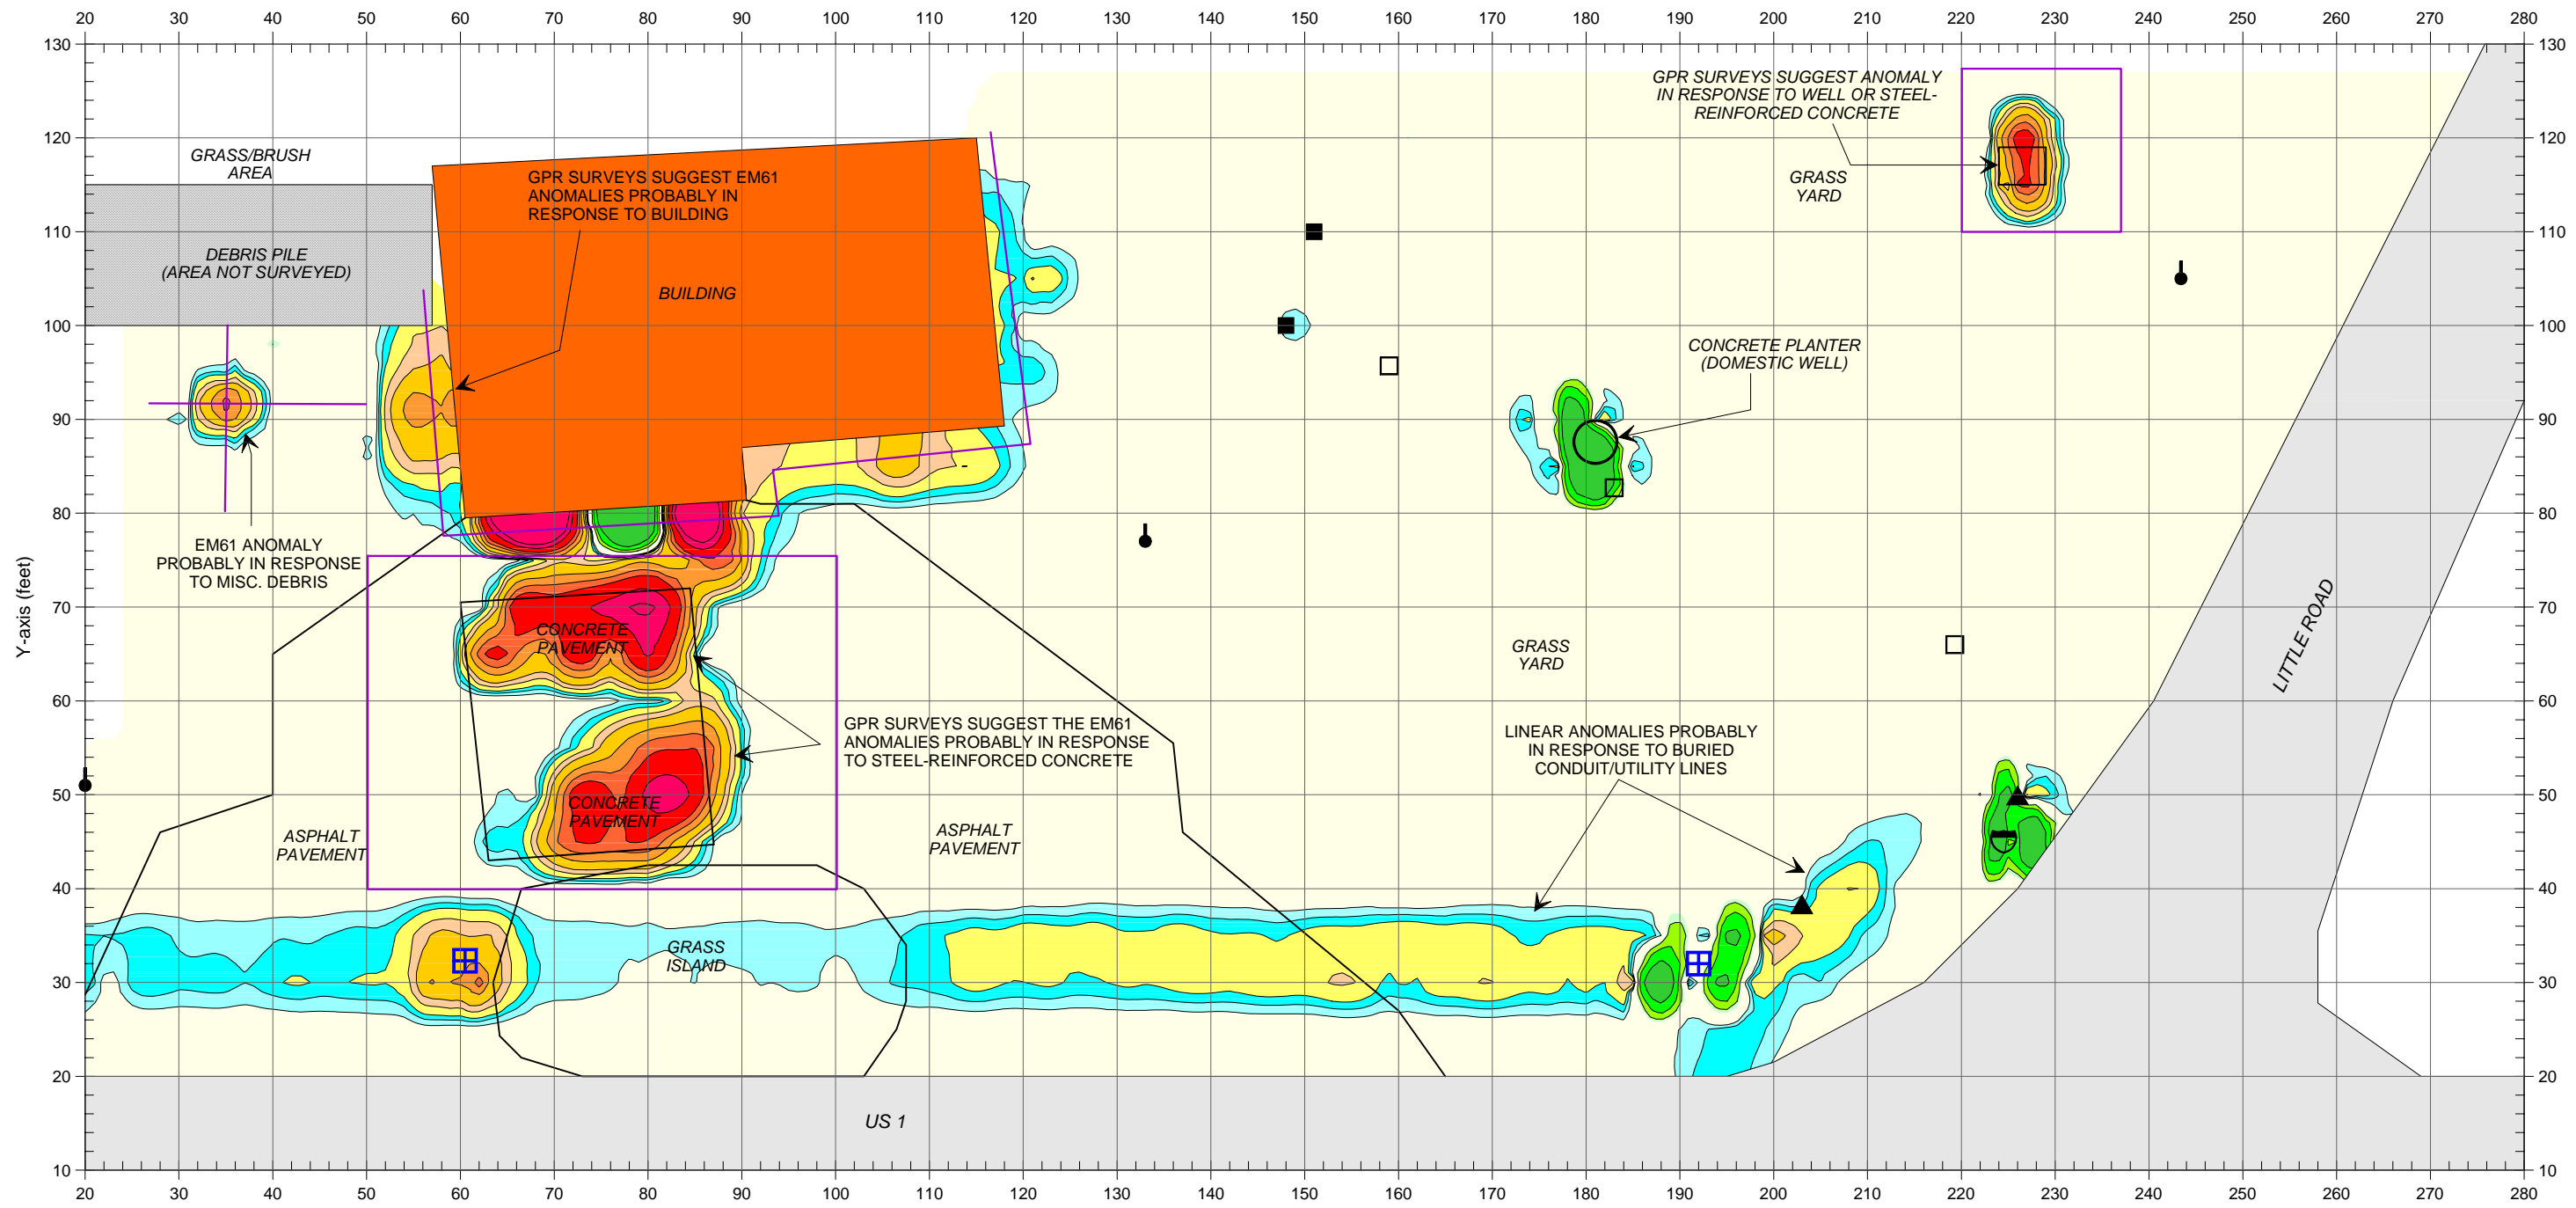
FIGURE 15

Note: The contour plot shows the differential results of the EM61 metal detection survey in millivolts (mV). The differential response focuses on larger, buried metallic objects such as drums and USTs and ignores smaller miscellaneous, buried, metal debris. The EM metal detection data were collected on July 27, 2006 using a Geonics EM61 instrument. Ground penetrating radar (GPR) data were acquired on August 16, 2006 using a Geophysical Survey Systems SIR 2000 instrument with a 400 MHz antenna.

The geophysical results suggest the proposed ROW area does not contain metallic USTs.

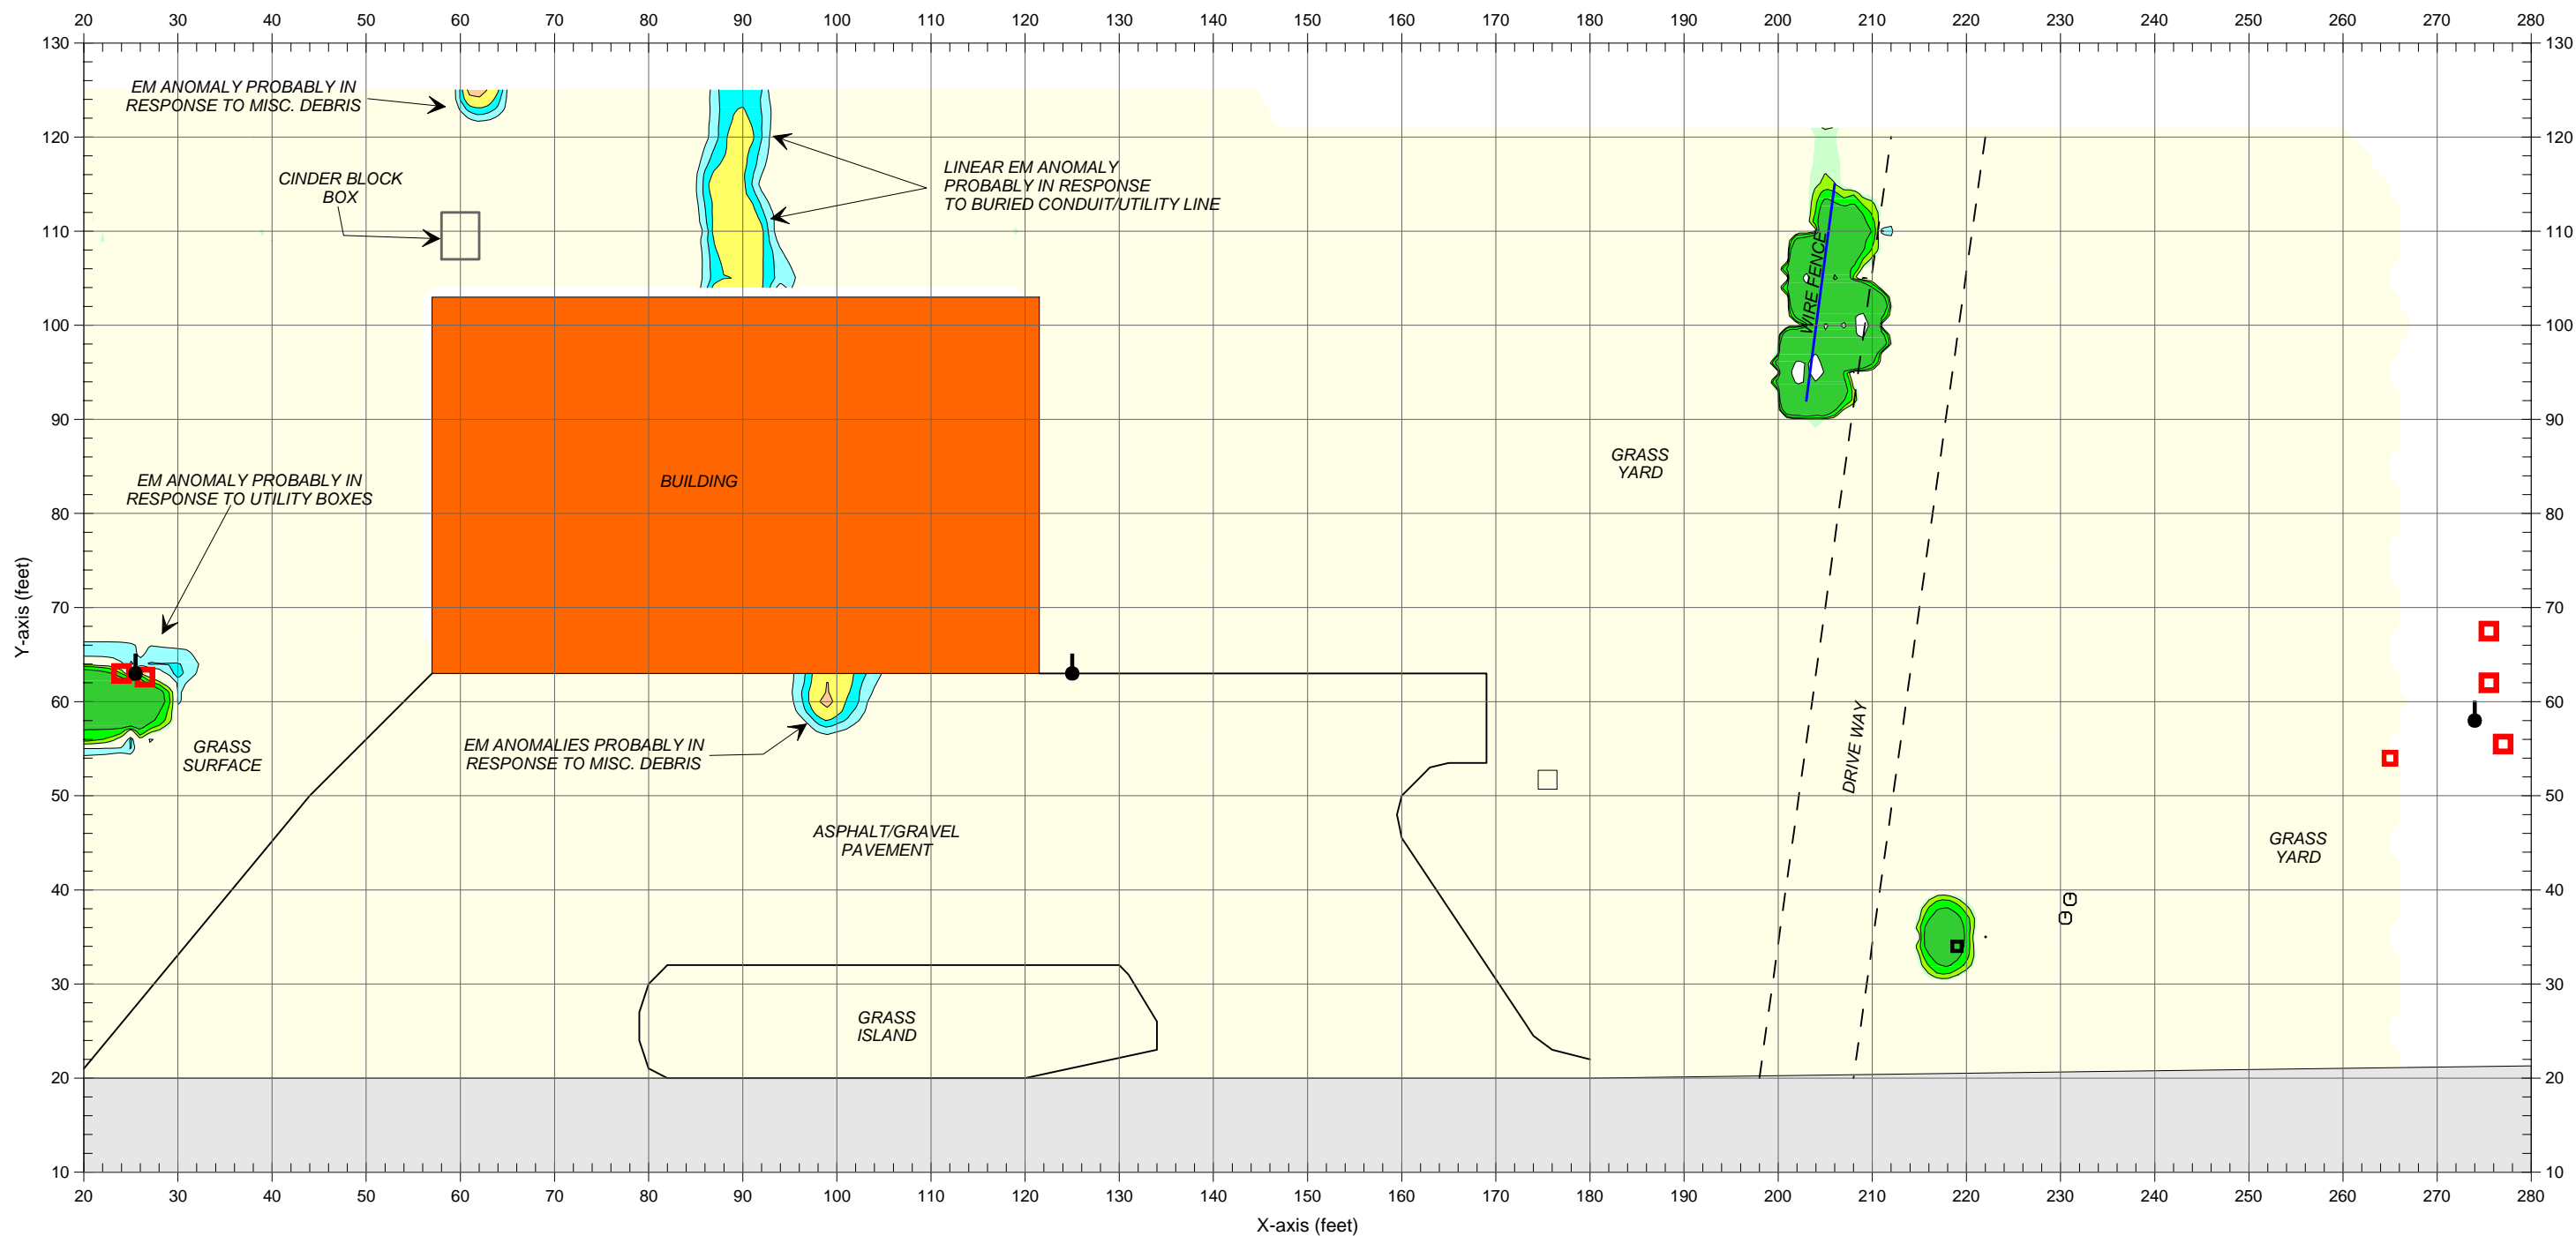
Note: The contour plot shows the differential results of the EM61 metal detection survey in millivolts (mV). The differential response focuses on larger, buried metallic objects such as drums and USTs and ignores smaller miscellaneous, buried, metal debris. The EM metal detection data were collected on July 27 and August 14, 2006 using a Geonics EM61 instrument. Ground penetrating radar (GPR) data were acquired on July 28, 2006 using a Geophysical Survey Systems SIR 2000 instrument with a 400 MHz antenna.

The geophysical investigation suggests that the survey area does not contain metallic USTs.

EM61
DIFFERENTIAL
RESULTS

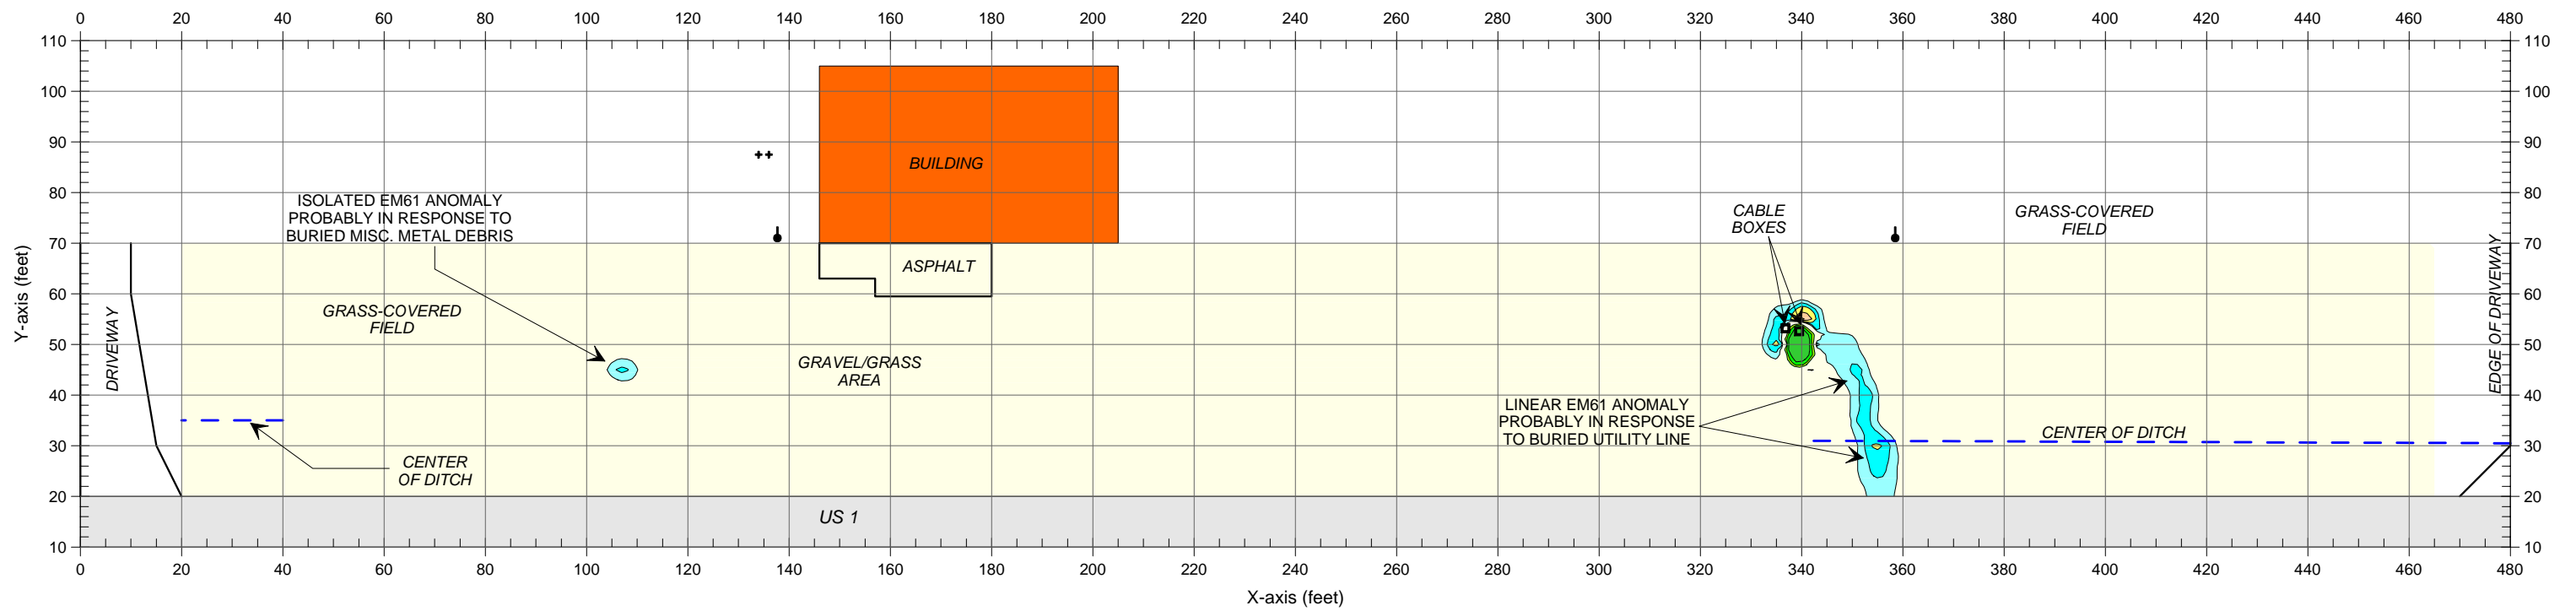
Note: The contour plot shows the differential results of the EM61 metal detection survey in millivolts (mV). The differential response focuses on larger, buried metallic objects such as drums and USTs and ignores smaller miscellaneous, buried, metal debris. The EM metal detection data were collected on July 27, 2006 using a Geonics EM61 instrument. Ground penetrating radar (GPR) data were acquired on July 28, 2006 using a Geophysical Survey Systems SIR 2000 instrument with a 400 MHz antenna.

The geophysical investigation suggests that the survey area does not contain metallic USTs.

EM61
DIFFERENTIAL
RESULTS
