STRUCTURE SUBSURFACE INVESTIGATION

PROJECT DESCRIPTION BRIDGE NO. 85 OVER
MILL CREEK ON SR 1106 (RAILROAD GRADE ROAD)

DESCRIPTION: Bridge No. 85 Over Mill Creek on SR 1106 (Railroad Grade Road)

SUBJECT: Geotechnical Report of Structure Subsurface Investigation

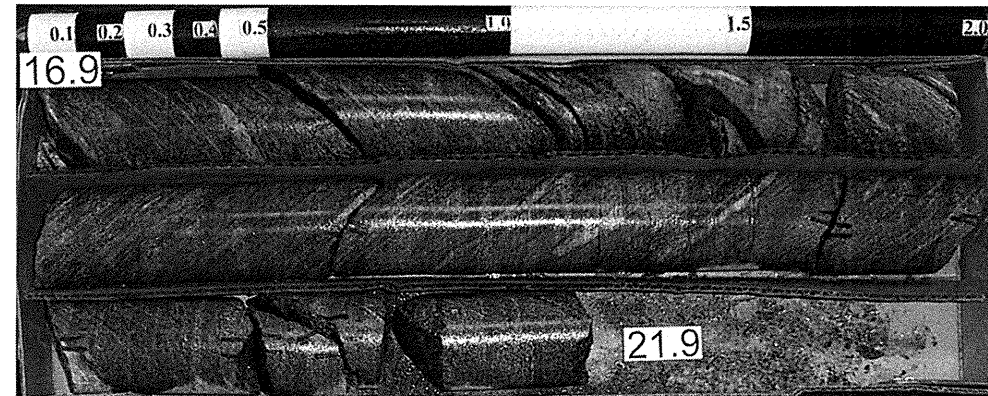
Bridge No. 85 over Mill Creek on SR 1106 (Rairoad Grade Road)
Ashe County, North Carolina
NCDOT Project No. 33379.1.1 (B-4011)
TEB2-A

Box 1 of 5
Scale = 1:4

Box 2 of 5
Scale = 1:4

Box 3 of 5
Scale = 1:4

Box 4 of 5
Scale = 1:4

Box 5 of 5
Scale = 1:4

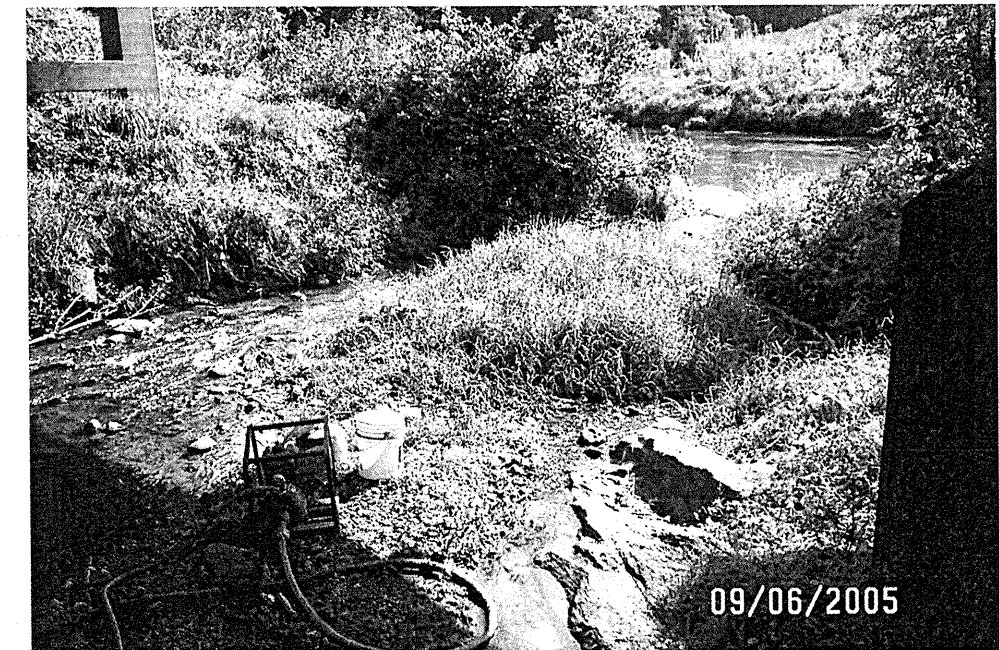
Photograph 4 – View Looking Downstream from Under Bridge

CHANNEL BANKS: None observed on west bank; east bank has minor undercutting causing slope failure

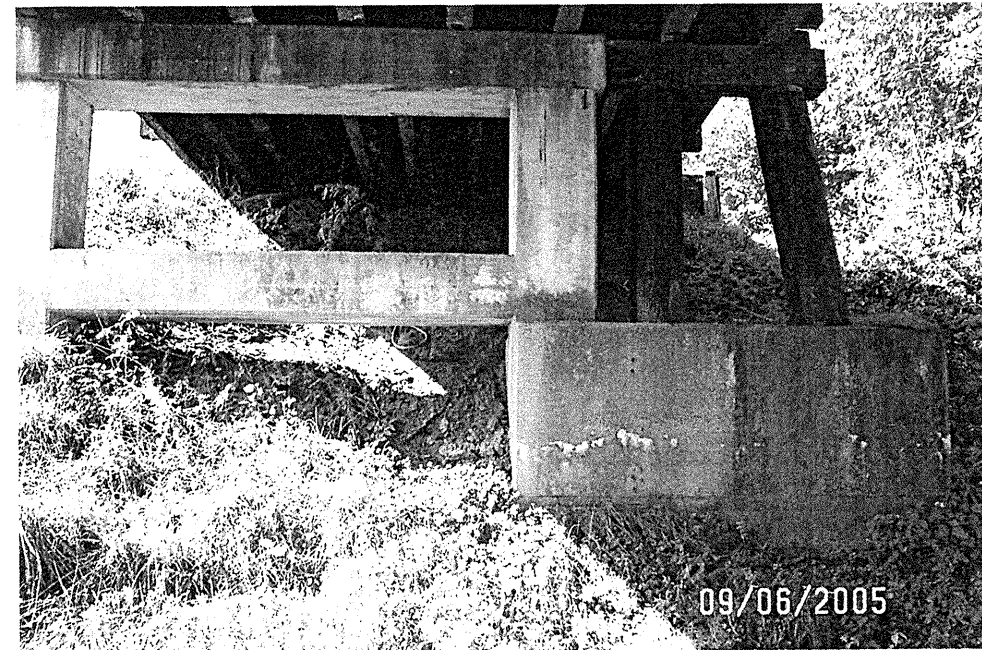
Photograph 6 – View of Interior Bent Support Structure at Bent-1

FOUNDATION TYPE: Timber deck with asphalt surface supported by wood and concrete vertical supports with timber abutments

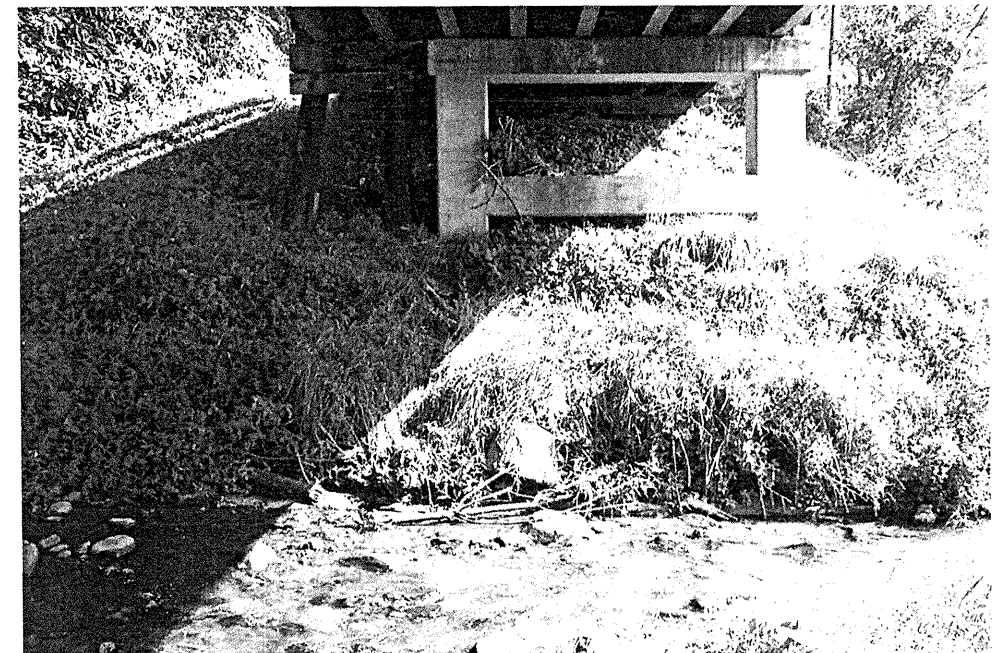
Photograph 7 – View of Interior Bent Support Structure at Bent-2

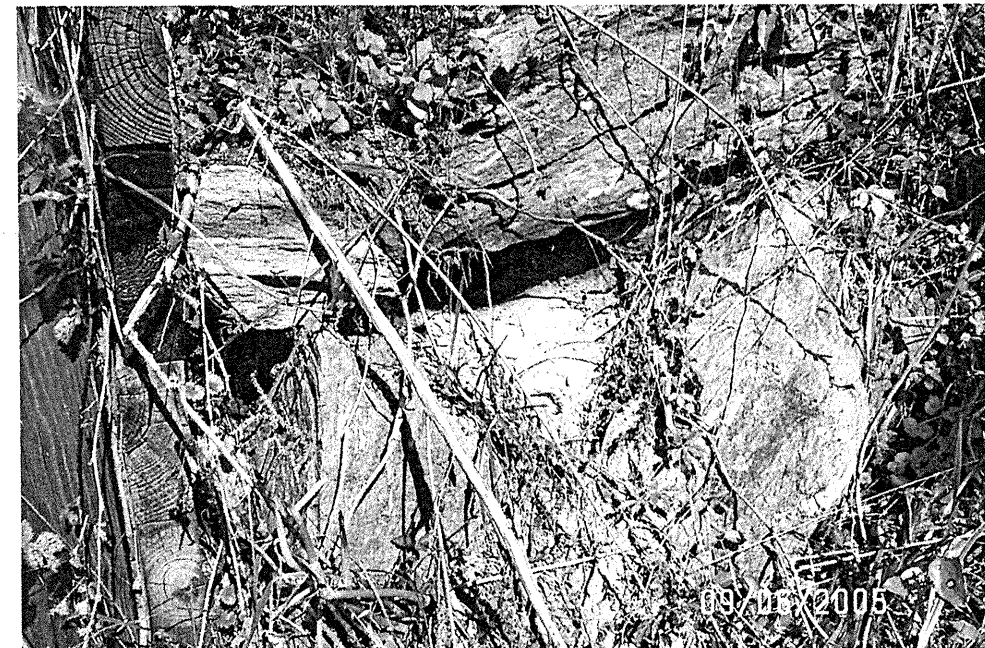
Photograph 8 – View of Boulders with Prominent Voids Near EB2-B
