**PRELIMINARY SITE ASSESSMENT
CHURCH OF THE LIVING GOD PROPERTY
804 WILSON LEE BOULEVARD
STATESVILLE, NORTH CAROLINA
STATE PROJECT: B-2576
WBS ELEMENT: 32669.1.1**

Solutions-IES Project No. 3460.07A3.NDOT

GEOPHYSICAL INVESTIGATION REPORT

GEOPHYSICAL SURVEYS FOR THE DETECTION OF METALLIC USTS

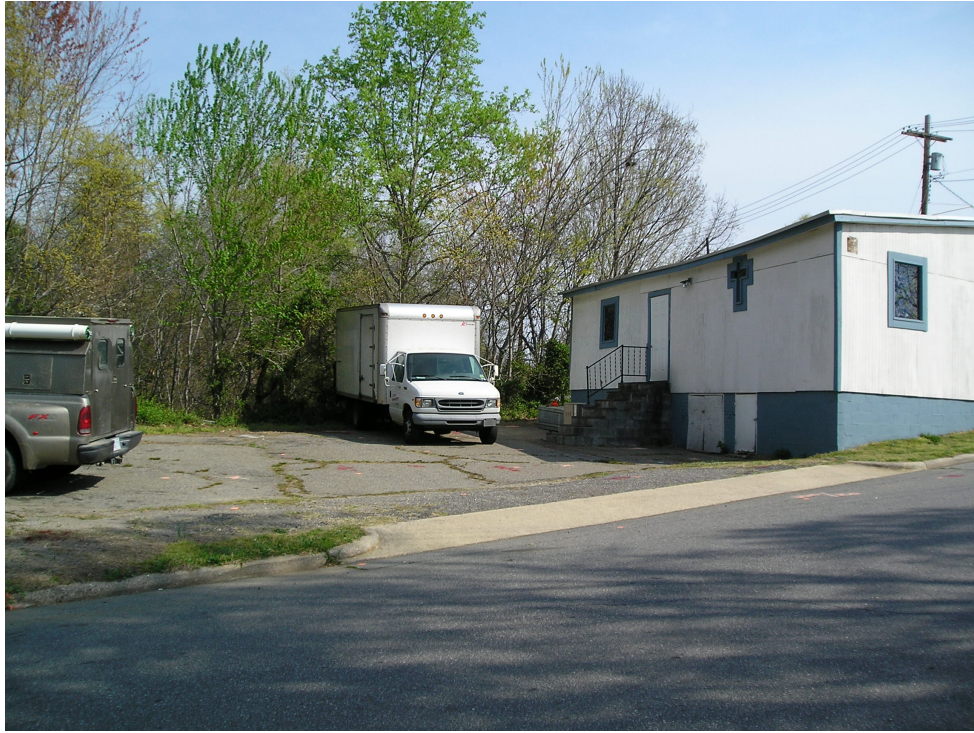
Photograph 1 - Looking north at the property. Boring locations are marked with orange paint.

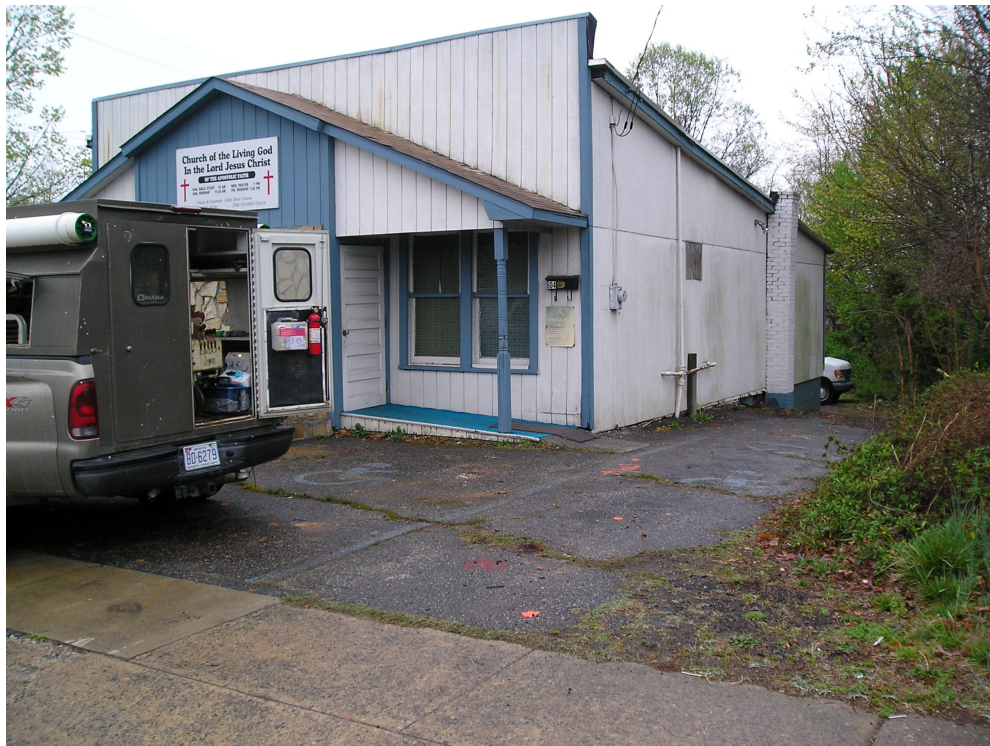
Photograph 2 - Looking southwest at property. Boring locations are marked with orange paint.

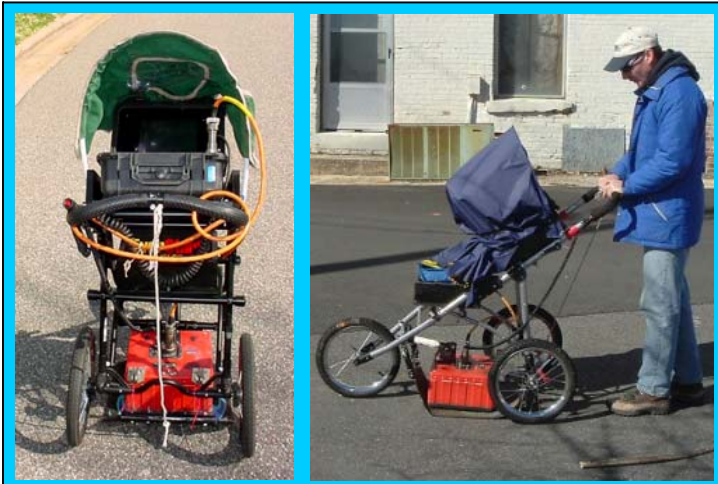
The photos show the SIR-2000 GPR system equipped with a 400 MHz antenna that were used to conduct the ground penetrating radar investigation at the Church of the Living God site on March 22, 2007.

GPR surveys were conducted across selected EM61 differential anomalies, steel-reinforced concrete and along the perimeter of the church using a Geophysical Survey Systems SIR-2000 unit equipped

with a 400 MHz antenna. GPR data were digitally collected in a continuous mode along the X-axis and/or Y-axis survey lines spaced 2.5 to 5 feet apart, using a vertical scan of 512 samples, at a sampling rate of 32 scans per second. An 80 MHz high pass filter and an 800 MHz low pass filter were used during data acquisition with the 400 MHz antenna. GPR data were collected to a maximum investigating depth of approximately 6 feet based on an estimated two-way travel time of 9 nanoseconds per foot.

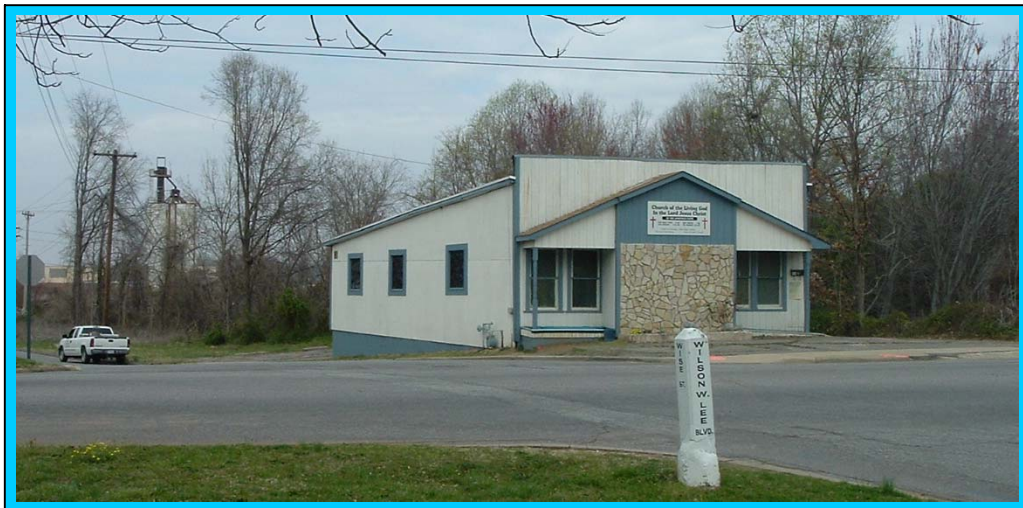
The photo shows a portion of the geophysical survey area located at the Church of the Living God site. The photo is viewed in a westerly direction.
