PRELIMINARY SITE ASSESSMENT ARNOLD AND MARJORIE ROBBINS PROPERTY 801 WILSON LEE BOULEVARD STATESVILLE, NORTH CAROLINA STATE PROJECT: B-2576 WBS ELEMENT: 32669.1.1

Preliminary Site Assessment State Project: B-2576, WBS Element: 32669.1.1

GEOPHYSICAL SURVEYS FOR THE DETECTION OF METALLIC USTS

James Hunter & Marjorie C. Robbins Properties Statesville, North Carolina

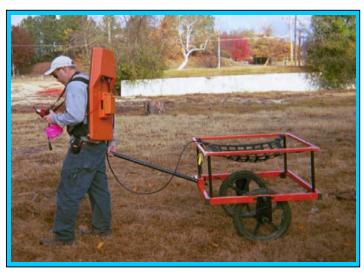
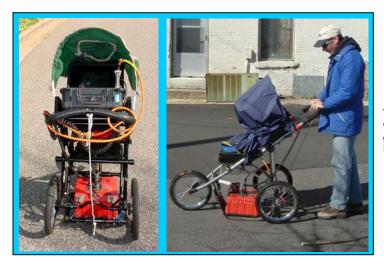
The photograph shows the Geonics EM61 metal detector that was used to conduct the metal detection survey at the Hunter and Robbins sites on June 4, 2007.

The photographs show the SIR-2000 GPR system equipped with a 400 MHz antenna that were used to conduct the ground penetrating radar investigation at the Hunter and Robbins sites on June 4 and 5, 2007.

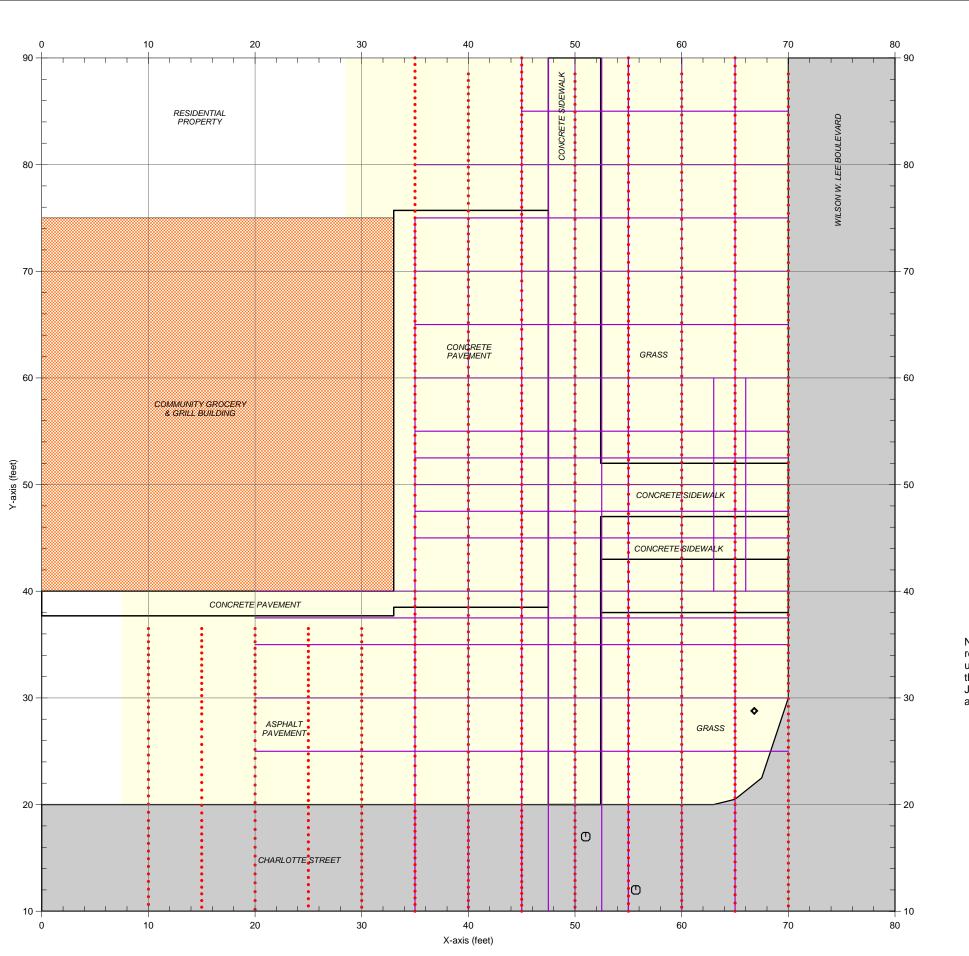
Note: The map shows the geophysical survey area at the Hunter site. The red dots represent the EM61 survey lines that were acquired on June 4, 2007 using a Geonics EM61 metal detection instrument. The purple lines represent the ground penetrating radar (GPR) survey lines that were also acquired on June 4, 2007 using a Geophysical Survey Systems SIR 2000 instrument with a 400 MHz antenna.

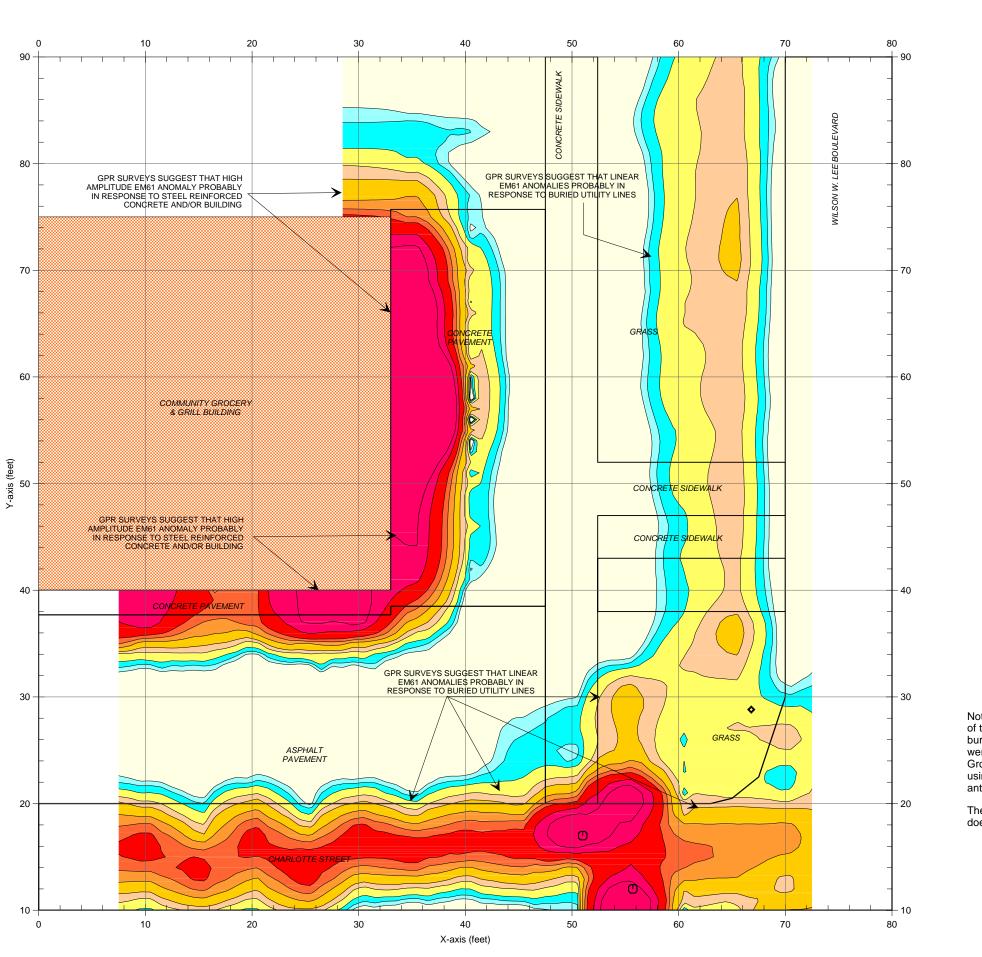
EM61 BOTTOM COIL RESULTS

Note: The contour plot shows the bottom coil (most sensitive) response of the EM61 instrument in millivolts (mV). The bottom coil response shows buried metallic objects regardless of size. The EM metal detection data were collected on June 4, 2007 using a Geonics EM61 instrument. Ground penetrating radar (GPR) data were also acquired on June 4, 2007 using a Geophysical Survey Systems SIR 2000 instrument with a 400 MHz antenna.

The geophysical investigation suggest that the surveyed portion of the site does not contain metallic USTs.

Contour plots of the EM61 bottom coil results and the EM61 differential results for the Hunter site are presented in **Figures 3 and 4**, respectively. The bottom coil results represent the most sensitive component of the EM61 instrument and detect metal objects regardless of size. The bottom coil response can be used to delineate metal conduits or lines, small, isolated metal objects, and areas containing insignificant metal debris. The differential results are obtained from the difference between the top and bottom coils of the EM61 instrument. The differential results focus on the larger

GPR surveys suggest the high amplitude EM61 bottom coil anomalies (contours shaded in red) centered near grid coordinates X=10 Y=37, X=27 Y=37 and X=35 Y=55 are probably in response to the building and/or steel reinforced concrete. GPR data also suggest that the linear EM61 anomalies centered near grid coordinates X=30 Y=16, X=65 Y=16 and X=65 Y=70 are probably in response to buried utility lines.

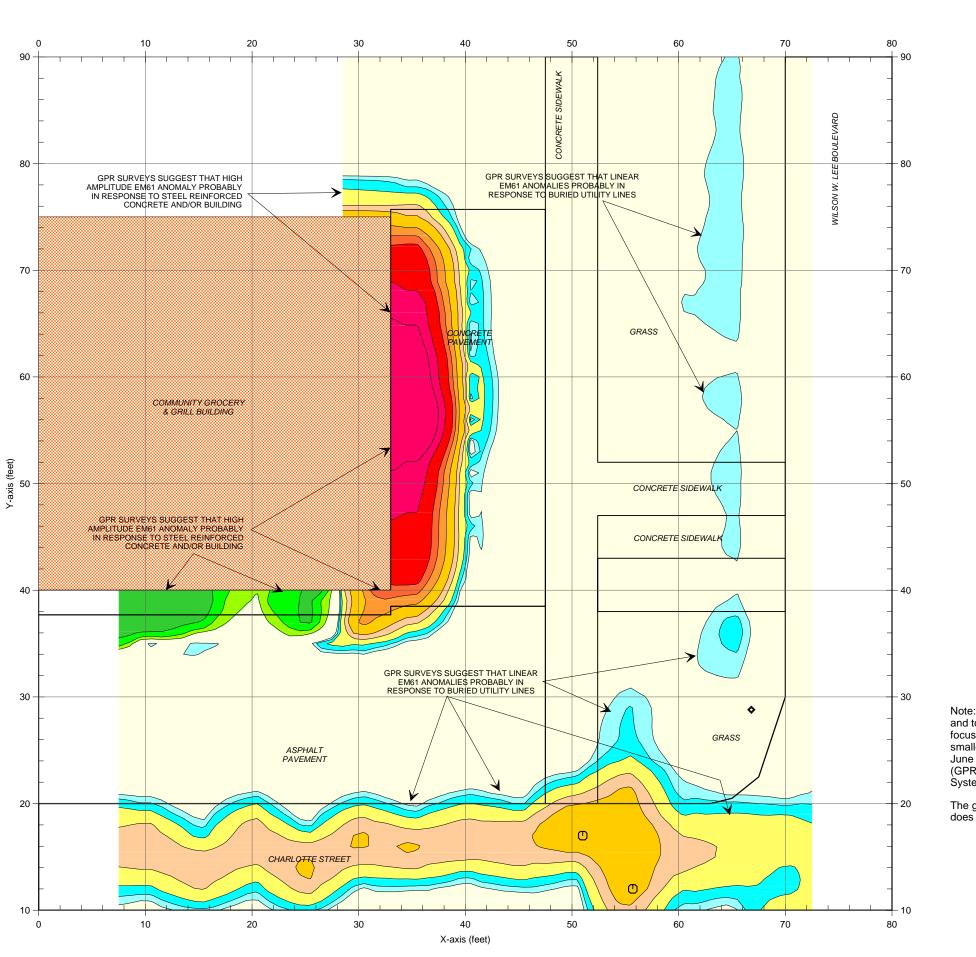
EM61 DIFFERENTIAL RESULTS

Note: The contour plot shows the differential response between the bottom and top coils of the EM61 instrument in millivolts (mV). The differential response focuses on larger, buried metallic objects such as drums and UST's and ignores smaller miscellaneous, buried, metal debris. The EM61 data were collected on June 4, 2007 using a Geonics EM61 instrument. Ground penetrating radar (GPR) data were also acquired on June 4, 2007 using a Geophysical Survey Systems SIR 2000 instrument with a 400 MHz antenna.

The geophysical investigation suggest that the surveyed portion of the site does not contain metallic USTs.

The EM61 differential results also show the anomalies that are probably in response to the building and utility lines. However, no other EM61 anomalies were recorded across the survey area suggesting that this portion of the Hunter site does <u>not</u> contain metallic USTs.

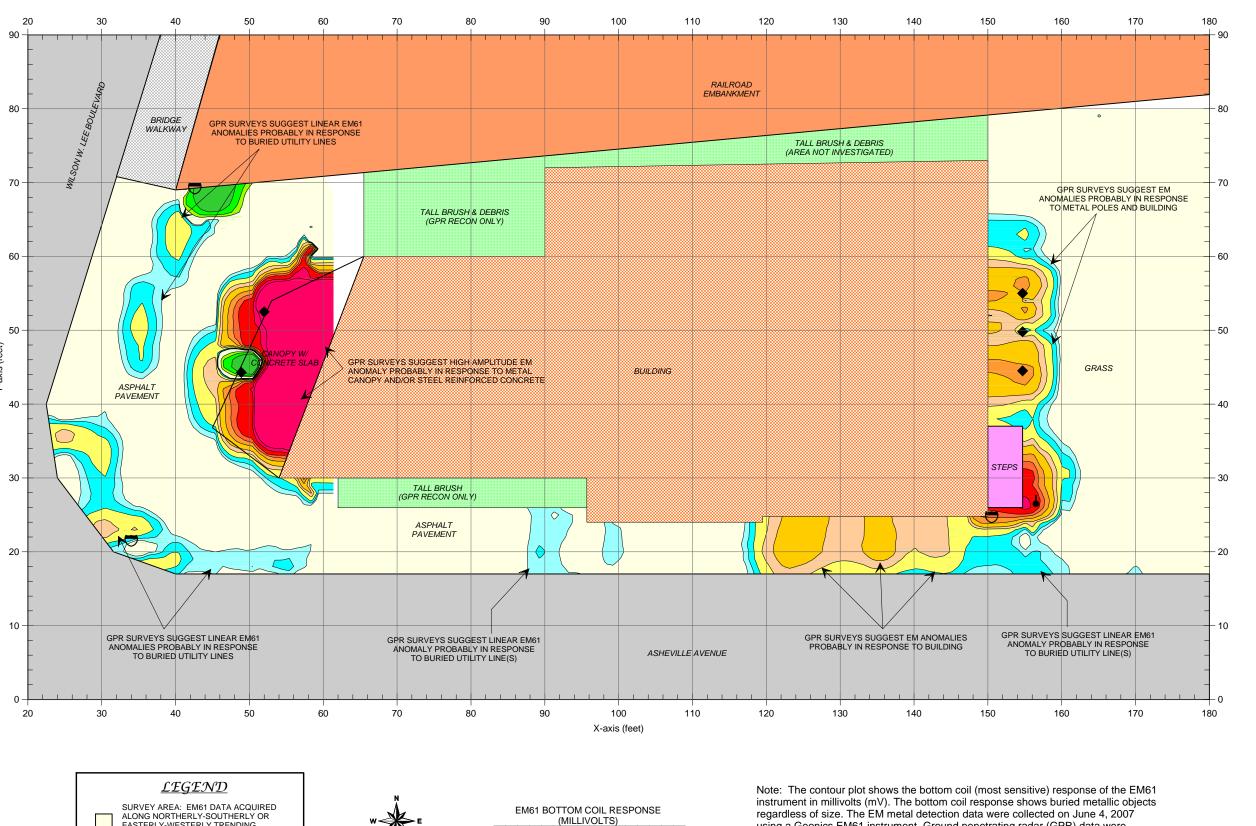
EM61 BOTTOM COIL RESULTS

regardless of size. The EM metal detection data were collected on June 4, 2007 using a Geonics EM61 instrument. Ground penetrating radar (GPR) data were acquired on June 5, 2007 using a Geophysical Survey Systems SIR 2000 instrument with a 400 MHz antenna.

The geophysical investigation suggests that the surveyed portion of the site does not contain metallic USTs.

Contour plots of the EM61 bottom coil results and the EM61 differential results for the Robbins site are presented in **Figures 6 and 7**, respectively. GPR data suggest that the linear EM61 bottom coil anomalies centered near grid coordinates X=30 Y=28, X=35 Y=50, X=40 Y=64, X=50 Y=19, and X=90 Y=20 are probably in response to buried utility lines. GPR data also suggest that the high amplitude EM61 anomaly centered near grid coordinates X=55 Y=45 is probably in response to steel reinforced concrete and/or the building canopy

Similarly, the bottom coil anomalies centered near grid coordinates X=124 Y=22, X=135 Y=22 and X=156 Y=28 are probably in response to the building and stairs. The EM61 anomalies centered near X=154 Y=44 and X=154 Y=54 are probably in response to the metal support poles.

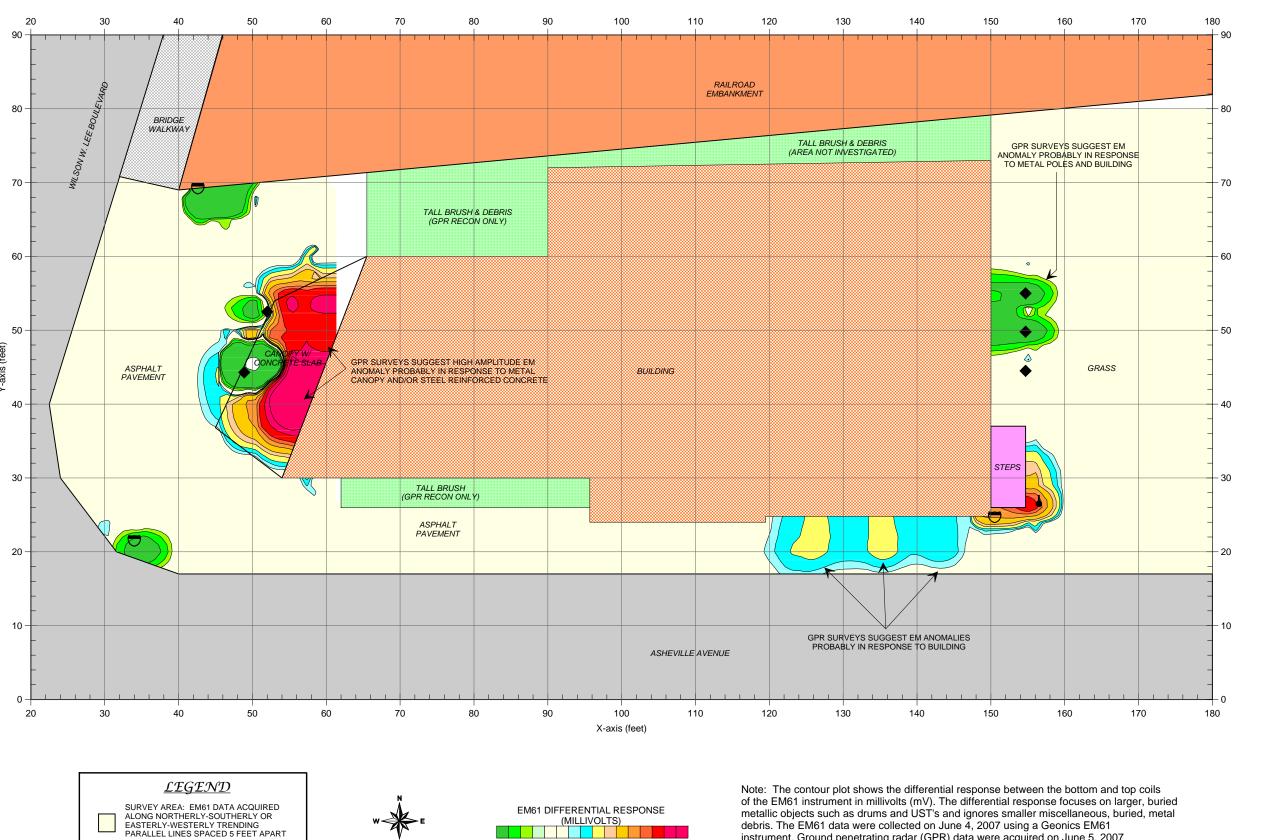
EM61 DIFFERENTIAL RESULTS

debris. The EM61 data were collected on June 4, 2007 using a Geonics EM61 instrument. Ground penetrating radar (GPR) data were acquired on June 5, 2007 using a Geophysical Survey Systems SIR 2000 instrument with a 400 MHz antenna.

The geophysical investigation suggests that the surveyed portion of the site does not contain metallic USTs.

The EM61 differential results show several anomalies that are probably in response to steel reinforced concrete, the building or other known cultural features. No other differential anomalies were recorded suggesting that that the surveyed portion of the site does <u>not</u> contain metallic USTs.
