PROJECT NO. U-4438
PASQUOTANK COUNTY
STATION: 15+25.75 -L1-

ELIZABETH CITY BRIDGE OVER
PASQUOTANK RIVER

BRIDGE NO. 27
REPAIRS TO BASCULE GIRDER

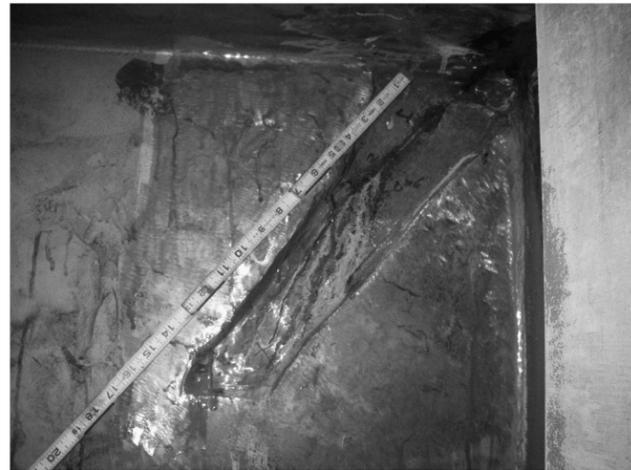
NORTH (UNCRACKED) GIRDER AND INSIDE OF PIER

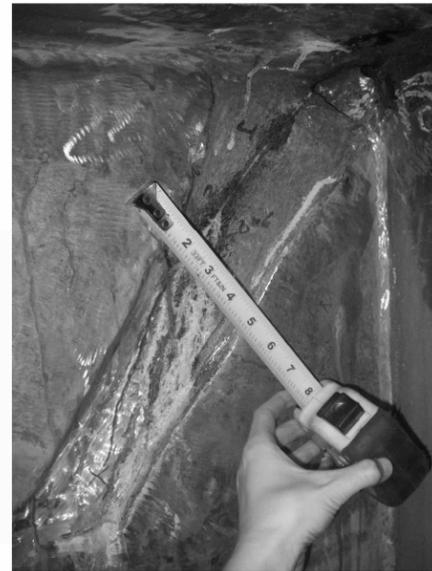
SOUTH GIRDER - DIAGONAL CRACK PRIOR TO STIFFENER REMOVAL

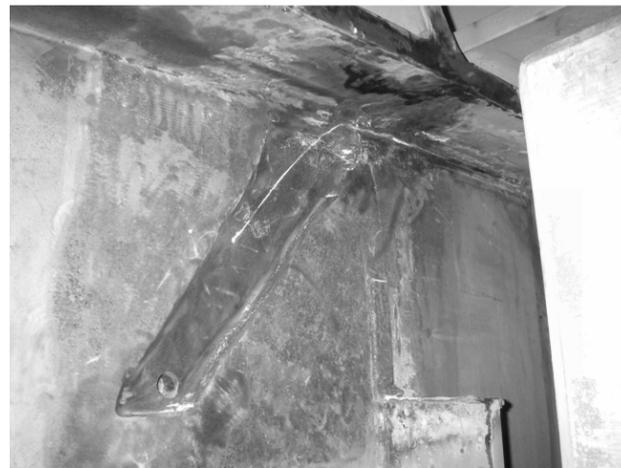
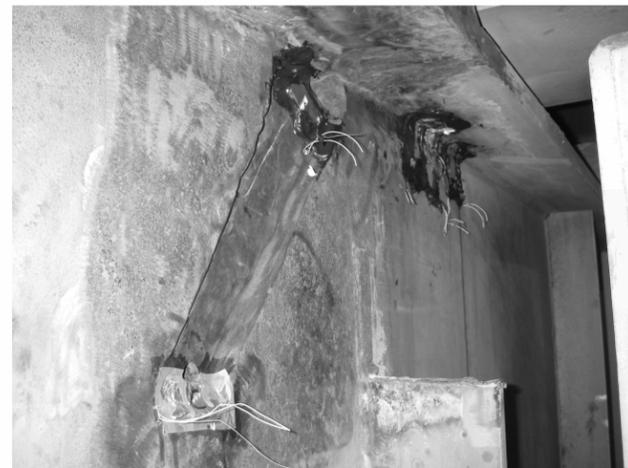
SOUTH GIRDER
DIAGONAL CRACK AFTER STIFFENER REMOVAL
