# **GeoEnvironmental Impact Evaluation**

Project 34831.1.1 (TIP # U-2550B)  
Morganton – NC 18 (Sterling Street) and I-40 Interchange

Burke County

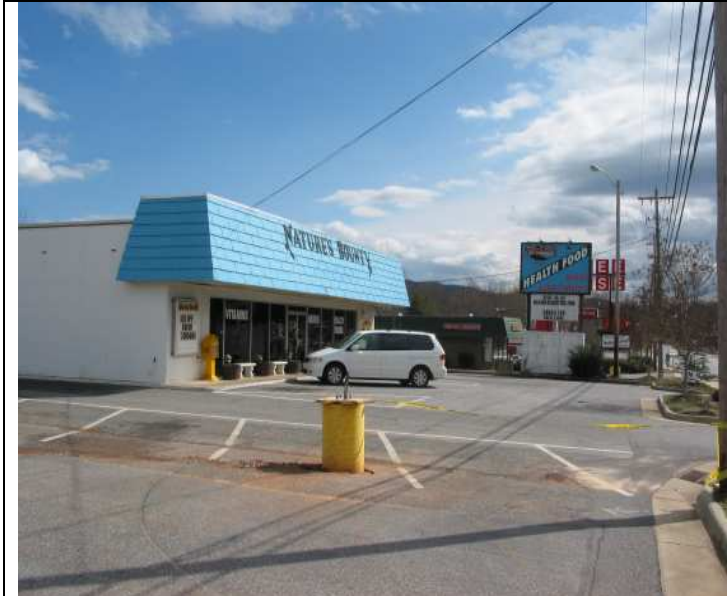
**Site 1:** Nature's Bounty. View to the East.

This active health food store is located on the north side of NC 18 (S. Sterling Street) and 560 feet northeast of Grace Hospital Road. The storefront is set back 95 feet from the NC 18 median. From appearances, this store may have once been a convenience store-gas station. However, the property does not appear on the UST Section's registry. There is no evidence of USTs, vets, or UST removal. **This site will have a low impact to this project.**

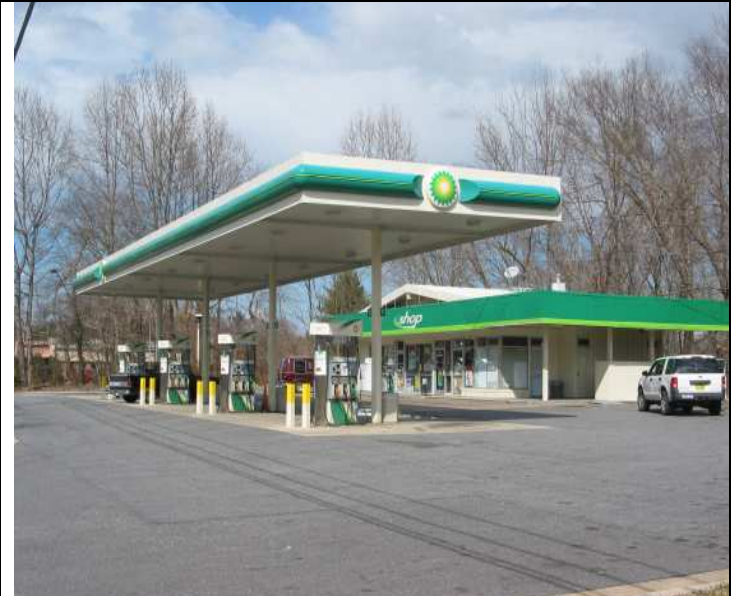
**Site 2:** NC Express BP gas station. View to the North.

This active BP gas station and convenience store is located on the east corner of NC 18 (S. Sterling Street) and Grace Hospital Road. The USTs are northwest of the store and set back 73 feet from the center of NC 18. The UST Section's registry shows three (3) USTs were removed from the property in April 1990, and three (3) additional USTs were removed in June 1998. Contamination was found during the 1990 removal, and the property was assigned incident # 16200. There is no other evidence of USTs or UST removal, or monitoring wells. **This site will have a low impact to this project.**

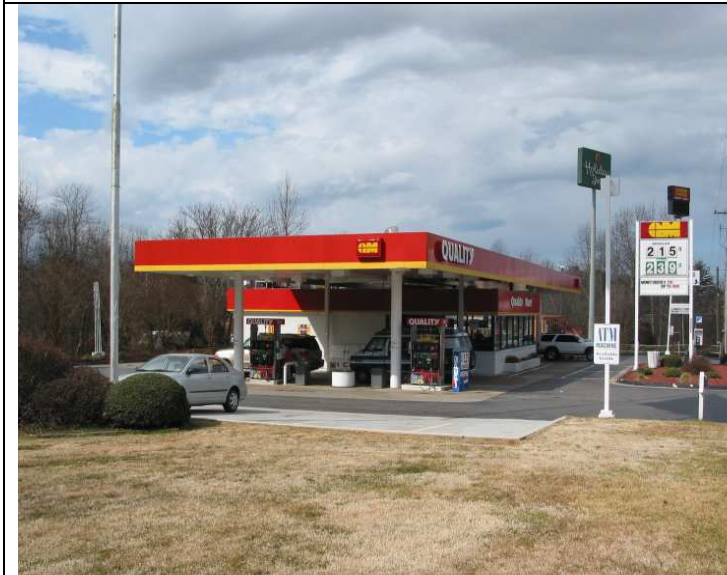
**Site 3:** Quality Mart 22 gas station. View to the southeast.

This active gas station and convenience store is located near the south quadrant of the I-40 and NC 18 (S. Sterling Street) interchange. The storefront is 87 feet south from the NC 18 median. The four (4) USTs are located behind the building and are 145 feet from the highway. The UST Section's registry does not show any incidents or previous tank removals for this location. There is no other evidence of monitoring wells, USTs or UST removal. **This site will have a low impact to this project.**

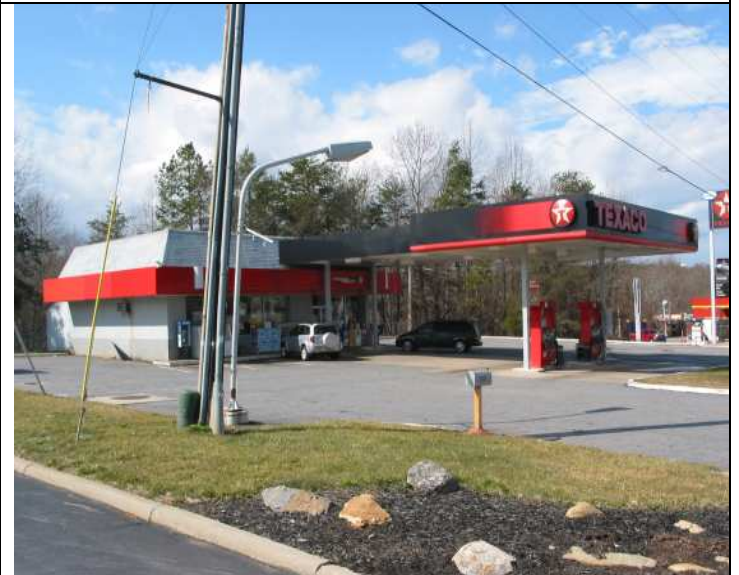
**Site 4:** Southern Convenience Texaco gas station. View to the east.

This active Texaco gas station and convenience store is located on the south side of NC 18 and across from the SR 1816 (Steakhouse Rd) intersection. Four (4) USTs are located on site. Two (2) tanks each are located on the northwest and southeast edges of the property. The tanks and pump island are all set back 55 feet from NC 18 (S. Sterling Street). There is no other evidence of monitoring wells, USTs or UST removal. **This site will have a low impact to this project.**

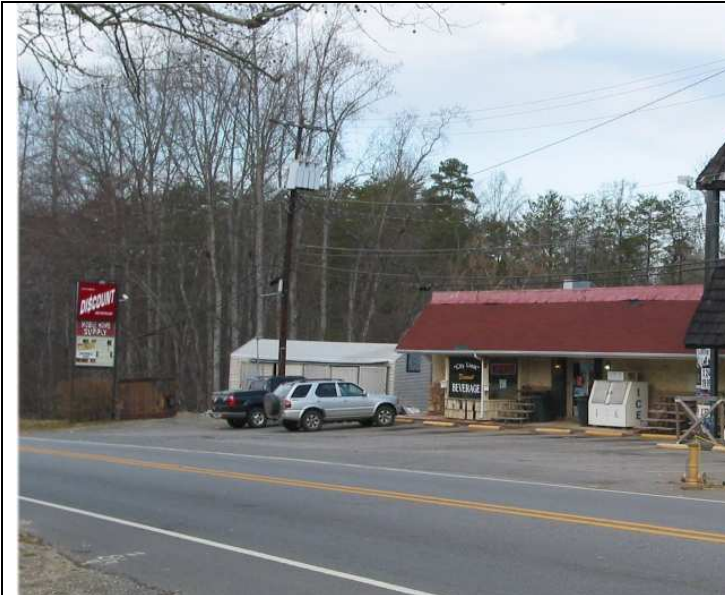
**Site 5:** Discount Beverage. View to the northwest across NC 18.

This specialty convenience store is located north of NC 18 and set back 55 feet from the highway median. The building design is similar to most 60's-80's gas stations and convenience stores. The owners-managers of Discount Beverage stated that a gas station was never located on this parcel. The UST Section's registry does not have a record for this site and there is no evidence of USTs or UST removal. **This site will have a low impact to this project.**

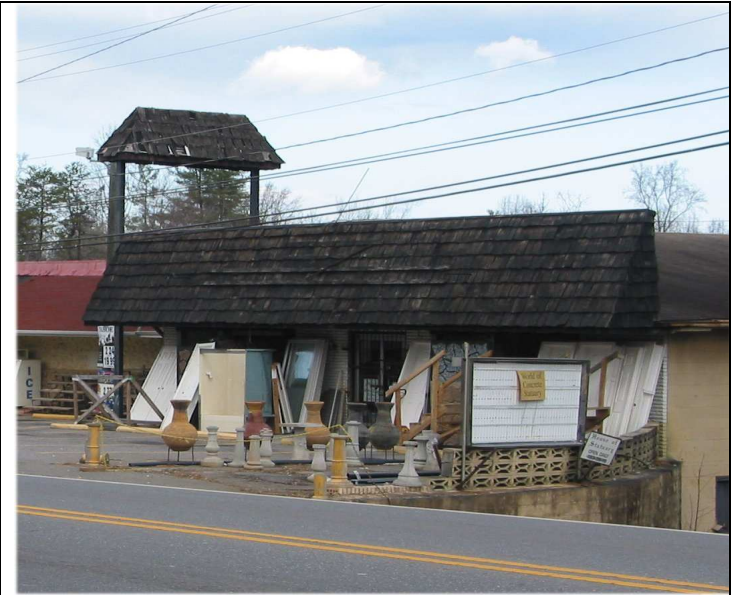
**Site 6:** World of Concrete Statuary. View to the northwest across NC 18.

This closed business is attached to, and southeast from Discount Beverage on the north side of NC 18. The storefront is set back 53 feet from the NC 18 centerline. The building design is similar to most 60's-80's gas stations and convenience stores. The owners-managers of Discount Beverage stated that a gas station was never located on this parcel. The UST Section's registry does not have a record for this site and there is no evidence of USTs or UST removal. **This site will have a low impact to this project.**

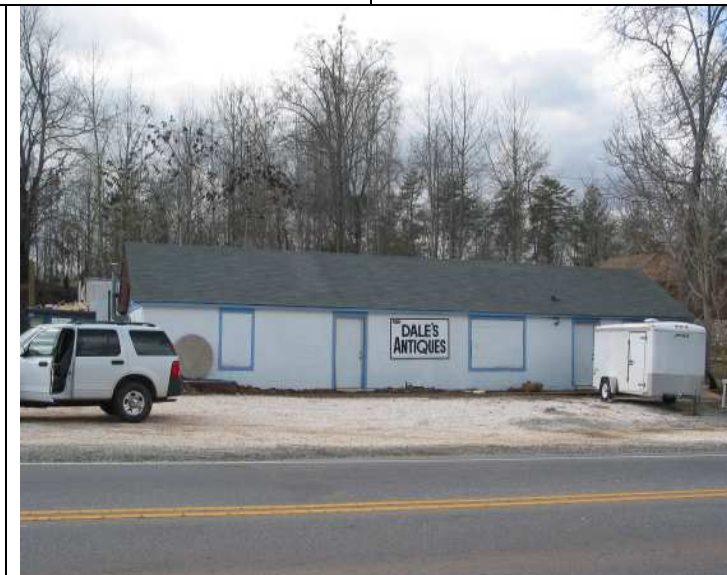
**Site 7:** Dale's Antiques. View to the southwest across NC 18.

This storage building for an antique business appears to be a former auto repair garage. The structure is 62 feet from the NC 18 median and is on the south side of the highway. The Burke County 1994 aerial photos show an active business, with vehicles parked at the front of, and behind this building. The local residents did not recall the history of this parcel. There is no visible evidence of hydraulic lifts, USTs or UST removal. **This site will have a low impact to this project.**
