REPORT OF PRELIMINARY SITE ASSESSMENT

JERRY AND STEVE ISAACS PROPERTY, PARCEL #2 STATE PROJECT U-2550B, TIP NO. 34831.1.1 2205 SOUTH STERLING STREET MORGANTON, NORTH CAROLINA

Subject: Report on Geophysical Surveys for Parcel 2, Morganton, NC Schnabel Engineering Project 09210013.19

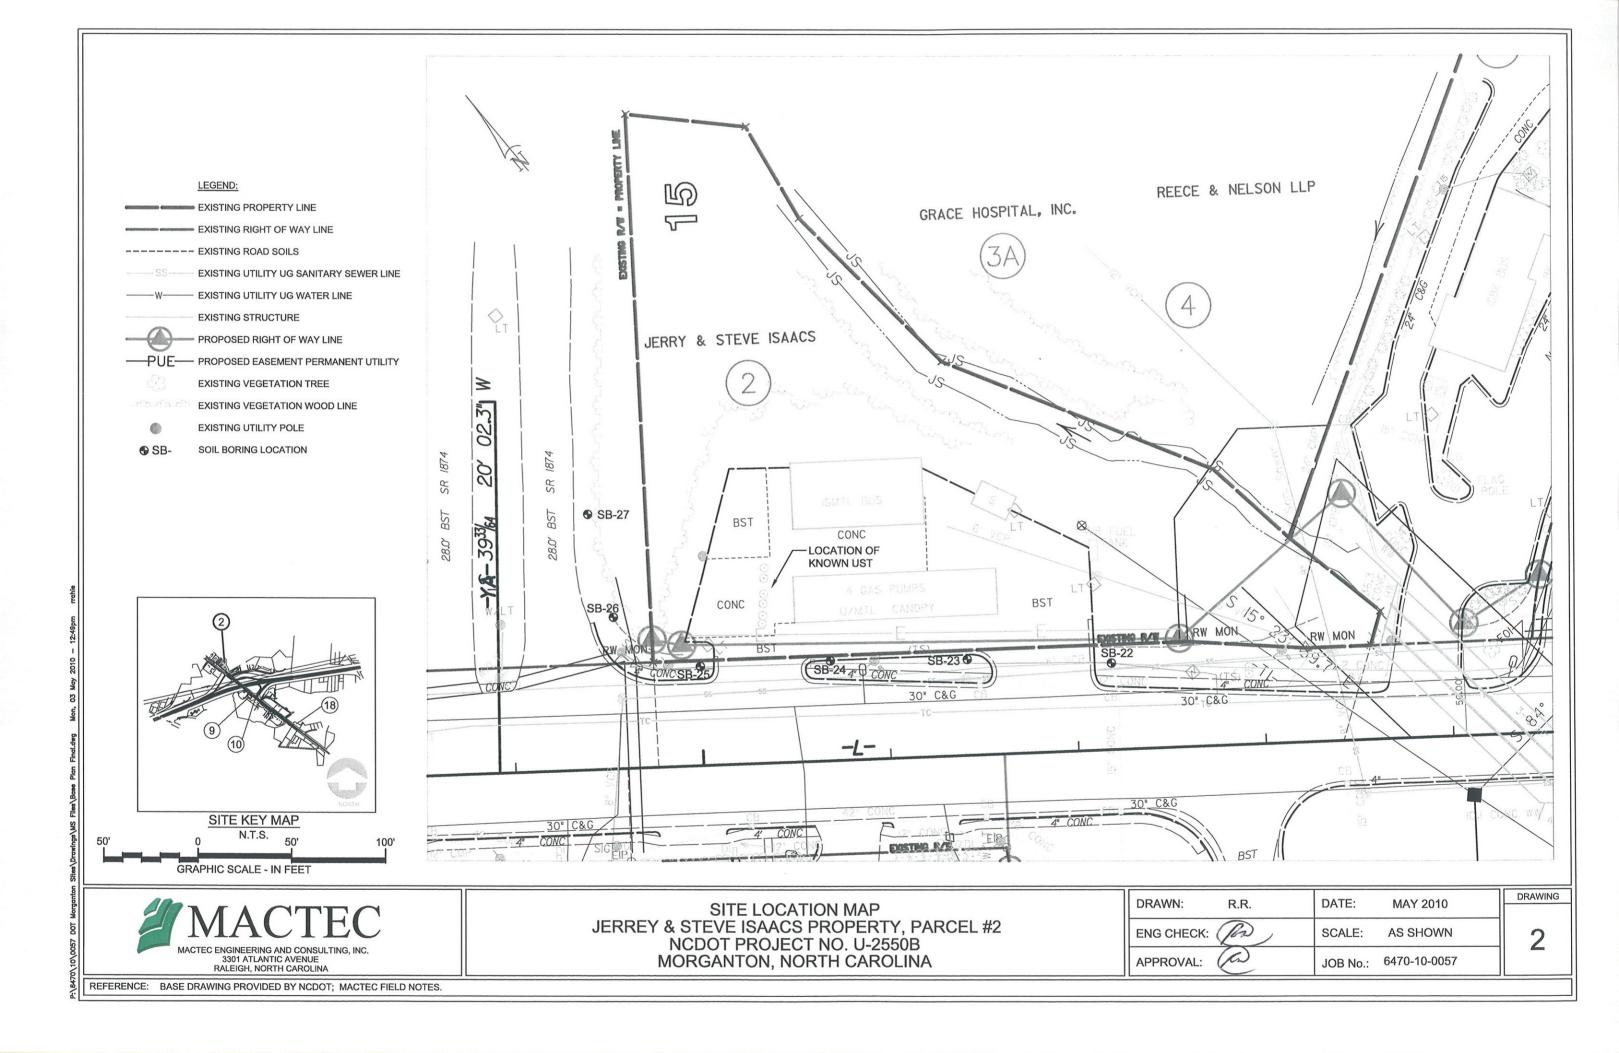
On April 2, 2010, Troxler Geologic Services, Inc. (Troxler), under contract to MACTEC, advanced six soil borings (Nos. SB-22 through SB-27) at the subject site using a GeoprobeTM direct-push technology. Soil boring locations were selected based on the proposed NCDOT right-of-way, results of the geophysical investigation and field observations. Figure 2 shows a site layout and the locations of the soil borings.

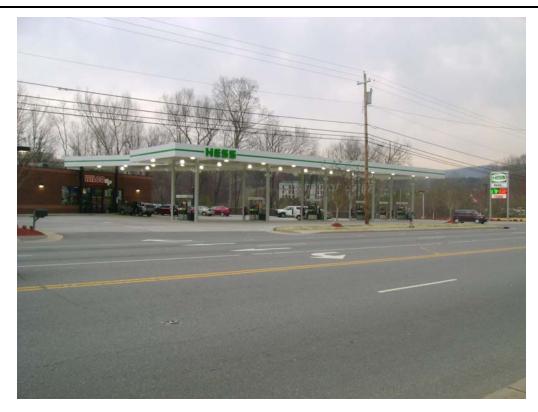
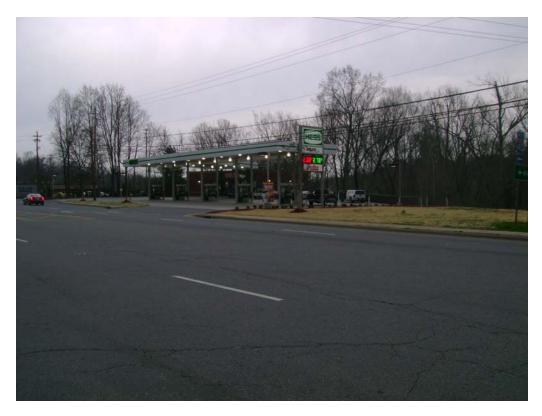
FIGURE 1

Parcel 2 – Jerry & Steve Issacs Property, looking northeast

Parcel 2 - Jerry & Steve Issacs Property, looking north

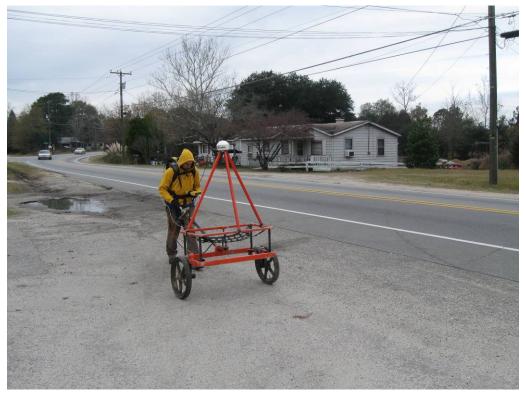
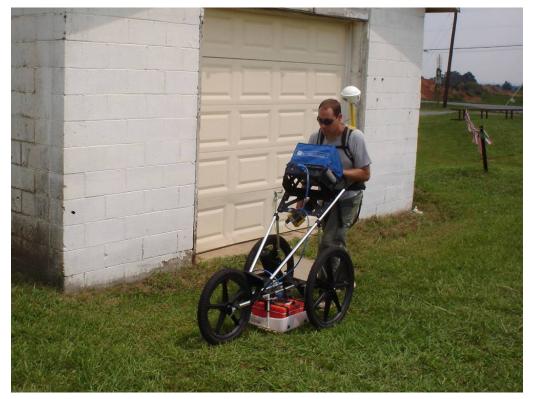
FIGURE 2

The geophysical investigation consisted of electromagnetic (EM) induction surveys using a Geonics EM61-MK2 instrument. The EM61 metal detector is used to locate metal objects buried up to about eight feet below ground surface. Ground-penetrating radar (GPR) investigations of selected EM61 anomalies, including areas of reinforced concrete, were conducted using a Geophysical Survey Systems SIR-3000 system equipped with a 400 MHz antenna. Photographs of the equipment used are shown on Figure 2.

Geonics EM61-MK2

GSSI SIR-3000

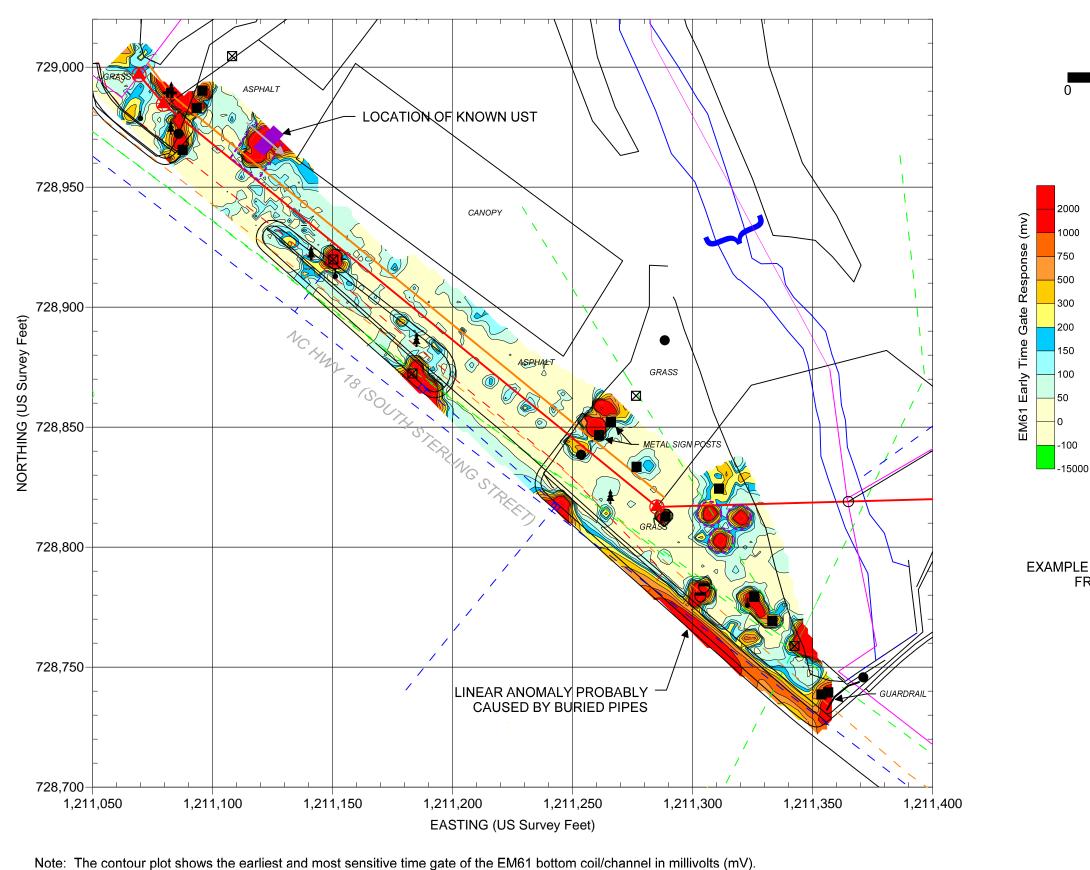
The contoured EM61 data for Parcel 2 are shown on Figures 3 and 4. The EM61 early time gate results are plotted on Figure 3. The early time gate data provide the more sensitive detection of metal objects, regardless of size. Figure 4 shows the difference between the response of the top and bottom coils of the EM61 instrument (differential response). The difference is taken to remove the effect of surface and very shallowly buried metallic objects. Typically, the differential response emphasizes anomalies from deeper and larger objects such as UST's.

The EM data were collected on March 25, 2010, using a Geonics EM61-MK2 instrument. Positioning for the EM61 survey was provided using a submeter Trimble ProXRS DGPS system. Coordinates are in the US State Plane 1983 System, North Carolina Zone 3200, using the NAD 1983 datum. GPR data were acquired on March 31, 2010, using a Geophysical Survey Systems SIR 3000 equipped with a 400 MHz antenna.

The early time gate and differential results show anomalies apparently caused by buried utilities, buried metal, or known site features (Figures 3 and 4). The GPR data collected near the westernmost canopy corner on Parcel 2 indicated the presence of a known UST located approximately 10 feet northwest of the westernmost canopy corner. The UST is outside the limits of the planned right-of way and/or easement. An example GPR image showing the reflection from the known UST on Parcel 2 is shown on Figures 3 and 4. Figures 3 and 4 also include the location of the known UST as marked in the field. The GPR data indicate that the known UST on Parcel 2 is buried approximately 2.5 to 3.5 feet below ground surface and is about 5 feet in diameter and about 18 feet long, equivalent to a capacity of about 3000 gallons. Photographs of the known UST location, as marked in the field, are included on Figure 5.

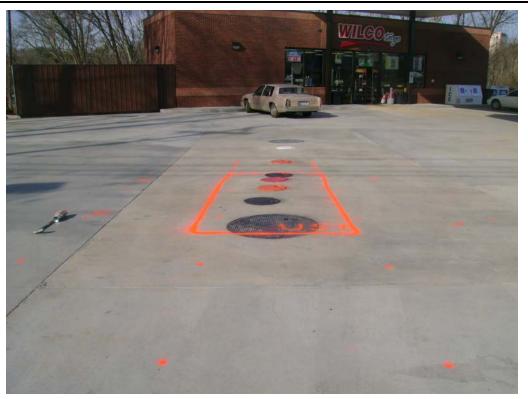
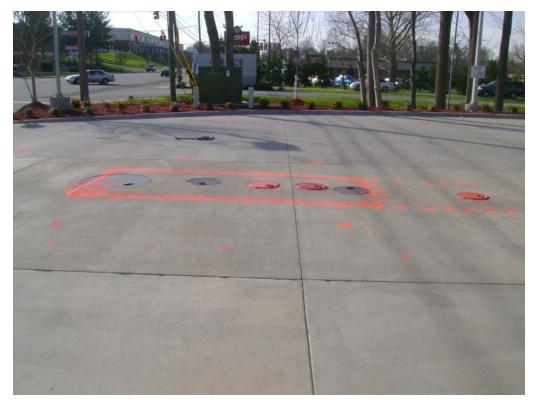
STATE PROJECT U-2550B BURKE CO., NORTH CAROLINA NC DEPT. OF TRANSPORTATION PROJECT NO. 09210013.19 PHOTOS OF KNOWN UST LOCATION FIGURE 5

The geophysical data indicate the presence of a known UST on Parcel 2 located approximately 10 feet northwest of the westernmost canopy corner. The UST is outside the planned right-of-way and/or easement. The known UST is about 270-gallon capacity and is buried about 2.5 to 3.5 feet below ground surface.

Parcel 2 – Jerry & Steve Issacs Property, looking northeast. Photo shows approximate marked location of the known UST near the westernmost corner of the canopy.

Parcel 2 – Jerry & Steve Issacs Property, looking northwest. Photo shows approximate marked location of the known UST near the westernmost corner of the canopy.
