REPORT OF PRELIMINARY SITE ASSESSMENT

RAJ RN, LLC. PROPERTY, PARCEL #10 STATE PROJECT U-2550B, TIP NO. 34831.1.1 2308 SOUTH STERLING STREET MORGANTON, NORTH CAROLINA

Report of Preliminary Site Assessment RAJ RN, LLC. Property, Parcel #10 State Project U-2550B, TIP No. 34831.1.1

Subject: Report on Geophysical Surveys for Parcel 10, Morganton, NC

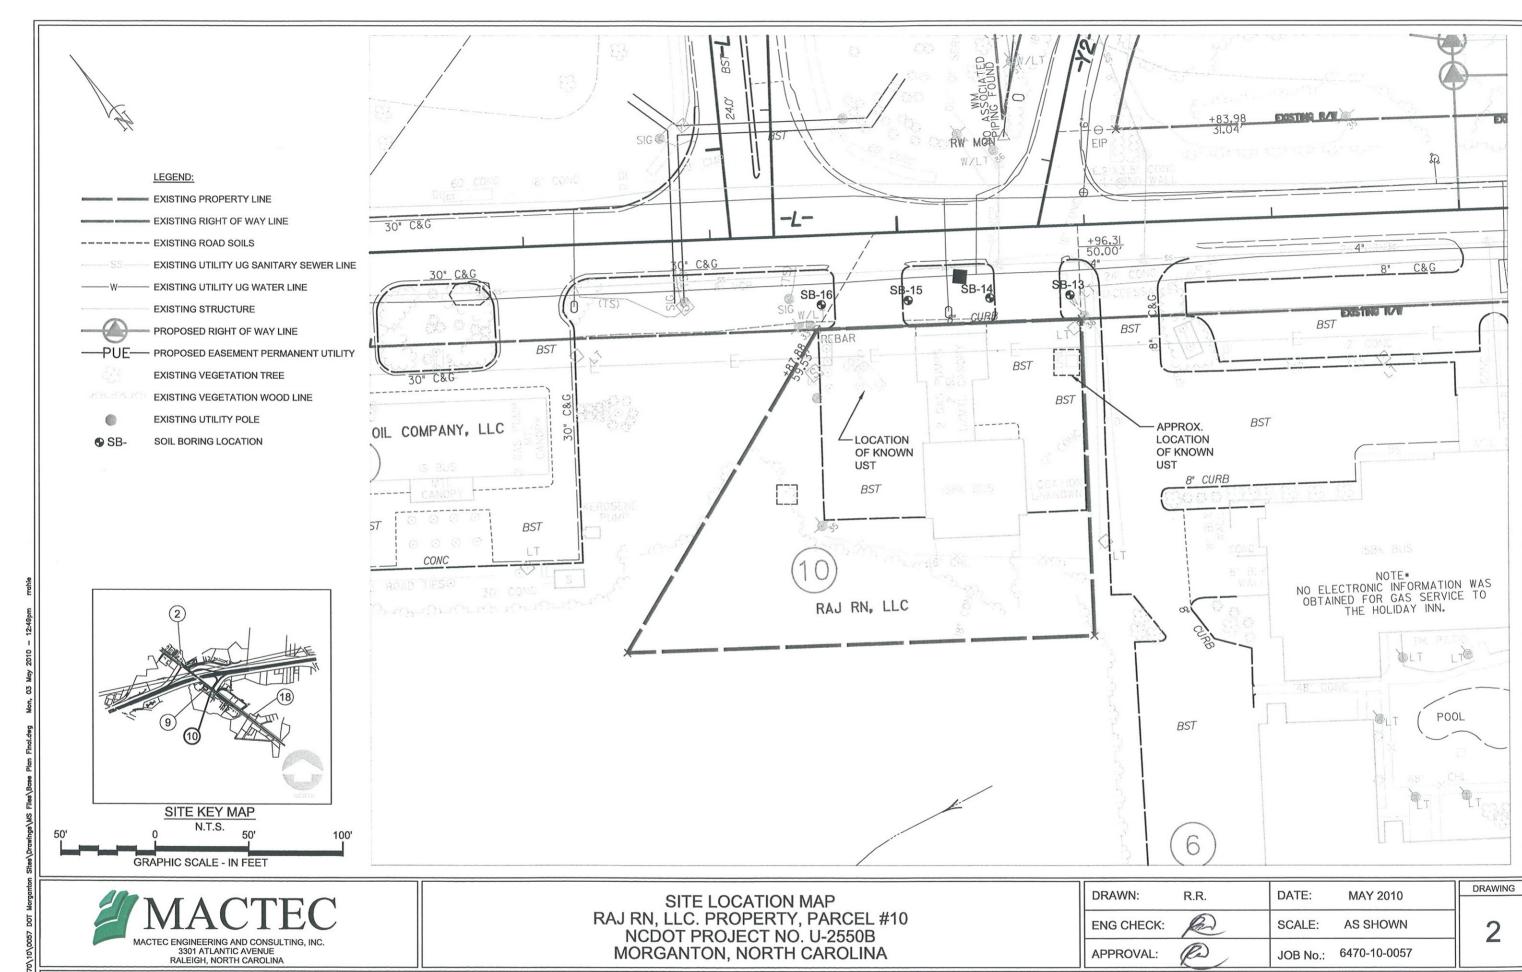
of the geophysical investigation and field observations. Figure 2 shows a site layout and the locations of the soil borings.

The RAJ property is located at 2308 South Sterling Street in Morganton, Burke County, North Carolina. The site is developed with a Texaco gas station/convenience store. The Burke County Geographic Information Services (GIS) identifies the site as parcel identification number (PIN) 2712271859. The site is bound to the northeast by South Sterling Street, across which is a Sagebrush Restaurant; to the southeast by Quality Inn; to the southwest by wooded, undeveloped land; and to the northwest by Parcel #9 (Quality Oil Co.) (Figure 2).

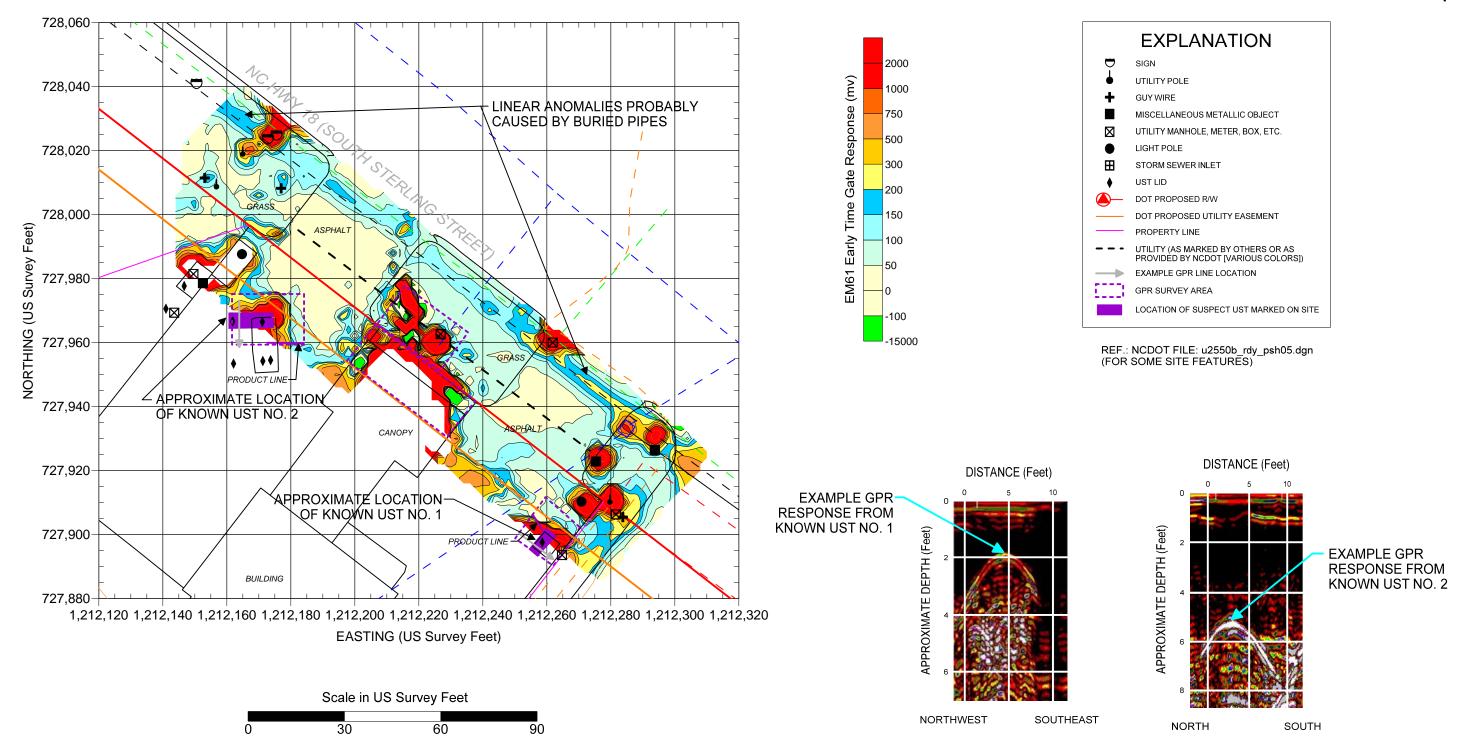
STATE PROJECT U-2550B BURKE COUNTY, NORTH CAROLINA NC DEPARTMENT OF TRANSPORTATION PROJECT NO. 09210013.19 PARCEL 10 EM61 EARLY TIME GATE RESPONSE

The contoured EM61 data for Parcel 10 are shown on Figures 3 and 4. The EM61 early time gate results are plotted on Figure 3. The early time gate data provide the more sensitive detection of metal objects. Figure 4 shows the difference between the response of the top and bottom coils of the EM61 instrument (differential response). The difference is taken to remove the effect of surface and very shallowly buried metallic objects. Typically, the differential response emphasizes anomalies from deeper and larger objects such as UST's.

Note: The contour plot shows the earliest and most sensitive time gate of the EM61 bottom coil/channel in millivolts (mV). The EM data were collected on March 25, 2010, using a Geonics EM61-MK2 instrument. Positioning for the EM61 survey was provided using a submeter Trimble ProXRS DGPS system. Coordinates are in the US State Plane 1983 System, North Carolina Zone 3200, using the NAD 1983 datum. GPR data were acquired on March 31, 2010, using a Geophysical Survey Systems SIR 3000 equipped with a 400 MHz antenna.

The early time gate and differential results show anomalies apparently caused by buried utilities, buried metal, or known site features (Figures 3 and 4). The GPR data collected near the southeastern edge of the parking lot on Parcel 10 indicated the presence of a known UST. The GPR data collected near the northwestern edge of the parking lot on Parcel 10 also indicated the presence of a known UST. The UST's appear to be less than 5 feet outside the limits of the planned right-of way and/or easement. Example GPR images showing the reflections from the known UST's on Parcel 10 are shown on Figures 3 and 4. Figures 3 and 4 also include the locations of the known UST's as marked in the field. The GPR data from Parcel 10 indicate that the southern known UST (UST No. 1) is buried approximately 1.5 to 2.5 feet below ground surface and is about 5 feet in diameter and about 18 feet long, equivalent to a capacity of about 3000 gallons. The GPR data from Parcel 10 indicate that northern known UST (UST No. 2) is buried approximately 4.5 to 5.5 feet below ground surface and is about 5 feet in diameter and about 12 feet long, equivalent to a capacity of about 2000 gallons. Photographs of the known UST locations, as marked in the field, are included on Figure 5.

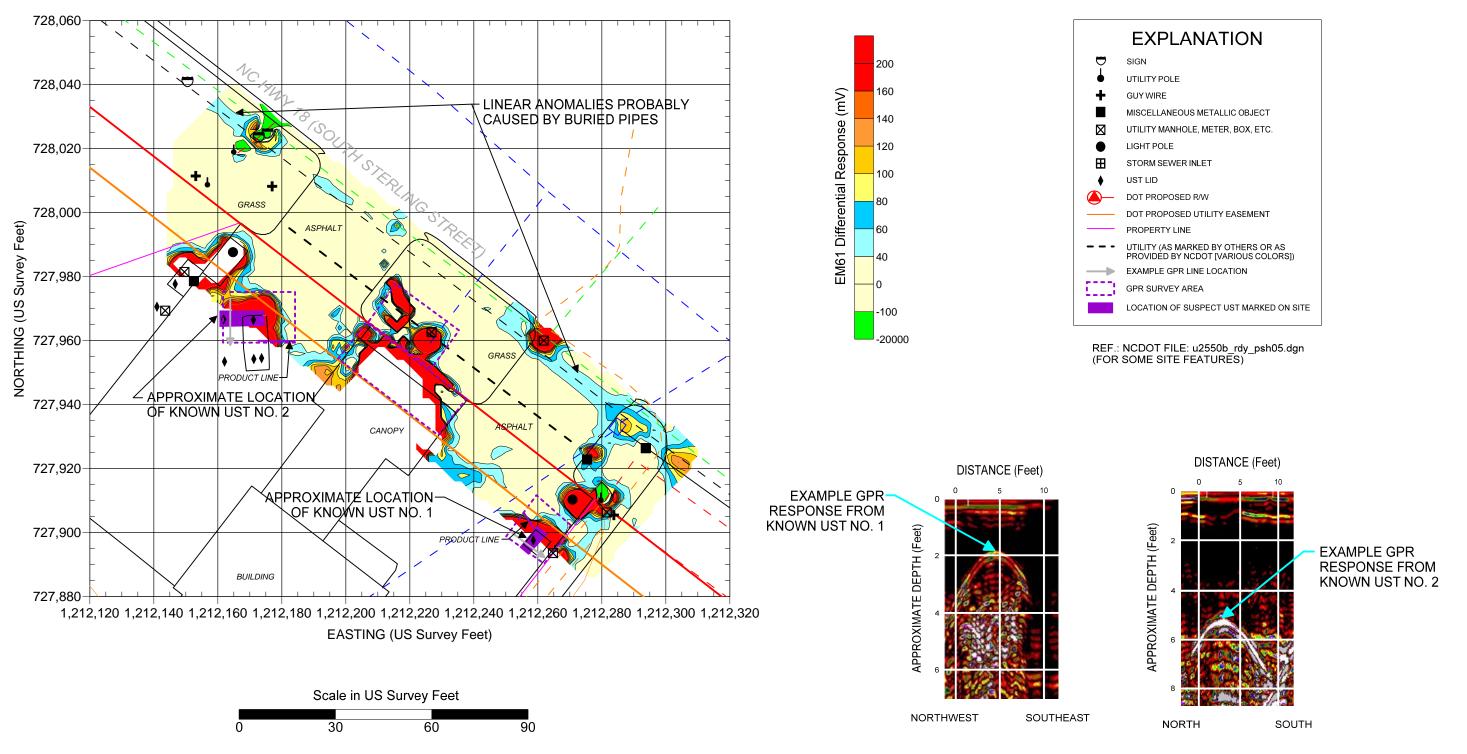
STATE PROJECT U-2550B BURKE COUNTY, NORTH CAROLINA NC DEPARTMENT OF TRANSPORTATION PROJECT NO. 09210013.19 PARCEL 10 EM61 DIFFERENTIAL RESPONSE

Note: The contour plot shows the difference, in millivolts (mV), between the readings from the top and bottom coils of the EM61. The difference is taken to reduce the effect of shallow metal objects and emphasize anomalies caused by deeper metallic objects, such as drums and tanks. The EM data were collected on March 25, 2010, using a Geonics EM61-MK2 instrument. Positioning for the EM61 survey was provided using a submeter Trimble ProXRS DGPS system. Coordinates are in the US State Plane 1983 System, North Carolina 3200 Zone, using the NAD 1983 datum. GPR data were acquired on March 31, 2010, using a Geophysical Survey Systems SIR 3000 equipped with a 400 MHz antenna.

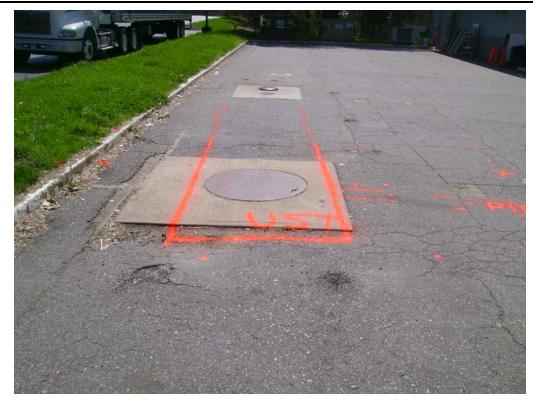
Parcel 10 – Rutherford Marketer, Inc. Property, looking southwest. Photo shows approximate marked location of Known UST No. 1, near the southeastern edge of the parking lot.

The geophysical data indicate the presence of two known UST's located approximately five feet outside of the planned right-of-way and easement. The southern known UST (known UST No. 1) is about 3000-gallon capacity and is buried about 1.5 to 2.5 feet below ground surface. The northern UST (known UST No. 2) is about 2000-gallon capacity and is buried about 4.5 to 5.5 feet below ground surface. Another known UST is located next to UST No. 2 but was not part of the geophysical survey area.

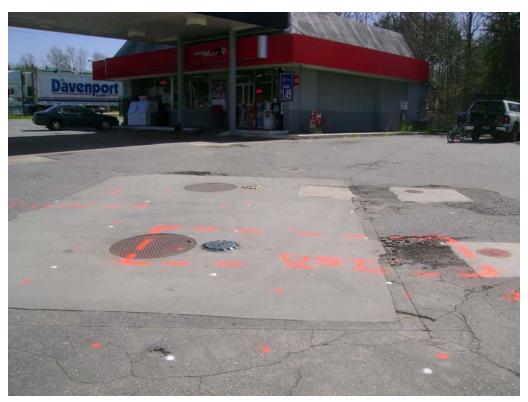
Parcel 10 – Rutherford Marketer, Inc. Property, looking south. Photo shows approximate marked location of Known UST No. 2, near the northwestern edge of the parking lot.
