REPORT OF PRELIMINARY SITE ASSESSMENT

CLAUDE E. WHITT PROPERTY, PARCEL #18 STATE PROJECT U-2550B, TIP NO. 34831.1.1 2507 SOUTH STERLING STREET MORGANTON, NORTH CAROLINA

MACTEC Project No. 6470-10-0057

Report of Preliminary Site Assessment Claude E. Whitt Property, Parcel #18 State Project U-2550B, TIP No. 34831.1.1

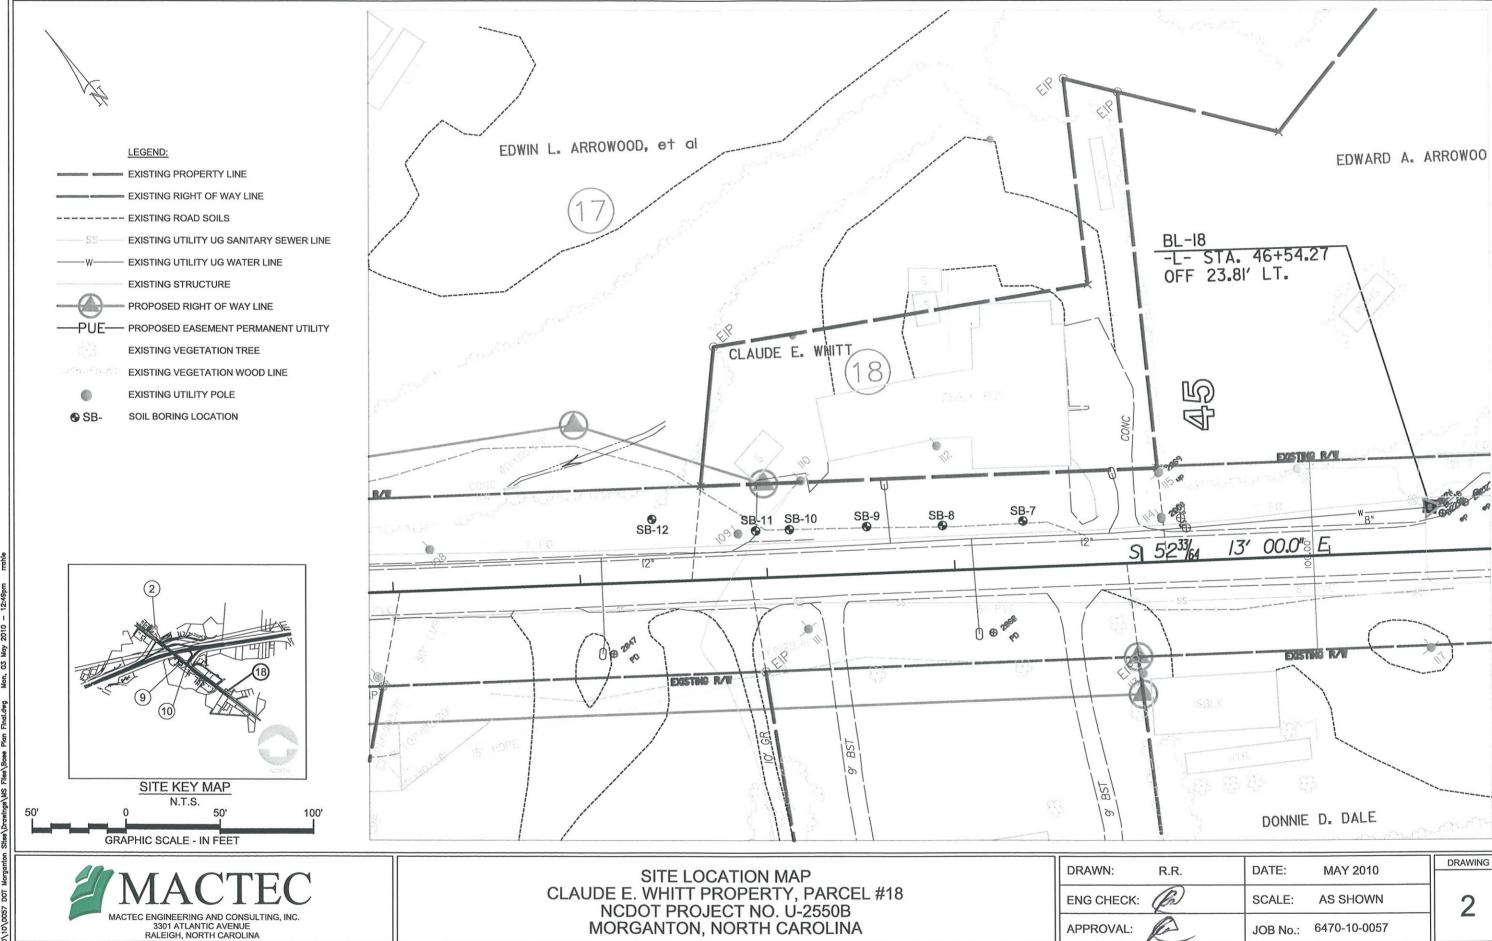
Figure 2 – Site Layout Showing Soil Boring Locations

of the geophysical investigation and field observations. Soil boring SB-12 was placed across the Whitt property boundary onto the Edwin Arrowood property at the request of Mr. Terry Fox, Geoenvironmental Manager for NCDOT. Figure 2 shows a site layout and the locations of the soil borings.

The Whitt property is located at 2507 South Sterling Street in Morganton, Burke County, North Carolina. The site is developed with a Discount Beverage convenience store and a mobile home supply store. The Burke County Geographic Information Services (GIS) identifies the site as parcel identification number (PIN) 2712373256. The site is bound to the northeast by an automobile junkyard; to the southeast by wooded undeveloped land; to the southwest by South Sterling Street, across which is a single-family residence; and to the northwest by wooded undeveloped land and an automobile junkyard (Figure 2).

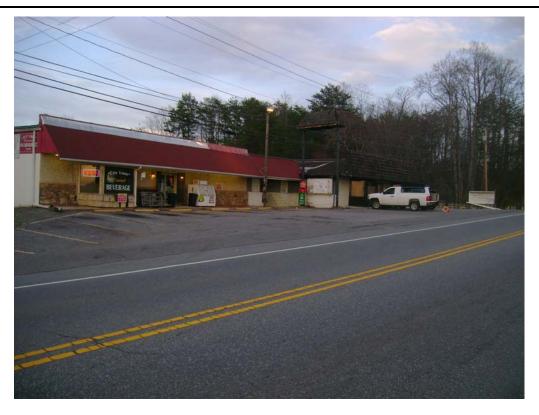
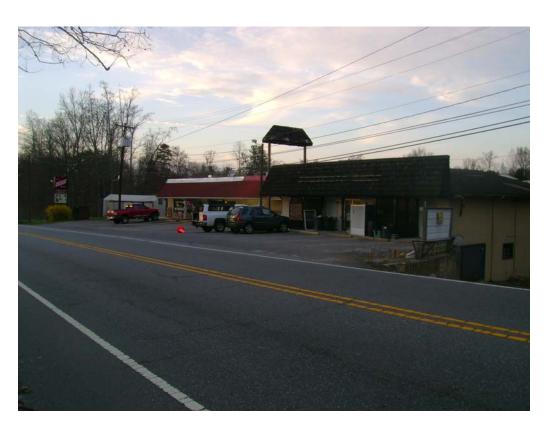
PARCEL 18 SITE PHOTOS

Parcel 18 - Claude and Shirley Whitt Property, looking east

Parcel 18 - Claude and Shirley Whitt Property, looking north

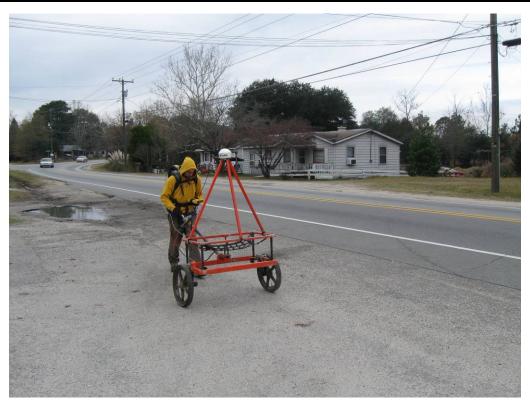
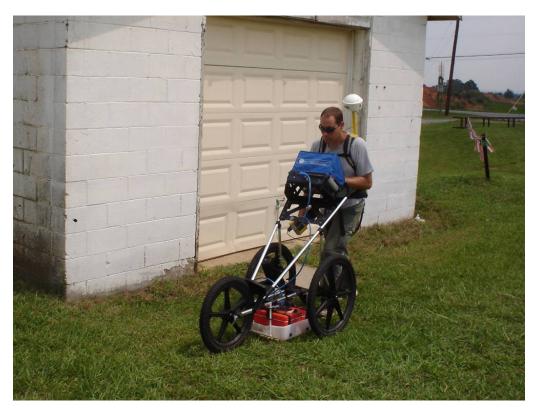
STATE PROJECT U-2550B BURKE CO., NORTH CAROLINA NC DEPT. OF TRANSPORTATION PROJECT NO. 09210013.19 PHOTOS OF GEOPHYSICAL EQUIPMENT USED

The geophysical investigation consisted of electromagnetic (EM) induction surveys using a Geonics EM61-MK2 instrument. The EM61 metal detector is used to locate metal objects buried up to about eight feet below ground surface. Ground-penetrating radar (GPR) investigations of selected EM61 anomalies

were conducted using a Geophysical Survey Systems SIR-3000 system equipped with a 400 MHz antenna. Photographs of the equipment used are shown on Figure 2.

Geonics EM61-MK2

GSSI SIR-3000

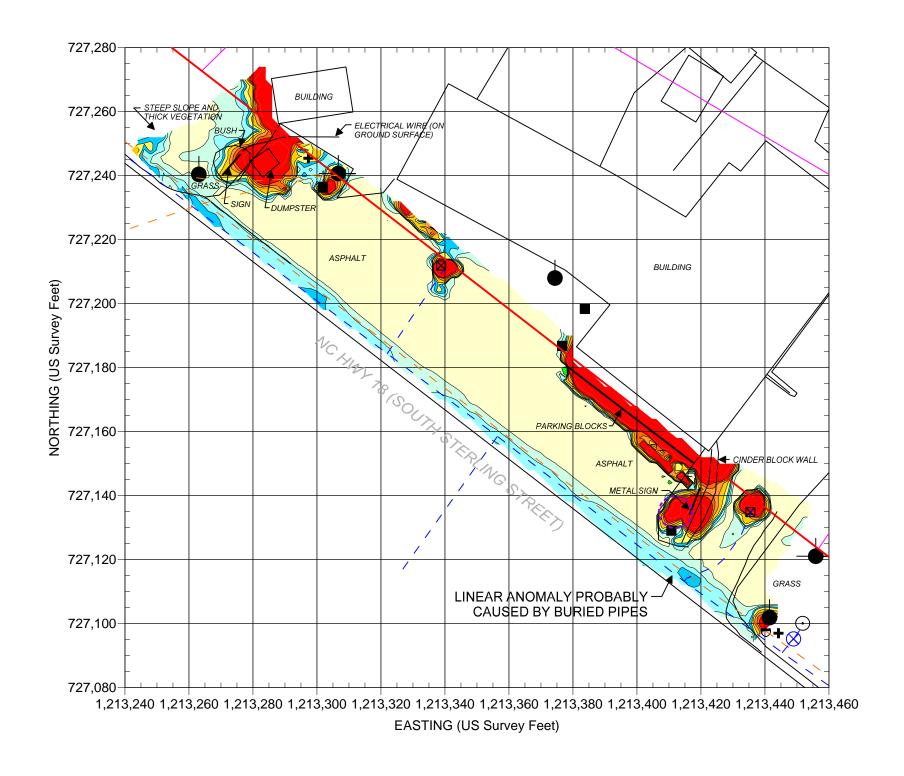
STATE PROJECT U-2550B BURKE COUNTY, NORTH CAROLINA NC DEPARTMENT OF TRANSPORTATION PROJECT NO. 09210013.19 PARCEL 18 EM61 EARLY TIME GATE RESPONSE

The contoured EM61 data for Parcel 18 are shown on Figures 3 and 4. The EM61 early time gate results are plotted on Figure 3. The early time gate data provide the more sensitive detection of metal objects. Figure 4 shows the difference between the response of the top and bottom coils of the EM61 instrument (differential response). The difference is taken to remove the effect of surface and very shallowly buried metallic objects. Typically, the differential response emphasizes anomalies from deeper and larger objects such as UST's.

Note: The contour plot shows the earliest and most sensitive time gate of the EM61 bottom coil/channel in millivolts (mV). The EM data were collected on March 24, 2010, using a Geonics EM61-MK2 instrument. Positioning for the EM61 survey was provided using a submeter Trimble ProXRS DGPS system. Coordinates are in the US State Plane 1983 System, North Carolina Zone 3200, using the NAD 1983 datum. GPR data were acquired on March 31, 2010, using a Geophysical Survey Systems SIR 3000 equipped with a 400 MHz antenna.

The early time gate and differential results show anomalies apparently caused by buried utilities, buried metal, or known site features (Figures 3 and 4). GPR data collected coincident to the differential EM61 anomaly located immediately south and west of the metal sign, next to the cinder block wall, does not indicate the presence of a metallic UST (Figures 3 and 4). However, that anomaly was partially blocked by a mobile home during GPR data collection. Therefore, our level of confidence is lower than usual, but we believe we have enough GPR data to suggest that it is unlikely that there is a UST in that area. The geophysical data collected on Parcel 18 did not indicate the presence of metallic UST's within the right-of-way and/or easement.

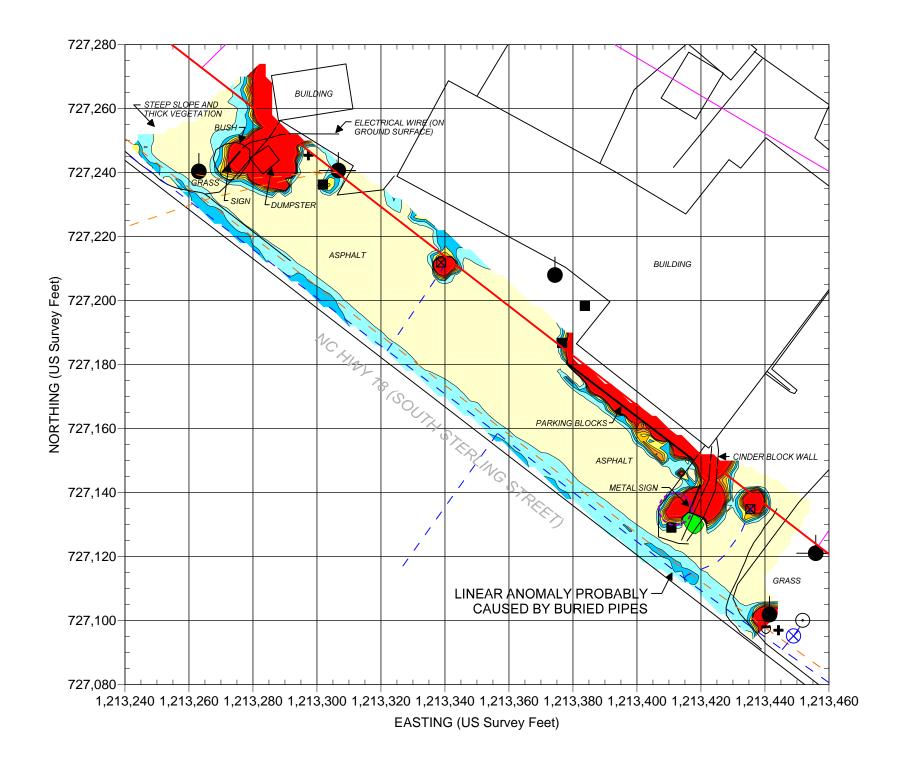
STATE PROJECT U-2550B BURKE COUNTY, NORTH CAROLINA NC DEPARTMENT OF TRANSPORTATION PROJECT NO. 09210013.19 PARCEL 18 EM61 DIFFERENTIAL RESPONSE

Note: The contour plot shows the difference, in millivolts (mV), between the readings from the top and bottom coils of the EM61. The difference is taken to reduce the effect of shallow metal objects and emphasize anomalies caused by deeper metallic objects, such as drums and tanks. The EM data were collected on March 24, 2010, using a Geonics EM61-MK2 instrument. Positioning for the EM61 survey was provided using a submeter Trimble ProXRS DGPS system. Coordinates are in the US State Plane 1983 System, North Carolina 3200 Zone, using the NAD 1983 datum. GPR data were acquired on March 31, 2010, using a Geophysical Survey Systems SIR 3000 equipped with a 400 MHz antenna.

The geophysical data do not indicate the presence of metallic UST's in the areas surveyed on Parcel 18.
