LIMITED SITE ASSESSMENT REPORT

Former Thrif-Tee Korner
89 Park Street
Canton, North Carolina 28716

UST Incident No. 28364

Mountain Environmental Group Project No. 6-TOC01-1A

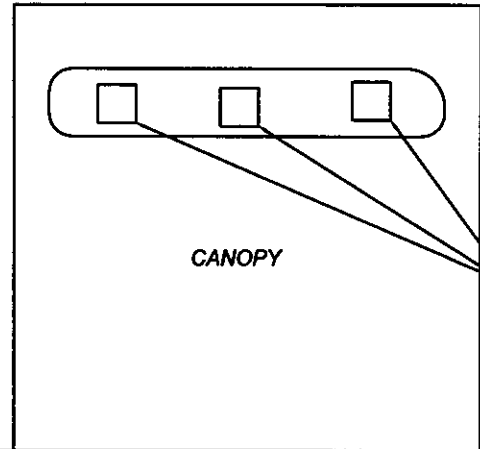
1580 Plegah Drive - Canton, NC 28716		FIGURE 3 SITE MAP Thriftee Korner Canton, North Carolina		
		DRAWN BY: L. Whitt	PROJECT NO. 6-TOC01-1A	DATE March 20, 2006
APPROVED BY: D. Williams		FILE NAME ..\Thriftee Korner\LSA\6-TOC01-1A Maps.dwg

On December 28-29, 2005, Mountain Environmental visited the site to oversee the removal of the UST system associated with the Thrif-Tee Korner service station. Mountain Environmental contracted HydroPro Services of Clyde, North Carolina to remove the UST system consisting of two (2) 4,000-gallon gasoline USTs, two (2) 3,000-gallon gasoline USTs, one (1) 3,000-gallon kerosene UST, and associated dispensers. *Figure 2* and *Figure 3* show the location of the former USTs and dispensers. A track-hoe was utilized to remove the USTs and contaminated soil encountered. Approximately 37.31 tons of impacted soil was removed during the UST removal and temporarily stockpiled on plastic at the site. The contaminated soil was sent to Environmental Soils, Inc. in Lattimore, North Carolina, for disposal. The USTs were sent to Biltmore Iron and Metal (a commercial metal recycling and reclamation company) in Asheville, North Carolina for disposal. No groundwater was encountered in the excavation area; therefore, appropriate soil samples were taken at a depth of 1.5 feet to 2 feet below each UST and dispenser. The final excavation measured approximately 25 to 30 feet wide by 60 feet long. The total depth of excavation was 8 to 9 feet. The completed excavation cavity was backfilled with fill dirt and compacted with the track-hoe bucket.

The location for monitoring well MW-1 was chosen based on soil analytical results from the UST removal, proximity to the former UST excavation, and drill rig access. Based on the soils observed during the installation of MW-1 the soils consist primarily of a black, well sorted, fill sand to a depth of approximately 10 feet BGS and a black, micaceous, sandy, clay from 10 to 18 feet BGS. Drill rig refusal was encountered at approximately 18 feet BGS; therefore, MW-1 was installed to a depth of 18 feet BGS. Based upon the site location with respect to the Pigeon River, the source area appears to be located within the flood plain of the river. **Figure 3** depicts the location of MW-1 and **Appendix C** includes a soil boring log and monitoring well construction details.

1. All site structures were removed by March 1, 2006.
1. Soil sample MW-1 was collected on February 20, 2006 at a depth of 9-10 feet below ground surface (BGS).
1. T-1 was a 3,000-gallon kerosene tank.
4. T-2 and T-3 were 3,000-gallon gasoline tanks.
5. T-4 and T-5 were 4,000-gallon gasoline tanks.
